RE: BASELINE ENVIRONMENTAL STUDY  
BULK FUELS FACILITY  
CRAIG, ALASKA

**BASELINE ENVIRONMENTAL STUDY  
BULK FUELS FACILITY  
CRAIG, ALASKA**

June 1996

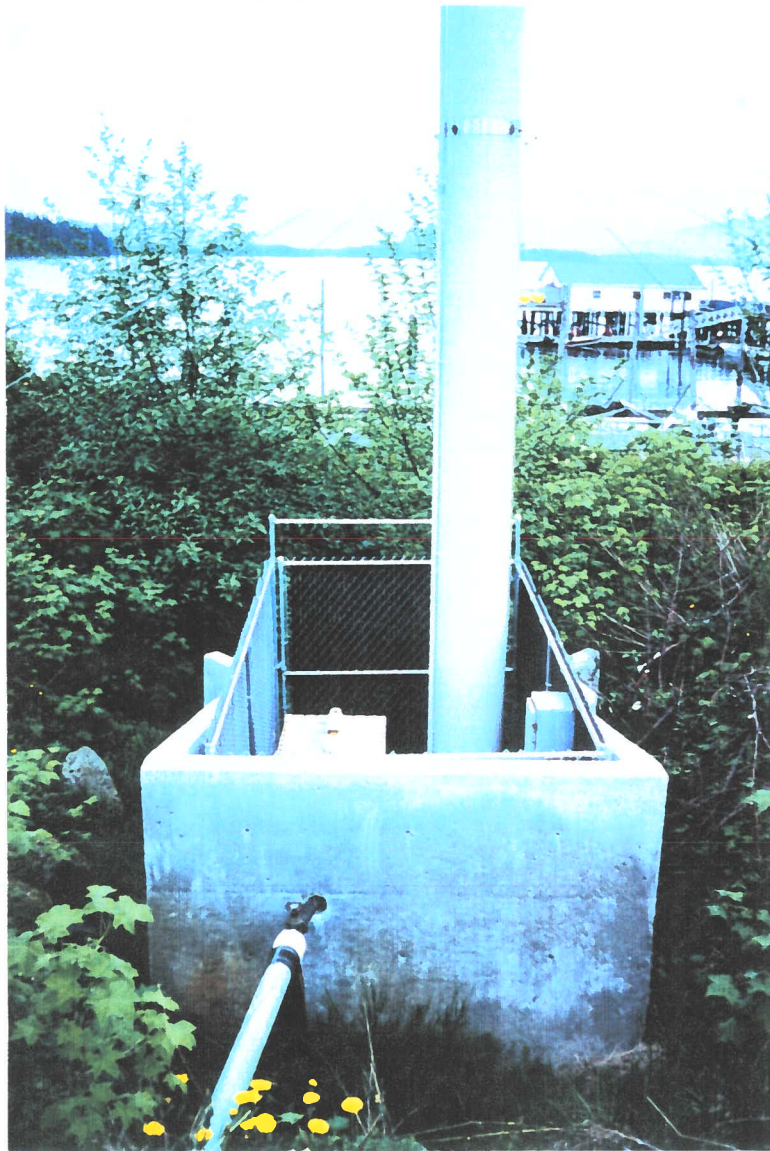
During the reconnaissance, Mr. Liechty noted the location of the air-stripping tower and associated water storage tank. The air stripper was shut down in approximately 1993, but since the water supply is a passive dewatering trench, it continues to drain water from beneath the bulk fuels facility. A ground water remediation system schematic is provided as Figure 2.

AIR STRIPPING TOWER

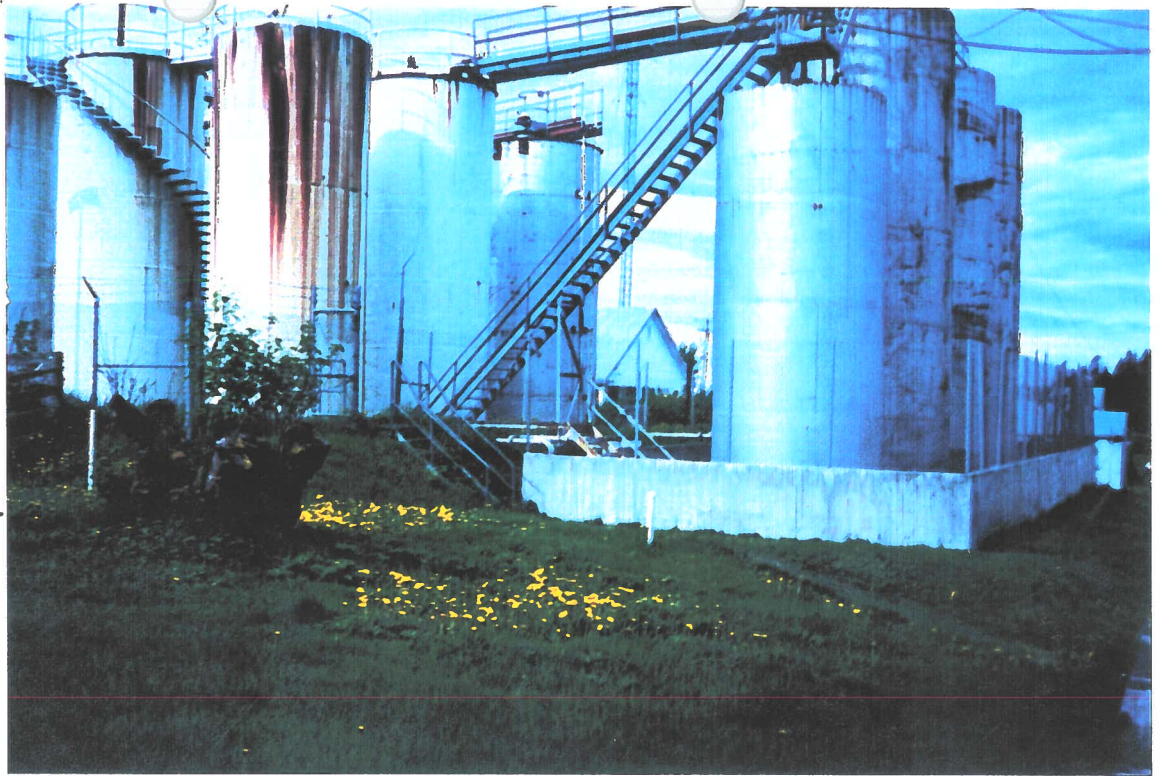
Within the bulk fuels storage area AEE observed evidence of distressed vegetation was noted at several locations. The distressed vegetation was located near the valves at the base of each tank. Additionally, it was noted that drainage from the TTLR is directed into the bermed area with the eight ASTs. An oil water separator removed free-phase hydrocarbons prior to the discharge. Photographs of the site are presented in Appendix B.

ORIGINAL TANK FARM WITH EARTHEN BERM & EXPANSION WITH CONCRETE CONTAINMENT

- The passive dewatering trench remains active and is discharging contaminated water beyond the existing plume. No treatment of this water is performed prior to discharge. Additionally, the earthen berm which contains eight of the ASTs is unlined. Should a release occur, fuel could readily flow into the trench and subsequently discharge beyond the constraints of the secondary containment system. AEE recommends that this system be grouted and abandoned. Since the trench appears to lie beneath the four ASTs of the tank farm expansion, the closure must properly investigated and engineered. "As built" information for the tank foundation and dewatering system, if available, should be reviewed prior to performance of any work.

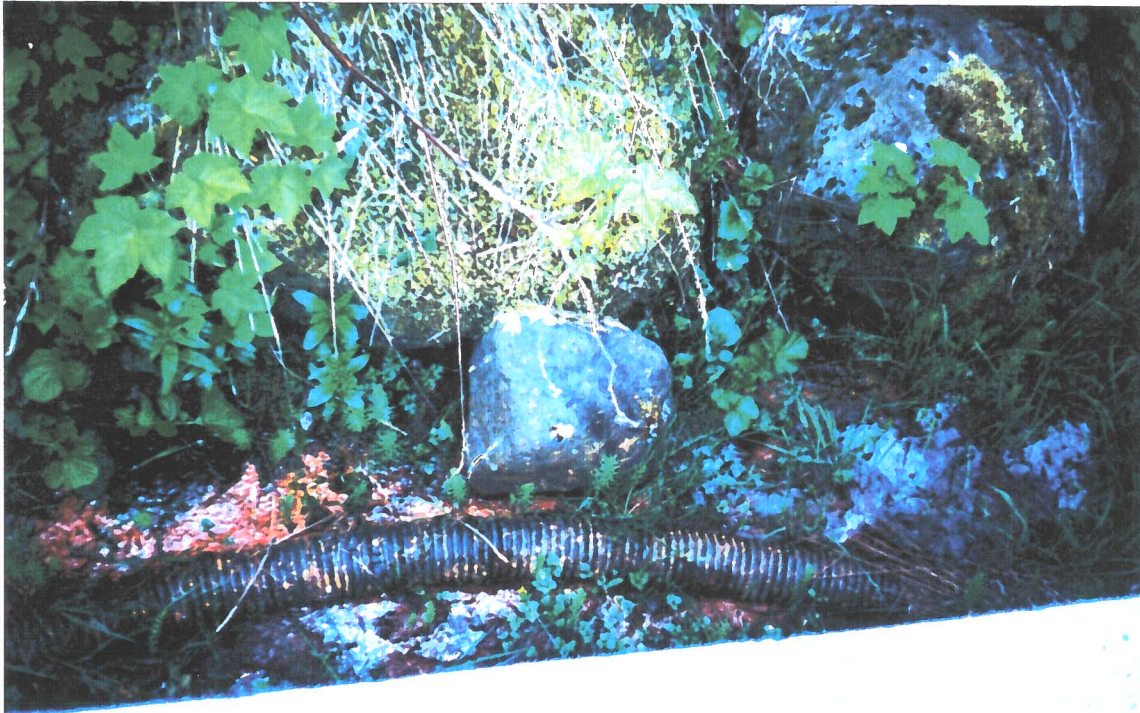
Since the air stripper is non-operational and the water storage tank is full, excess water leaks from the valve leading to the air stripper's water holding tank. An iridescent sheen was noted on the pooled water below the leaking connection. Mr. Liechty stated that during a prior environmental assessment (by an unknown party) this sheen caused some concern that it might be petroleum based. This sheen was thought to be "tannin", a group of complex vegetable hydrocarbons. The field determination was made by disturbing the sheen and noting the reaction. A tannin-based sheen will not readily reconnect, where as a petroleum hydrocarbon sheen will instantaneously reconnect. This sheen dispersed and did not reconnect after disturbance. Two water samples and a soil sample were collected to verify the observed results, Strip In and Strip W. Strip In was collected from the leaking valve, and Strip W was collected from the pooled water with the tannin. Analytical results indicate gasoline and diesel range organics are present in these samples. However, concentrations indicate these are dissolved phase hydrocarbons which would not be visible as a sheen. Photographs of the remediation system and tannin sheen are provided in Appendix B.

During this assessment, diesel range hydrocarbons were analyzed up to 6,500  $\mu\text{g/l}$  (6.5 ppm) in the groundwater (MW-1). An MCL for DRO has not been established by ADEC. DRO was detected in the surface water sample, Strip-W, collected from standing water with an iridescent sheen. However, the 600  $\mu\text{g/l}$  of DRO is not sufficient to produce the obvious sheen that was observed. The sheen was probably tannin as was surmised in Section 3.1 of this report.

SHEEN OBSERVED ON WATER NEAR AIR STRIPPER

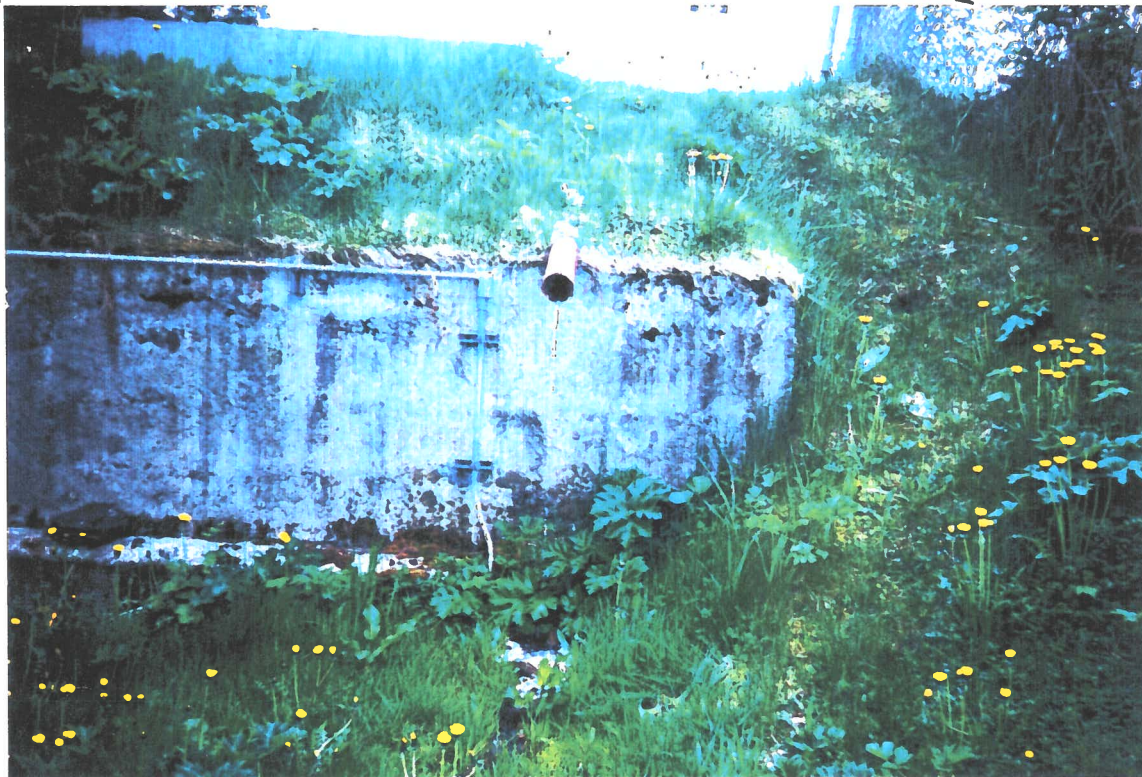
TTLR STORM/COLLECTION WATER DISCHARGE POINT

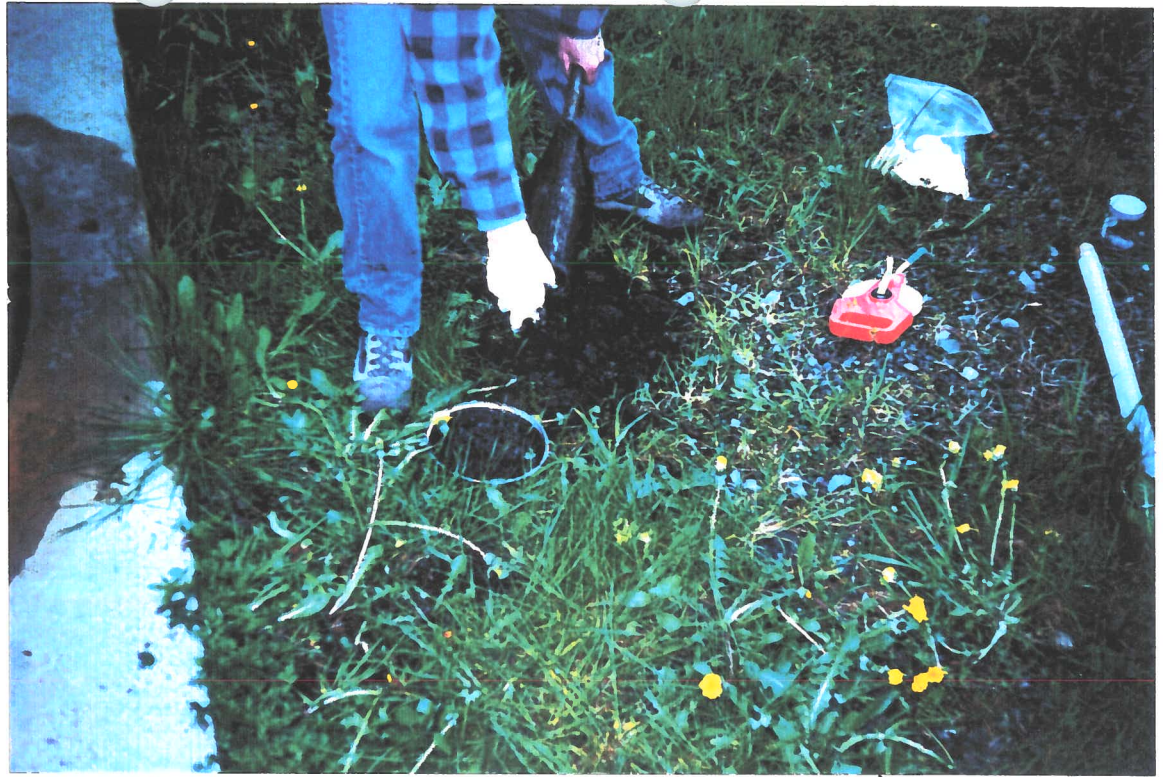
Indication of petroleum contamination was observed in B95-2 at a depth of 3 feet bgs. Soil sample B95-2 was collected from this level. The boring was continued to approximately 5.5 bgs and terminated due to drilling resistance. Ground water was encountered at 4.1 feet bgs.

COLLECTION OF SOIL SAMPLE B95-2 (NEAR) MEAR MW1

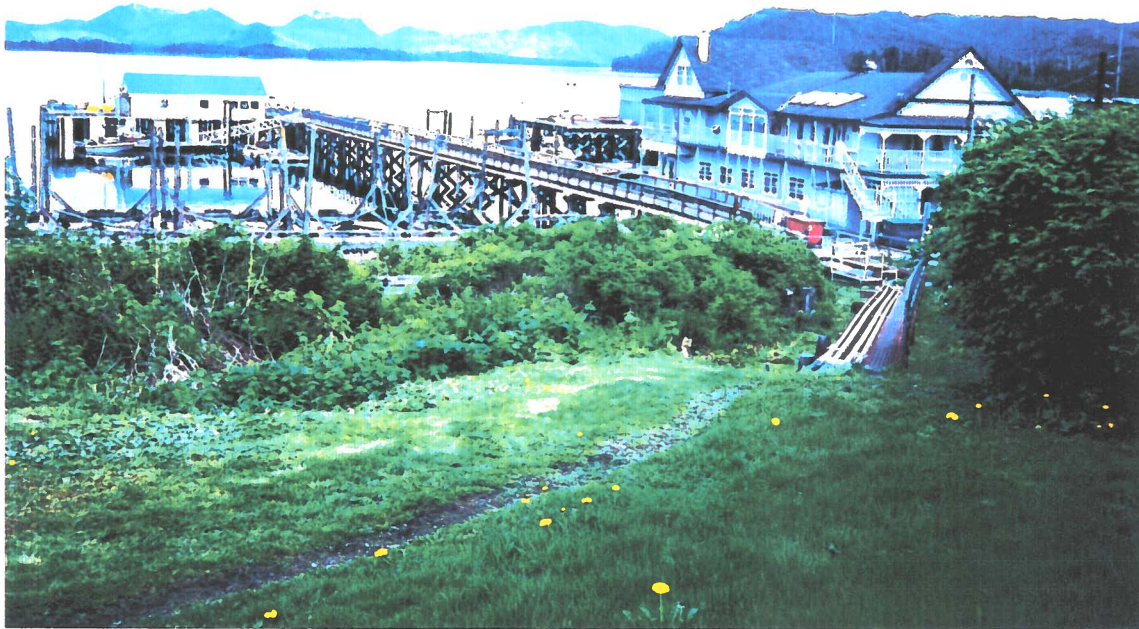
FUEL DISTRIBUTION LINES AND LOADING DOCK
