May 10, 2007

Mr. Kurt Steinert
Municipality of Anchorage
Department of Project Management and Engineering
4700 South Bragaw St., 2nd Floor
Anchorage, Alaska 99508

**Re: Remedial Action Report for AFD Station Number 4
Anchorage, Alaska
ADEC RecKey No. 19942100024503,
ADEC Event No. 00407
8397-13**

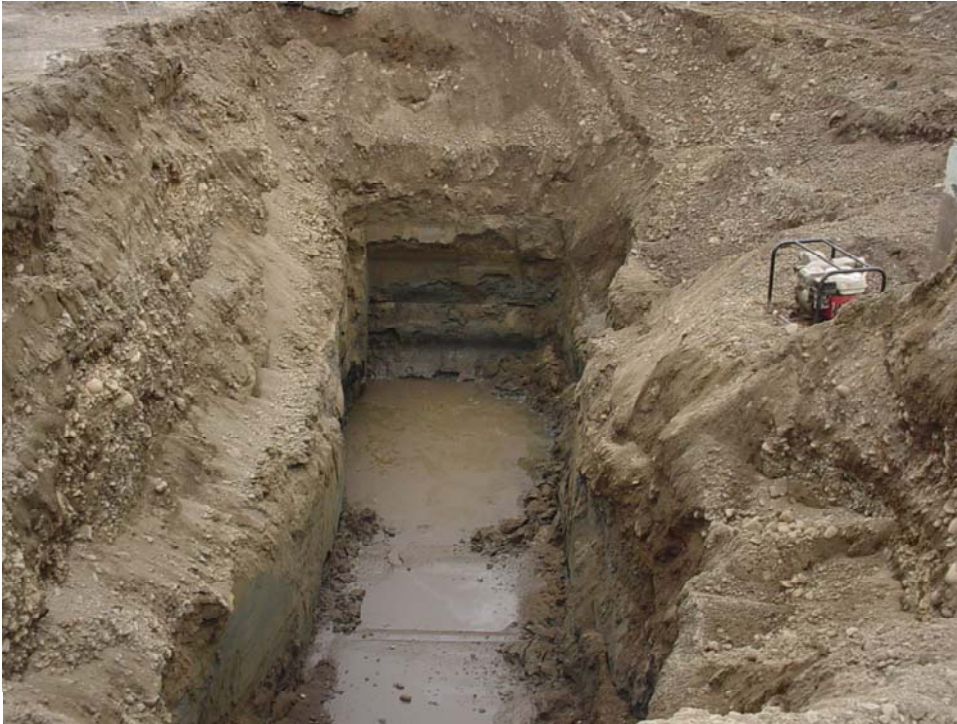
Photograph A2-1: Final excavation on 5/1/07 with groundwater and free-phase hydrocarbons prior to pumping

Water and free-phase hydrocarbons were observed to be entering the excavation very slowly, therefore an additional "sump" was dug on the east end of the excavation to a depth of 14 feet bgs. While waiting for water to enter the excavation, six soil samples were collected from the sidewalls at 8 to 8.5 feet bgs for laboratory analysis of BTEX, GRO, and DRO to assess remaining hydrocarbon levels in the excavation. The water was then allowed to accumulate overnight.

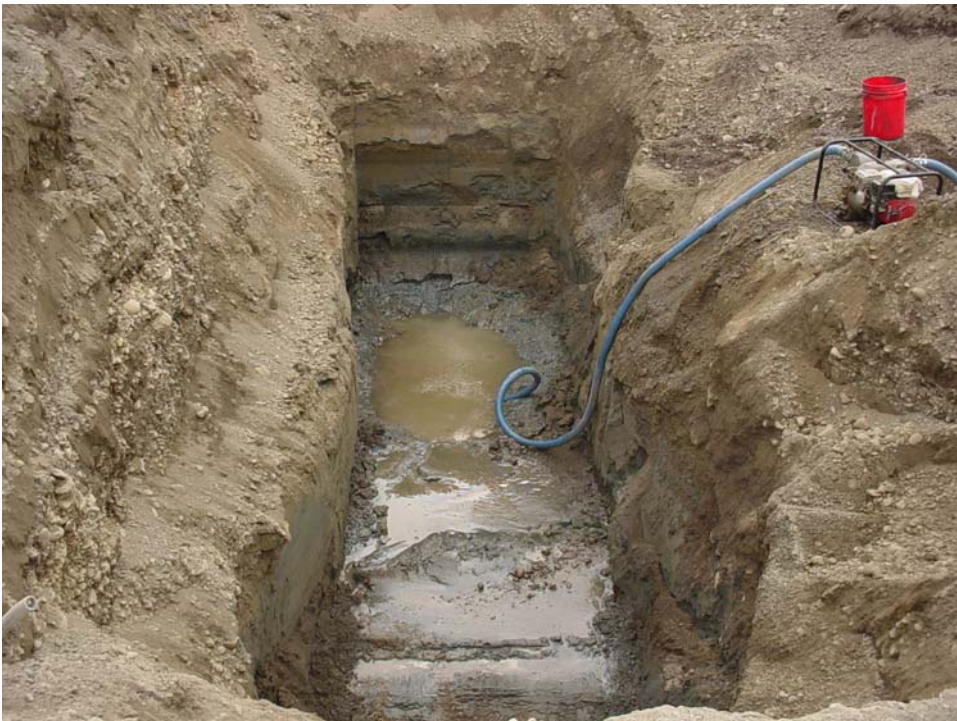
Photograph A2-2: Pumping hydrocarbon and groundwater emulsion.

On May 1, 2007, 250 gallons of free-phase hydrocarbons and groundwater emulsion were pumped into an on-site storage tank (Photograph A2-2). The excavation was allowed to sit an additional hour and another 25 gallons was then pumped into the tank. Emerald Services subsequently pumped this tank out for disposal.

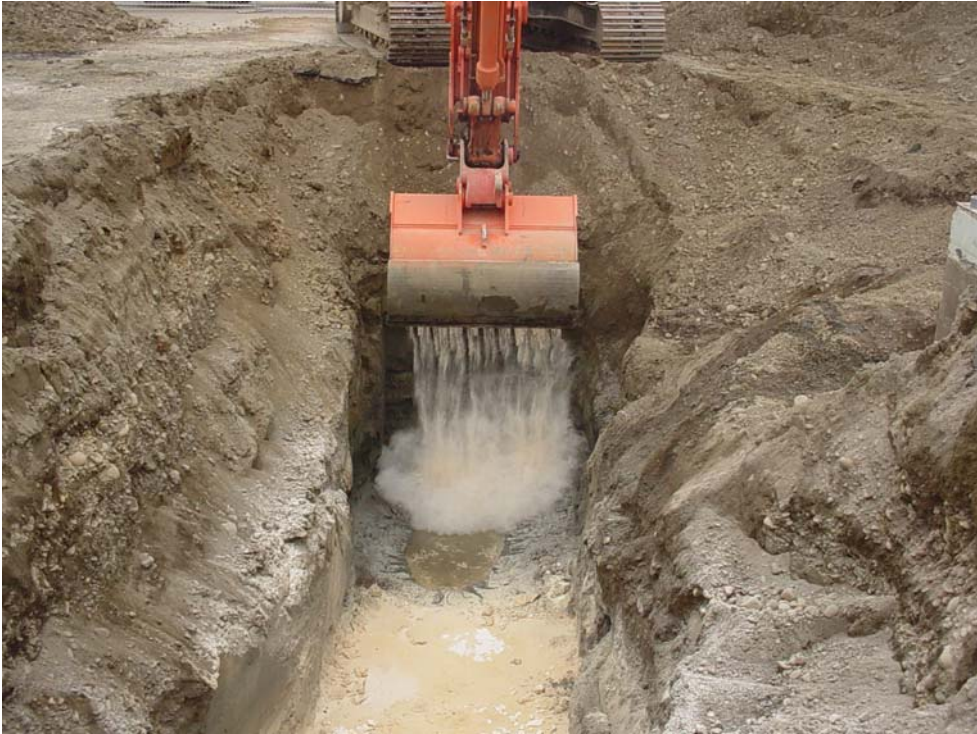
Photograph A2-3: Placing ORC-A in excavation.

After completion of pumping, 100 pounds of Oxygen Releasing Compound Advanced® (ORC-A) was placed into the groundwater within the excavation (Photograph A2-3). After backfilling with clean soils to just above the groundwater interface, an additional 50 pounds of ORC-A was placed in the smear zone prior to backfilling. The remainder of the excavation was then backfilled with clean soils and the area graded and compacted as required by the construction plans for this area.

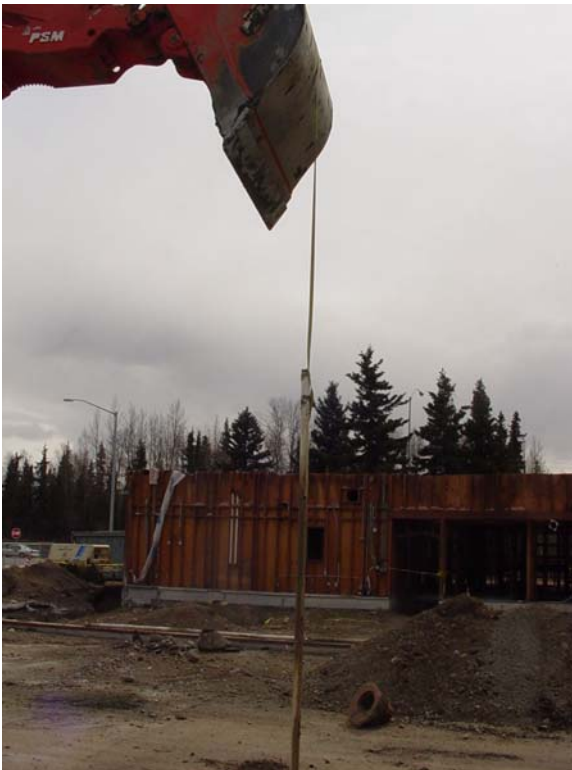
Photograph A2-2: Removal of casing and screen from MW-3a.

As stated above, MW-1, RW-1, and RW-2 were removed during excavation of the former UST area. MW-3a was located beneath the future building extension footprint (Figure 2). It was decommissioned on April 30, 2007. Using a backhoe, the well monument was removed followed by pulling of the screen and casing from the subsurface (Photograph A2-4). Following removal of the casing and screen, bentonite chips were poured into the remaining void space to within 1 foot of the surface and hydrated with approximately 10 gallons of water.

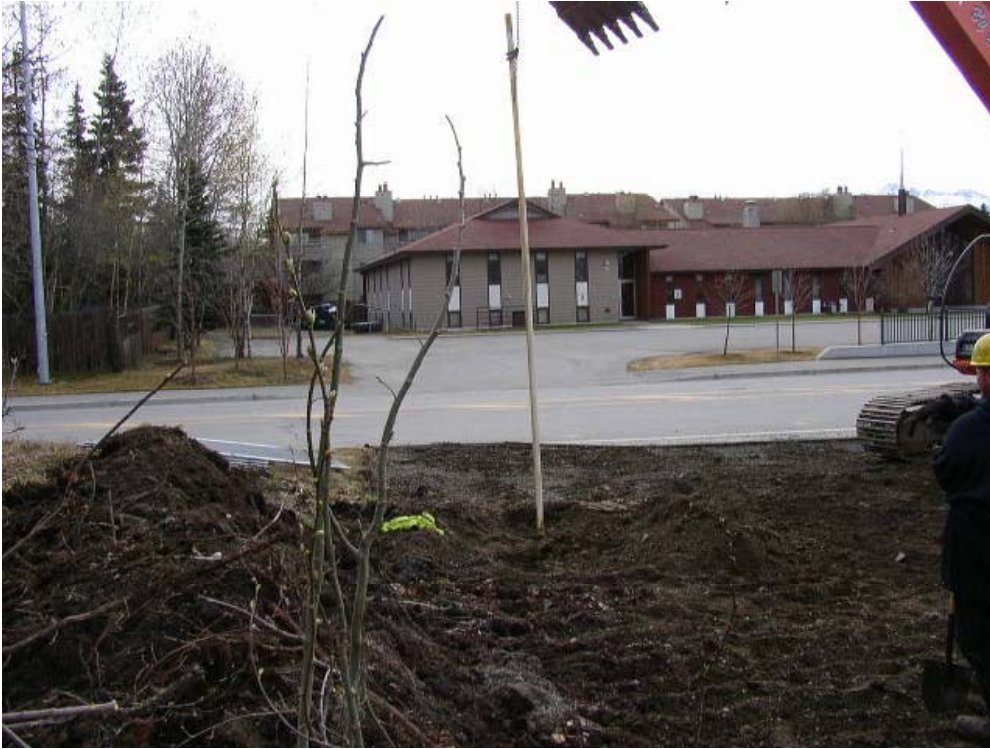
Photograph A2-5: Removal of casing and screen from MW-2.

On May 9, 2007, MW-2 and MW-4 were decommissioned as described for MW-3a above. Photographs A2-5 through A2-8 document decommissioning activities for these wells.

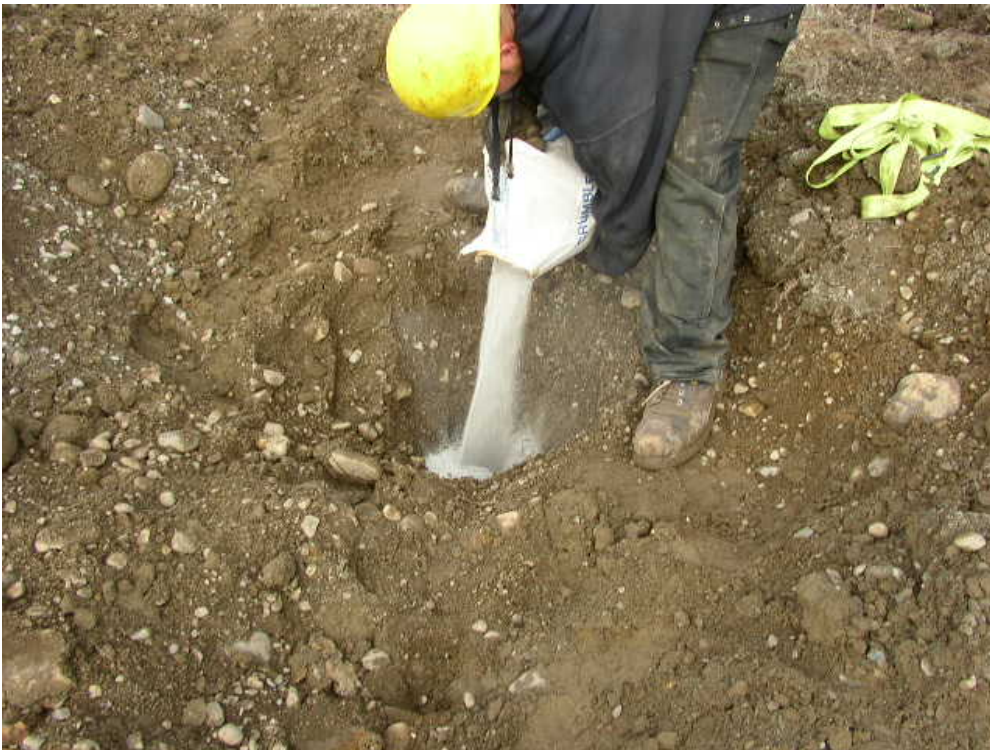
Photograph A2-6: Placing bentonite chips in hole, MW-2.

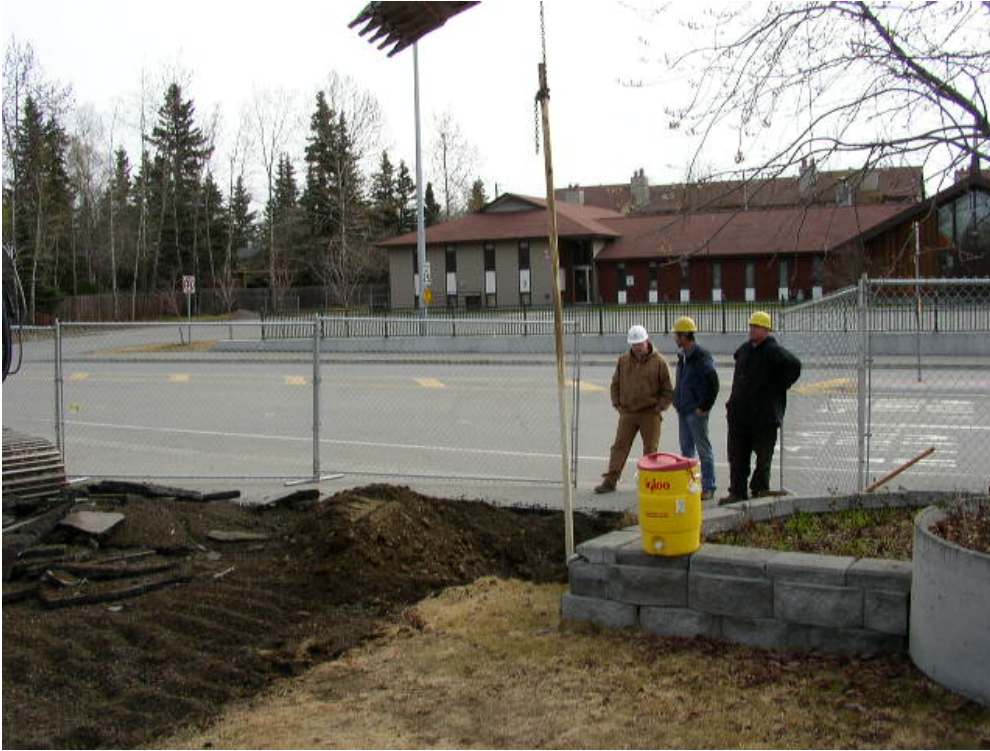
Photograph A2-7: Removal of casing and screen from MW-4.

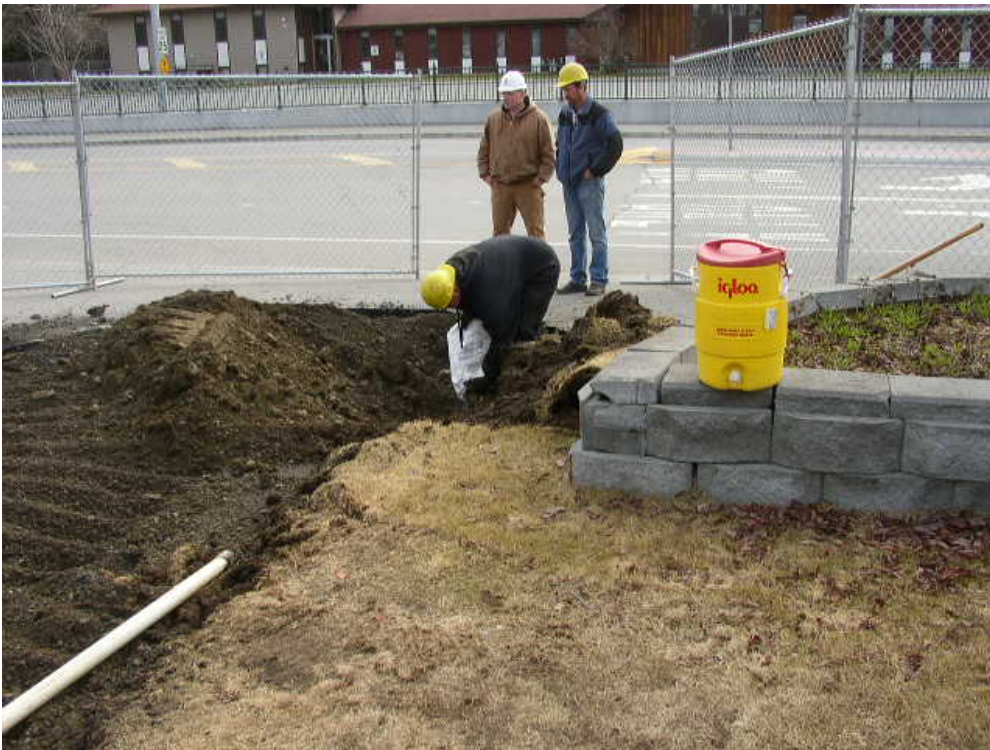
Photograph A2-8: Placing bentonite chips in hole, MW-4.
