**Clean Sweep Program
Cape Romanzof LRRS, Alaska**

Draft Final Report

January 2004

**United States Air Force
611 CES
Elmendorf AFB, Alaska**

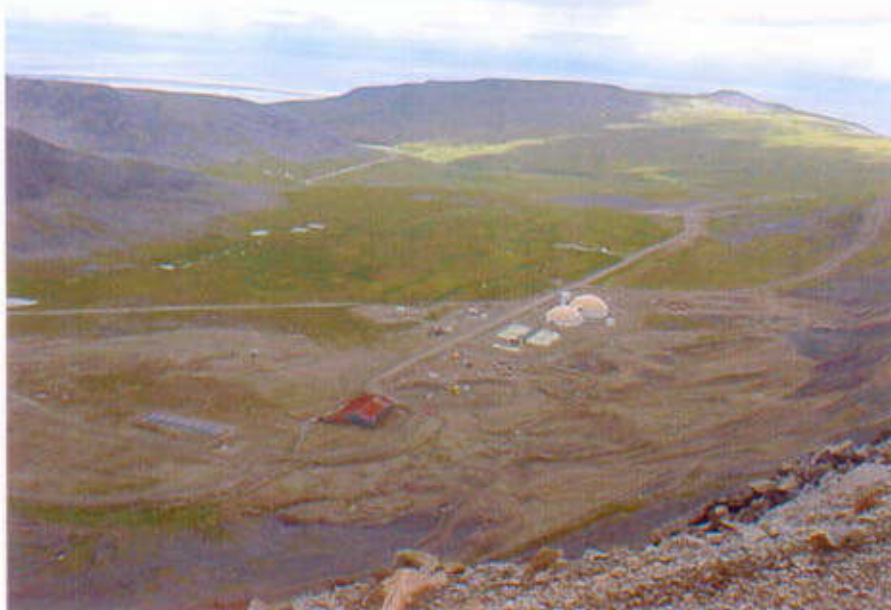
Photograph 1. A view of lower camp looking west. A biocell soil treatment cell, cold storage building, fuel storage and domes are visible in the foreground. One mile beyond the domes, on the left hand side of the road, is LF-003. The end of the runway is visible at the end of the road.

The site consists of a Lower Camp, Upper Camp, and an airstrip. The Lower Camp has the support facilities (housing, power plant, and fuel storage) (Photograph #1) and the Upper Camp contains the Long Range Radar equipment at the top of the mountain. A new composite facility was constructed in 1984 which provides industrial and living facilities for station personnel. Most of the older facilities at Lower Camp and the White Alice site at Upper Camp have been demolished. Upper and Lower Camps are connected by a tramway (Photograph #2).

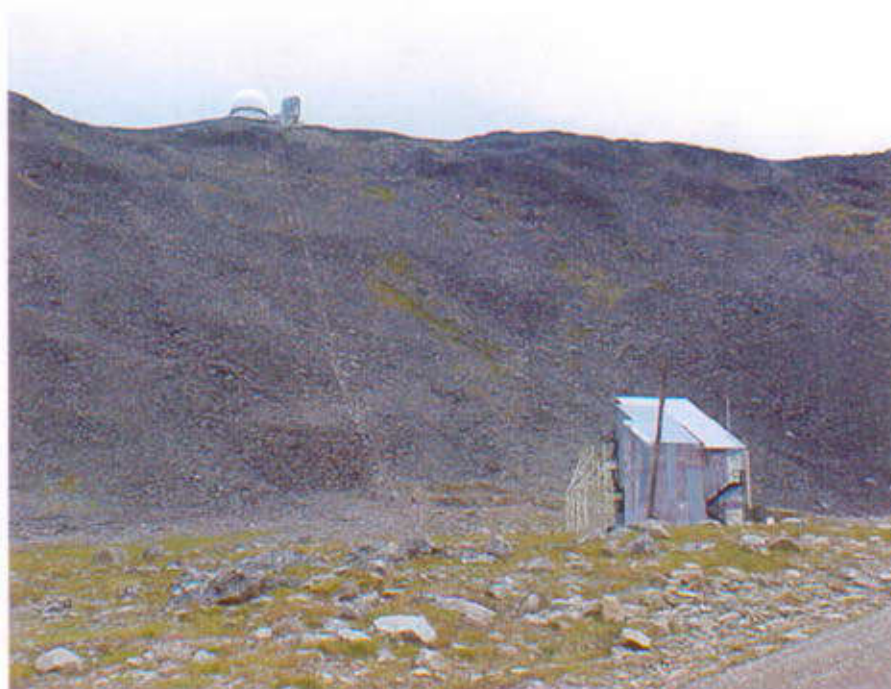
Photograph 2. A view from lower camp looking east that illustrates the location of the tram from lower camp to upper camp.

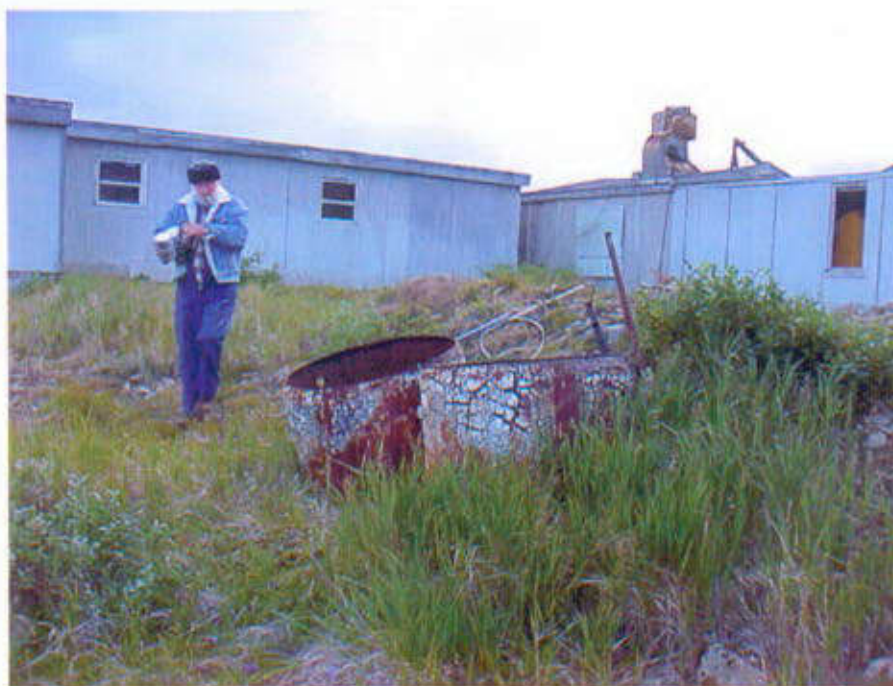
Photograph 3. A view of the septic man-ways above the septic tank behind building #4100 (the old weather station).

During the summer 2003 activities, the former sanitary sewerage system was demolished in place and abandoned (Figure 3). Prior to demolition, the contents of the septic tanks were assessed for potential hazards (Photograph #3) Sample 53031038001 was analyzed for DRO (AK102), PCBs/ pesticides (8082), metals, volatile (8260) and semi-volatile (8270) organic compounds. Analytical results indicate no contaminants of concern were found at levels sufficient to warrant remedial action. Complete analytical results are located in appendix B.

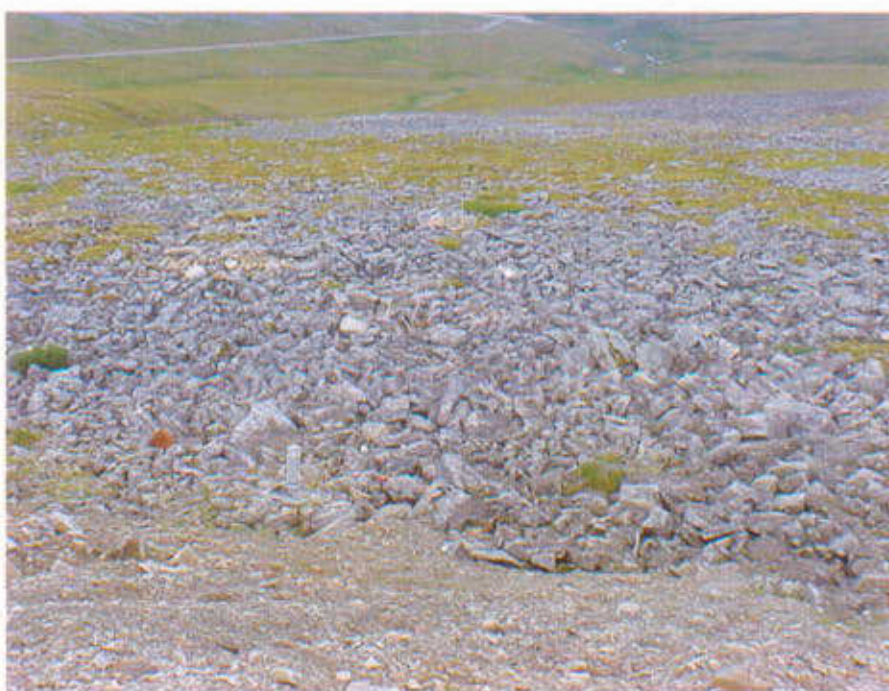
The landfill cap was in serviceable condition although there were several locations where the edges of the membrane were visible along the margins of the landfill. Observations indicate the sediment located at previous sample location SD-2 was being deposited from the landfill via a seep that surfaces at the toe of the landfill. A sediment sample collected at SD-2 contained 60.2 mg/Kg of Aroclor 1260 and another sample that was collected approximately 120 feet downstream contained an Aroclor 1260 concentration of 395 mg/Kg. The extent of the PCB contamination initially documented at SD-2 cannot be

determined until removal of the overlying boulder field has commenced. One sediment sample collected upgradient of the landfill indicate no PCB contamination.

Photograph 4. The boulder field west of LF-003 extends from the toe of the landfill to Nilumat Creek. Sample site SD-2 (sample #53031038002) is several feet to the right of the monitoring well in the foreground. Sample #53031038003 was collected approximately 120 feet west of SD-2.

- Detailed mapping of the sub-surface stream course that is bearing PCB contaminated sediments. The mapping should include the streams outfall into Nilumat Creek

- Because there are numerous pockets of sediments in the boulder field interstices, only sediment samples that can be confidently identified as having been deposited by the sub-surface stream in question should be sampled. This sampling may involve moving boulders in order to gain access to the sediment samples. Invasive sampling of this type should be initiated at the downstream end of the drainage and proceed in a methodical upstream direction in order to prevent cross contamination.

- Variations in the streams depth and width due to influxes of rainwater/seasonal meltwater dictate that sediment samples on either side of the streams present configuration be sampled as well. Again, only samples that can be confidently identified as having been deposited by the sub-surface stream in question should be sampled.

- Following definition of the contaminated area, the contaminated sediment will have to be collected and shipped off site for disposal.
