2314.26.031
South Central Tesoro-Homer

Limited Site Assessment

Dan Aalfs
305 East Pioneer Avenue, "Old Homer Tesoro"
Homer, Alaska
ADEC File #2314.26.031

November 2011

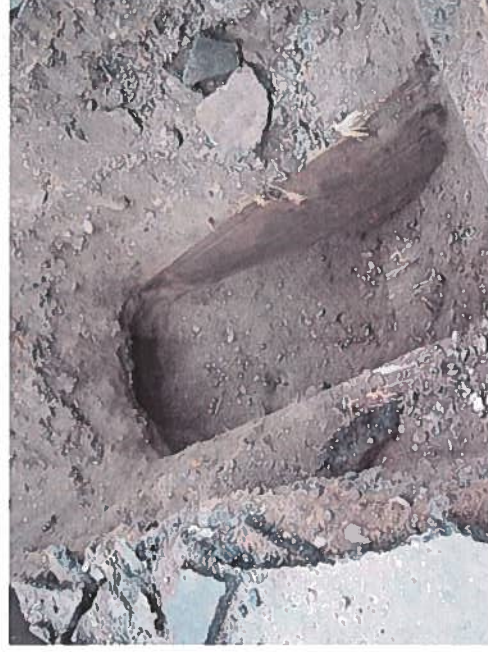
Photo 4. Wooden Crib in Test Pit One

Test pit TP1 was excavated to a depth of 8 feet bgs in the probable location of the former dispenser islands. A wooden box approximately 8ft x 3ft x 4ft was encountered approximately 3 ft bgs (Photograph 4 in Appendix A). This box may have acted as the foundation for the dispenser island (previously removed). The top of the box was open, and the bottom of this crib was located approximately 7 ft bgs. Material above 7 ft bgs, including within the box, consisted of well graded sand (SW) with silt (SM). The excavator bucket was used to break through the bottom of the crib. A relatively dense layer of silt with poorly graded fine sand (ML-SP) was encountered below the crib at a depth of approximately 7 ft bgs. Impacted soil was encountered heterogeneously throughout the excavation. Two analytical samples were collected from this excavation, one at the depth of 3ft bgs (TP1-3), which exhibited the greatest field screening result, and the other from the ML-SP layer beneath the wooden crib at a depth of approximately 8 ft bgs (TP1-8).

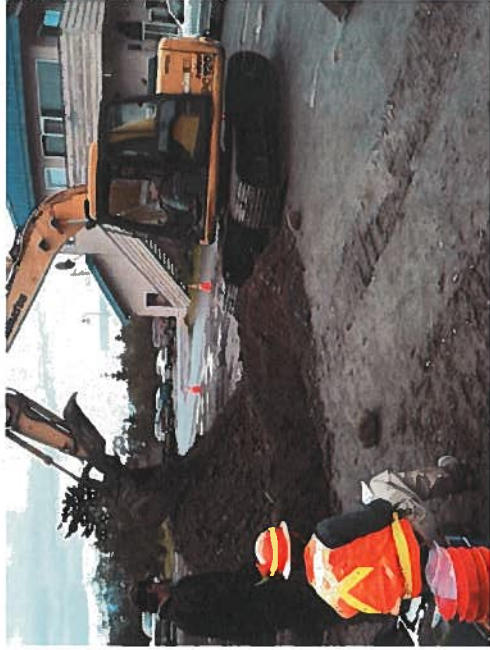
Photo 5. Test Pit Two (Looking Southwest).

Test pit TP2 was excavated in the reported vicinity of the former tanks. The initial test pit was excavated to a depth of 7.5 ft bgs. No staining or olfactory evidence of hydrocarbons was encountered until 7.5 ft bgs, where impacted soil was encountered. A trench was advanced from TP2 to the south and impacted soil was again encountered at 6.5 ft bgs. A flexible pipe coupled to a copper pipe was encountered within the zone of impacted soil at approximately 7 ft bgs. This line was tentatively identified as the water service to the building. A portion of this line was removed, and a remaining portion was crimped and left in place. The location was marked above grade using an "I" beam and timber. TP2 was completed to a depth of 11 ft bgs. Material above 10 ft bgs appeared to consist of relatively unconsolidated fill materials consisting of a heterogeneous mixture of well graded sand with silt (SW-SM). Occasional large cobbles and debris was encountered. Apparent native material was encountered at 10 ft bgs and consisted of ML-SP. Two analytical samples were collected from this excavation, one at the depth which returned the greatest field screening result at a depth of 6 ft bgs (TP2-6), and the other from native material at a depth of approximately 11 ft bgs (TP2-11).

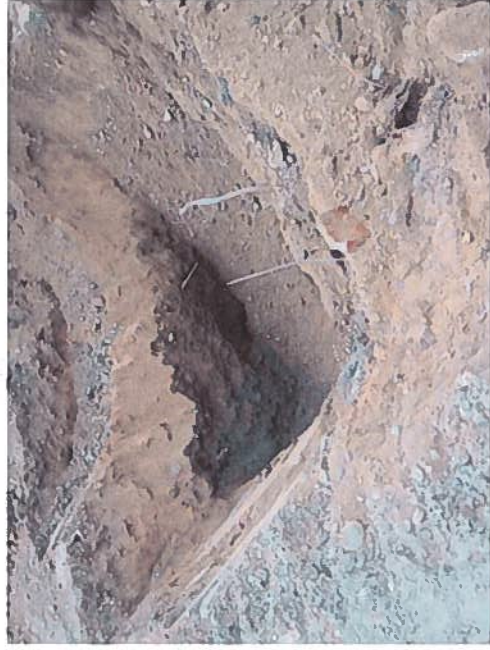
Photo 6. Typical Test Pit containing debris, including wiring, concrete, building materials and bricks.

Test pit TP4 was excavated to the west of the former USTs, near the boundary of the adjoining property to the west. TP4 contained mixed debris (wiring, bricks, concrete and building materials) and fill material consisting of SW-SM. Heterogeneous areas within the excavation were impacted by hydrocarbons. The excavation was completed to a depth of approximately 13 ft bgs, where apparent native soil consisting of brown organic silt (OL) with poorly graded fine sand (SP). Two analytical samples were collected from this excavation, one from the fill material overlying the native soil at 11 ft bgs (TP4-12), and the other from the native soil at a depth of 13 ft bgs (TP4-13). The sample from 13 ft bgs exhibited a relatively high PID result for the site and was chosen to characterize VOCs at the subject property.

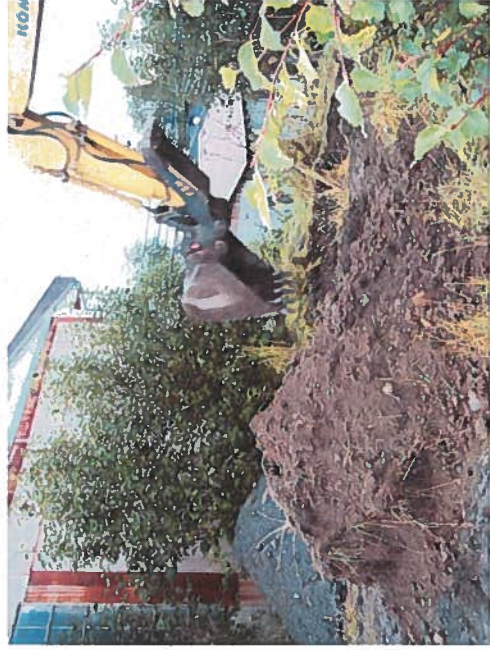
Photo 7. Breaking Ground at Test Pit Six located to the South of the Garage (Looking North)

Test pit TP6 was excavated to the south of the "New Garage" in the vicinity of the former "Wood Shop" building, which is no longer present on site. TP6 contained mixed debris (including a truck bumper) and fill material consisting of SW-SM. Heterogeneous regions of hydrocarbon impacted fill material were present throughout the excavation. TP6 was completed to a depth of 12 ft bgs, where native material consisting of ML was encountered. One analytical (TP6-12) and one duplicate sample (TP6-XI) were collected from native material at the completed depth in this excavation.

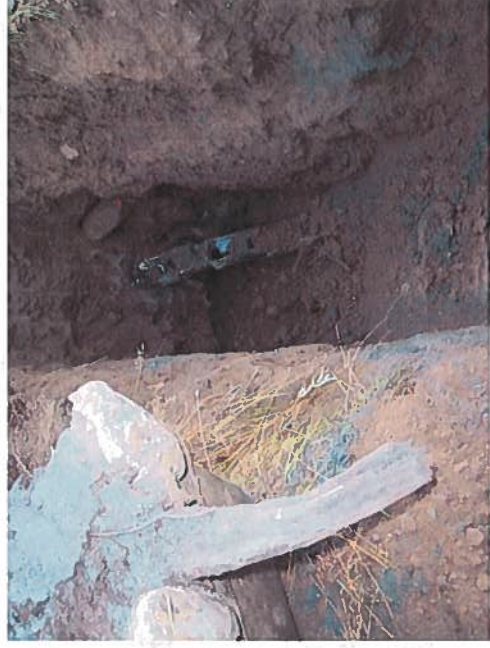
Photo 8. Debris and impacted soil encountered in Test Pit Six.

TP6 was located to the south of the new garage, in the vicinity of a wood shed that was previously removed from the subject property. TP6 contained mixed fill, debris, including a truck bumper, and impacted soil throughout the excavation. It should be noted that DRO was present at concentrations not only exceeding the ADEC cleanup criteria, but also exceeding DRO concentrations encountered in other test pits on site. This test pit also exceeded the ADEC cleanup criteria for benzene. The presence of large quantities of DRO and benzene in the relative absence of GRO, toluene, ethylbenzene, and xylenes in this area may indicate a unique source.
