**5/4-7/20 PL-33 BACKFILLING,  
BIOCELL SOIL SPREADING &  
REMOVAL OF MONITORING WELLS**

**PHOENIX LOGGING SHOP & STORAGE YARD**

**Klawock, Alaska**

**May 2020**

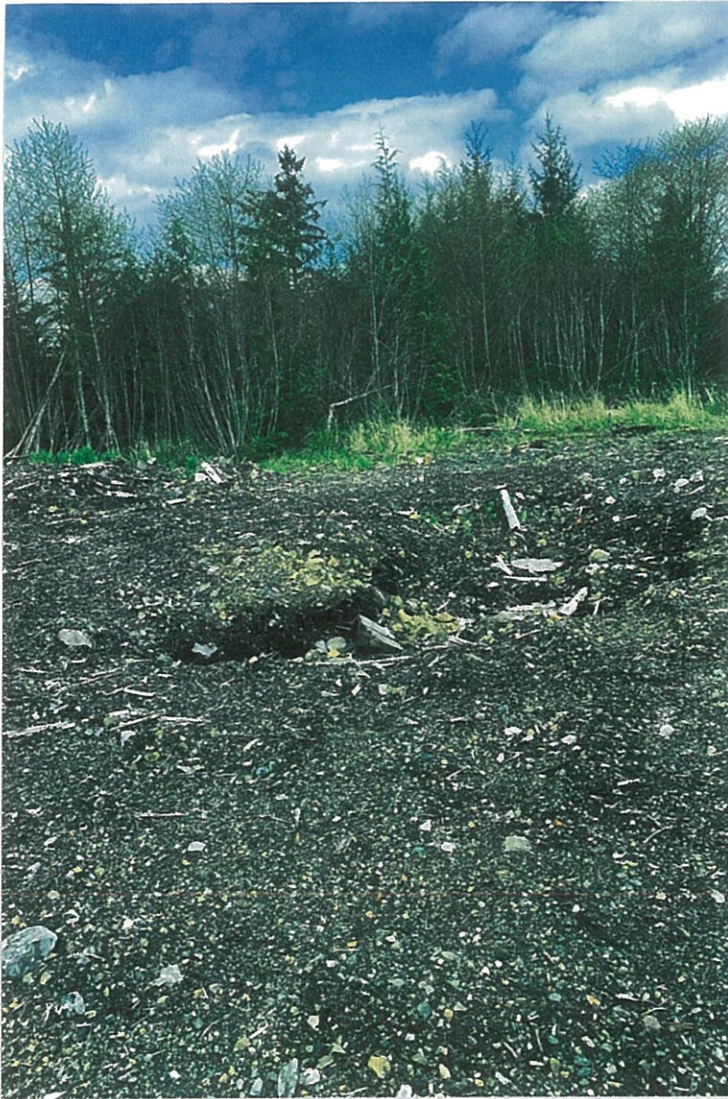
Photo #1 in Appendix B (page B2) shows the Phoenix Logging sort yard's PL-33 excavation site at the start of 5/4/20, just prior to being backfilled. The PL-33 site was backfilled with clean rock/gravel fill from the adjacent biocell containment berms, as described in Reference Doc. #6 (page C10) and shown in Photos #2-#5 (pages B2-B4).<sup>8</sup>

**Photo #1:** 5/4/20 photo looking west across the partially backfilled PL-33 excavation on the Phoenix Logging storage yard, just before it was completely filled in with fill from the side containment berms from Biocells #1-#4. See next 2 photos.

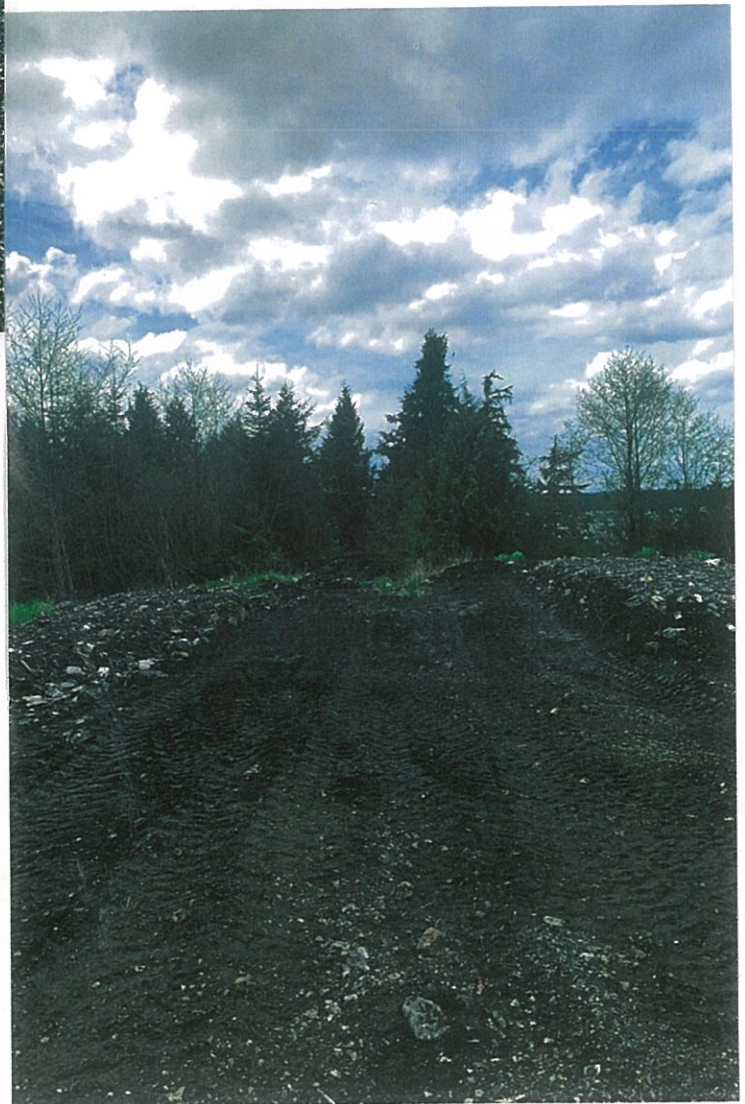
**Photo #2:** 5/4/20 view looking SW between Biocells #3 & #4, where its adjacent rocked containment berms had been removed and used as fill for the PL-33 excavation.

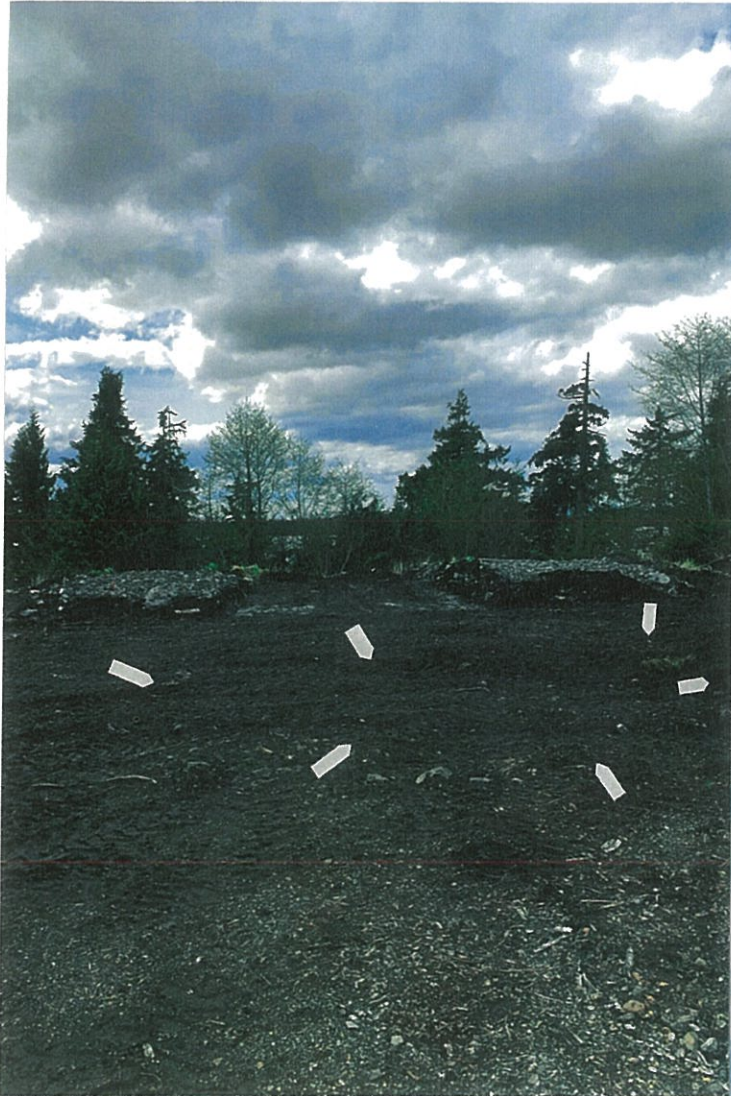
**Photo #3:** 5/4/20 view looking SW between Biocells #2-#3, showing the removed containment berms without affecting the biocell soils. Arrows show the approximate perimeter of the backfilled PL-33 excavation (see also next photo).

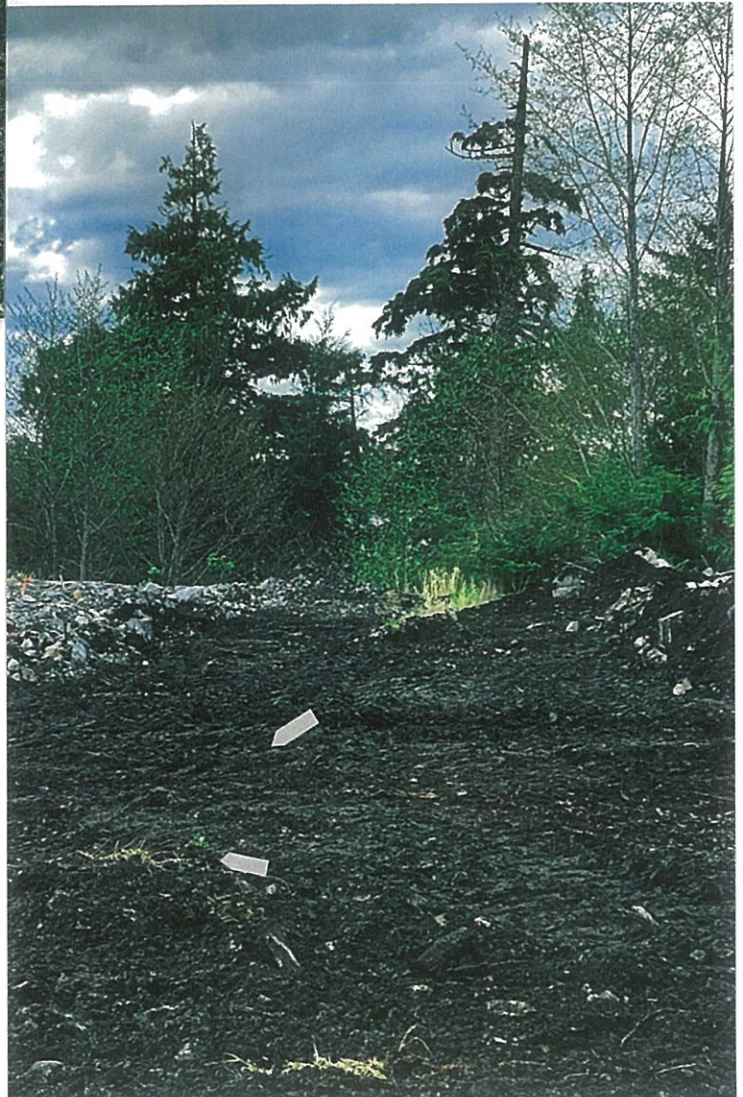
**Photo #4:** 5/4/20 view looking SW along the outer side of Biocell #1, showing its removed side containment berm to help fill in the PL-33 excavation (outlined by arrows).

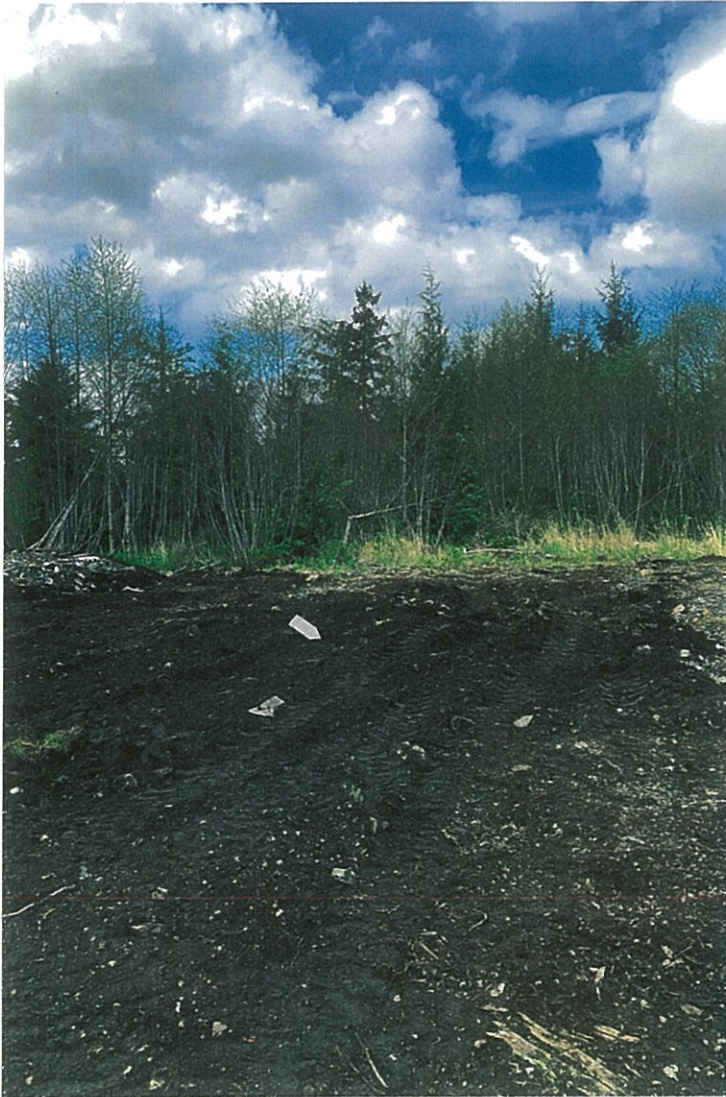
**Photo #5:** 5/5/20 view looking west across the area where the PL-33 excavation took place, now totally backfilled prior to spreading of the biocell soils.

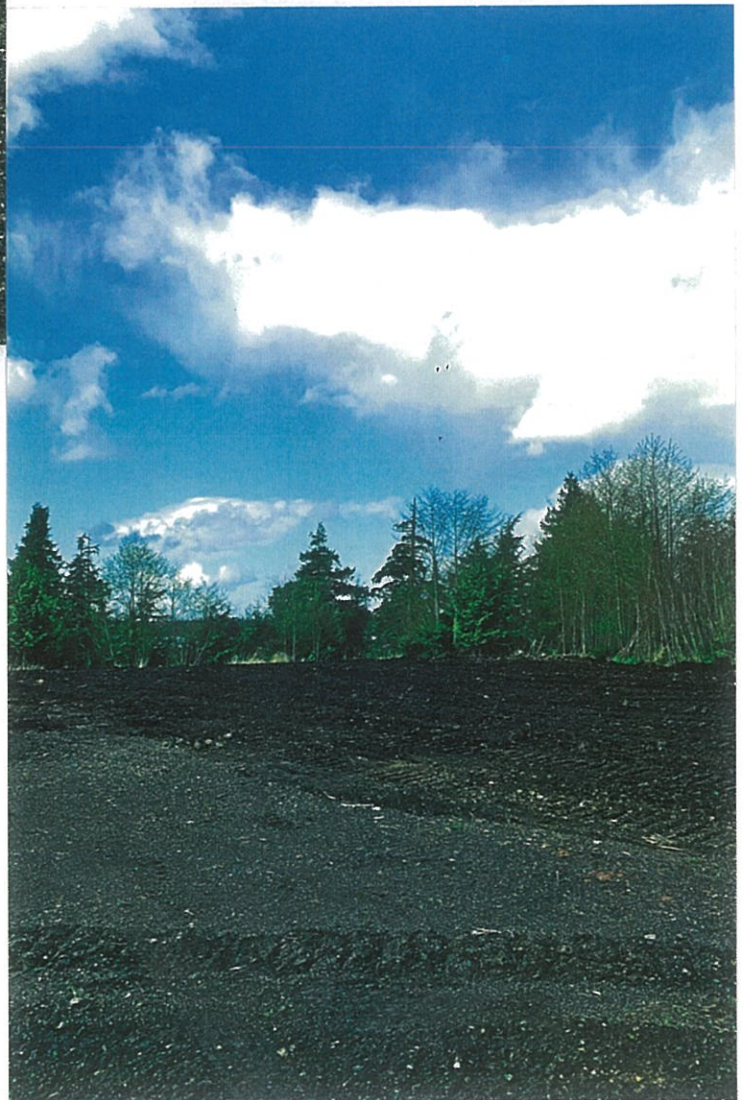
**Photo #6:** 5/5/20 view looking SW across the 5"-6" thick layer of soils from Biocell #1. The spread soils extended considerably more to the right, as shown in the next photo.

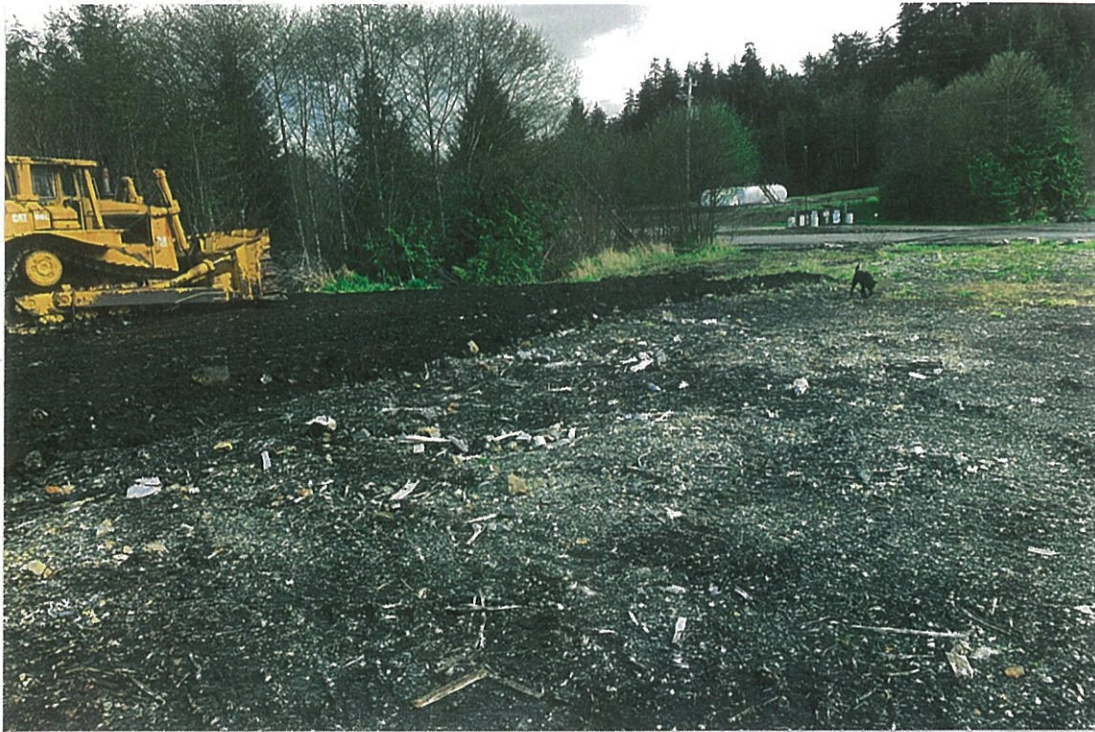
**Photo #7:** 5/5/20 view looking NE across the end of the Biocell #1 soils, as being spread to a 5"-6" thickness and a 180'-190' length.

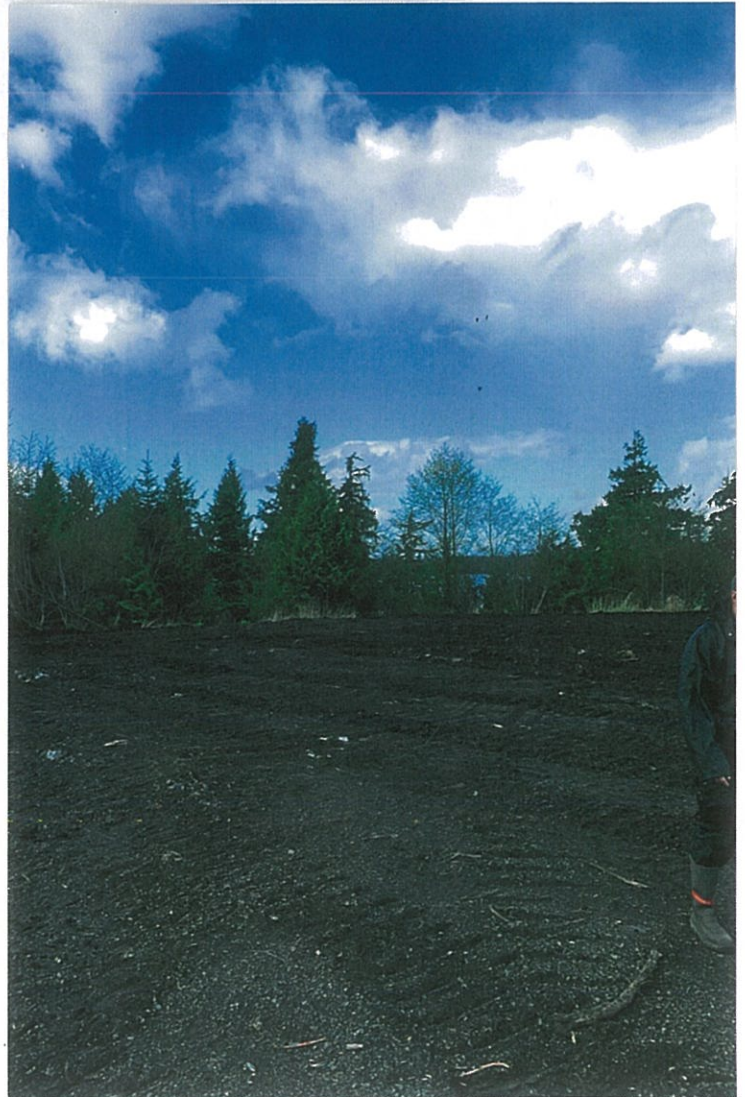
**Photo #8:** Closer 5/5/20 view looking SW across the upper end of the Biocell #1's soils, after being bladed and smoothed with the D9 cat to a 5"-6" thickness throughout.

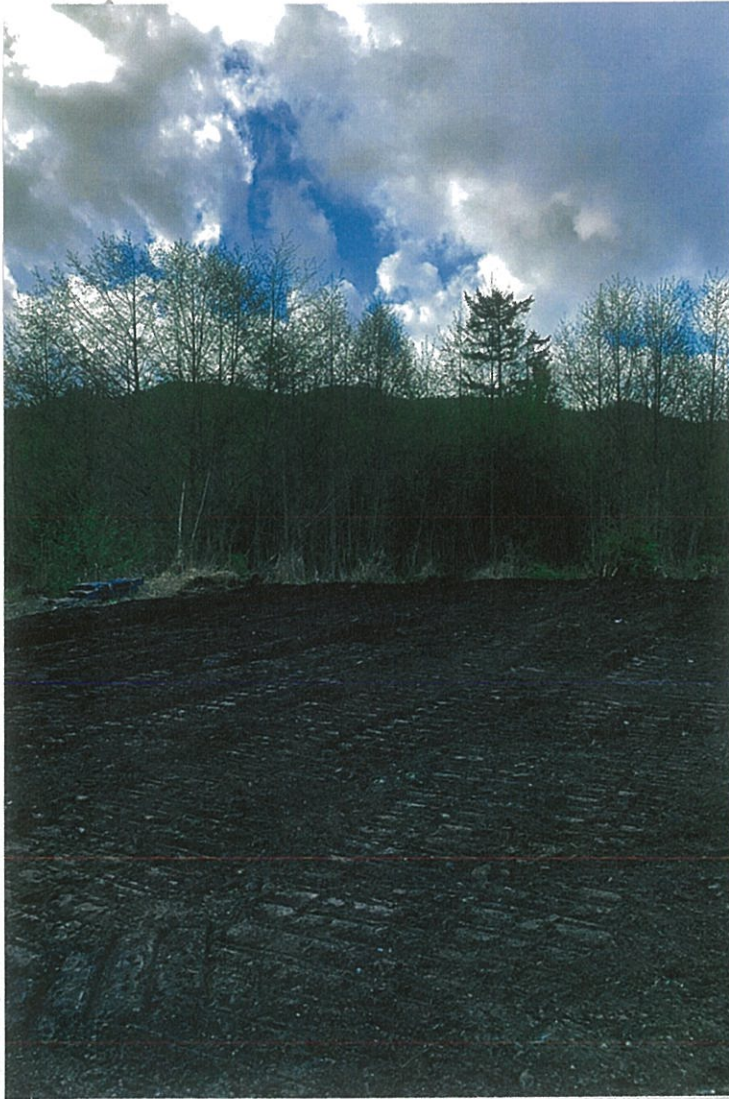
**Photo #9:** 5/5/20 view looking SSW across the far end of Biocell #4, after its soils had been spread to a 5"-6" thickness and contoured by the D9 tracks.

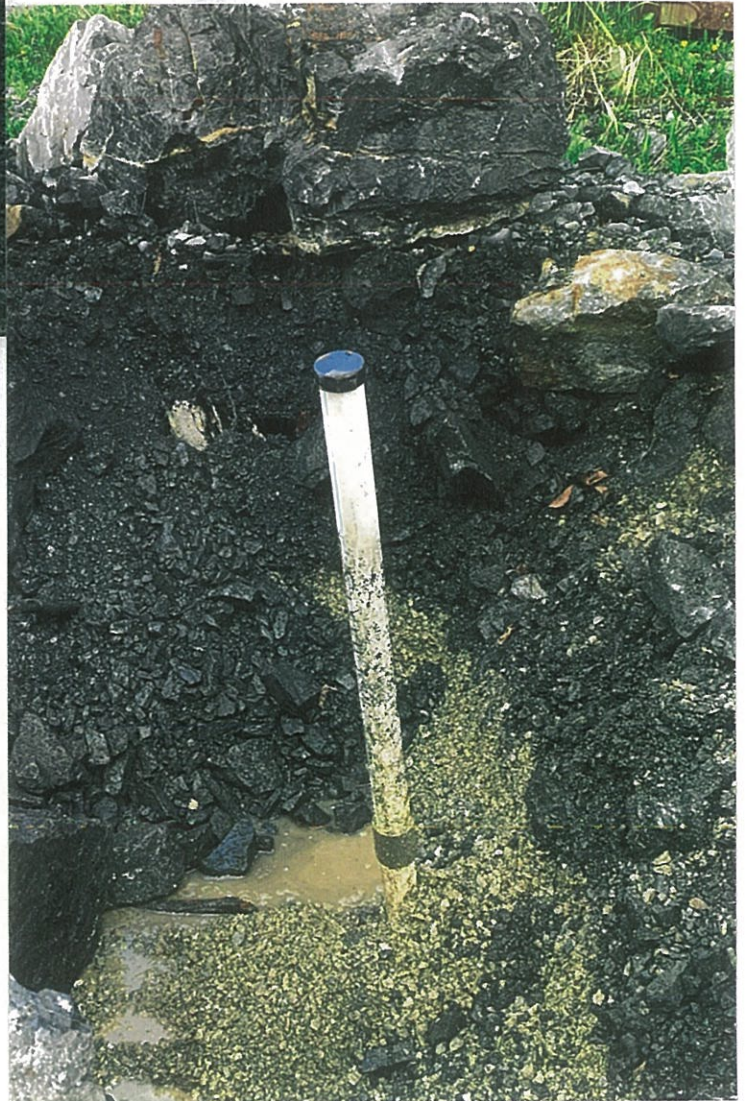
1. The monitoring well in front of the shop was removed first. The shot rock fill first was carefully removed from around the pipe stem (Photo #10, page B6), down to the pipe coupling that was about 6" above the ponded groundwater.

**Photo #10:** 5/6/20 view looking down the 4' deep excavation at the groundwater well in front of the shop, exposing the pipe coupler that was about 10" above the ponded groundwater. See next 2 photos.

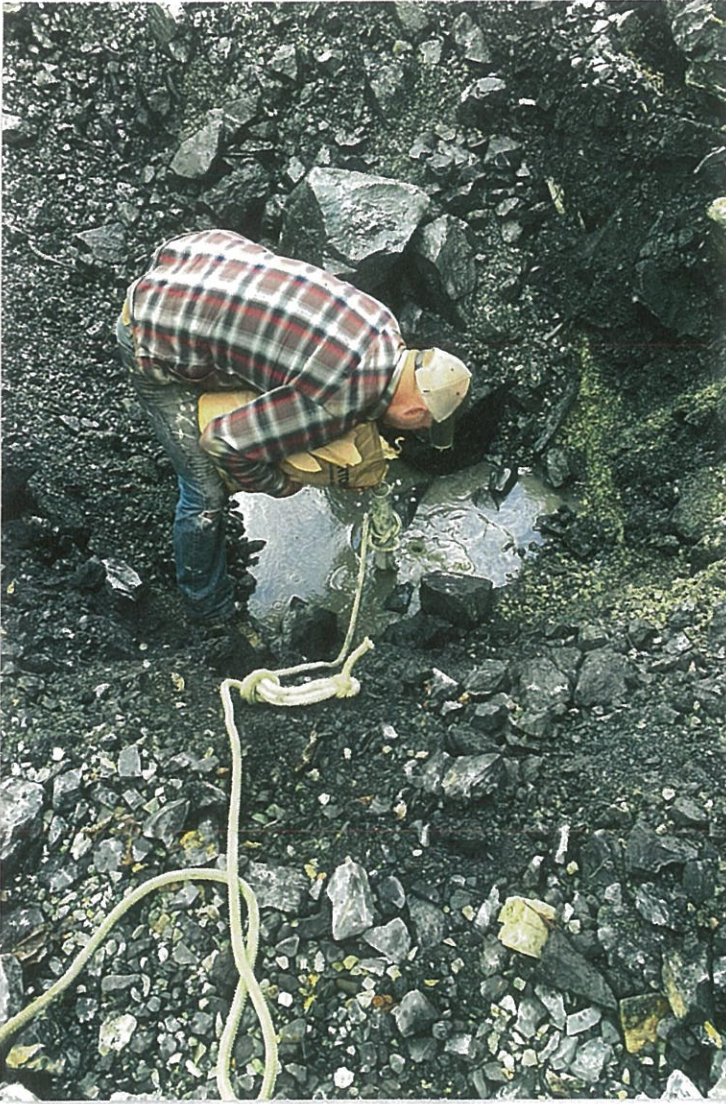
2. The initial coupled length of the well stem was removed, after which a strap was wrapped around the well pipe and attached to the backhoe bucket. Bentonite chips were poured into the pipe and rammed (with some difficulty) down and out the bottom to the well pipe.<sup>11</sup> Photos of the process are shown on page B7.

**Photo #11:** 5/6/20 view of the groundwater well in front of the Phoenix Logging shop, after its initial length and coupler had been removed. Bentonite chips had just been poured into the pipe, then rammed quickly down and out before they could swell and plug the pipe.

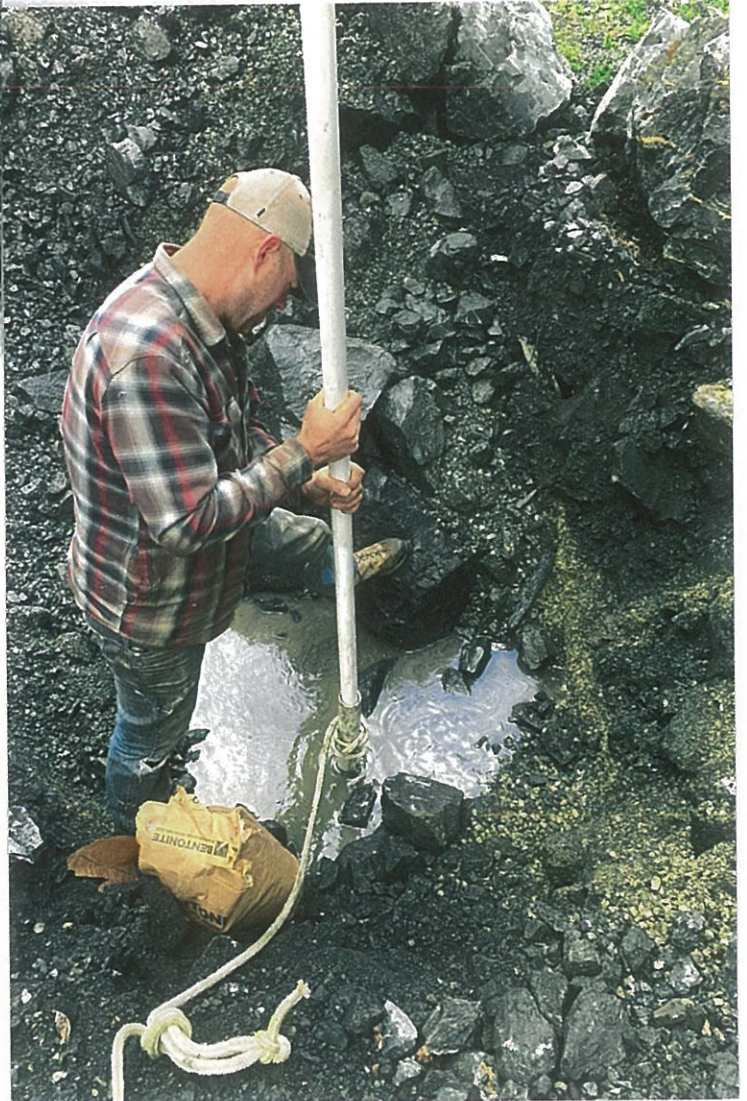
3. The backhoe then proceeded to pull the remainder of the pipe out in 1'-1.5' lifts, each time adding more chips to be rammed down the pipe until the pipe was completely removed from the ground.

**Photo #12:** 5/6/20 view of more bentonite chips being poured down the groundwater pipe stem, after which the bentonite was rammed down the pipe and the backhoe pulled the pipe about 1'-1.5' out of the ground. More bentonite chips then were added, rammed down the pipe and then the backhoe raised the pipe an additional 6". This process was repeated until the pipe was completely removed from the ground.

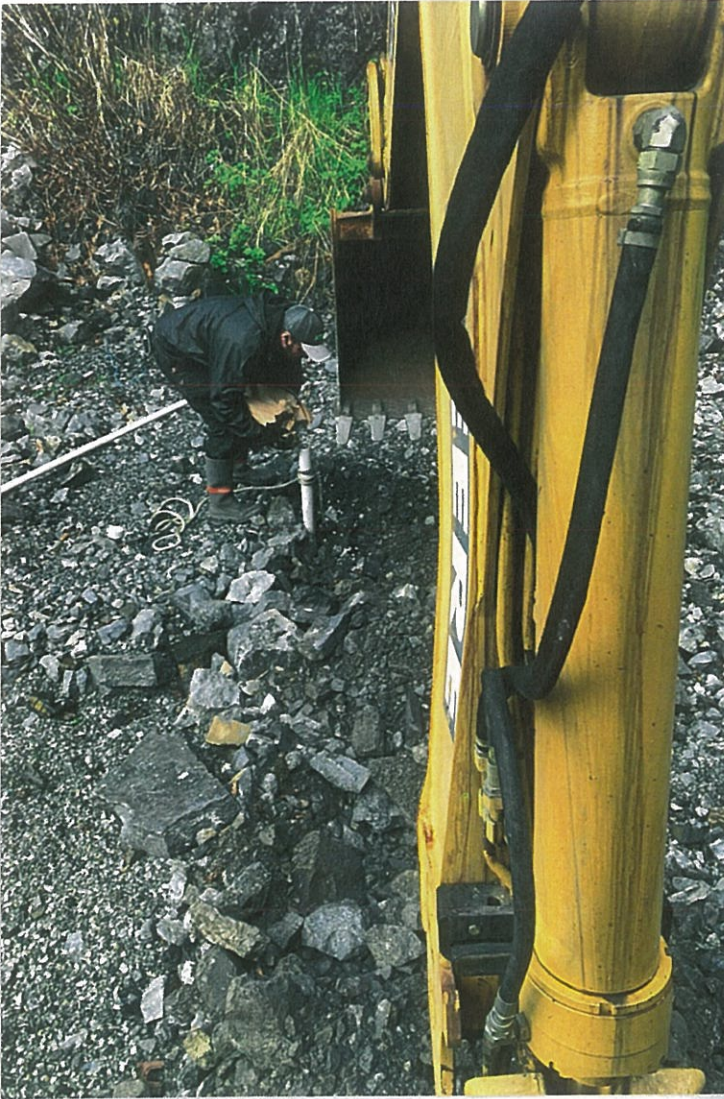
5. The monitoring well behind the shop was removed in a similar manner as the first well. Photos of the removal process are shown on page B8.
6. Photos on page B9 show the shop's two former groundwater monitoring well sites, after being backfilled with shot rock and gravels.

**Photo #13:** 5/6/20 view of the groundwater well pipe stem in the back of the Phoenix Logging shop, as bentonite chips were being poured down the pipe. Once the chips were rammed out the bottom of the pipe, the backhoe pulled the pipe about 1'-1.5' out of the ground, and additional bentonite was poured into the pipe (see photo below).

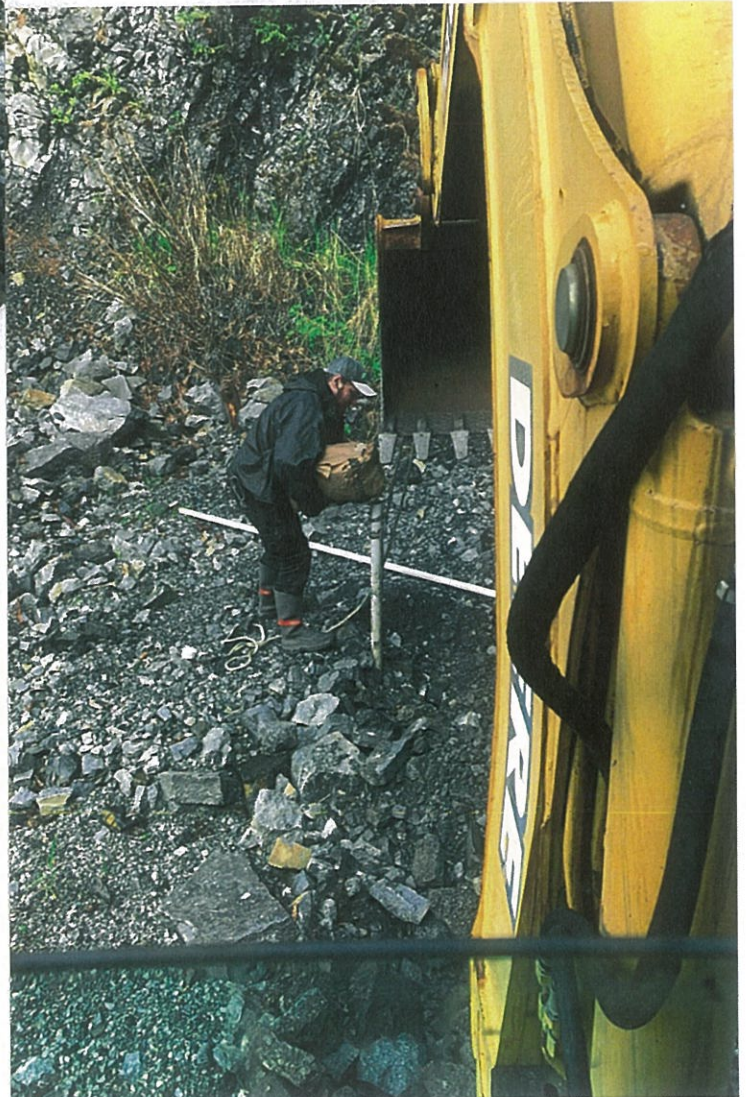
**Photo #14:** 5/6/20 view of the groundwater well in the back of the Phoenix Logging shop, as it had been pulled about 3' from the ground and more bentonite was being added. The pipe continued to be pulled from the ground in 1'-1.5' increments until it was completely removed from the ground.

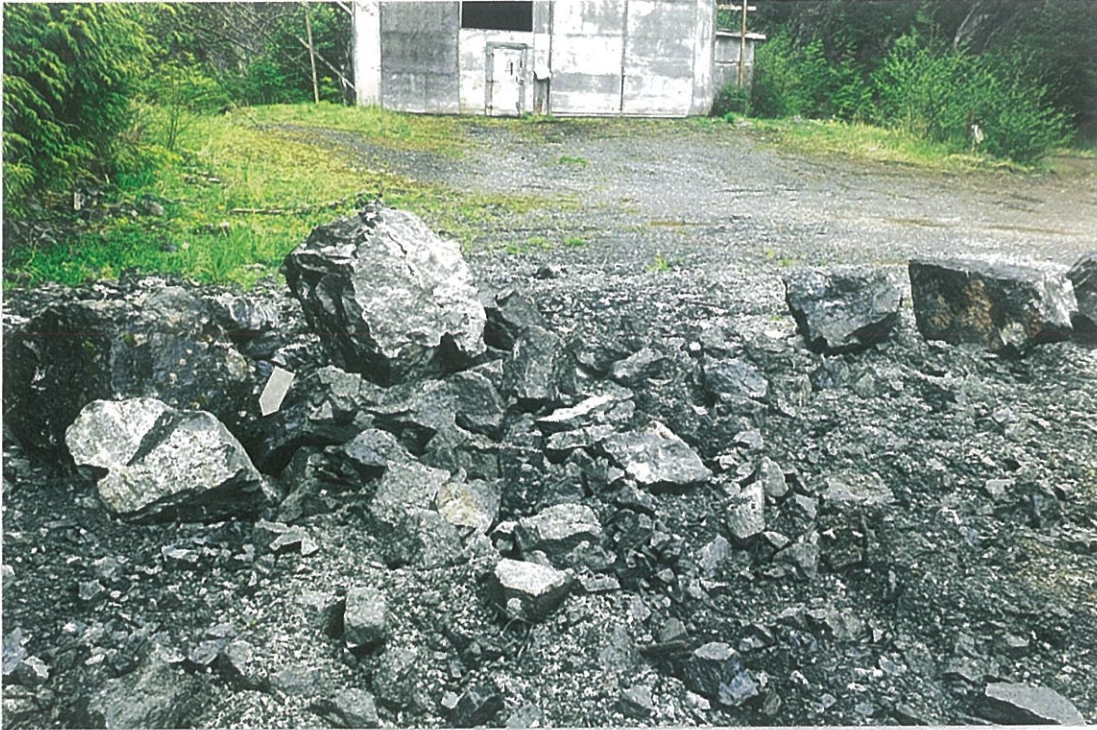
**Photo #15:** 5/6/20 view looking at the area in front of the Phoenix Logging shop, where the groundwater well pipe (arrow) had just been removed and the area backfilled.

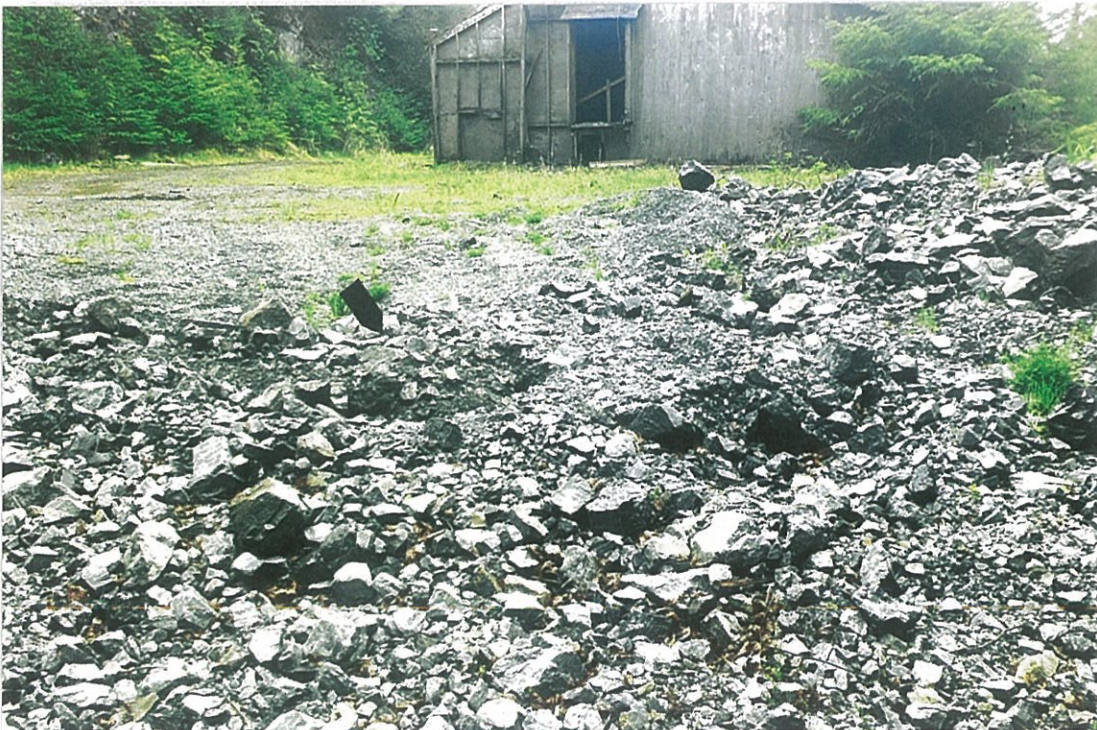
**Photo #16:** 5/6/20 view looking at the area in back of the Phoenix Logging shop, where the groundwater well pipe had just been removed and the area backfilled. The area shows the approximate location of the former groundwater well (arrow). The pipe stems for both wells were removed from the jobsite and sent to the municipal landfill.
