**Environmental
Resources
Management**

14 November 2014

**Subject: 2013 Drainage Pond Groundwater Monitoring
Report-Final**

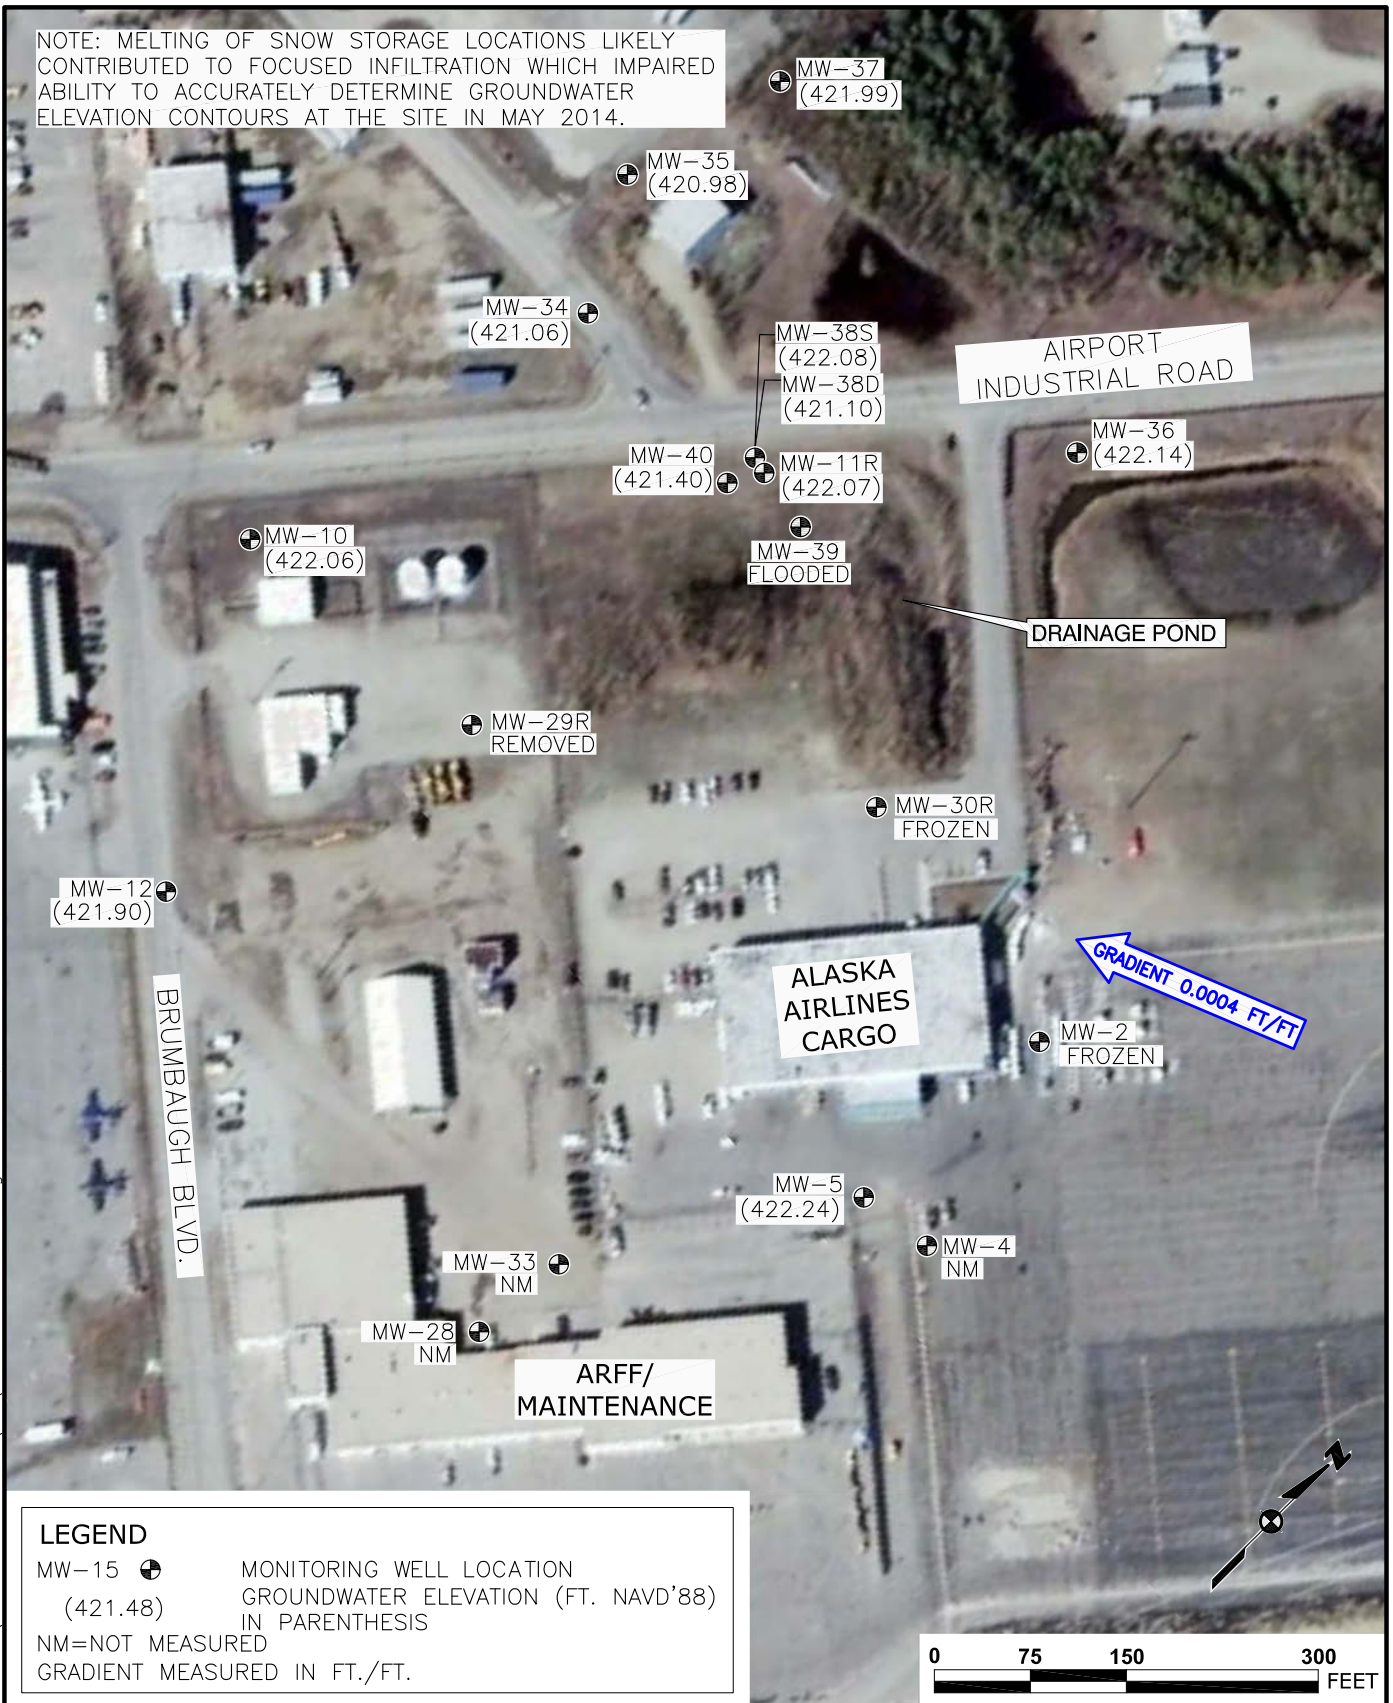
Datalogger information indicates the monitoring well integrity survey and elevation survey conducted during the May field event corresponded with rapid groundwater elevation change due to spring break up. There were several large snow storage locations which likely contributed to focused infiltration at the site. This impairs the ability to accurately determine groundwater contours. However, groundwater flow is generally consistent with regional groundwater flow west towards the Chena River.

NOTE: MELTING OF SNOW STORAGE LOCATIONS LIKELY CONTRIBUTED TO FOCUSED INFILTRATION WHICH IMPAIRED ABILITY TO ACCURATELY DETERMINE GROUNDWATER ELEVATION CONTOURS AT THE SITE IN MAY 2014.

MW-15 MONITORING WELL LOCATION
 (421.48) GROUNDWATER ELEVATION (FT. NAVD'88)
 IN PARENTHESIS
 NM=NOT MEASURED
 GRADIENT MEASURED IN FT./FT.

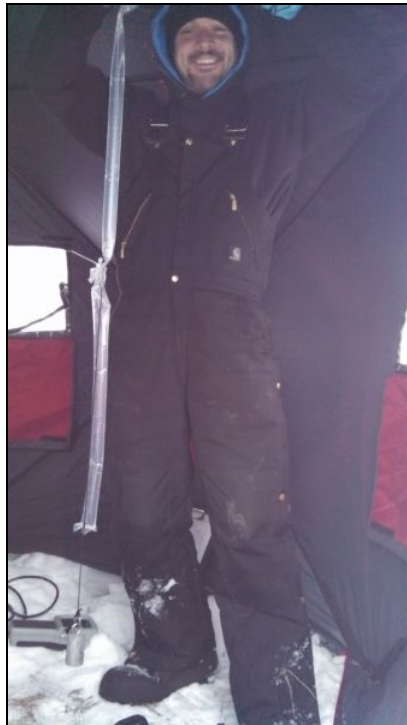
PHOTOGRAPH 1: MW-11R DEPLOYMENT OF PDB 5 DECEMBER 2013.

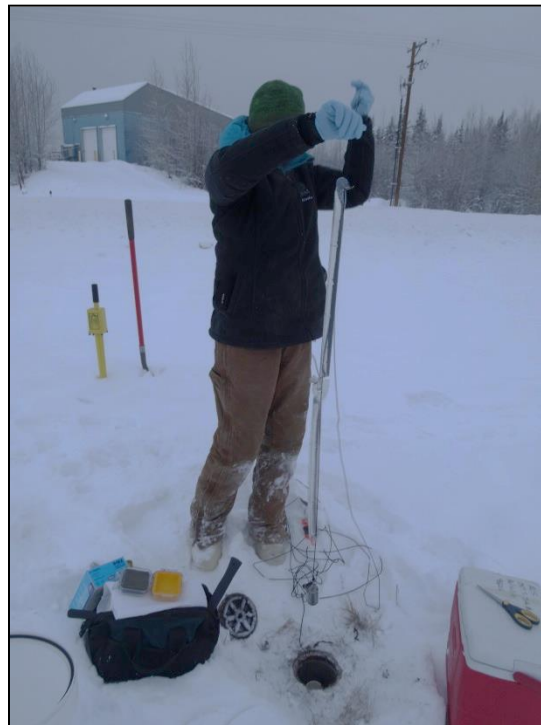
PHOTOGRAPH 2: MW-11R PDB RETRIEVAL 19 DECEMBER 2013.

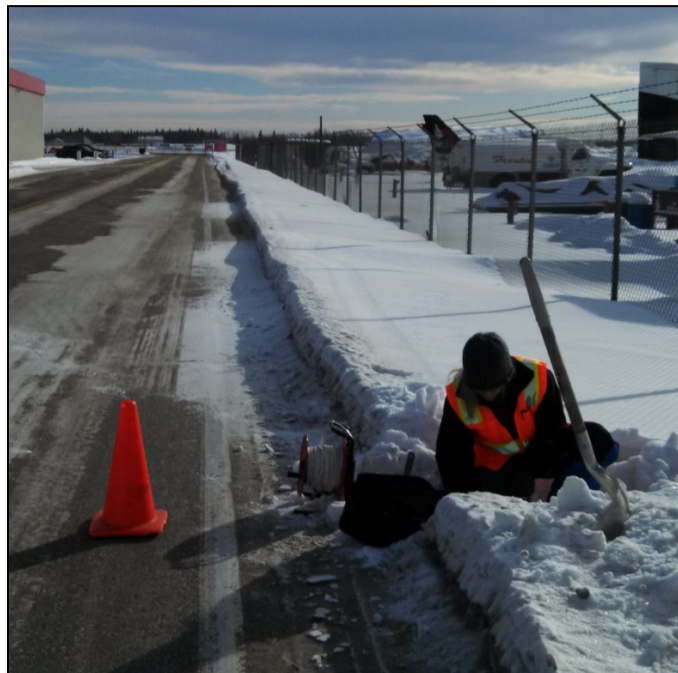
PHOTOGRAPH 4: MW-12 WELL INTEGRITY SURVEY AND DATALOGGER DEPLOYMENT

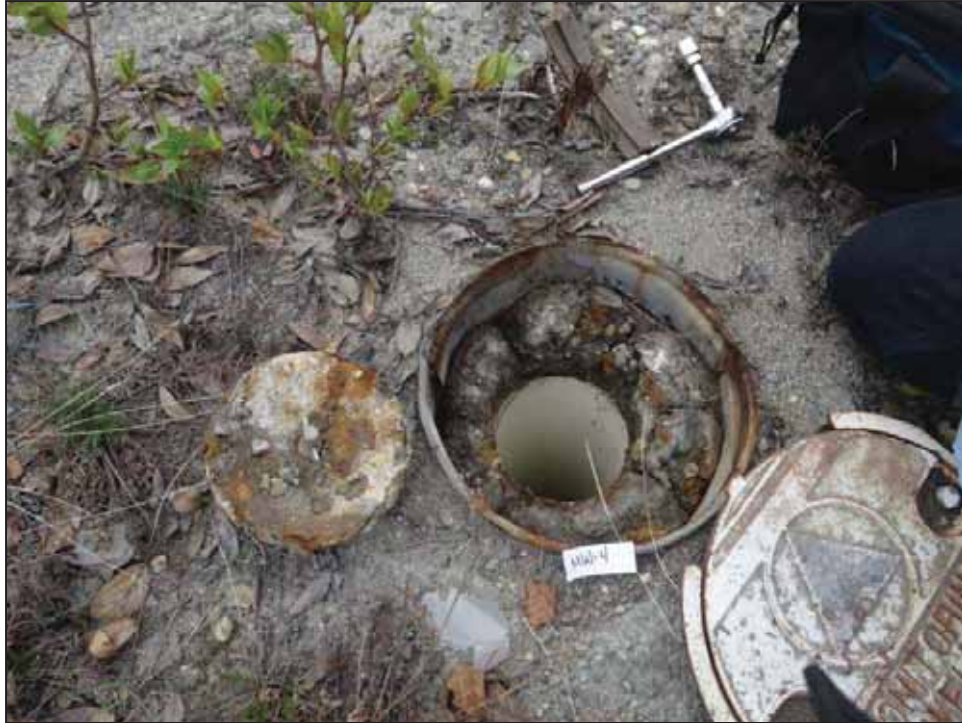
PHOTOGRAPH 3: MW-4 - POOR CONDITION, MONUMENT LID DOES NOT ATTACH AND BENTONITE SMEARED AROUND TOP OF CASING

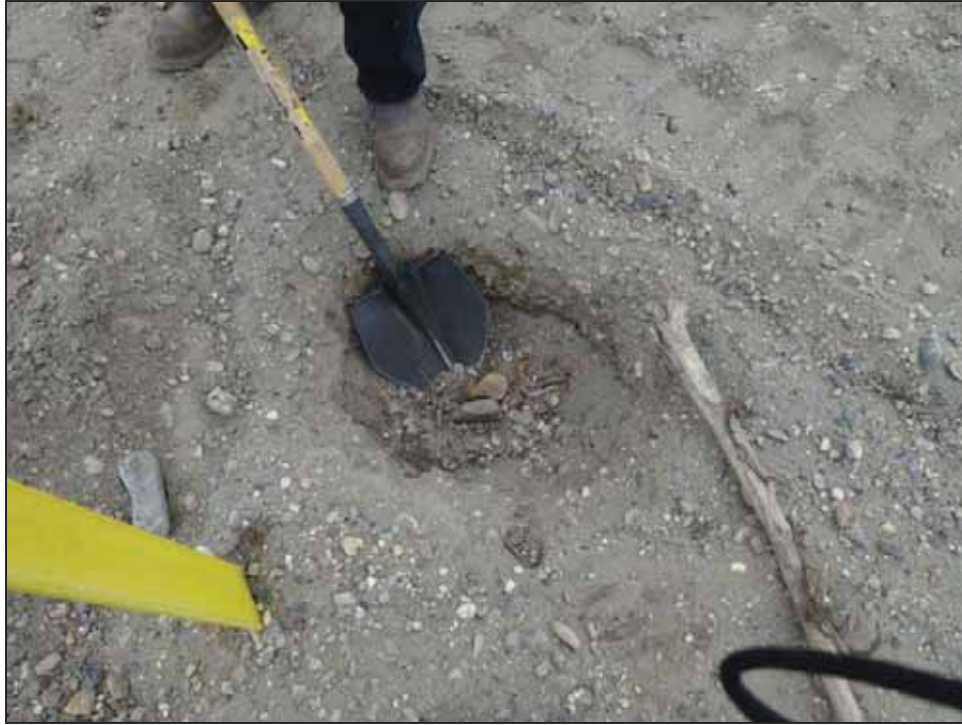
PHOTOGRAPH 7: MW-10 - BURIED 12-12 INCHES ON NEWLY PLACED GRAVEL PAD

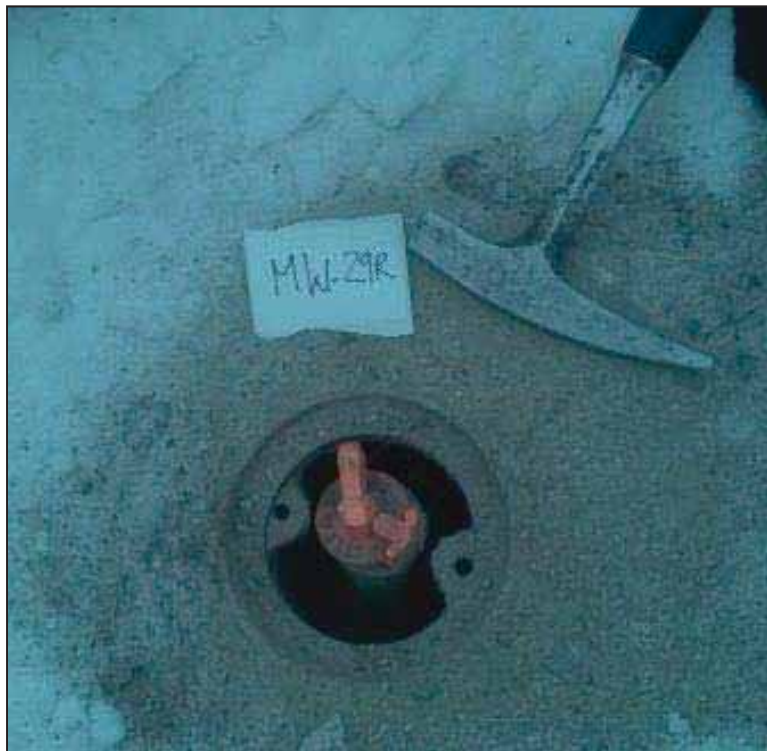
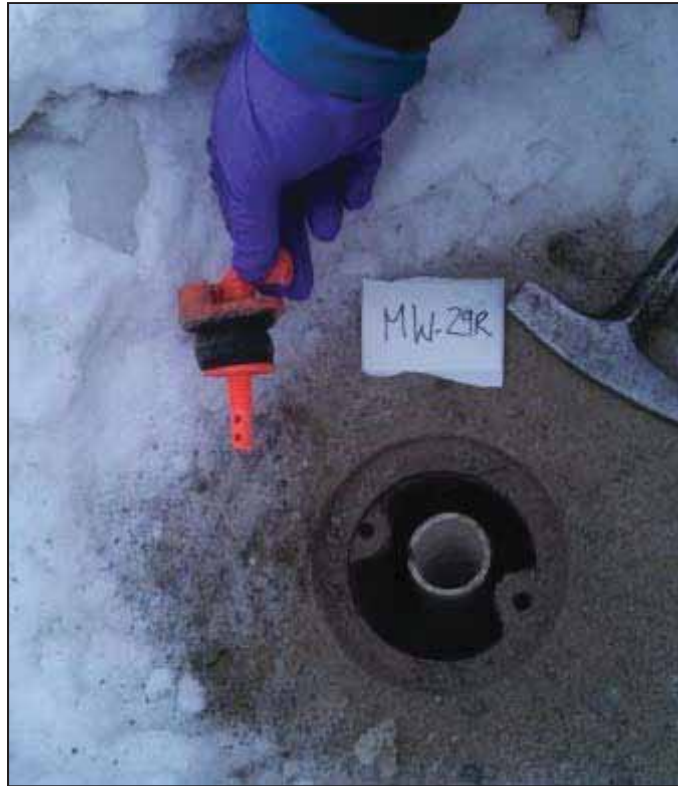
| Well ID | Year Installed | Screen Length (Ft) | Casing Diameter (in) | Monument Lid Diameter (in) | Bolt Size | Total Depth (ft btoc) | Casing Type | Condition | Notes |
|---|---|---|---|---|---|---|---|---|--|
| MW-29R | 2006 | 10 | 1.5 | 6" | 1/2" | 18.07 | PVC | MODERATE | Near Construction area. Concrete around monument is heaving slightly. Well cap is hitting monument cover due to frost jacking. Datalogger installed 12/5/13. WELL REMOVED APRIL 2014 DURING CONSTRUCTION |

PHOTOGRAPH 14: MW-29R MODERATE CONDITION - CASING IS ALMOST TOUCHING MONUMENT LID - WELL REMOVED APRIL 2014

PHOTOGRAPH 15: MW-29R MODERATE CONDITION - CASING IS ALMOST TOUCHING MONUMENT LID - WELL REMOVED APRIL 2014

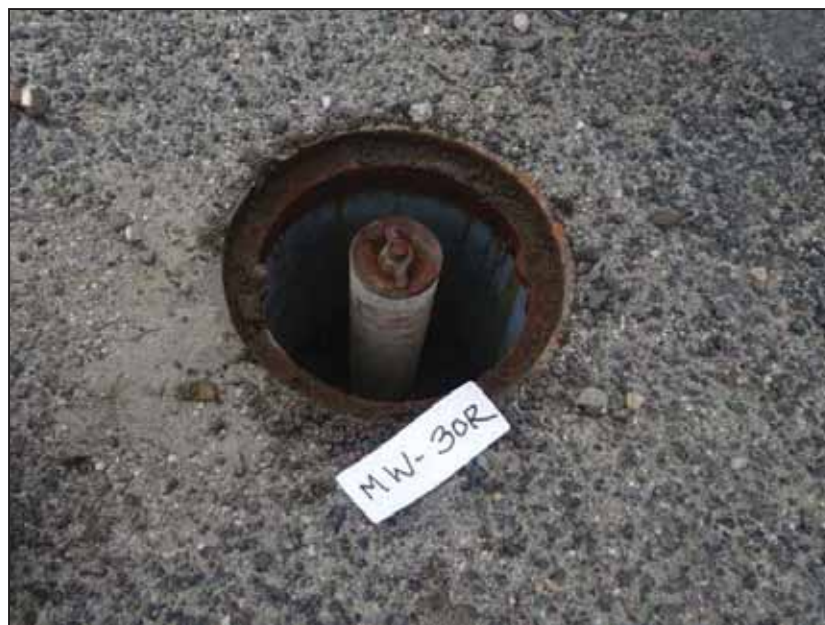
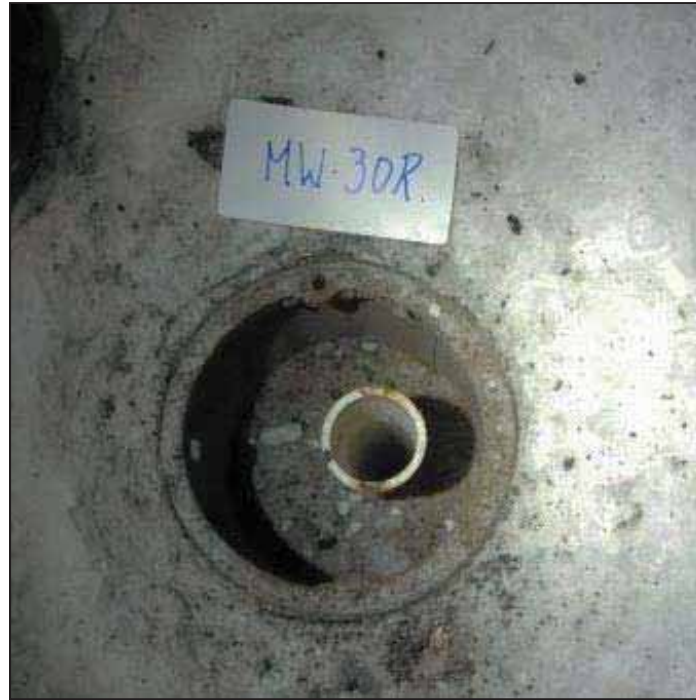
| Well ID | Condition | Notes |
|---|---|--|
| MW-30R | POOR | Blockage above water table in December 2013. Evidence of frost jacking present. Casing is slanted. |

| Well ID | Year Installed | Screen Length (Ft) | Casing Diameter (in) | Monument Lid Diameter (in) | Bolt Size | Total Depth (ft btoc) | Casing Type | Condition | Notes |
|---|---|---|---|---|---|---|---|---|--|
| MW-30R | 1999 | 10 | 2 | 6" | 1/2" | 11.05 | PVC | POOR | blockage above water table Dec 2013. Frost jacking present. Casing is slanted |

PHOTOGRAPH 16: MW-30R - MODERATE CONDITION - BLOCKAGE IN NOV. 2013 AND MINOR FROST JACKING

PHOTOGRAPH 17: MW-30R - MODERATE CONDITION - BLOCKAGE IN NOV. 2013 AND MINOR FROST JACKING

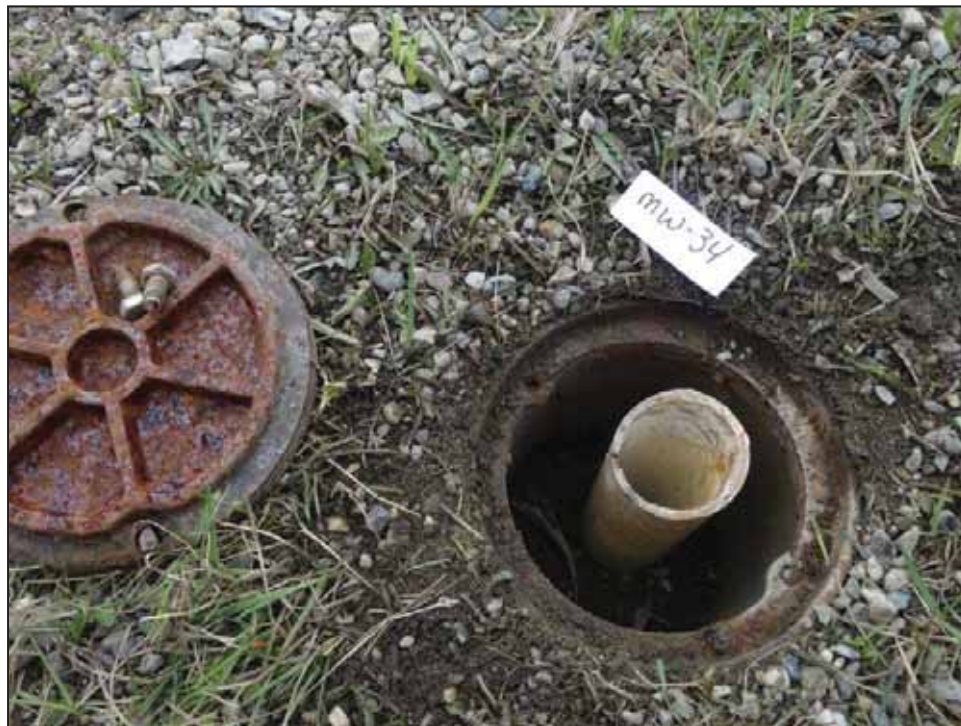
| Well ID | Condition | Notes |
|---|---|--|
| MW-34 | MODERATE | Well casing has frost jacked and is preventing placement of well cap. |

PHOTOGRAPH 18: MW-34 MODERATE CONDITION - CASING IS JACKED AND NO LONGER ABLE TO PLACE WELL CAP UNDER MONUMENT LID.

The PVC casing in MW-34 and MW-35 should be cut down and repaired to allow room for a proper fitting well cap and monument cover. The monument at MW-35 should be reset and the PVC casing should be shortened to allow a flush mount monument and monument cover.

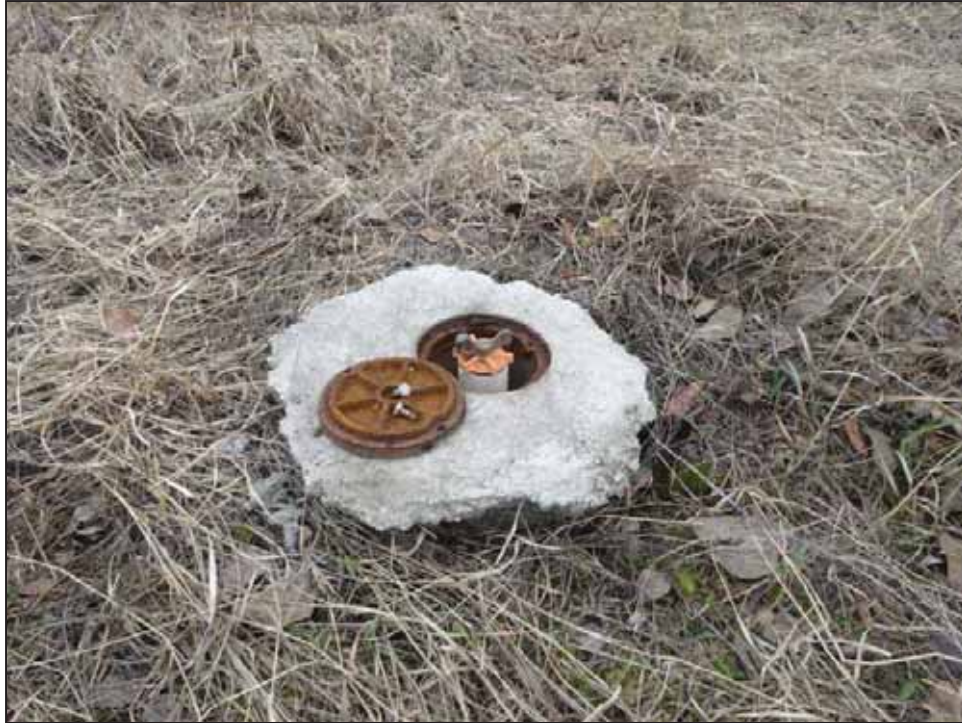
| Well ID | Condition | Notes |
|---|---|--|
| MW-35 | MODERATE | Concrete monument is frost-jacked. |

| Well ID | Year Installed | Screen Length (Ft) | Casing Diameter (in) | Monument Lid Diameter (in) | Bolt Size | Total Depth (ft btoc) | Casing Type | Condition | Notes |
|---|---|---|---|---|---|---|---|---|--|
| MW-35 | 2005 | 10 | 2 | 6" | 1/2" | 10.31 | PVC | MODERATE | Monument surrounded by concrete which is frost-jacked, but well itself is ok. Datalogger installed 12/5/13 |

PHOTOGRAPH 19: MW-35 - MODERATE CONDITION - EVIDENCE OF FROST JACKING, CONCRETE IS NO LONGER BURIED.

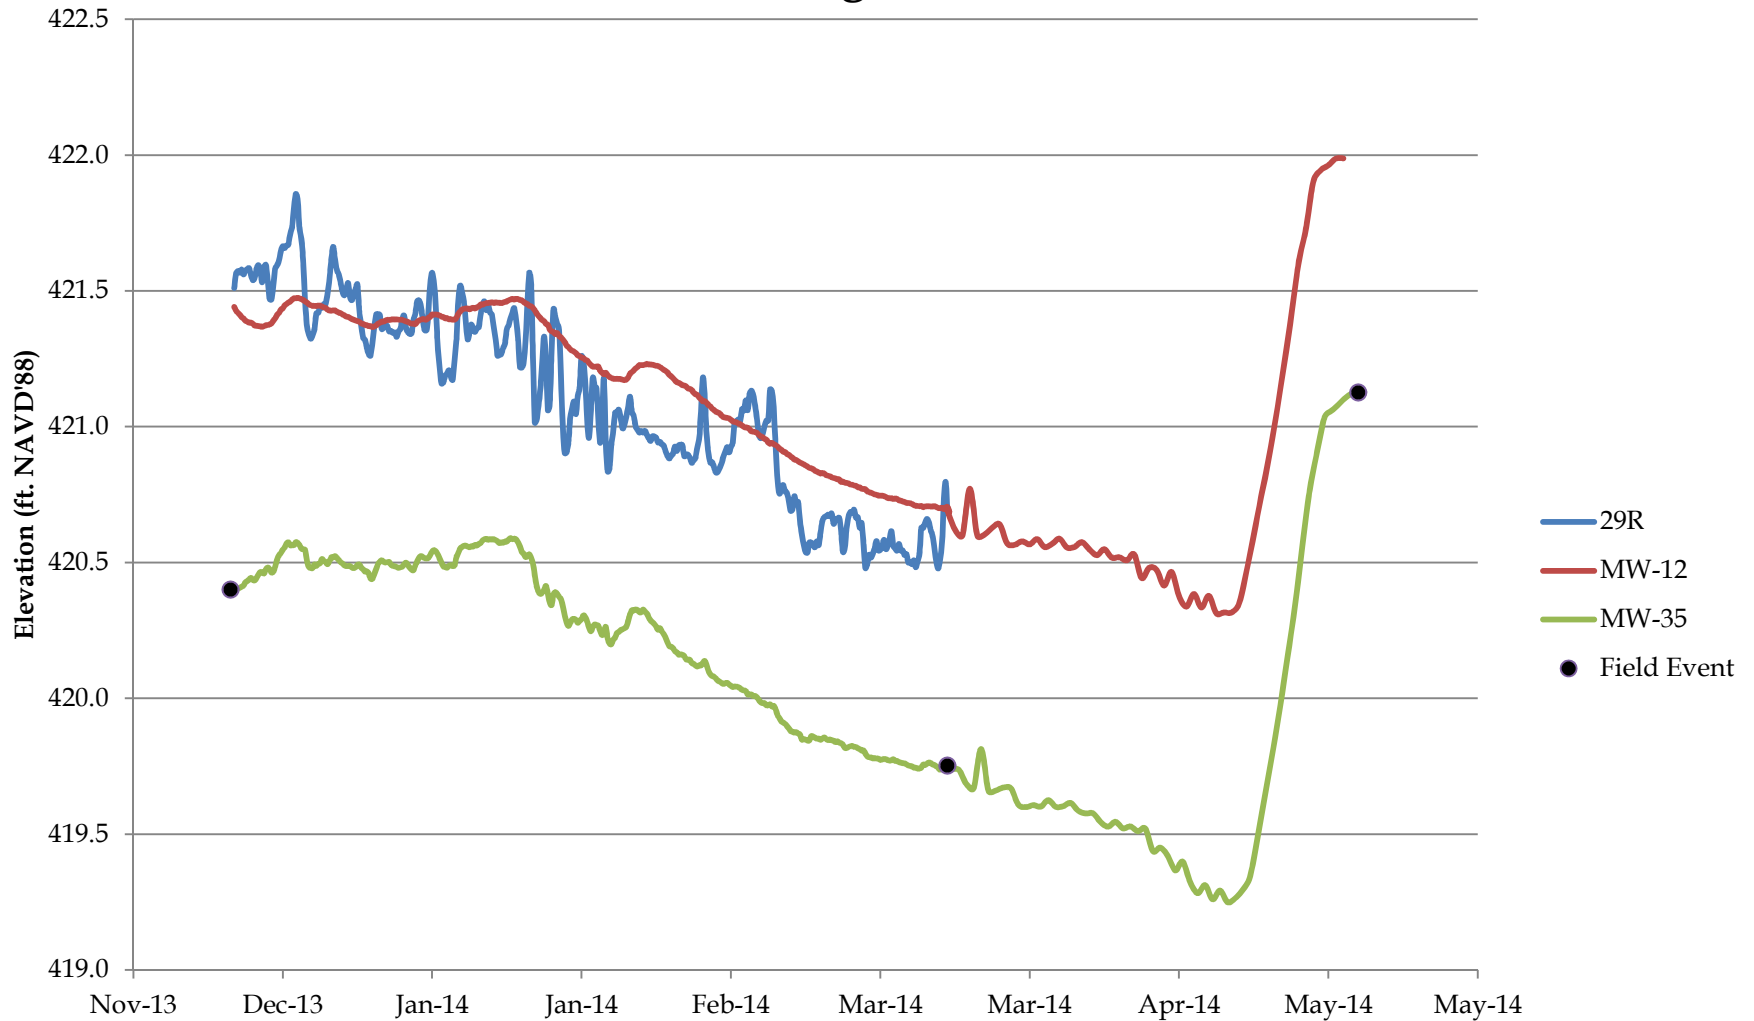
Groundwater Elevation December 2013 to May 2014 FIA Drainage Pond

NOTE: The datalogger installed in MW-29R was downloaded in March 2014. The well was removed in April 2014 before the remaining data could be downloaded. MW-29R was not surveyed in 2014.
