Re: U.S. Bureau of Indian Affairs as a Potentially Responsible Party at White Mountain BIA School,
Alaska

Re: White Mountain National Guard Site Preliminary Assessment

TRIP REPORT

DATE: October 20, 1998
TO: John Meyer, Task Monitor, EPA, Mail Stop ECL-115
FROM: Len Marcus, Project Manager, E & E, Anchorage, AK
SUBJ: White Mountain National Guard Site
REF: TDD 97-02-0010

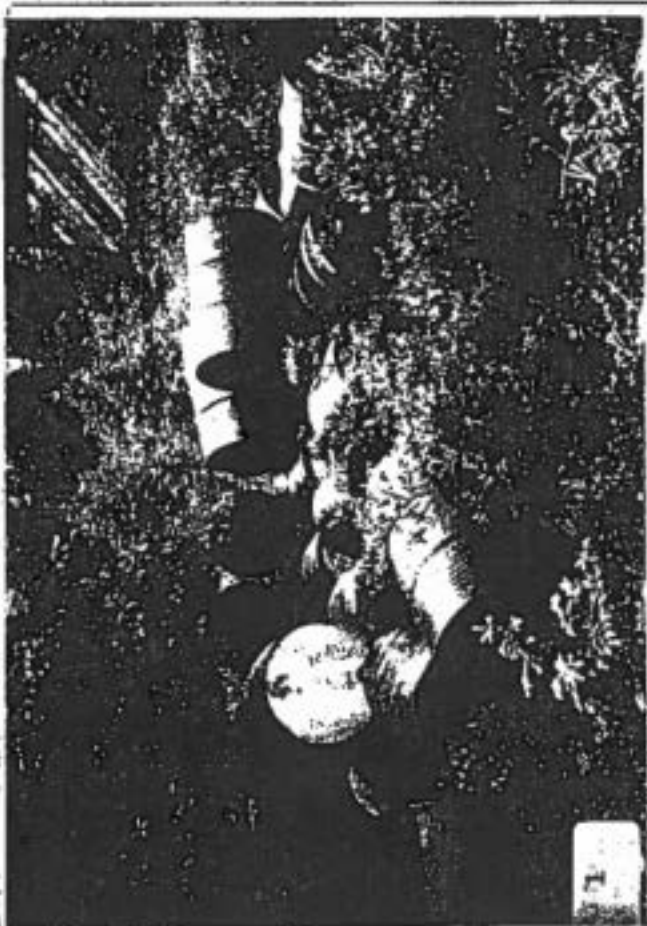
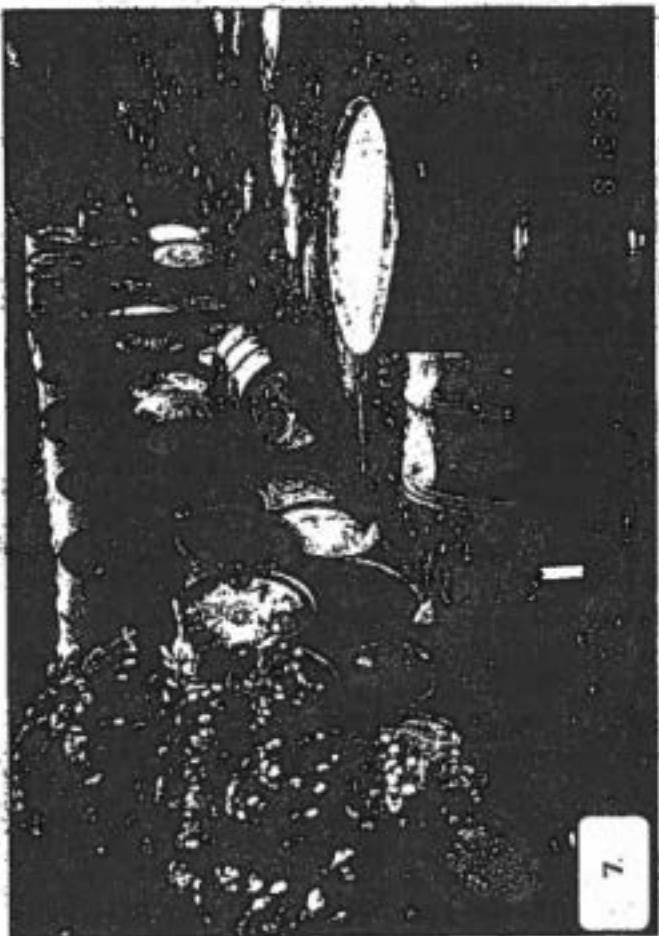
White Mountain National Guard PA (1 of 4)

Photo No.	Date	Time	By	Description and Orientation
1	8-12-98	1207	LM	Sample SS01 location, facing west. Old pump house is in background.
2	8-12-98	1208	LM	Sample SS01 location, facing southwest.
3	8-12-98	1215	LM	Sample SS02 location, facing south.
4	8-12-98	1218	LM	Sample SS02 location, facing south.
5	8-12-98	1225	LM	Drum group from where sample SS03 was collected (at far left), facing south.
6	8-12-98	1228	LM	Drums in group from where sample SS03 was collected, facing west.
7	8-12-98	1230	LM	Sample SS03 location, facing west.
8	8-12-98	1235	LM	Sample SS04 material.
9	8-12-98	1240	LM	Markings on a drum near sample SS04 location.
10	8-12-98	1245	LM	Sample location SS04 (red stake at center), facing southwest.
11	8-12-98	1246	LM	Drums on east side of all-terrain vehicle road, facing north.
12	8-12-98	1247	LM	Sample SS05 being collected, facing north.
13	8-12-98	1255	LM	Sample SS05 location, facing west.

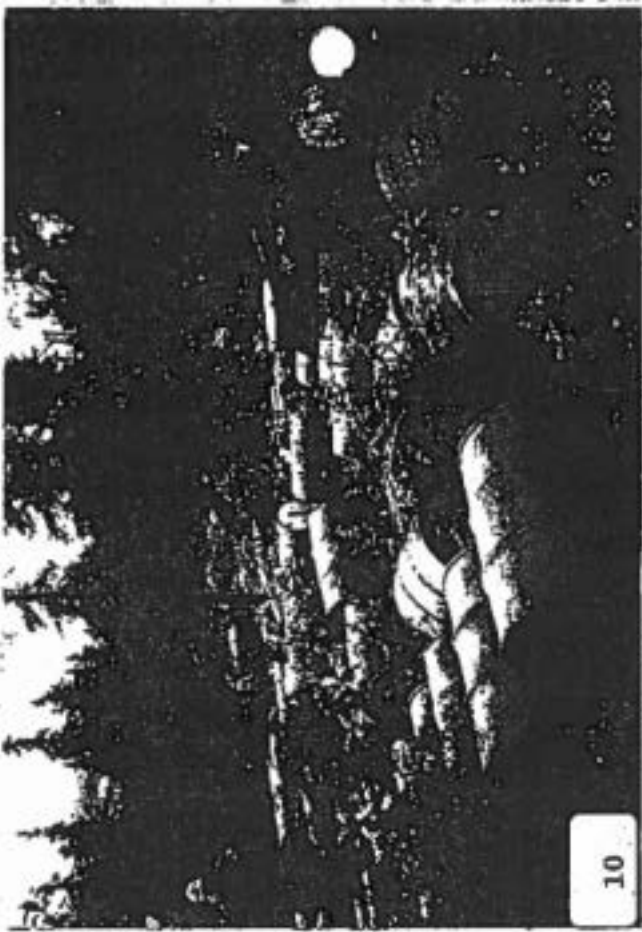
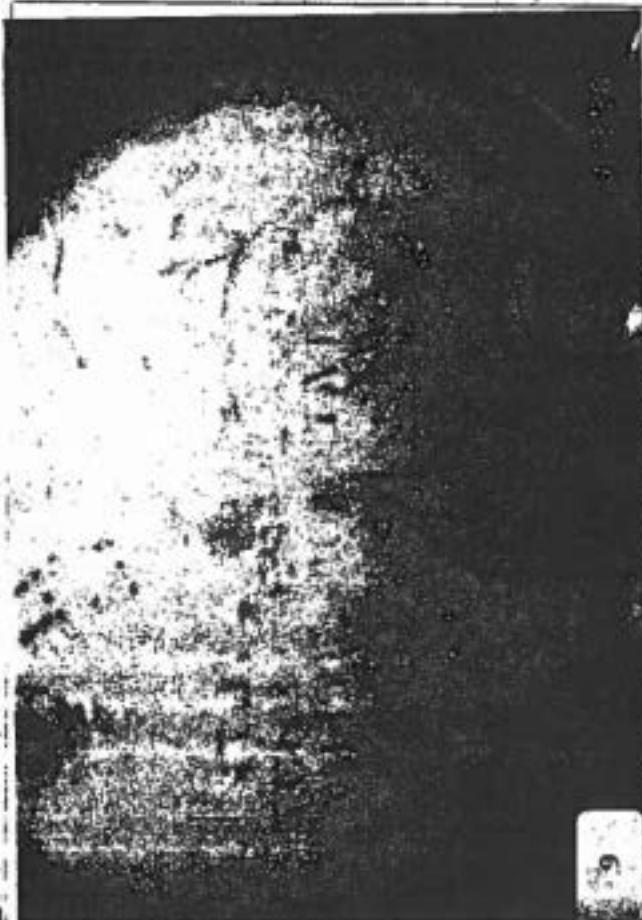
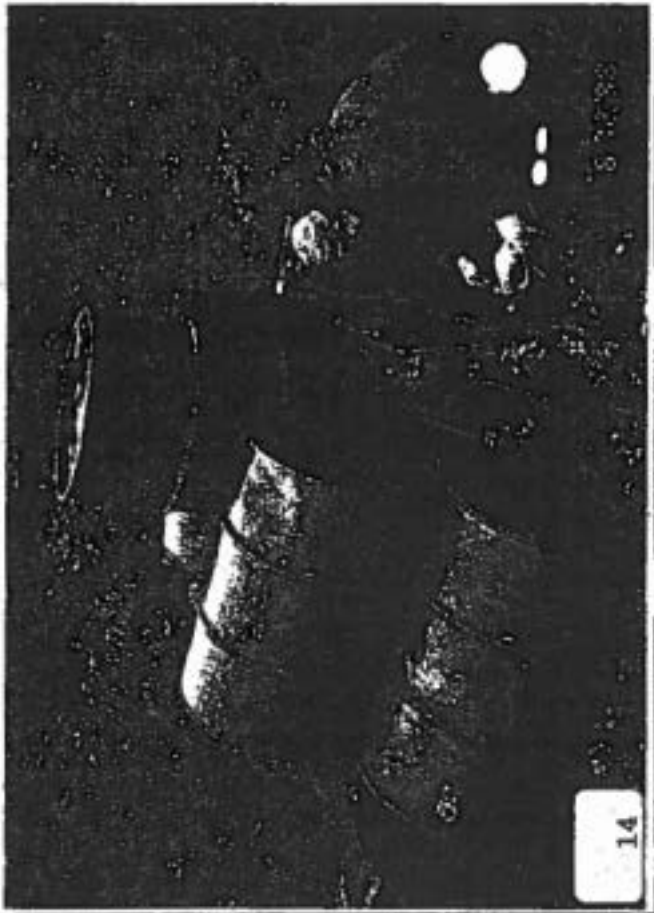
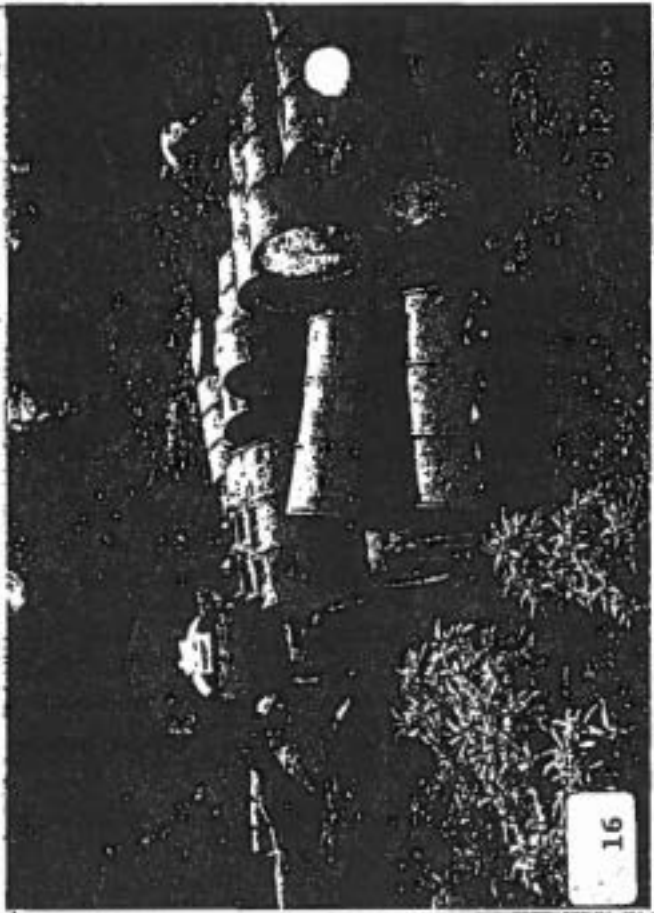
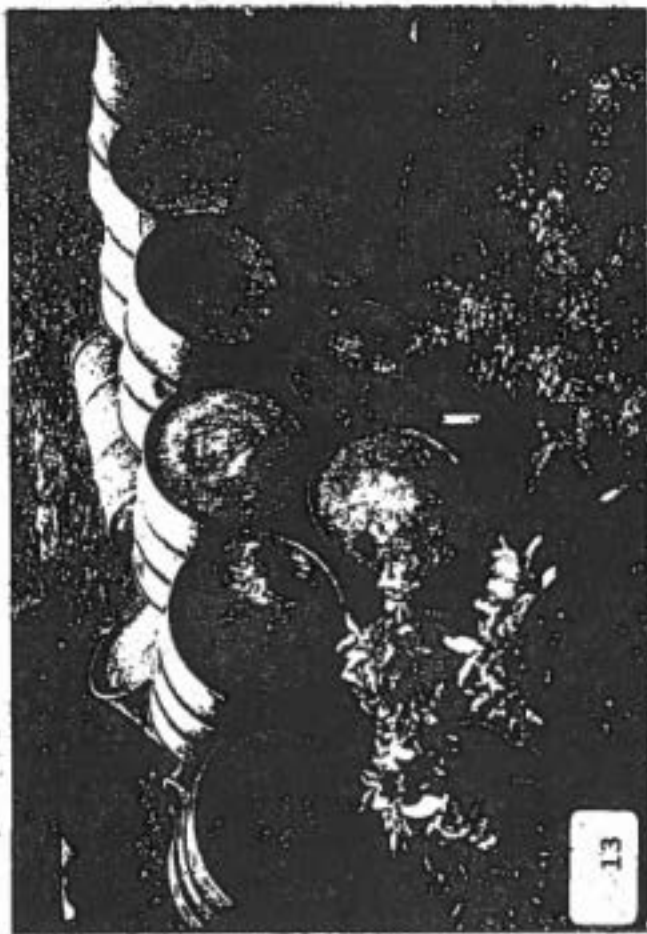
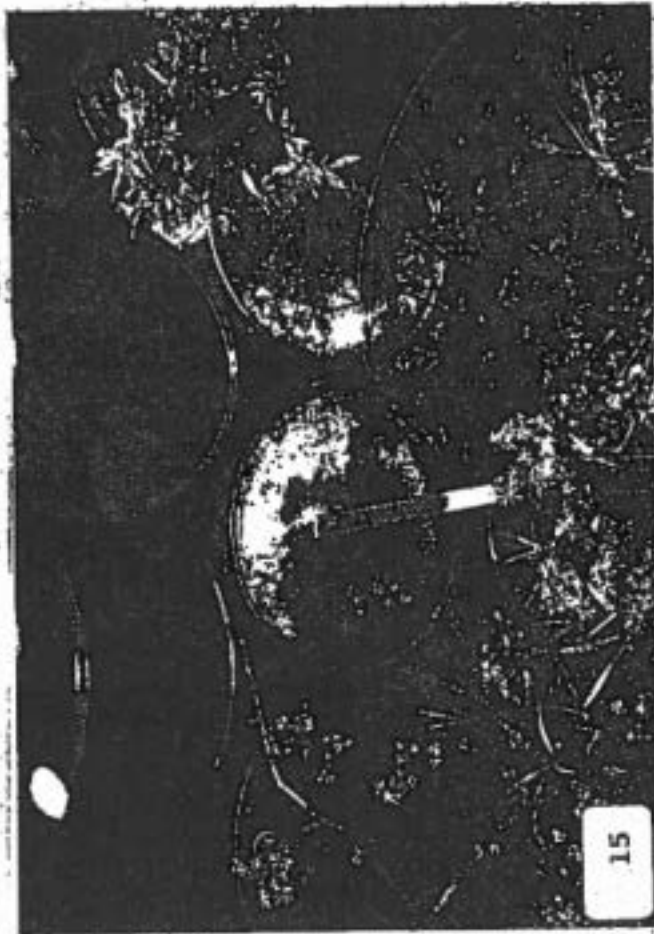
White Mountain National Guard PA (2 of 4)

14	8-12-98	1259	LM	Collecting sample SS06, facing south.
15	8-12-98	1305	LM	Sample SS06 location, facing west.
16	8-12-98	1310	LM	Sample SS07 being collected.
17	8-12-98	1320	LM	Various drum groups, facing west.
18	8-12-98	1322	LM	Drum group from where sample SS07 was collected (on near side), facing west.
19	8-12-98	1323	LM	Sample location SS07, facing east.
20	8-12-98	1325	LM	Sample location SS08.
21	8-12-98	1337	LM	Drums scattered to north from sample location SS08, facing north.
22	8-12-98	1340	LM	Drums scattered to the north from near sample location SS08, facing north.
23	8-12-98	1345	LM	Drums scattered to north from sample location SS08, facing north.
24	8-12-98	1346	LM	Drums scattered to west from sample location SS08, facing west.
25	8-12-98	1350	LM	Drums on west side of the all-terrain vehicle road, facing northwest.
