**RE: FINAL SOIL AND GROUNDWATER HANDLING, 1717 TIDEWATER ROAD,
ANCHORAGE, ALASKA; HAZARD ID. 25938; ADEC FILE NO. 2100.38.535**

This report presents the results of soil and groundwater handling activities conducted during the repair of a waterline at 1717 Tidewater Road in Anchorage, Alaska. A vicinity map and site plan are included as Figures 1 and 2, respectively.

Site Plan

Detailed Site Plan

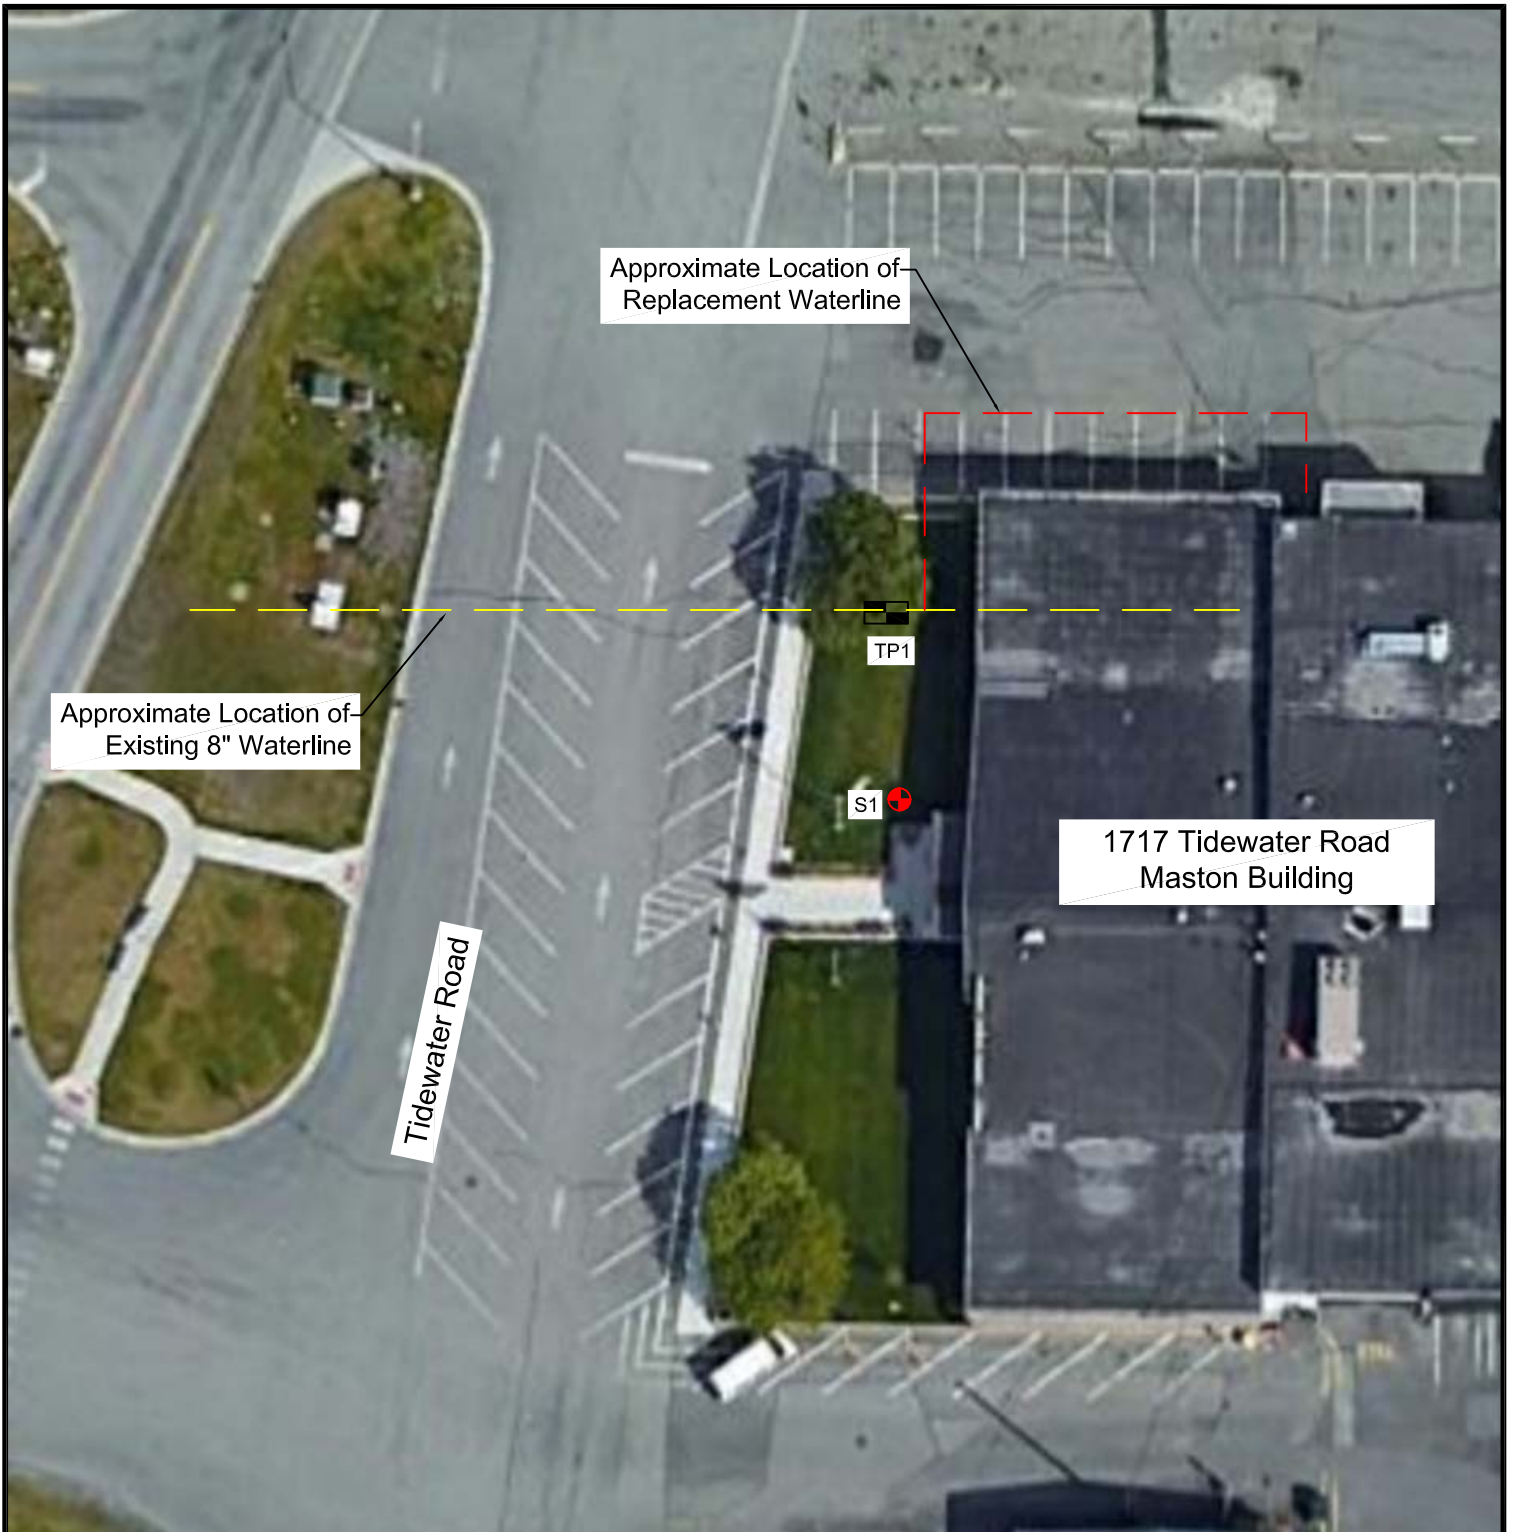
FIG. 2

Approximate Location of Test Pit TP1, advanced on December 5, 2019.

Approximate location of groundwater Sample S1, collected on November 21, 2019.

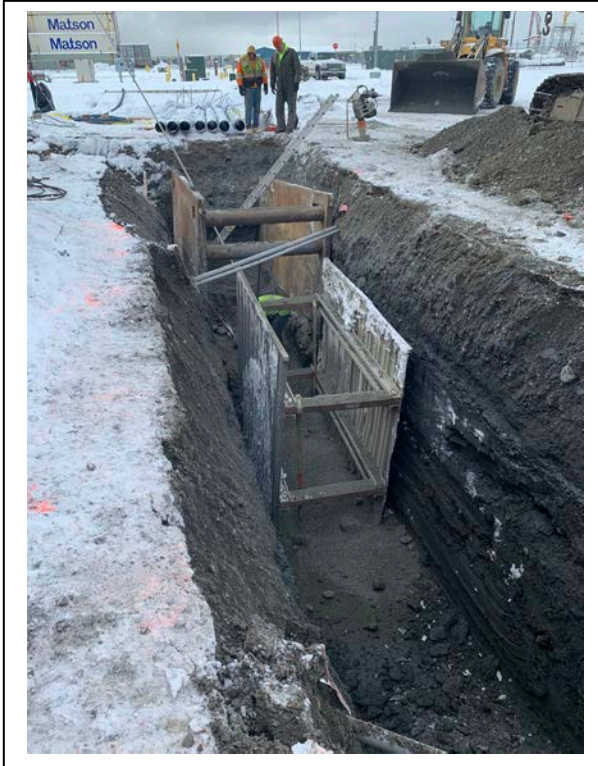
Photo 1: Looking west into the excavation. (February 25, 2020)

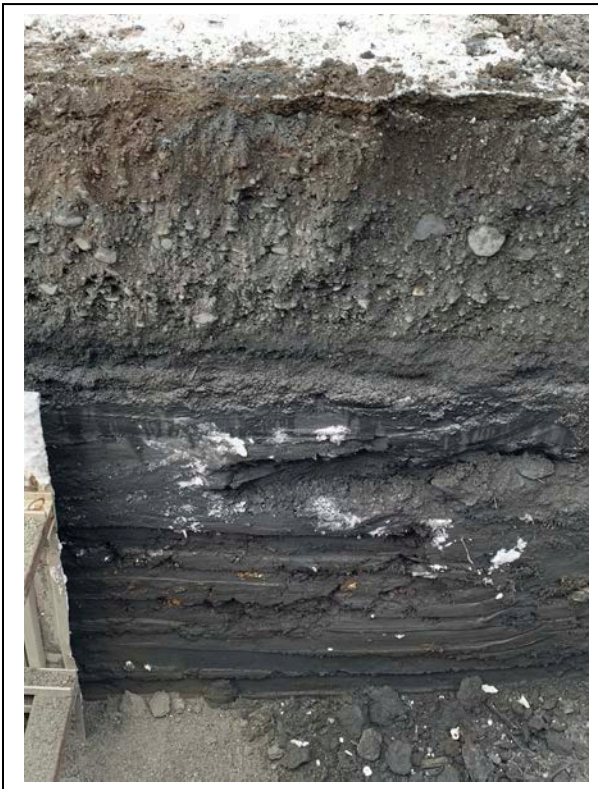
The soil encountered during excavation generally consisted of sand and silt with gravel from the surface to approximately 4 to 5 feet bgs. The remainder of the excavation consisted of silt and clay with organics (Photo 2). Groundwater was observed to seep into the excavation from directly above the silt/clay. Over time, groundwater accumulated in the base of the excavation and required dewatering, as discussed below.

Photo 2: Looking west at the excavation sidewall. Gravel, sand, and silt was present from the ground surface to about 4 to 5 feet bgs. The remainder of the excavation consisted of silt with clay and organics. (February 22, 2020)

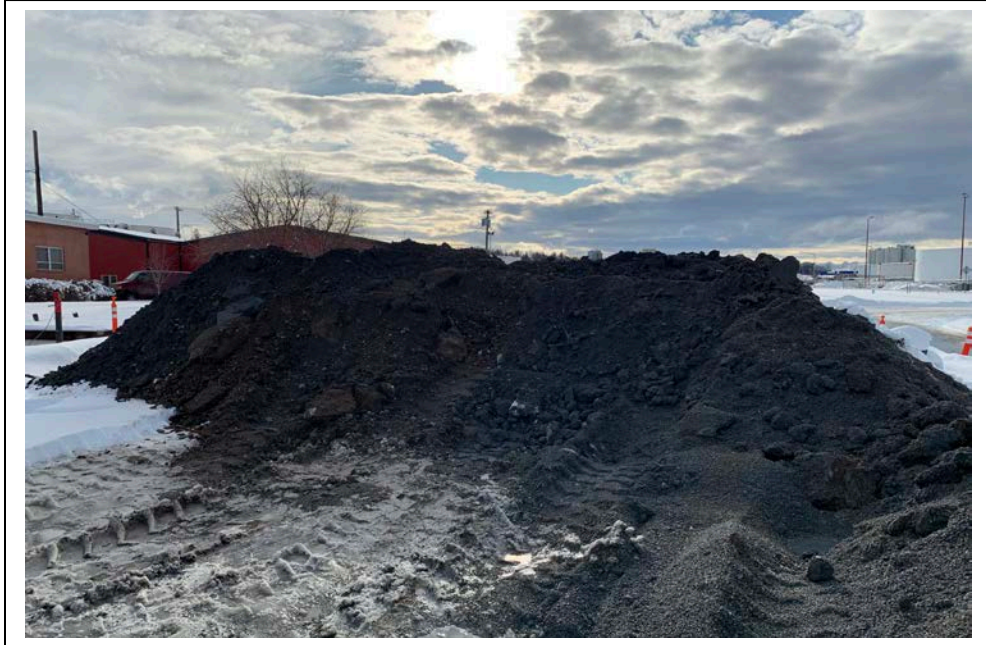
Soil with PID readings greater than 20 ppm, staining, or petroleum odors was temporarily stockpiled in a lined area onsite for transport to ASR for thermal remediation (Photo 3). The soil excavated using the vac-truck was also transported to ASR for thermal remediation. Soil with PID readings less than 20 ppm and geotechnically suitable for reuse, was temporarily stockpiled adjacent to the excavation. Soil that was stockpiled greater than one day was covered with a 6-mil liner to prevent precipitation runoff from the stockpile.

Photo 3: Looking south at the temporary soil stockpile, prior to transport to ASR. (February 20, 2020)

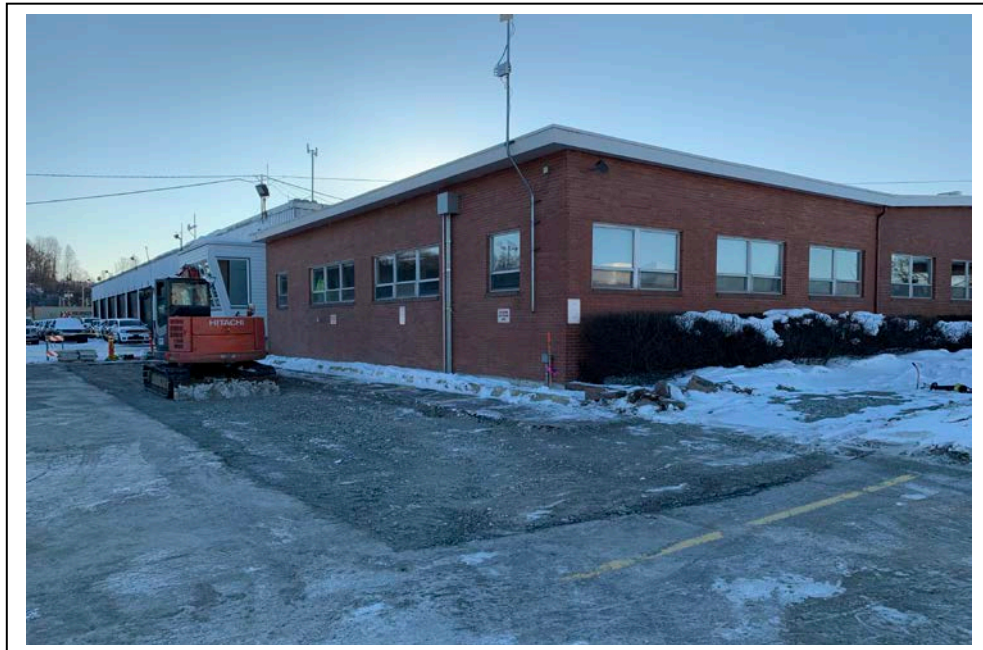
Imported bedding material was placed around the new pipe. Excavated material with PID readings less than 20 ppm, no visual or olfactory evidence of contamination, and geotechnically suitable was used to backfill the excavation. The remainder of the excavation was backfilled with imported fill material (Photo 4).

Photo 4: Looking east at the excavation, following backfilling. (March 5, 2020)
