2019 SUMMARY REPORT
Interior Texaco
DELTA JUNCTION, ALASKA

Subject: FINAL 2019 SUMMARY REPORT, INTERIOR TEXACO, DELTA JUNCTION,
ALASKA

Interior Texaco Delta Junction, Alaska	
Completed Site Characterization	
November 2020	31-1-11809-019
SHANNON & WILSON, INC. <small>GEOTECHNICAL AND ENVIRONMENTAL CONSULTANTS</small>	
Figure 2

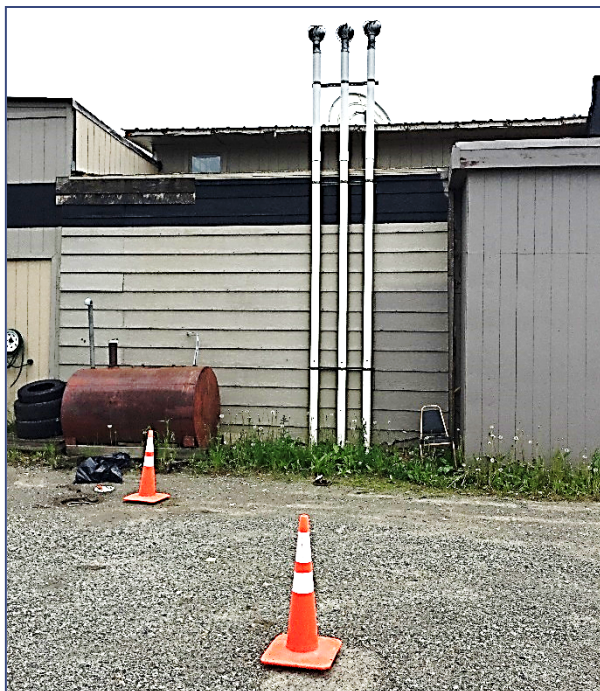
Exhibit 2-1: Wind-driven turbine ventilators mounted on the top of the passive remediation system on the north side of the building.

Details of the system were included in our *Corrective Action Summary Report* (dated November 19, 1999). The system consists of slotted PVC well casing installed vertically in borings to a depth near or below the local water table. The slotted casing extended from the bottom of the boring up to 2-feet bgs. These casings are attached to horizontal underground piping. The horizontal piping was attached to vertical vent stacks extending above the roofline of the building. Wind-driven turbine ventilators are mounted at the top of these stacks. The strong prevailing winds power the turbines. The turbines create a pressure differential between the extraction well and surrounding soil. That pressure difference (vacuum) volatilizes the hydrocarbons and extracts the resulting vapors from the contaminated soils surrounding the wells.

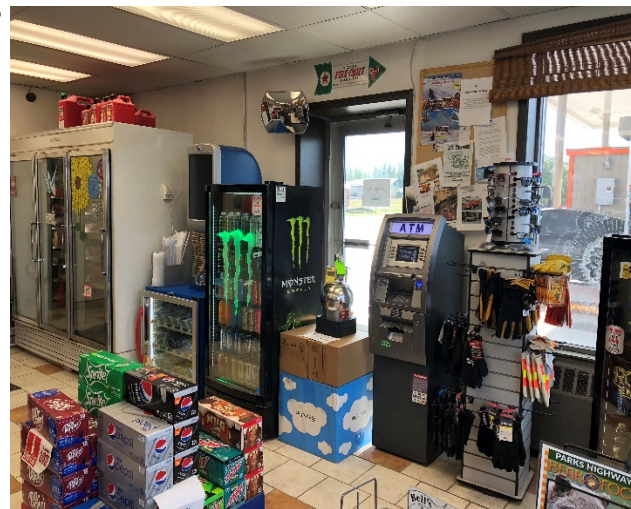
Exhibit 3-1: Indoor air sampling in progress (IA-01 sample location inside the store).

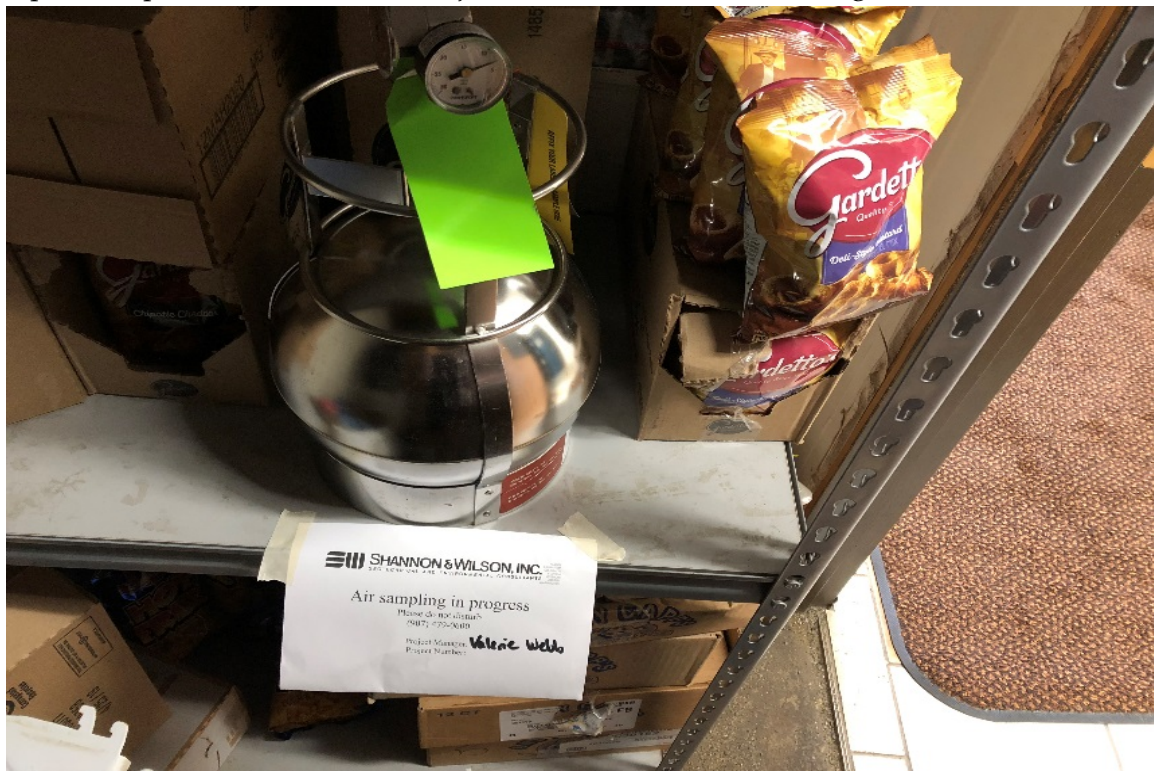
Exhibit 3-2: Indoor air sampling in progress inside the store closet (IA-02 sample location)

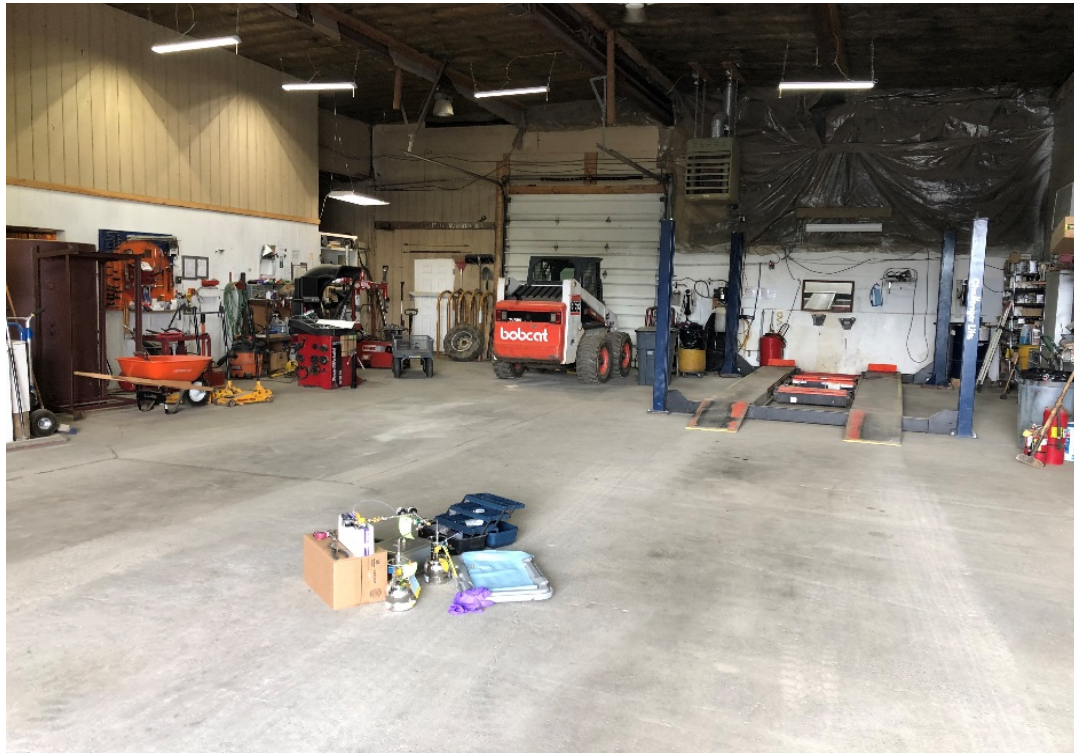
Exhibit 3-3: Subslab soil-gas sampling in progress inside the shop.

Sampling was completed in general accordance with our 2019 DEC-approved work plan and the November 2017 DEC *Vapor Intrusion Guidance*. We collected the samples using 6-liter summa canisters equipped with 24-hour flow controllers.

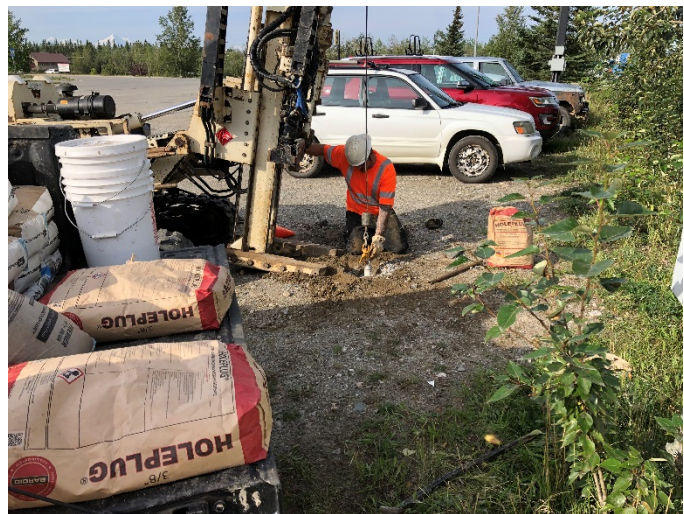
The wells were completed at depths of 30 to 50 feet below ground surface (bgs). Decommissioning activities were in general

Exhibit 3-4: Decommissioning MW-13 in August 2019

accordance with the September 2013 DEC *Monitoring Well Guidance*. The well casings were removed with the drill rig and the boreholes filled with sand and bentonite and finished at the ground surface with pea gravel.

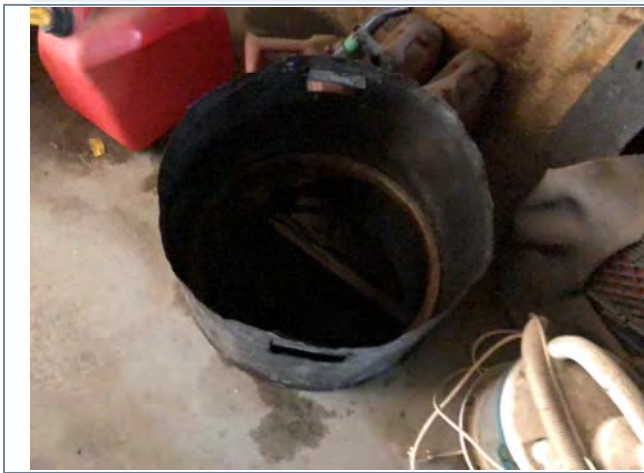
Photo 33: Used Oil Container with Apparent Surface Staining Inside the Shop Garage

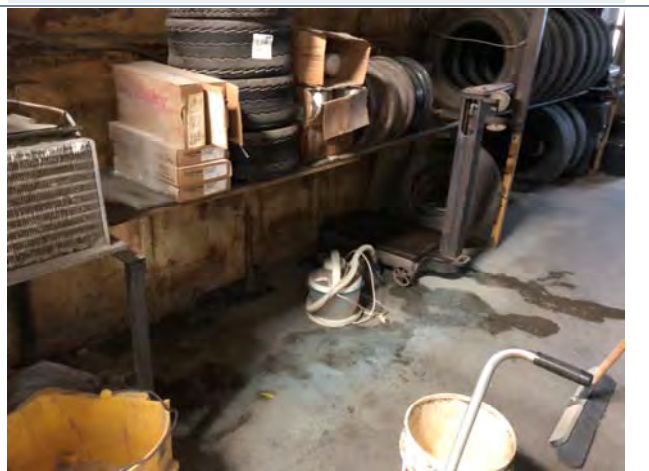
Photo 78: Tires & Tire Rims with Surface Staining
