SITE CLOSURE REPORT

3201 Hurst Rd.,
North Pole, Alaska 99705

December 6, 2013

ADEC File # 100.02.155

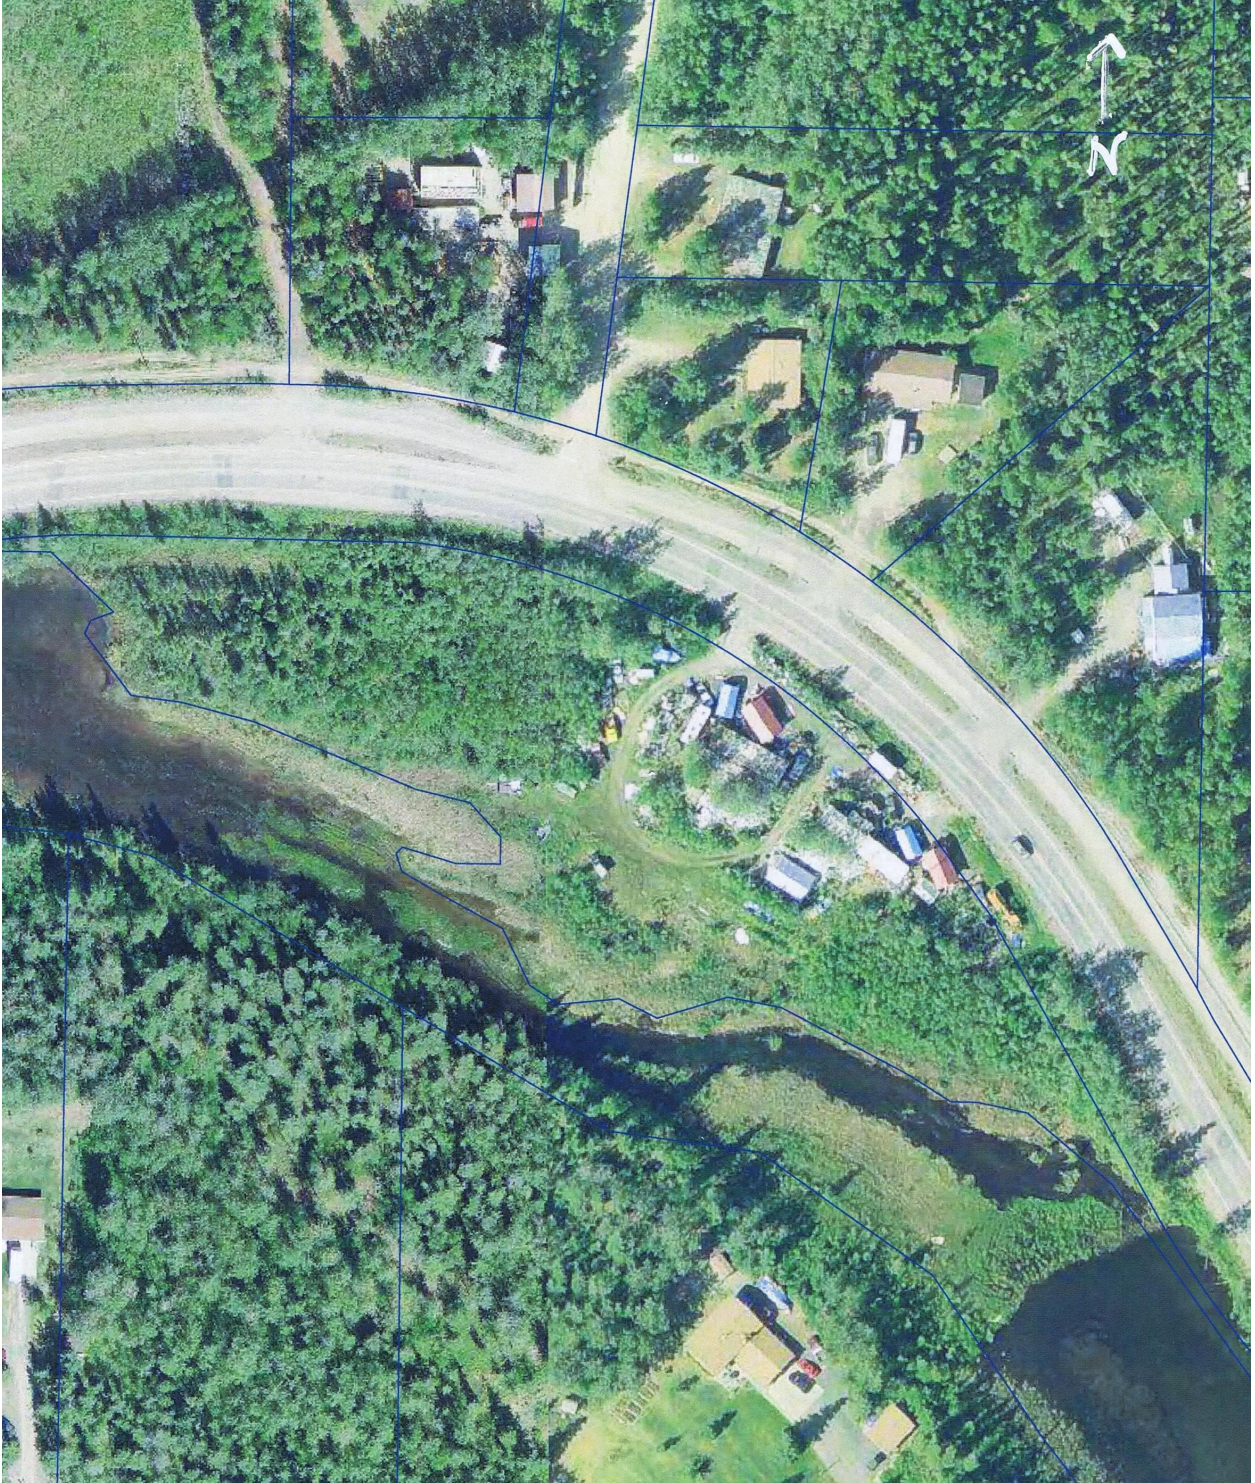
Figure 3. FNSB (2007) photo of 3201 Hurst Rd., North Pole, Alaska
(center of photo)

Figure 3 is a 2007 photograph taken by the FNSB. The property is featured in the center of the picture. This 1.75 acre Lot is located on an accreting (growing) side of Chena Slough which means the erosion is on the opposite side of the waterway. The property lines on Figure 3 are approximate and need to shift to the northeast. The site of the accident/spill is the red-roofed cabin to the west of the car seen travelling on Hurst Road. A shallow (30 foot deep) potable well (summer use) is located between the 2 red roofed cabins, to the NW of the spill site, adjacent to the horseshoe-shaped driveway. Another well lies 30 feet to the NW beyond the first well.

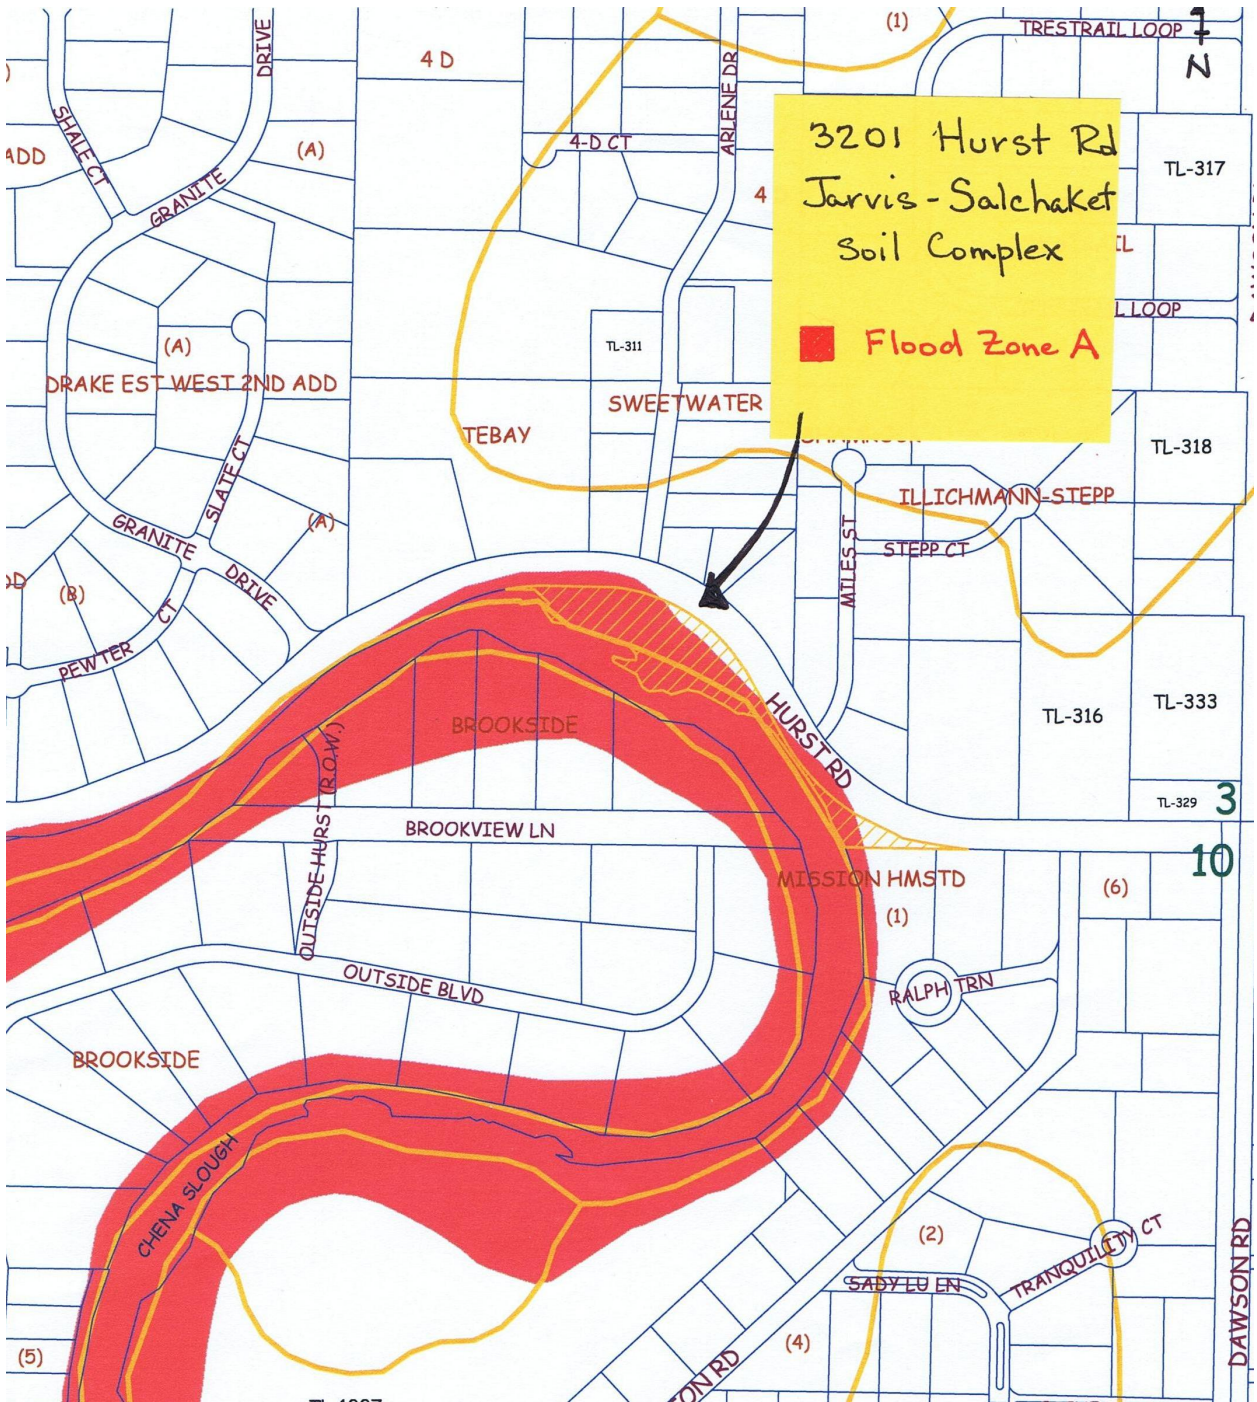
Figure 4. FNSB Soils and National Flood Insurance Rate Map

Figure 4 is a FNSB soils and flood zone map, based on a May 2010 topography map. The subject property lies within the Jarvis-Salchaket Soil Complex. Jarvis soils are very fine sandy loam, moderately deep, well-drained and do not contain permafrost. Salchaket soils are nearly level, well-drained soils recently deposited, These soils are sandy with some layers of silt and are underlain by thick deposits of coarse sand and gravel. Mr. Burnett brought in gravel to build the site up 3 ½ feet many years ago (personal communication). Most of property is located in Flood Zone A, a special flood hazard area inundated by the 100-year flood.

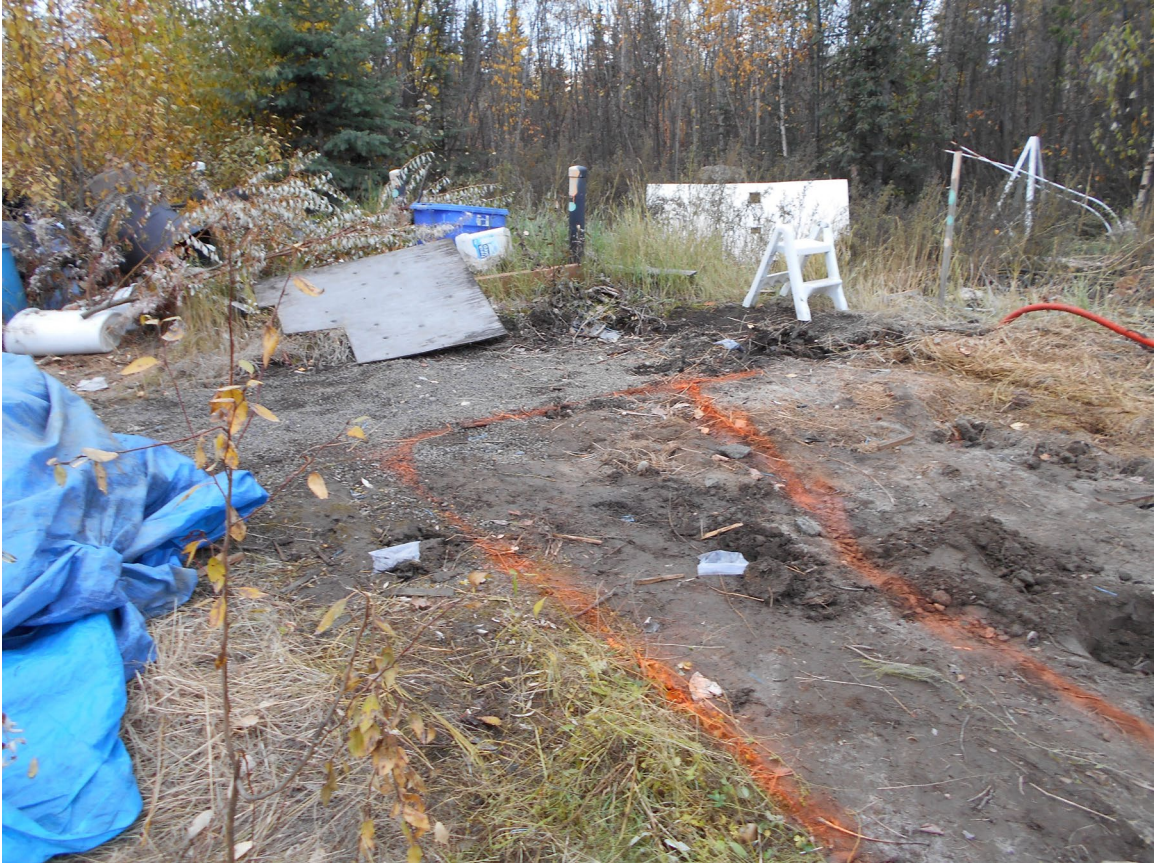
Figure 6 shows the pre-soils excavation AST/cabin site location during field screening.

Figure 6. Looking SE at a pre-soils excavation view of the cabin and above-ground fuel storage tank site, during soils field screening at 3201 Hurst Road, North Pole, AK, on September 26, 2013

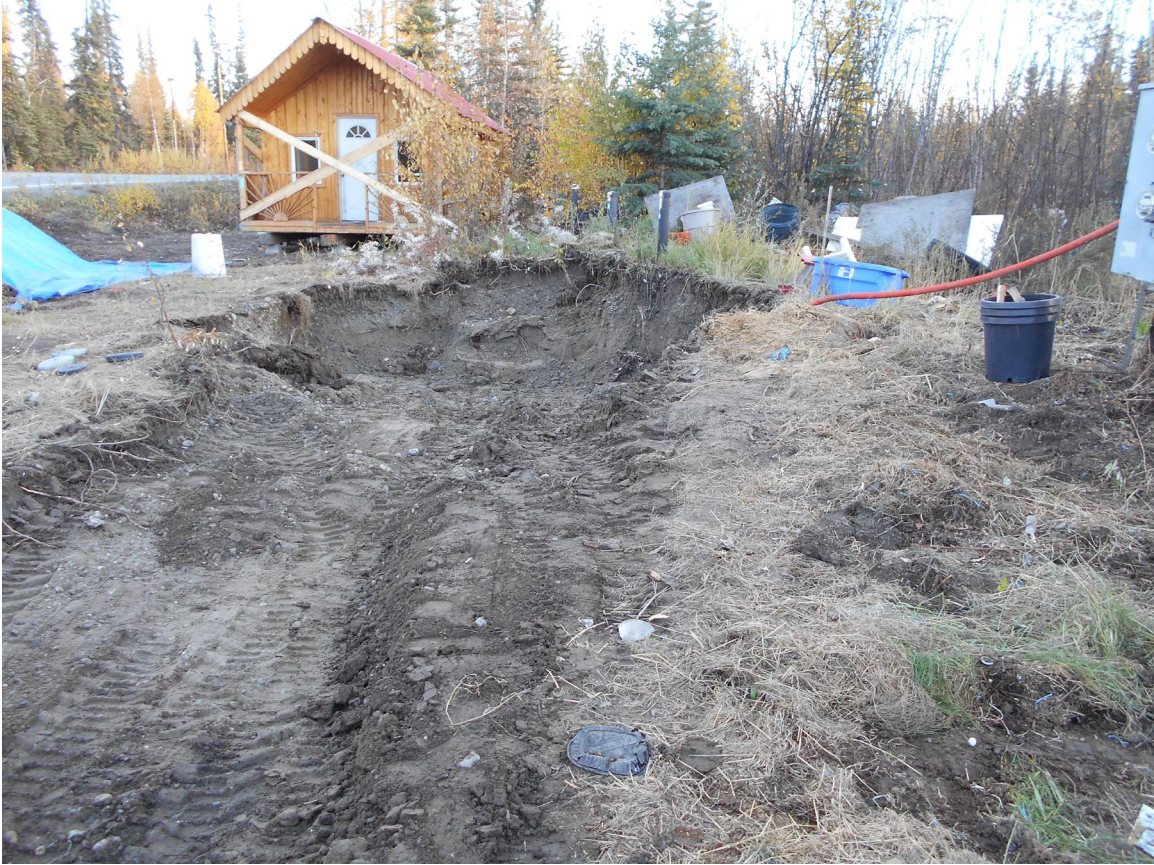
The ADEC authorized the Site Characterization Work Plan (Appendix A). Soil removal and stockpiling, field screening and soils sampling began on September 27, 2013. The temperature was sunny and 47 deg F. Spud Burnett, under the direction of Amundsen Environmental, used his Mustang Skidsteer to excavate contaminated soils from the former site of the AST and stockpile it on tarps laid out to the north (Fig.7). Figure 8 shows the stockpiled soils as of October 6th.

Figure 7. Looking east on September 27, 2013 at the former cabin and AST site after hydrocarbon-contaminated soils were removed and temporarily stockpiled under the blue tarp to the left in the photo

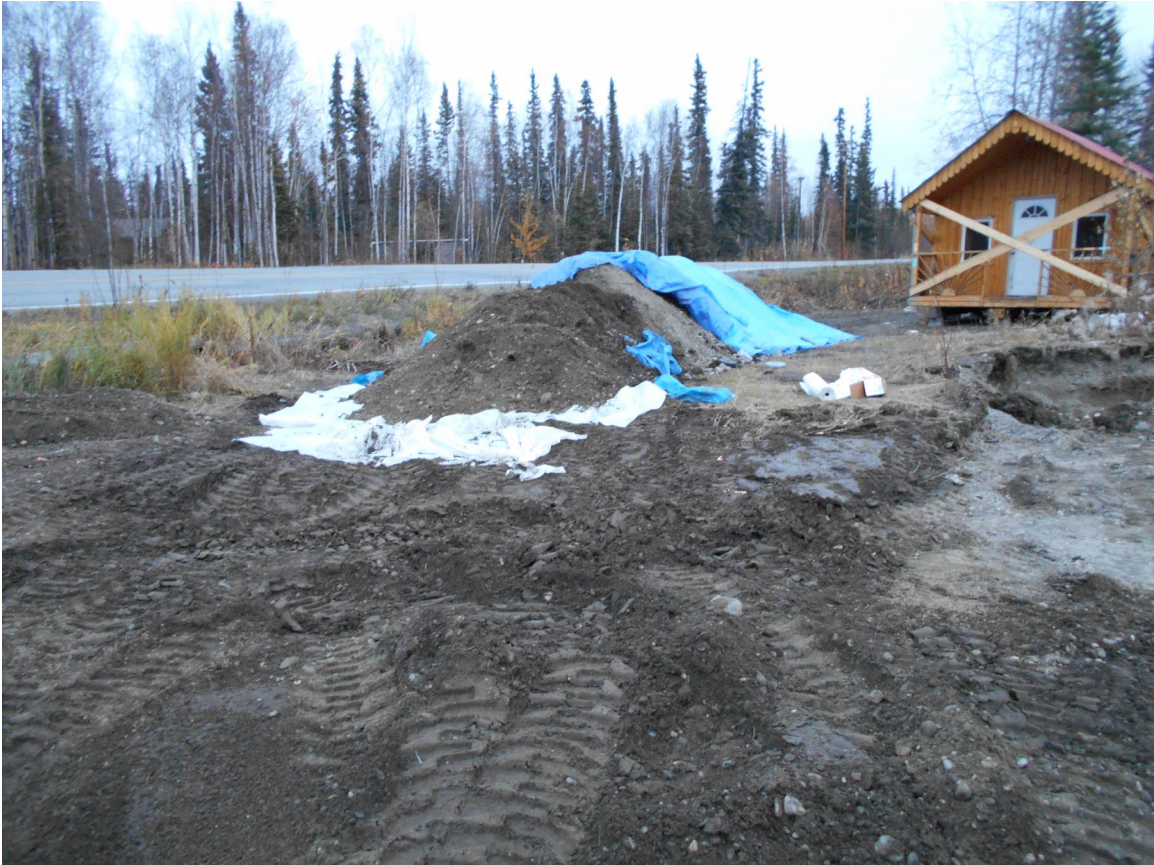
Figure 8. Looking NE on October 6, 2013 at the growing, temporary hydrocarbon stockpile at 3201 Hurst Rd.

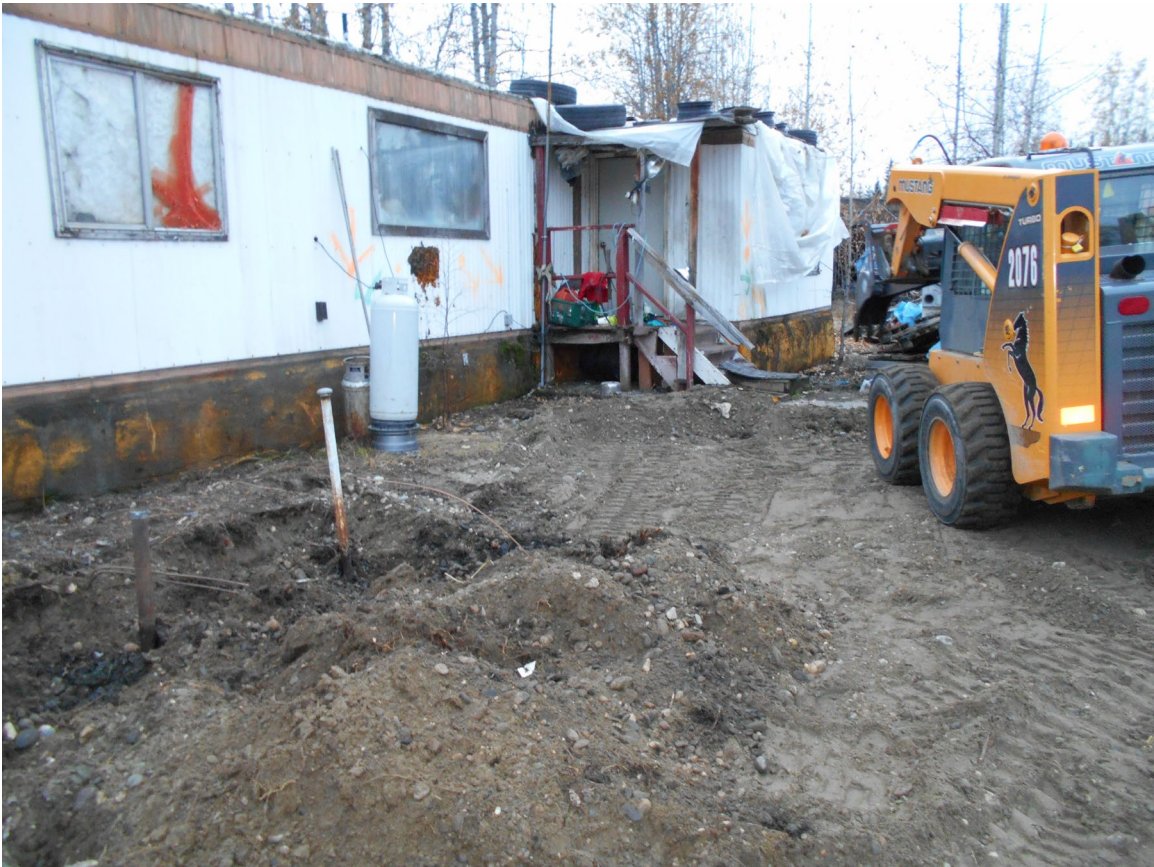
Figure 9. Looking West on October 6, 2013 at soil removal from the path of hydrocarbon transport during snowmelt and rainfall
