**FORMER GENERATOR BUILDING  
KOYUKUK, ALASKA  
PHASE I AND LIMITED PHASE II ENVIRONMENTAL SITE ASSESSMENT**

**AUGUST 2008**

**Submitted to: Yukon River Inter-Tribal Watershed Council**

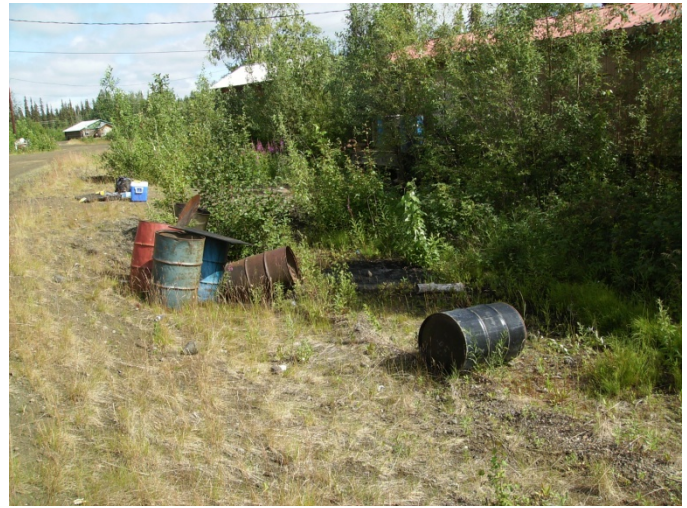
**Photo 2. Drums, Looking North**

porch on the west side of the building, and five more drums were located in a drainage ditch along Vista Street, to the west of the former generator building (Photograph 2 in Appendix A). Four of these drums appeared to be empty at the time of our site reconnaissance, but at least two had apparently discharged their contents onto the ground in the spring of 2008 (Photograph 3 in Appendix A). Soil stained by releases associated with these drums appeared to be impacted primarily by used engine oil, which was consistent with the reported drum contents. In general, the lot surrounding the building was covered with thick vegetation. An area with low vegetation, dominated by berry bushes and grasses, was located to the south of the former generator building (Photograph 4 in Appendix A). A pipeline that was used to supply fuel to both the former generator building and the school, located across Vista Street, was observed to the south of the building (Photograph 5 in Appendix A). This area was reportedly used historically for transporting fuel from tanks to a generator facility. A UST was located to the north of the former generator building, but this UST appeared to be abandoned and did not contain fuel. No staining was observed in association with this UST. Two pipes, reportedly belonging to a waste heat transfer system, emerged from the northern side of the generator building and made right turns, descending into the ground (Photograph 6 in Appendix A). Spools of insulated electrical wire were located to the north and to the east of the building.

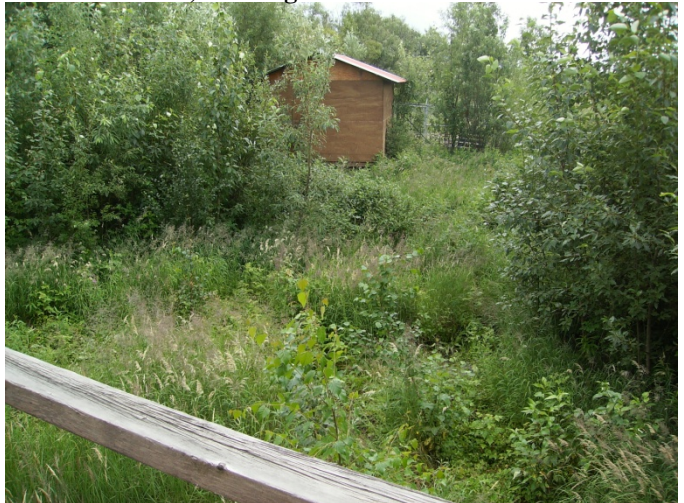
**Photo 4. Low-Lying Area, Looking South**

a low-lying area in which meltwater pools during the spring and in which fuel oil was reported to have pooled after overfill accidents. Soil in this area appeared to be uncontaminated for approximately the first two feet bg, but below that depth, exhibited staining and strong hydrocarbon odors. A soil sample taken from this location contained only one constituent greater than the applicable ADEC cleanup criterion, DRO, was detected at a concentration of 22,800 mg/kg.

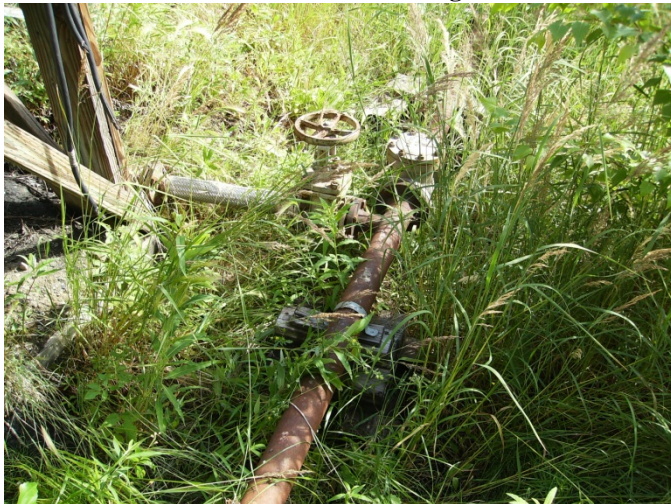
**Photo 5. Former Fuel Pipeline**

Another hand boring, GBS4, was located to the southeast of the former generator building in the general vicinity of a welded pipeline joint, located where the pipeline extended eastward into the thick brush, off of the subject property. This location exhibited its greatest PID reading of 859 ppm at a depth of 4 feet bg. This reading is consistent with concentrations of analytes of concern observed at GBS1 and GBS3.

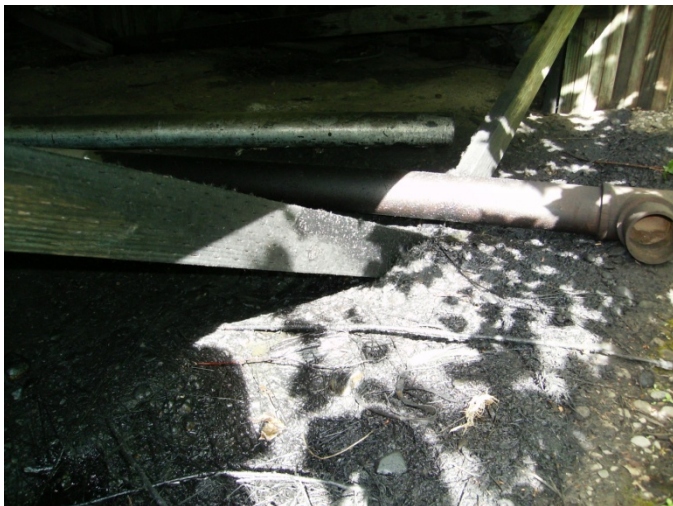
**Photo 7. Saturated Soil Beneath the Former Generator Building**

Portions of the ground surface below the former generator building were observed to be impacted by hydrocarbon contamination. In particular the area beneath the engine mounts was saturated with what appeared to be used motor oil (Photograph 7 in Appendix A). This staining appeared to be relatively localized and little evidence of further staining or impacts to surface soil were observed beneath the northern, southern, and western portions of the generator building, with the exception of staining in the immediate vicinity of the former fuel supply pipeline that supplied the former generator building day tank. It is our opinion that the presence of staining and soils that appear to be contaminated with both used engine oil and diesel fuel are recognized environmental conditions with respect to the subject property.

excavation as deep as it exists or until permafrost prohibits advancement of excavation, or until groundwater is encountered, or remediated by in situ technologies. Based on the relative remoteness of the site, excavation is likely to be the most cost-efficient method of cleanup. After removal of the maximum practical volume of contaminated soils, the excavation area should be backfilled with clean soils to mitigate the inhalation exposure pathway. The inhalation pathway may already be mitigated by construction practices in the City of Koyukuk. Many buildings are constructed on pilings that leave a large amount of draft space between the ground and the structure, potentially mitigating the exposure of building inhabitants to volatile constituents. Future construction on the subject property should take this practice into account if contaminants are left in place after completion of excavation or other remedial actions.

Based on the estimated large volume (potentially greater than 200 cubic yards) of contaminated soils, a likely remedial alternative for these soils, would be placing the soils in a long-term biocell designed to store and treat the soils. Fertilizer could be added to the soils to promote biological degradation. Vent piping with a variety of potential ventilation systems could be placed within the pile to actively or passively promote both volatilization and biological degradation. Unfortunately, some soils at this location appear to be contaminated with significant quantities of RRO, which is unlikely to volatilize or break down rapidly, even under favorable conditions. Soils containing large quantities of RRO should be segregated from other soils. After attenuation has been tracked over several seasons, it may be possible to determine if soils contaminated with RRO will eventually meet ADEC cleanup levels, or if they should be subjected to another active remedial option, such as thermal treatment.

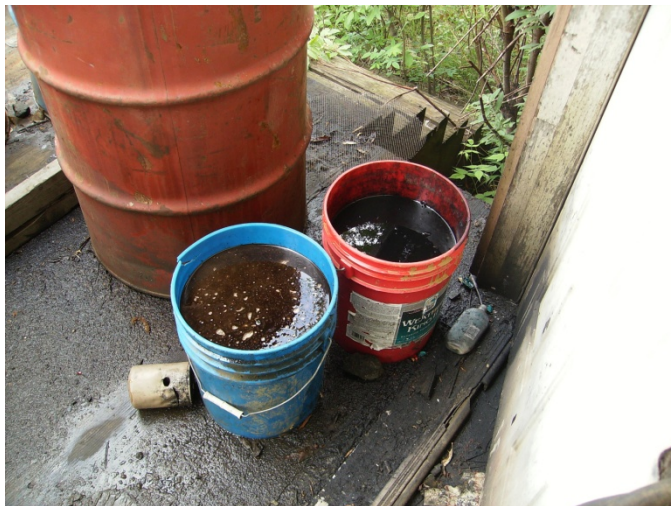
**Photo 8. Buckets of Used Oil**

variety of equipment and supplies associated with the operation of a rural power plant. Buckets of used oil were located throughout the building's interior, as well as on the porch located on the east side of the building (Photographs 8 through 10 in Appendix A). Five drums were located on the porch (Photograph 1 in Appendix A). These drums appeared to be full and their contents were not clearly marked. Bags containing oily absorbent rags and other waste were also observed in this area. While hydrocarbon staining was observed both on the porch and on the concrete floor in the building's interior, the only area of surface soil that appeared to be impacted by these releases was located beneath the engine mounts in the eastern portion of the building as was previously discussed in section 6.2.1, above. Other items noted inside the generator building included batteries (Photograph 10 in Appendix A), fluorescent lighting, fluorescent tubes, hardware, containers of battery acid, cases of unused motor oil, empty motor oil containers, a space heater, a tool cabinet, belts, engine parts, used oil and fuel filters, unused oil and fuel filters, and debris (Photographs 11 through 13 in Appendix A).

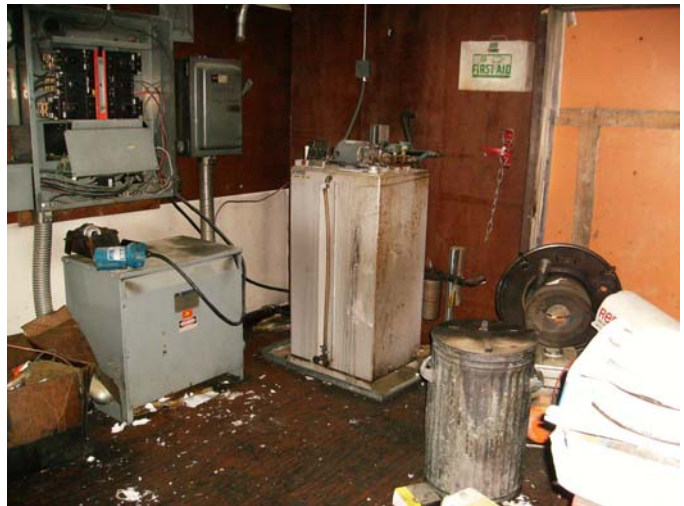
**Photo 14. Former Generator Building Day Tank**

The former generator building's day tank was located in the southern portion of the building, near the building's primary electrical breaker box (Photograph 14 in Appendix A). The day tank appeared to have a capacity of approximately 50 gallons and had a shallow containment basin located around the base. No evidence of leaks or releases was observed in association with this day tank. Overfilling of this day tank was reported to be the source of at least two historical releases. Observations of the building's interior were consistent with reports that fuel was not released from the tank inside the building, but rather was forced out the vent spout onto the roof due to the failure of a fuel monitor that allowed the day tank supply pump to continue pumping after the tank was full.

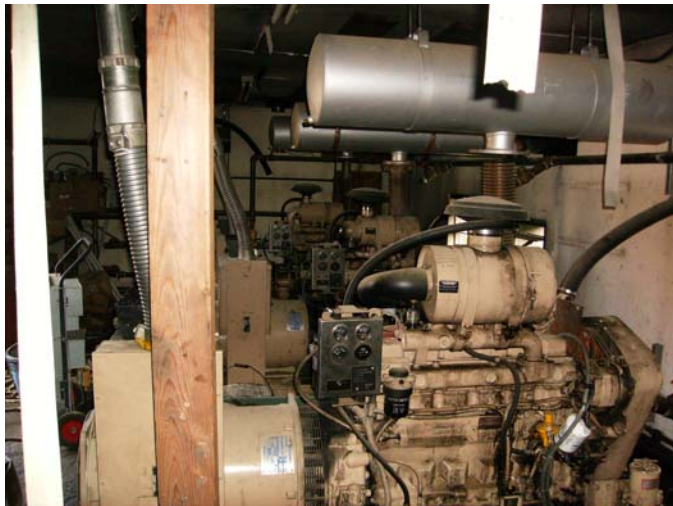
**Photo 15. Electrical Generators**

Three generators were mounted in the east-central portion of the building (Photograph 15 in Appendix A). The floor beneath the generators appeared to be saturated with diesel, and the ground beneath the generators appeared to be saturated with used oil, likely mixed with diesel. This saturated soil has previously been cited as a recognized environmental condition in section 6.2.1, above. The engine cooling system, heat exchanger, and waste heat piping system were located in the northern portion of the generator building (Photograph 16 in Appendix A).

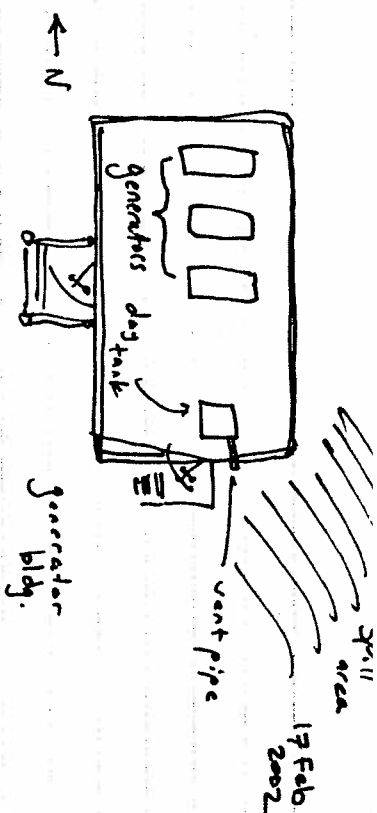
Fuel overfilled the day tank. The automatic shut-off failed. Fuel came out the air vent pipe onto the roof as well as out of another hole (fill hole?) on the tank and spilled inside the bldg. The roof is pitched so that contamination started at the S.E. corner where the fuel ran off of the roof.

The ground beneath the bldg. is very contaminated. It appears that a great deal of the fuel (large majority?) went under the building. No where was the soil completely soggy with oil except for right near the corner (S.E.).

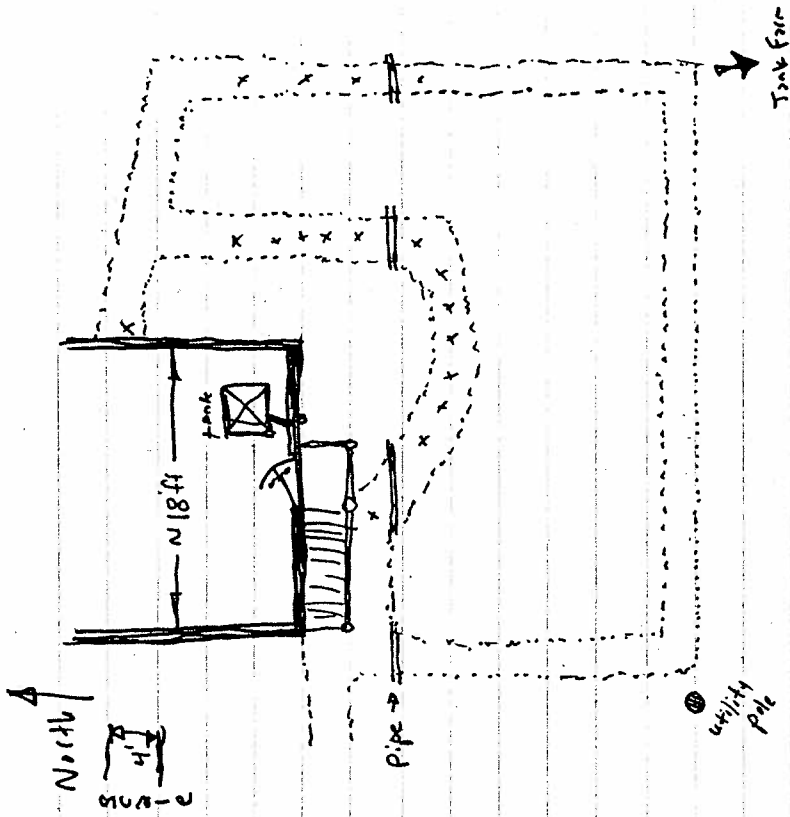
0800 I started jotting down notes and digging a new outer perimeter trench. There was a little contamination (designated with "x") as shown in diagram on eastern side but nothing anywhere else.
