KENAI AIRPORT FUEL SERVICE
Phase I December 1991
UST Site Assessment Report
Kenai Airport
Kenai, Alaska

Project No. 91189
December 1991

Re: Phase I UST Site Assessment

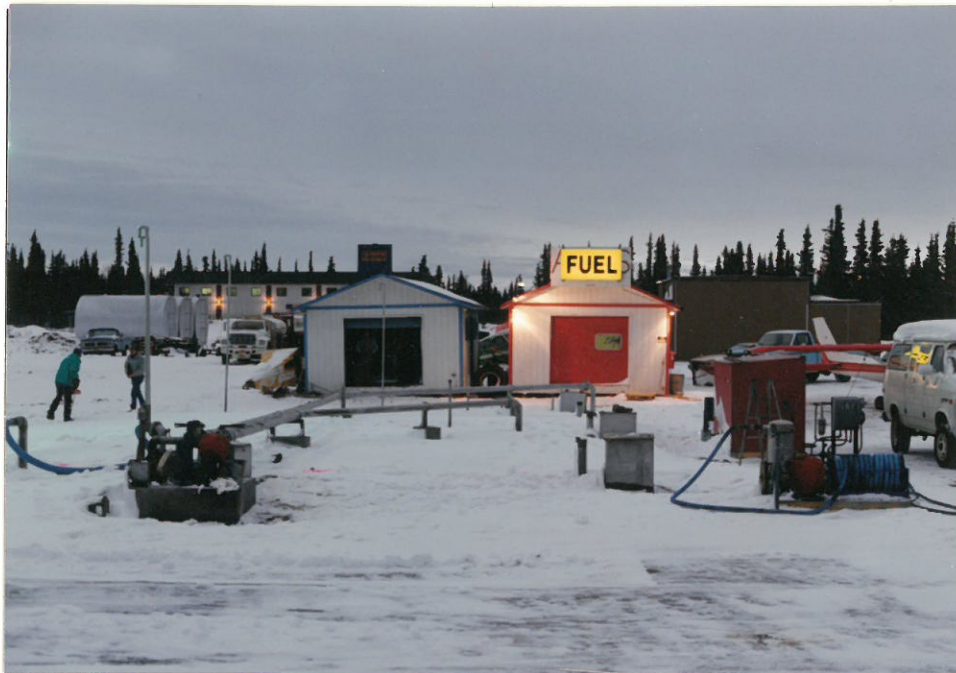
Photo #1: Kenai Airport Fuel Service

The USTs, three 10,000 gallon tanks and one 1,000 gallon tank are located between the Kenai Airport terminal and the air traffic control tower. The facility is

used to fuel airplanes and is located next to Alaska Flying Network. See Photo #1: Kenai Airport Fuel Service. The tanks currently contain jet aviation fuel, aviation gasoline, 100 low lead and the 1,000 gallon tank contains regular unleaded gasoline.

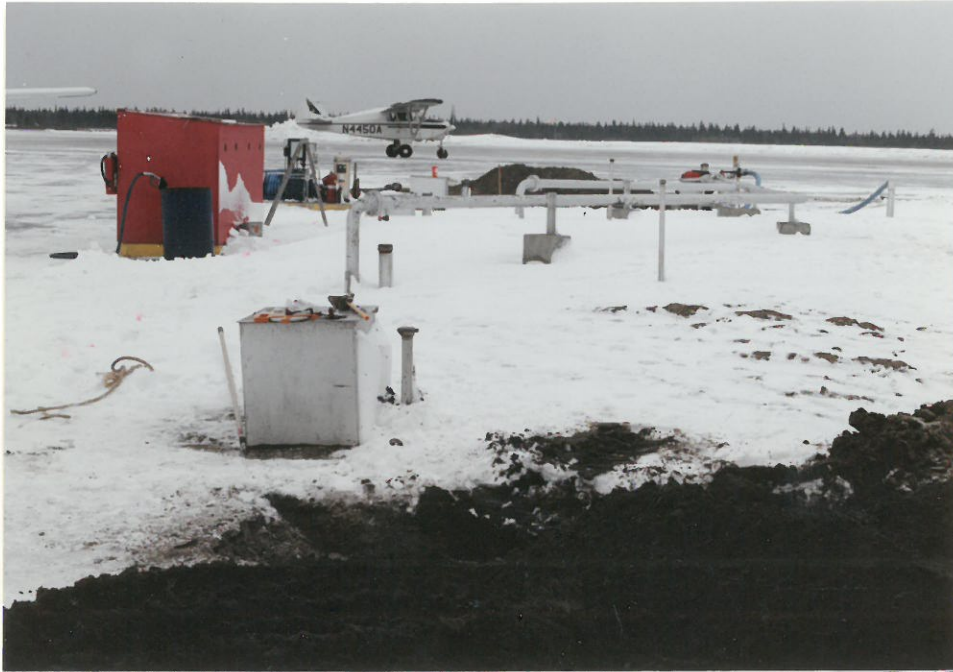
Photo #2: TP#1 in Background and TP#3 in Foreground

Our initial site visit was conducted on December 3, 1991. The tank area was inspected for gross contamination. Evidence of fuel was present on the ground in the area of the western pump island. A test pit was excavated in the area of the western pump island. See Figure 2: Sample Location Map and Photo #2: TP #1 in Background TP#3 in Foreground. Test Pit #1 (TP#1) was excavated to a depth of nine feet below ground level. OVM readings in the soil increased with depth as the excavation was expanded. OVM Readings are presented in Table 2: Test Pit #1 OVM readings.

OVM #	DEPTH	OVM READING
1	1.5 feet	1280 ppm
2	2.5 feet	1351 ppm
3	5 feet	1555 ppm
4	6 feet	1733 ppm
5	7 feet	3177 ppm

There was a slight fuel sheen on the surface of the water in the excavation.

The Phase I site assessment did not identify the extent of contamination at the site. test pits were located in easily accessible areas that did not require excavation on the airport tarmac. A Phase II assessment should be conducted with the installation of a minimum three monitor wells to determine the direction of groundwater flow and extent of soil and groundwater contamination.

Soils on site need to be remediated. Available alternatives include incineration, bio-remediation, landfilling, landfarming, or solidification. Groundwater remediation on site must also be considered.

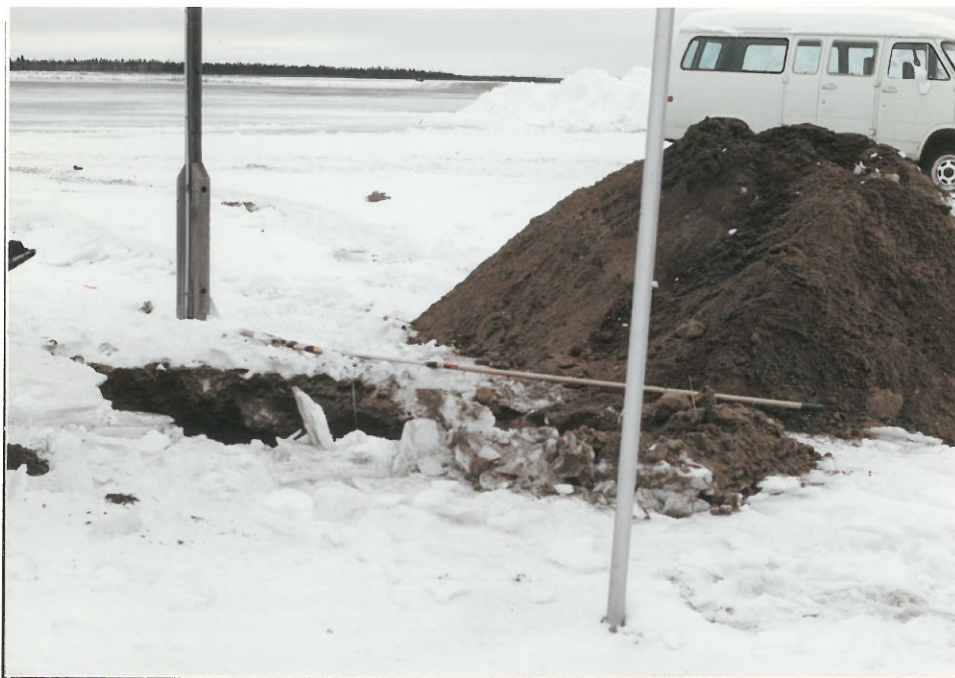
Photo #3: Test Pit #2

Test Pit #2 (TP#2), was excavated on the north side of the tank field, five feet

north of the vent pipes. See Photo #3: Test Pit #2. The excavation was extended to 8 feet BGL where water was encountered. OVM samples were measured as the excavation was expanded. OVM sample results are presented in Table 4: TP#2 OVM Results.

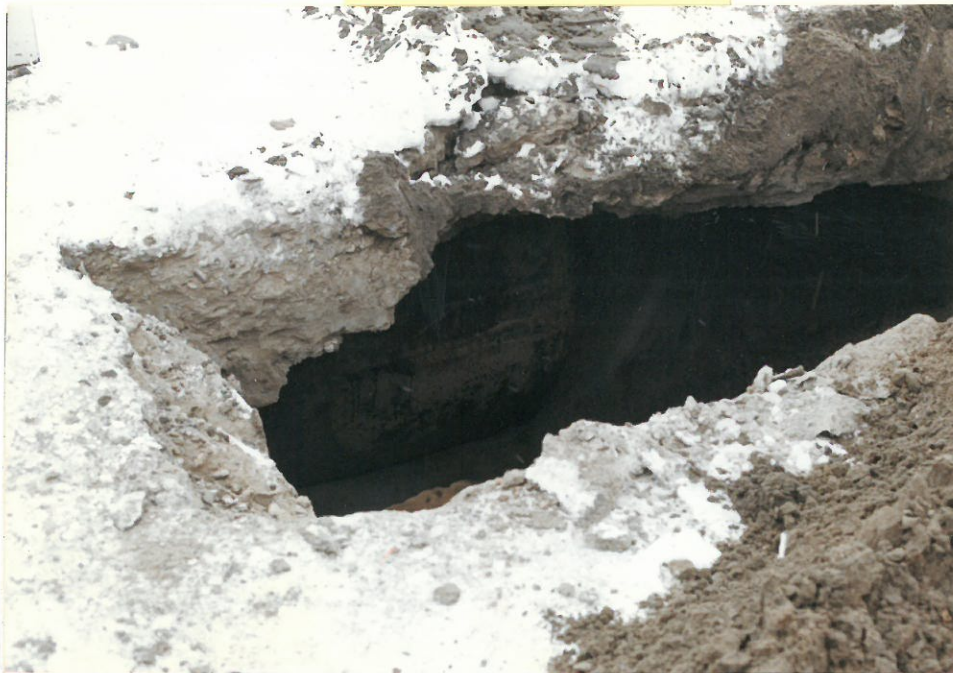
Photo #4: Test Pit #3

Test Pit #3 (TP#3), was excavated near the [redacted] tank field, 25 feet east

of the office building. See Photo #4: Test Pit #3. The excavation was extended to 6.5 feet BGL where water was encountered. Soil samples were measured with the OVM as the excavation was expanded and there were no elevated OVM readings in the excavation.
