**KENAI AIRPORT FUEL SERVICE
UST REMOVAL SITE ASSESSMENT
Kenai Airport
Kenai, Alaska**

**Northern Test Lab
35186 Spur Highway
Soldotna, AK. 99669**

**Project No. 91189
January 1994**

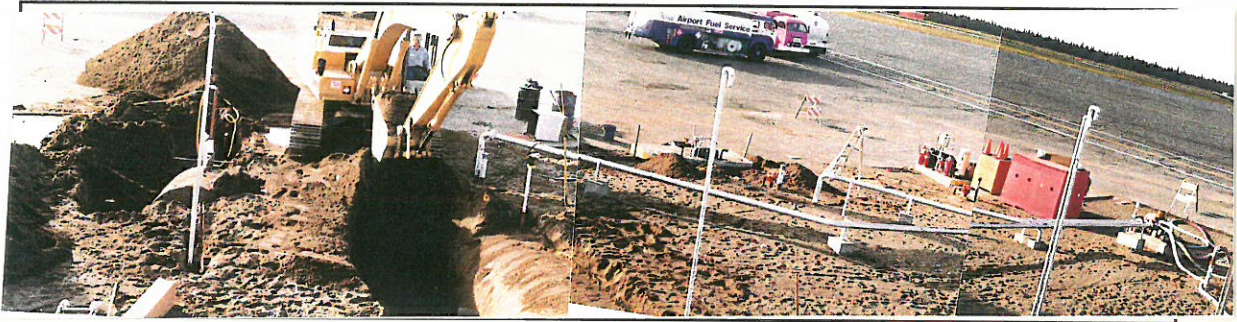
As venting continued on Tank #1, we began excavating on the east side of Tank #2. See Photo #1: Tank Layout

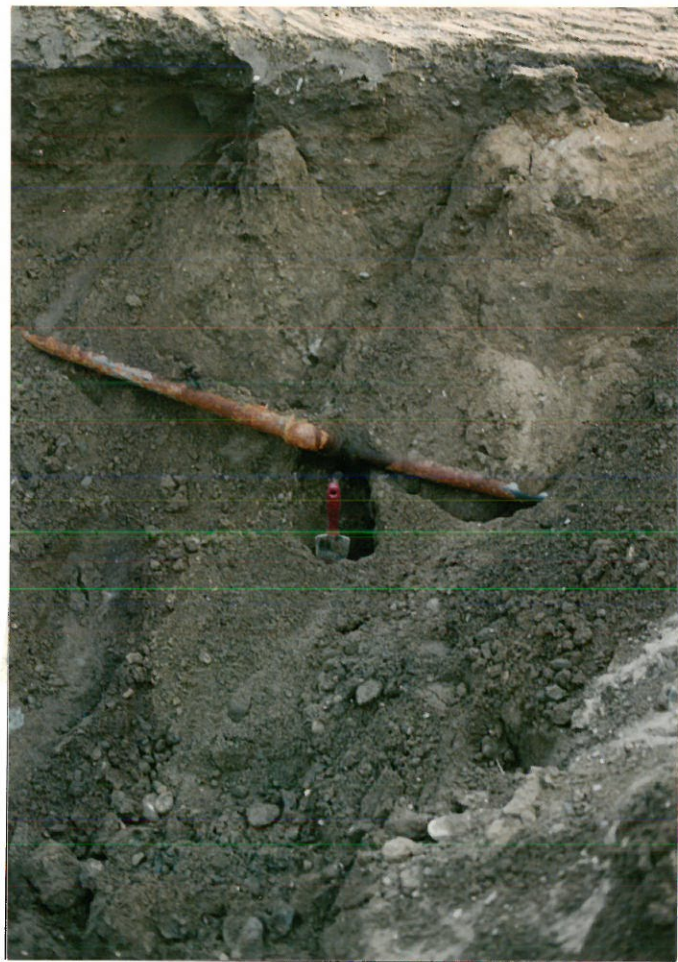
Photo #3: Product Piping Sample Location

Tank #2 was inspected and no direct evidence of leaking was identified. Minor pitting was noted on the tank, but no breach was identified. The tank was in good condition. However, every joint examined in the underground piping network appeared to be a source of contamination. See Photo #3: Product Piping Sample Location. Fuel can be seen leaking from the pipe joint. Soil sample KF-01-10-ULP was collected from this area, which was the unleaded fuel tank pump piping. The soils adjoining the tanks were grossly contaminated, with strong fuel odors emanating from the excavated soils.

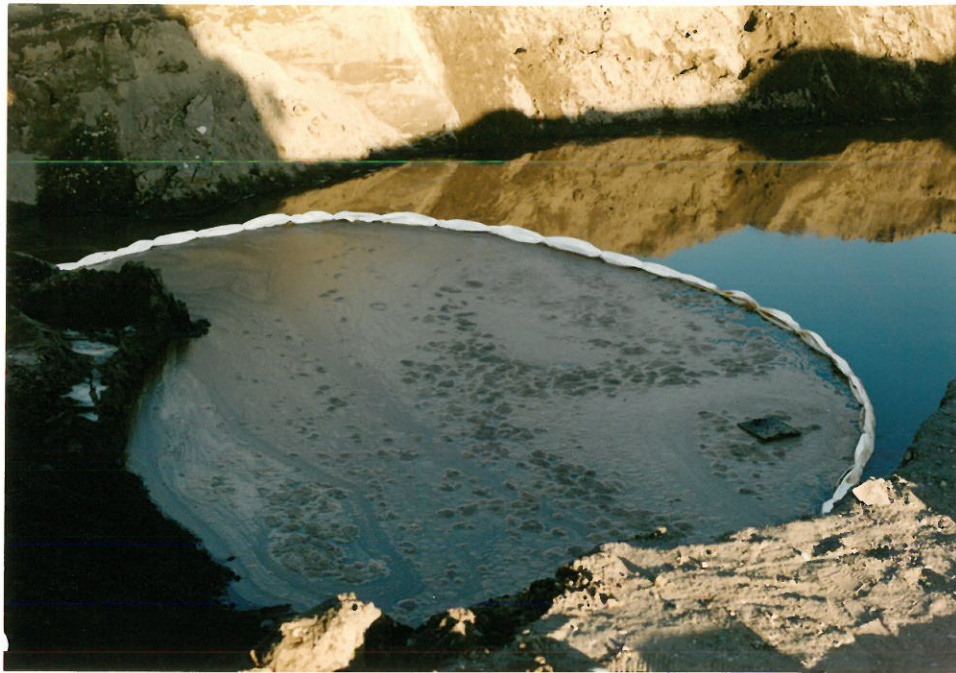
Photo #4: Free Product Recovery

Free product was entering the excavation from the excavation sidewalls at the watertable. One of our first goals was free product recovery. The fuel contaminated soils were removed to approximately one foot below the water table. Free product was then captured using sorbent material as a boom. See Photo #4: Free Product Recovery.

Approximately 600 gallons of free product was then skimmed off the water surface into a pumper truck owned by Chumley's, and hauled to Tesoro Refinery in Nikiski for disposal. Tesoro refused to accept the material, it was kept in one of Chumley's trucks, until the truck was called to Kenai Pipe Line Company where it was pumped into a recovered oil tank so the truck could be used for other purposes. After the free product had been removed, product continued to leach into the excavation from the southwest and south sidewall and from the area under Pump Island #3. See Photo #5: Leaching fuel.

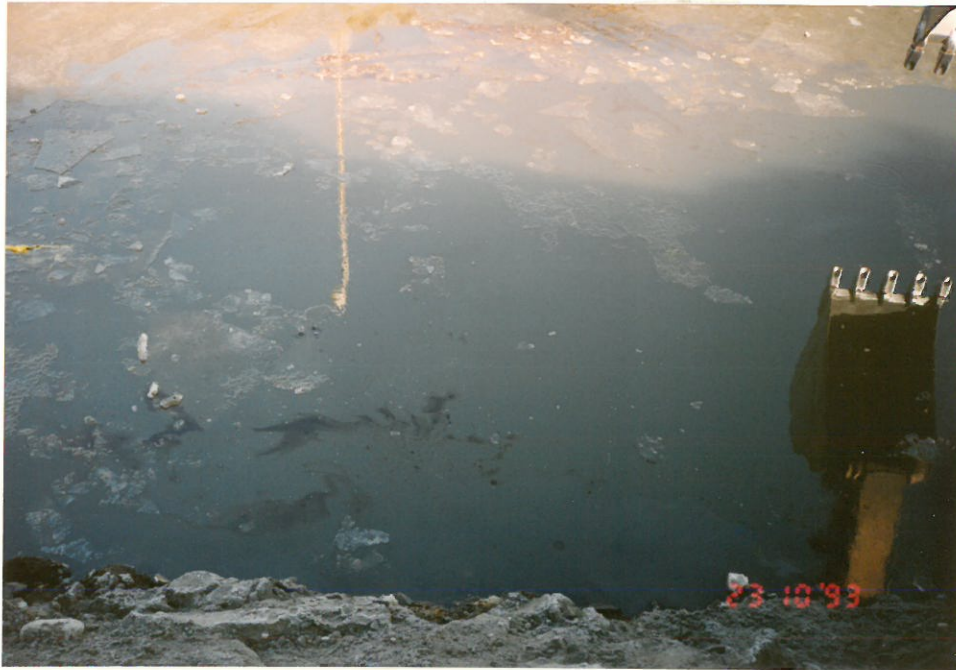
Photo #6: Leaching Product and Ice on Water Surface

A thick oily substance was leaching into the excavation from the south side wall near the end of Tank 2. See Photo 6: Leaching product and ice on water surface. Additional attempts were made on 10/23/93 to capture petroleum on the excavation water surface. Boom material was drawn across the water surface and then wrung out into a fifty-five gallon drum. Approximately 25 gallons of product was captured. After the water surface was skimmed with the boom material, a water sample was collected to characterize water in the excavation. A sample was collected by immersing a disposable bailer into the water and transferring the sample into the appropriate container. Sample results are presented in Table 6: Excavation Base Water Sample.
