**FAIRBANKS ENVIRONMENTAL SERVICES**

RE: 2014 Soil Gas Survey Report, Rev2  
Former Mammoth Trucking Site  
Anchorage, Alaska  
ADEC Hazard ID – 23887 / File ID – 2100.26.202

**EXECUTIVE SUMMARY**

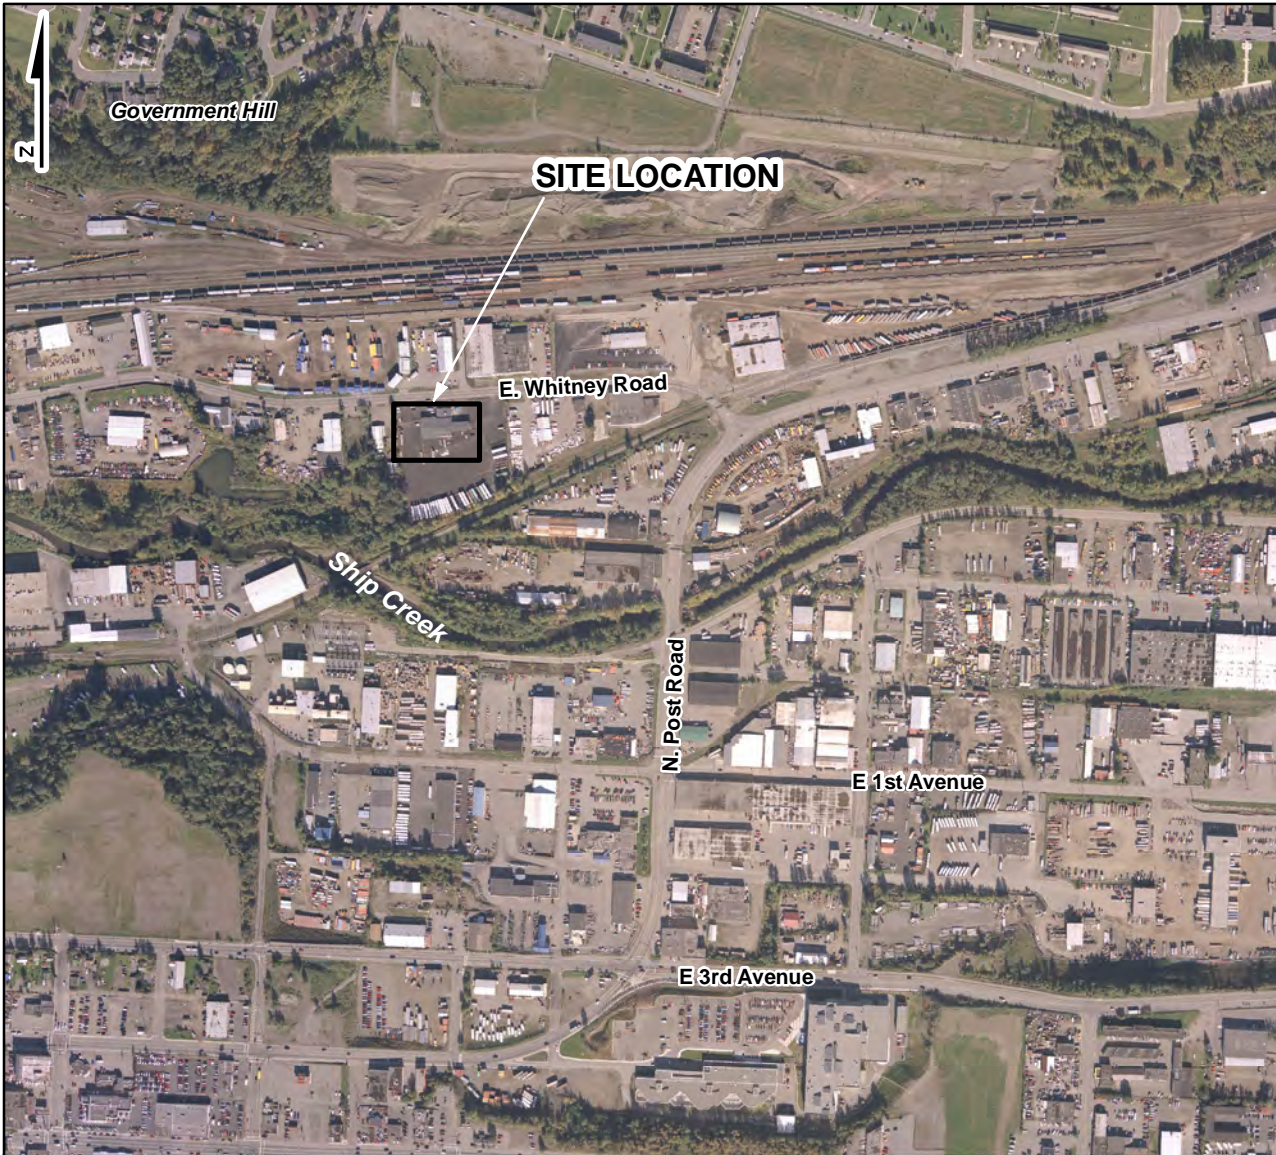
FIGURE:  
1

The Former Mammoth Trucking Site is located at 1048 E. Whitney Road in Anchorage, Alaska.

**Vicinity Map**

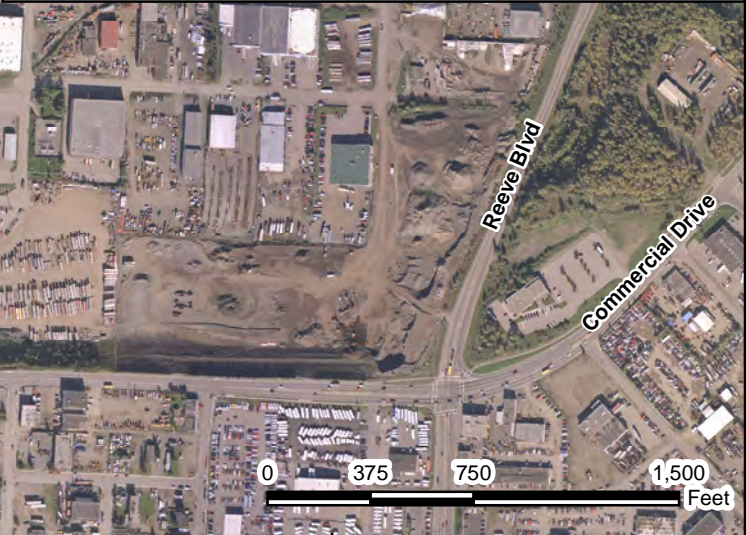
CONTRACT: 85304	FIGURE: 2	DATE: 12/14
--------------------	--------------	----------------

Only results in excess of ADEC groundwater and Method Two soil cleanup levels are displayed. Groundwater results are displayed in milligrams per liter (mg/L). Soil results are displayed in milligrams per kilogram (mg/Kg).

**Previous Groundwater and Soil Cleanup Level Exceedances**  
 2014 Report  
 Former Mammoth Trucking Site  
 Anchorage, Alaska

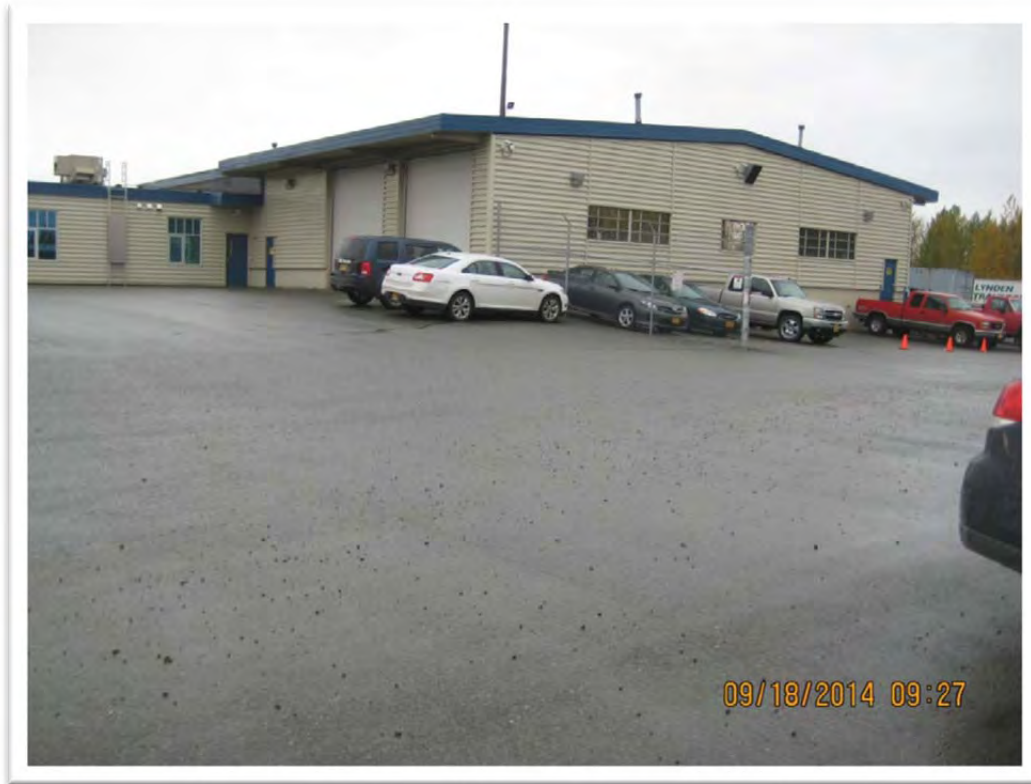
Photograph 1 – View of the site. View to the southeast.

The former Mammoth Trucking site is located at 1048 East Whitney Road in Anchorage, Alaska (Figures 1 and 2). The subject property is currently leased to Alaska West Express by the ARRC. Site improvements include a building surrounded by a large, paved yard. The site is underlain by a shallow, unconfined aquifer. The building which was constructed on a slab-on-grade foundation includes a shop with two large bays on the extreme west end, and office space immediately east of the shop. As shown in Photograph 1 in Appendix A, the local topography slopes to the south.

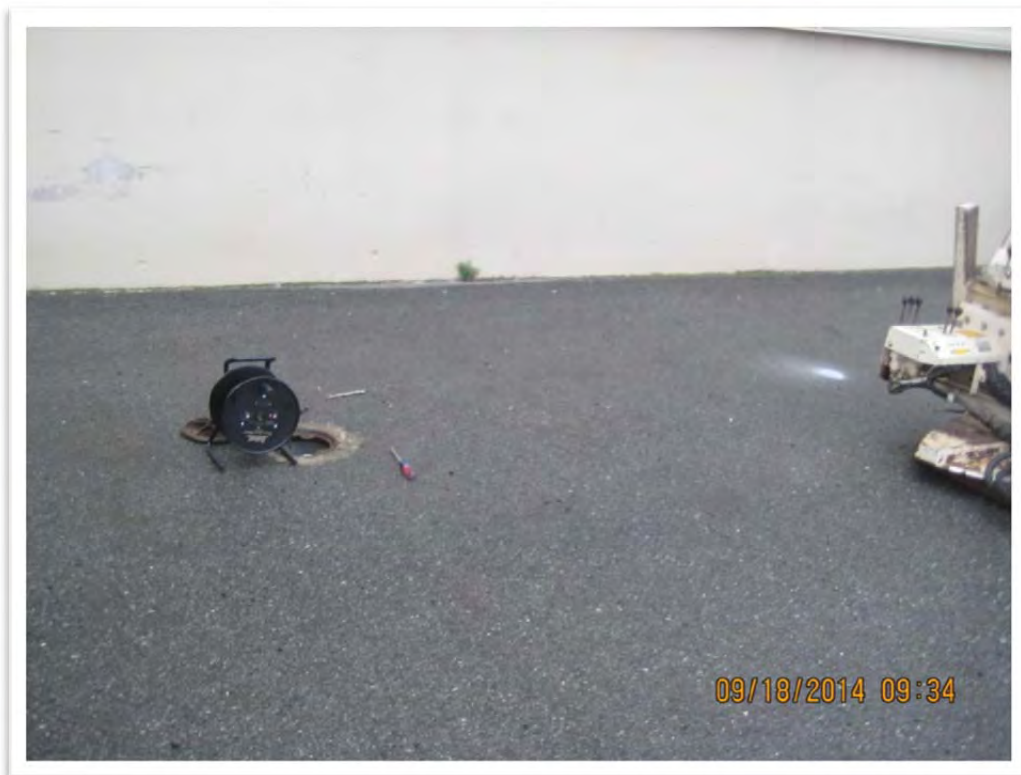
Photograph 2 – Water levels were measured in adjacent existing wells to determine depth of soil gas monitoring wells; boreholes were advanced to approximately 1 foot above the water table. View to the north.

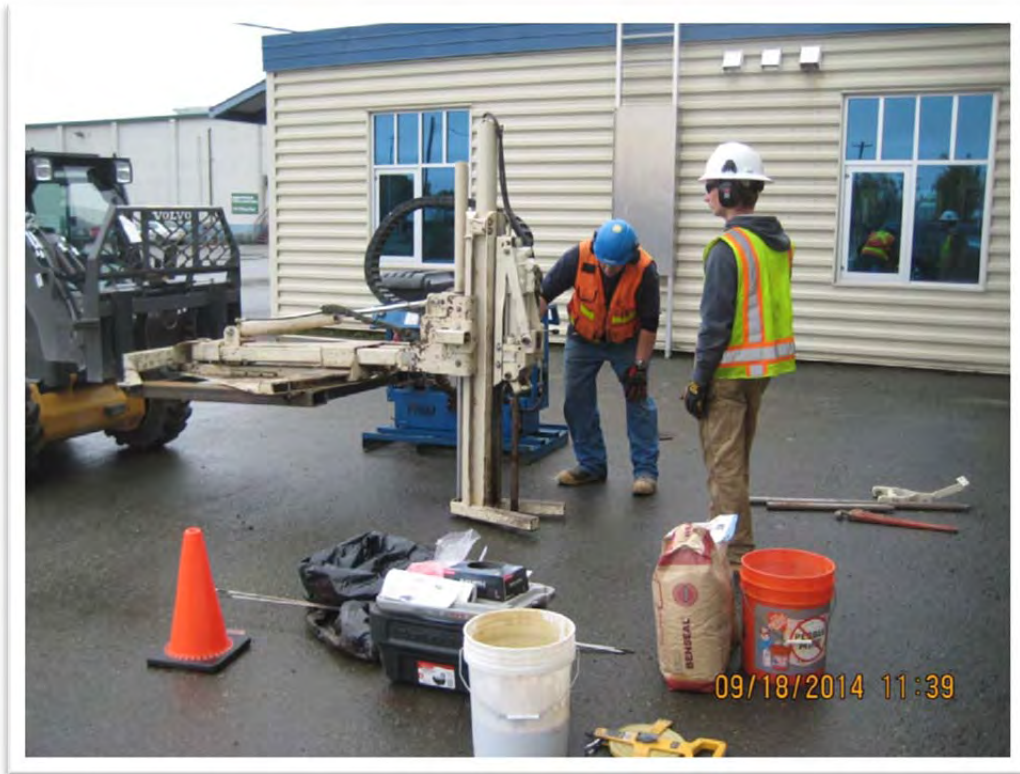
Photograph 3 – Boreholes were installed using percussive techniques. View to the northeast.

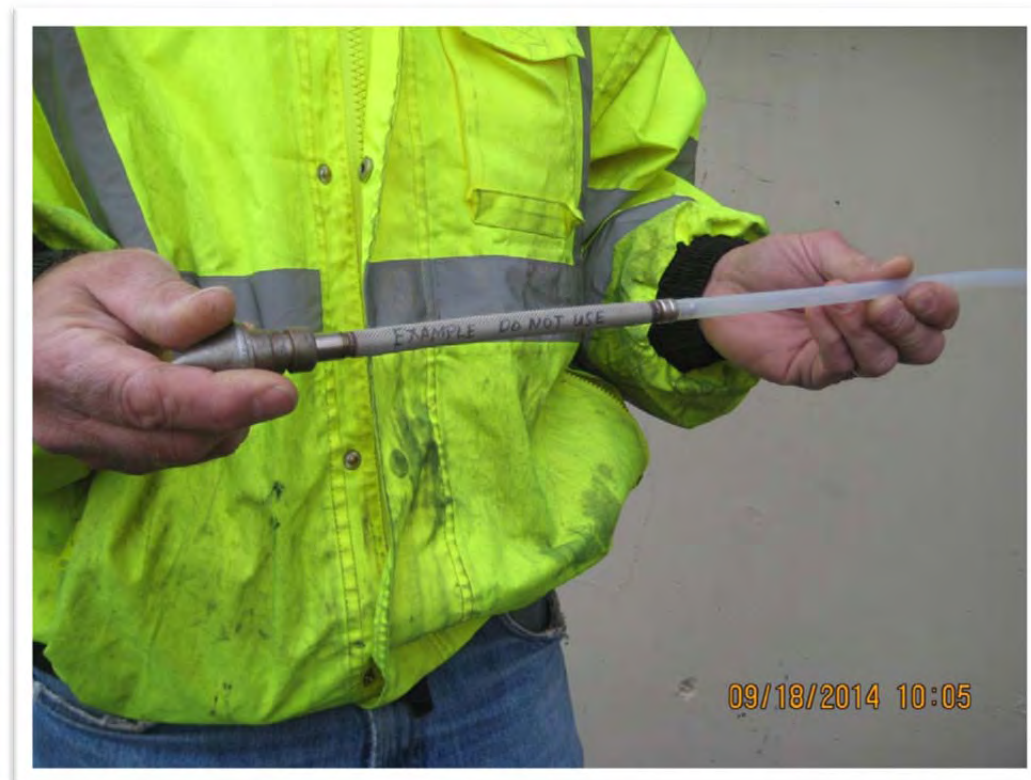
Photograph 4 – Example of Geoprobe 6-inch-long stainless steel implant connected to Teflon-lined tubing used in the construction of the soil gas monitoring wells.

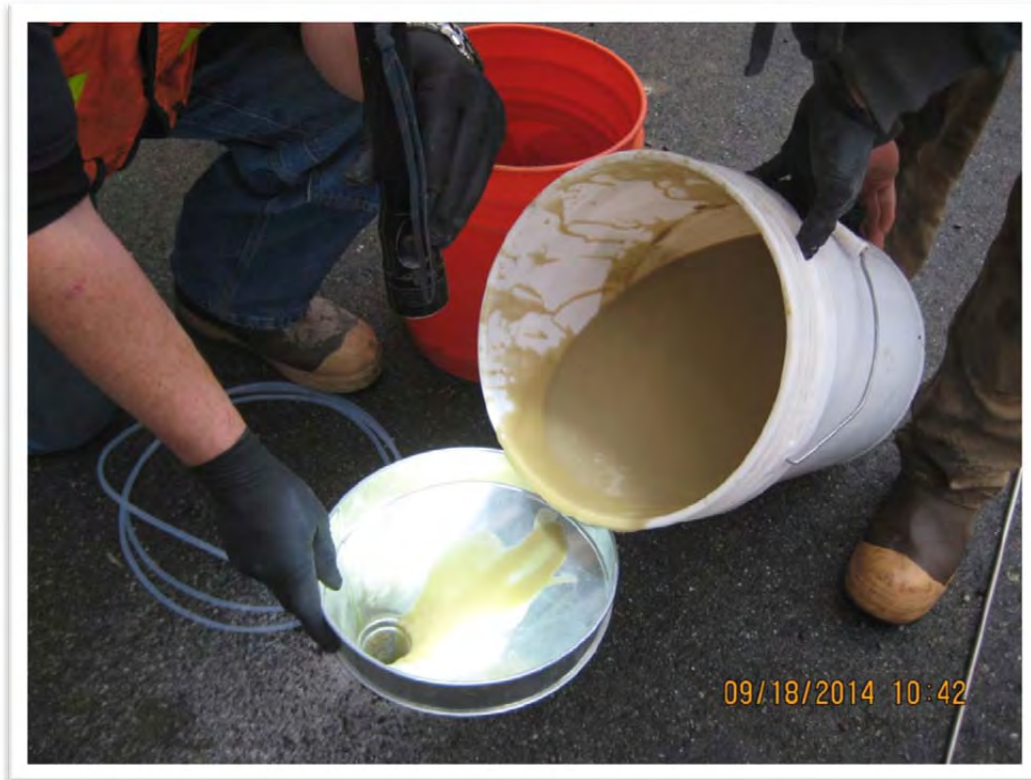
Photograph 5 – A grout slurry was added above the sand pack to seal each soil gas monitoring well.

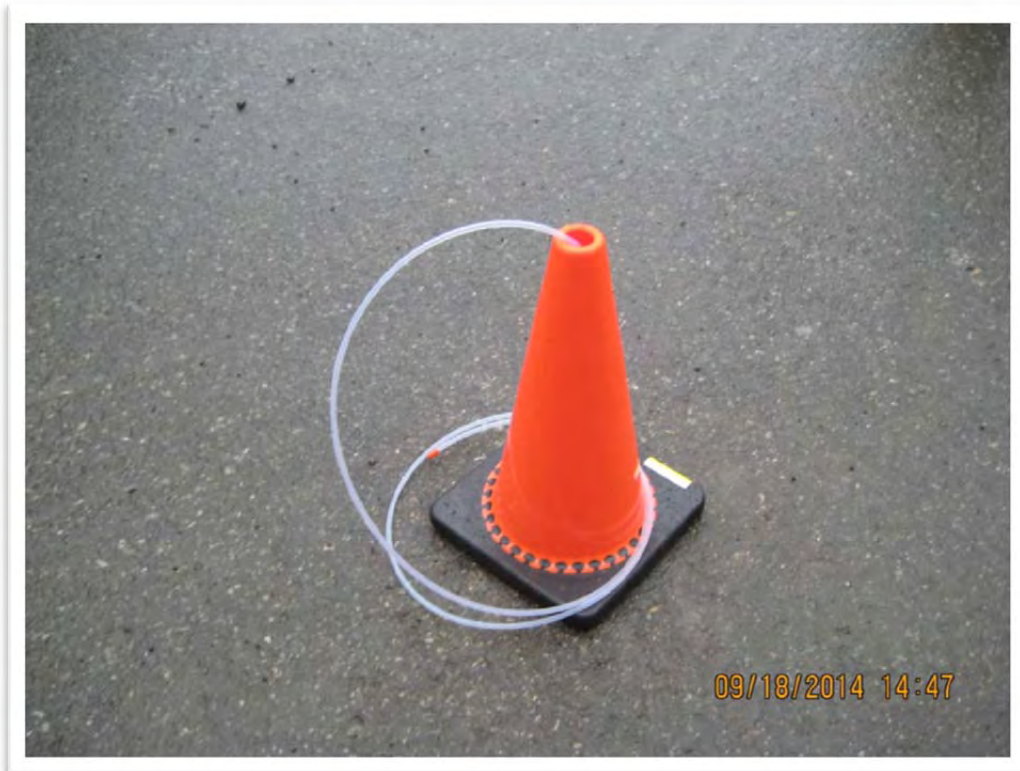
Photograph 6 – Example of a completed soil gas monitoring well (SGMW-3).

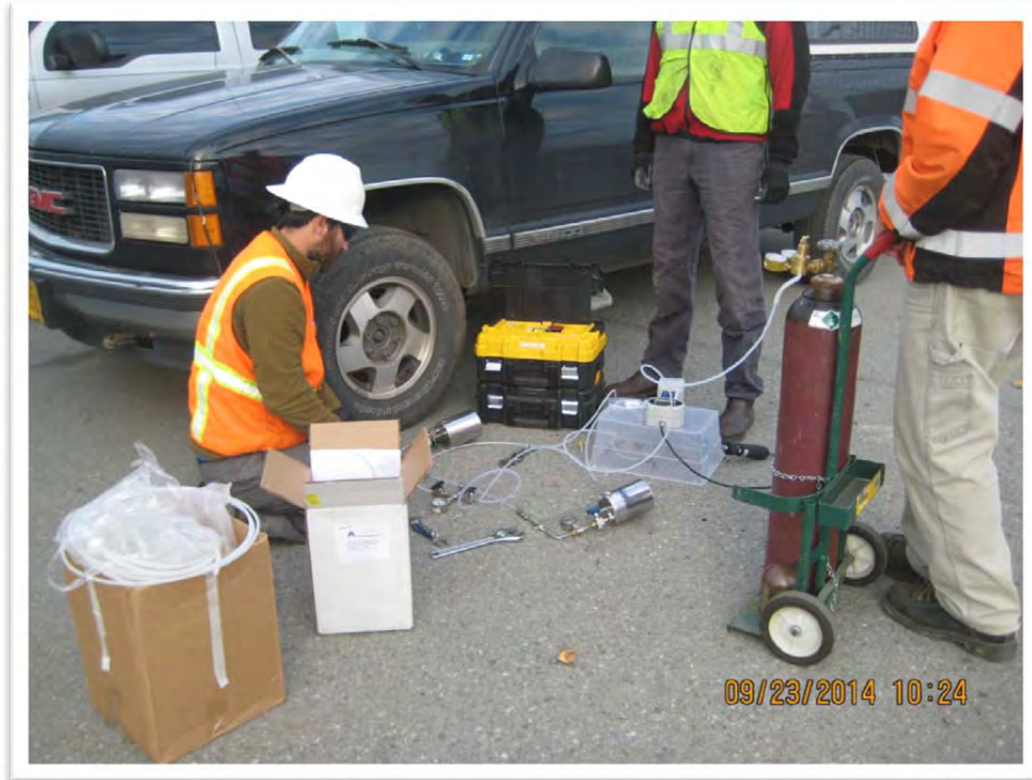
Photograph 7 – Leak tests were performed prior to sample collection using helium as shown here. Samples were collected in 1-liter stainless steel Summa canisters (both primary and field duplicate are shown).

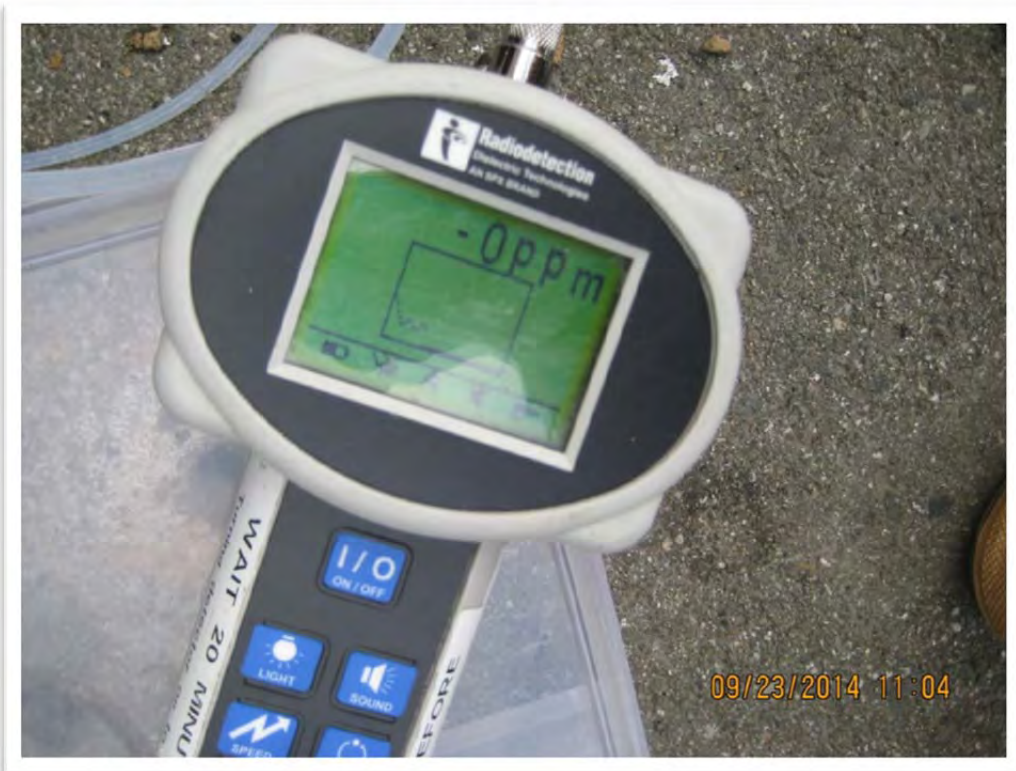
Photograph 8 – Instrument used to measure the concentration of helium in parts per million.
