February 17, 2010

Subject: Iliamna Fuel Release Response Report, Iliamna, Alaska

SITE LOCATION MAP

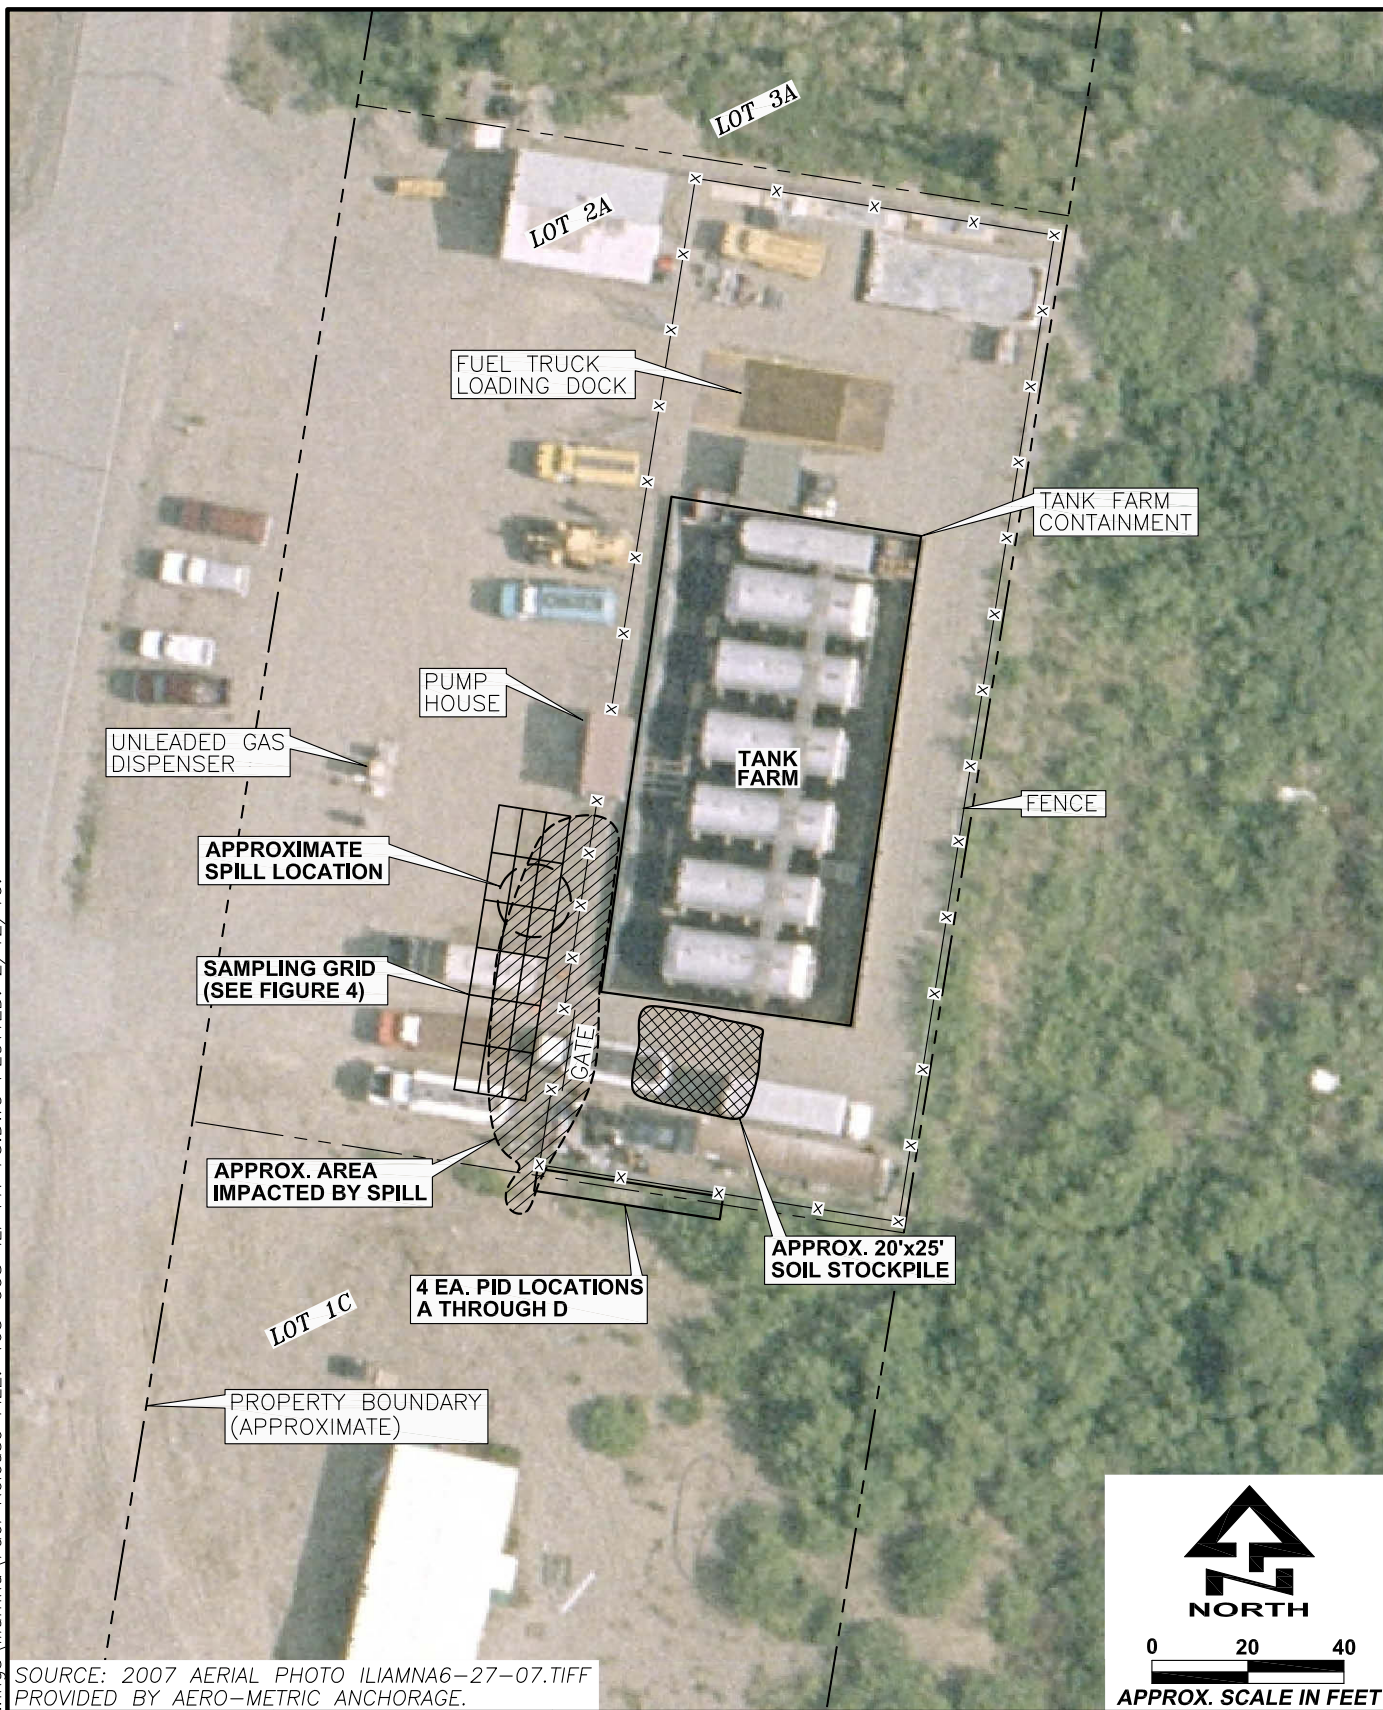
SITE DETAIL

OASIS initially delineated the surface area of impact by collection of surface samples for both heated headspace analysis and in situ analysis. OASIS's pre-excavation sampling grid extended from the north side of the pump house to 10 feet south of the southern boundary of the leased lot; west approximately 25 feet; and east between the tank farm fence and tank farm containment. Screening also was conducted between pallets and other stored material located at the southwestern corner of the fenced area. OASIS additionally collected field screening samples outside of the fenced area along the southern boundary of the site. The initial estimated area of impact based on in situ and heated head space PID field screening is presented in Figure 3.

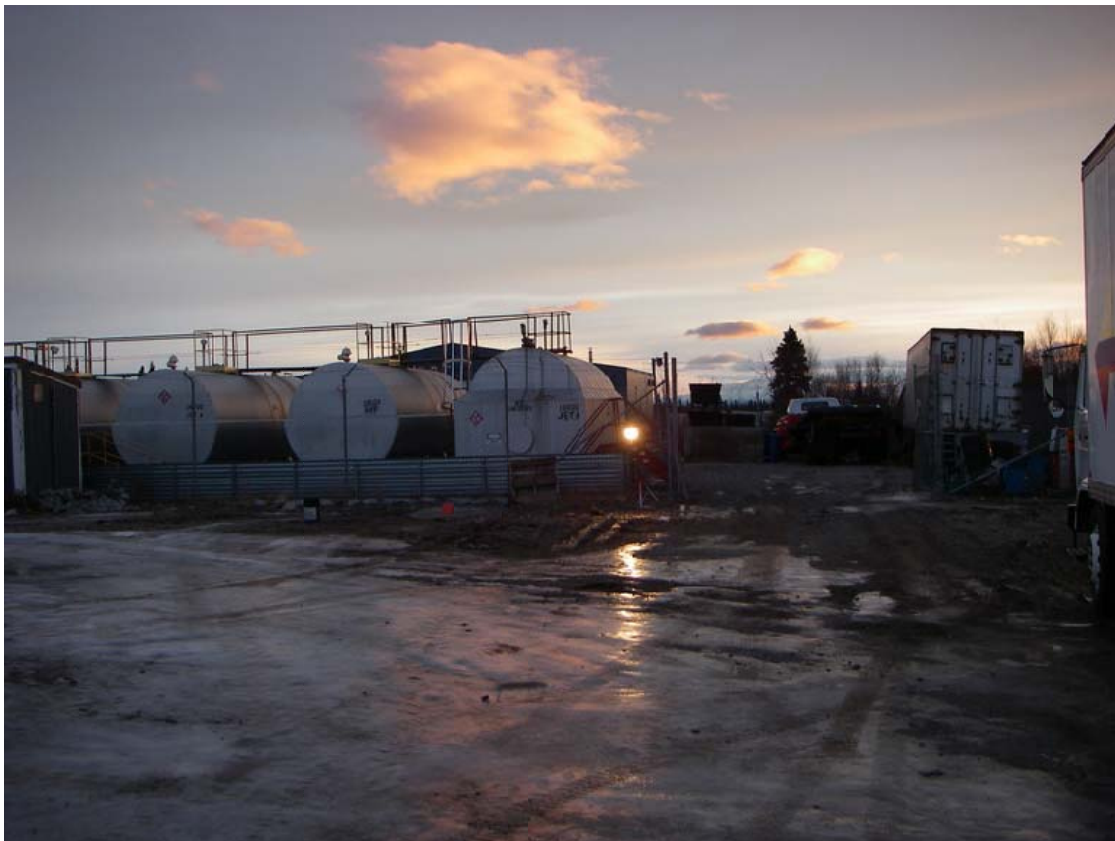
Photo: 1 Time: 1030 Date: 12/29/2009 Direction: Northeast
Subject: Spill area and western fence line of tank farm containment.
Orange wheel block marks location of tanker truck's rear wheel location during spill.

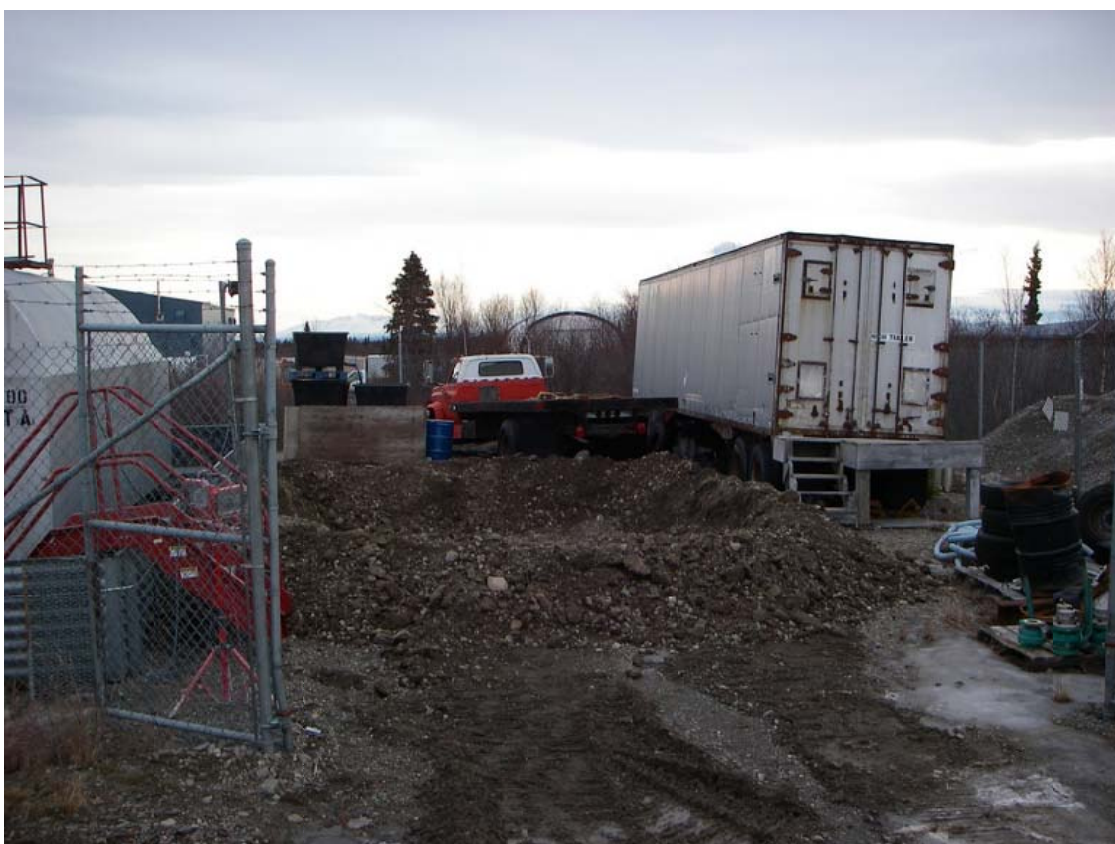
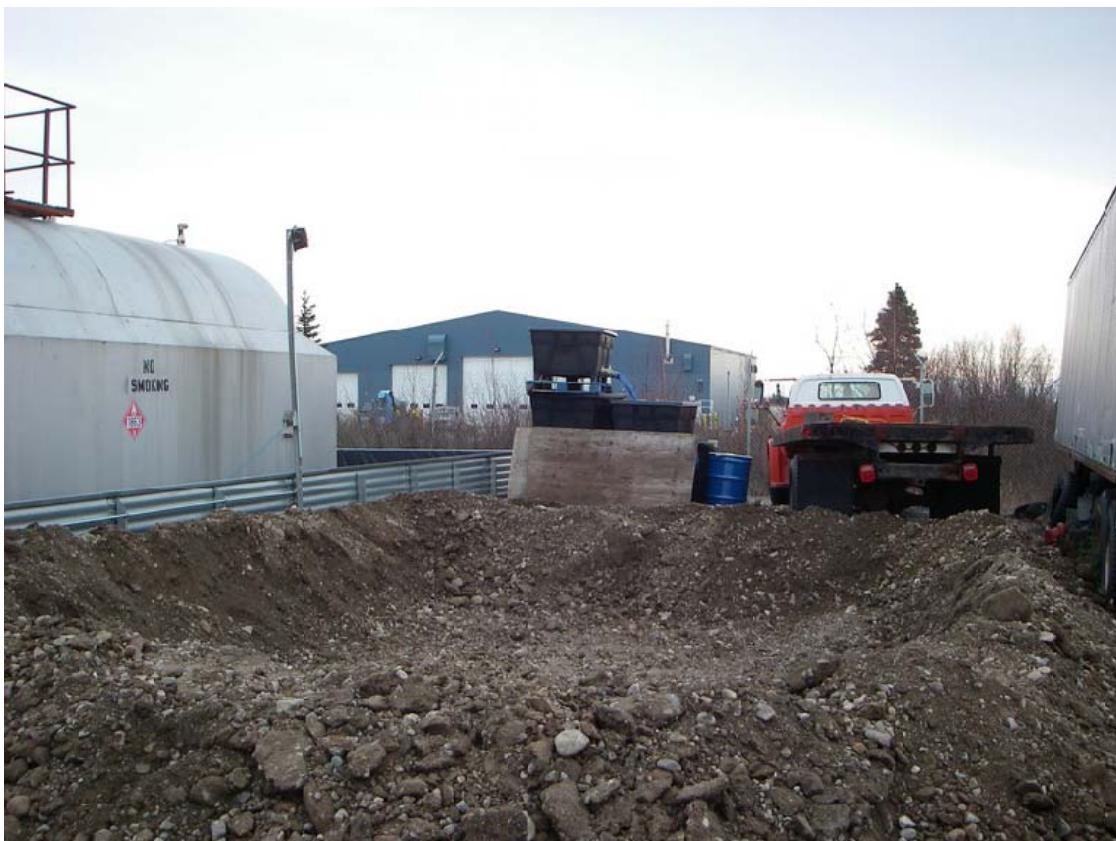
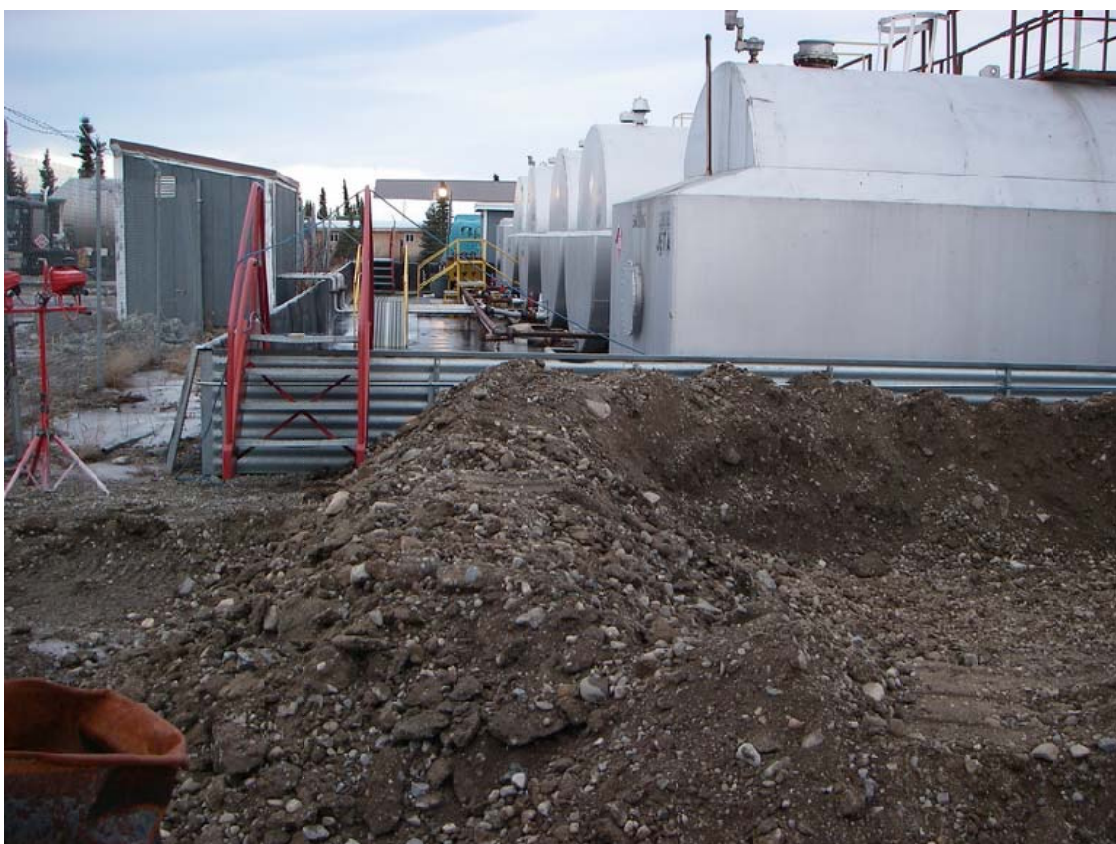
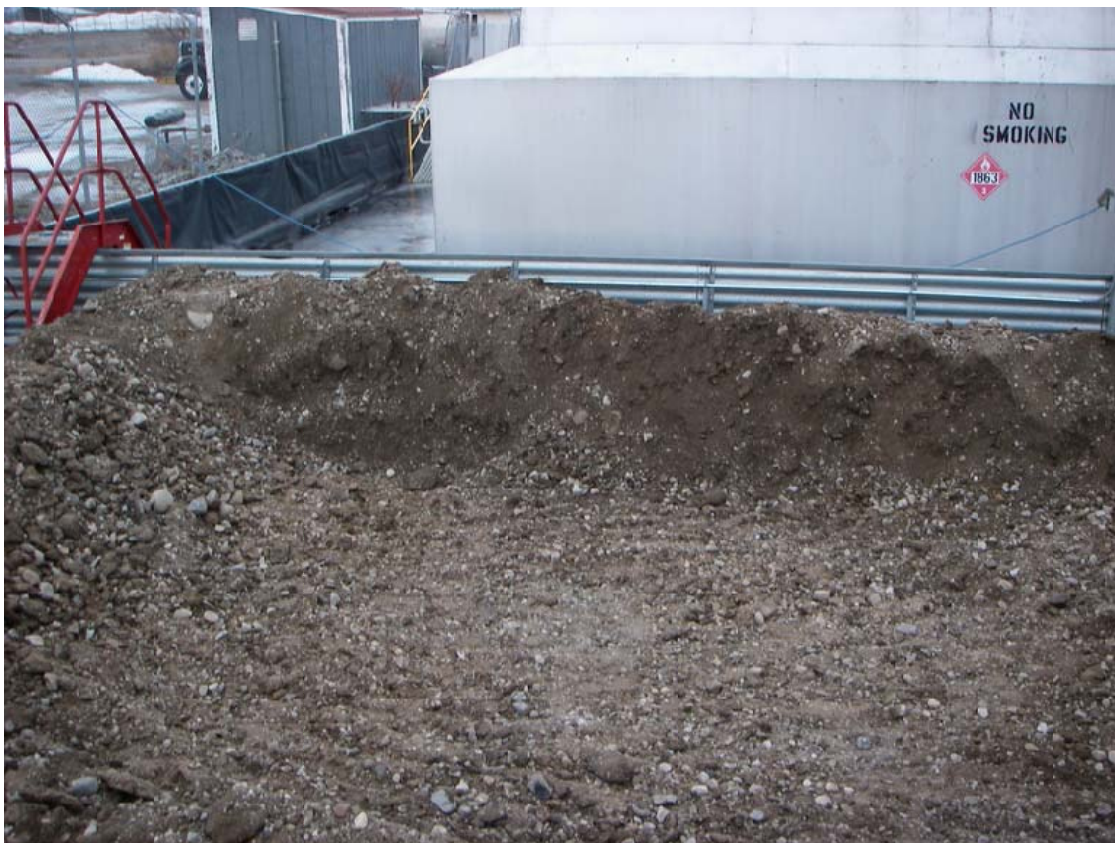
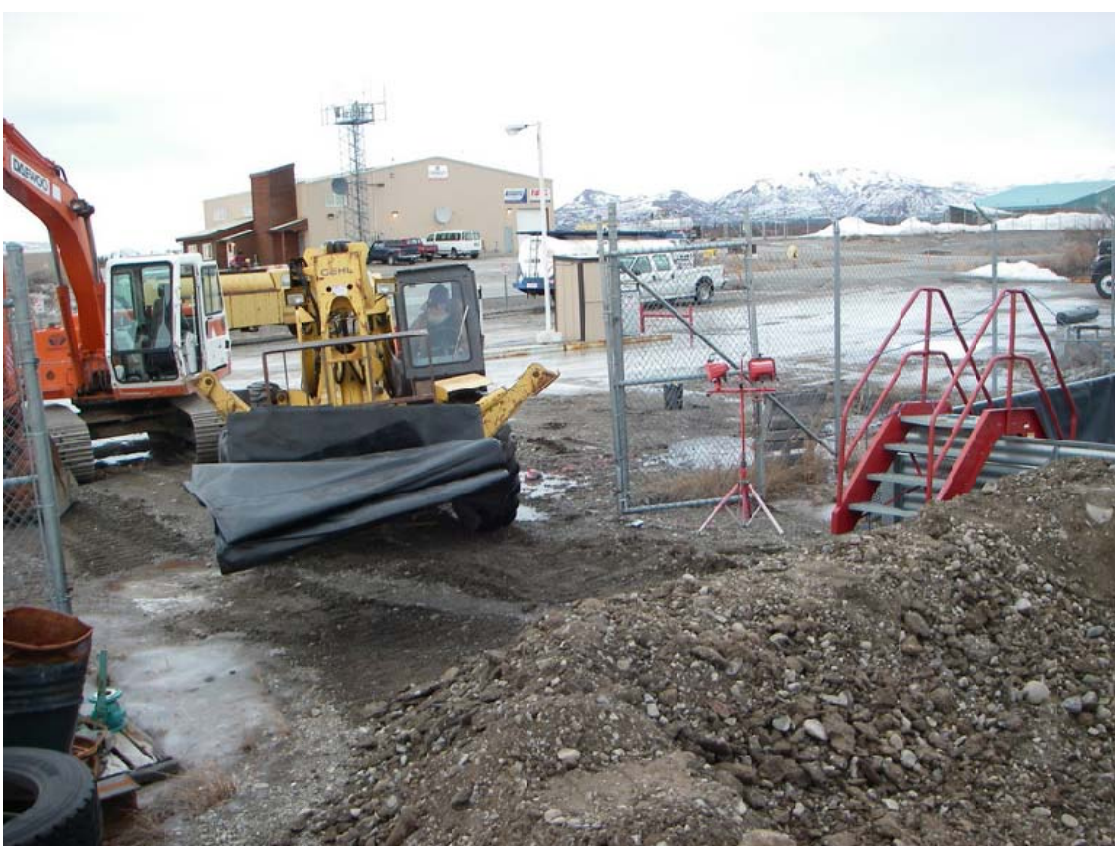
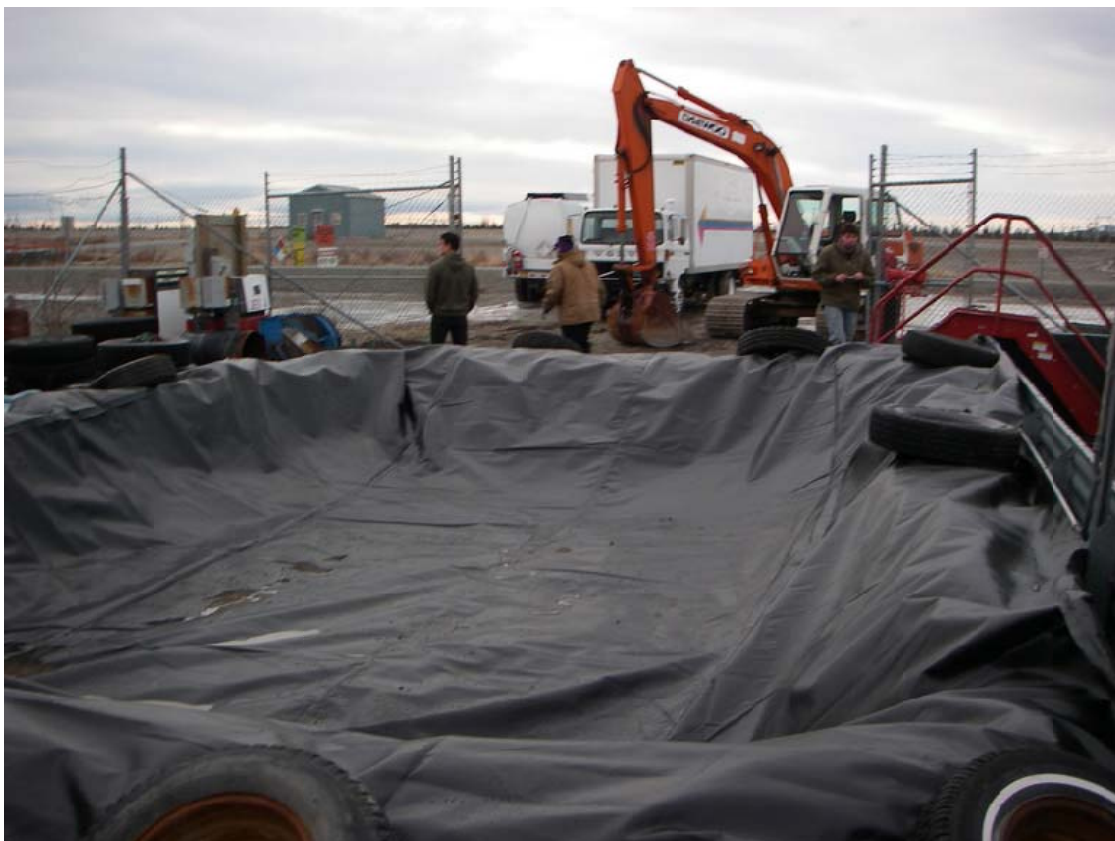
a five-spot composite sample from the bottom of the containment footprint (Sample No. 09-ILM-01-SS). A 20-mil thick, oil-resistant reinforced polyethylene geo-membrane liner was then put into place, with 2 feet of liner material extending beyond the containment berm (Photograph Nos. 8 through 13).

Photo: 8 Time: 1316 Date: 12/29/200 Direction: East
Subject: Stockpile containment.

Photo: 9 Time: 1317 Date: 12/29/200 Direction: East
Subject: Stockpile containment.

Photo: 10 Time: 1317 Date: 12/29/200 Direction: North
Subject: Stockpile containment.

Photo: 11 Time: 1317 Date: 12/29/200 Direction: North
Subject: Stockpile containment floor.

Photo: 12 Time: 1318 Date: 12/29/200 Direction: West
Subject: Stockpile containment; loading in 20-mil liner.

Photo: 13 Time: 1329 Date: 12/29/200 Direction: West
Subject: Stockpile containment; loading in 20-mil liner.

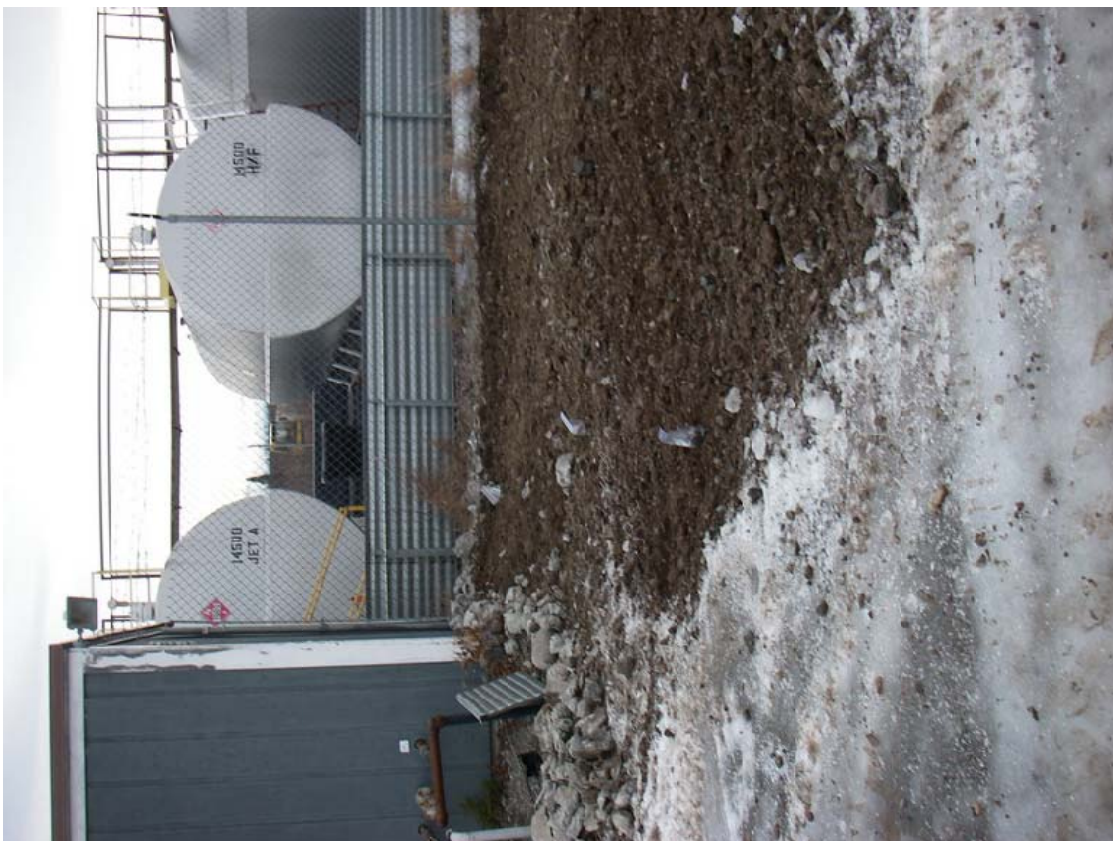
Photo: 19 Time: 1402 Date: 12/29/200 Direction: East
Subject: Northern limit of excavation area; headspace samples visible in centerline. Pump house on left.

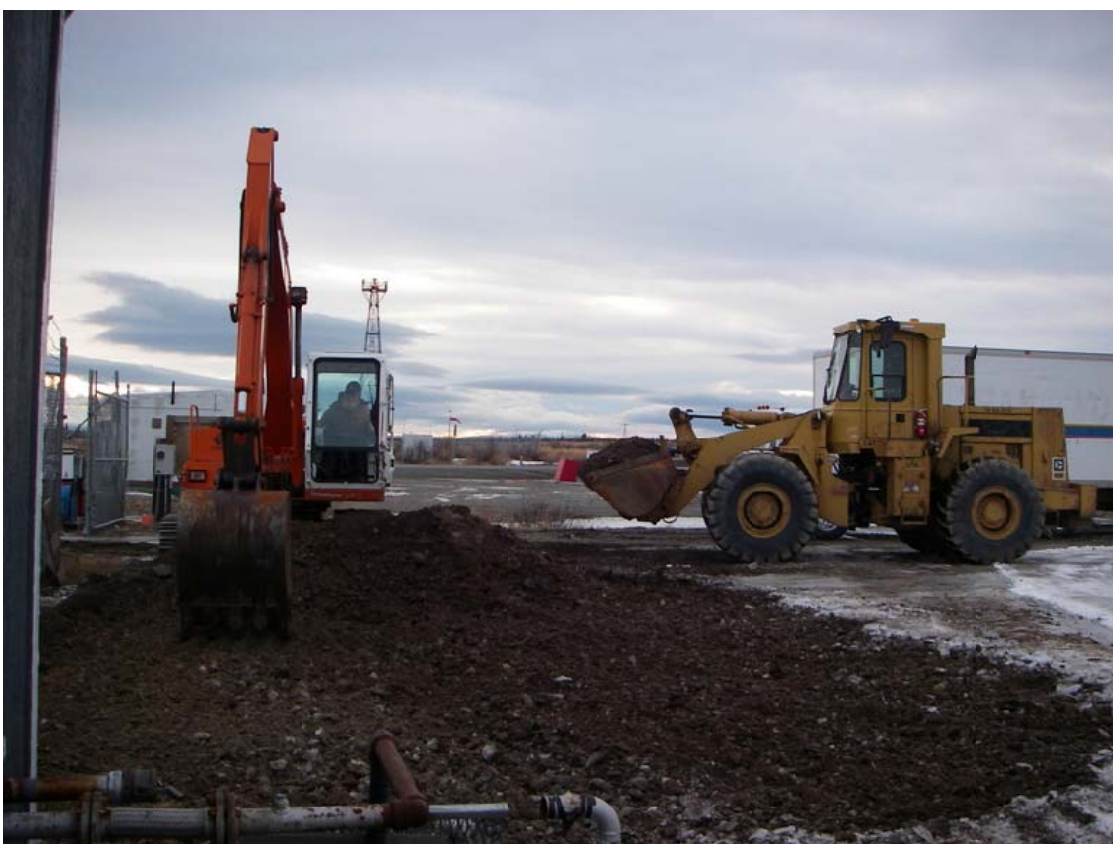
Photo: 20 Time: 1419 Date: 12/29/200 Direction: South
Subject: Excavation area. Soil loaded into loader for transfer into the stockpile containment.

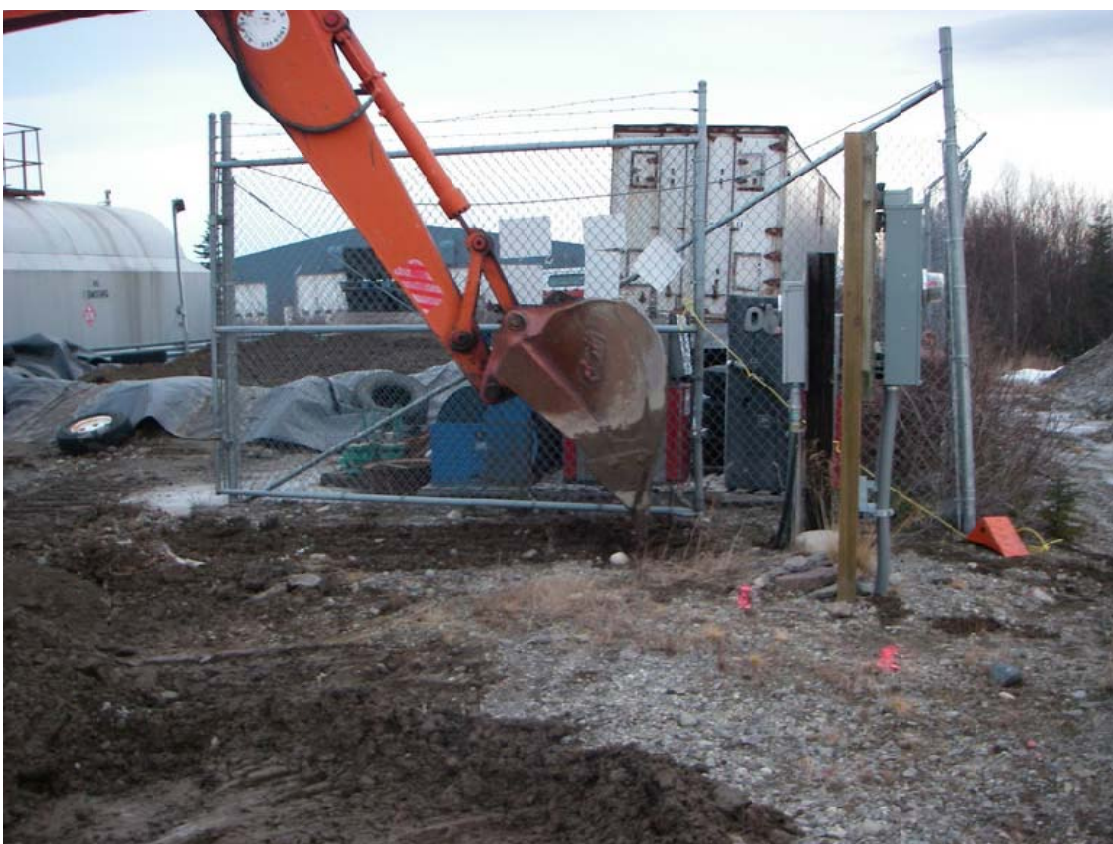
Photo: 34 Time: 1552 Date: 12/29/200 Direction: East
Subject: Excavation progress at southern edge of fencing.
Progress limited by INNEC Meter/Pole.

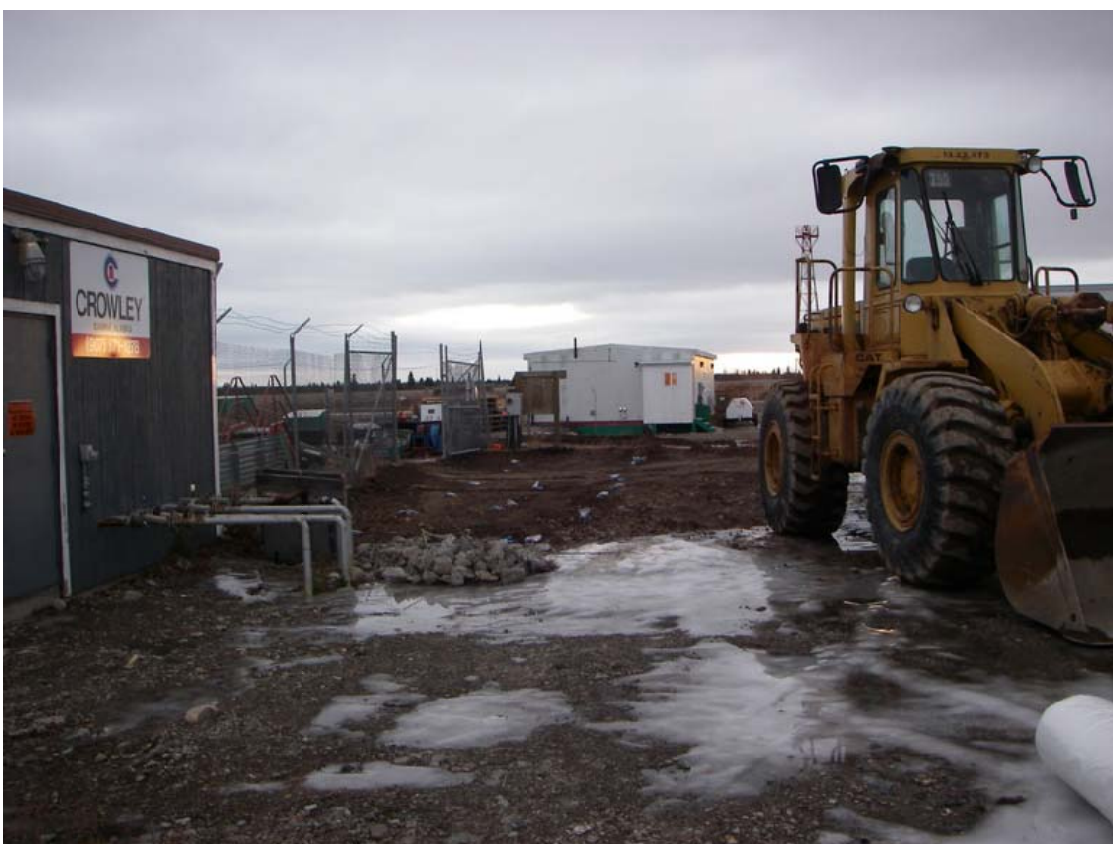
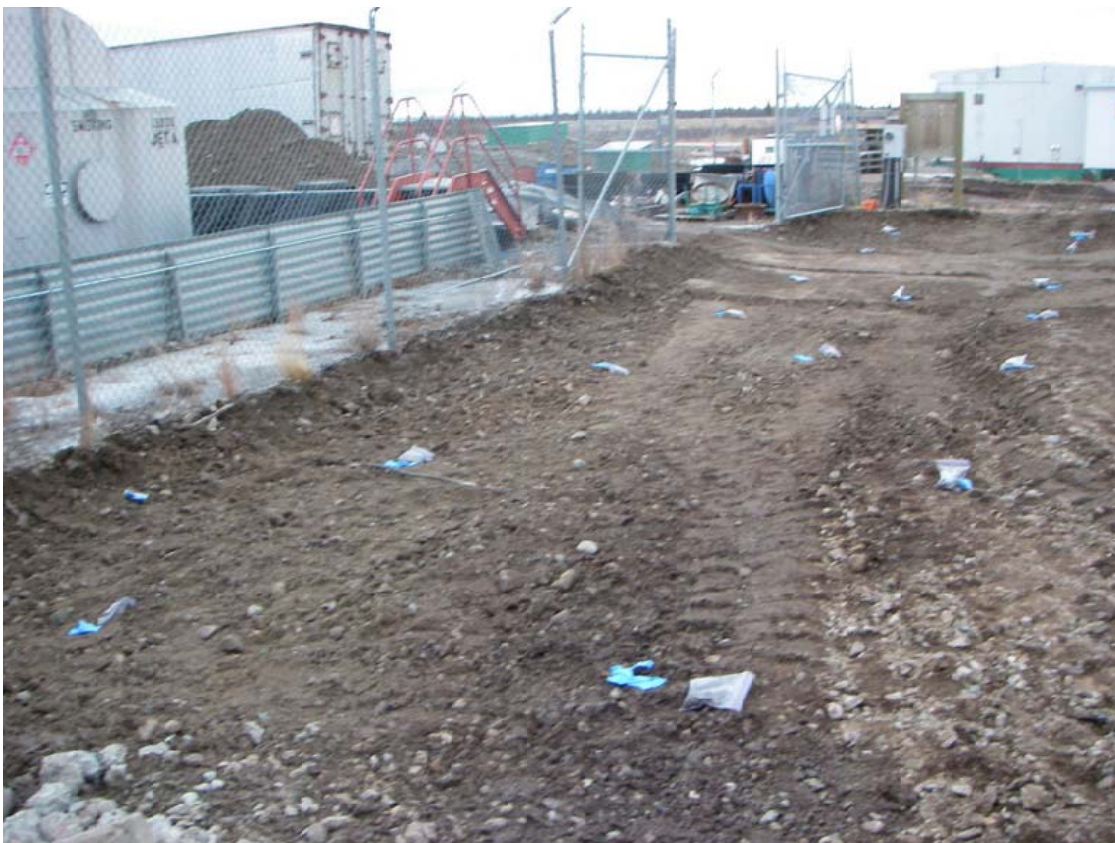
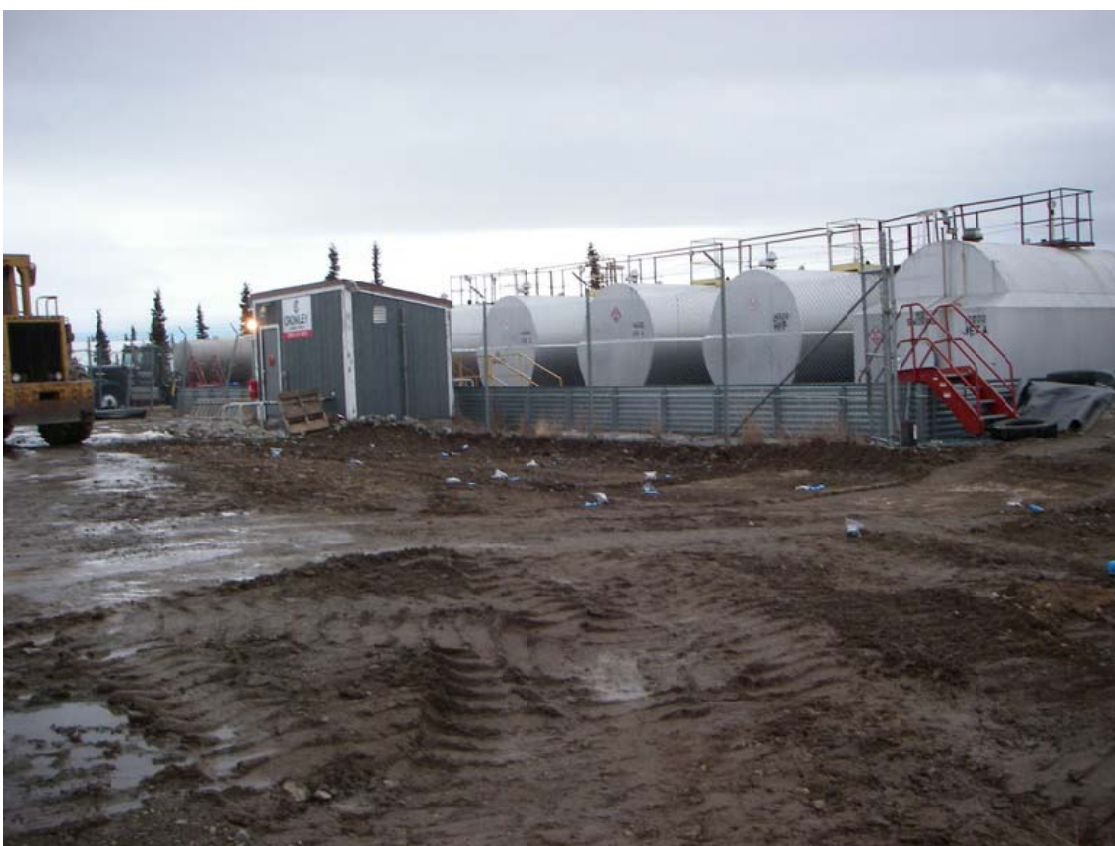
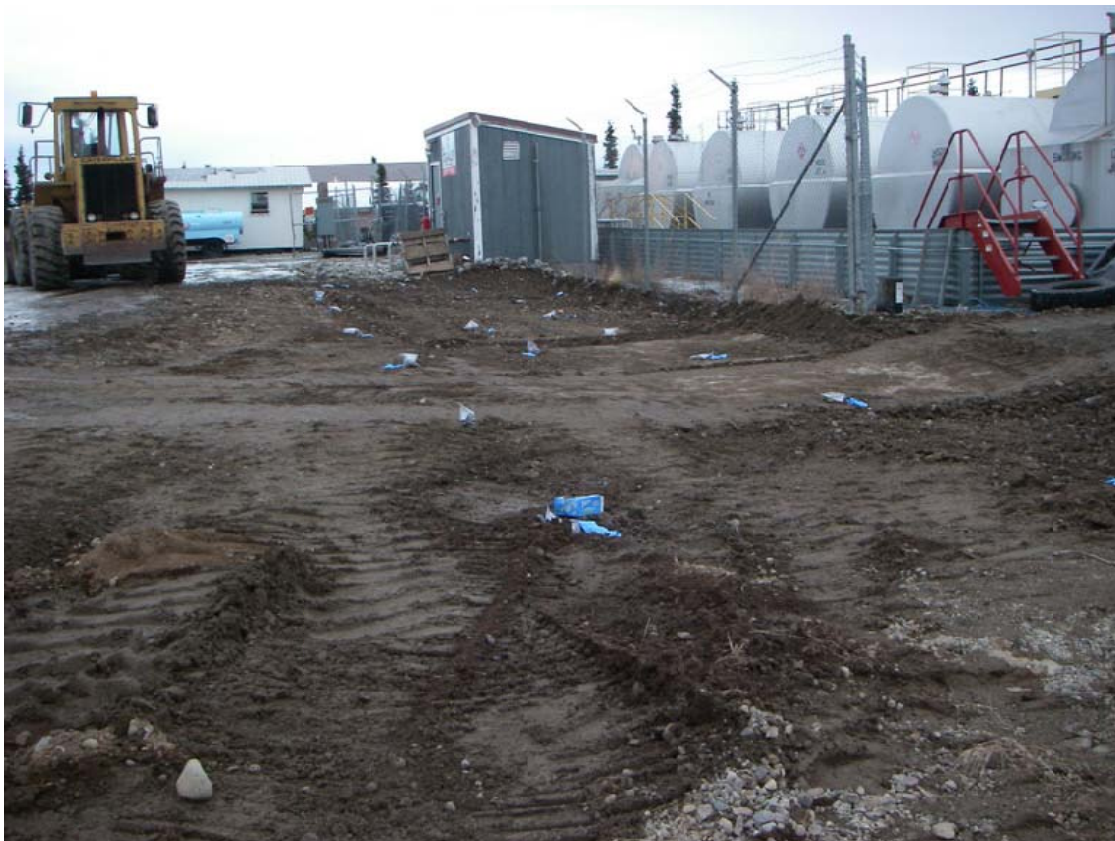
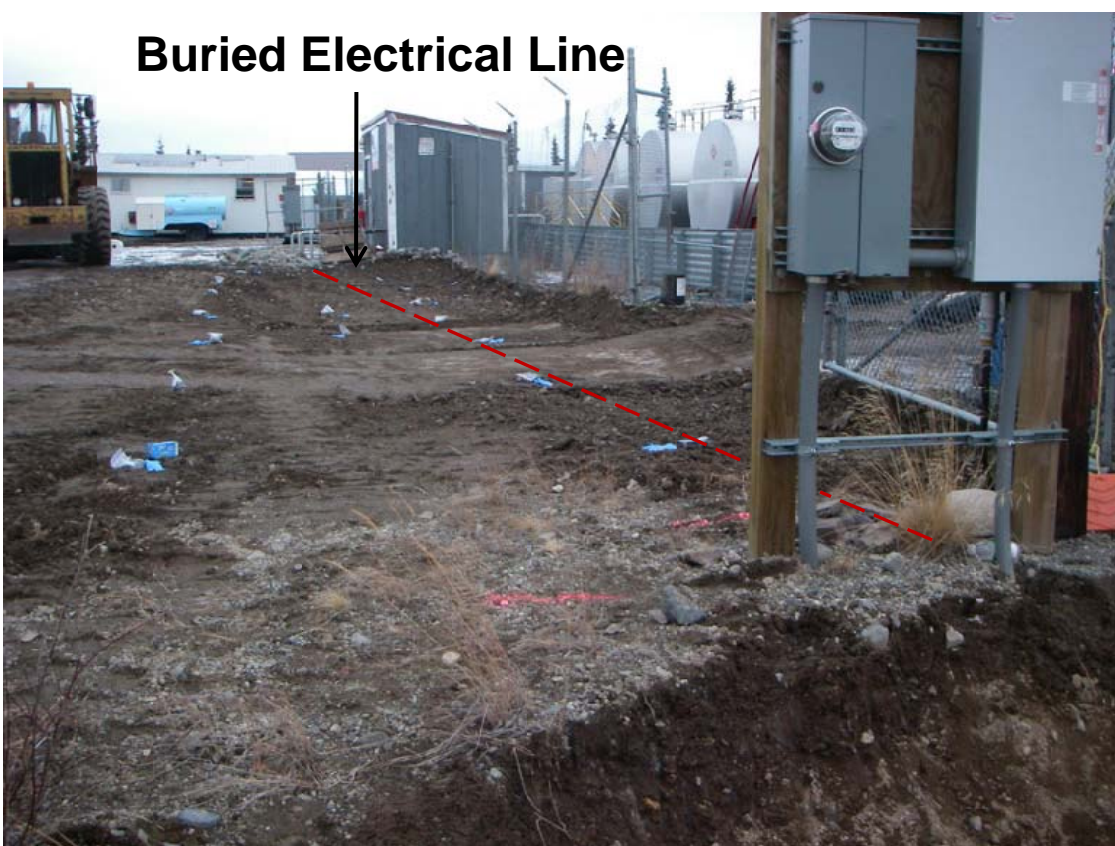
The resulting excavation, based on in situ and heated headspace PID testing, was a concave shape about 6 inches in depth at the sides and nearly 2 feet deep at the deepest point. Vertical excavation was halted when buried flagging warning of the buried electrical line was encountered (Photograph No. 46).

Photo: 42 Time: 1402 Date: 12/30/200 Direction: South
Subject: Final excavation extent/depth. PID sample locations
1 through 16 visible.

Photo: 43 Time: 1404 Date: 12/30/200 Direction: South
Subject: Final excavation extent/depth. PID sample locations
1 through 16 visible.

Photo: 44 Time: 1404 Date: 12/30/200 Direction: North
Subject: Final excavation extent/depth. PID sample locations
1 through 16 visible.

Photo: 45 Time: 1405 Date: 12/30/200 Direction: North
Subject: Final excavation extent/depth. PID sample locations
1 through 16 visible.

Photo: 46 Time: 1405 Date: 12/30/200 Direction: North
Subject: Final excavation extent/depth. PID sample locations
1 through 16 visible.

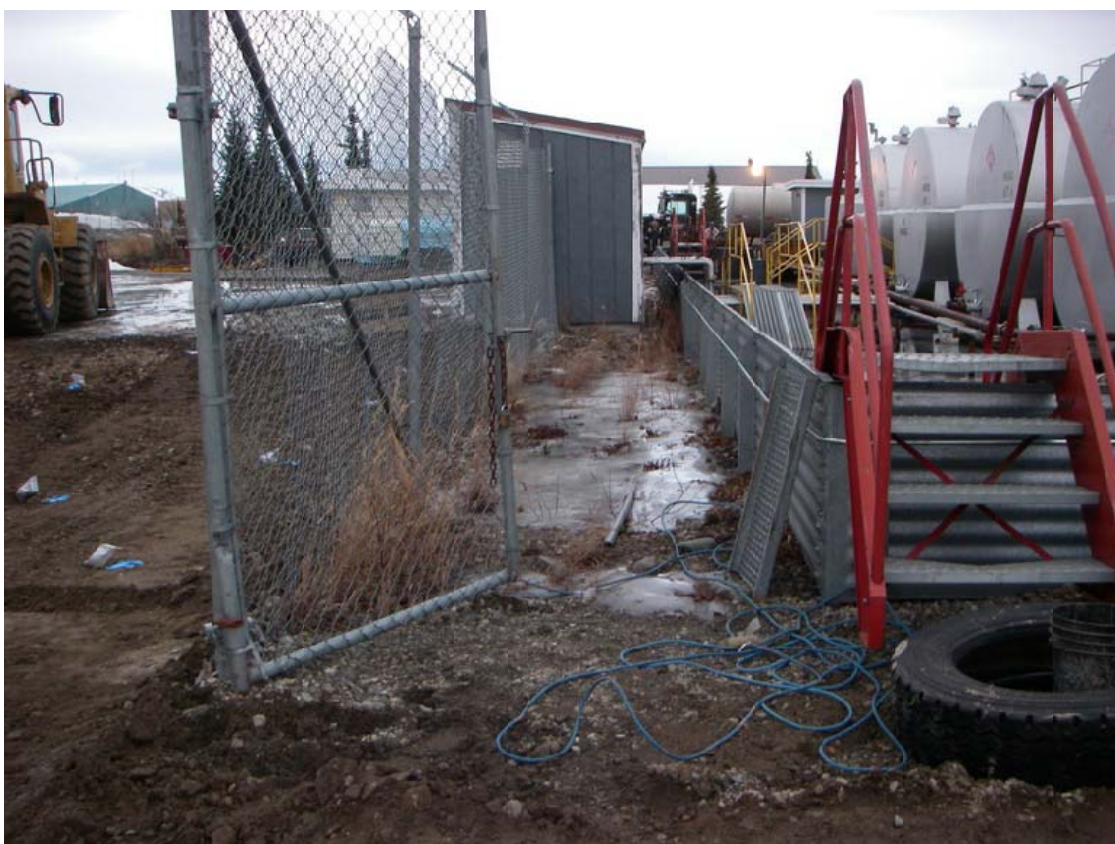
OASIS evaluated possible migration from the spill location in a southeasterly direction through the southwestern corner of the fenced area and to a low area located along the southern lot line (Photograph Nos. 29 and 30). Field screening did not indicate impact outside of the fenced area along the southern boundary. OASIS collected four samples at 10-foot intervals beginning with location "D" approximately at the southwest corner of the tank farm fence. The PID locations were identified as A, B, C, and D. PID results were 17 ppmv at locations A, 15 ppmv at location B, 9 ppmv at location C, and 50 ppmv at locations D (Photograph No. 36). Field screening between the fence and the tank farm containment wall indicated an area of impact between these two structures running along the fence line from about 5 feet south of the pump house to the southwest corner of the fenced area (Photograph No. 54).

Photo: 54 Time: 1407 Date: 12/30/200 Direction: North
Subject: Gap between western fence and tank farm containment.

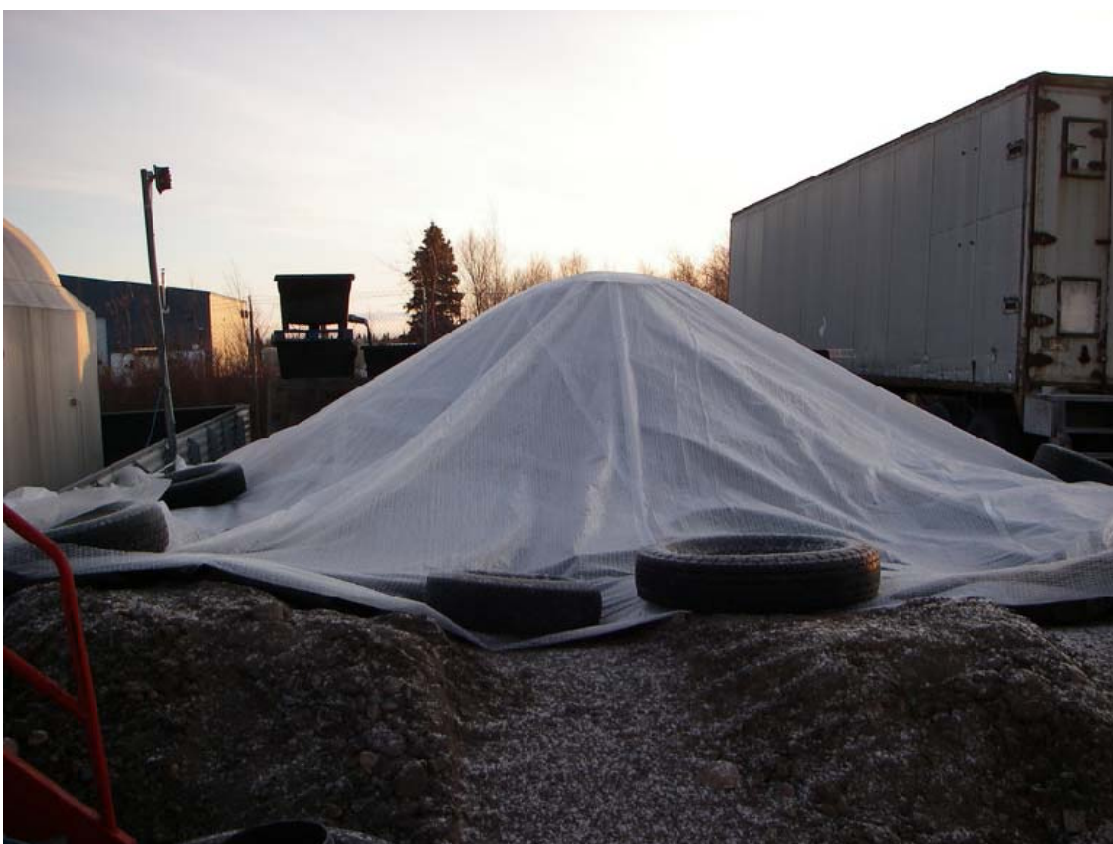
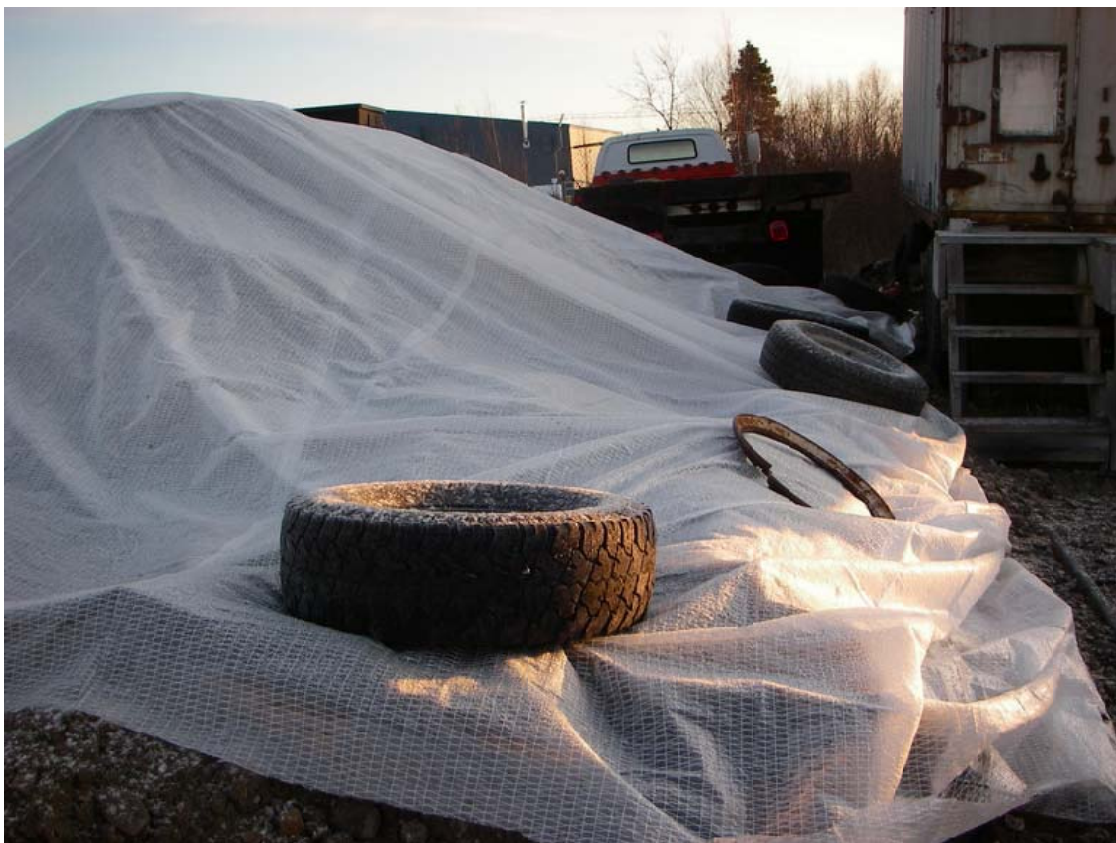
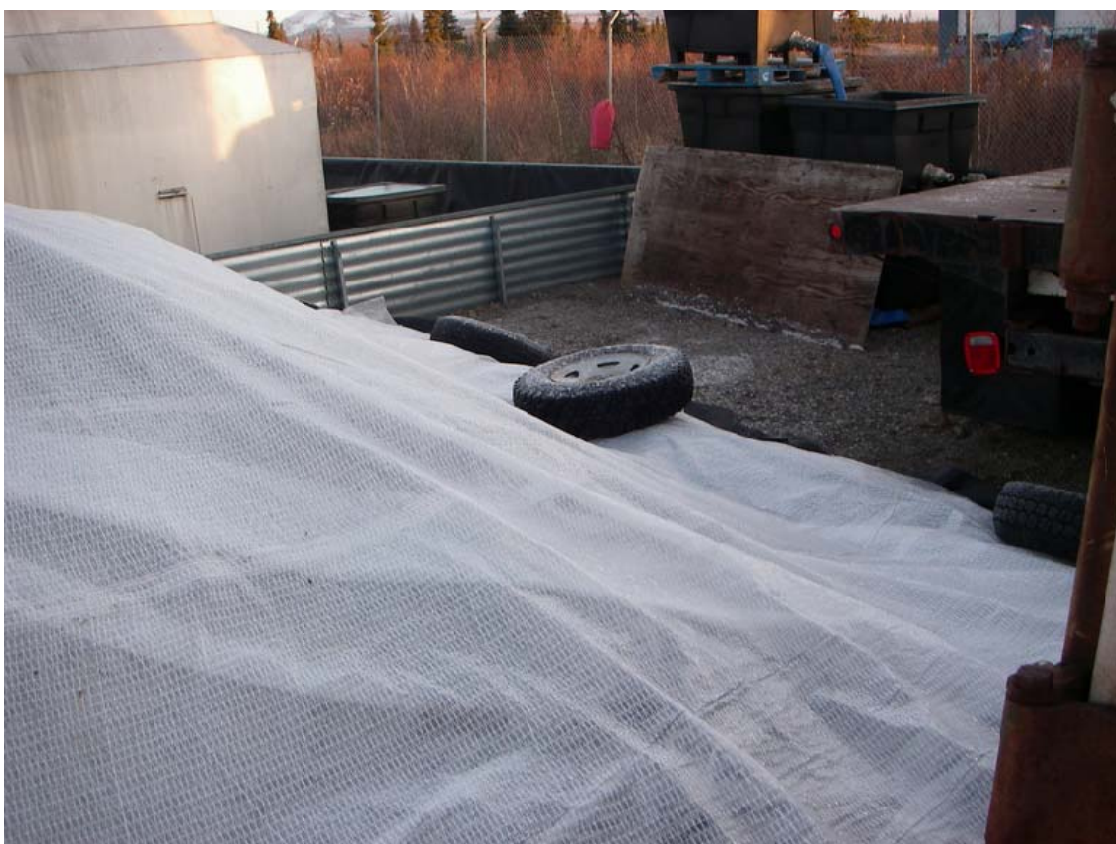
Photo: 68 Time: 1058 Date: 12/31/200 Direction: East
Subject: Soil stockpile with 6-mil reinforced cover.

Photo: 69 Time: 1059 Date: 12/31/200 Direction: East
Subject: Soil stockpile with 6-mil reinforced cover.

Photo: 70 Time: 1059 Date: 12/31/200 Direction: Northeast
Subject: Soil stockpile with 6-mil reinforced cover.
