**FOCUSED SITE INVESTIGATION REPORT
FORMER COASTAL DRILLING SITE,
SOLDOTNA ALASKA
ADEC FILE NO. 2333.38.013**

Reeves Amodio LLC

September 2010

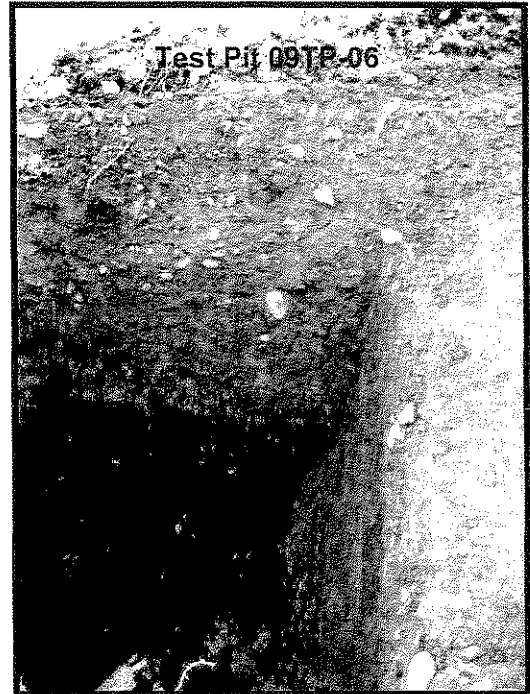
Two test pits (09TP-05 and 09TP-06) were excavated in the covered pit area. The location for test pit 09TP-05 was selected to be near where the drain pipe from the grate area described in prior reports discharged into the pit. The drain pipe was not located during this site investigation however. Both excavations encountered approximately five feet of sandy, gravelly silt cover material, the upper three feet of which were frozen. Underlying the cover material was visibly stained soil with slight hydrocarbon odors and miscellaneous metal debris (including an engine block, cable, and drum). The bottom of test pit 09TP-06 was at 9 feet and appeared to be saturated, as a small volume of water seeped into the test pit while it was open (see adjacent photograph).

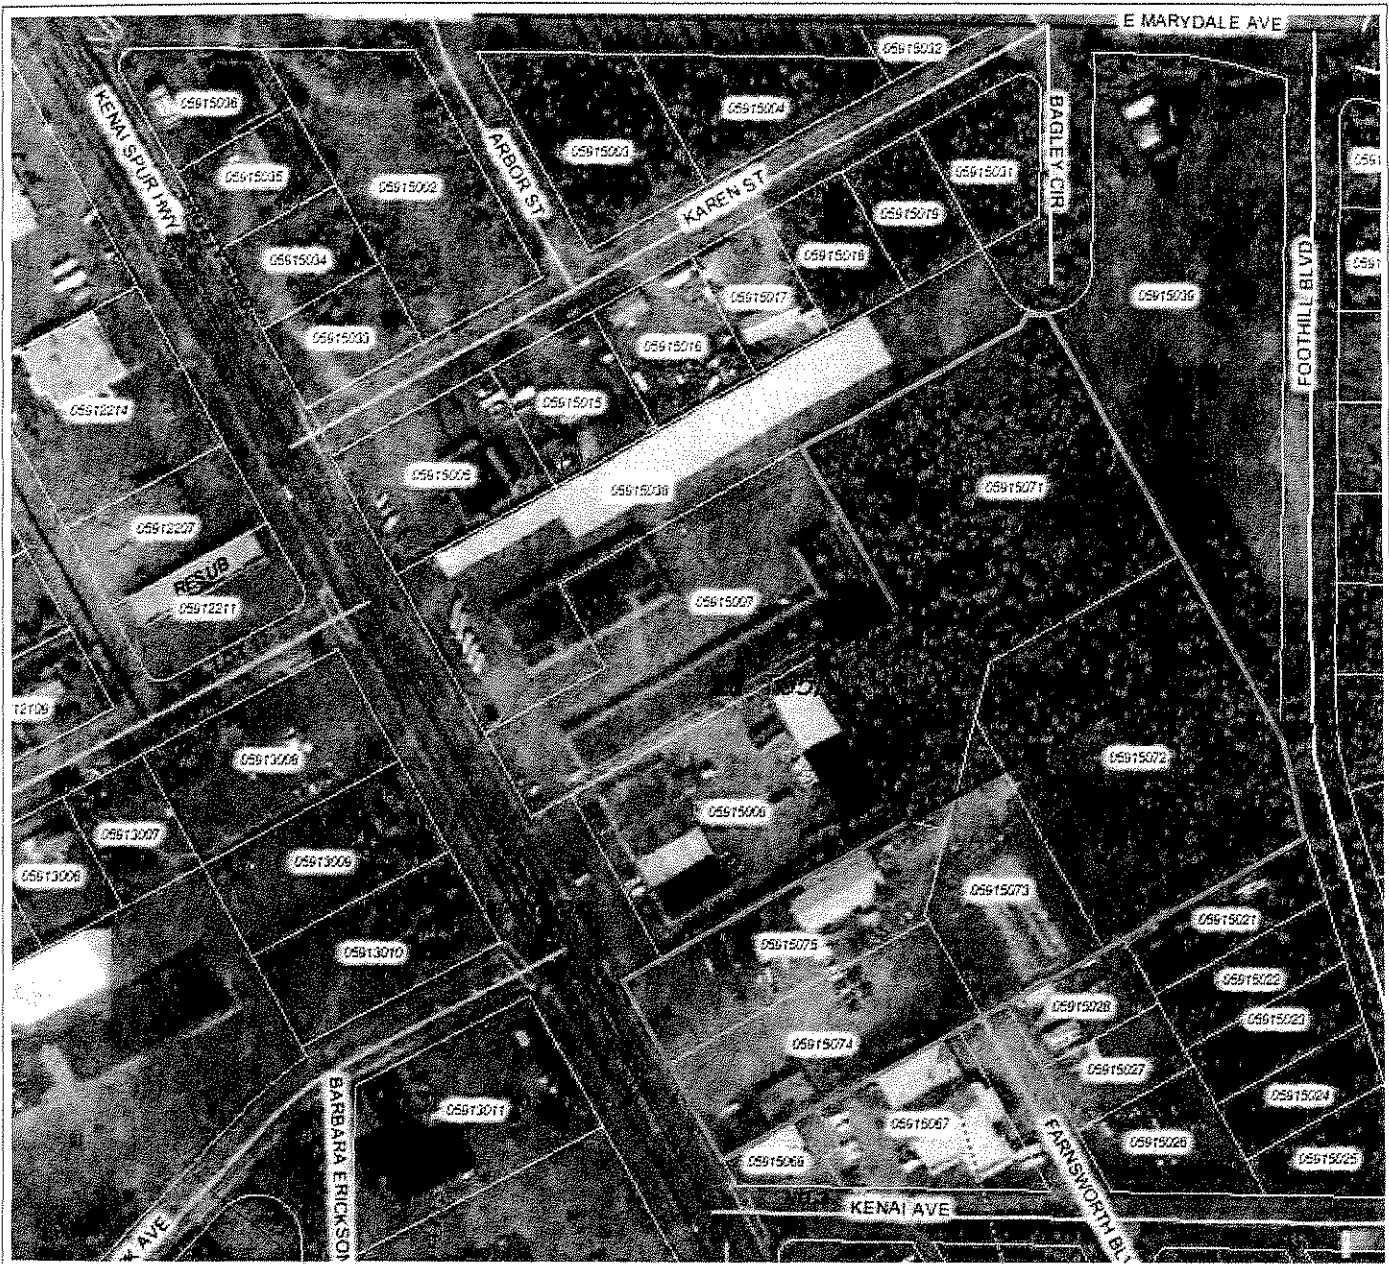
**FIGURE
2**

The former Coastal Drilling facility is located at mile 0.5 Kenai Spur Road, Soldotna, Alaska. The legal description of the Property is described as the eastern half of Section 29, T5N, R10W, Seward Meridian. The entire property includes several adjacent parcels totaling approximately 7 acres as shown on Figure 2. The investigation described in this report is focused primarily on the area within the chain link fence also shown on Figure 2.

SITE PLAN

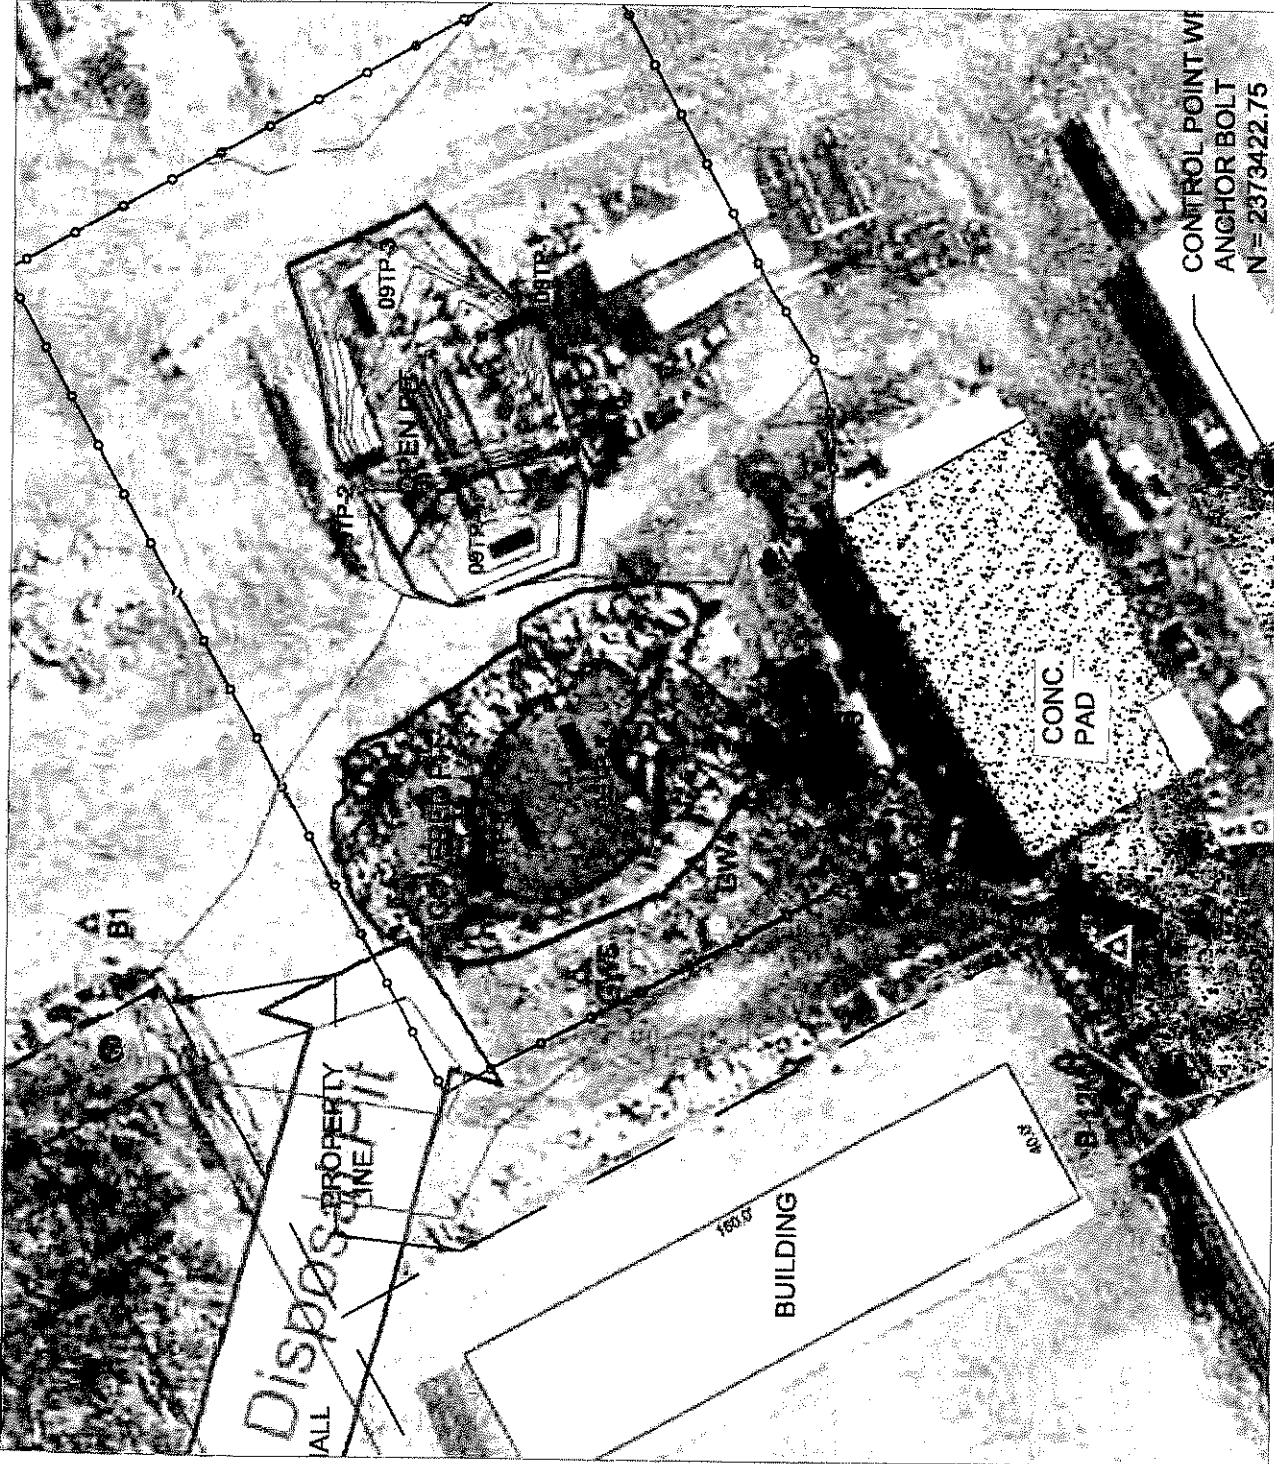
FIGURE
3

A site topographic survey was conducted to provide a baseline map for future work. McLane Surveyors conducted the ground survey on November 10, 2009 and re-surveyed it on April 1, 2010. Appendix A provides the site topography and survey details. Figure 3 shows the elevation survey overlain onto a 1970 air photo of the site showing the location of the covered pit prior to being covered.

1970 Air Photo with 2009 Ground Survey Data

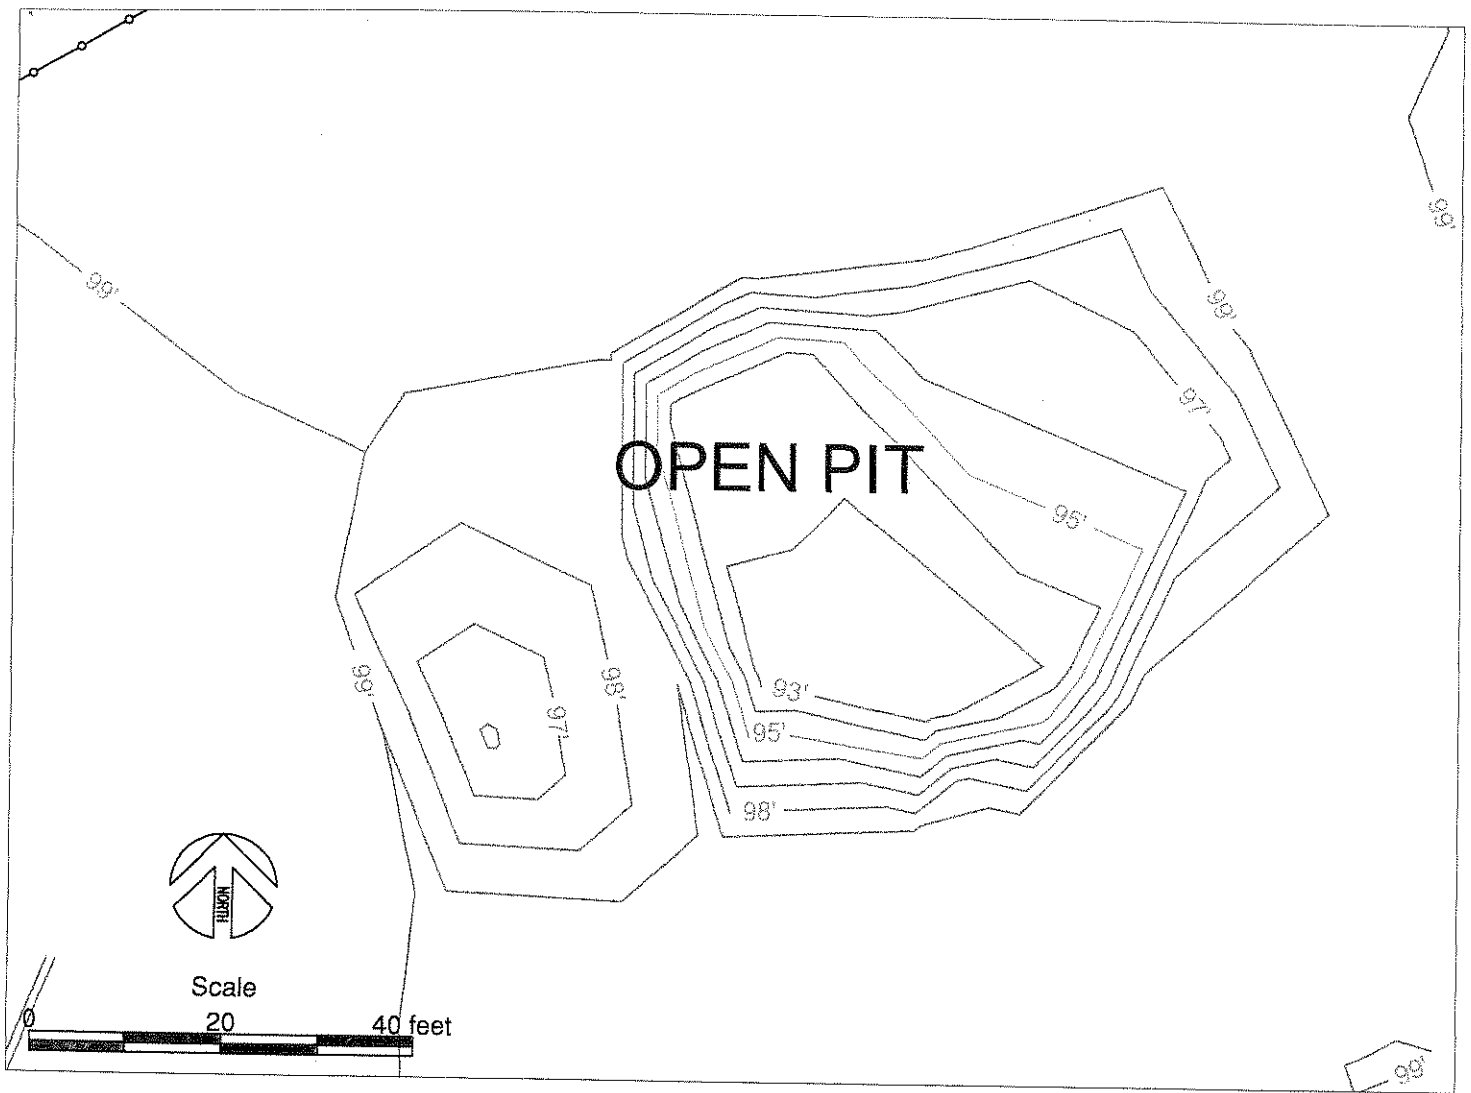
The volume of the open pit was estimated assuming that the pit bottom is essentially flat and by integrating the area within the pit using one foot “slices” based on the topographic contours shown on Figure 5. The total volume of the pit is estimated to be approximately 550 cubic yards.

Contour Elevation 1	Area Inside Contour Interval 1	Contour Elevation 2	Area Inside Contour Interval 2	Cubic Feet
A99	5025.12	A98	3583.49	V0 = 4,304.31
A98	3583.49	A97	2642.5	V1 = 3,113.00
A97	2642.5	A96	1840.58	V2 = 2,241.54
A96	1840.58	A95	1424.54	V3 = 1,632.56
A95	1424.54	A94	1056.66	V4 = 1,240.60
A94	1056.66	A93	428.56	V5 = 742.61
A93	428.56	A92	2115.29	V6 = 1,271.93
Total Cubic Feet =				14,546.54
Total Cubic Yards =				538.76
