Environmental & Geotechnical Solutions

**SITE CLEANUP PLAN
FORMER COASTAL DRILLING SITE,
SOLDOTNA ALASKA
ADEC FILE NO. 2333.38.013**

Reeves Amodio LLC

April 2014

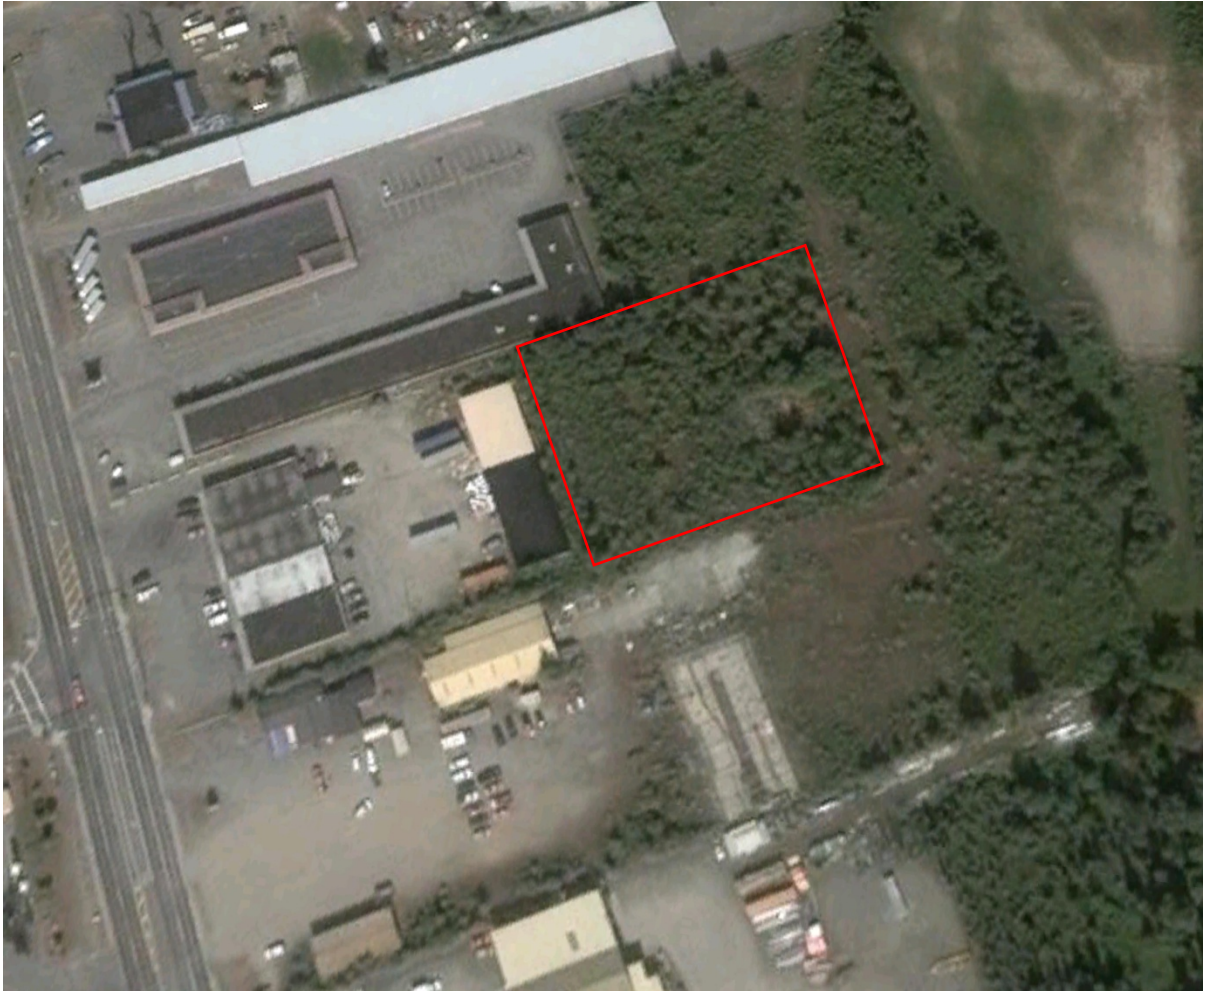
FORMER COASTAL DRILLING SITE

Prior reports indicate that site development included digging a debris disposal pit and constructing a machine shop, a drilling shop, and an office building. During the time the drilling companies operated the site, scrap iron, engines, lumber, and other drilling rig junk were placed in the debris disposal pit. A grate and drain associated with the drilling shop (now demolished) is also reported to have received rig wash water which was conducted to the disposal pit via a 6-inch pipe (referred to as the “grate area”). This pit was subsequently filled and is referred to as the “covered pit”. A second pit was excavated and remains open. This second pit is referred to as the “open pit” and is visible on the air photo in the frontispiece to this report.

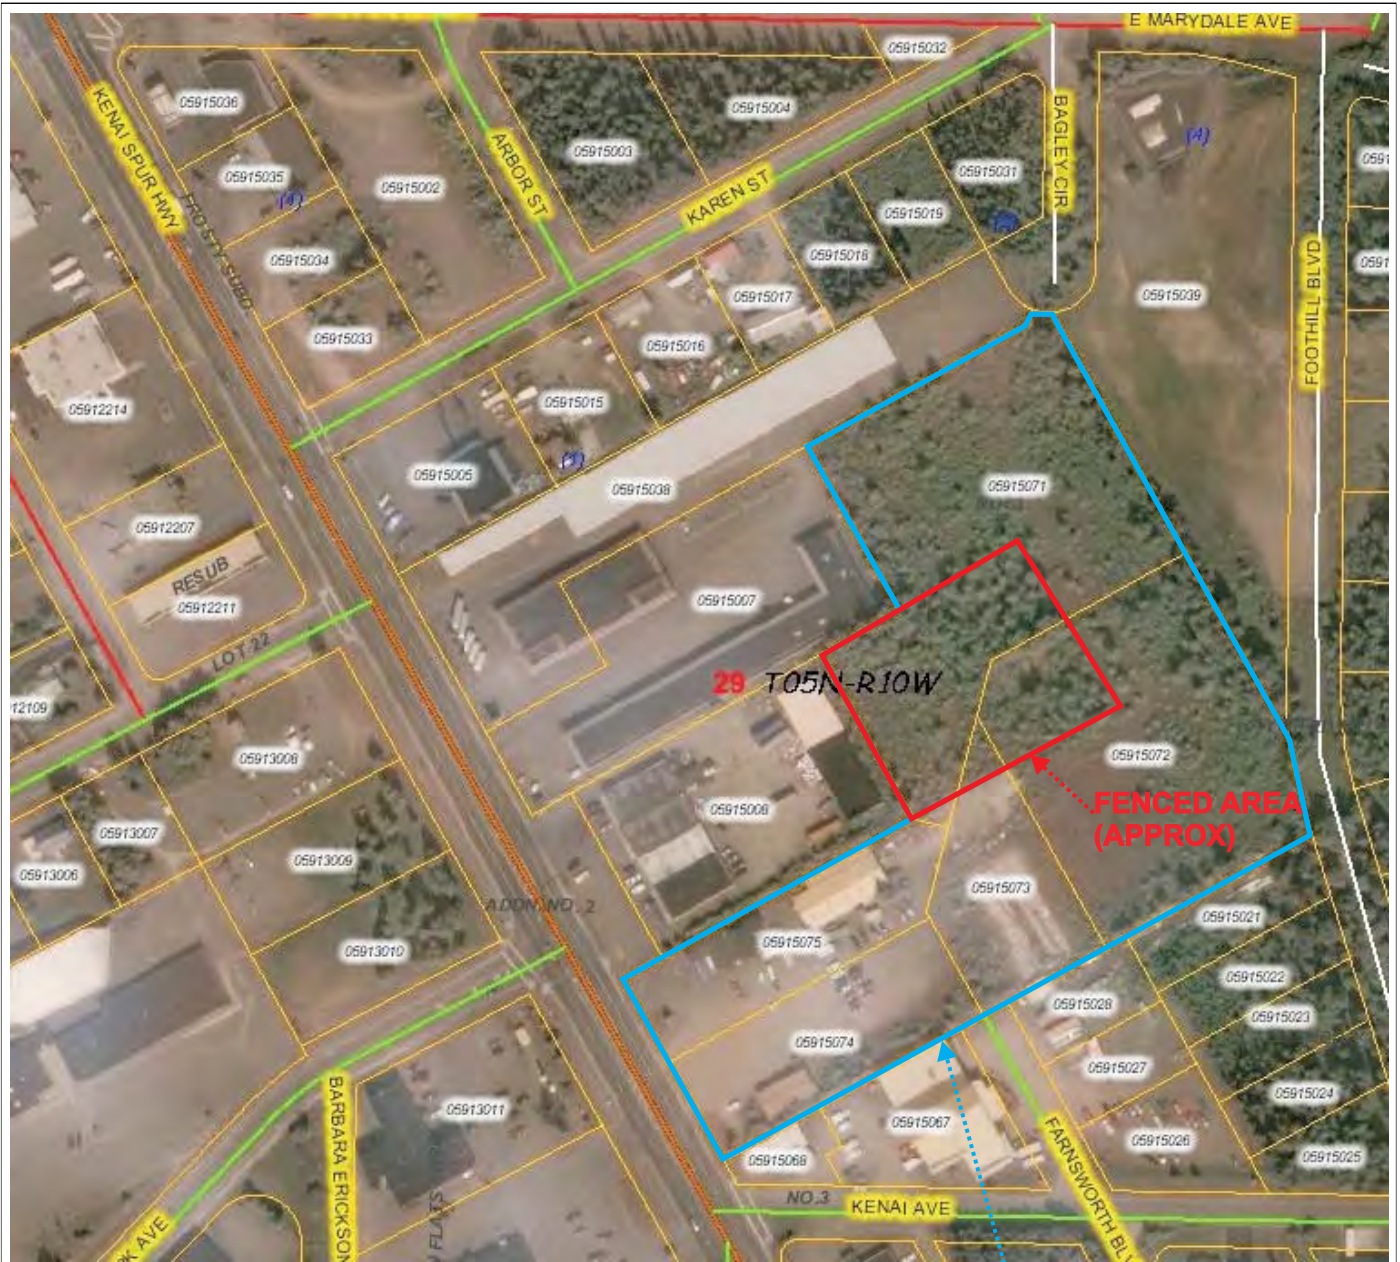
SITE PLAN

**FORMER COASTAL DRILLING
PROPERTY BOUNDARY**

The former Coastal Drilling facility is located at mile 0.5 Kenai Spur Road, Soldotna, Alaska. The legal description of the Property is described as the eastern half of Section 29, T5N, R10W, Seward Meridian as shown on Figure 1. The entire property includes several adjacent parcels totaling approximately 7 acres as shown on Figure 2. The proposed site cleanup described in this report is focused primarily on the area within the chain link fence also shown on Figure 2.

Upon completion of the proposed cleanup, all portions of the site with the exception of the covered pit area will meet ADEC's Method Two cleanup levels as defined in 18 AAC 75 and no institutional controls will be needed for these areas. The covered pit area will then also qualify for a determination of *Cleanup Complete – Institutional Controls*. It is anticipated that the institutional controls will require maintenance of the asphalt cap and preclude excavation in that area without ADEC approval. This will apply to only one of the parcels comprising the property as shown on Figure 2.
