RE: Site Characterization Report  
229/233 Madcap Lane, Fairbanks, Alaska

**NORTECH** Environmental Engineering, Health & Safety (**NORTECH**) is please to provide this site characterization report for the property located at 229/233 Madcap Lane in Fairbanks, Alaska (see Figures 1 through 3). The work outlined in this report was completed in general accordance with the work plan approved by ADEC in April 2008. This report details field work that was conducted in June 2008, as well as with **NORTECH**'s observations, comments, and recommendations regarding the site.

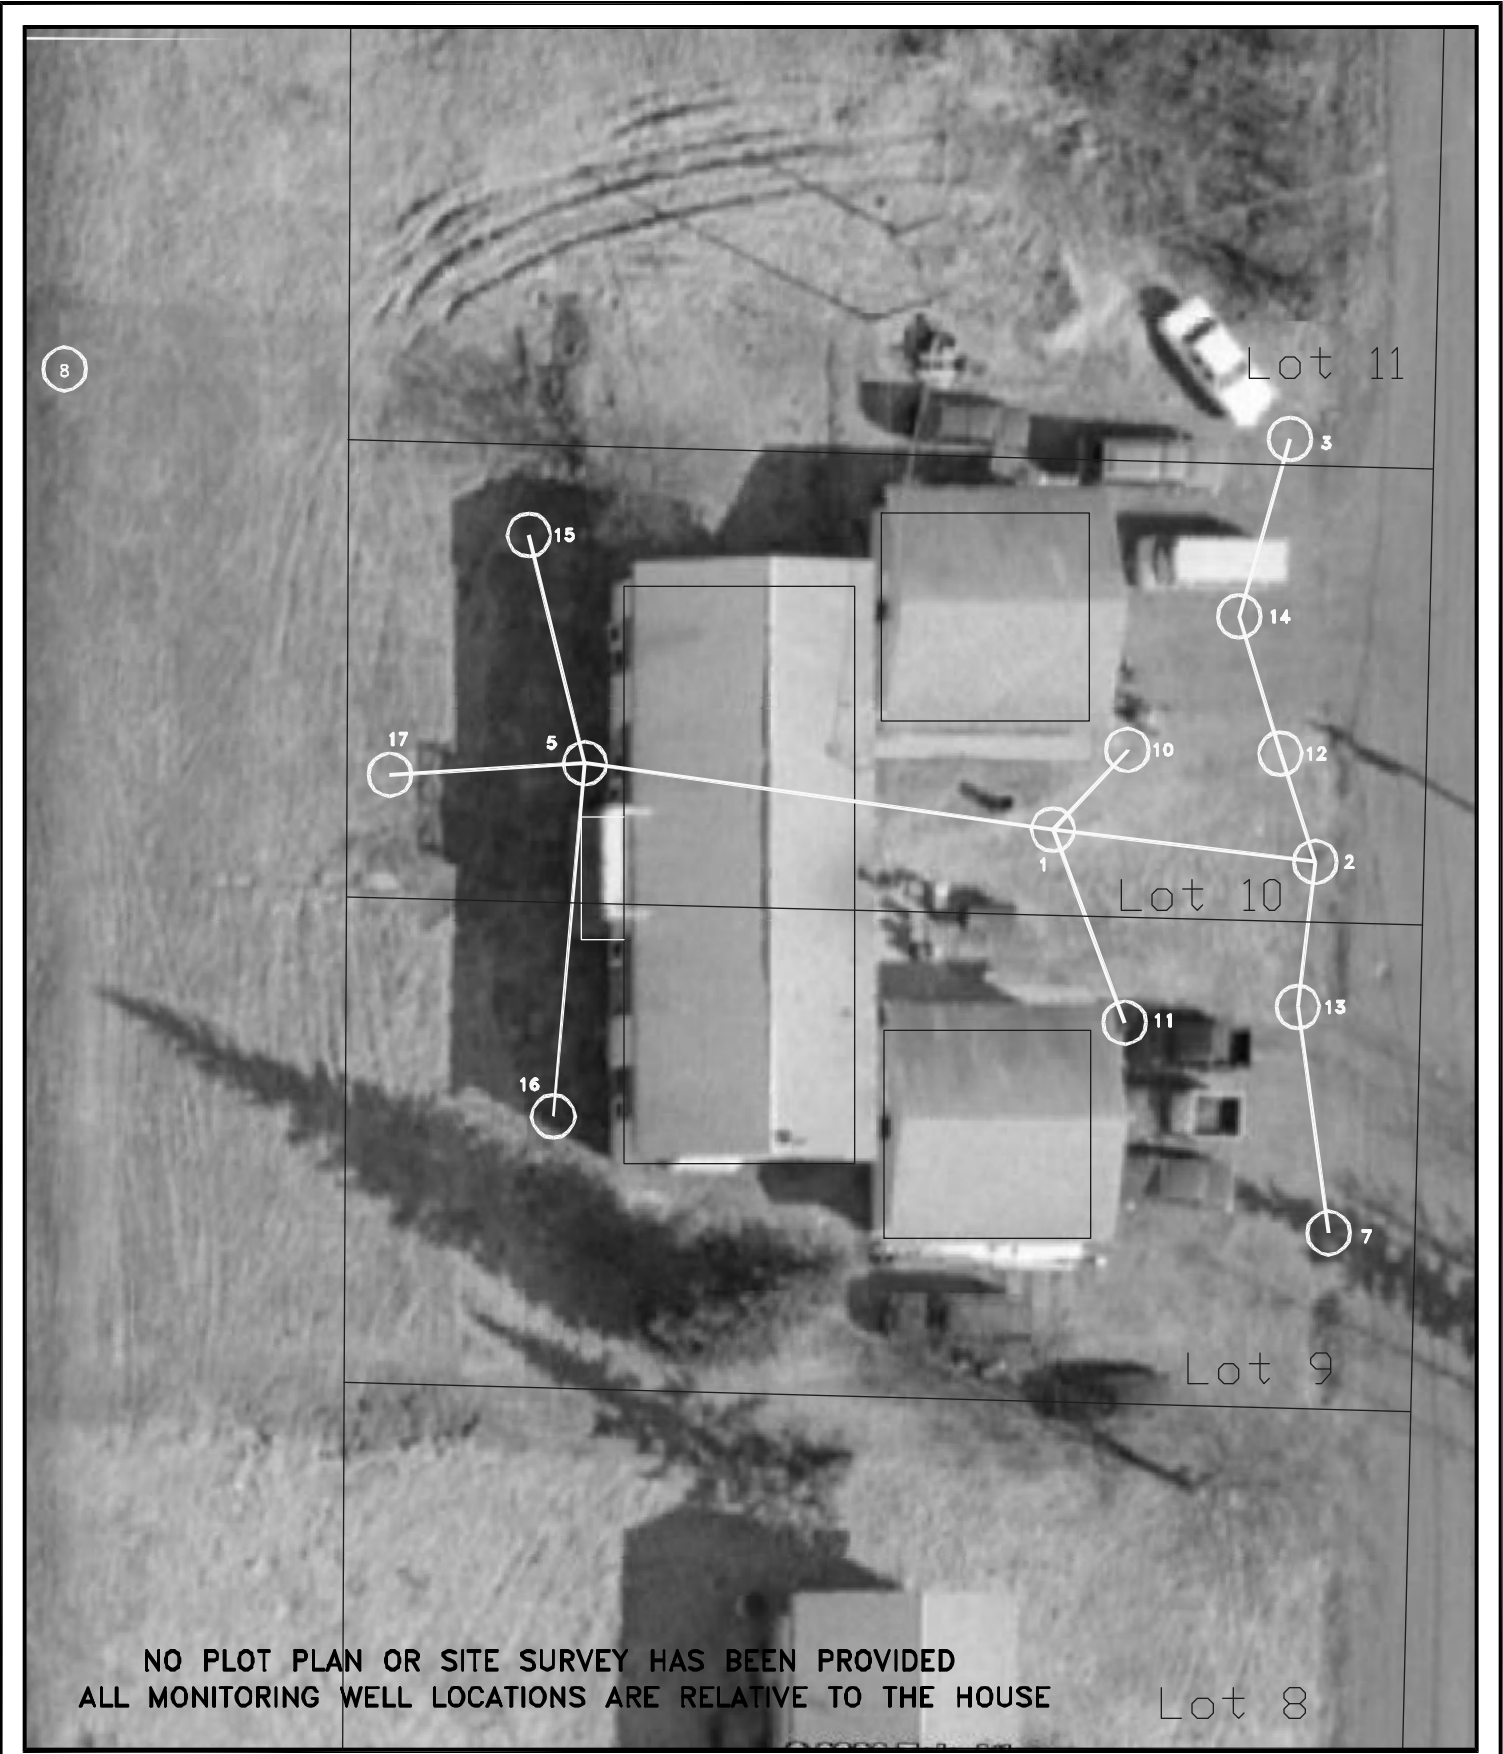
Development at 229/233 Madcap Lane (the Site) consists of a four-unit residential structure and two detached garages; one northeast of the structure and one southeast of the structure as visible in Figure 3. In 1997, the buried heating oil fuel tank was removed and replaced. Upon the removal of the former tank, heating oil was observed at the bottom of the open excavation and in the sump of the nearby underground boiler room. A total of approximately 1,650 gallons of heating oil was recovered from the site; 826 gallons from a recovery well, 744 gallons from the sump in the underground boiler room located adjacent to the former tank, and 80 gallons from the bottom of the tank excavation. No additional site assessment or other release investigation activities were reported to ADEC following the tank removal.

A total of 14 soil borings were advanced in locations primarily east and west of the primary structure as shown in Figure 3. The location, rationale, and field observations (including PID results) for each boring are summarized below. Detailed logs for each

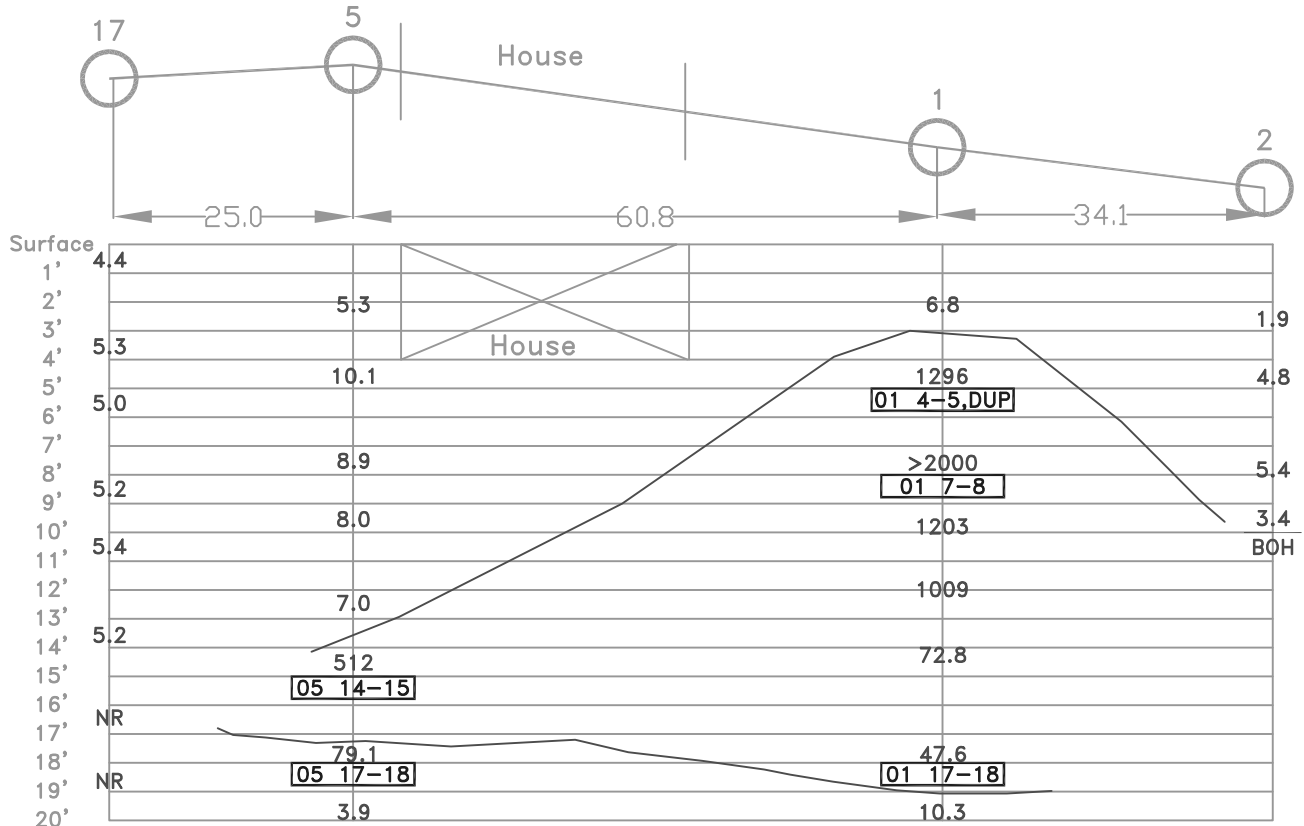
area. SB-12 had no recovery due to permafrost below 15 feet and a clean lower limit was not identified. The adjacent borings, SB-2 (south) and SB-14 (north) were clean to 10 feet, but no data was collected below 10 feet due to refusal. Borings near the property corners, SB-7 (south) and SB-3 (north) confirm that the contamination has not migrated off the property in these directions. These results generally confirm the gradual deepening of contamination with distance from the source area seen in cross section 17-2. These results also suggest that soil contamination has extends offsite beyond the eastern property boundary. Additional characterization (up to four borings) should be completed to verify the depth and north-south extents of the soil contamination along the eastern boundary.

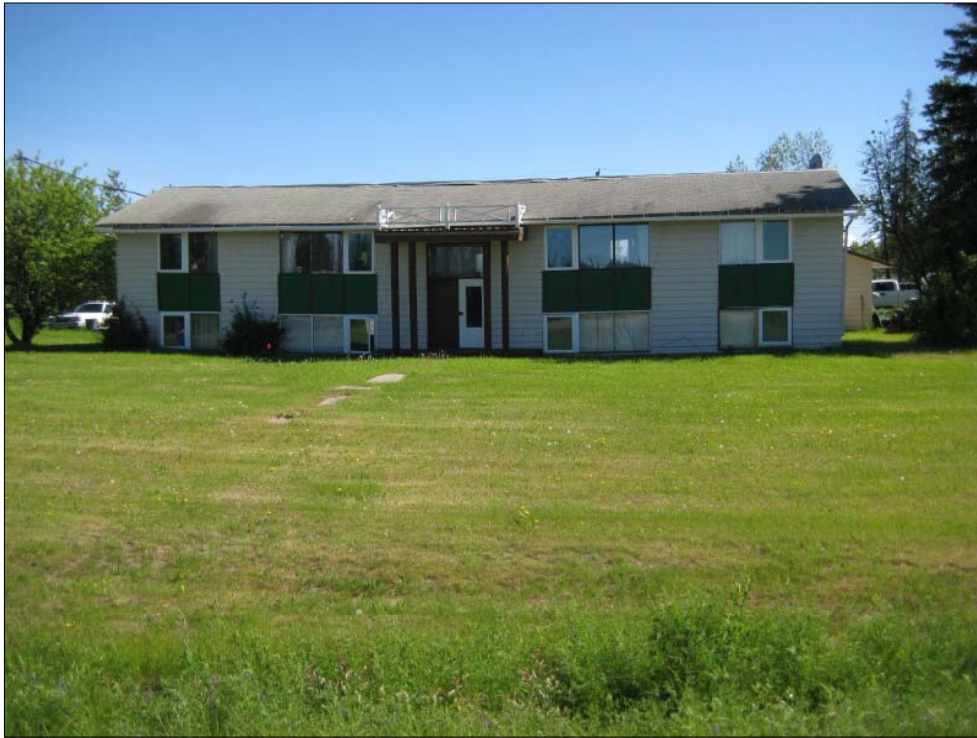
Photo 01 - Looking east at the west side of the primary structure

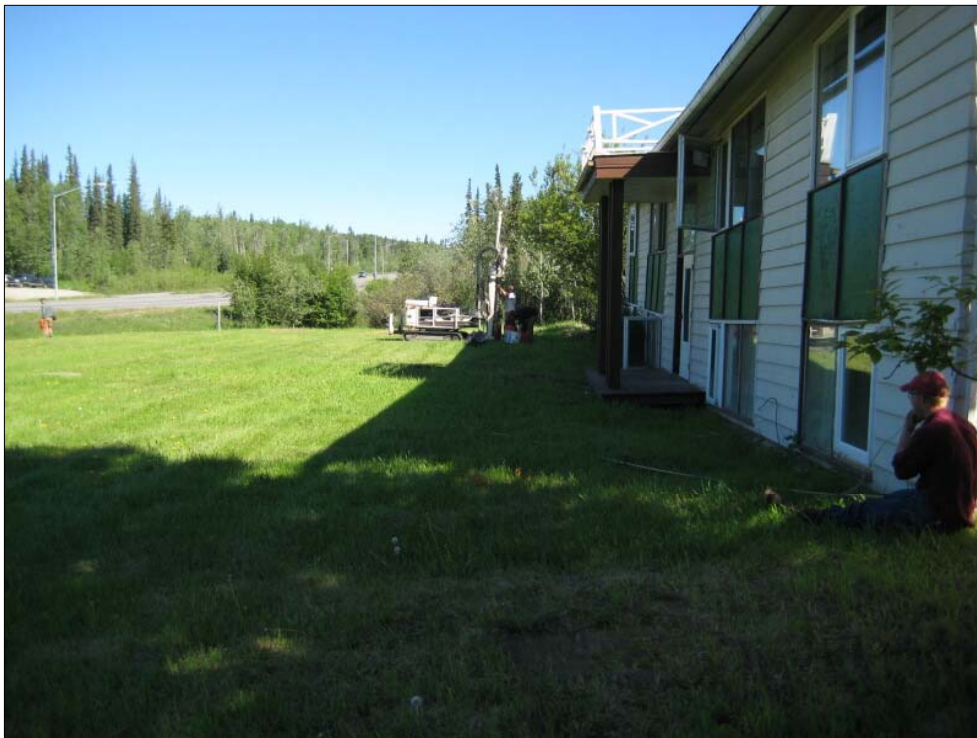
Photo 02 - Looking north along west side of structure at installation of SB-15

**SB-15** – This boring was located near the northwest corner of the primary structure to delineate potential contamination beneath the structure and contaminant migration to the northwest. The boring was advanced to a depth of 20 feet. No odor or staining was observed in recovered soil and the highest PID reading was 6.2 ppm, within the background range.

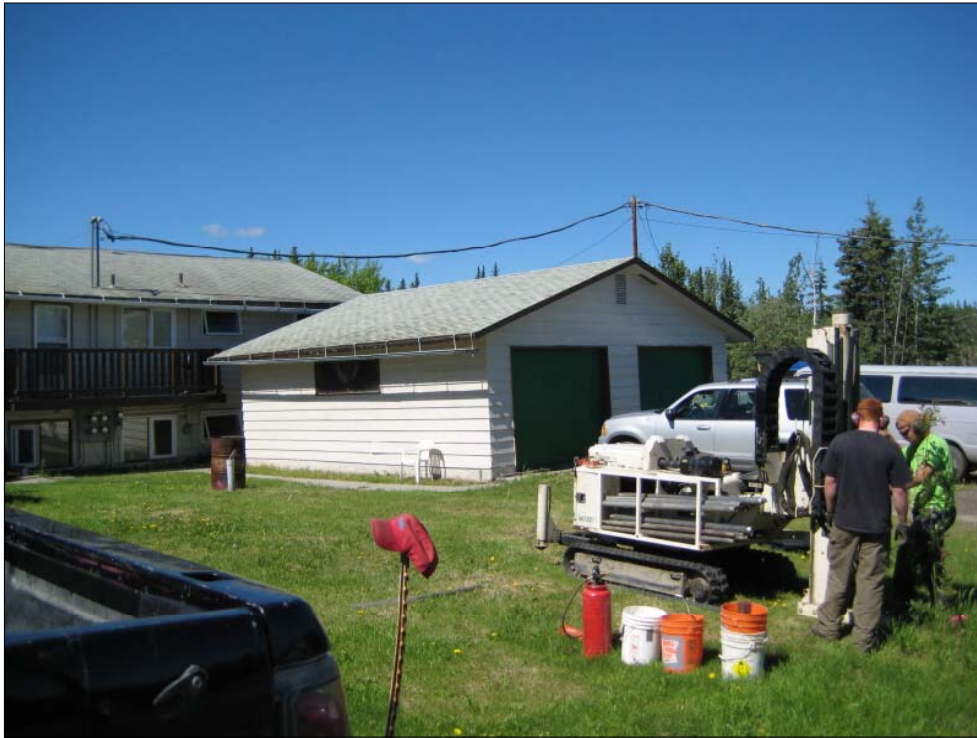
Photo 03 - Looking northwest at installation of SB-02; SB-01 location near drum in background

**SB-02** – This boring was located near the eastern property line, directly east of the source area and was selected to evaluate the potential migration towards Madcap Lane. The boring was advanced to a depth 10 feet, where the wastewater service line was encountered and the boring was discontinued. No odor or soil staining was observed in recovered soil and the highest of the four PID readings was 5.4 ppm.

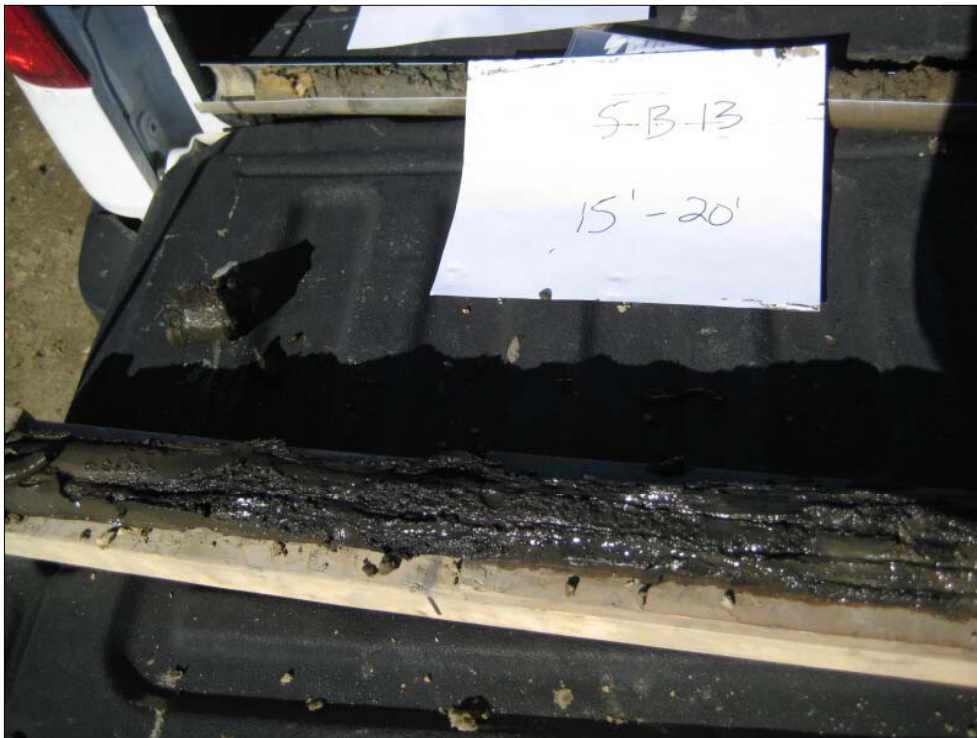
Photo 04 - Recovered soil core from 15-20 foot depth of SB-13, moist/saturated fine silt with organics, but is too fine to produce water

**SB-13** – This boring is located directly east of SP-11 and south of SB-2, near the eastern boundary of the property. SB-13 was intended to evaluate the potential for contaminant migration to the east and southeast between SB-2 and SB-7. The soil boring was advanced to a depth of 20 feet and no odor or soil discoloration was observed in recovered soils. The highest PID result was 6.3 ppm and each result was considered in the background range.

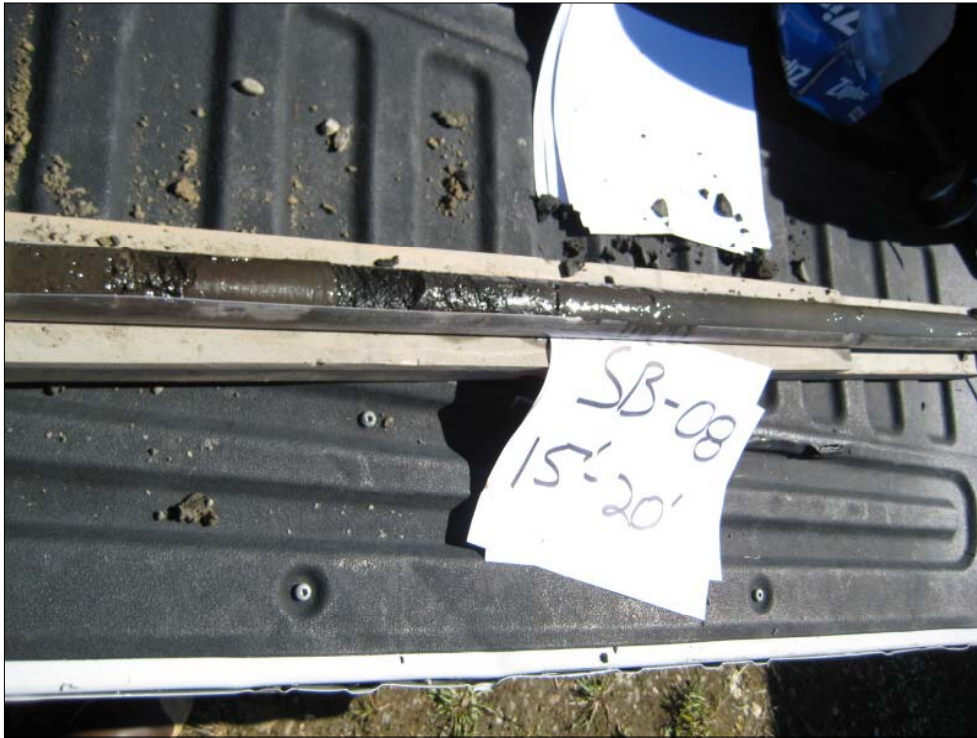
Photo 05 - Recovered soil core from 15-20 foot depth of SB-08, frozen fine silt with organics

**SB-08** – This boring was located approximately 80 feet northwest of the primary structure with the goal of identifying a clean limit in this direction. The soil boring was advanced to a depth of 20 feet and no odor or soil discoloration was observed in recovered soils. The highest PID result was 4.2 ppm and each result was considered in the background range.

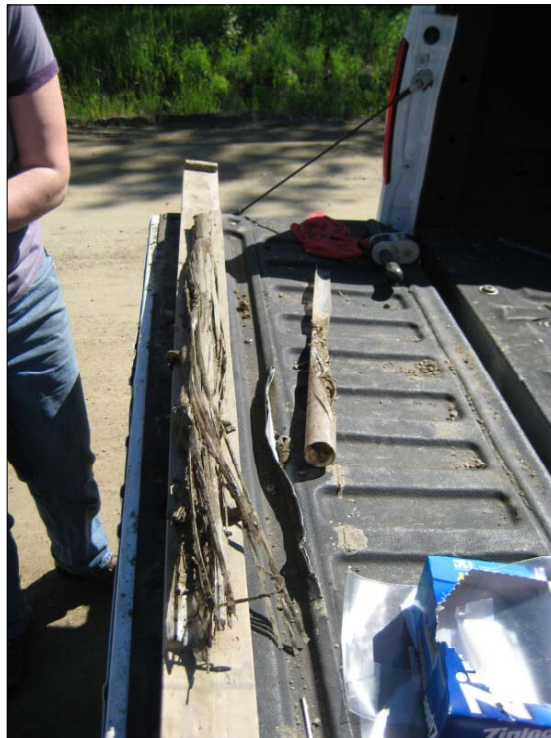
Photo 06 - Shattered soil core sleeve with no recovery in frozen silt
