File: Speedway Store 5313 (Former Tesoro 2Go Mart 101) & IFC
UST Facility #2960, ADEC File 100.26.022

Date: November 10, 2021

Reference: Speedway Store 5313 (Former Tesoro 2Go Mart 101) & IFC - Report on the Installation of the New 2021 Drainfield for Discharge of Effluent from Groundwater Treatment Aeration Tank

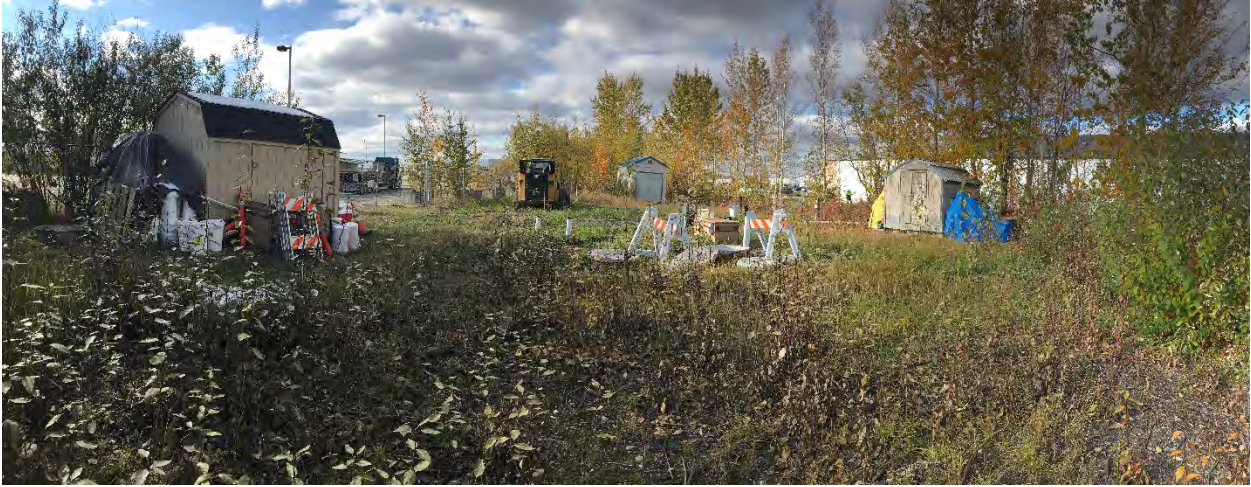
Photo #1 – Panoramic View of Site Prior to Start of 2021 Drainfield Installation (looking west)

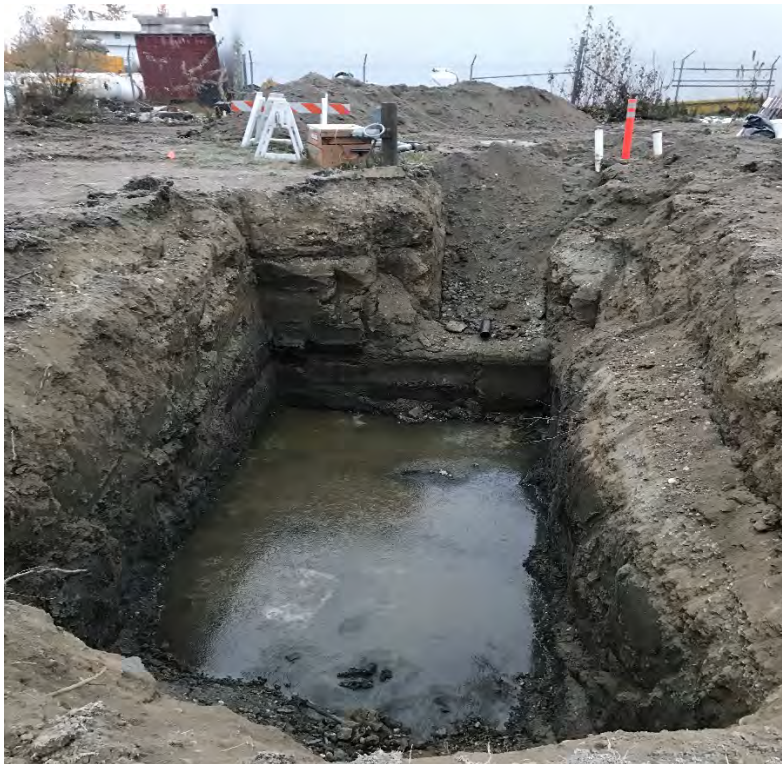
Photo #2 – Start of East End of Trench Excavation (looking east). Note sheen on groundwater and stained contaminated soil strata at bottom of trench.

The drainfield trench was excavated to the following dimensions: 10-feet wide, 45-feet long, and approximately 12 feet deep bgs. Petroleum contaminated soil was encountered in the entire excavation at a depth of approximately 9.5-feet bgs and extended to the bottom of the excavation. Groundwater was encountered at a depth of approximately 10 to 11-feet bgs and was observed to have a heavy petroleum sheen.

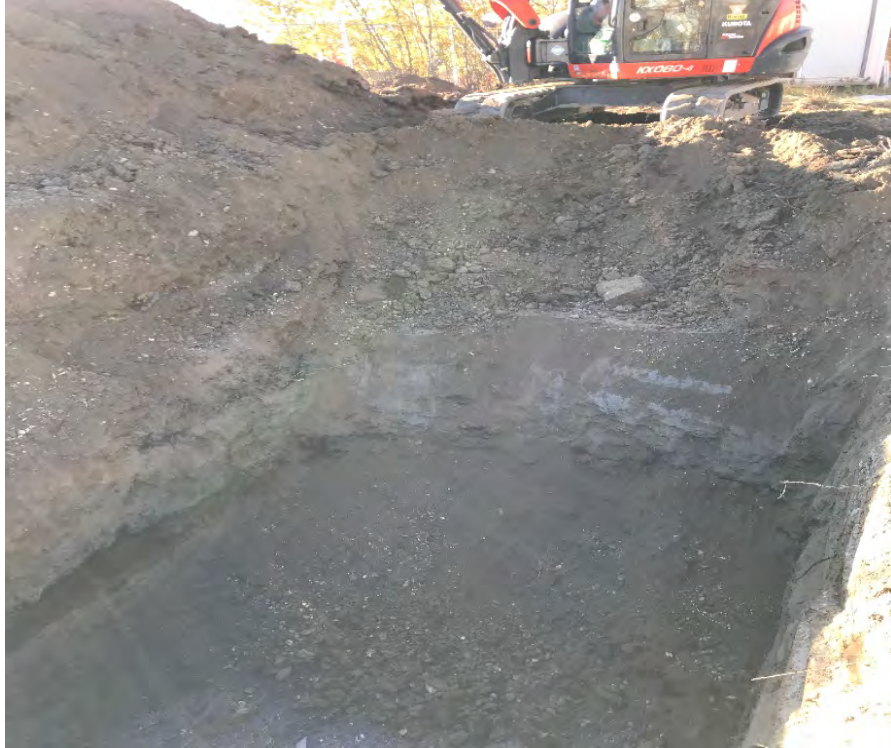
Photo #3 – Excavation of West End of Trench. Note stained soil strata near bottom of excavation.

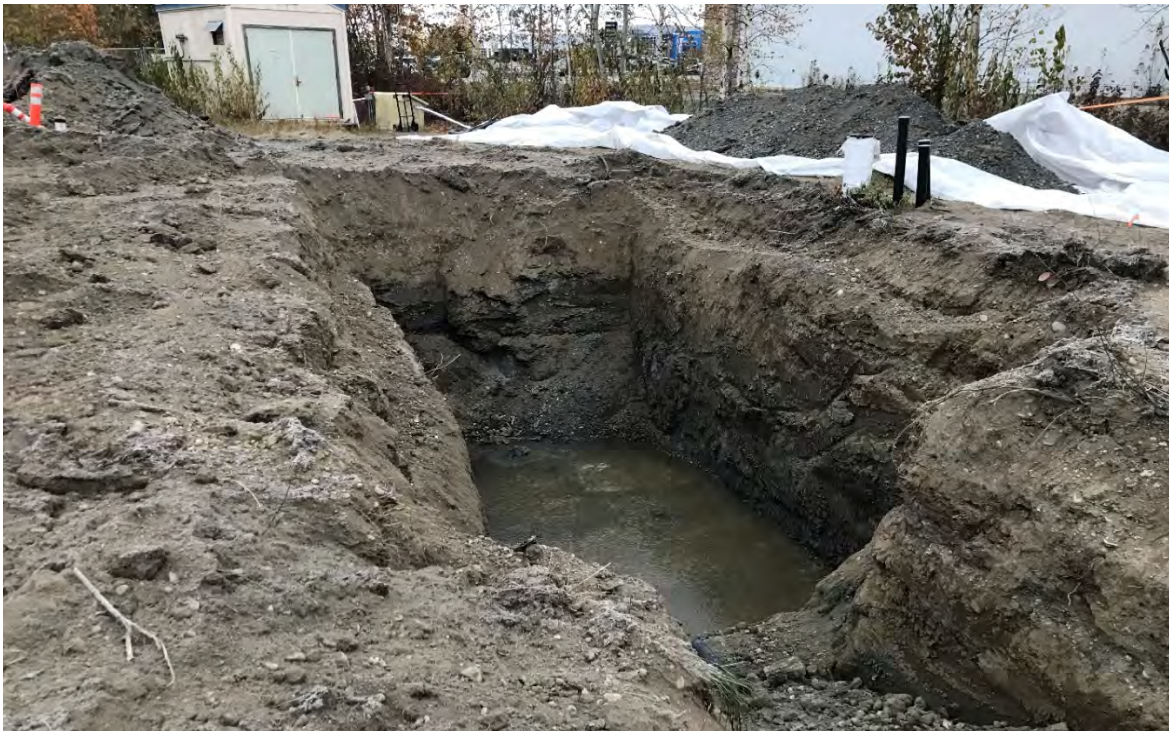
Photo #4 – Excavation of Trench (looking west) towards Shed for WRW well. Note dark stained soil strata at bottom of trench. Note the stockpile of contaminated soil in the background.

A stockpile of contaminated soil was constructed onsite for temporary storage of the soil until next year for subsequent removal and treatment. The stockpile was placed on 10-mil visqueen and securely covered with 10-mil visqueen. The stockpile contains approximately 40-cubic yards of soil and was placed along the northern edge of the site, nearly parallel to the 2021 Drainfield.

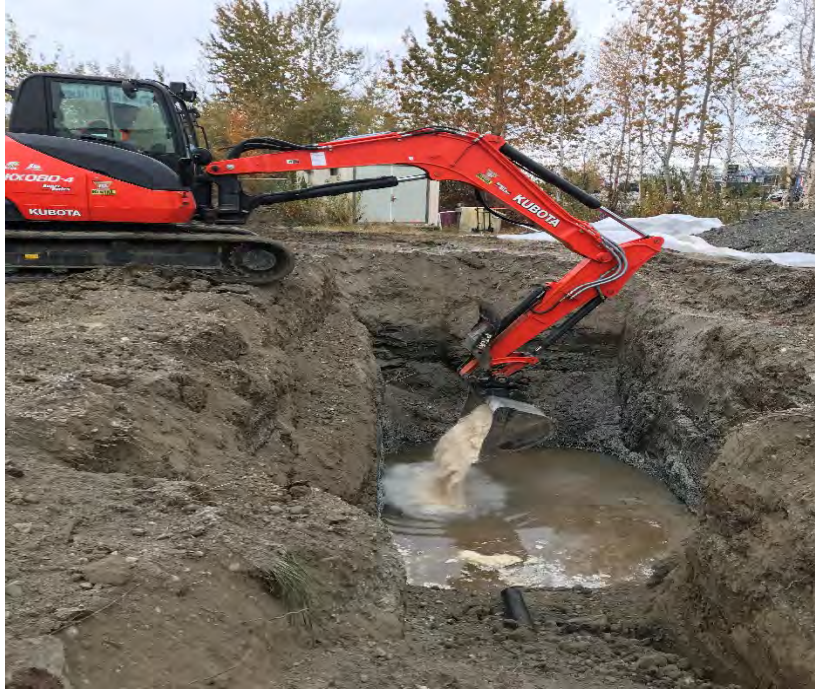
Photo #5 – Application of Klozur™ CR powder on the bottom of trench in contaminated groundwater.

Upon completion of the excavation of the drainfield trench, Stantec directed the placement of the Klozur CR™ product into the bottom of the trench that contained petroleum contaminated groundwater and soil. The Klozur CR™ consists of a powder that is a self-activating persulfation product (a persulfate oxidation system) with calcium peroxide. The powder was uniformly spread/broadcast with the excavator bucket across the entire bottom of the trench. The application rate of the Klozur CR™ was approximately 5.2 pounds per square foot which is within the manufacturer recommended application rate for in-situ treatment. In summary, a total of 2,340 pounds of Klozur CR™ was used for the in-situ treatment of the exposed contaminated groundwater and soil at the bottom of the trench. A photo of the application of the Klozur CR™ powder is provided in the photo log (Attachment A).

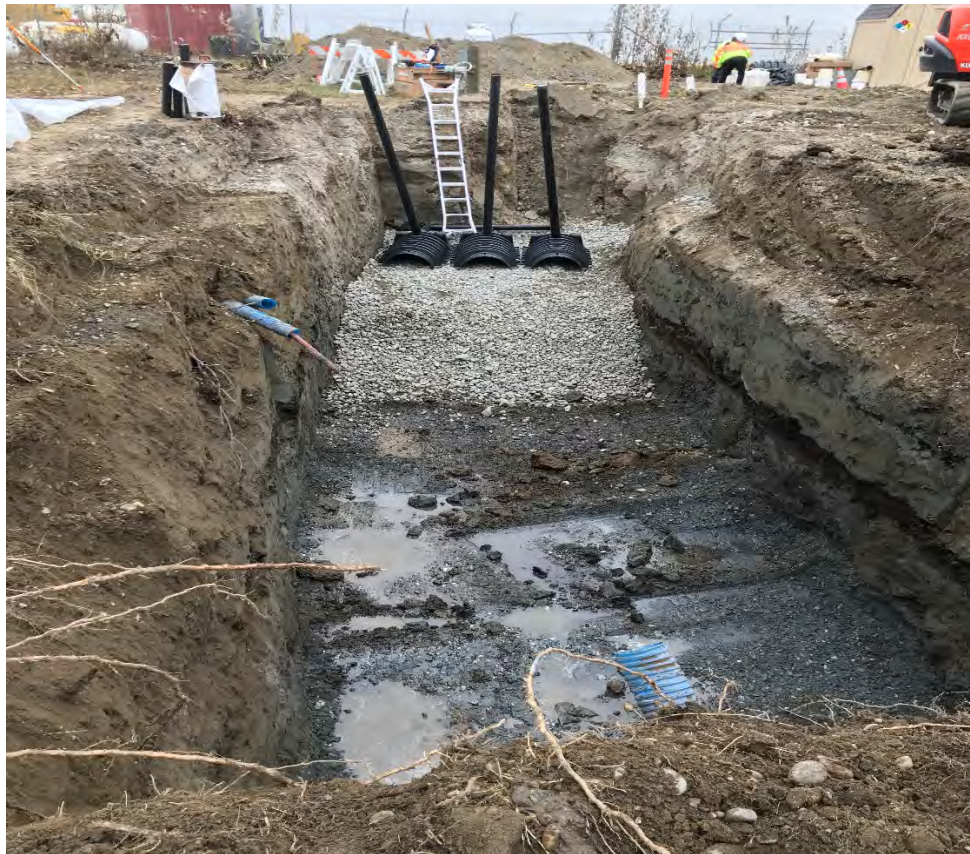
Photo #6 – Start of Installation of Infiltrators™ with Sewer Rock.

Following the spreading of the Klozur product on the bottom of the trench, the excavation was filled with approximately 3 to 4 feet of screened sewer rock up to the base of the Infiltrators™. The bottom drainage area of the drainfield was determined to be approximately 450 square feet. The sewer rock is similar to what has been used in the existing 2006 drainfield. The sewer rock was also used to cover the Infiltrators™. Approximately 96 cubic yards of sewer rock was placed in the drainfield trench excavation.

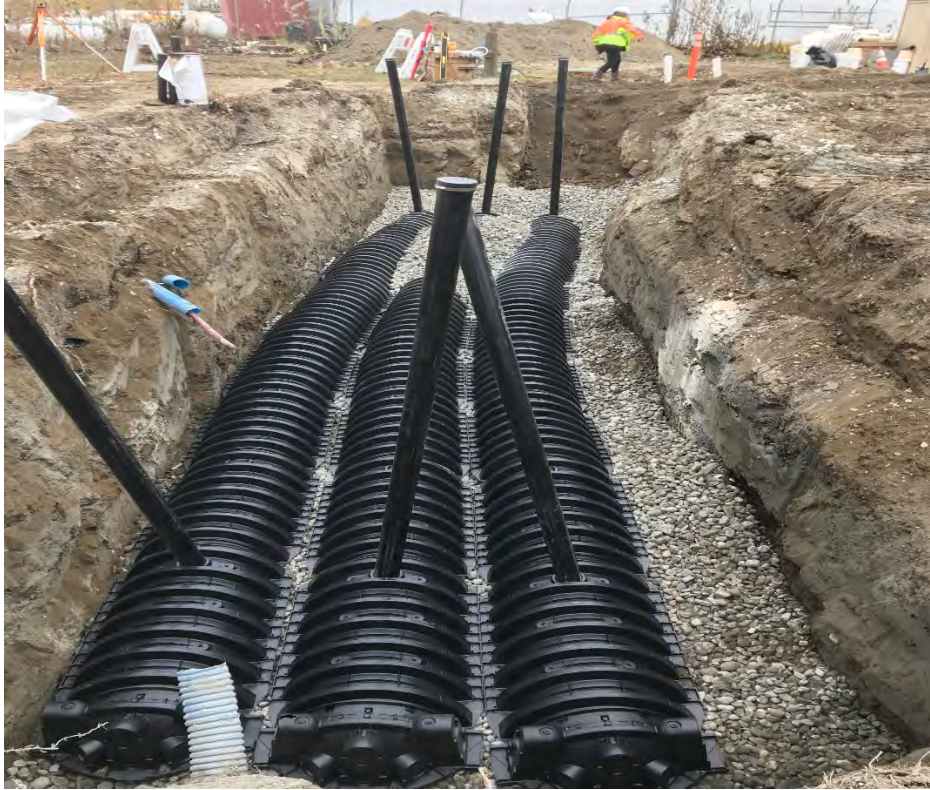
Photo #7 - Completed Installation of Infiltrators prior to placement of Fabric Material

The Infiltrators™ were placed nearly level in 3 parallel rows in a bed layout over the screened rock base that covered an area of approximately 10-feet by 45-feet. The bed of the Infiltrators™ was slightly sloped to the far end (west end) of the drainfield to facilitate gravity flow across the bed. A total of 27 Infiltrators™ chambers (9 chambers for each row) were installed for the drainfield. 4-inch diameter PVC observation/monitor pipes were installed vertically at the end of each row to allow future measurement of water levels in the drainfield Infiltrator™.

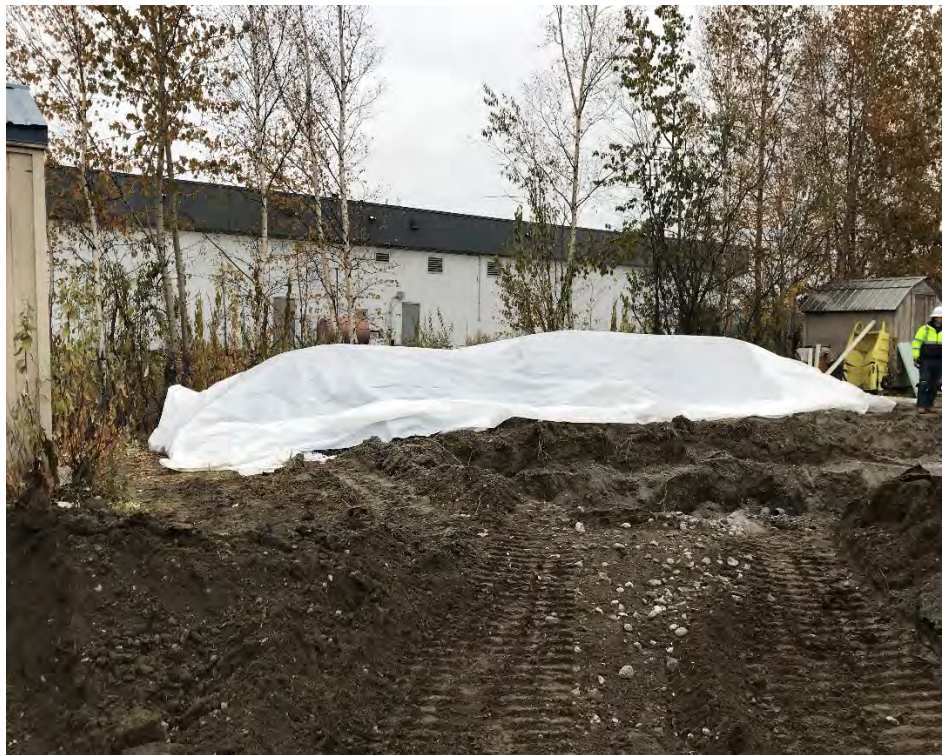
Photo #8 - Covered 40 CY Stockpile of Contaminated Soil (looking north)

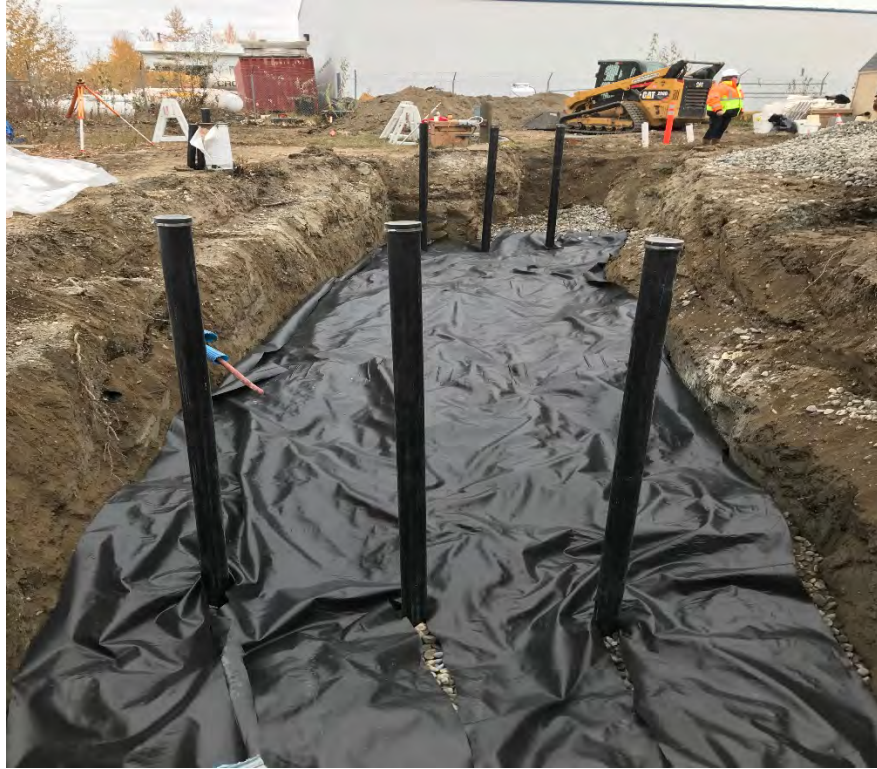
Photo #9 – Installation of Fabric Material of Completed Infiltrator Drainfield (looking east).

A geofabric material was placed over the top of the Infiltrators™ to prevent soil backfill from infiltrating into the Infiltrators™ and sewer rock. The fabric material was placed at approximately 5.5-feet below the ground surface. Non-contaminated native soil that was originally excavated from the trench excavation was used to backfill over the Infiltrators™. The backfill brought the final grade of the drainfield to match the existing ground surface with some mounding for potential future settlement and positive drainage of surface water.

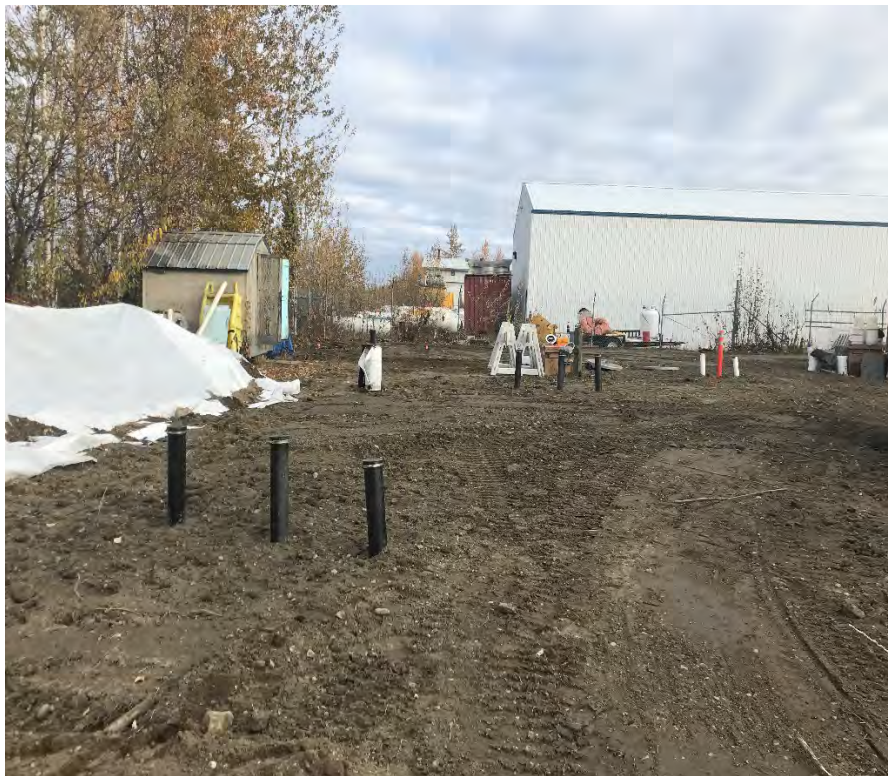
Photo #10 – Completed Installation of Backfill over 2021 Drainfield with Observation Pipes
