January 11, 2017
G-Logics Project Number 01-0294-E

**Subject: Technical Assistance and Soil Sampling - DRAFT
 Former Chevron Truck Loading Rack Property
 147 Front Street
 Hoonah, AK 99829
 Hazard ID No.: 26601**

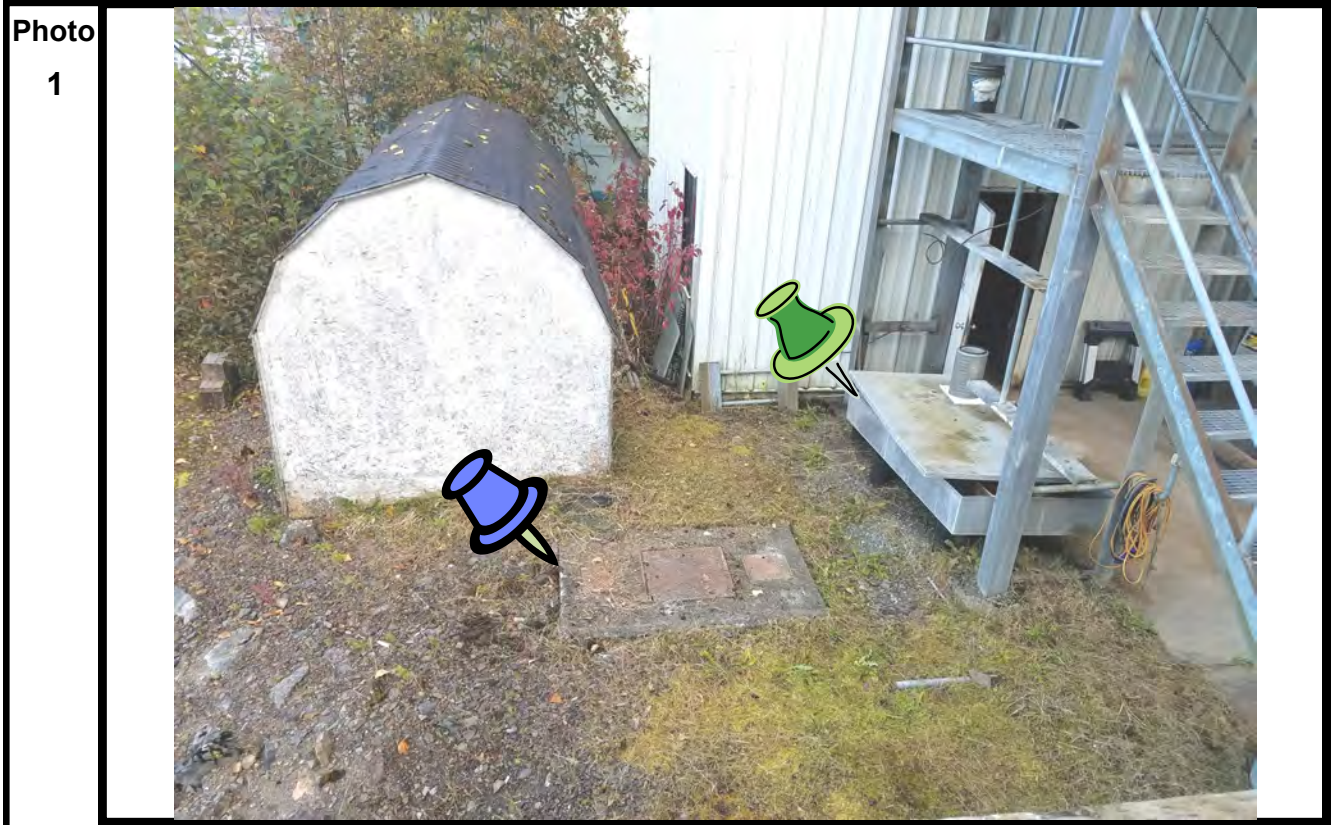
Description: Looking north at the former truck-loading rack assembly, prior to removal (green pin). Oil/water separator (blue pin).

Comments: The silver box was a spill catchment for the loading-rack dispenser. The fuel pipes and dispenser were removed in 2015.

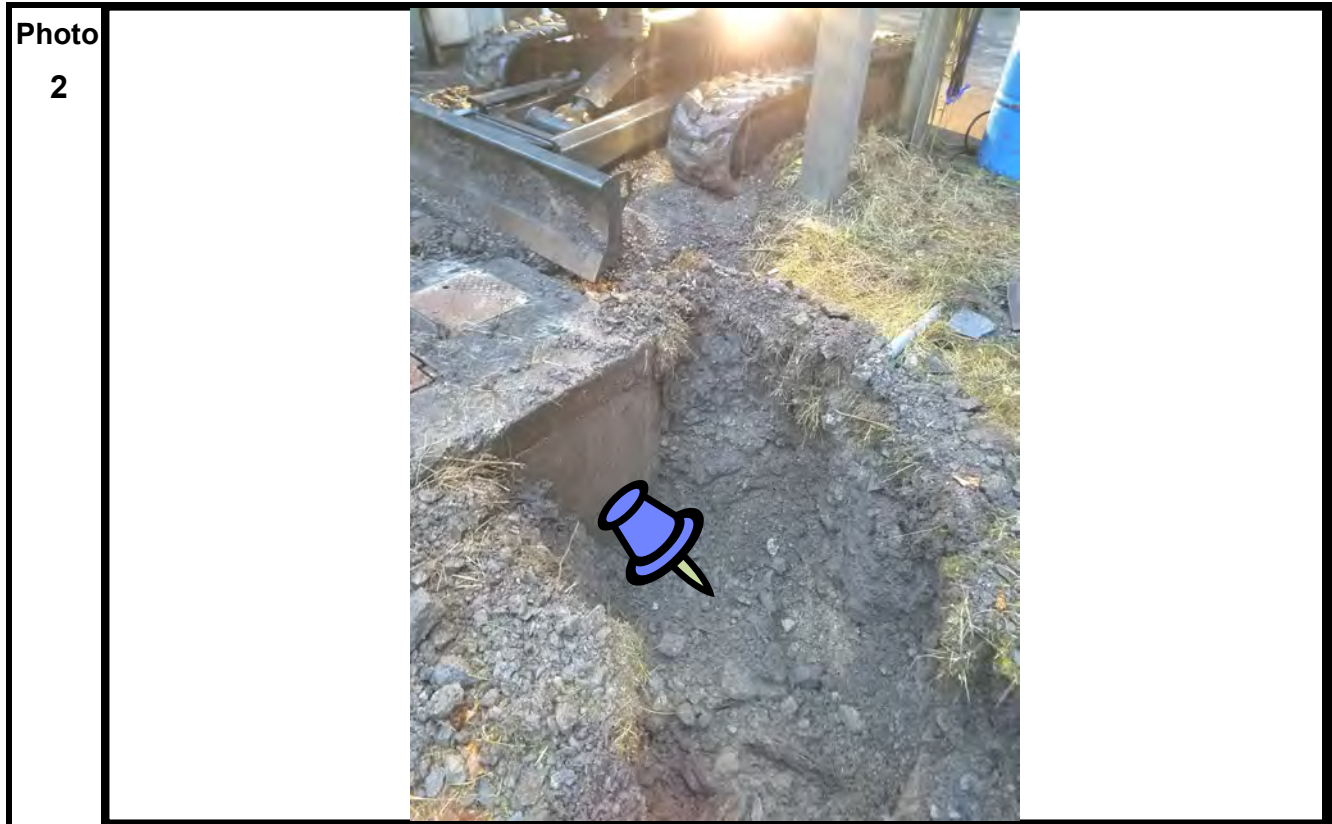
Description: Looking northwest towards the former location of the truck-rack assembly (where the excavator is located).

Comments: The blue pin indicates the testpit advanced to the south of the truck-loading rack remedial excavation.

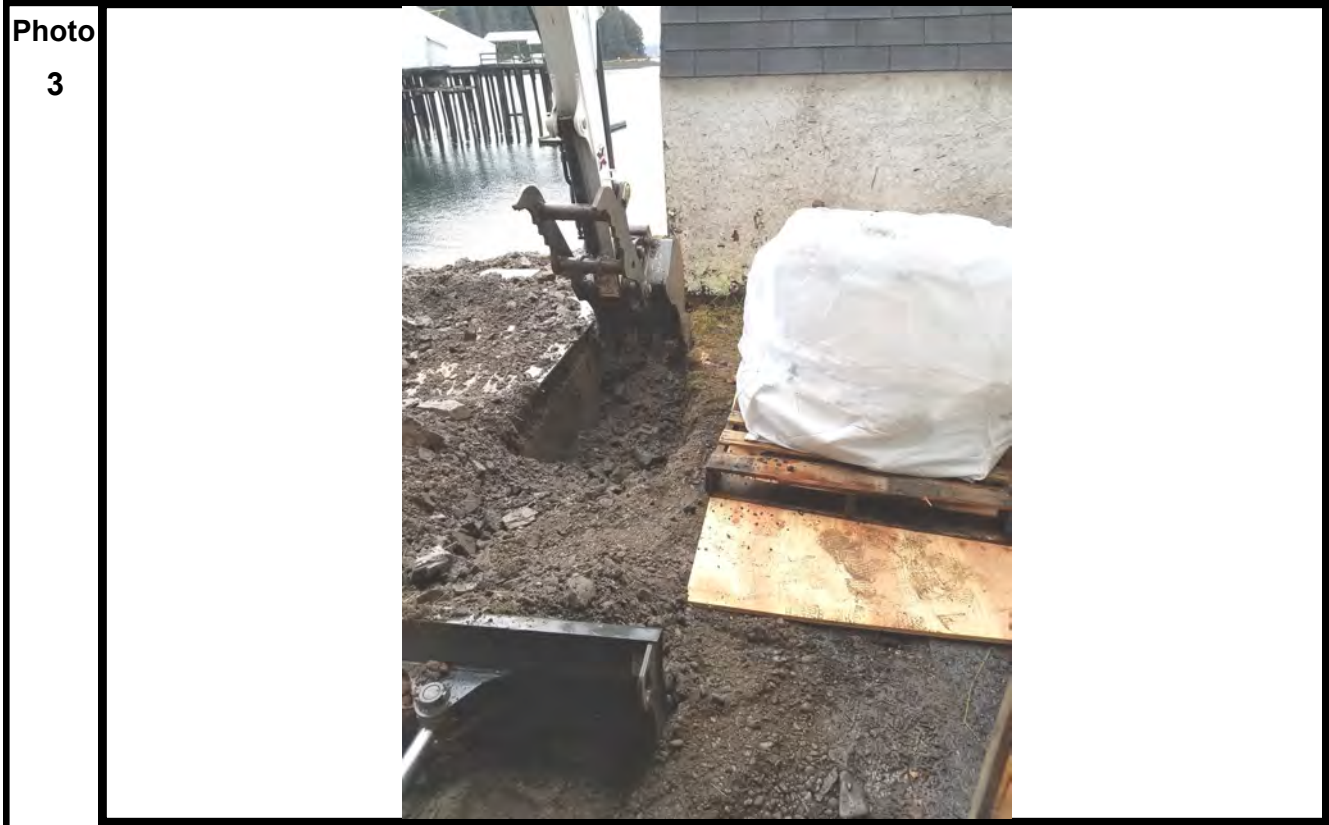
Description: Beginning the remedial excavation beside the former truck-loading rack.

Comments: Contaminated soil was removed and placed into plastic lined, one cubic-yard supersacks.

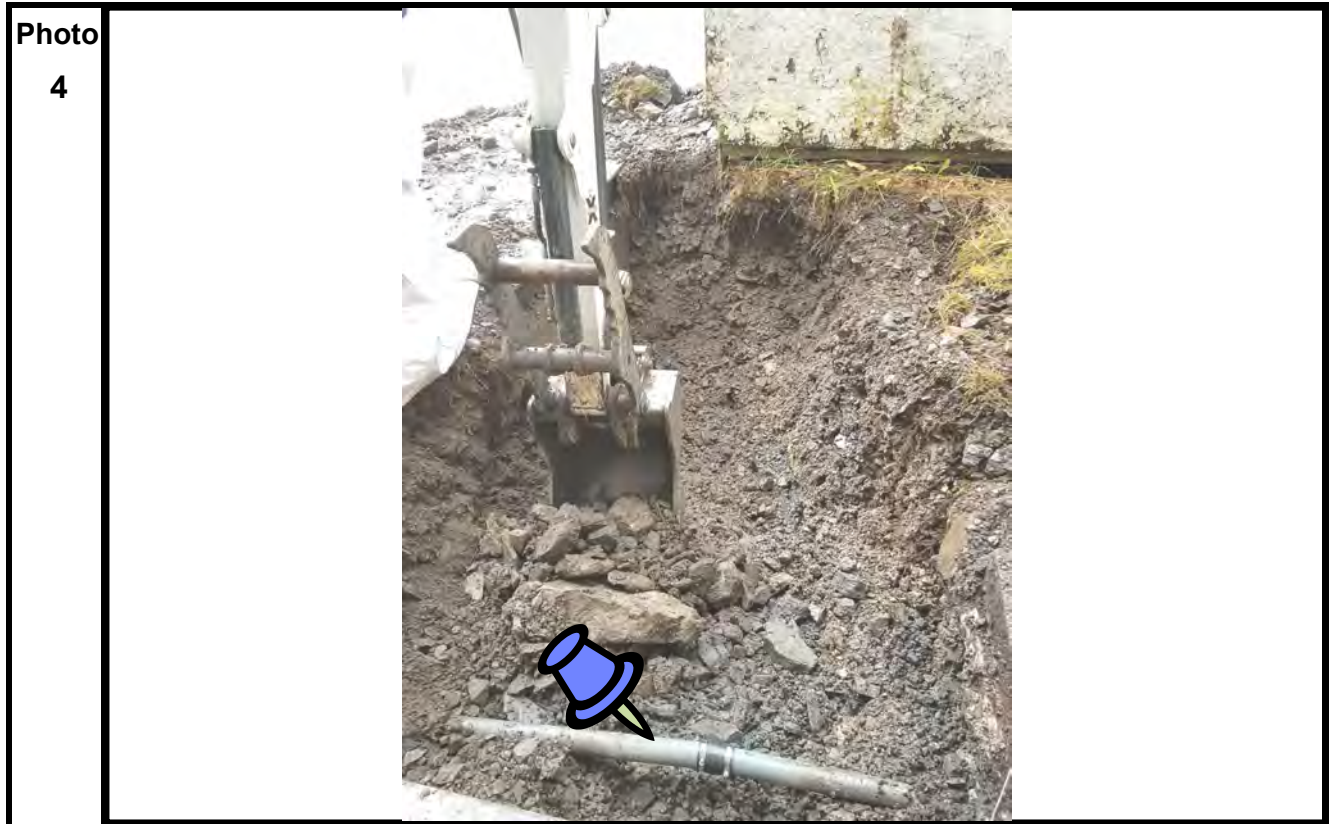
Description: An electric line was encountered running north-south across the excavation (blue pin).

Comments: Contaminated soil was left onsite due to the electrical line and the concrete slab present (just out of the photo).

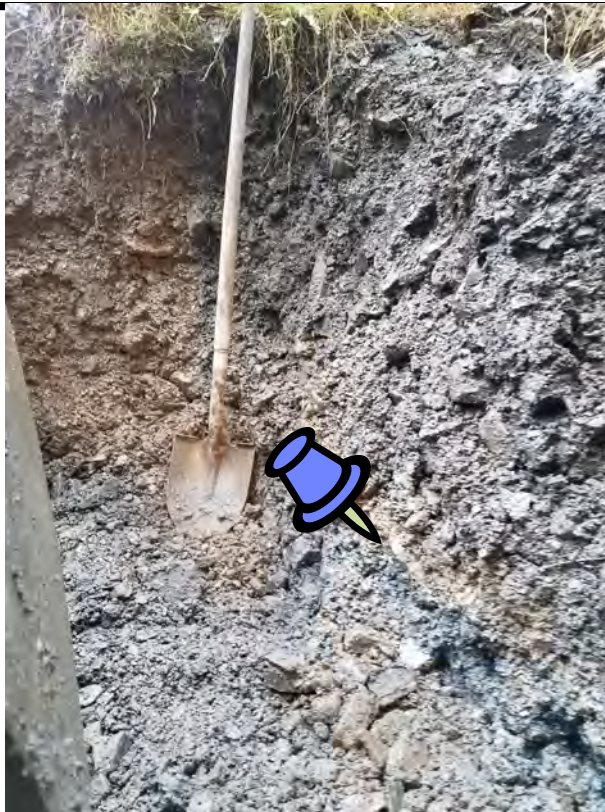
Photo
5

Description: The excavation extended approximately 4.5 feet deep.

Comments: Dark gray, stained soil can be seen on the north sidewall of the excavation (blue pin).

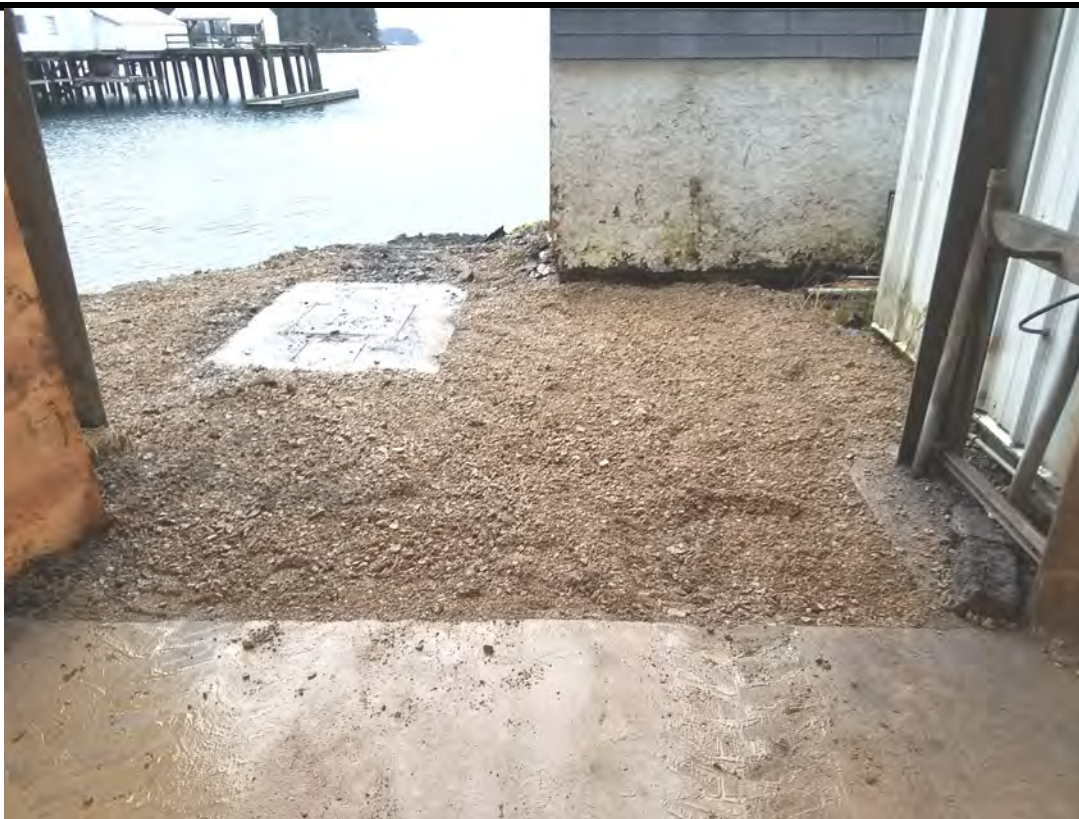
Photo
6

Description: After accessible contaminated soil was removed, the excavation was backfilled with imported material.

Because of this, G-Logics recommends implementing engineering and institutional controls in this area of the Property in order to obtain site closure through ADEC. Engineering controls could include concrete capping and stormwater capture to prevent surface water infiltration through the contaminated soil (thus limiting the migration to groundwater pathway). Institutional controls, such as administrative and/or legal controls (i.e., deed restriction), could be implemented in conjunction with engineering controls to further minimize the potential for human exposure to the remaining contamination. Engineering and institutional controls would require ADEC approval prior to implementation.

Comments: This area could be capped with concrete to prevent surface-water infiltration.

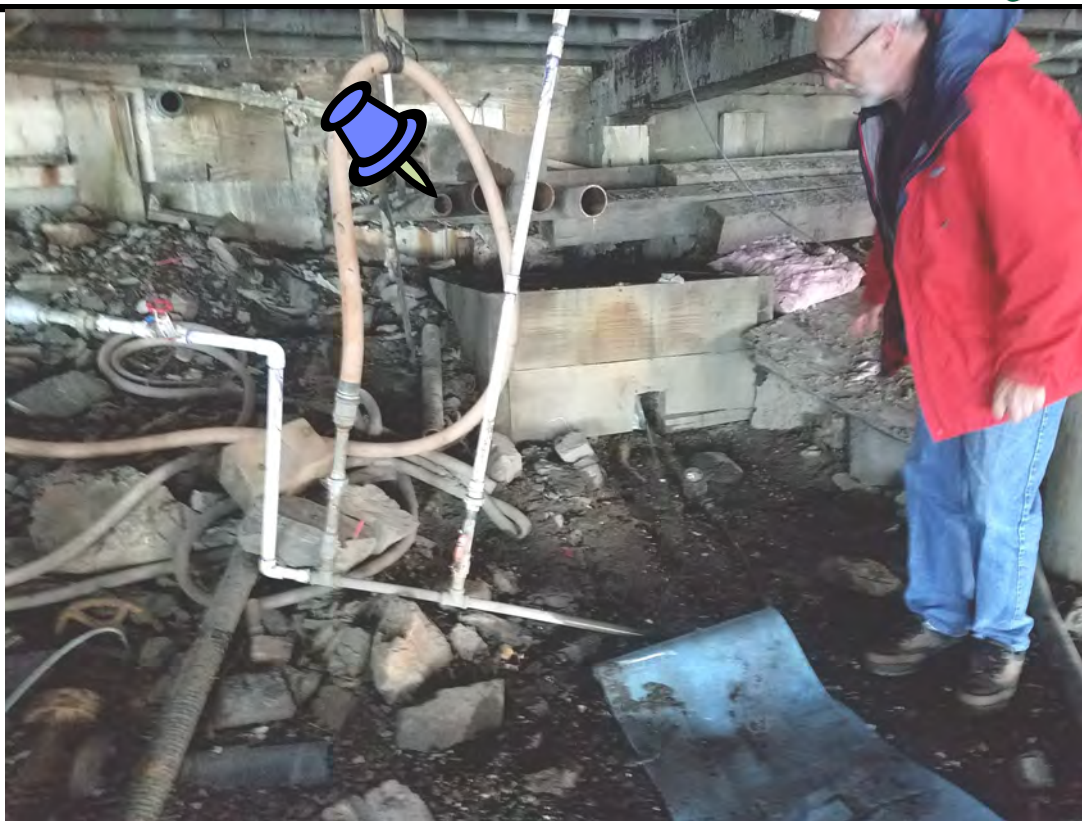
7

Description: Fuel-pipe area, underneath the Hoonah Trading Company store parking lot. Looking east toward the shoreline bulk head.

Comments: The fuel pipes formerly (blue pin) were decommissioned during the tank farm removal on the adjacent property.

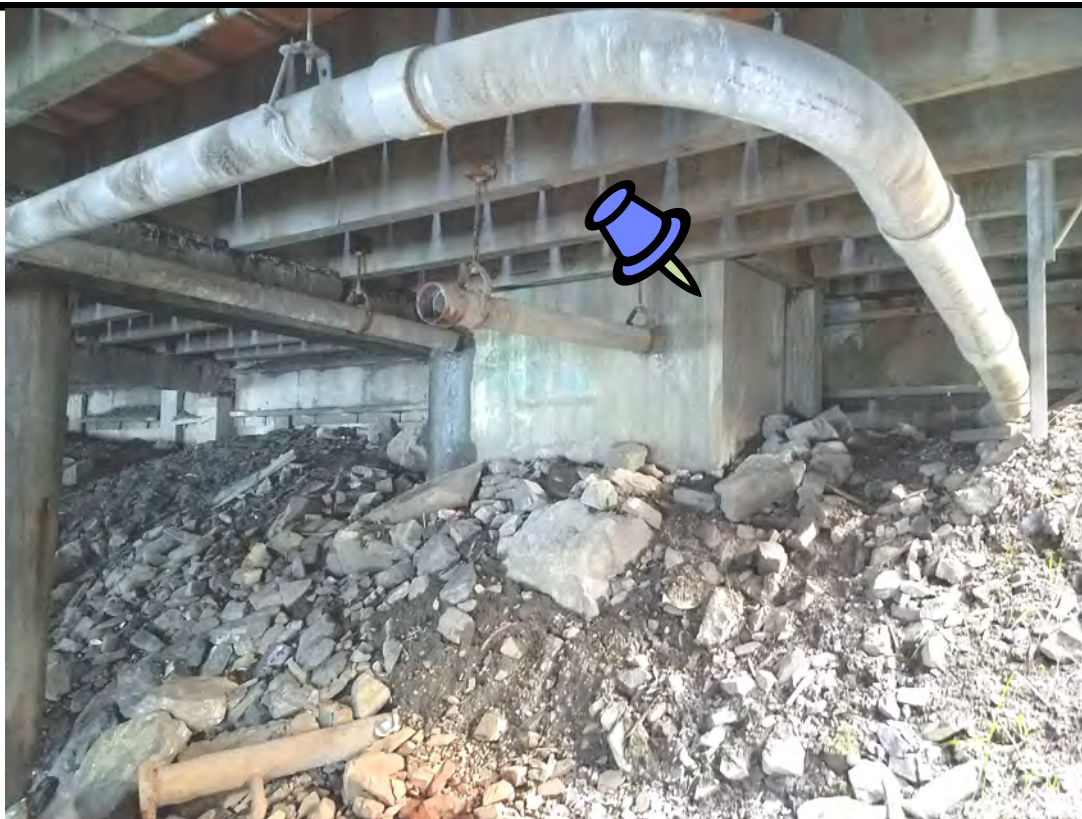
8

Description: View of the oil/water separator located beneath the Hoonah Trading Company store parking lot (blue pin).

Comments: The oil/water separator collects surface water runoff from the Front Street right-of-way and discharges water below the parking lot.
