**PROPOSED CLEANUP PLAN -**  
**WRANGELL LUMBER MILL SITE**

-----  
6.5-Mile Zimovia Highway  
Wrangell, Alaska  
-----

-----  
April 2012  
-----

*Prepared by*  
**Southeast Management Services**  
1061 Mendenhall Peninsula Road; Juneau, Alaska 99801

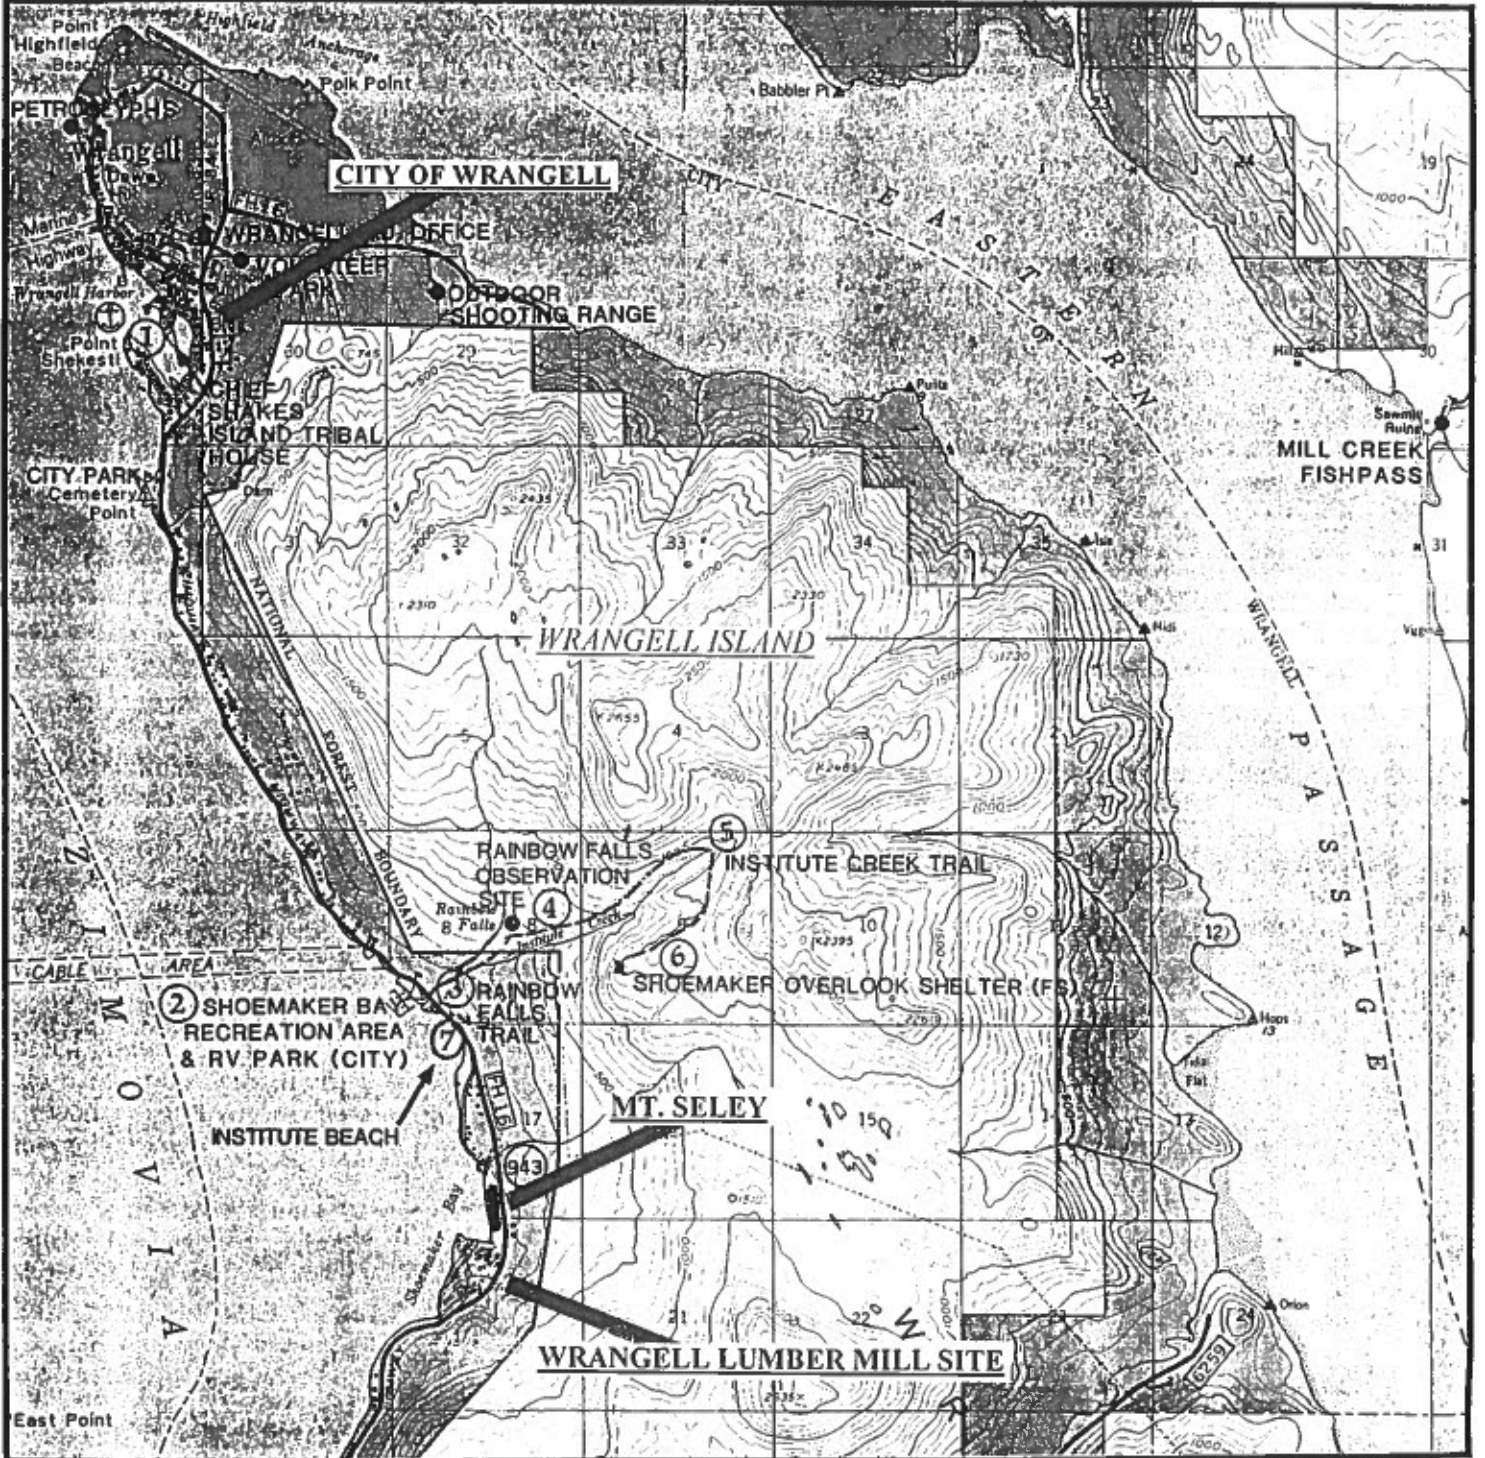
**FIGURE 1:**  
**VICINITY LOCATION: WRANGELL**  
**LUMBER MILLSITE & MT. SELEY**  
 -----  
 Wrangell, Alaska

Figure 1 (page 2a) provides a map of the City of Wrangell vicinity and the Wrangell Lumber mill site, which is located 6.5 miles south of the city along the shore of Shoemaker Bay. Figure 2 (page 2b) provides a 1990's site plan of the Wrangell Lumber sawmill when it was in full operation. The entire mill site covers about 50 acres, of which 22 acres is paved with asphalt and drains into a large oil/water separator before discharging to Shoemaker Bay. Also shown on Figure 2 is the closed Mt. Seley woodwaste disposal site immediately north of the mill. Its 7-acre top surface was capped in 1991 with a 10"-18" thick layer of compacted clay and rock, that was topped with a 1'-2.5'-thick layer of protective 18"-minus shotrock.

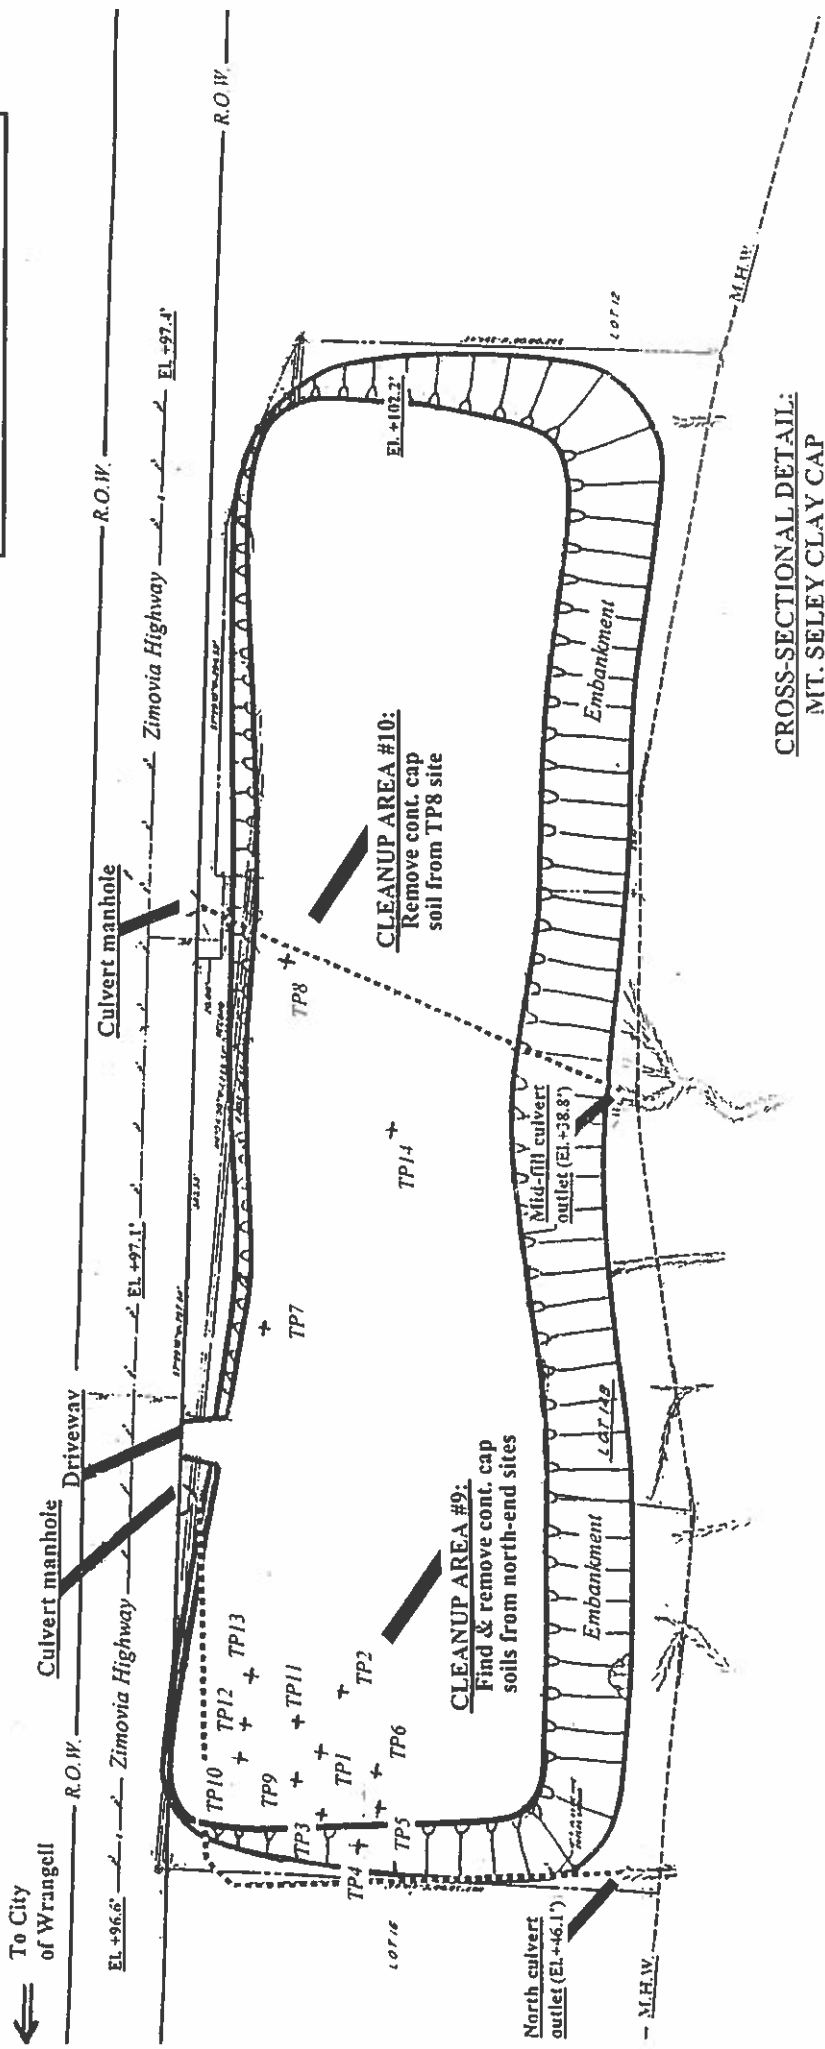
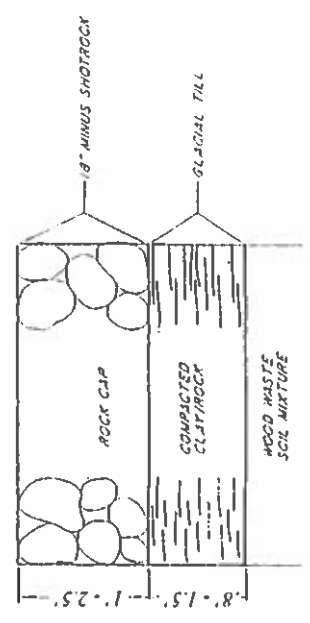
**FIGURE 5:**  
MT. SELEY CLEANUP AREAS

**NOTE:**  
 10/13/11 NORTECH test pit locations TP1 through TP14 are shown by small crosses. Three test pits were sampled, & DRO levels for TP3, TP8 & TP1 were 3,470, 308 & 149 mg/m<sup>3</sup>

CROSS-SECTIONAL DETAIL:  
MT. SELEY CLAY CAP

Cleanup Area #9 - North end of Mt. Seley. A portion of the Mt. Seley cap where Nortech's test pits #TP3, #TP4 & #TP9 are located (see Figure 5, page 7b) will have its top 1'-1.5' layer of clay/rock peeled off. The underlying clay/rock will be inspected for any visual indications of contamination, and any found will be removed for treatment. Contaminated soils or clay to be removed are estimated to be 2-5 c.y.

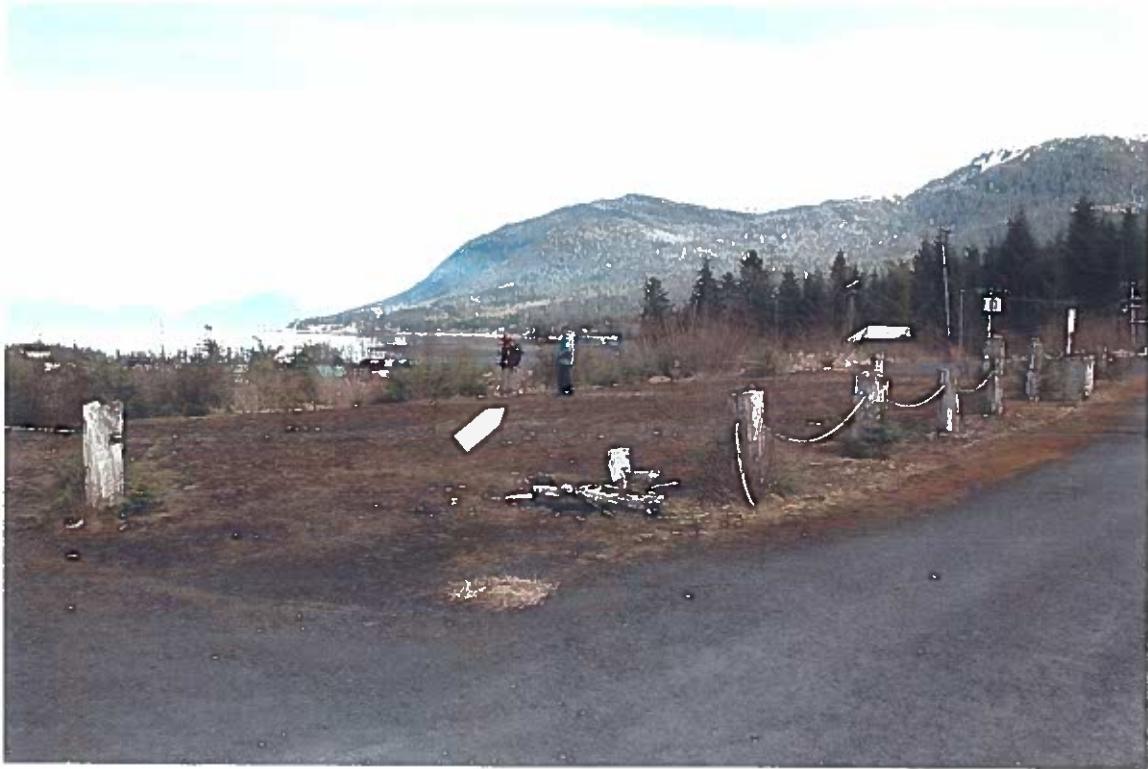
**Photo #1:** 3/26/12 view looking north across the Wrangell Lumber mill's former helicopter landing area near the mill office, showing where the 750-gallon Jet-A fuel tank had been located.

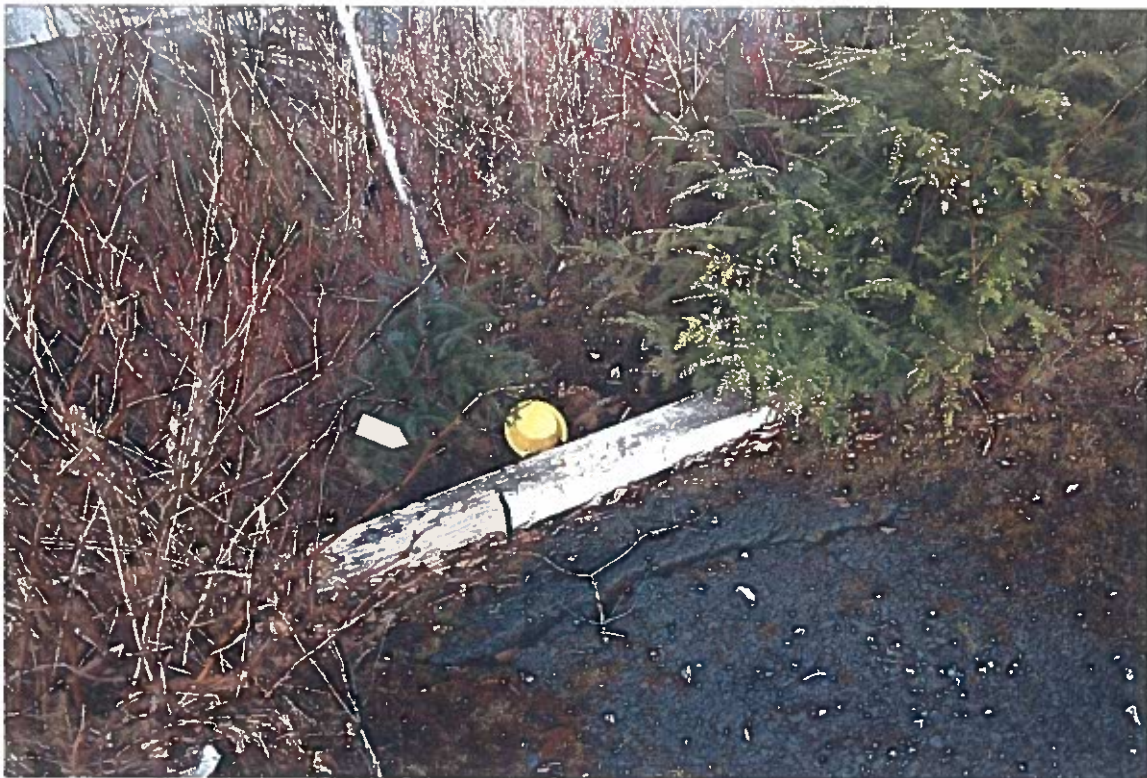
1. Office tank area. The former 750-gallon Jet-A fuel tank site behind the mill office (photos on page A2) was paved with asphalt, except for where the tank may have extended just beyond the west embankment. Any runoff from the tank would have drained in this direction, and Nortech's shallow sampling hole was found. The DRO level of 404 mg/kg was slightly over the Method-2 cleanup criteria, and there were no signs of significant contamination.

**Photo #2:** 3/26/12 view along the downslope edge of where the former Wrangell Lumber Jet-A fuel tank had been located, and where NORTECH's 10/13-14/11 sample had a DRO level of 404 mg/kg.

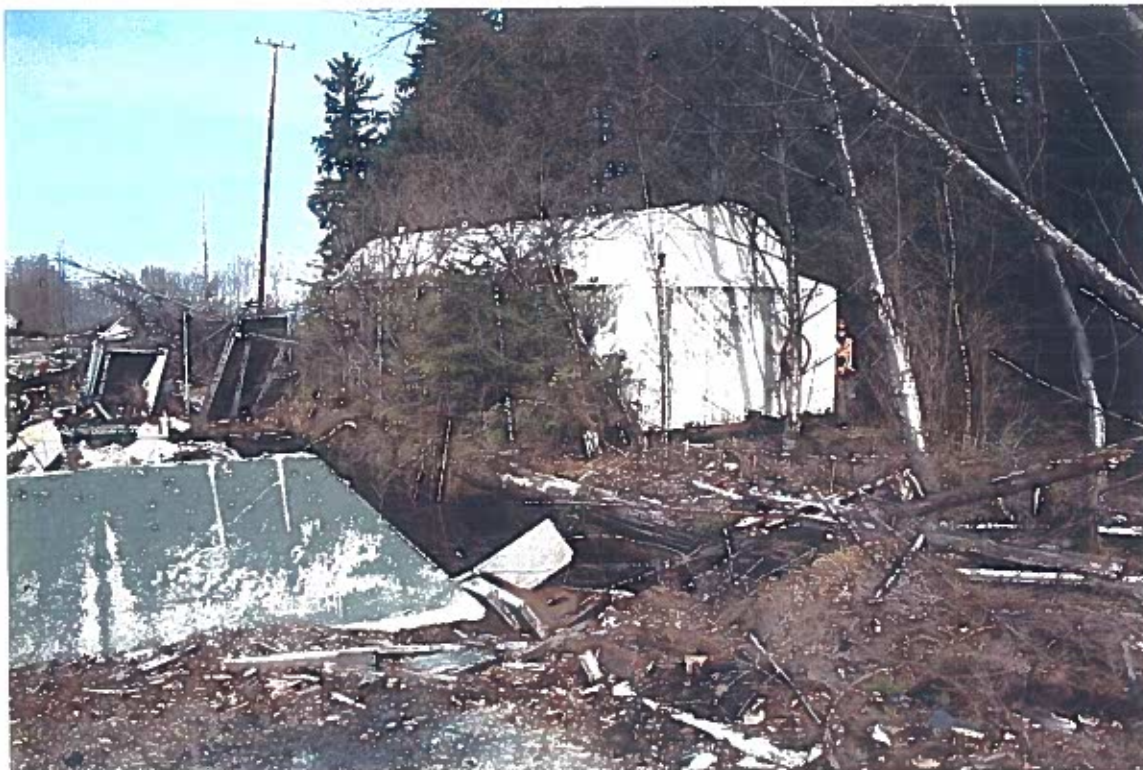
2. Generator fuel tank. The 20,000-gallon self-contained diesel generator tank was inspected (photos on page A3) and there was no apparent contamination along its west side or under the tank. There was a still-connected rubber hose to the tank's outlet pipe on the east side, where Nortech's shallow sampling hole was found which had a DRO level of 1,420 mg/kg. There were no signs of significant contamination.

**Photo #3:** 3/26/12 view looking northwest at Wrangell Lumber's 20,000-gallon former generator diesel oil tank, along the north side of the mill site. See photo below.

Cleanup Area #2 - *Generator tank site.* The fuel hose connected to the 20,000-gallon generator tank will be removed and the tank emptied of its roughly 1.5' of mixed water & fuel. The tank then will be moved out of the way and about 1-3 c.y. are estimated to be excavated.

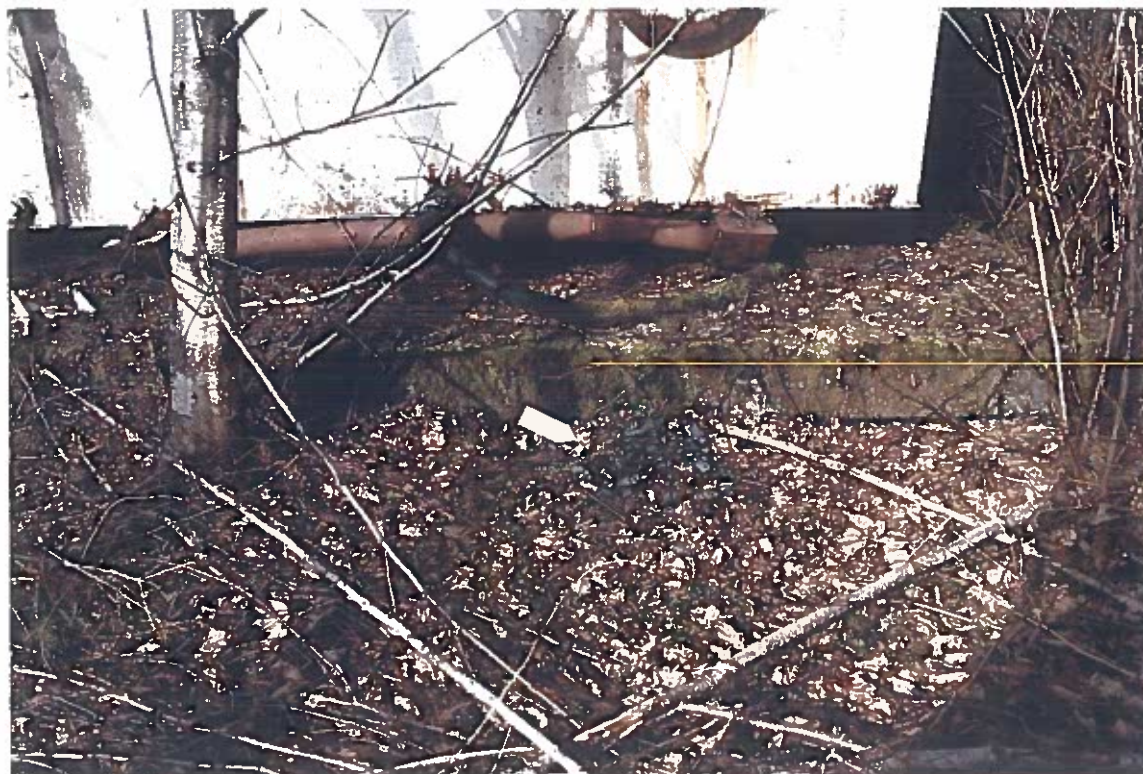
**Photo #4:** 3/26/12 view of the mill's 20,000-gallon diesel generator tank's east end, where NORTECH's 10/13-14/11 soil sample #GT2 had a DRO level of 1,710 mg/kg.

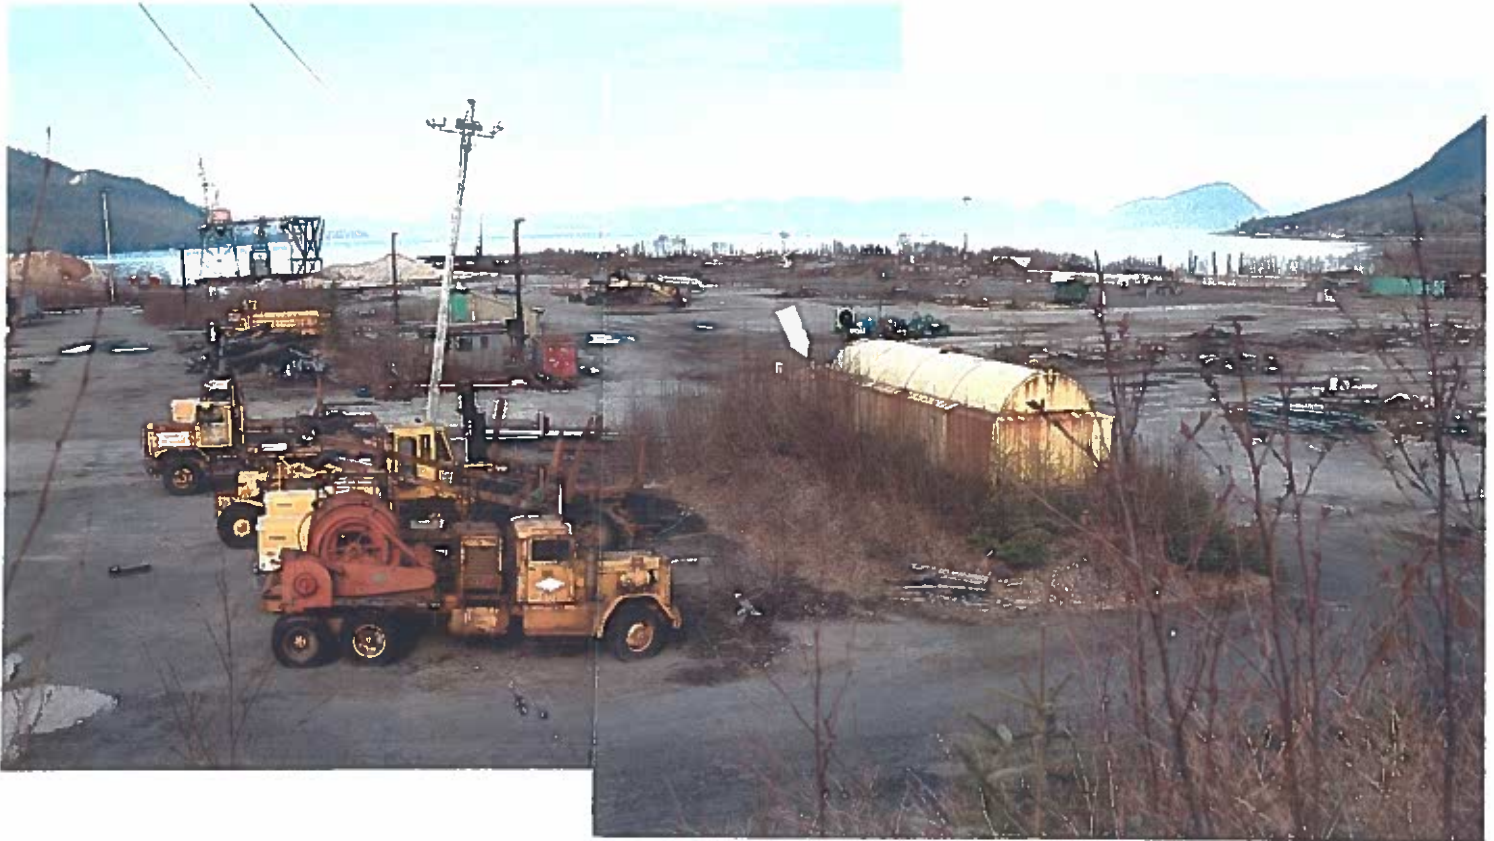
3. Fuel depot. The 20,000-gallon diesel tank and 2,000-gallon gasoline tank at the Wrangell Lumber mill site's fuel depot are shown in the photos on page A4. Photo #6 shows the two fuel dispenser stations on the depot's oil-stained wood bulkhead. Dark oil-stained soils were readily apparent behind and around the diesel oil dispenser and its adjacent diesel tank fill pipe (Photo #7, page A8). Oil-stained soil also was observed beneath the diesel tank's pipe outlet (Photo #8), where Nortech's sample #TF3 had a high DRO level of 8,110 mg/kg.

**Photo #5:** 3/26/12 view looking northwest across Wrangell Lumber's fuel depot, which has a 20,000-gallon diesel oil tank and a 2,000-gallon gasoline tank (arrow) along its west end. See next 3 photos.

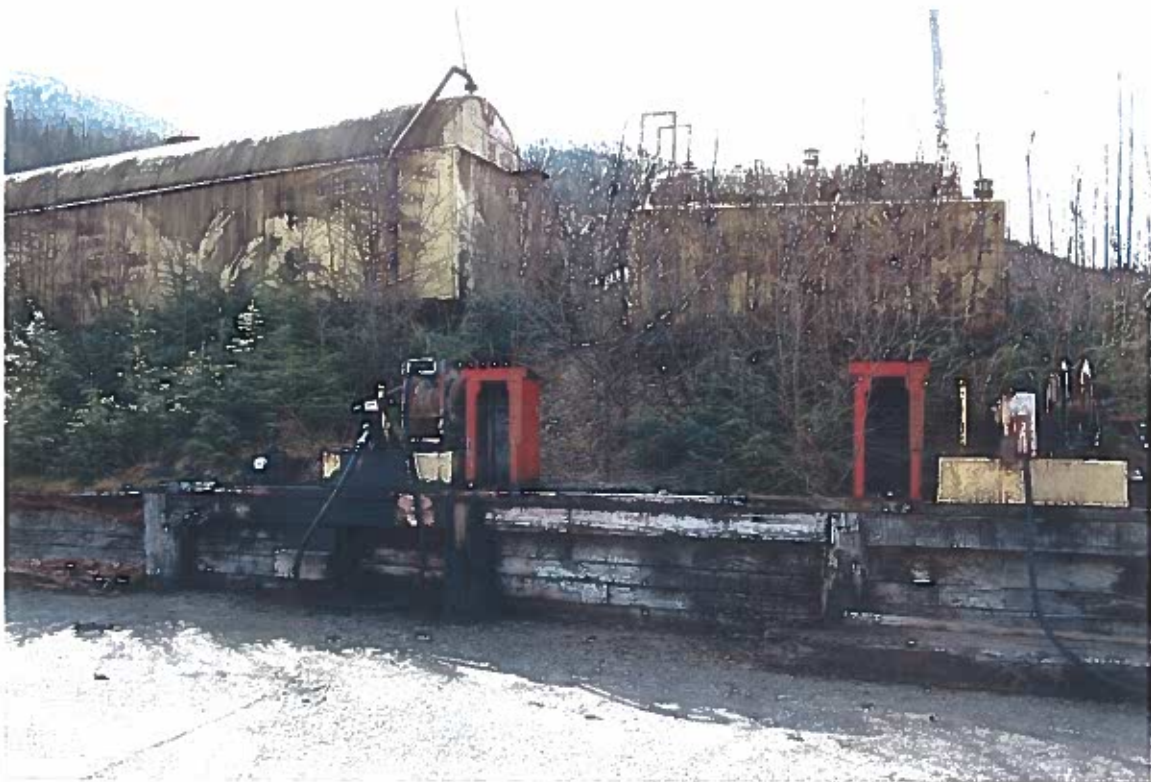
**Photo #6:** 3/26/12 view of the Wrangell Lumber fuel depot bulkhead, showing oil staining that is darkest around the diesel dispenser.

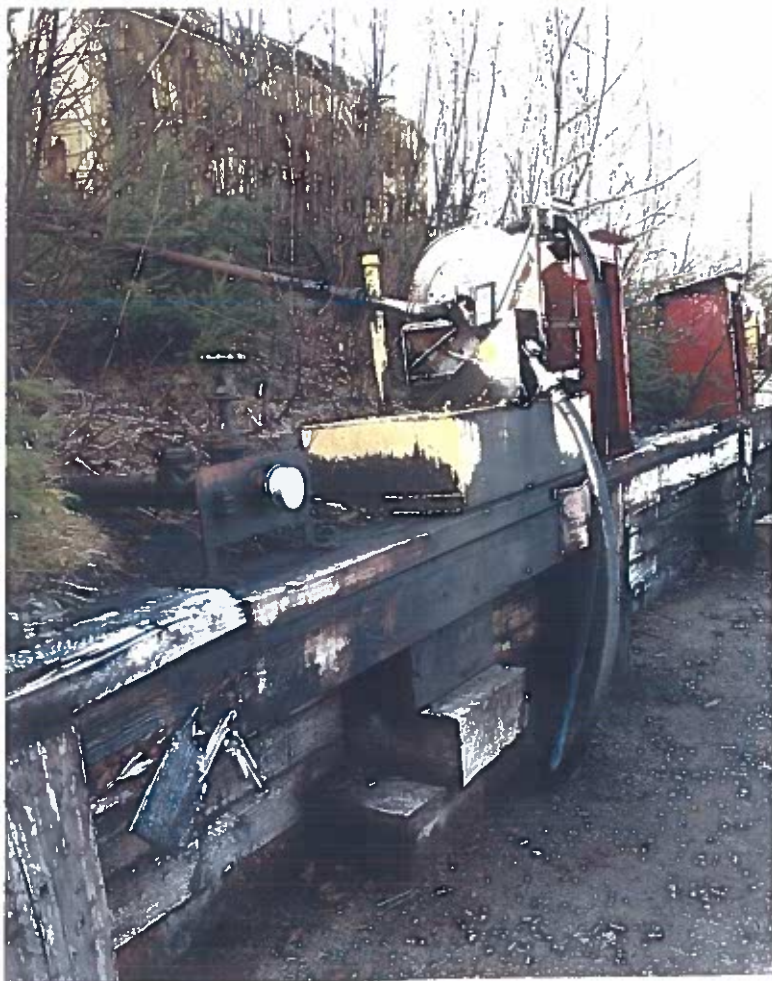
**Photo #7:** 3/26/12 closer view of the Wrangell Lumber fuel depot's diesel oil dispenser, showing black oil stains extending into the soil behind the bulkhead.

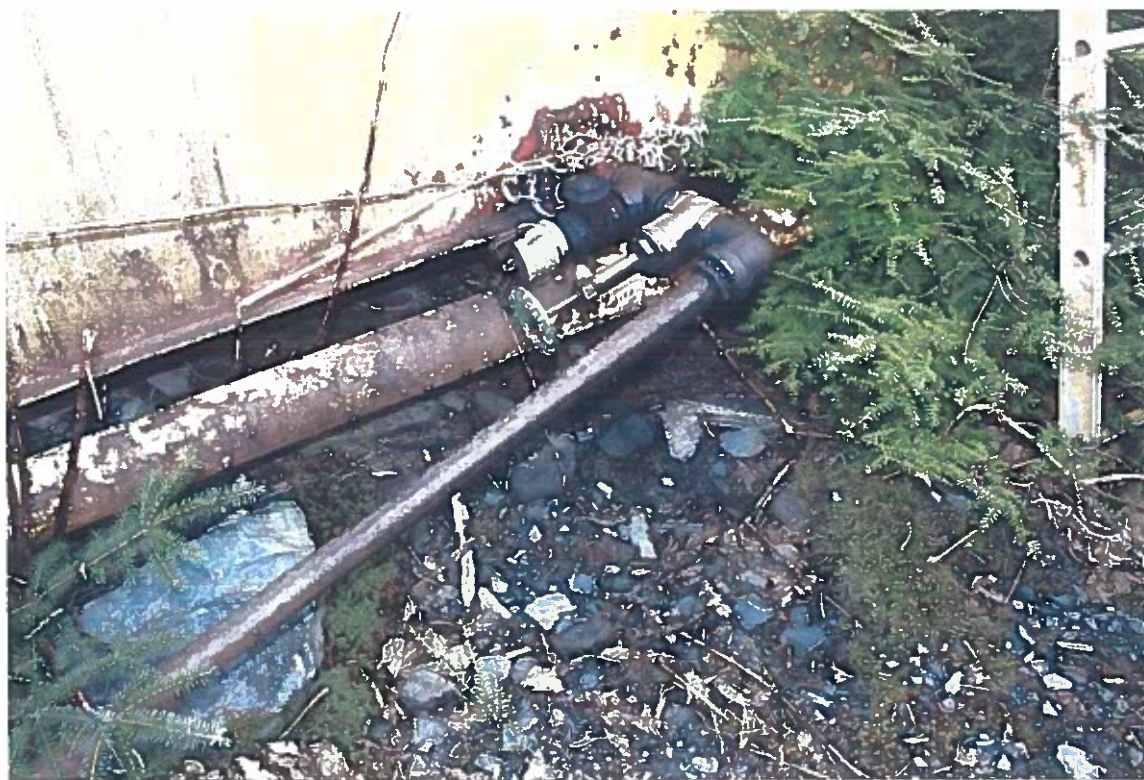
**Photo #8:** 3/26/12 view of the Wrangell Lumber fuel depot's 20,000-gallon diesel oil tank outlet, showing oil-stained soil where NORTECH sample #TF3 had a high DRO level of 8,110 mg/kg.

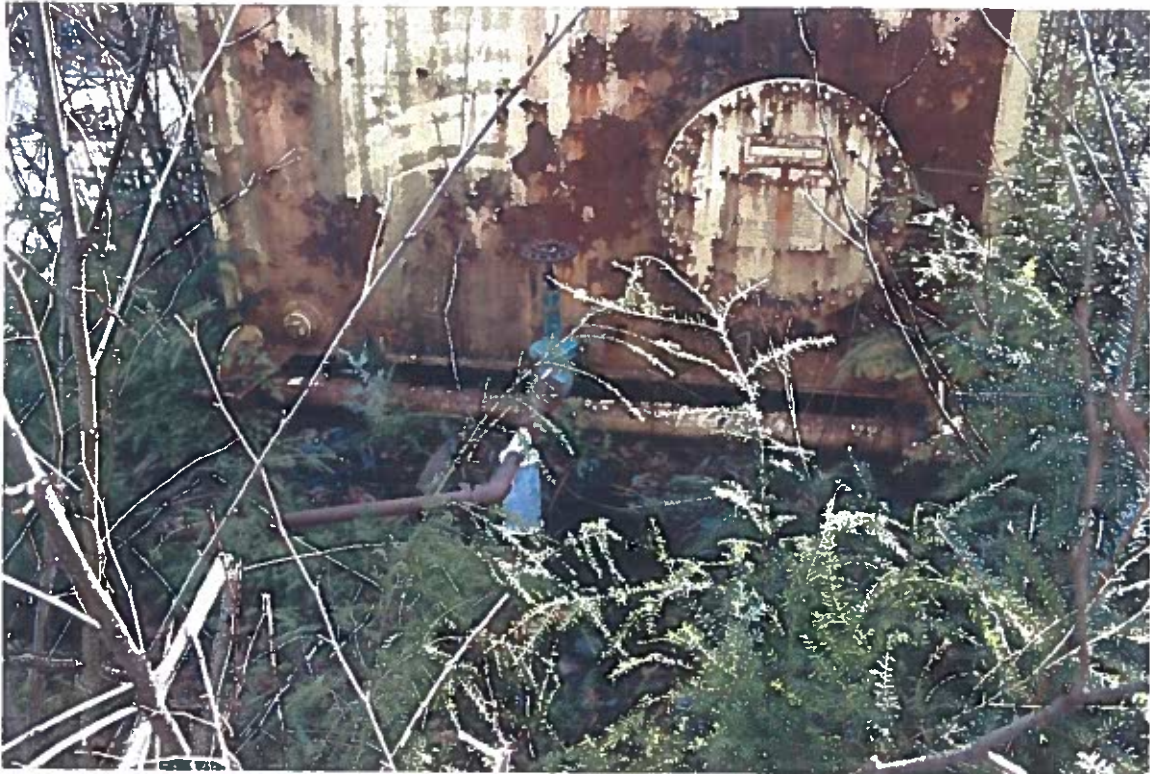
**Photo #9:** 3/26/12 view of the outlet fuel filter and piping from the Wrangell Lumber fuel depot's 2,000-gallon gasoline tank, where NORTECH's sample #TF2 had low levels of GRO at 1 mg/kg and DRO at 124 mg/kg.

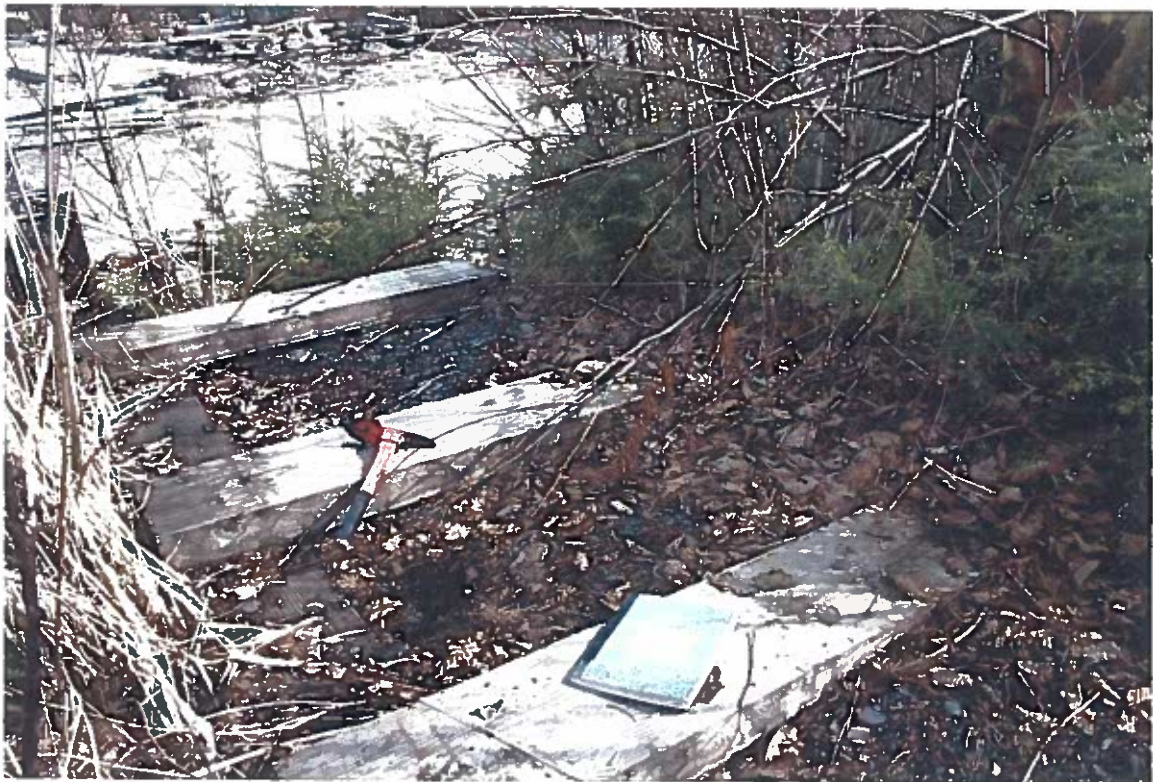
**Photo #10:** 3/26/12 view looking northeast across the Wrangell Lumber fuel depot's former 1,000-gallon highway diesel tank, where no signs of oil-stained soil were found.

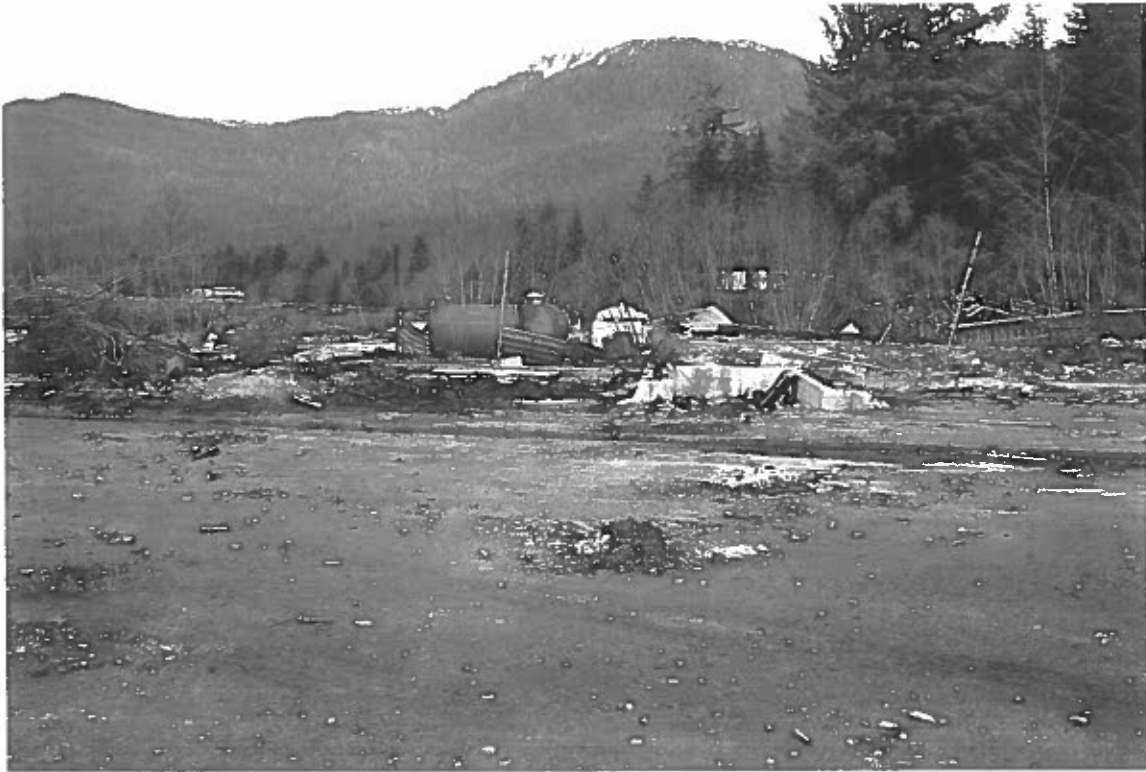
4. Fuel tanks at the former emergency generator site. Three small empty fuel tanks were sitting on the former emergency generator concrete pad (photos on page A7). There were no indications of leakage from the tanks. However, the 9'-wide area between the former generator and transformer concrete pads had very dark-stained oily soil (photos on page A8), where Nortech found high DRO and RRO levels of 51,300 mg/kg and 12,300 mg/kg.

**Photo #11:** 3/26/12 view looking north-northeast at the 3 empty fuel tanks sitting on the Wrangell Lumber concrete pad for the former emergency generators. See Photos #12 - #20.

Cleanup Area #3 - *Generator/transformer pad site.* The three small tanks on the emergency generator pad will be removed, along with all debris and brush piles in the vicinity. Excavation will begin by removing the contaminated soil between the two concrete pads, and then breaking out and removing about 10' from along the north side of the transformer concrete pad. Excavations will resume until the

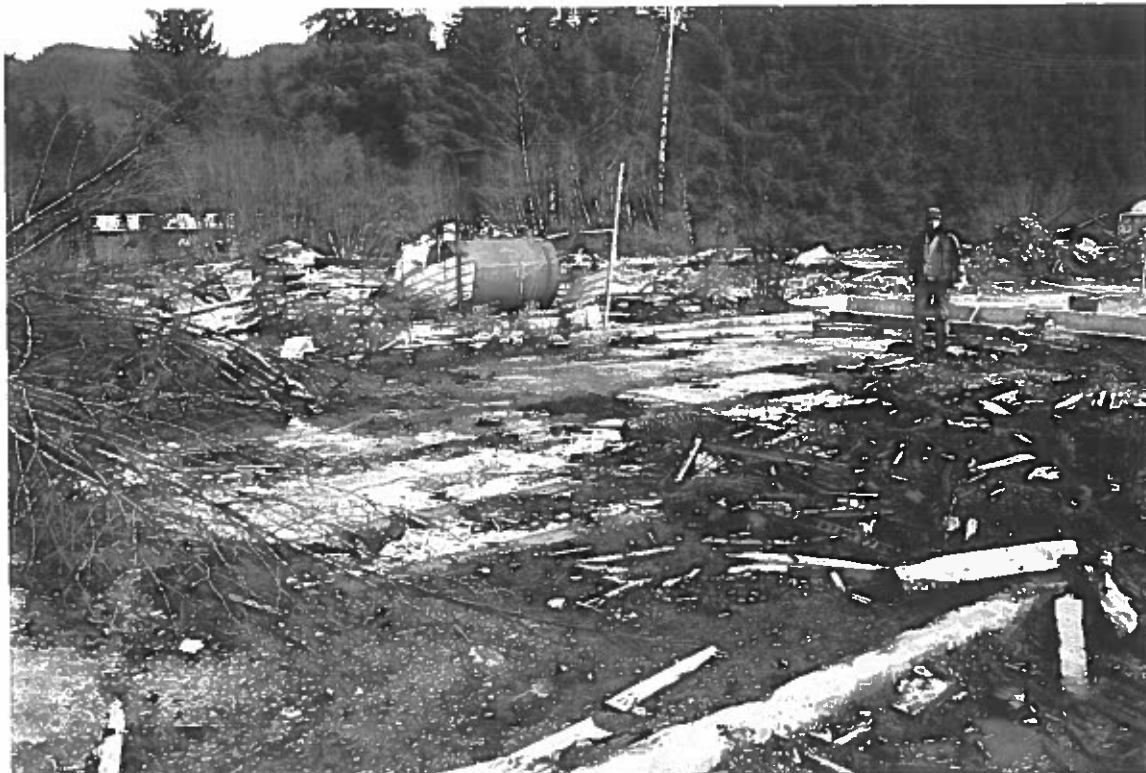
**Photo #12:** 3/26/12 view looking northeast across the concrete pad for the Wrangell Lumber sawmill building's transformers, showing the former emergency generator concrete pad's 3 empty tanks in the background.

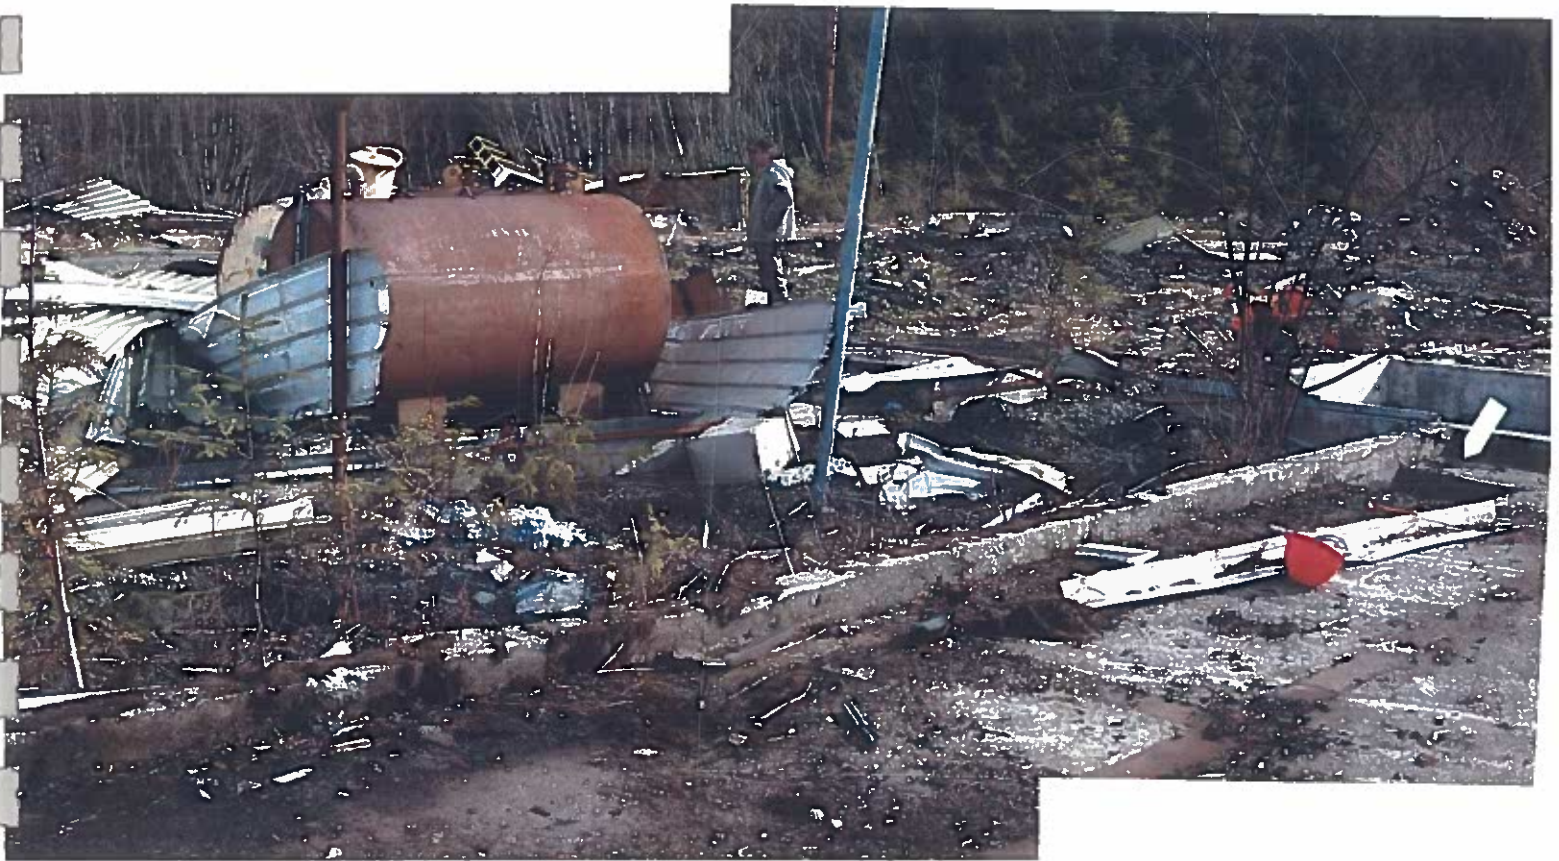
**Photo #13:** 3/26/12 view looking northeast across the 9'-wide gap between the Wrangell Lumber sawmill's concrete pads for its former transformers (foreground), and the emergency generator building where 3 empty fuel tanks were being stored. Arrow points to the former transformer pad's surface water catchment drain.

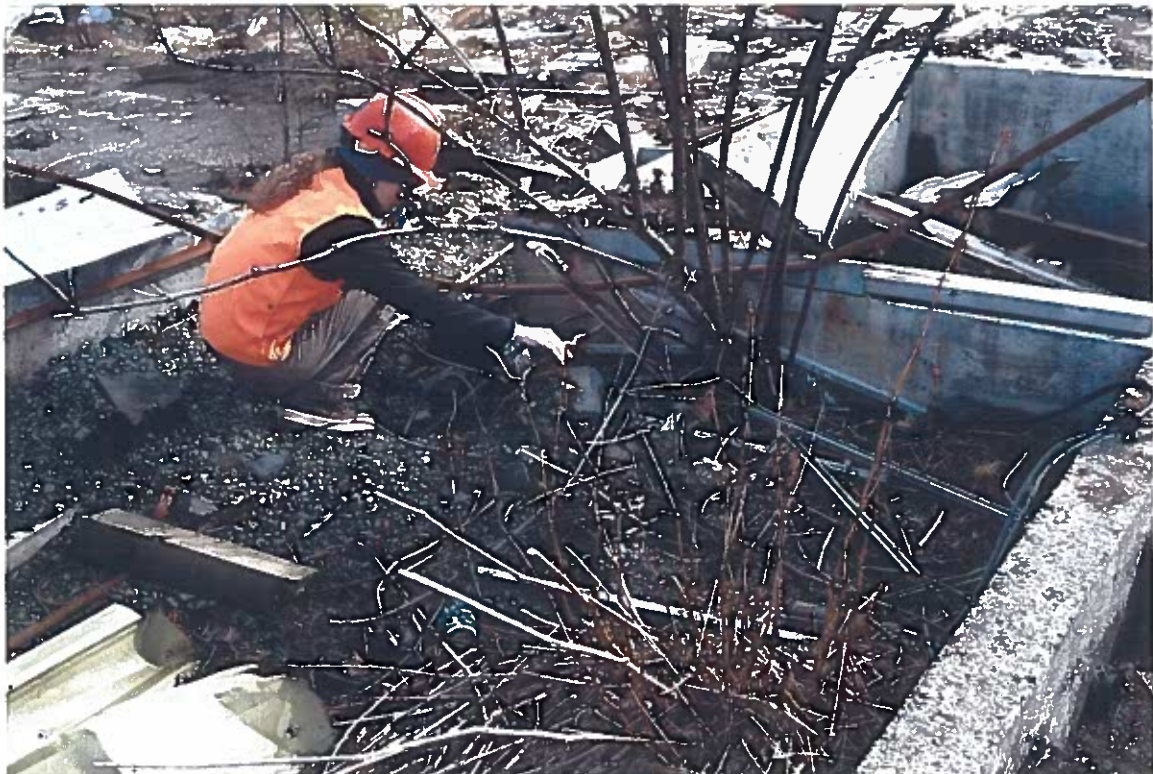
**Photo #14:** 3/26/12 view looking northeast at the oil-contaminated soil just beyond the Wrangell Lumber sawmill's transformer concrete pad catchment drain. See next photo.

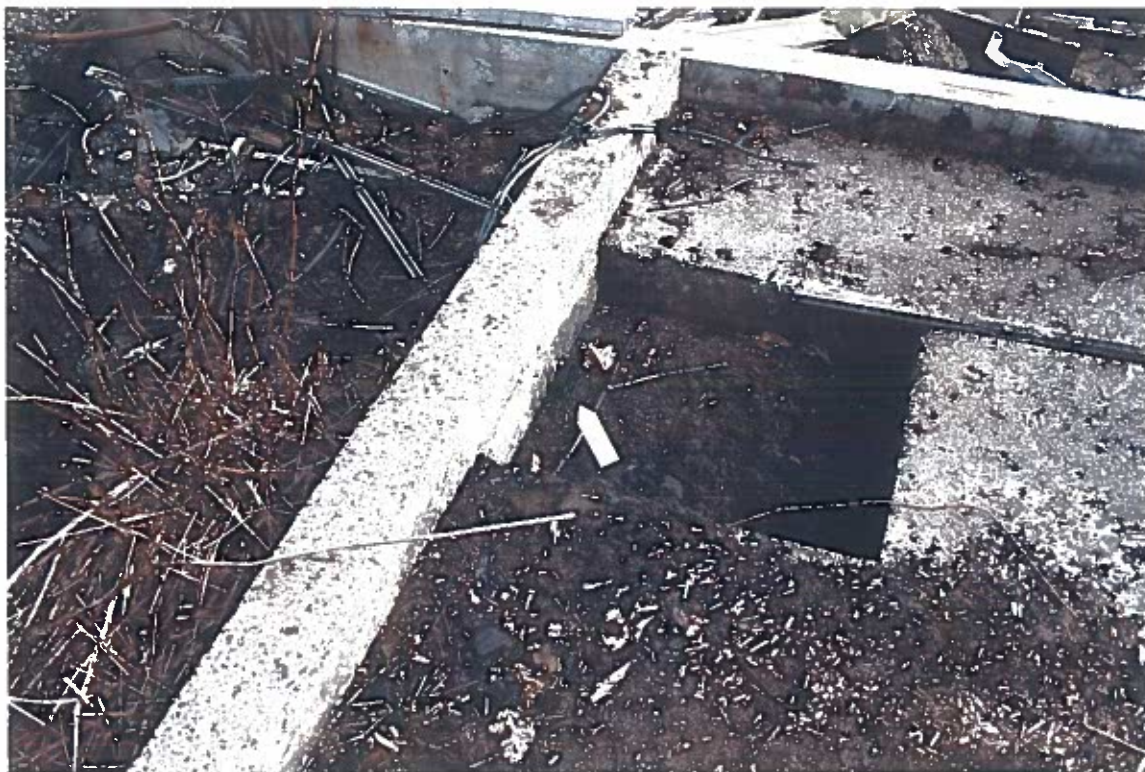
Photo #15 (page A9) shows the transformer pad's catchment basin and discharge pipe, which discharged directly to the oil-stained area and was the likely source of the contamination. The same black-stained soil can be seen in the prior-year photos on pages A10-A11, which were taken on 9/26/96. At that time the dark-stained soils were tested only for PCB's (found to be non-detect at 33-66 ug/kg) because of some leakage from the 3 non-PCB transformers. The prior-year photos

**Photo #15:** 3/26/12 view looking northeast at the Wrangell Lumber sawmill's transformer pad's catchment basin, showing its 2"-dia drain pipe (arrow). NORTECH's 10/13-14/11 sample #3T1 was taken just beyond the end of the pipe and had high DRO & RRO levels of 51,300 mg/kg & 12,300 mg/kg. See Photo #18.

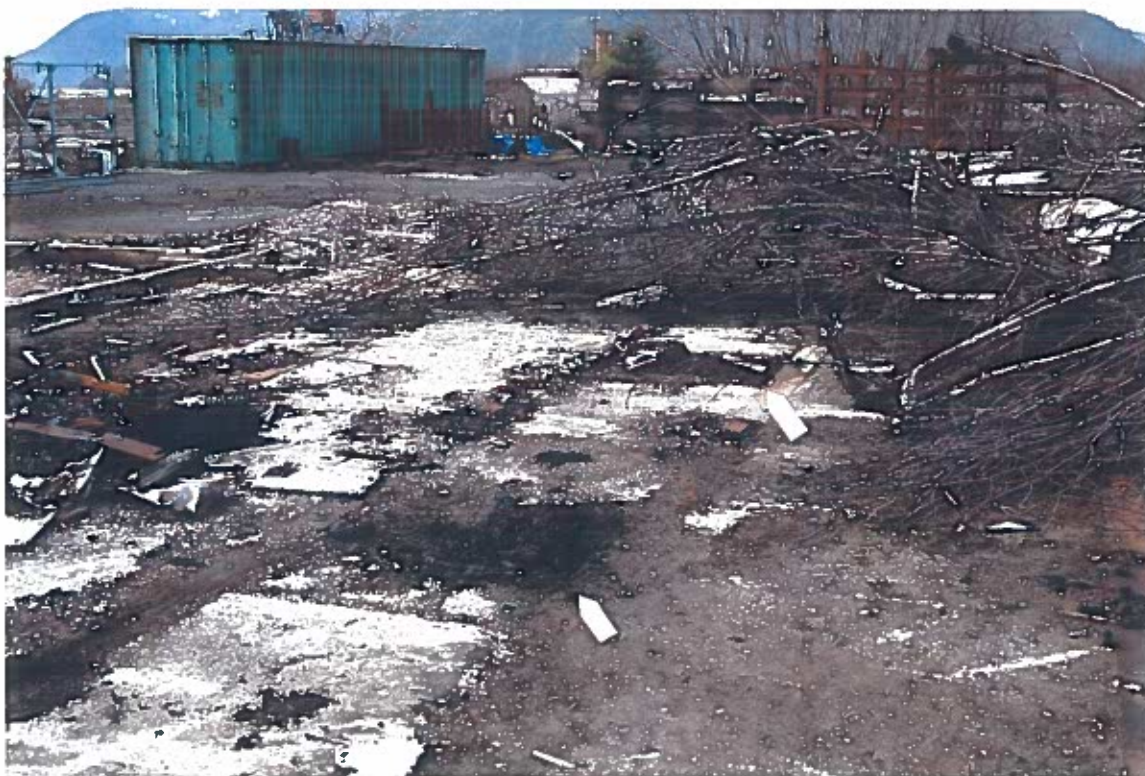
Two additional dark-stained areas were found 9' apart and 10' in from the transformer pad's north side. They were along a flat steel bar that was embedded into the concrete surface as shown on Photo #16 (page A9), where deteriorated concrete appeared to have allowed seepage under the concrete pad. These areas appeared to be about where the transformer roof supports had been located.

**Photo #16:** 3/26/12 view looking southwest across the Wrangell Lumber sawmill's former transformer concrete pad, showing two dark oil-stained areas of deteriorated concrete (arrows) that extended beneath the metal bar embedded in the concrete. Compare w/next photo.

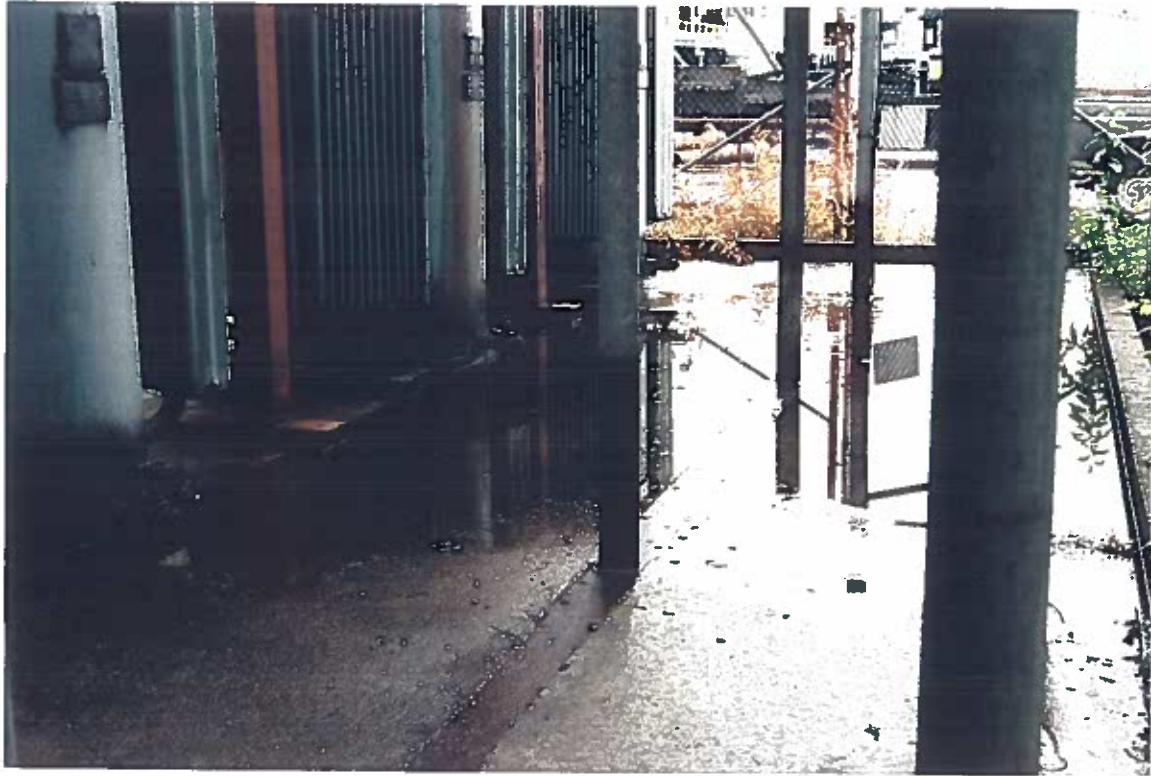
**Photo #17:** *Prior-year photo.* 9/26/96 photo looking southwest across the Wrangell Lumber sawmill building's concrete transformer pad, showing the 1,000-KVA transformers in place and the pad's vertical roof supports that rested directly on the metal bar embedded in the concrete.
