**PROPOSED CLEANUP PLAN -**  
**WRANGELL LUMBER MILL SITE**

-----  
6.5-Mile Zimovia Highway  
Wrangell, Alaska  
-----

-----  
April 2012  
-----

*Prepared by*  
**Southeast Management Services**  
1061 Mendenhall Peninsula Road; Juneau, Alaska 99801

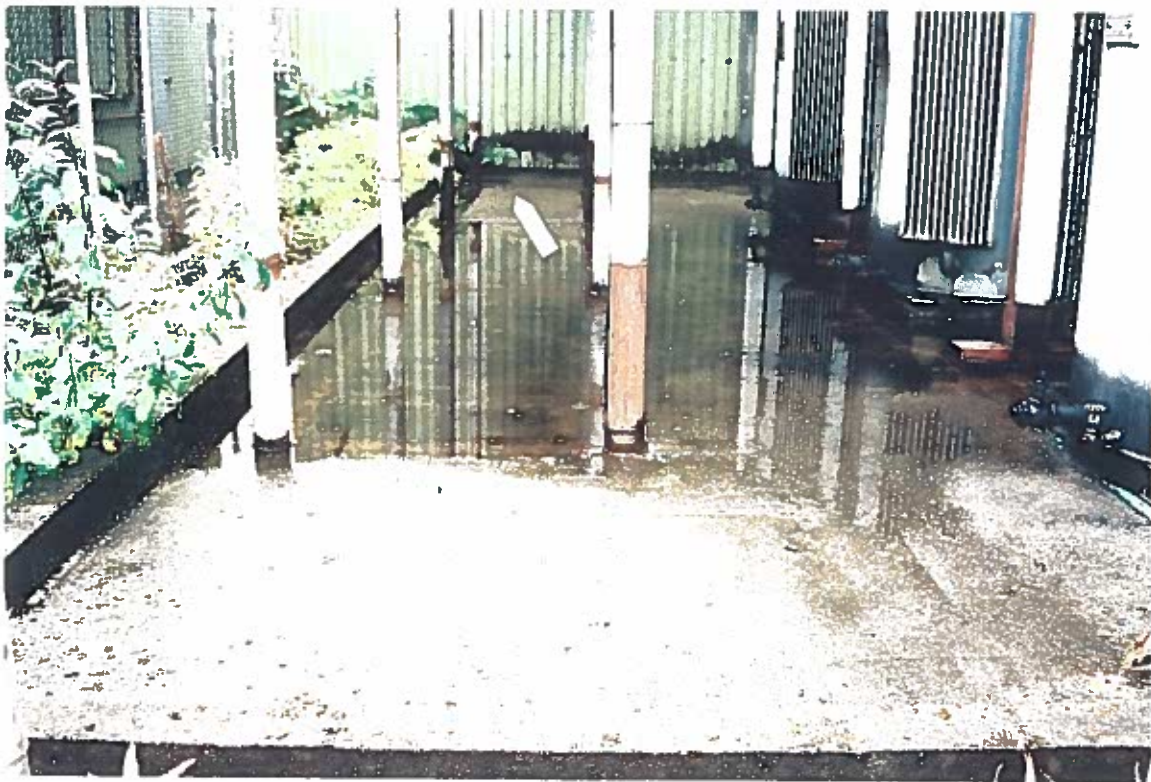
**Photo #18:** *Prior-year photo.* Another 9/26/96 photo of the Wrangell Lumber sawmill building's concrete transformer pad, showing the 1,000-KVA transformers in place and the pad's vertical roof supports. The surface water catchment drain is in the far left corner of the photo (arrow).

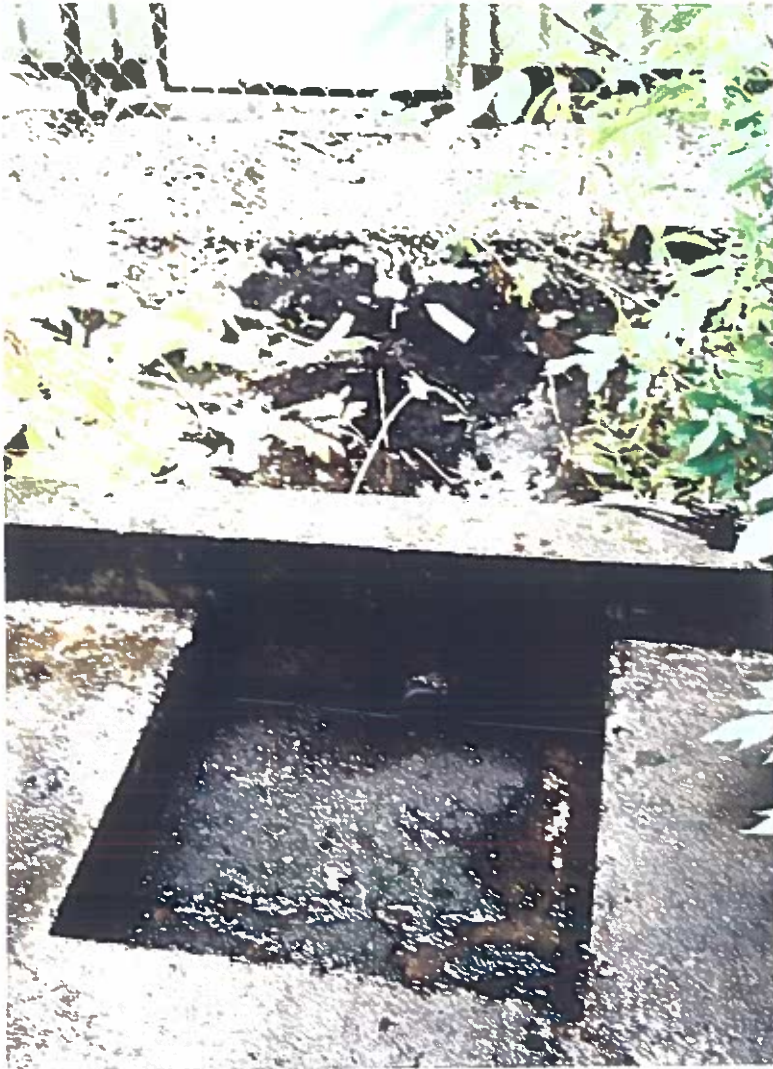
**Photo #19:** *Prior-year photo: 9/26/96 view looking north across the catchment basin for the Wrangell Lumber sawmill's concrete transformer pad, showing its 2" drain pipe and where sample #W-7 (arrow) was taken along the edge of the nearby emergency generator building. See photo below.*

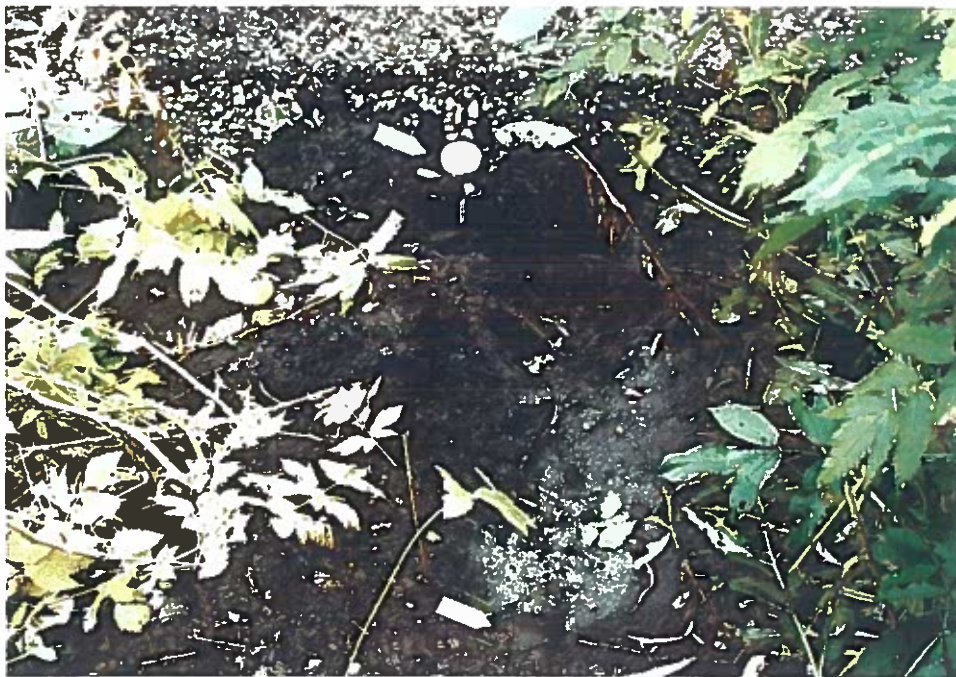
**Photo #20:** *Prior-year photo. 9/26/96 view looking north across the 9' between the Wrangell Lumber sawmill's transformer catchment basin drain (lower arrow) and where sample #W-7 (upper arrow) was taken by the emergency generator building foundation, showing oil-contaminated soil. Sample #W-7 was evaluated only for PCB's, and no PCB's were detected at MDL's of 33-66 ug/kg.*

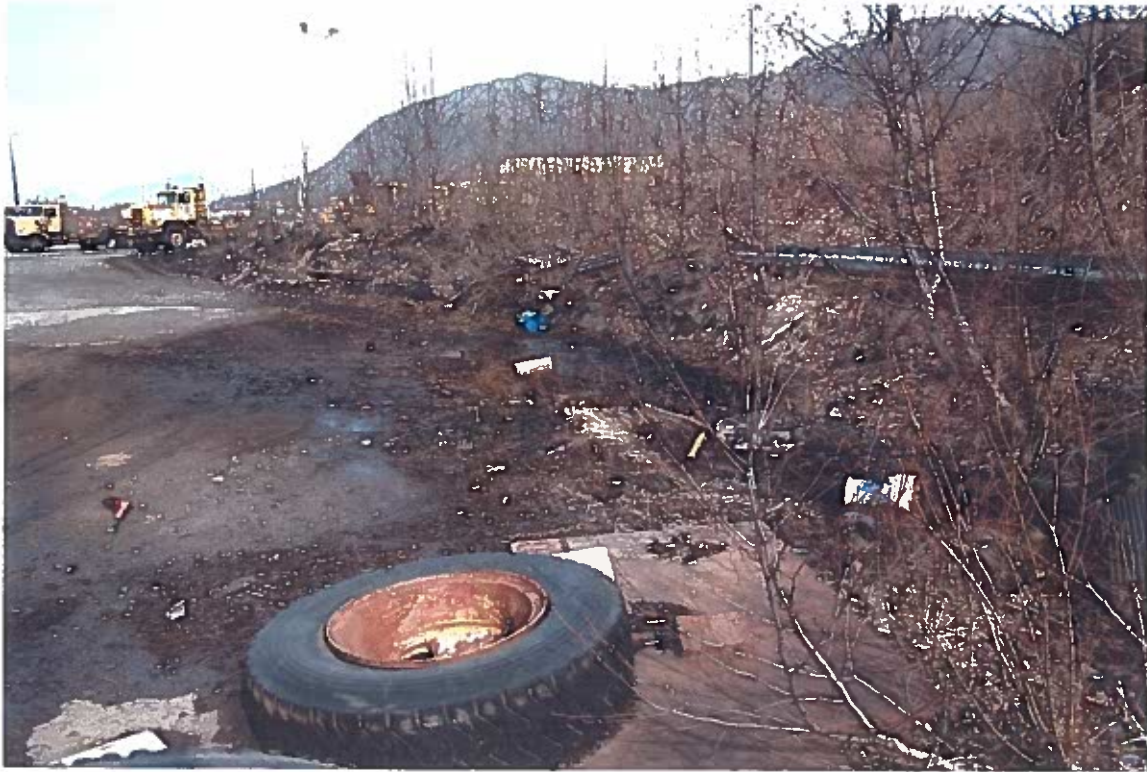
4. Tank area behind the equipment shop. The tank area behind the mill's equipment repair shop was paved and sloped to a poorly drained area of about 30'x10'-wide that was covered with a thin layer dark-stained mud & soil (Photo #21, page A12). A shallow 230'-long ditch then drained the shop's back area and connected to a 65'x12'-wide evaporation pond with a 1'-high wooden dam (photos on pages A12-A13). The pond's inlet was largely filled with sediment deposits, where Nortech's sampling detected 3 SVOC compounds to be above the cleanup criteria.
6. Oil/water separator settling pond area. Photos of the oil/water separator and its settling pond is provided on pages A14-A15. Mill personnel indicated that oil levels in the oil/water separator have been periodically checked and any oil found removed. They also stated that about 5 gallons of oil were removed when it was last checked in March.

**Photo #21:** 3/26/12 view looking north at the surface-stained shallow ponding area just behind the Wrangell Lumber shop, where the drainage ditch to the evaporator pond begins. See next 3 photos.

Cleanup Area #4 - Shop drainage ditch & pond. Prior to beginning excavations, the 1'-high dam of the evaporation pond (see Photo #24, page A12) will be removed. The shallow dark-stained mud/soil behind the shop and along its 230-long drainage ditch will be scrapped and 2-3 confirmation samples taken along the ditchline. Sediments in the upper end of the drained pond will be removed and the site evaluated for DRO, RRO and SVOC. The ditchline will be sampled only for DRO and RRO.

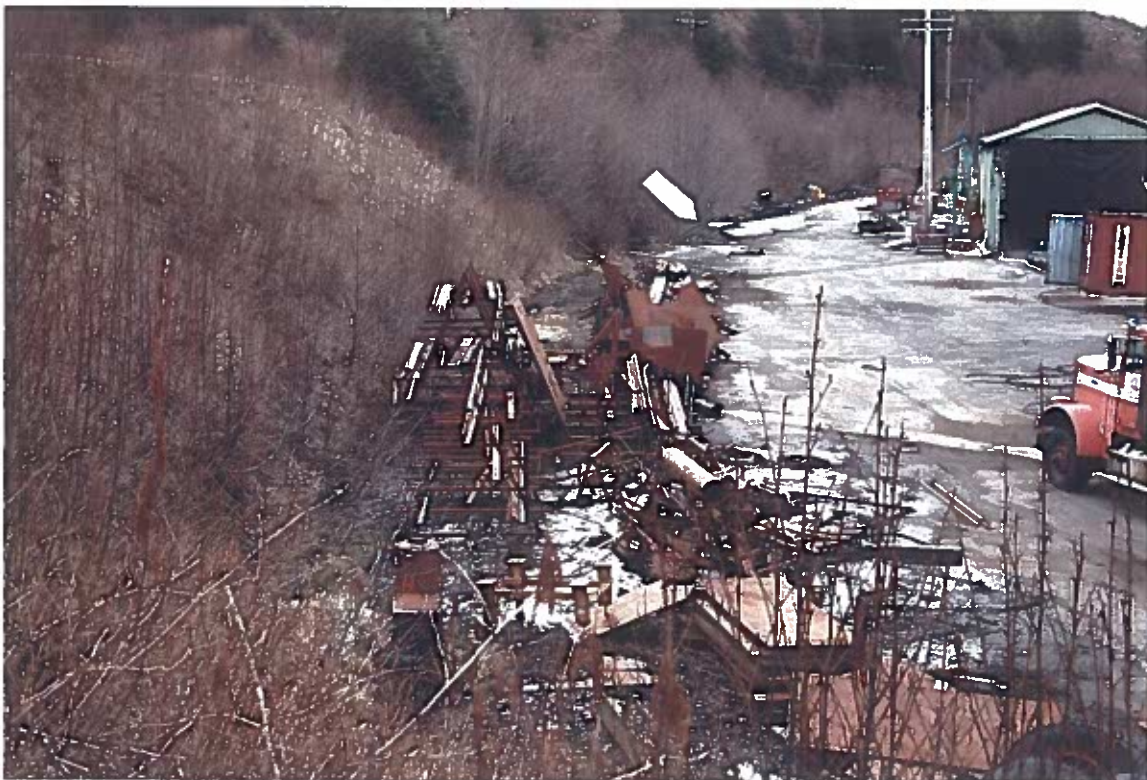
**Photo #22:** 3/26/12 view looking south down the small drainage ditch that begins behind the Wrangell Lumber shop and flows about 260' to the evaporator pond (arrow). See next 2 photos.

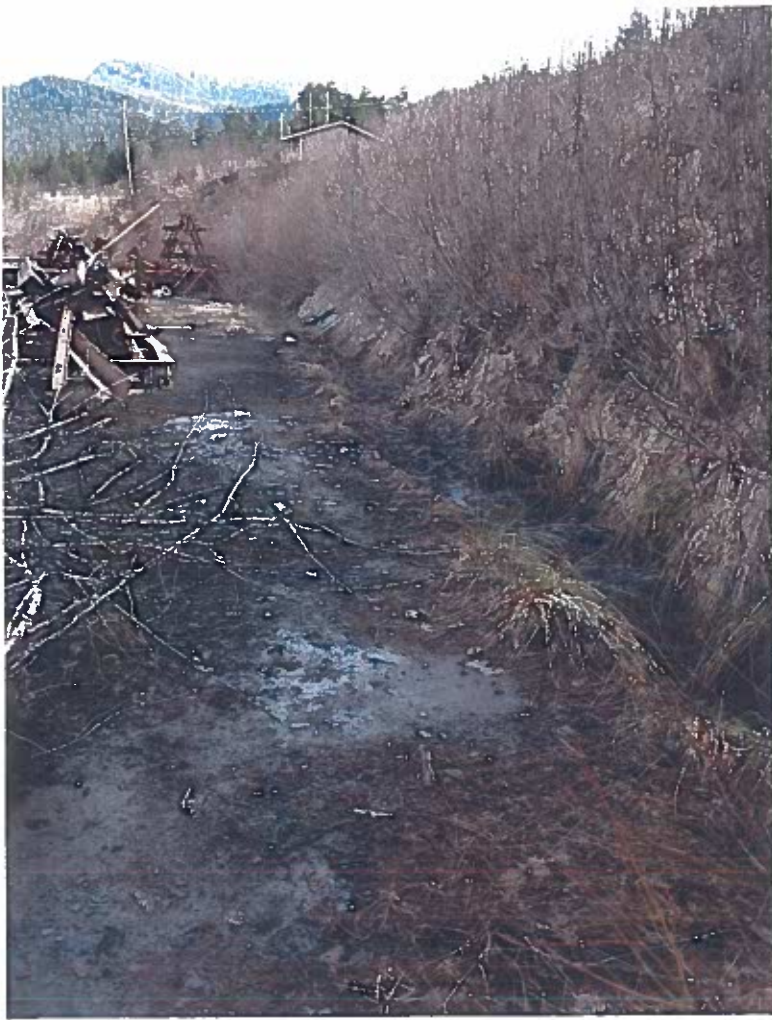
**Photo #23:** 3/26/12 view looking up the small drainage ditch that flows from behind the Wrangell Lumber shop, just before discharging to the evaporator pond shown below.

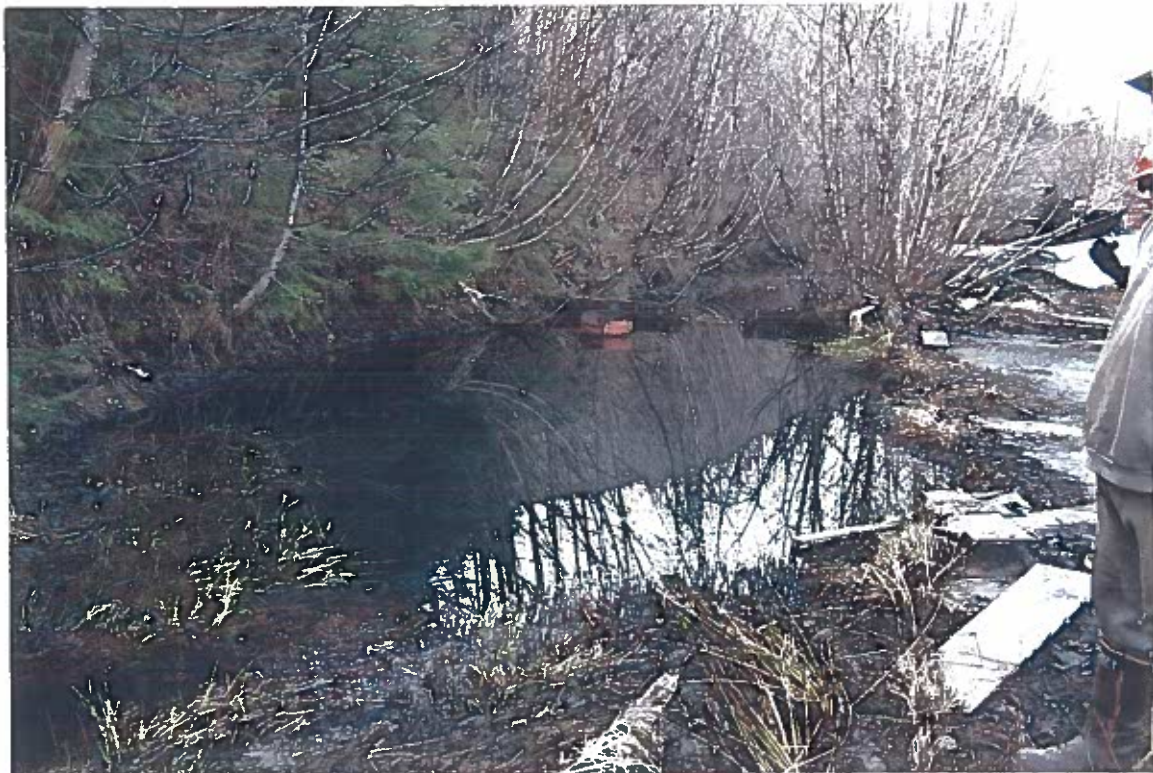
**Photo #24:** 3/26/12 view of the Wrangell Lumber evaporator pond and its 1'-high wooden dam. NORTECH's sample #EP had low DRO and RRO levels, but had 4 PAH compounds above cleanup criteria.

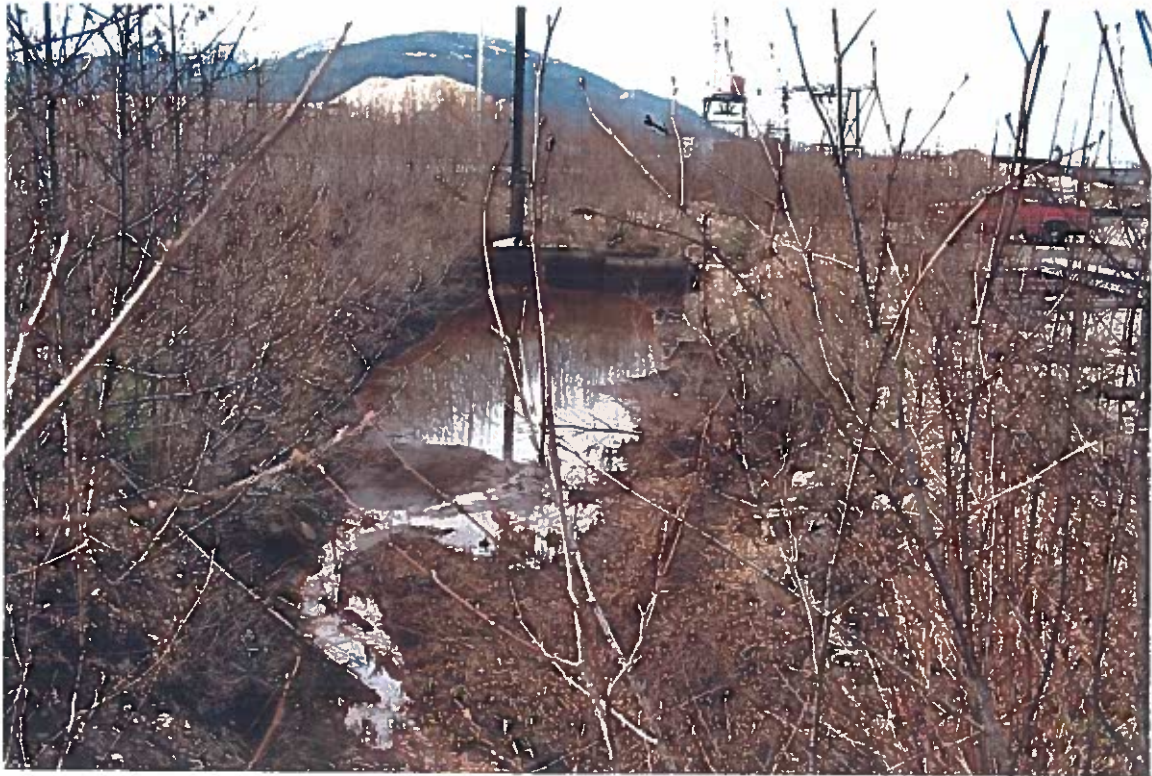
**Photo #25:** 3/26/12 view looking west at the Wrangell Lumber oil/water separator pond, see next 2 photos.

Cleanup Area #6 - Oil/water separator pond. The dark-stained soil ring around the oil/water settling pond will be excavated, along with the bottom sediments deposited along the north side of the pond. 5-10 c.y. of contaminated soils & sediment are expected to be removed for treatment.

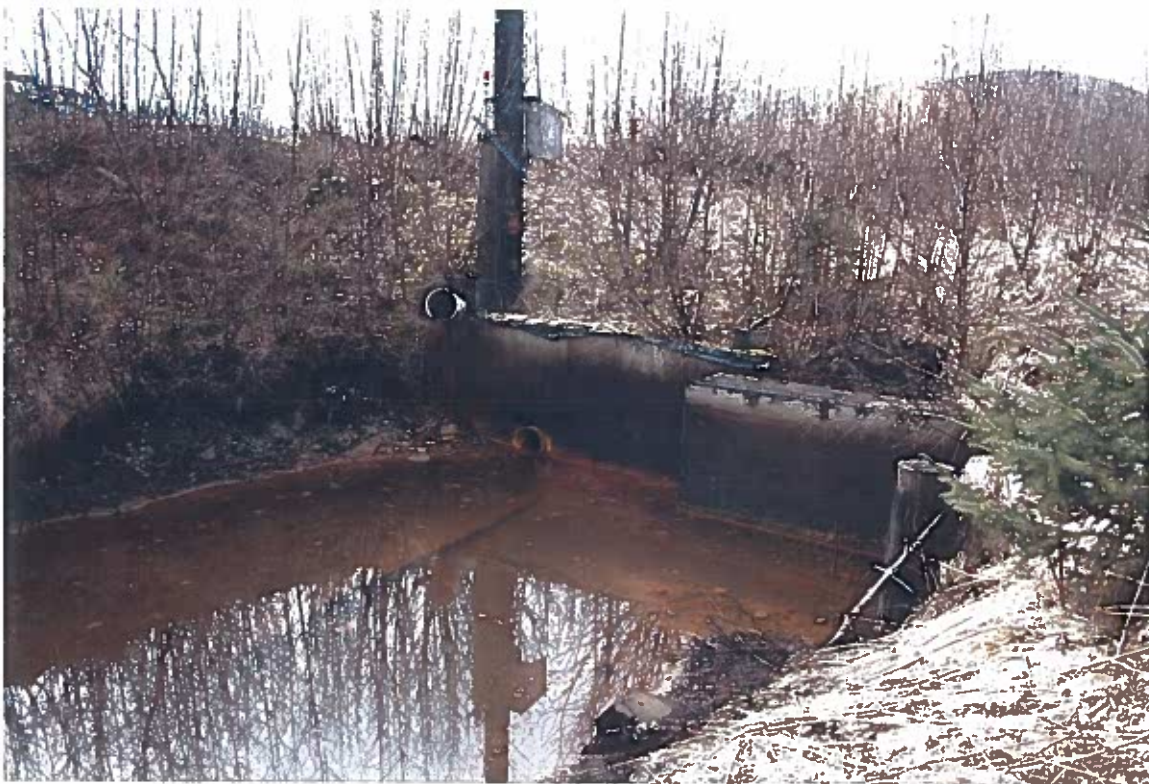
As shown in Photo #26, there was a 1'-1.5' thick rim of black-stained soil around the periphery of the settling pond, and Photo #27 also shows dark-stained bottom sediments along the pond's north side. Nortech's two samples had high DRO and RRO levels of up to 3,350 mg/kg and 15,600 mg/kg.

**Photo #26:** 3/26/12 view looking southwest at the Wrangell Lumber mill's oil/water separator inlet (arrow) and its dam structure. An approximately 1'-thick black soil ring was observed along the sides of the pond, where NORTECH's sample #SP1 had high DRO and RRO levels of 3,350 mg/kg and 15,600 mg/kg.

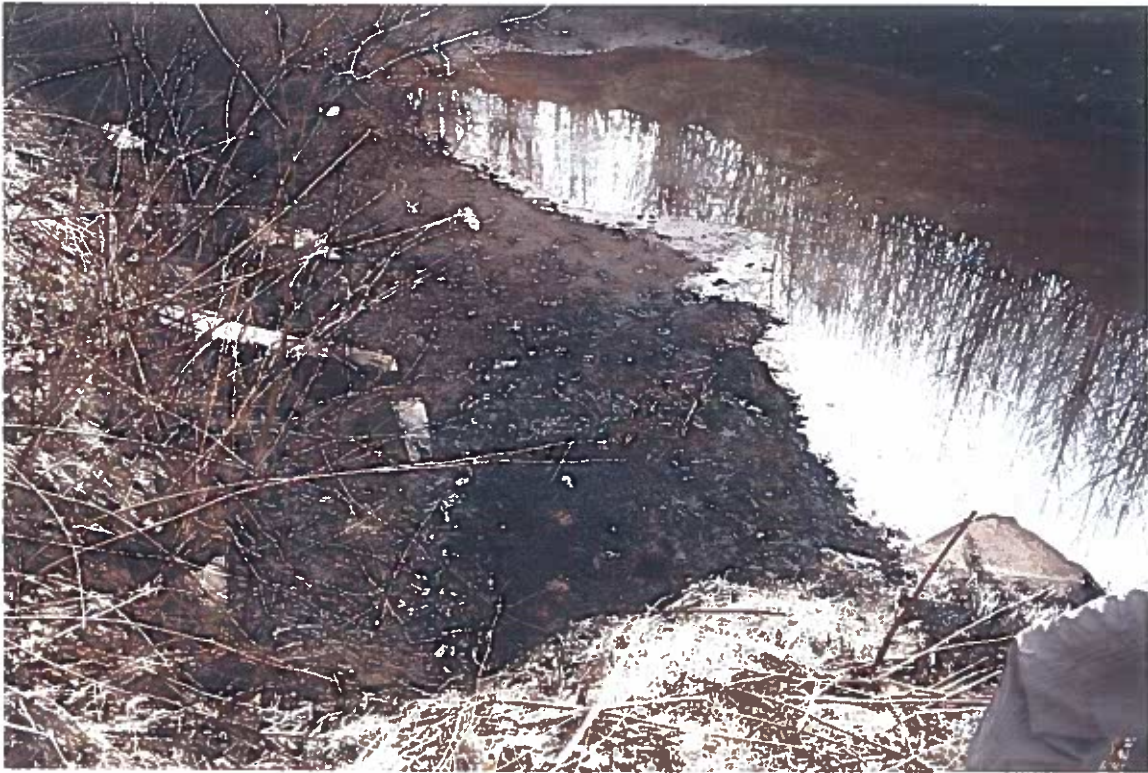
**Photo #27:** 3/27/12 looking down at the Wrangell Lumber oil/water pond sediments, where a thin layer of black-stained soil was present.

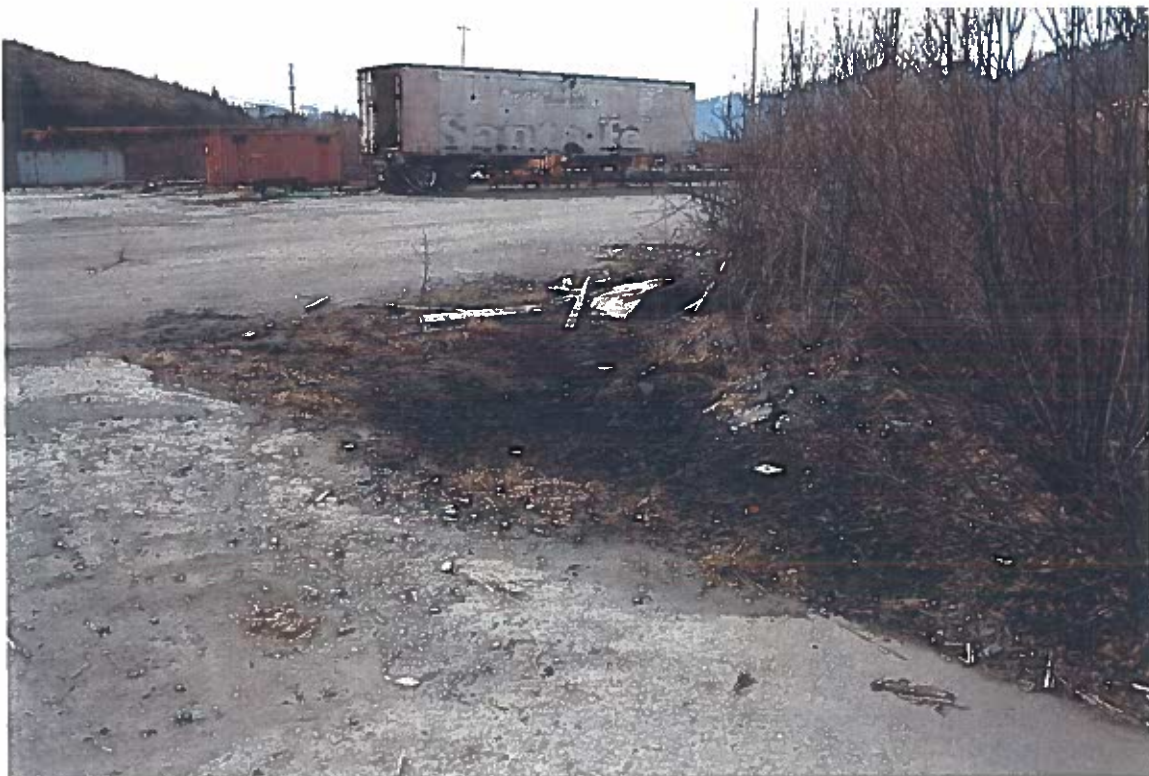
7. Surface-stained soil areas around mill property. Four blackish surface-stained areas were observed at various locations around the mill property, as shown in photos #28-#31 (pages A15-A17). The areas appeared to be little more than shallow contamination, which could and should be readily removed by scrapping with a backhoe bucket.

**Photo #28:** 3/26/12 view looking southwest along the Wrangell lumber roadway just before the oil/water separator, showing a thin layer of black surface-stained soil.

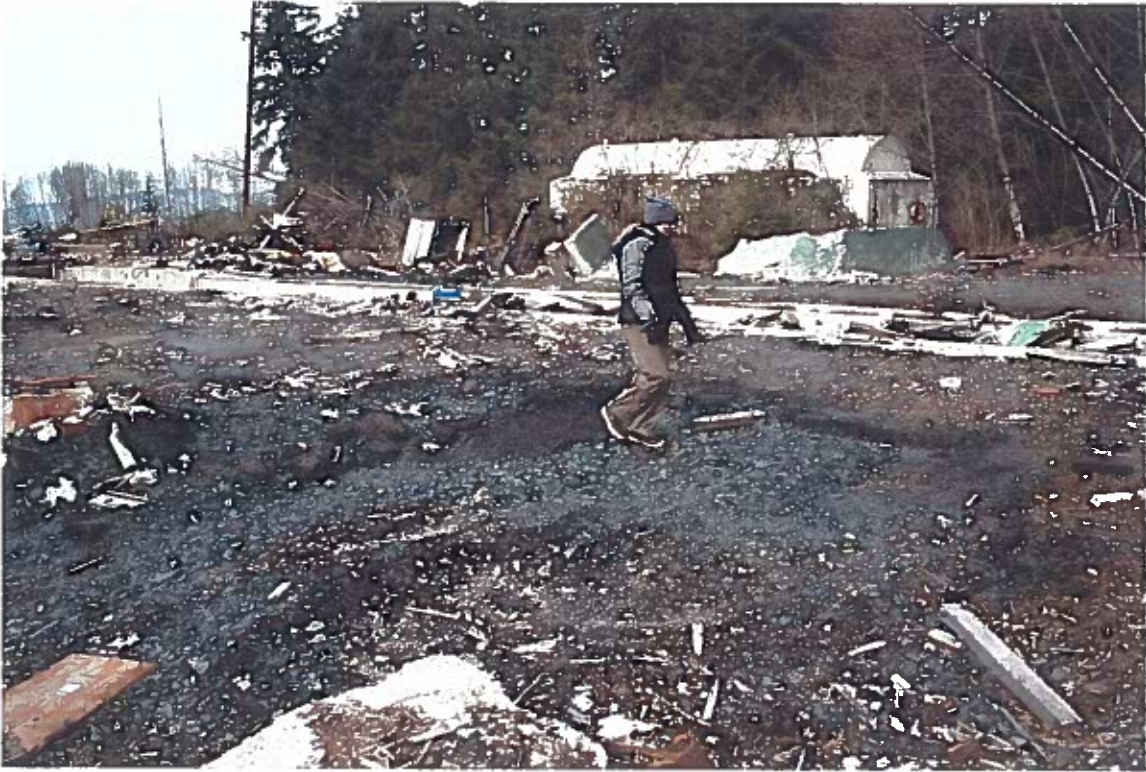
**Photo #29:** 3/26/12 view of a small oil-stained surface area along the northeast corner of the Wrangell Lumber mill site, to be scrapped clean.

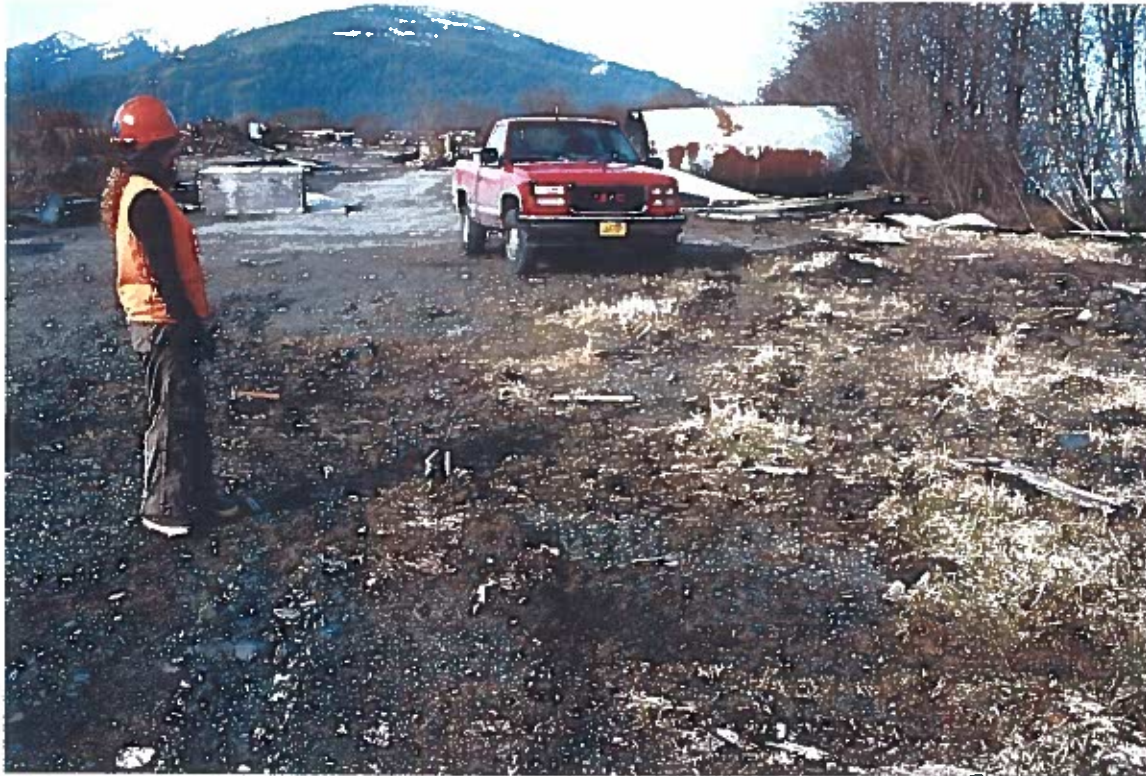
**Photo #30:** 3/26/12 view of another small oil-stained surface area along the north side of the Wrangell Lumber mill site, to scrapped and removed.

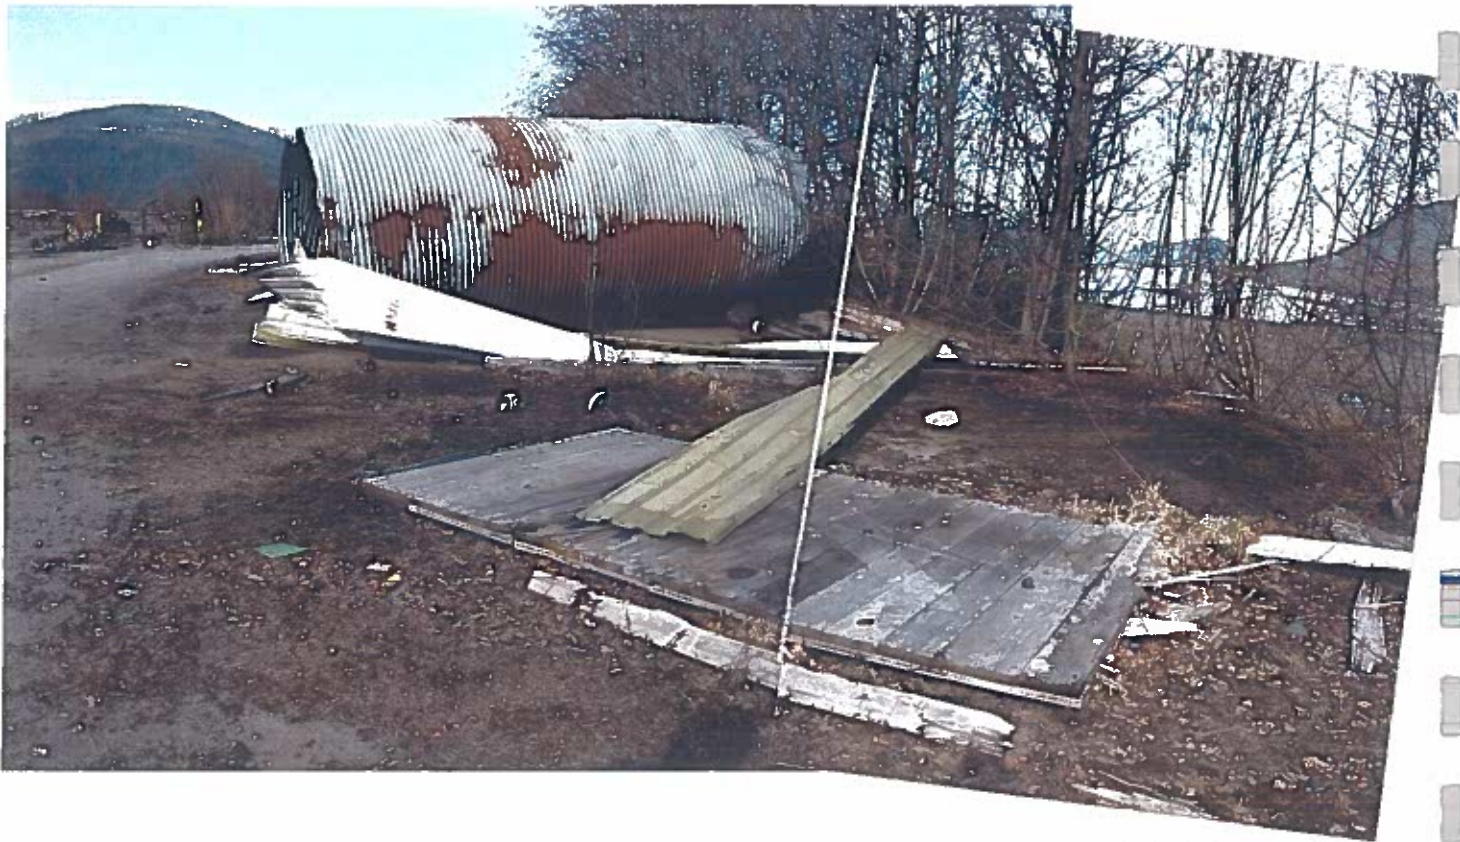
**Photo #31:** 3/26/12 view along the north edge of the Wrangell Lumber mill site, showing a relatively large area of surface-stained soil that will be scrapped and cleaned.

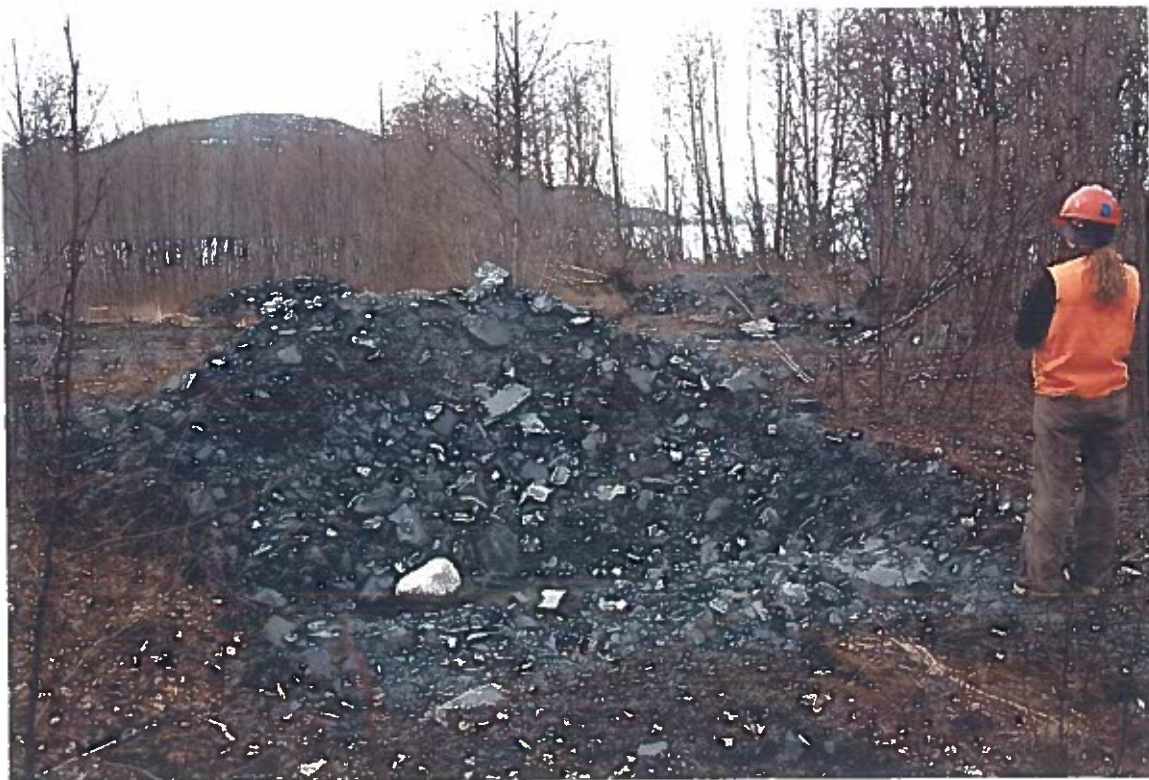
8. Mt. Seley. The Mt. Seley test pits created earlier by Nortech were inspected, and all were still open except for one filled-in pit. Photos #32 and #33 (pages A17-A18) show typical views of the 18 pits, of which one at the north end of Mt. Seley was never found. Nortech's sample at #TP3 had DRO and RRO levels of 3,470 mg/kg and 1,380 mg/kg. After returning to Juneau and further reviewing the Nortech sampling map, it appears that the filled-in excavation just beyond the open test pit shown in Photo #32 is the location of #TP3.

**Photo #32:** 3/26/12 view looking northwest at one of NORTECH's 10/13/11 exploratory excavations made in the north end of the Mt. Seley storage facility, showing the blue clay & rock making up the 2'-3' thick cap covering the top of the site.

Cleanup Area #9 - North end of Mt. Seley. A portion of the Mt. Seley cap where Nortech's test pits #TP3, #TP4 & #TP9 are located (see Figure 5, page 7b) will have its top 1'-1.5' layer of clay/rock peeled off. The underlying clay/rock will be inspected for any visual indications of contamination, and any found will be removed for treatment. Contaminated soils or clay to be removed are estimated to be 2-5 c.y.

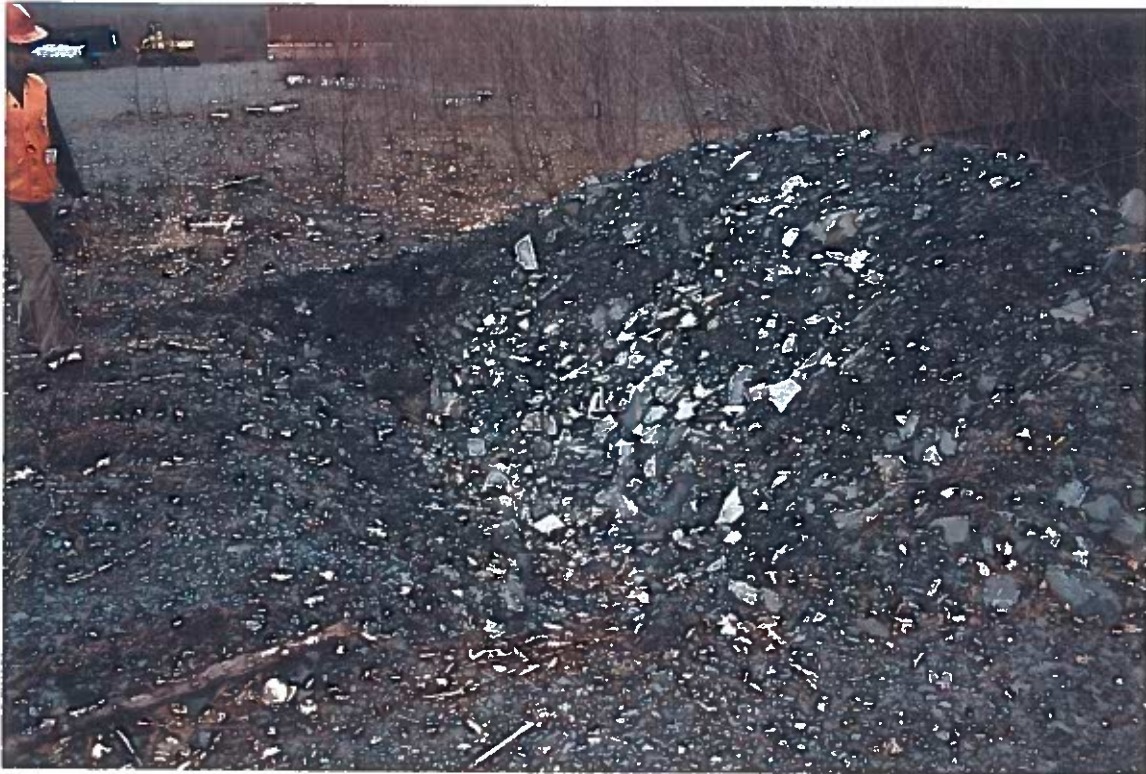
**Photo #33:** 3/26/12 view looking northeast across the 10/13/12 NORTECH exploratory excavation along the east side of the Mt. Seley storage facility, where sample #TP8 had a slightly elevated DRO level of 302 mg/kg.

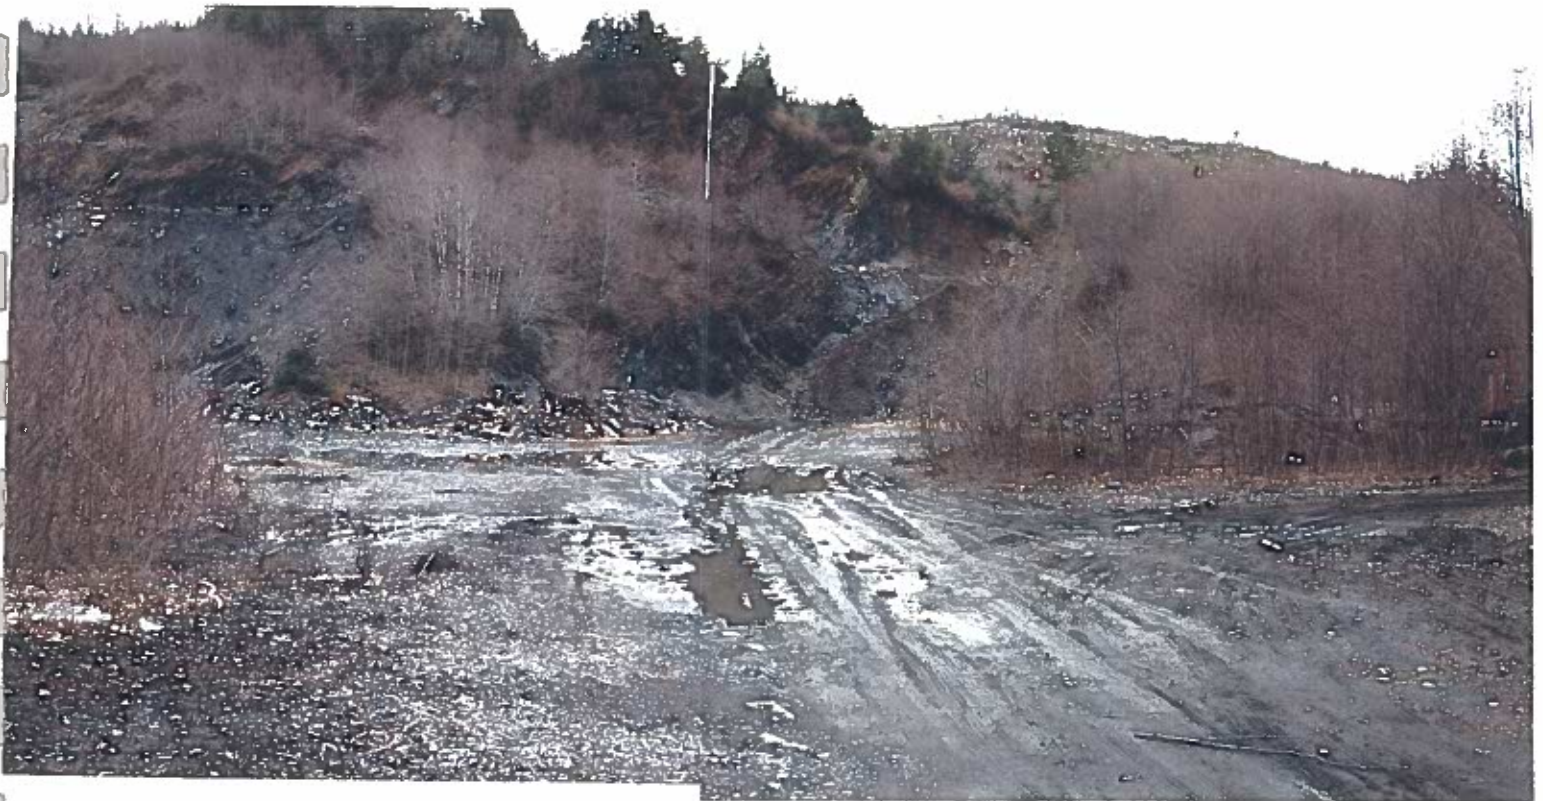
**Photo #34:** 3/26/12 view looking into the Wrangell Lumber rock quarry just above the mill and on the uphill side of Zimovia Highway. The proposed site for the soil bioremediation cell is just beyond the small alders on the right side of the photo. See next 2 photos.

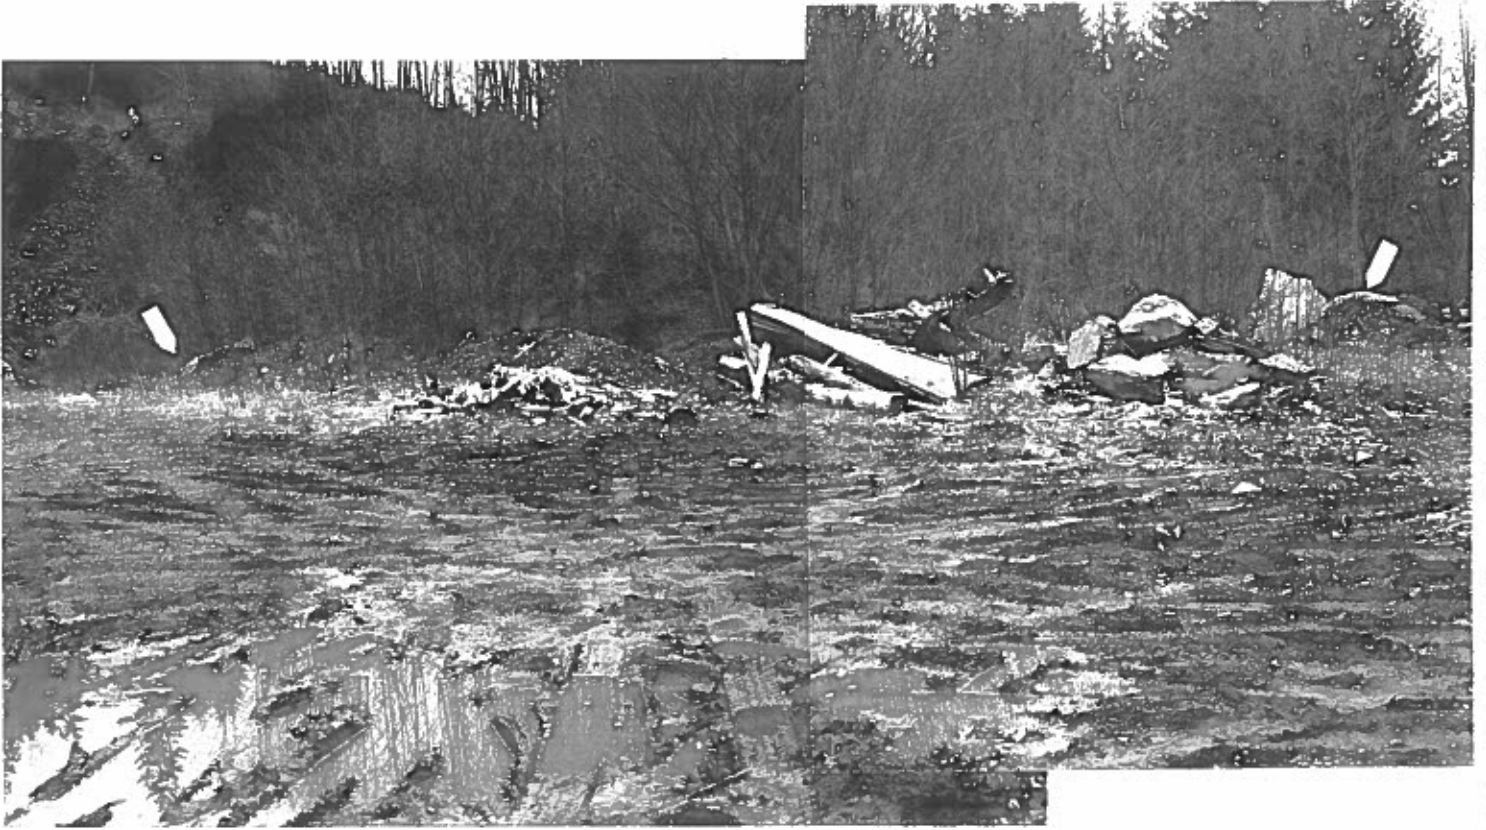
**Photo #35:** 3/26/12 view along the west side of the Wrangell Lumber rock quarry, showing the area (between the arrows) that will be cleared, leveled and used for bioremediating the excavated soil.

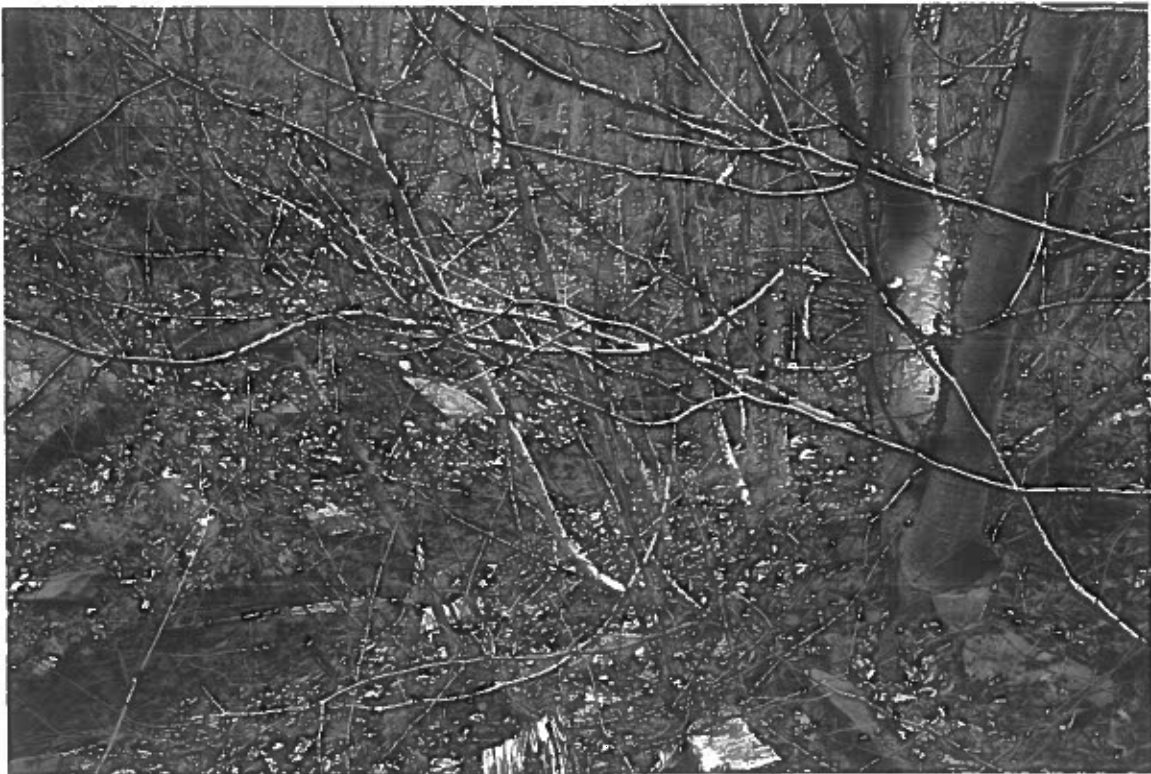
**Photo #36:** 3/26/12 view looking southwest and down at the small gulley behind the Wrangell Lumber rock quarry where the bioremediation cell will be located, showing the drainage where a lined water sump will be constructed for containing and treating any seepage from the back side of the cell.

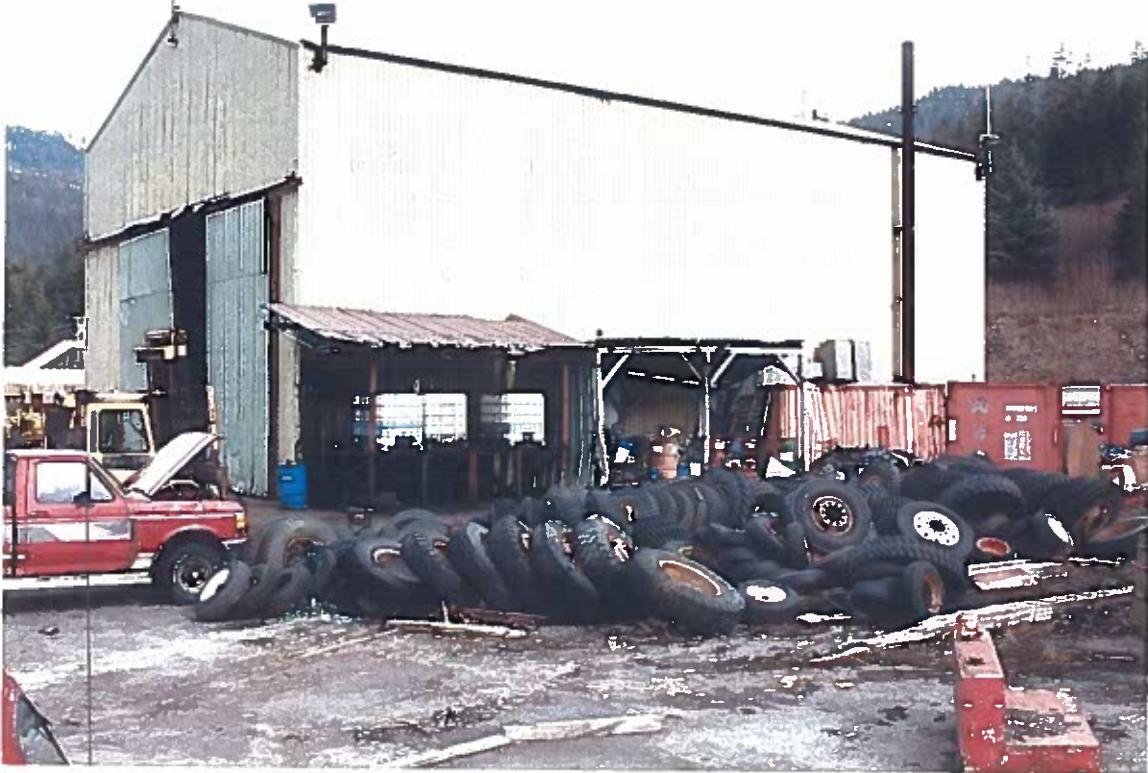
**Photo #37:** 3/26/12 view looking northwest at the Wrangell Lumber shop's south side, where the lube and hydraulic oil dispensers are located along with a shed for drums, which will be inventoried and evaluated for disposal or recycling as appropriate.

The City of Wrangell will be holding its voluntary household hazardous waste cleanup event in late May 2012, which will be overseen by Steve Haavig of Carson Dorn Inc. Immediately after that event, Mr. Haavig has agreed to extend his Wrangell trip to inspect and prepare paperwork for recycling and/or disposing of the mill site's remaining excess petroleum, oils and other

containerized materials. Recycling and/or disposal then will proceed as recommended by Mr. Haavig.

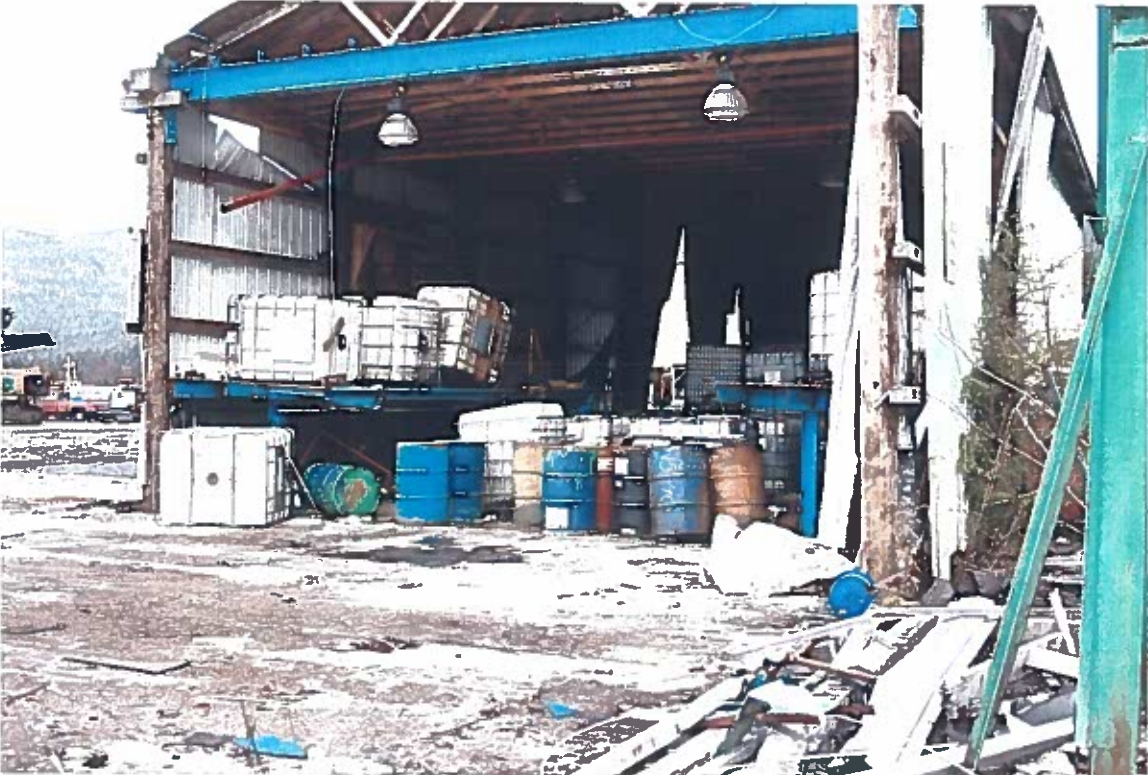
**Photo #38:** 3/26/12 view of Wrangell Lumber Storage Building #1 (formerly part of the planer building), where a number of barrels and 5-gallon container were present and will be inventoried for recycling or disposal.
