**FINAL
2021 REMEDIAL ACTION OPERATIONS LAND USE /
INSTITUTIONAL CONTROL REPORT**

**Cape Romanzof Long Range Radar Site, Alaska
Sites LF003, SS010, SS015, SS016, SS017, and ST009**

October 2022

North Wind-EA, JV
2525 C Street, Suite 130
Anchorage, Alaska 99503

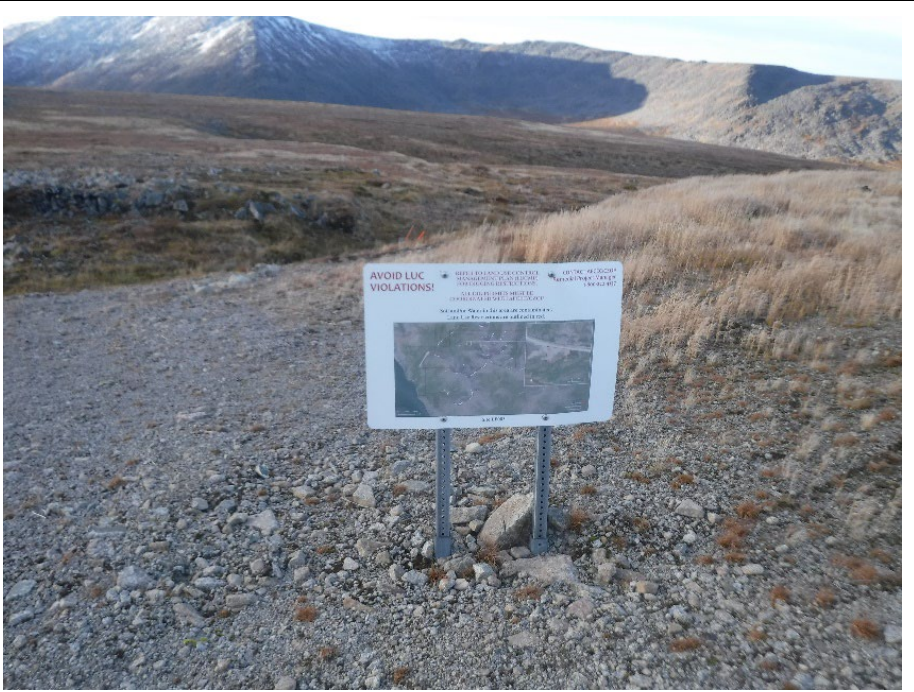
Photograph No.: 001	Date taken: 09-30-2021

Photograph taken by: Kristopher Ashton		
Direction: East	Location: LF003	
Description: Sign on south side of road, east side of site, facing NE. Good condition.

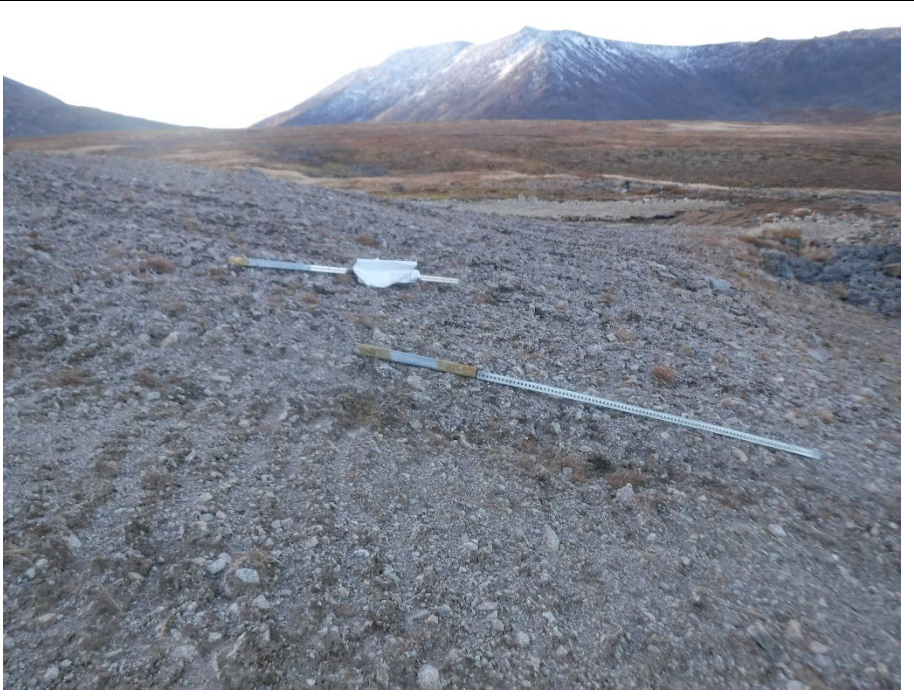
Photograph No.: 002	Date taken: 09-30-2021

LUC warning signs at each site were in good condition, legible, and not obscured by vegetation, with the exception of signs that have been downed by wind or snowplow, or removed since the previous visit at sites LF003, SS010 and SS015.

Photograph taken by: Kristopher Ashton		
Direction: South	Location: LF003	
Description: West side slope with destroyed sign, south side of road, west side of site.

- Replace the destroyed LUC warning sign at west end of the site.

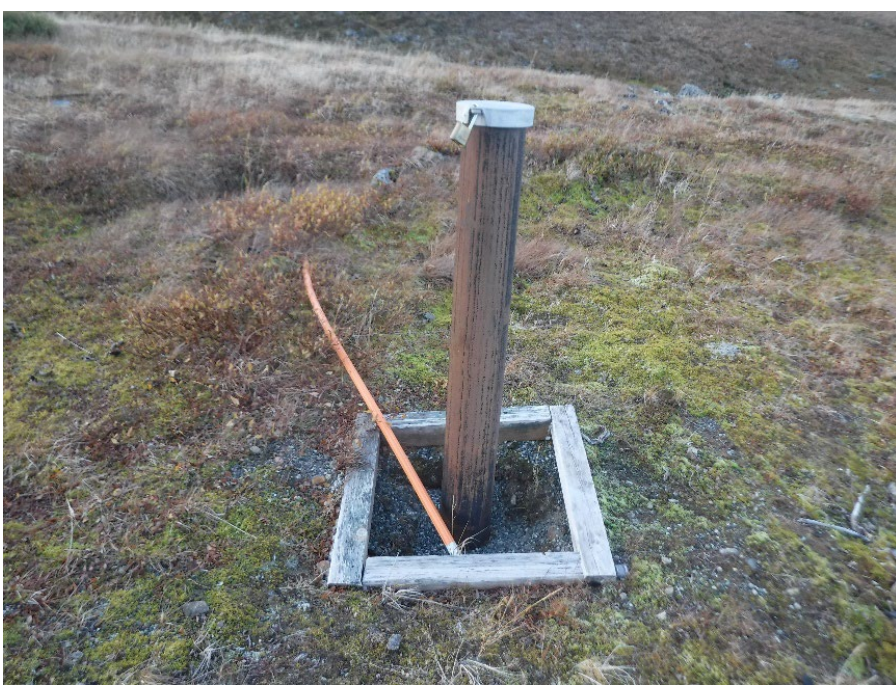
Photograph No.: 003	Date taken: 09-30-2021

Photograph taken by: Kristopher Ashton		
Direction: South	Location: LF003	
Description: CMW-07, frost-jacked outer casing, still serviceable.

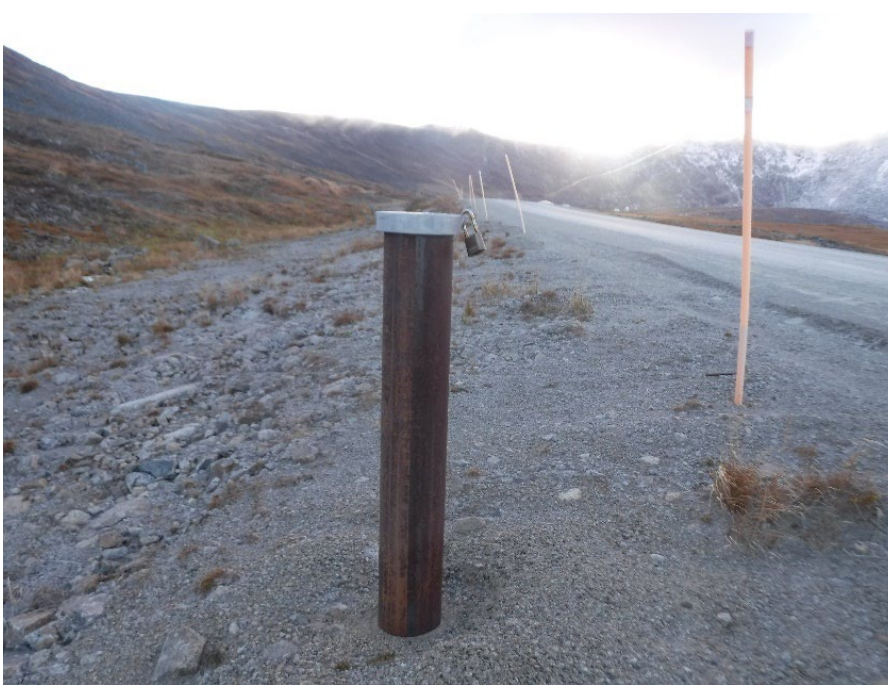
Photograph No.: 004	Date taken: 09-30-2021

Photograph taken by: Kristopher Ashton		
Direction: East	Location: LF003	
Description: MW-01, good condition.

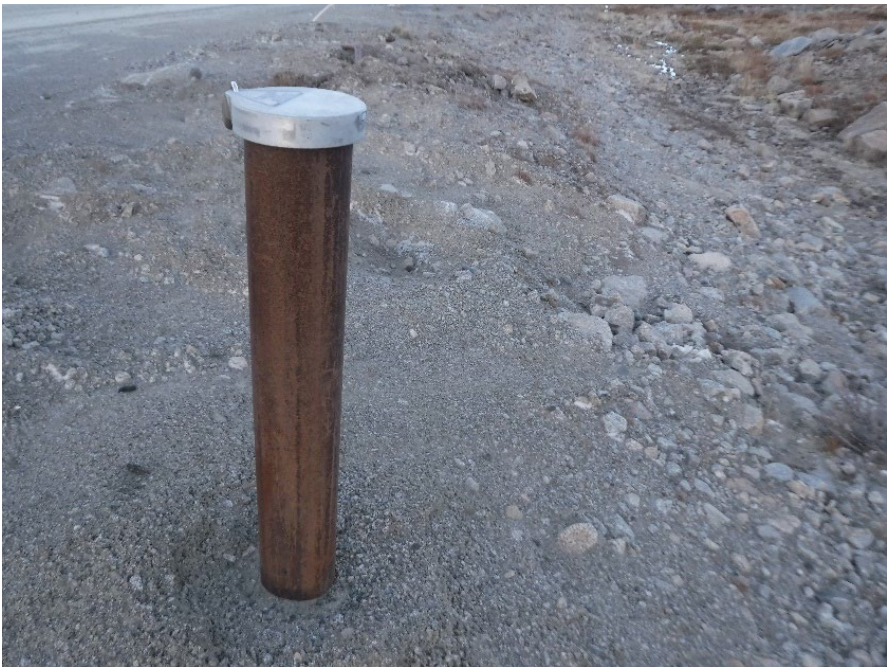
Photograph No.: 005	Date taken: 09-30- 2021

Photograph taken by: Kristopher Ashton		
Direction: Southwest	Location: LF003	
Description: MW-02, good condition.

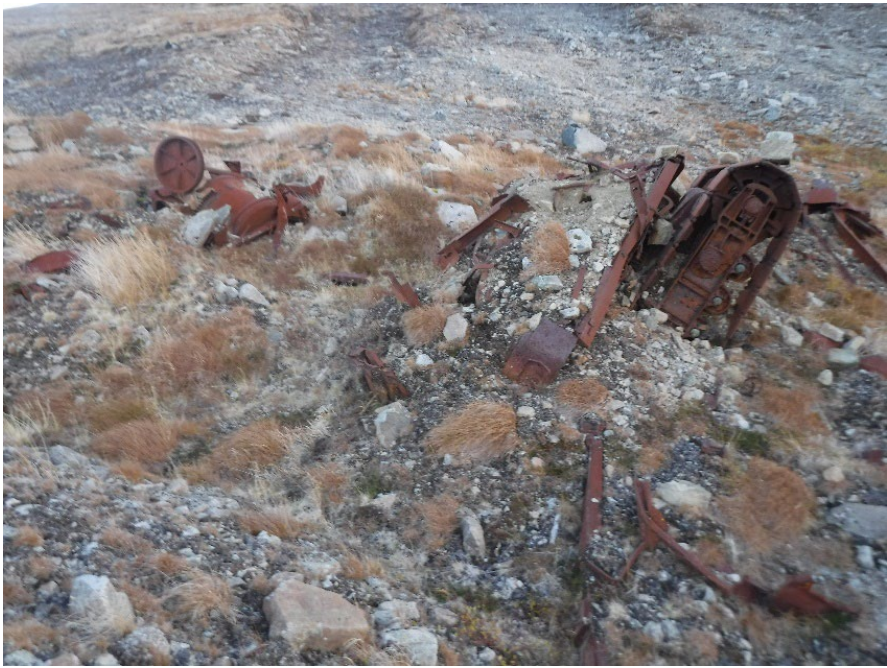
Photograph No.: 007	Date taken: 09-30-2021

Photograph taken by: Kristopher Ashton		
Direction: North	Location: LF003	
Description: Large, scattered debris north of the road.

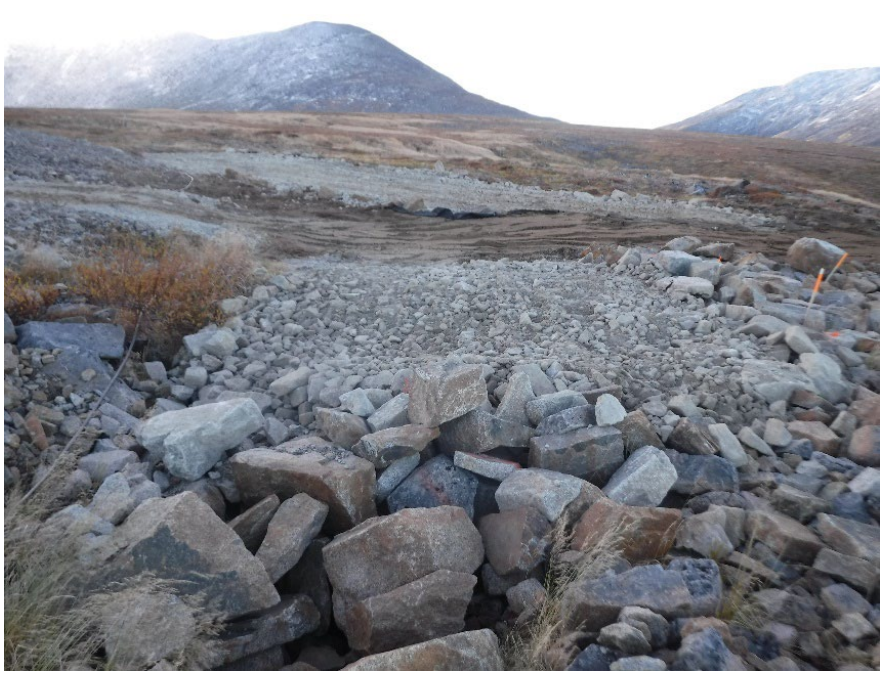
Photograph No.: 010	Date taken: 09-30-2021

Photograph taken by: Kristopher Ashton		
Direction: East	Location: LF003	
Description: South side slope with recent excavation and fill.

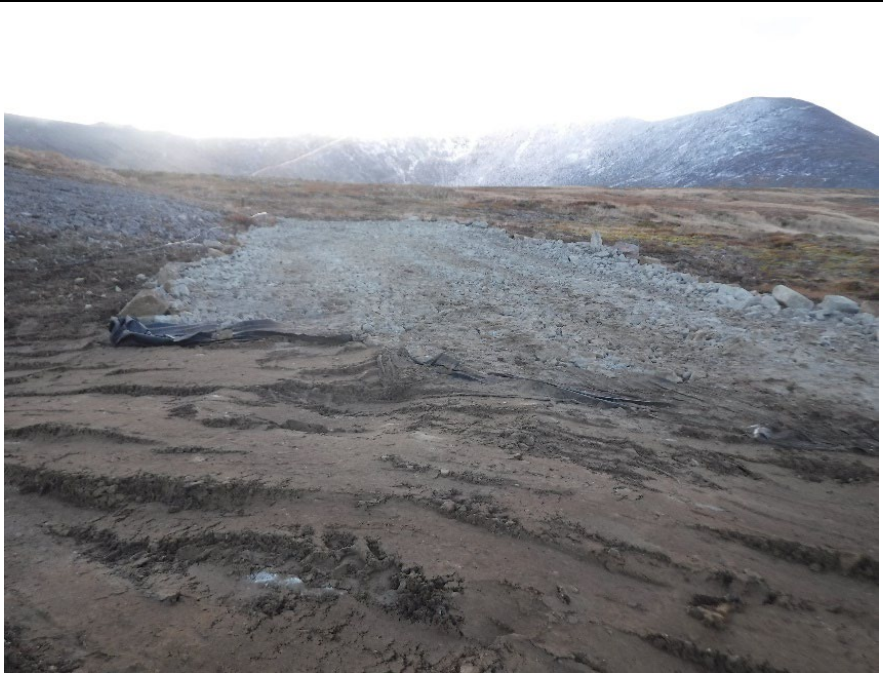
Photograph No.: 011	Date taken: 09-30-2021

Photograph taken by: Kristopher Ashton		
Direction: East	Location: LF003	
Description: South side slope with recent excavation and fill.

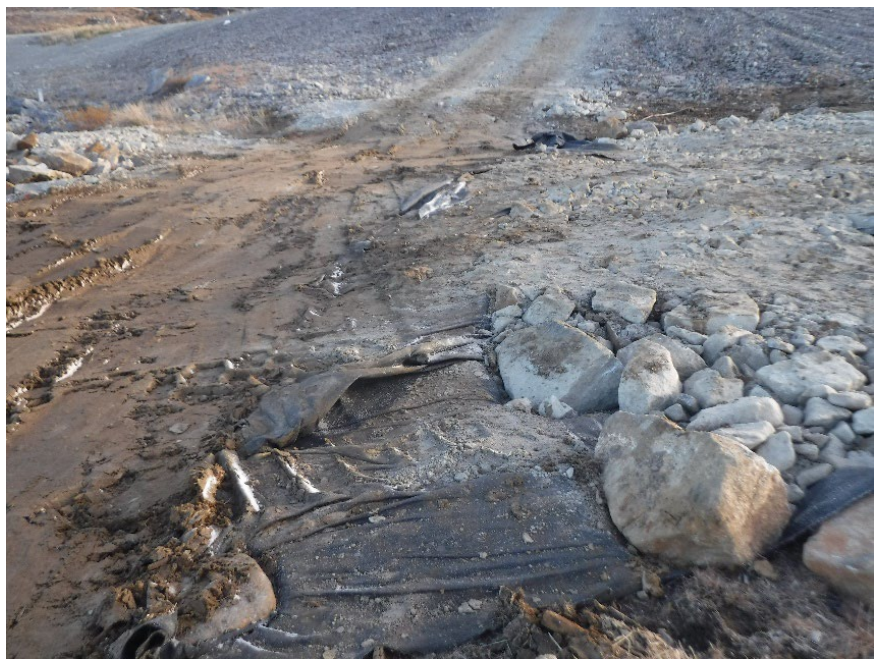
Photograph No.: 012	Date taken: 09-30-2021

Photograph taken by: Kristopher Ashton		
Direction: North	Location: LF003	
Description: Exposed cap liner, newly placed, on recent excavation and fill, south side slope.

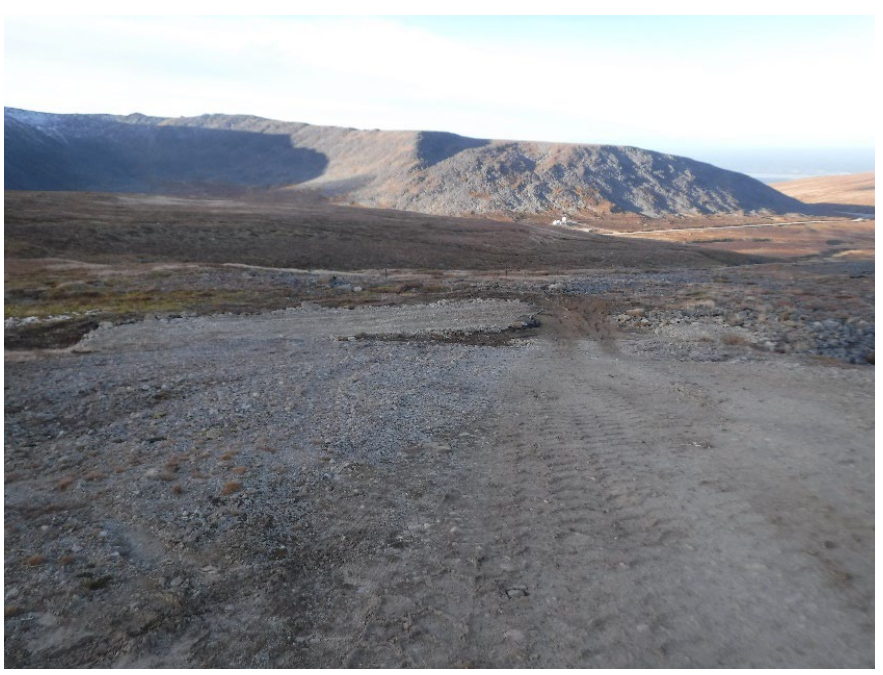
Photograph No.: 013	Date taken: 09-30-2021

Minor settling of the capped surface was observed. Ponded water was noted due to recent and ongoing rainfall and snowfall; no sheen was observed on the ponded water. Petroleum sheen and chemical odors were not observed or evident at the cap or at surface water downgradient to the southwest. The site had some debris and areas of possible escapement of landfill material including geotextile liners, plastics, and metal materials. Significant metal debris is present at the site, north of the road. An extracted well casing was laying on the ground at the bottom of the east side slope. Vehicle tracks were observed in the flat/pull-off area of the site, and recent excavation and fill activities were noted. The south and west side slopes had recently been graded. Surface erosion was observed on all side slopes of the landfill cap (water runoff areas) except for the road boundary. The site had damaged or missing silt fences. All silt fences were in various states of disrepair and non-operative condition due to high winds and require replacement. Damage to the silt fences include those done by wind damage where they were observed ripped and partially attached to bent posts and completely missing given by standalone posts with no attached fabric. No discolored vegetation was observed. Several birds of an unidentified species were present at the site. The site is not vegetated on the cap surface and south/west side slopes, and up to 70 percent vegetated on the east side slope. Signage at the west end of the site was destroyed and laying on the ground. Two signs were still in place and in good condition, though slightly faded. One was at the east end of the site on the south side of the road, the other was on the north side of the road.

Photograph taken by: Kristopher Ashton		
Direction: South	Location: LF003	
Description: Top of landfill cap.

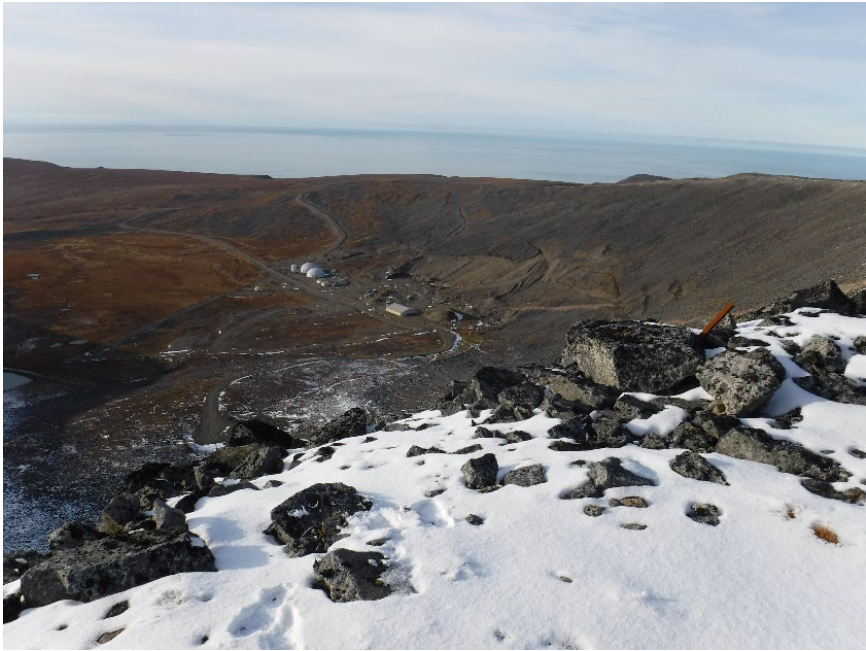
Photograph No.: 015	Date taken: 09-28-2021

Photograph taken by: Kristopher Ashton		
Direction: Northeast	Location: SS016	
Description: Previous upper tram station site. Minor metal and cement debris remains.

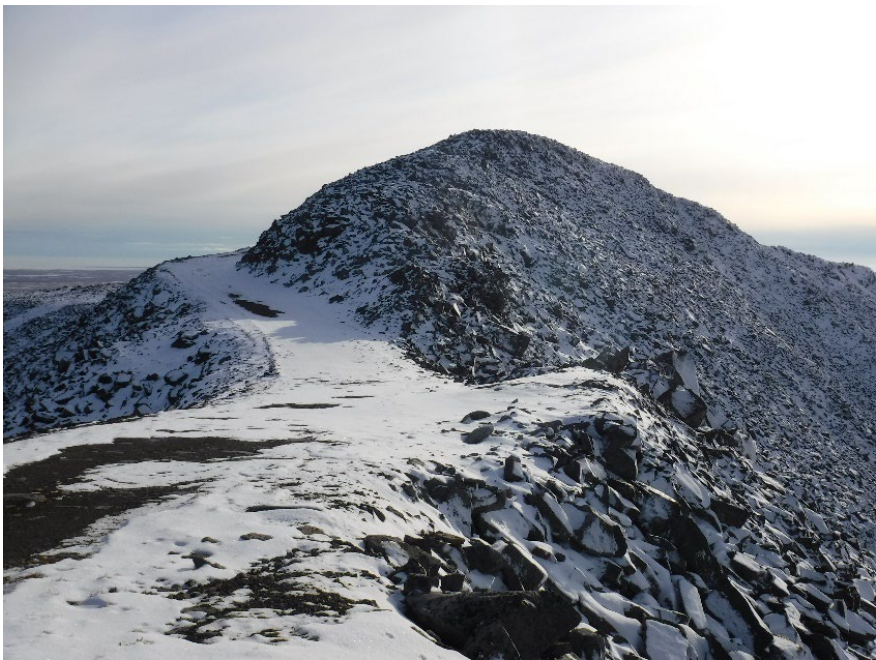
Photograph No.: 016	Date taken: 09-28-2021

Photograph taken by: Kristopher Ashton		
Direction: South	Location: SS016	
Description: Previous upper tram station site. Minor metal and cement debris remains.

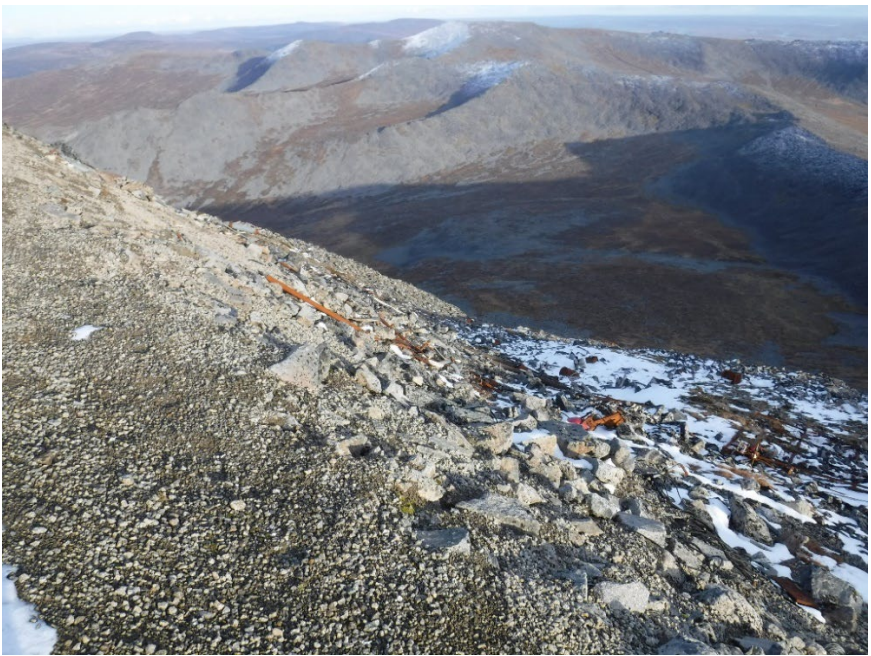
Photograph No.: 018	Date taken: 09-28-2021

Photograph taken by: Kristopher Ashton		
Direction: Northeast	Location: SS016	
Description: Metal and other debris on the east mountain slope.

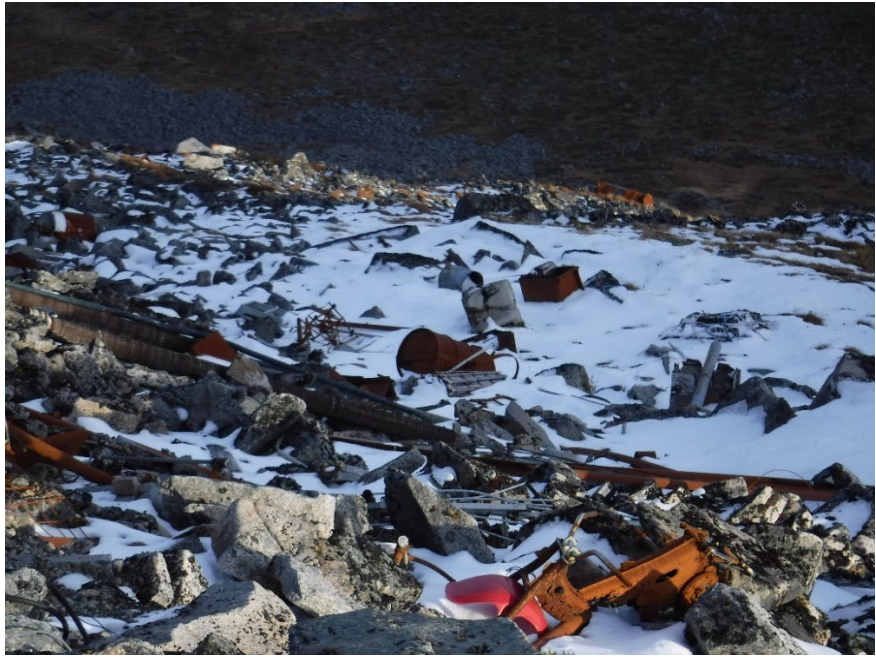
Photograph No.: 019	Date taken: 09-28-2021

Photograph taken by: Kristopher Ashton		
Direction: East	Location: SS016	
Description: Metal and other debris on the east mountain slope.

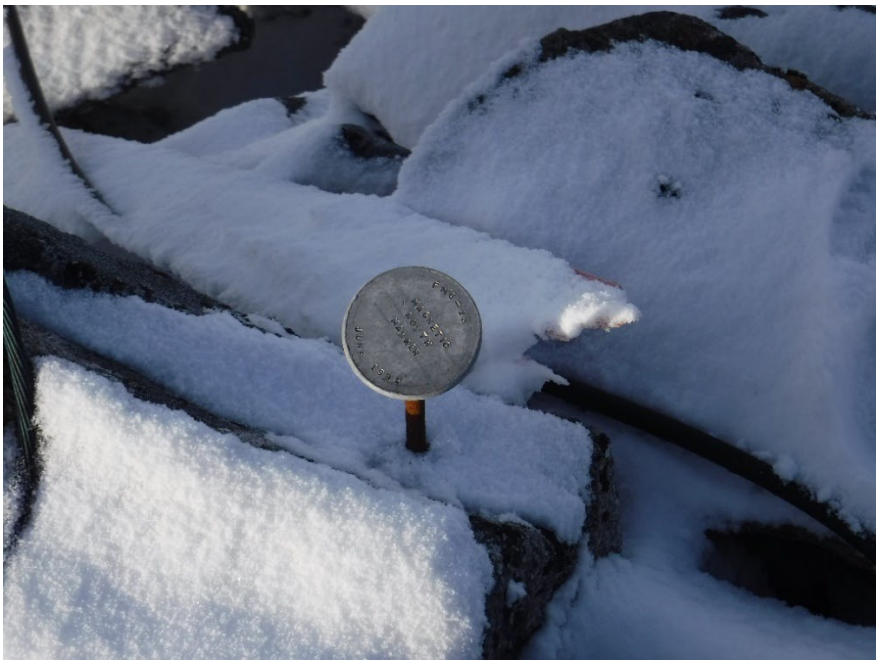
Photograph No.: 020	Date taken: 09-28-2021

Photograph taken by: Kristopher Ashton		
Direction: Northwest	Location: SS016	
Description: Survey marker.

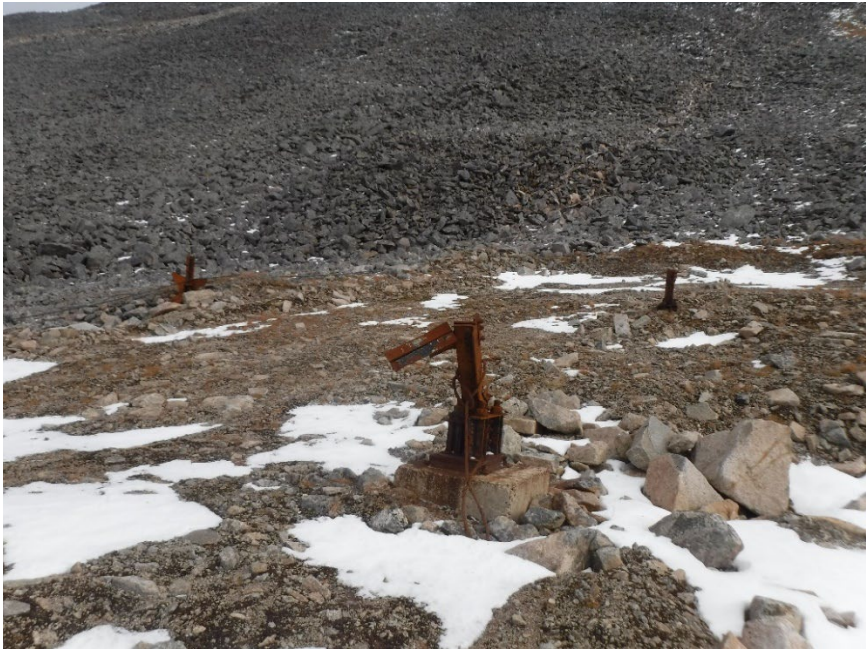
Photograph No.: 021	Date taken: 09-28-2021

Photograph taken by: Kristopher Ashton		
Direction: East	Location: SS017	
Description: Infrastructure remaining on site after building removal.

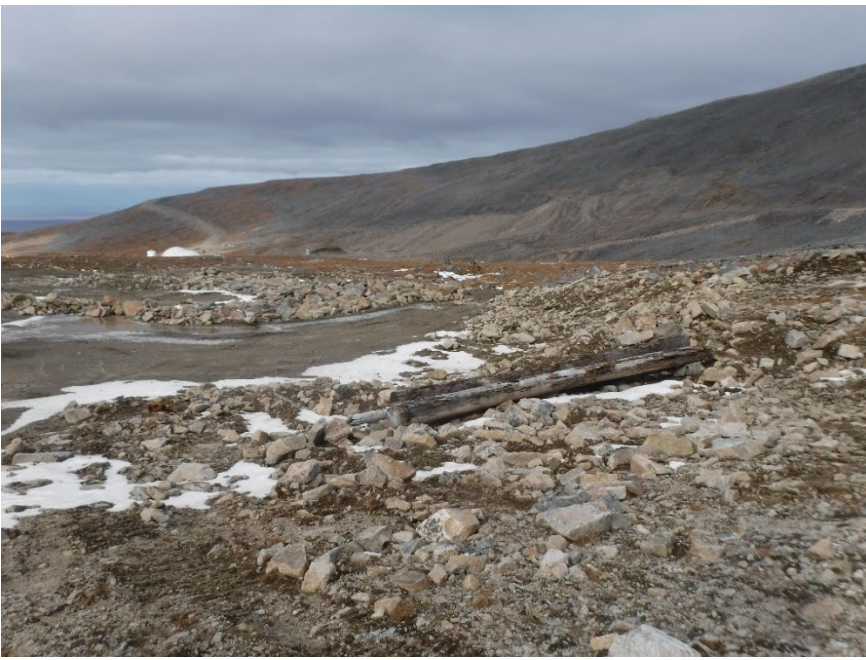
Photograph No.: 022	Date taken: 09-28-2021

Photograph taken by: Kristopher Ashton		
Direction: Northwest	Location: SS017	
Description: Wooden poles and debris remaining on site after building removal.

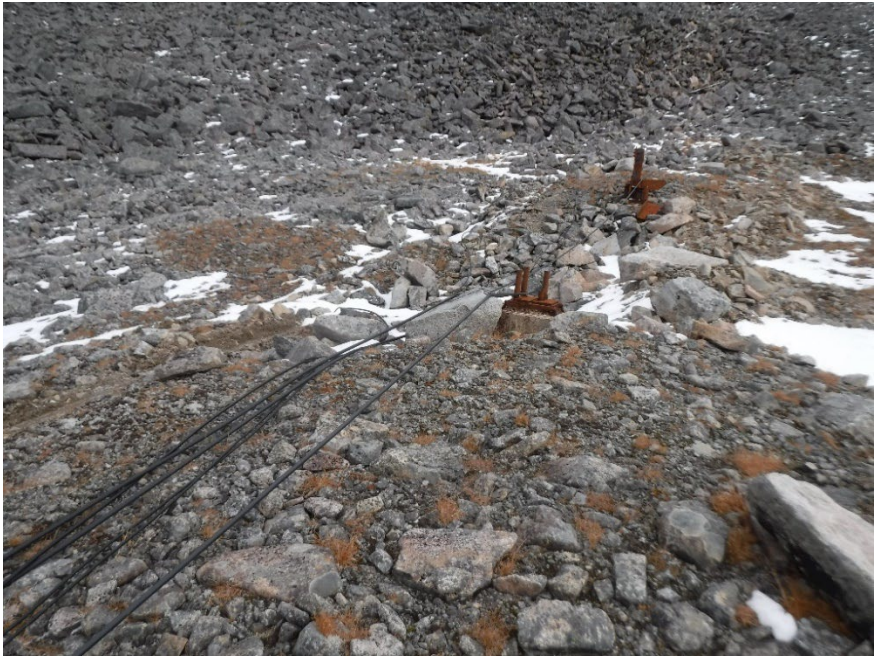
Photograph No.: 023	Date taken: 09-28-2021

Photograph taken by: Kristopher Ashton		
Direction: East	Location: SS017	
Description: Infrastructure remaining on site after building removal.

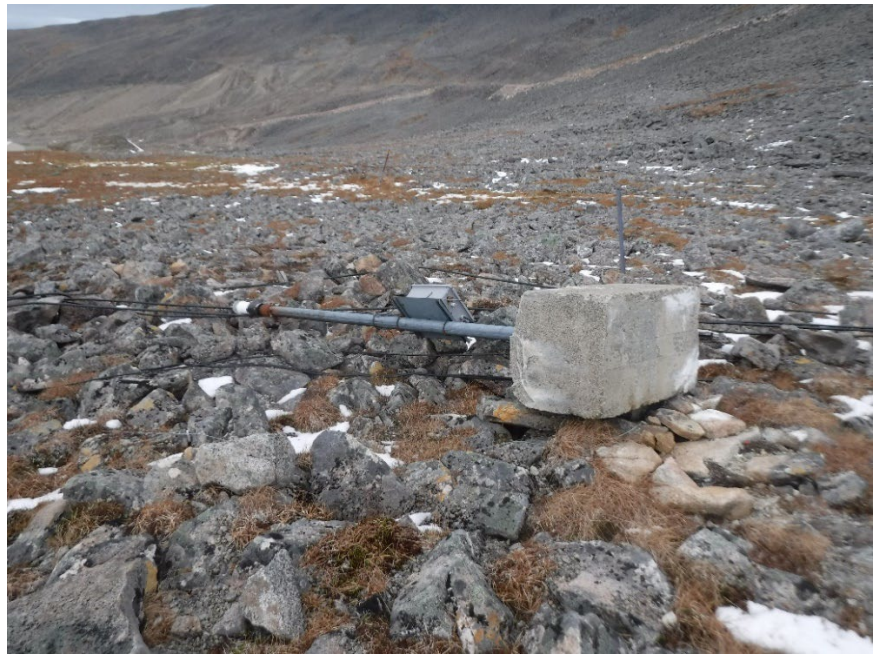
Photograph No.: 024	Date taken: 09-28-2021

Photograph taken by: Kristopher Ashton		
Direction: Northeast	Location: SS017	
Description: Infrastructure remaining on site after building removal.

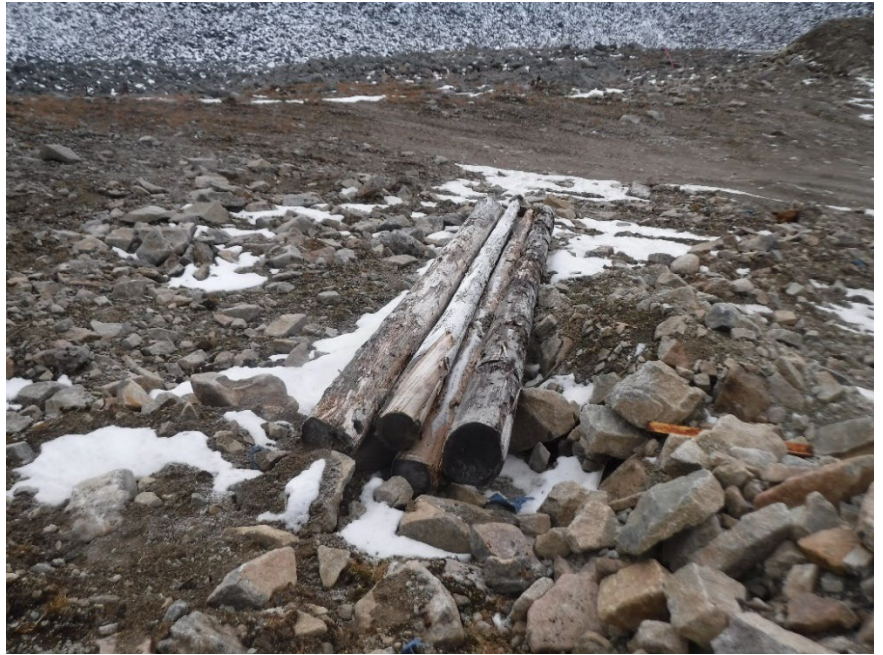
Photograph No.: 025	Date taken: 09-28-2021

Photograph taken by: Kristopher Ashton		
Direction: Southeast	Location: SS017	
Description: Wooden poles and debris remaining on site after building removal.

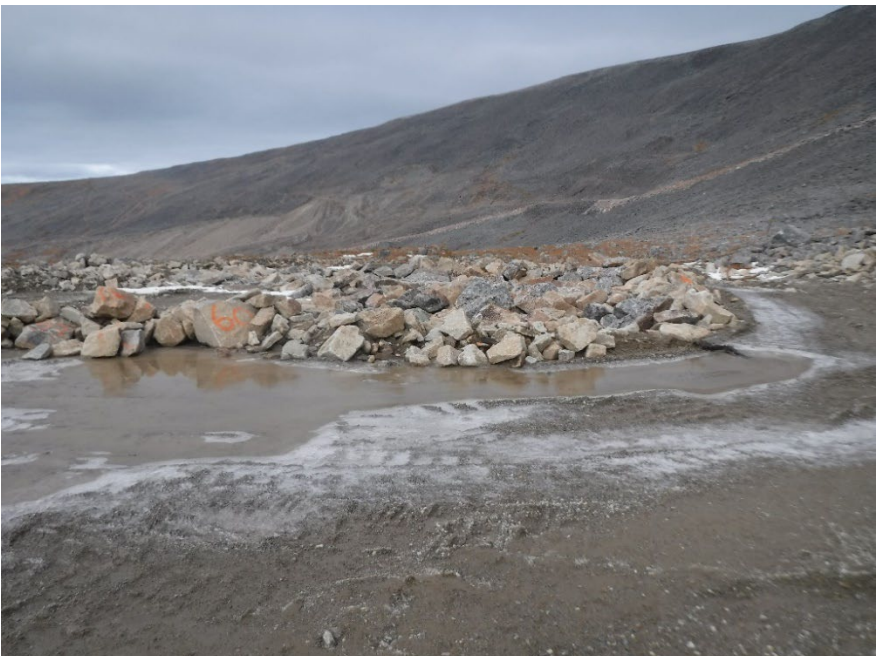
Photograph No.: 026	Date taken: 09-28-2021

Photograph taken by: Darion Carden		
Direction: North	Location: SS017	
Description: Access road and rock piles.

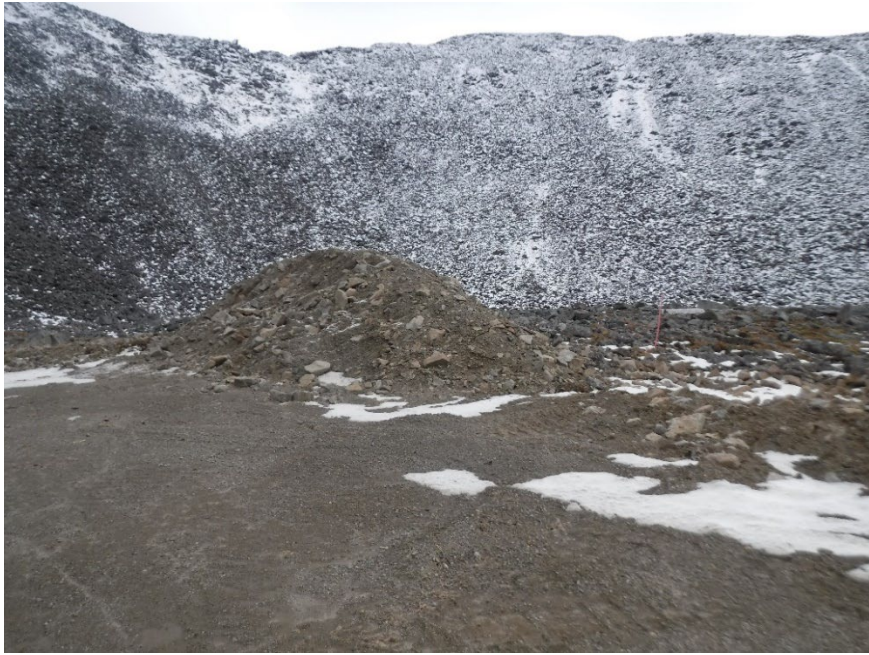
Photograph No.: 027	Date taken: 09-28-2021

Photograph taken by: Kristopher Ashton		
Direction: South	Location: SS017	
Description: Surface material consisting of soil, boulders, cobbles, pebbles, and sand.

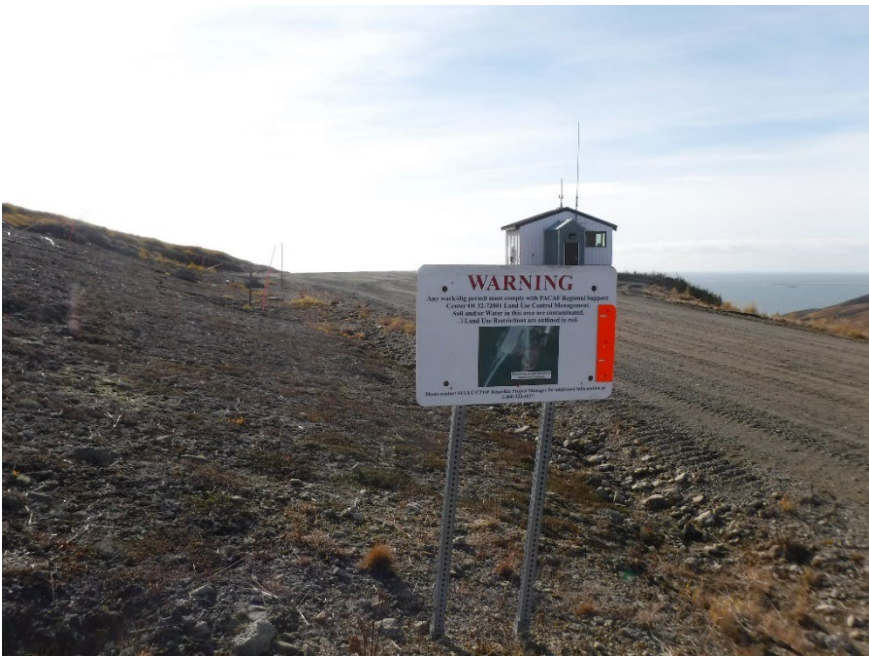
Photograph No.: 028	Date taken: 09-29-2021

Photograph taken by: Kristopher Ashton		
Direction: South	Location: SS010	
Description: Sign at access road, east side of road, facing north, good condition.

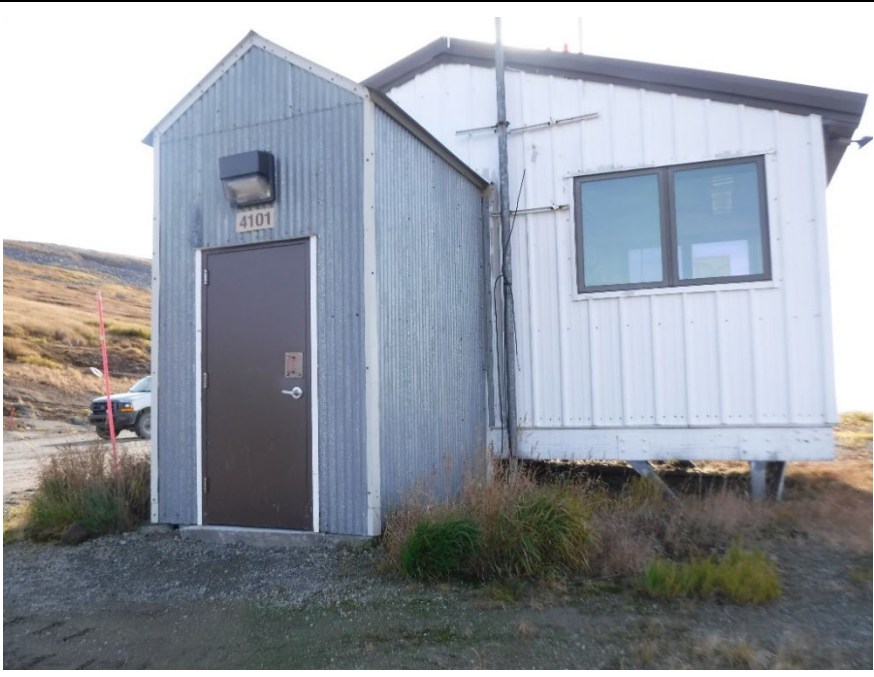
Photograph No.: 029	Date taken: 09-29-2021

Photograph taken by: Darion Carden		
Direction: South	Location: SS010	
Description: Weather station building on site, north side.

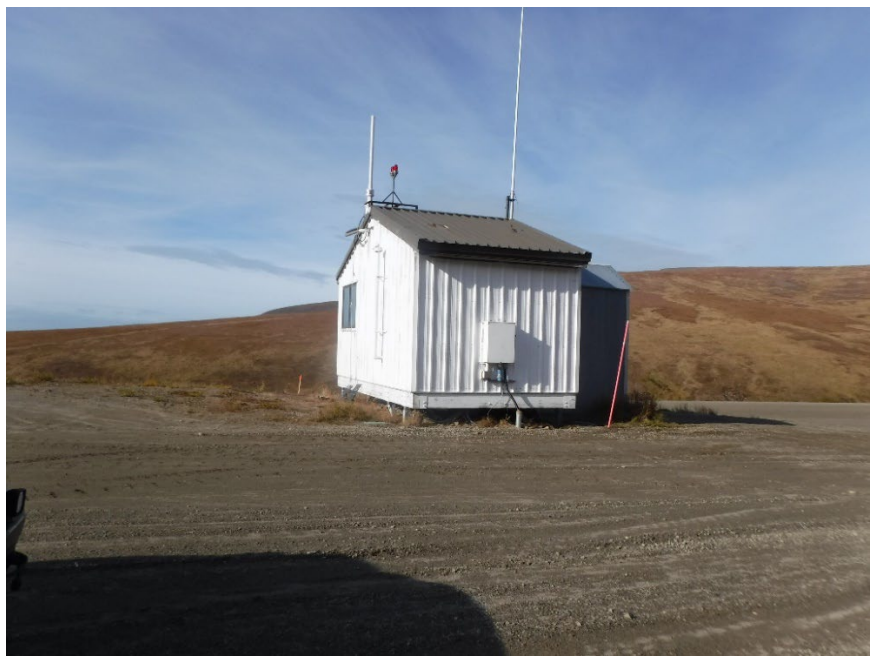
Photograph No.: 030	Date taken: 09-29-2021

Photograph taken by: Kristopher Ashton		
Direction: West	Location: SS010	
Description: Weather station building on site, east side.

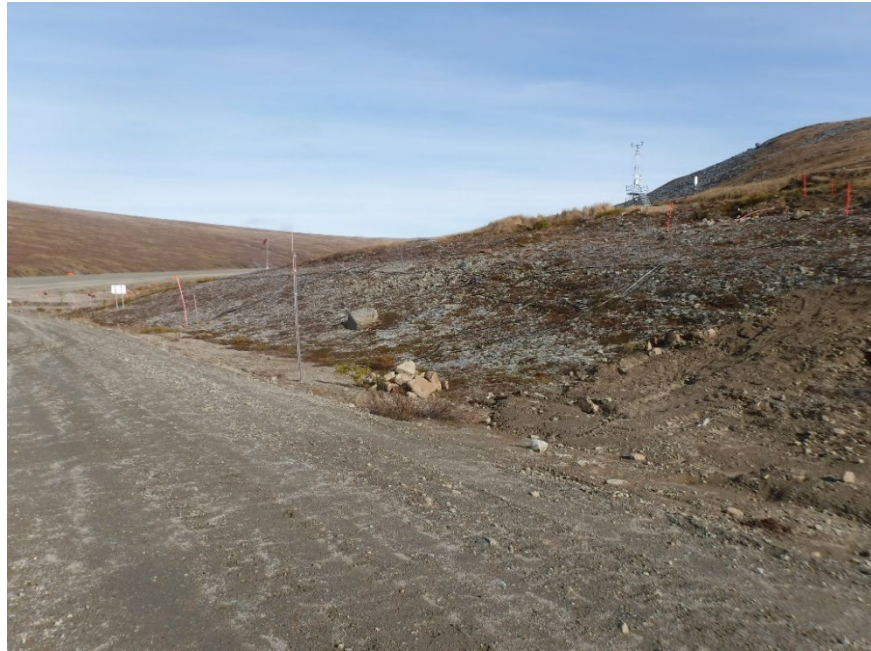
Photograph No.: 031	Date taken: 09-29-2021

Photograph taken by: Kristopher Ashton		
Direction: North	Location: SS010	
Description: Erosion of upper slope, east side of road, and minor repair fill.

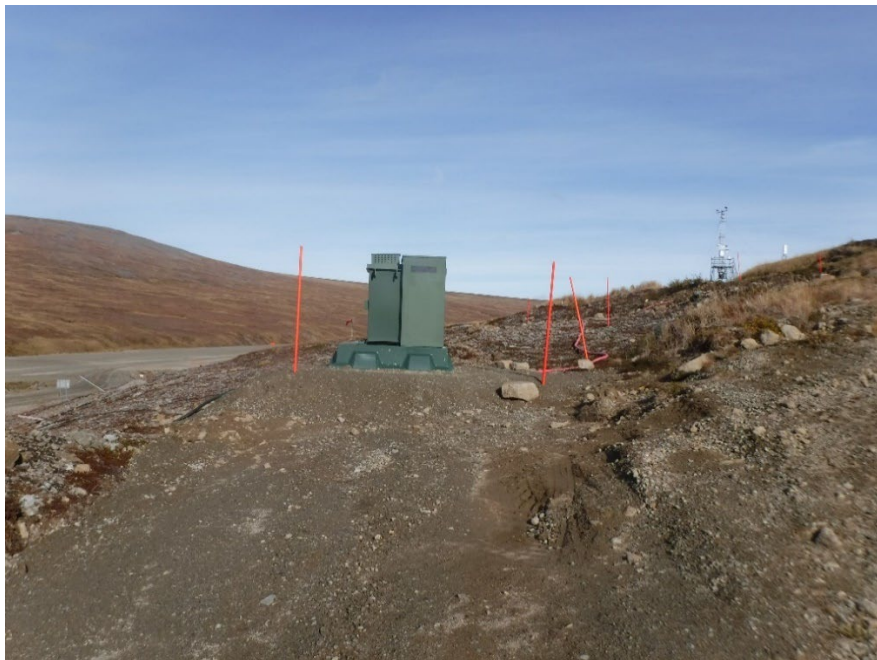
Photograph No.: 032	Date taken: 09-29-2021

Photograph taken by: Darion Carden		
Direction: North	Location: SS010	
Description: New power transformer and high-voltage wires on site.

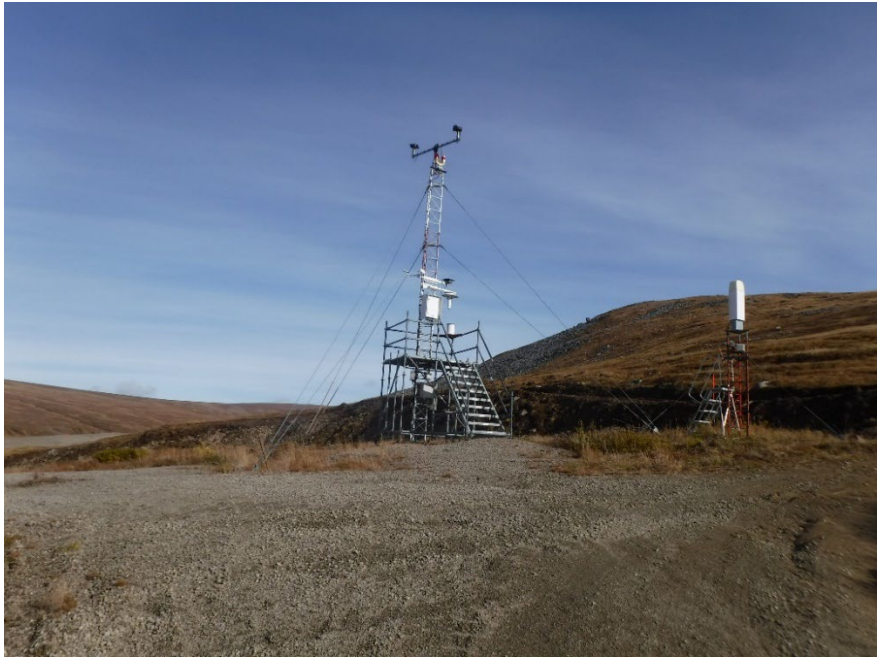
Photograph No.: 033	Date taken: 09-29-2021

Photograph taken by: Darion Carden		
Direction: North	Location: SS010	
Description: Weather station on site.

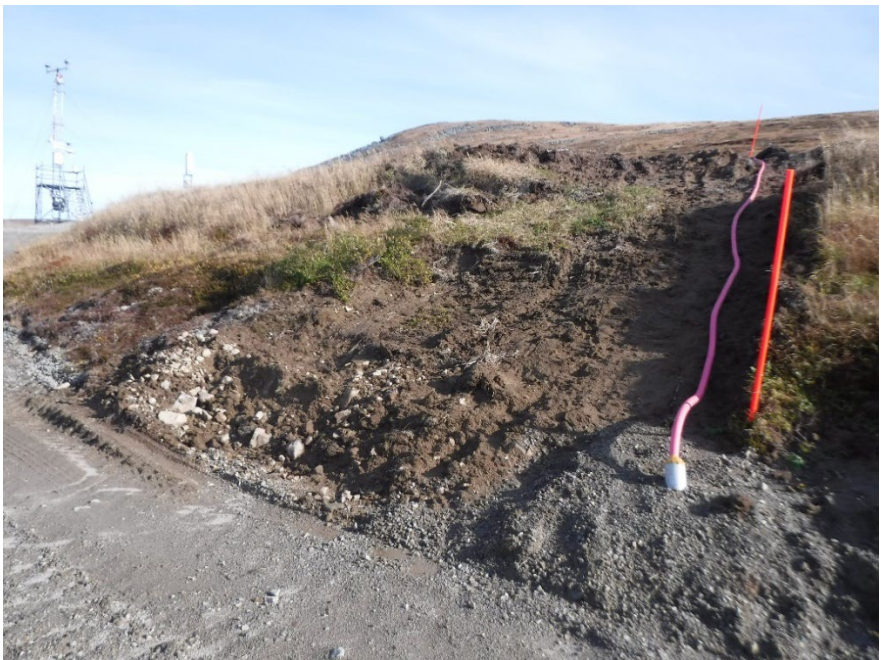
Photograph No.: 034	Date taken: 09-29-2021

Photograph taken by: Darion Carden		
Direction: Northeast	Location: SS010	
Description: Exposed high-voltage wires from recent electrical work.

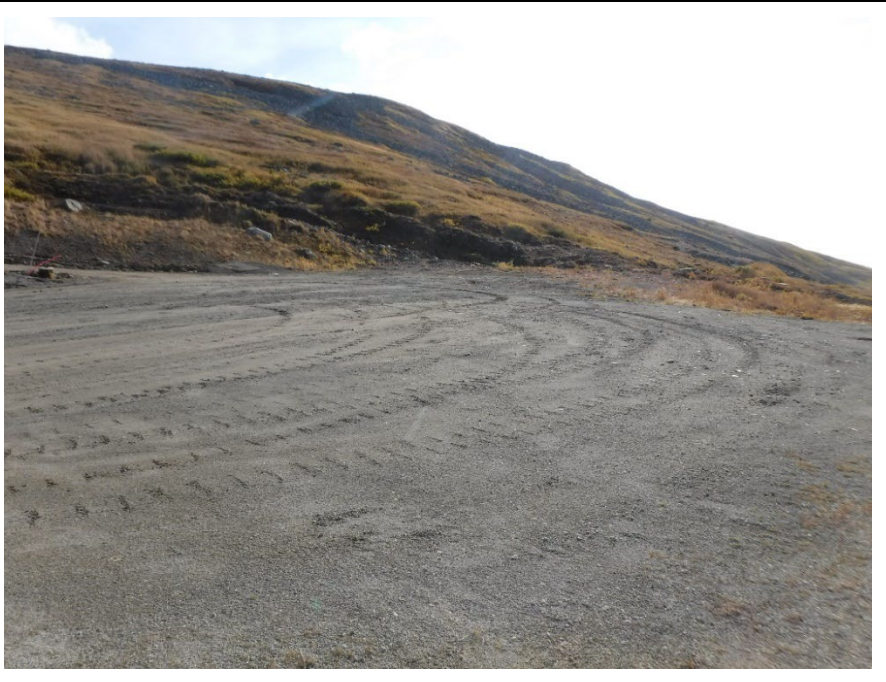
Photograph No.: 035	Date taken: 09-29-2021

Photograph taken by: Darion Carden		
Direction: Southeast	Location: SS010	
Description: Site access road and turnaround.

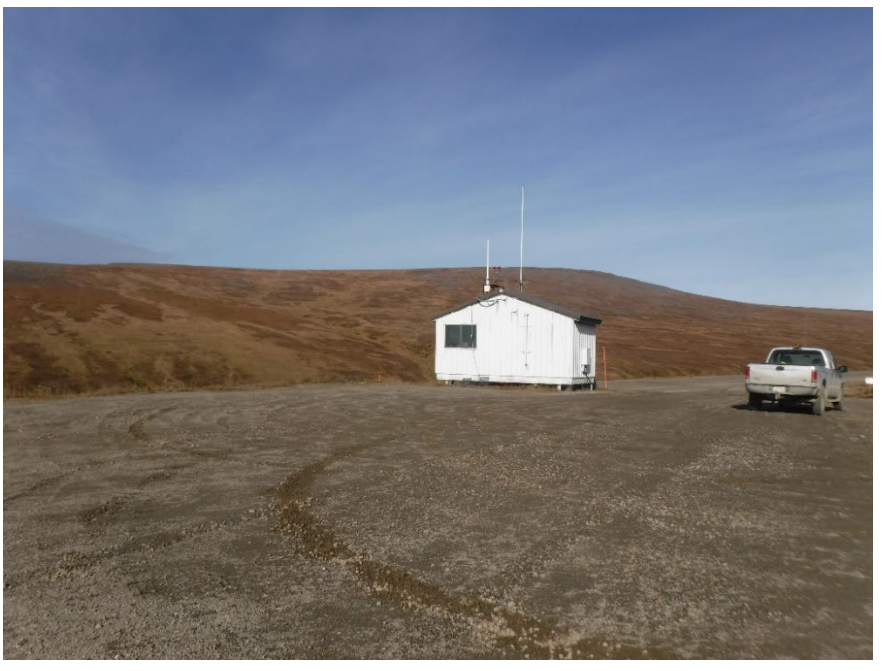
Photograph No.: 036	Date taken: 09-29-2021

Photograph taken by: Darion Carden		
Direction: Northwest	Location: SS010	
Description: Site access road and turnaround, south side of weather station building.

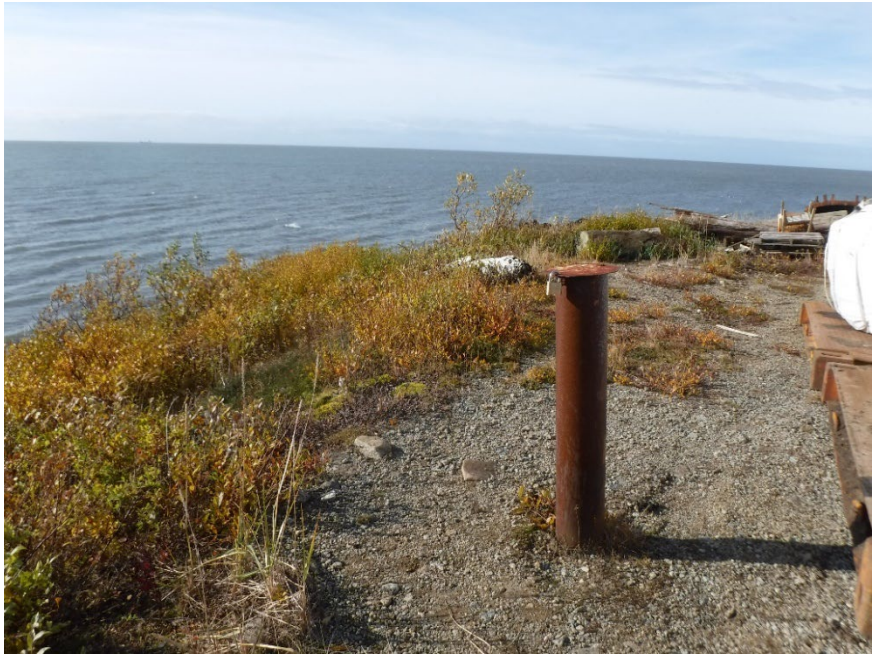
Photograph No.: 039	Date taken: 09-29-2021

MW-9 had an open lock which was corroded, so field personnel installed a new combination lock. Vehicle tracks were observed on the access road within the site boundary, as well as on the barge unloading area. Minor, natural erosion was observed on beach/in barge unloading dock area. Surface erosion, discolored vegetation, and previously buried debris were not observed. Seagulls, eagles, falcons, and unidentified scat was observed at the site. The site is 40 percent vegetated on the surface, and up to 15 percent vegetated on the side slopes. Well IDs were written on the inside of each outer casing to assist future fieldwork at this site. Two LUC warning signs were present and in good condition.

Photograph taken by: Darion Carden		
Direction: Southwest	Location: ST009	
Description: MW-09, good condition, installed new lock, labeled the inside of the outer casing.

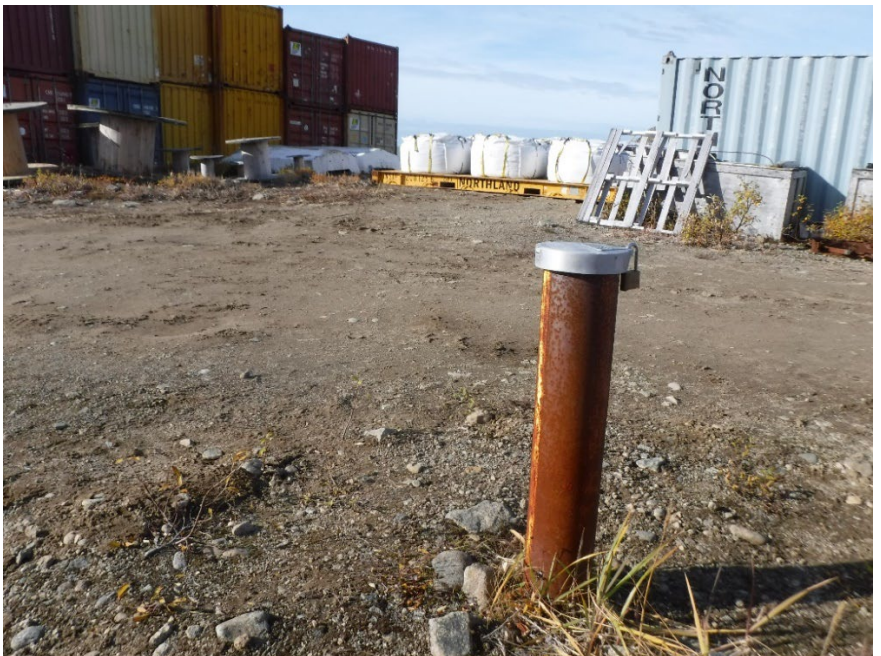
Photograph No.: 040	Date taken: 09-29-2021

Photograph taken by: Darion Carden		
Direction: North	Location: ST009	
Description: MW-07, good condition, labeled the inside of the outer casing.

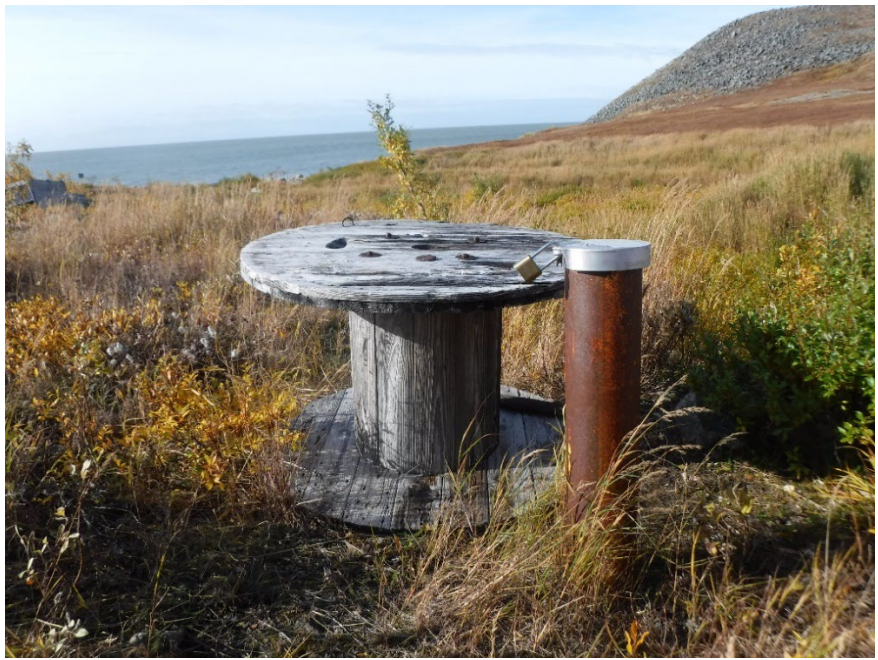
Photograph No.: 042	Date taken: 09-29-2021

Photograph taken by: Darion Carden		
Direction: North	Location: ST009	
Description: MW-04, good condition, labeled the inside of the outer casing.

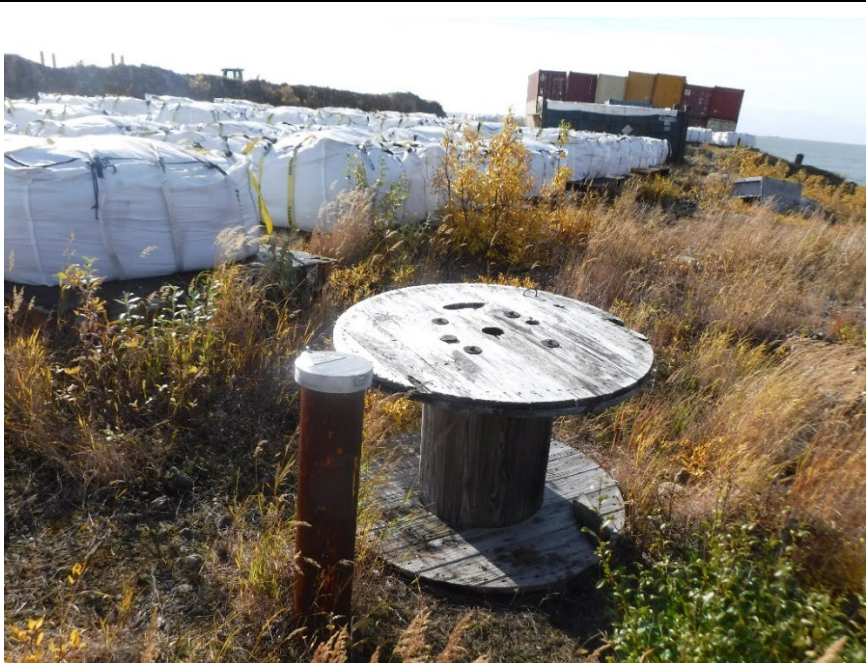
Photograph No.: 043	Date taken: 09-29-2021

Photograph taken by: Darion Carden		
Direction: Southeast	Location: ST009	
Description: MW-04, storage containers and supersacks.
