**FINAL
2021 REMEDIAL ACTION OPERATIONS LAND USE /
INSTITUTIONAL CONTROL REPORT**

**Cape Romanzof Long Range Radar Site, Alaska
Sites LF003, SS010, SS015, SS016, SS017, and ST009**

October 2022

North Wind-EA, JV
2525 C Street, Suite 130
Anchorage, Alaska 99503

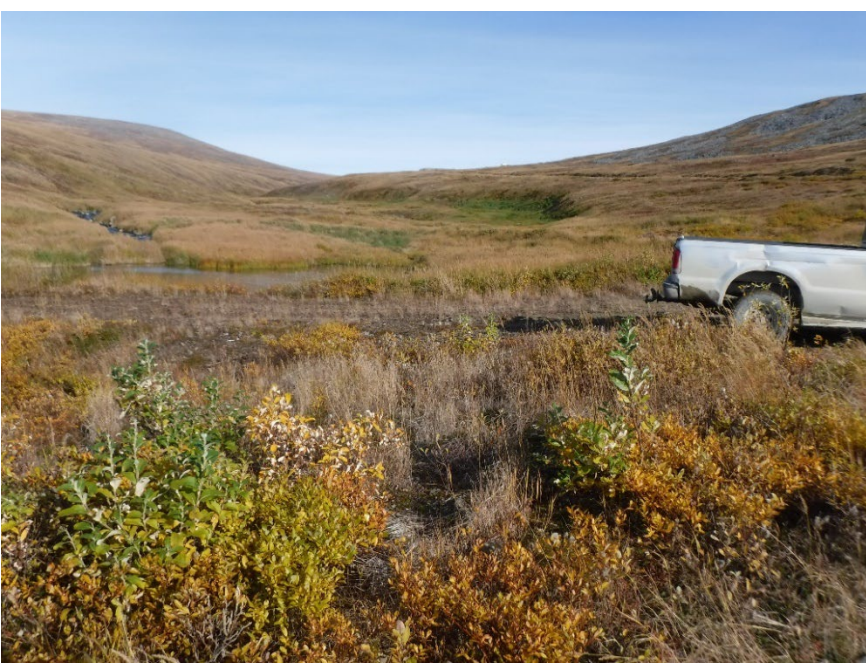
Photograph No.: 044	Date taken: 09-29-2021

Photograph taken by: Darion Carden		
Direction: North	Location: ST009	
Description: Looking north from MW-04 at the creek to the west of the site.

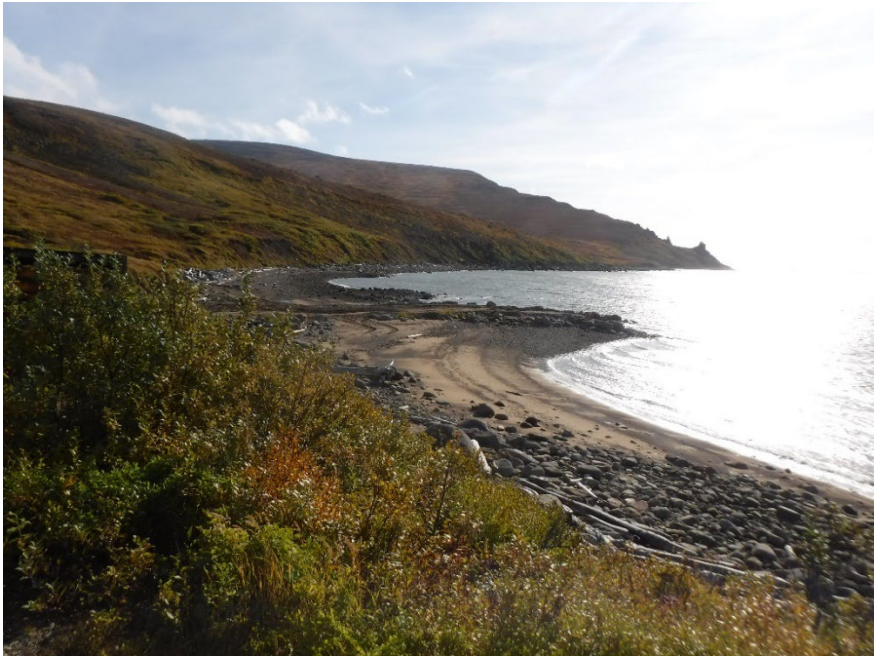
Photograph No.: 045	Date taken: 09-29-2021

Photograph taken by: Darion Carden		
Direction: Southeast	Location: ST009	
Description: The beach area and barge loading area.

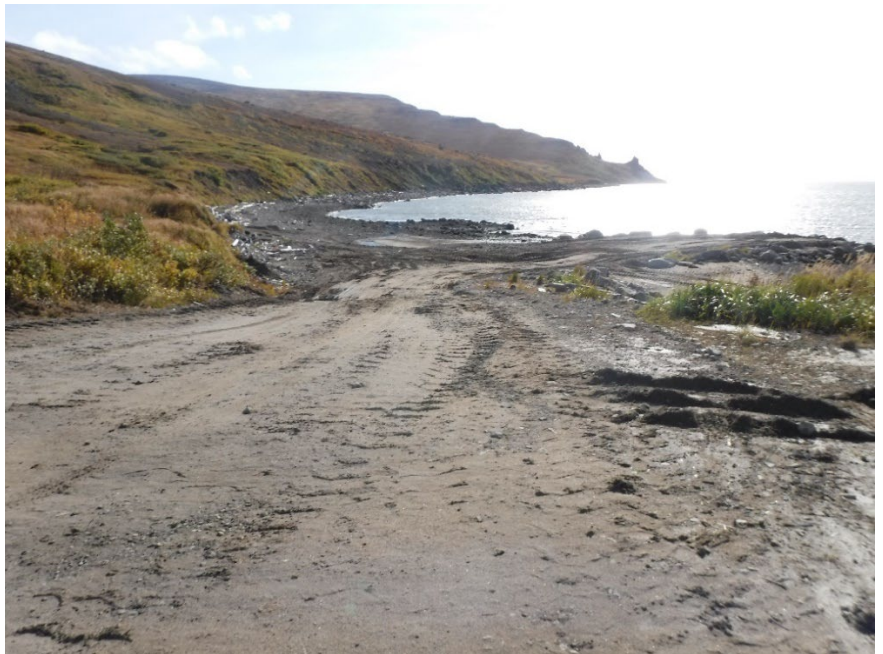
Photograph No.: 046	Date taken: 09-29-2021

Photograph taken by: Darion Carden		
Direction: South	Location: ST009	
Description: Access road to the barge loading area.
