Groundwater Sampling Fire Pit Training Area (MW-04)

Testing for Perfluorinated Compounds (PFOS and PFOA)

December 2016

Subj: Report for Monitoring Well MW-04 Installation

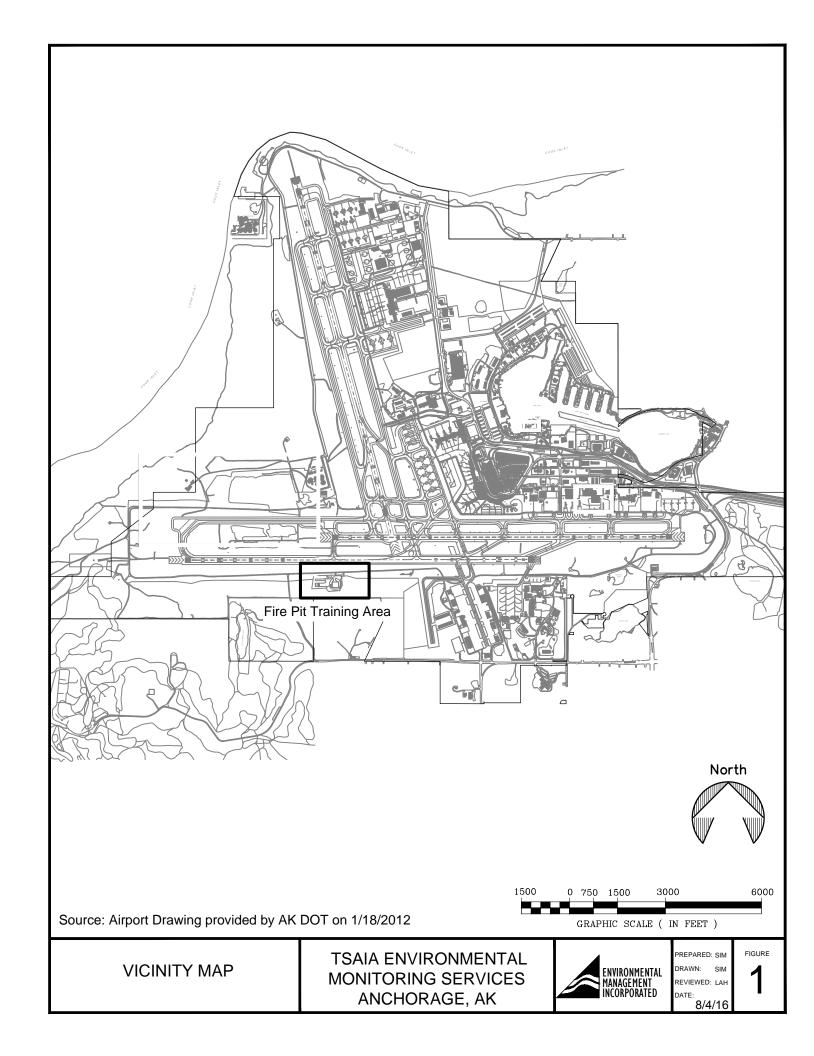
Encl: Figure 1 – Vicinity Map

EMI installed Monitoring Well MW-04 at the Fire Pit Training Area. The vicinity map is included as Figure 1, and the site plan is included as Figure 2. The well was installed at a depth of 81 feet bgs. A vicinity map showing the approximate location of the new well is included as Figure 2. The static water level in the monitoring well at the time of installation was 71.75 feet below ground surface (bgs). Soil conditions consisted mostly of dry brown gravel with silt in the top 10 feet, underlain by silty loam with gravel from 10 to almost 70 feet bgs. The bottom 11 feet was a light grey clay layer which was saturated. The well was installed with a 10 feet pre-packed screen with 2 feet of sand on top of the screen. The rest of the hole was filled with bentonite to within two feet or the surface. The hole was capped with pea gravel and a flush mount cap was installed. Photographs of the well installation activities are provided in the attached Photo Page (Attachment 1). Field notes are included in Attachment 2. The well log is included as Figure 3.
