MAYFLOWER ISLAND LIMITED MERCURY SOIL REMOVAL ACTION REPORT

FINAL

AUGUST 2020

**100 Savikko Road
Douglas, Alaska**

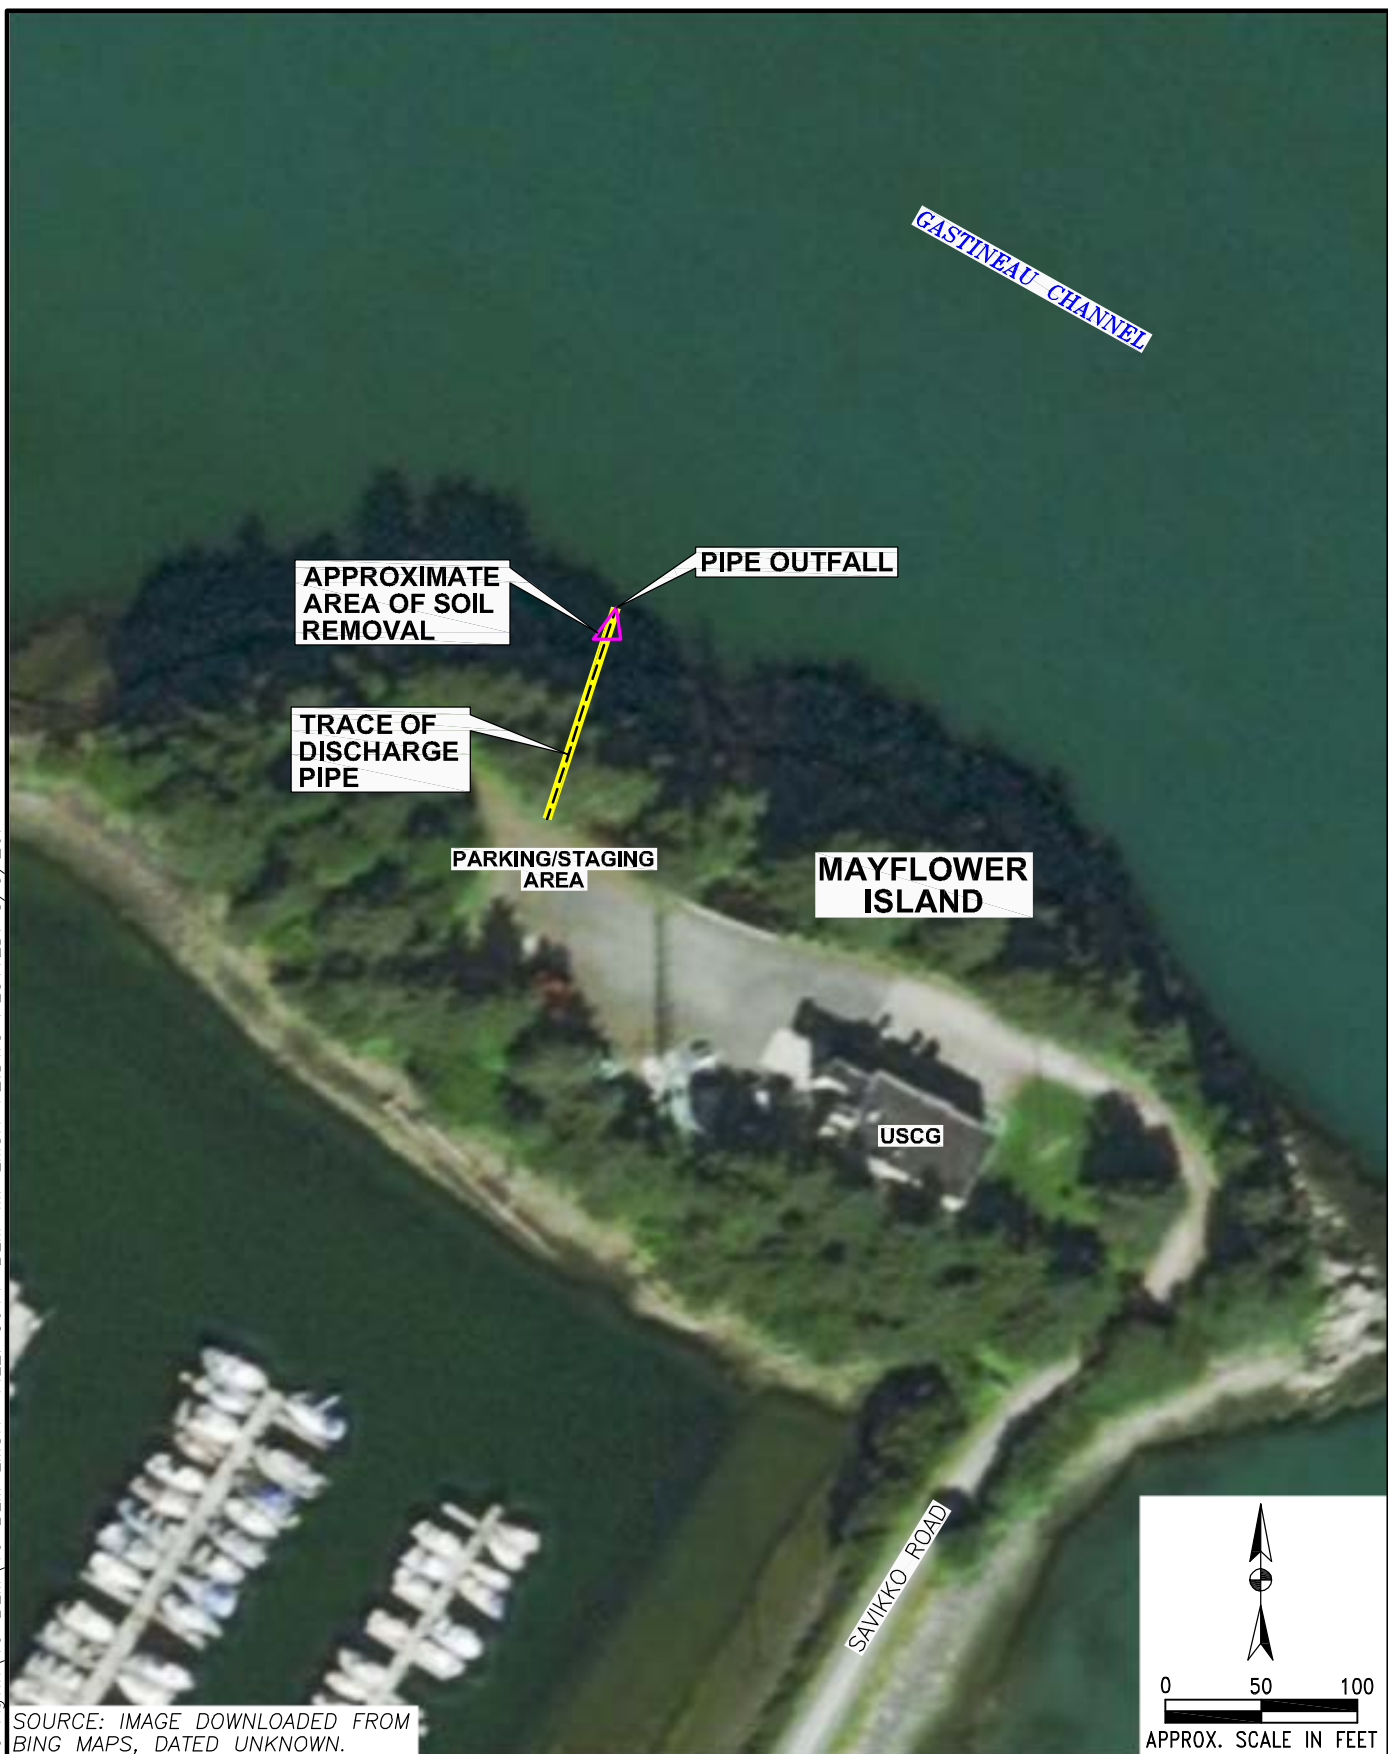
FIGURE
2

SITE PLAN

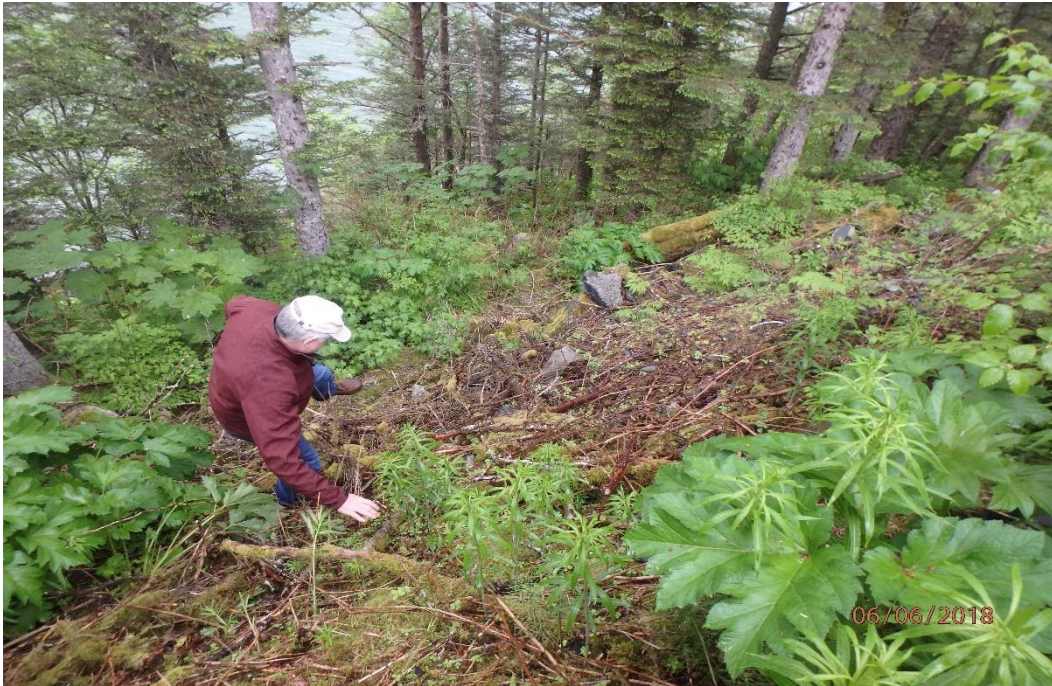
Photograph 1: June 6, 2018 Access down slope to outfall pipe from parking area

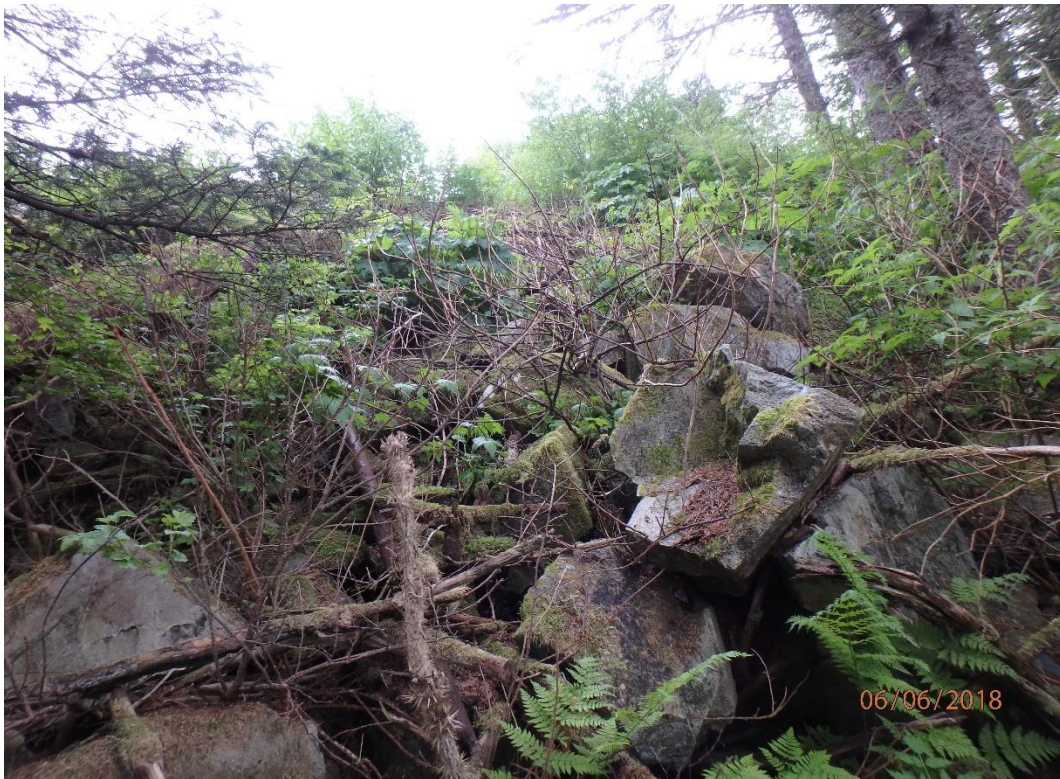
Photograph 2: June 6, 2018 Looking up slope from soil removal area to parking lot

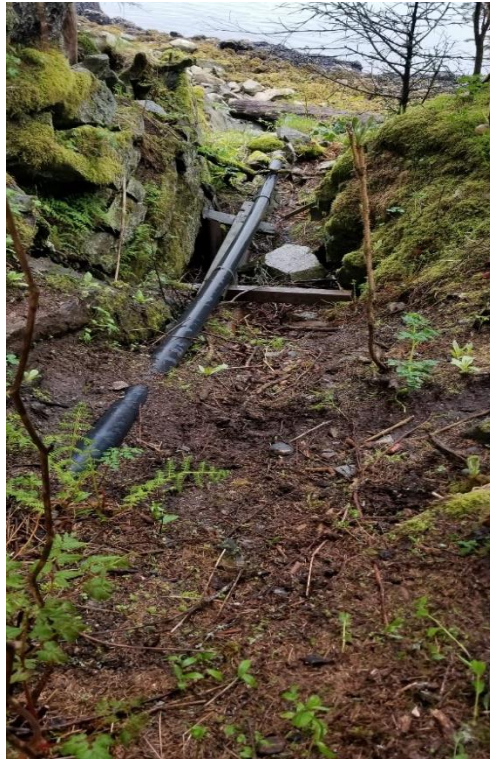
Photograph 3: May 10, 2019 Assay lab outfall discharge pipe

The plastic discharge pipe emanating from the demolished mineral assay lab and ran below ground, down slope from the parking area, until it daylighted approximately 20 feet above the outfall area. The pipe was cut approximately two feet above where it daylighted, in an area that had sufficient overburden soils so erosion would not uncover the cut end. The pipe and associated cribbing were hauled to the surface, cut into sections, and the pipe containerized and disposed with the excavated soils. Associated pipe cribbing was disposed as non-hazardous debris at the Juneau Landfill.

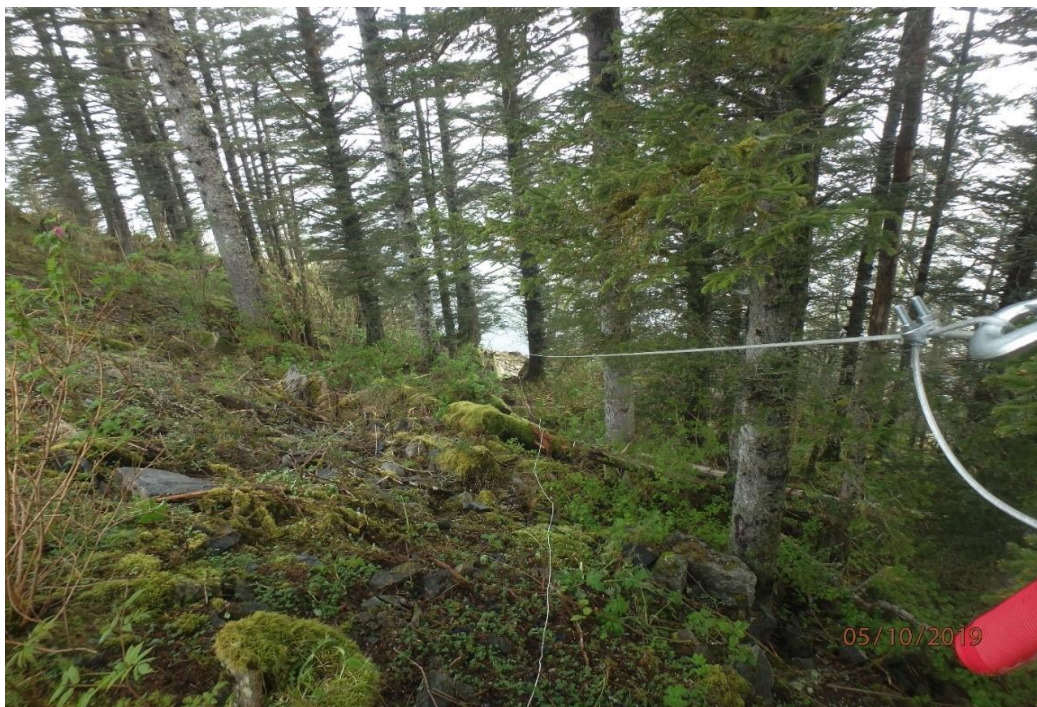
Photograph 4: May 10, 2019 Cable system used to haul soil buckets from removal area to parking area

A pathway was chosen for the pulley system, with clearing and grubbing performed to establish unimpeded operation. The pulley system was utilized for the hauling of buckets containing soil up the slope from the work area to parking area. The pulley system was constructed of 1/8" steel cable with two pulleys, one anchored at the top around a tree near the parking area and one anchored down slope near the removal area. The pulleys were placed high enough off the ground for the soil buckets to avoid vegetation and scraping on the ground when pulled up slope to the staging area.

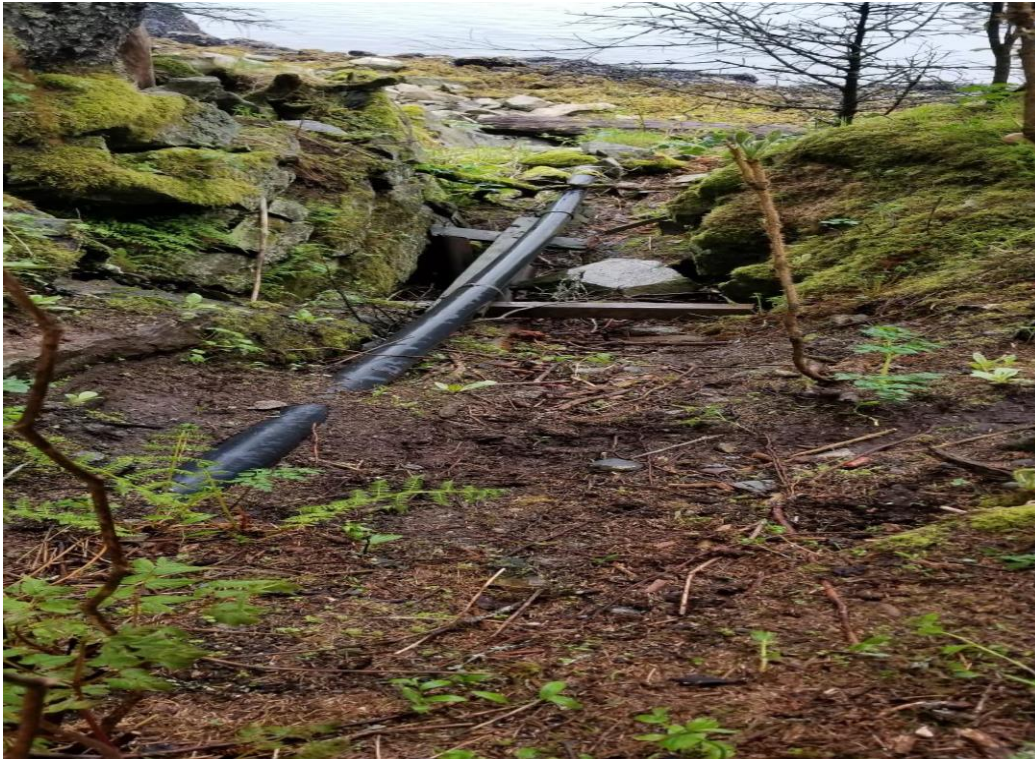
Photograph 5: May 10, 2019 Outfall pipe terminating above the high tide line

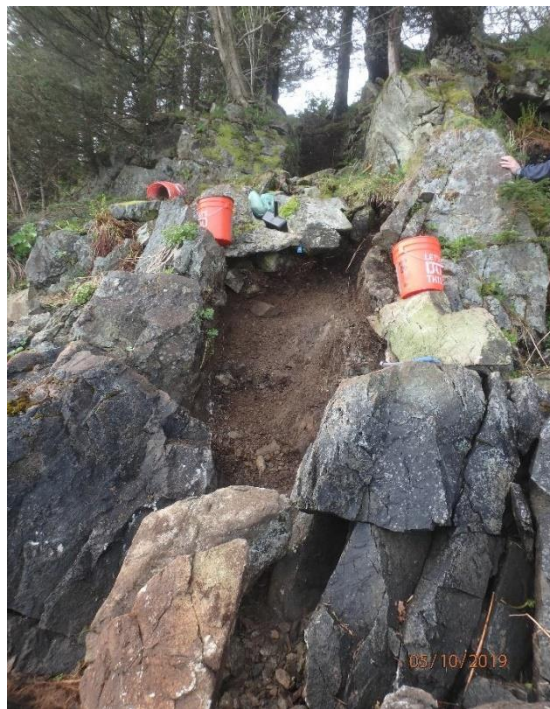
Photograph 6: May 10, 2019 Soil removal at discharge zone of removed pipe

Excavation commenced at the discharge point of the outfall and proceeded down slope to above the mean high tide line. Hand tools such as picks, trowels, brushes, and dust pans were utilized. Rocks and boulders that could be moved by hand or leveraging tools were placed aside to gain access to soils below or in crevices. Bedrock and rocks too large to move were considered refusal and allowed to remain in place. Excavation ceased at bedrock, considered refusal, and at the point near the high tide line where no soils were left to remove.

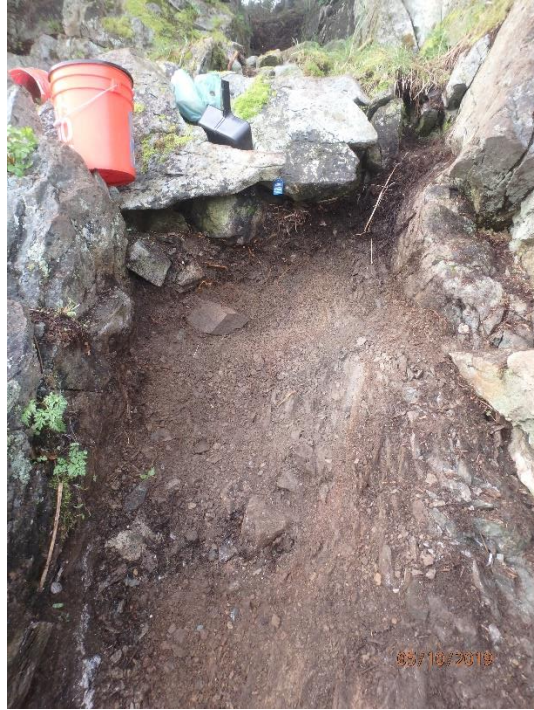
Photograph 7: May 10, 2019 Weathered friable bedrock below removed soil

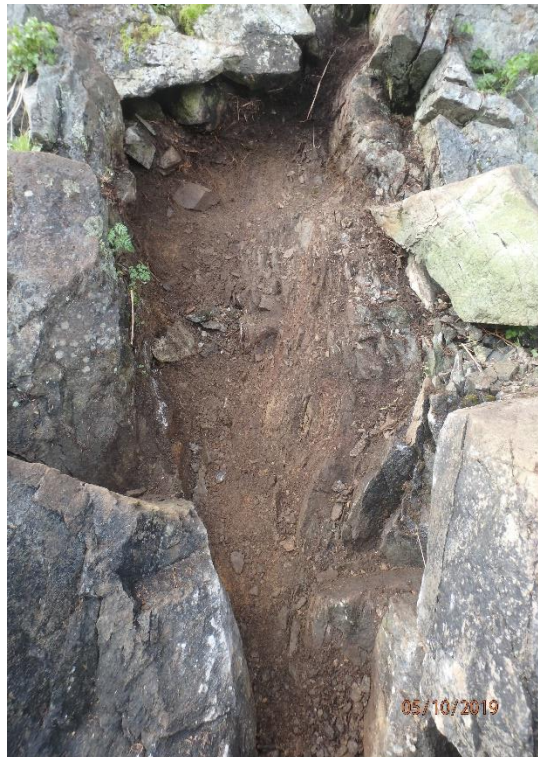
Photograph 8: May 10, 2019 All soil removed down to bedrock

Since the soil removal proceeded to refusal (bedrock), it was determined by AES, BLM, and ADEC that final confirmation soil sampling within the removal area was not necessary. Due to this, no soil samples were collected from the removal area. However, a single soil sample was collected from the soil drums for waste characterization purposes.
