Re: Galankin Island Defense Site

**Galankin Island Defense Site
Preliminary Assessment Report
Sitka, Alaska
TDD: 98-07-0021**

**GALANKIN ISLAND DEFENSE SITE
PRELIMINARY ASSESSMENT REPORT
SITKA, ALASKA**

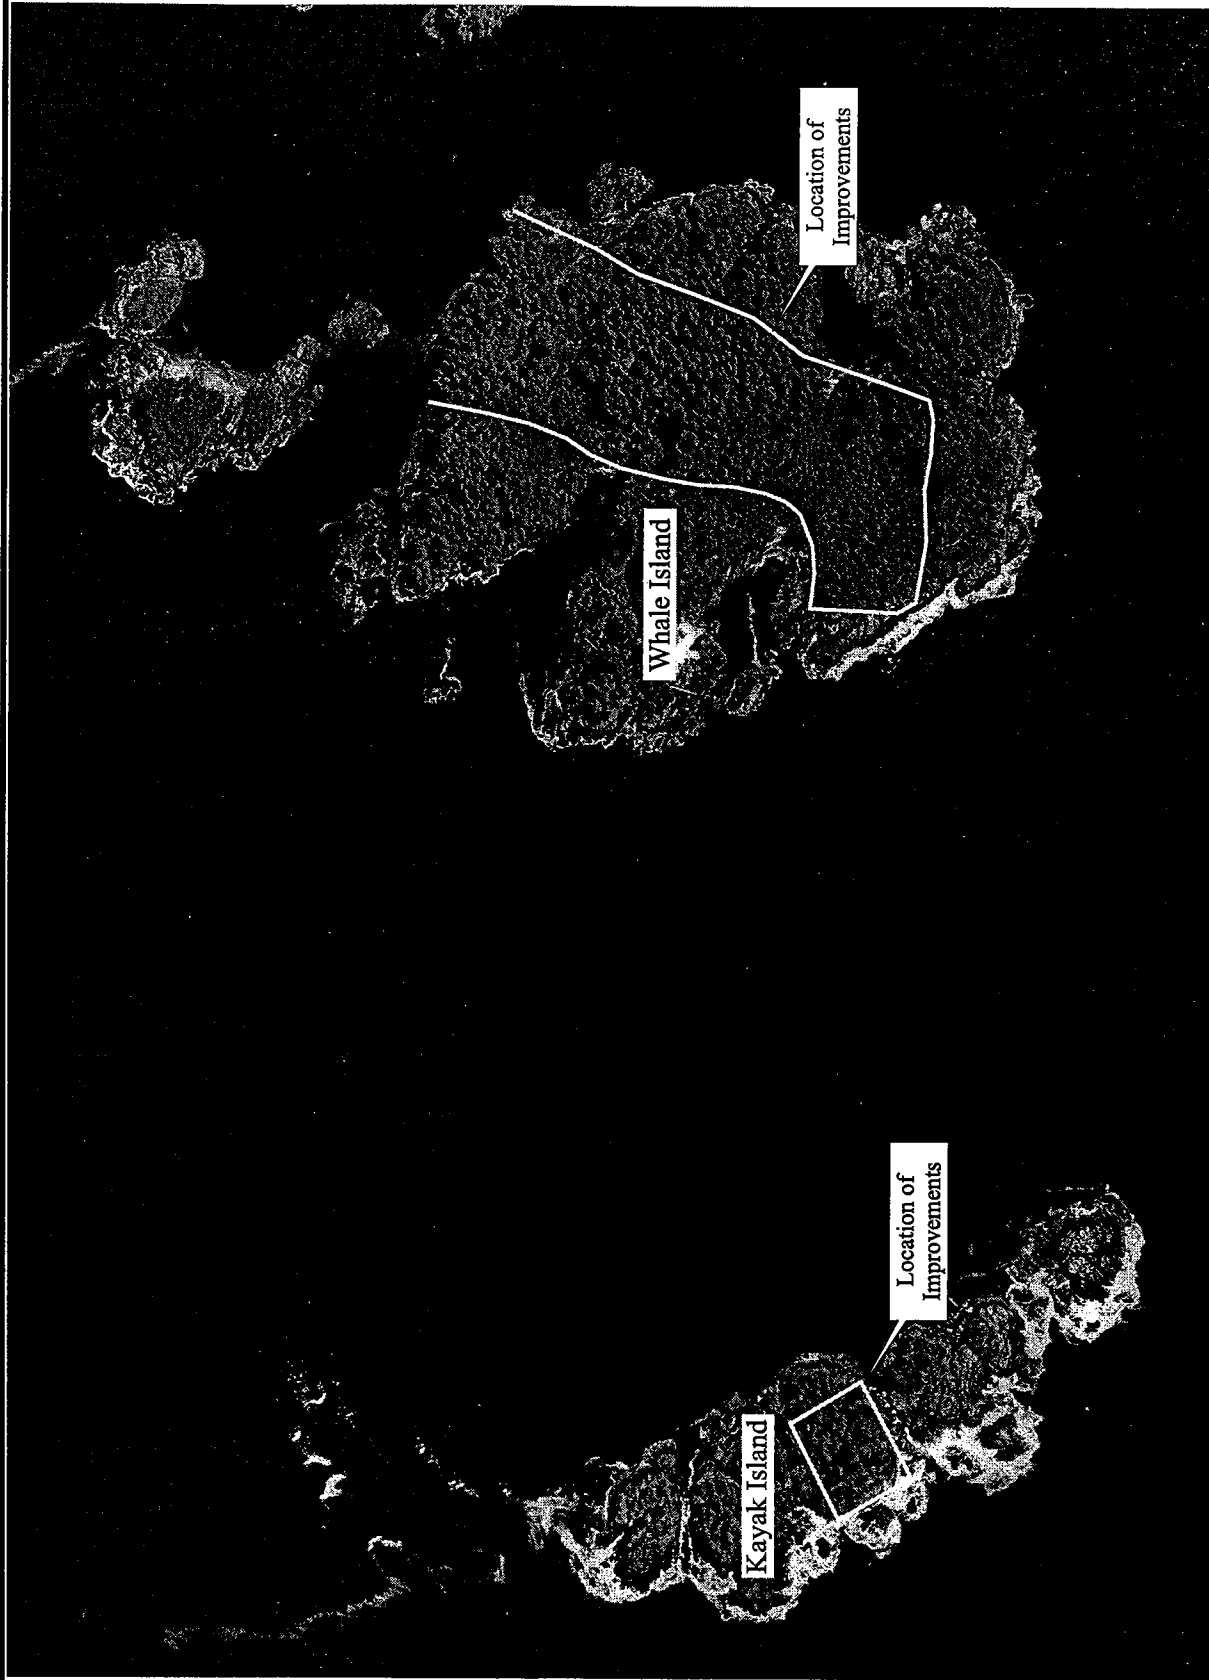
**Figure 2-3
 IMPROVEMENTS LOCATION MAP**

aboveground unit that stored diesel (USAED Alaska 1998). An unimproved road was cleared through the center of the island. The road started at the dock on the north side of the island and continued south through three-fourths of the island, linking the improvements scattered across Whale Island. The Army also ran power lines to the island's buildings. File information indicates that poles and trees were used to string the power lines together (USAED Alaska 1944a). Figure 2-3 shows the approximate location where improvements were constructed on Whale Island.

A plot plan for Kayak Island indicates that two barracks buildings, a mess hall, two searchlight sheds, two storage sheds, two lookout posts, two fuel tanks, and a powerhouse were formerly located on this island. A 6-inch sewer line ran from the area of the barracks and mess hall to the shoreline of the island. A system of power lines also was constructed at the area of the barracks and mess hall. Kayak Island had no dock (USAED Alaska 1944b). The START did not find any more specific information concerning these improvements. Figure 2-3 shows the approximate location where improvements were constructed on Kayak Island.

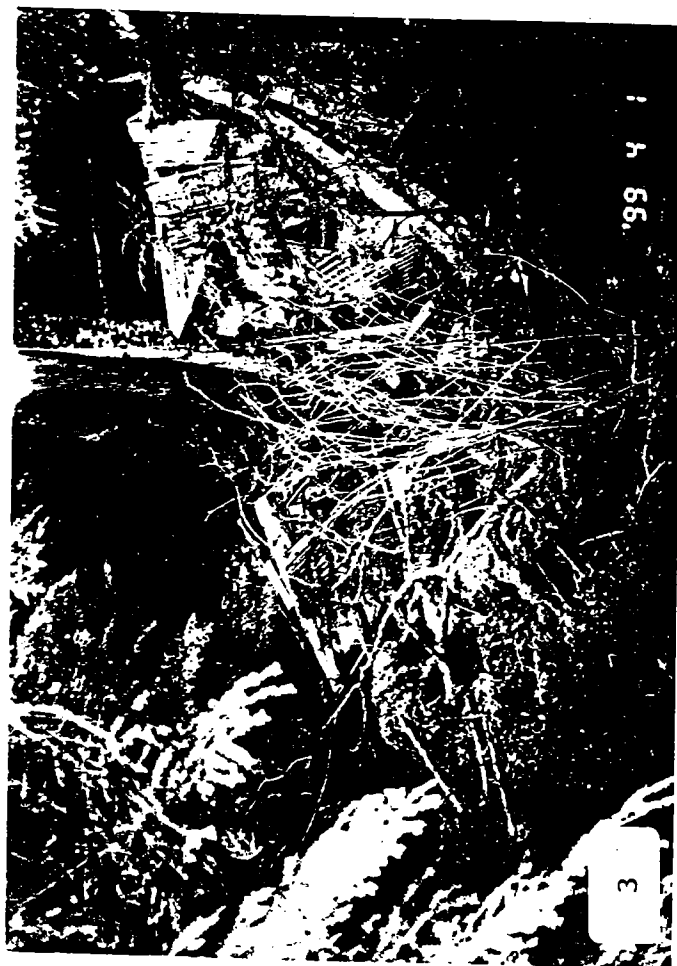
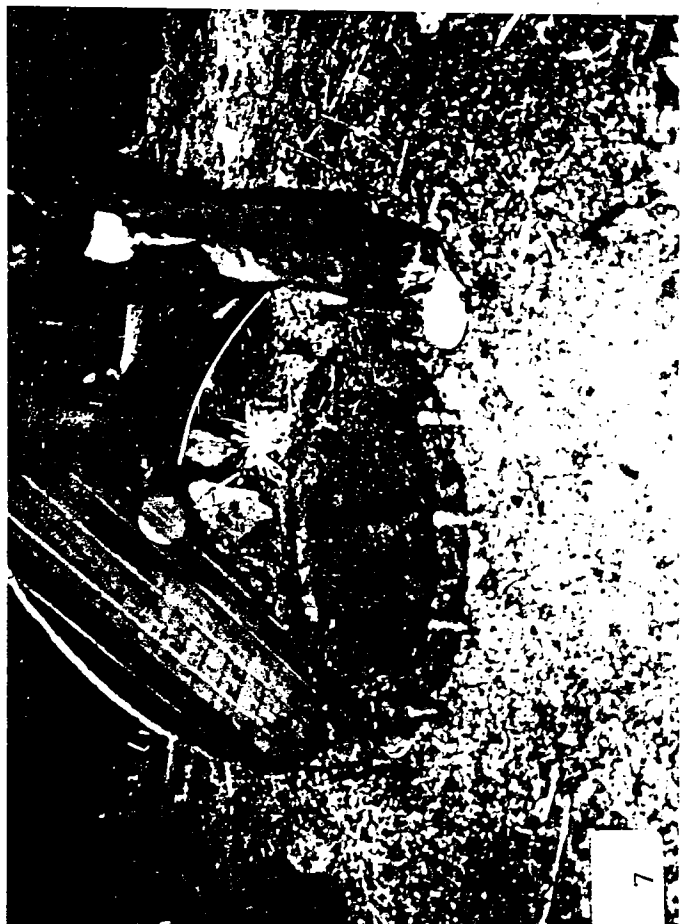
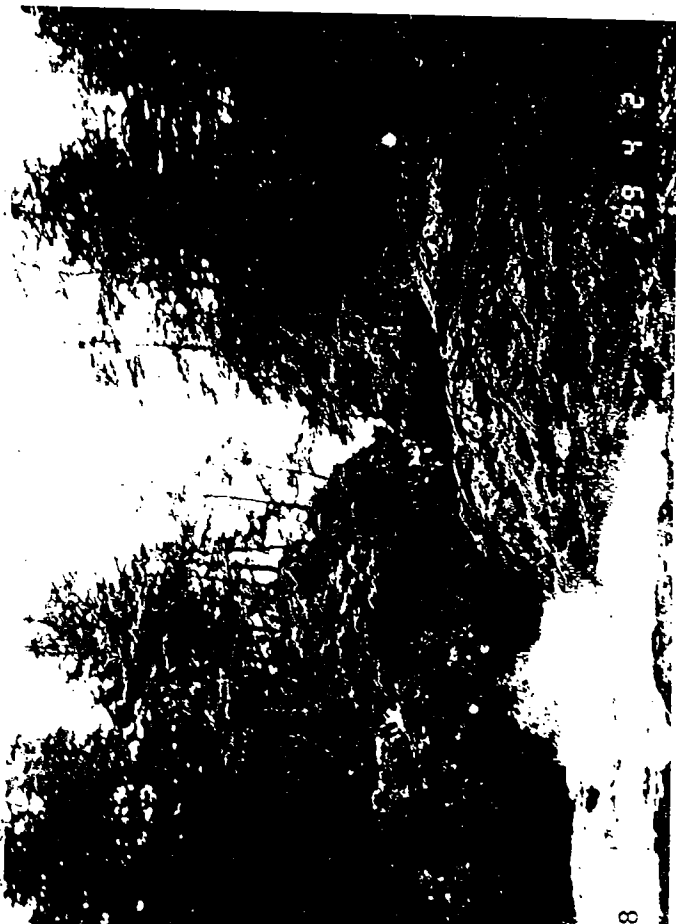
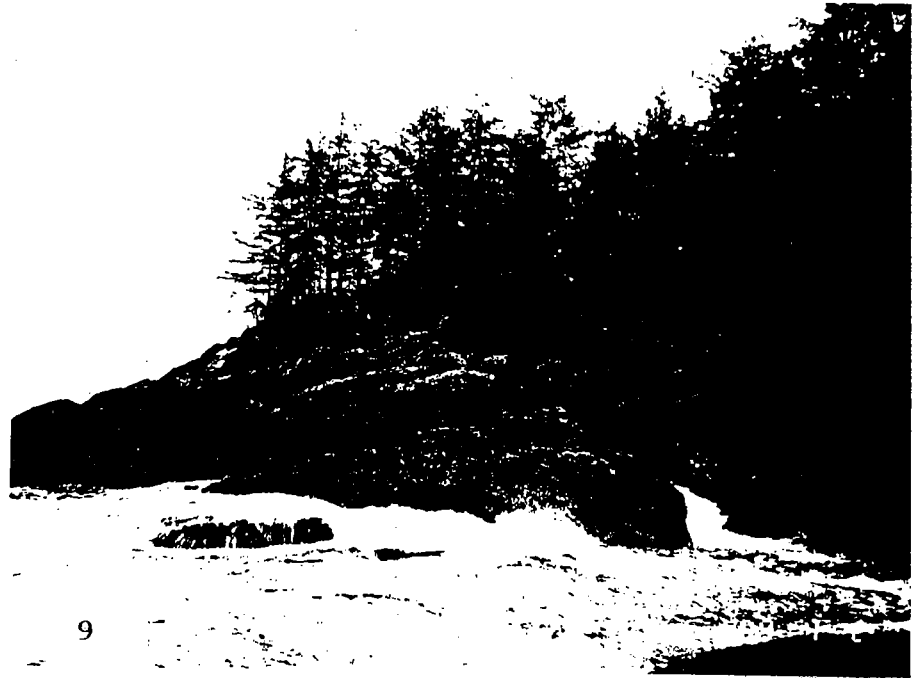
Photo	Date	Time	Photographer	Direction	Description and Orientation
1	04/01/99	1247	B. Martich	West	Sample No. 99040001 collected near rusty drum on Whale Island
2	04/01/99	1254	B. Martich	East	Quonset hut debris on Whale Island
3	04/01/99	1300	B. Martich	Northeast	Sample No. 99040002 collected at former powerhouse on Whale Island
4	04/01/99	1306	B. Martich	West	Sample No. 99040003 collected at west side of former fuel tank location on Whale Island with Sitka Sound in background
5	04/01/99	1310	B. Martich	North	Sample No. 99040004 collected at north side of former fuel tank location on Whale Island
6	04/01/99	1330	B. Martich	West	John Williams' sawmill and property on Whale Island
7	04/01/99	1445	B. Martich	North	Gun emplacement with wooden cover on south side of Whale Island
8	04/02/99	0908	B. Martich	Southwest	Kayak Island
9	04/02/99	0908	B. Martich	South	Kayak Island
10	04/02/99	0909	B. Martich	East	The START's boat charter

11	04/02/99	0936	B. Martich	Northeast	Lookout post on west side of Kayak Island
12	04/02/99	0937	B. Martich	Northeast	Two lookout posts on west side of Kayak Island
