INITIAL SITE CHARACTERIZATION REPORT

**801 VAN HORN ROAD
FAIRBANKS, ALASKA**

MAY 5, 2009

NC Machinery Company
Fairbanks, Alaska

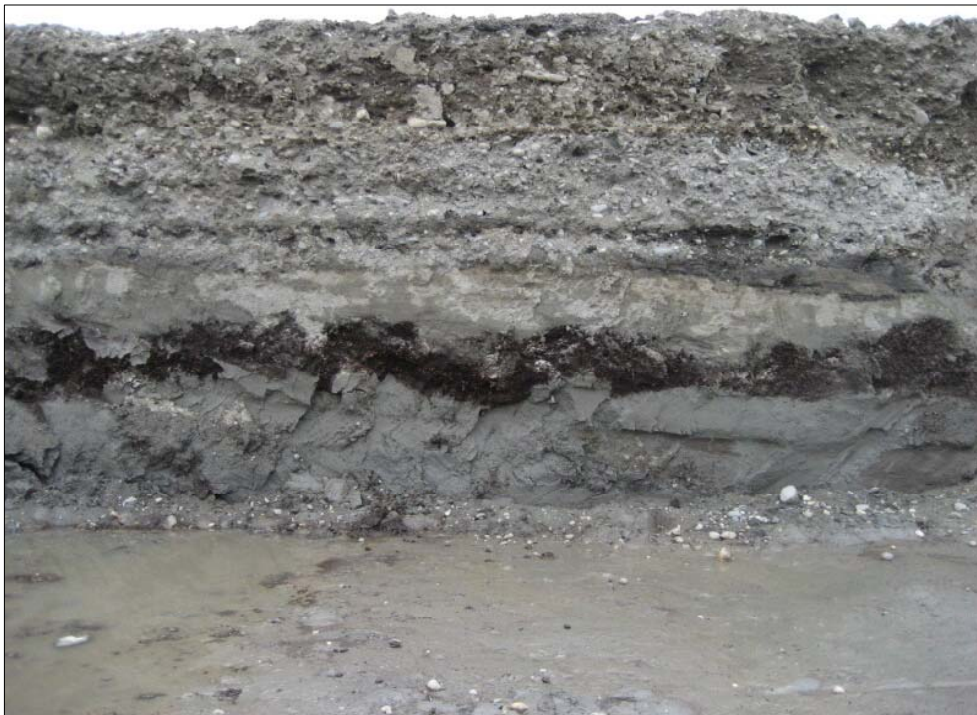
Photo 2 - West sidewall soil profile 9-15-08, showing sandy gravel imported fill overlying native alluvial sand, peaty/organic layer, and silty sand becoming clayey silt at bottom

The sidewalls of the excavation showed at least one layer of imported gravel fill over naturally deposited sand in some areas. These layers were each generally brown and they were separated by a thin layer of peaty organics in most areas. At about five feet deep, the material switched to very fine silt that was dark gray and appeared to be generally moist. This material was saturated at approximately six feet below the ground surface (one foot below the bottom of the excavation). A total of 22 field screening samples were collected from the excavation bottom and sidewalls at varying depths to assess these different materials. PID results ranged from 13.6 to 1148 parts per million (ppm), as shown. Only five locations were below 100 ppm and most of these were along the northern edge of the excavation. These elevated field screening results confirmed that soil contamination was present throughout the different layers across the excavated area. No obvious source had been observed during the excavation and none could be discerned from the available data.

During this initial assessment, four distinct layers of material were observed in the area: imported gravel fill to a depth of about 2.5 feet, a thin (<6 inches) layer of peat and organics representing the original site surface, and then a layer of sand grading to fine sand/silt approximately 2 feet thick. At approximately 5 feet below grade, the material changes to very fine silt that has some plasticity, indicating that a trace of clay may also be present. This material becomes saturated at a depth of approximately 6.5 feet below grade, although the recharge rate is extremely slow. A previous exploratory excavation done by Exclusive personnel inside the planned building footprint indicates that the fine silt extends to a depth at least 14 feet below grade. Where saturated, this layer also has very little structure and a test pit into the saturated zone would not remain open once the excavator bucket had been removed.

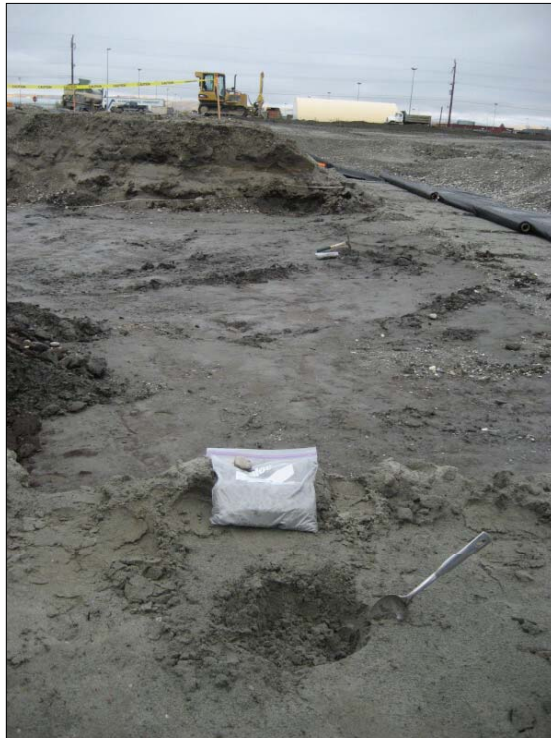
Photo 3 - Soil characterization sampling on 9-15-08 showing locations S3 (foreground) and S1 (background)

Three samples were collected from the locations with the highest field screening results within the three different soil types identified at the site: silt, sandy gravel, and sand. The sample S1 was collected from the moist silt at the excavation bottom, about five

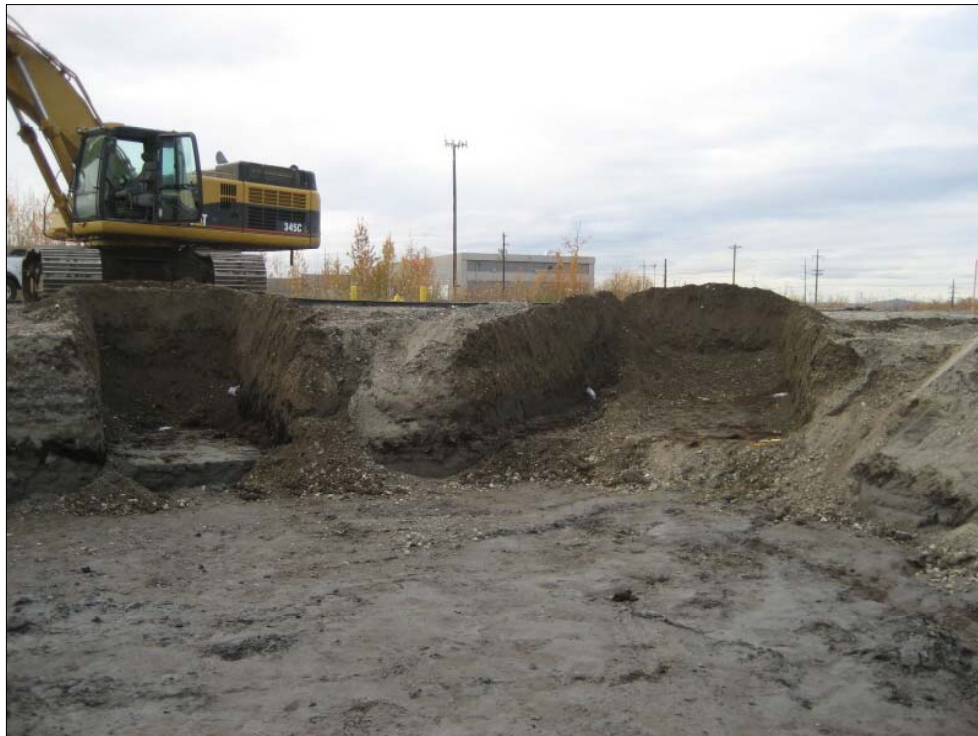
Photo 4 - Looking west at excavation of trenches 1 and 2 (9-24-08) to define limits of contamination

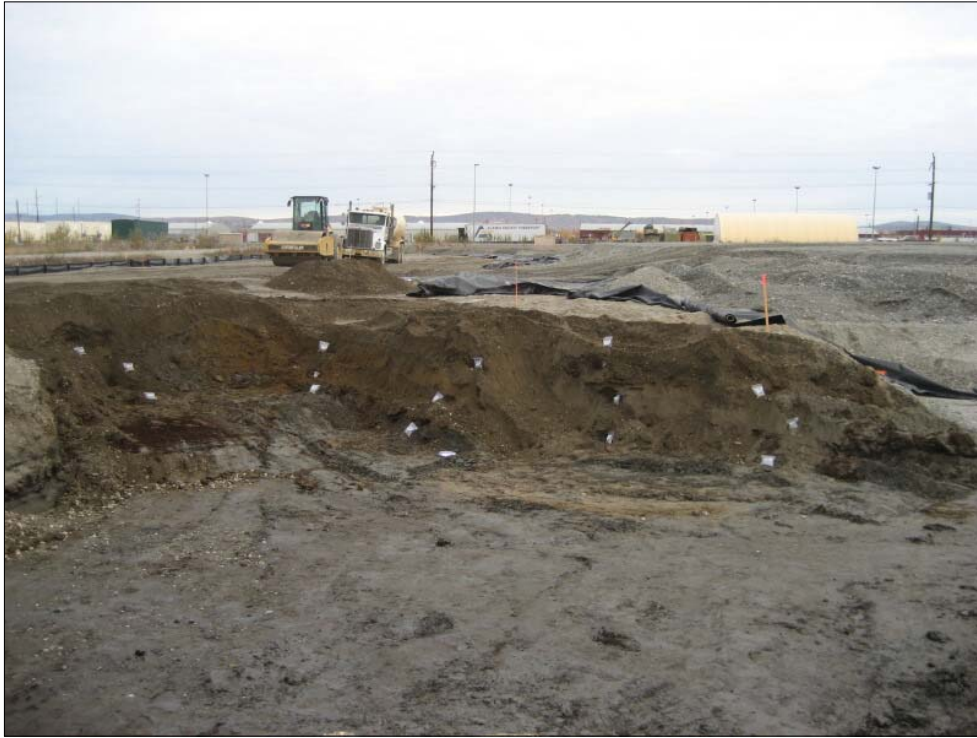
Photo 5 - Looking northwest at corrective action excavation 9-25-08, with reddish sand marking clean limits of sidewall with no POL odors or staining observed

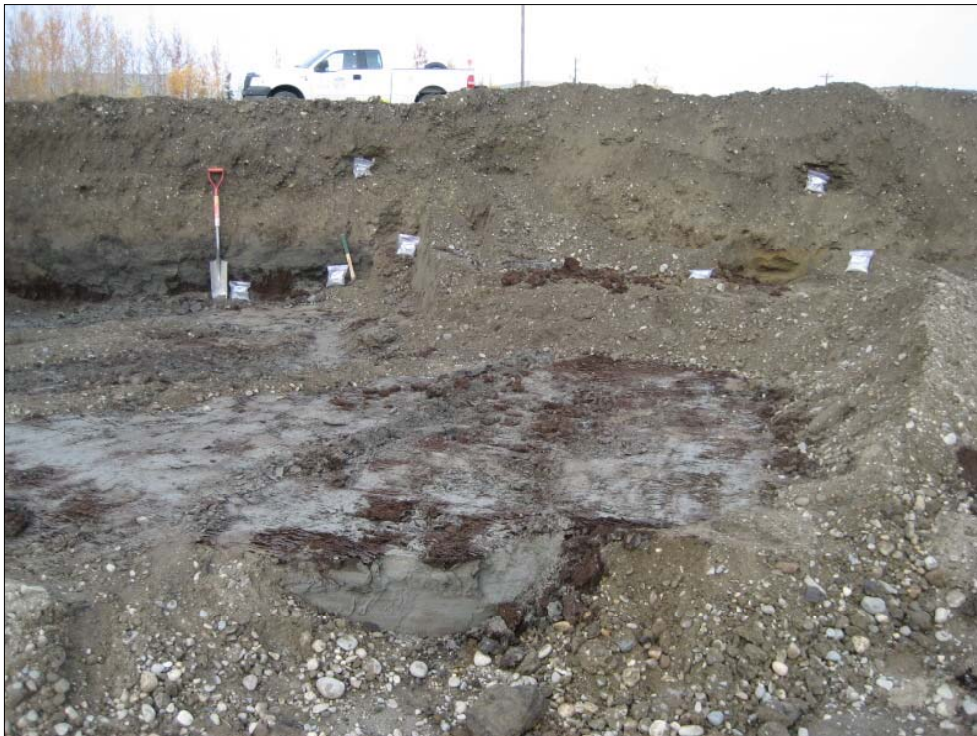
Photo 6 - Looking west at corrective action excavation 9-25-08, with sand (right) and gray sand/silt (left) with observed POL staining and odors prior to excavation

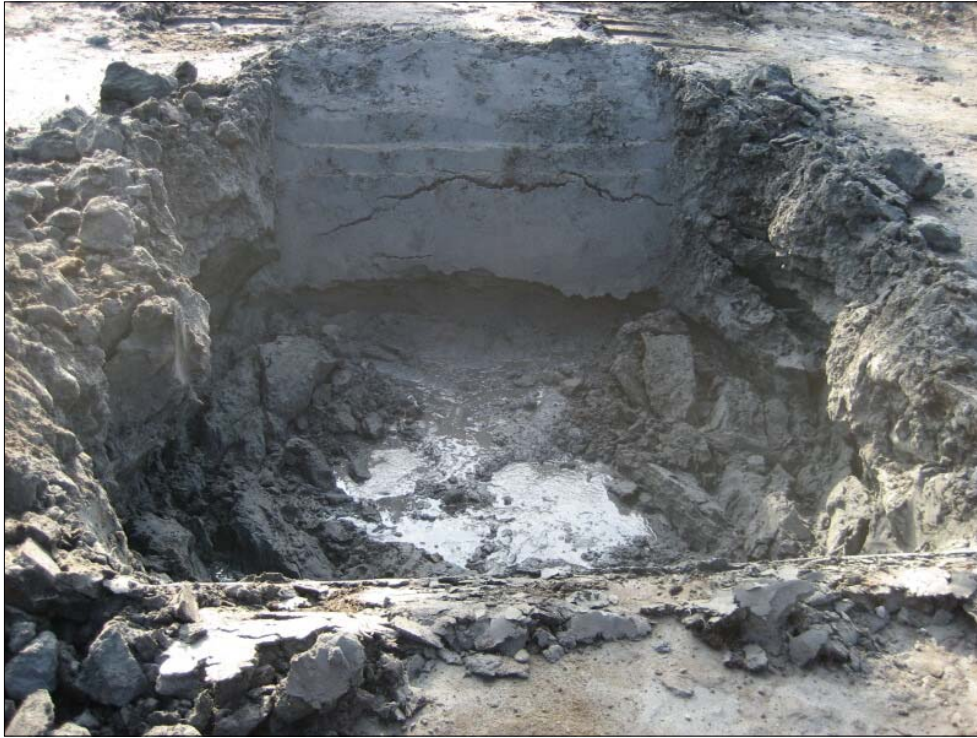
Photo 7 - Exploratory pit into groundwater through gray clayey silt at bottom of primary excavation on 9-25-08

The excavation extended about six feet below grade to the top of the smear zone, which was generally observed to be the top of the layer of fine silt. Although this layer was observed to be saturated, a water sample could not be collected due to the extremely low recharge rate in a temporary well. Results from a soil sample indicate that diesel range organics (DRO), benzene, naphthalene, 1-methylnaphthalene, and 2-methylnaphthalene exceed the ADEC Cleanup Levels at the top of the silt layer. A test pit in another area of the building footprint found that the silt layer extends to at least 14 feet below the ground surface.

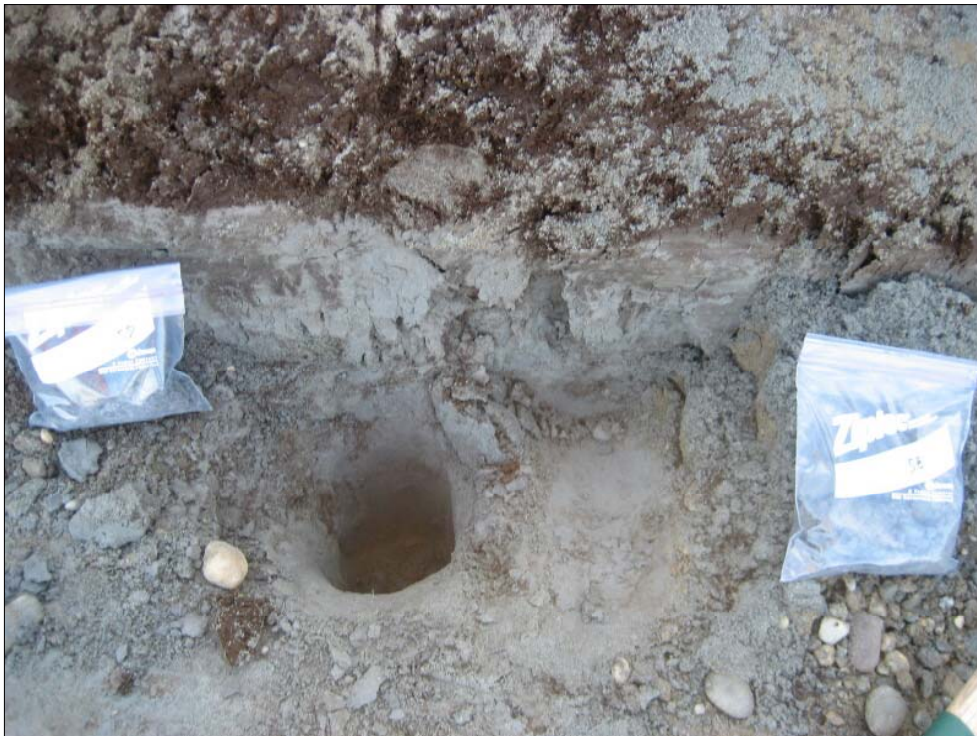
Photo 8 - Field screening of bottom southern excavation limits

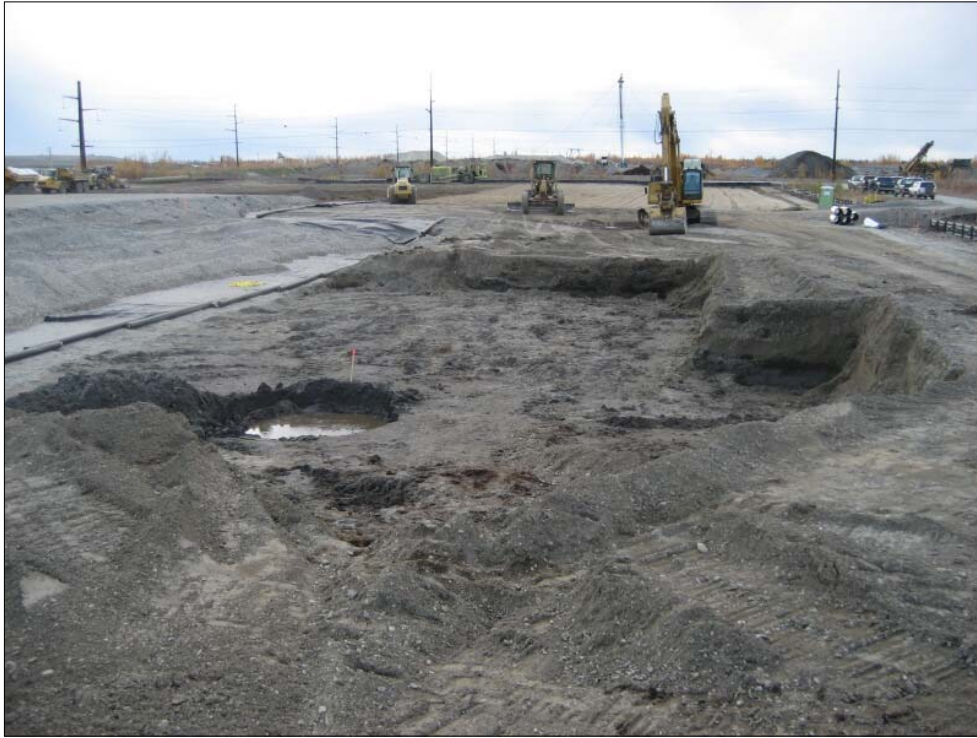
Photo 9 - Final limits of corrective action excavation looking south 9-26-08, exploratory pit to groundwater at left

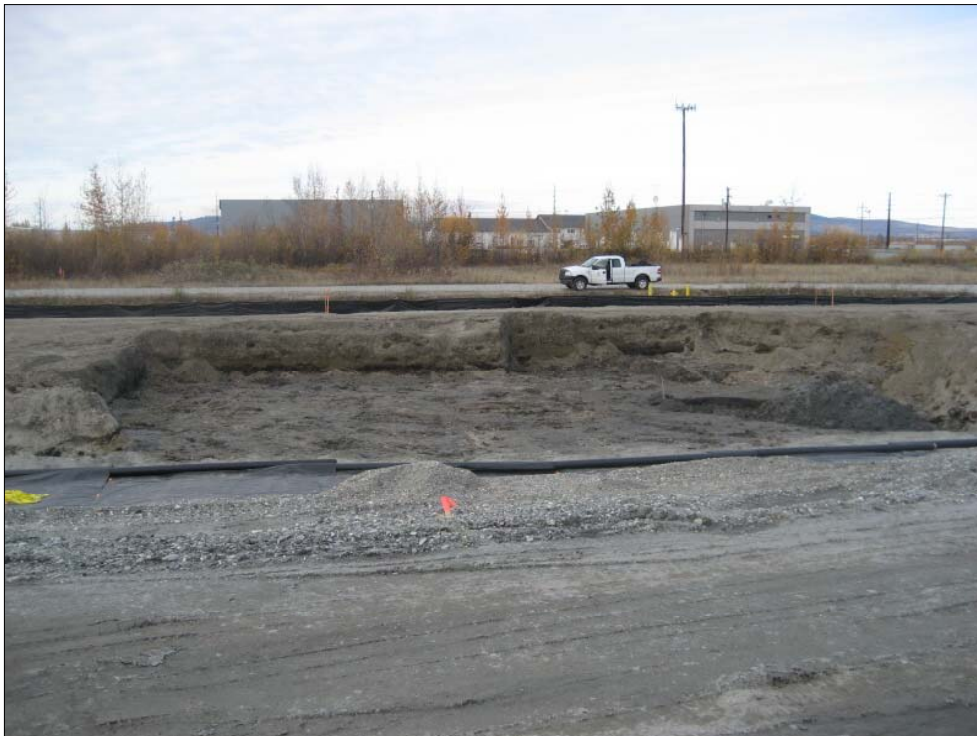
Photo 10 - Final limits of corrective action excavation looking west 9-26-08, with exploratory pit to groundwater at right
