**2022 Remedial Action-Operation and  
Long-Term Management Report  
North River Radio Relay Site  
Sites SO001, SS001, SS003**

**April 2023**

**611 CES North Group  
Optimized Remediation Contract, Alaska  
USACE Contract W911KB20D0002, Task Order W911KB20F0135**

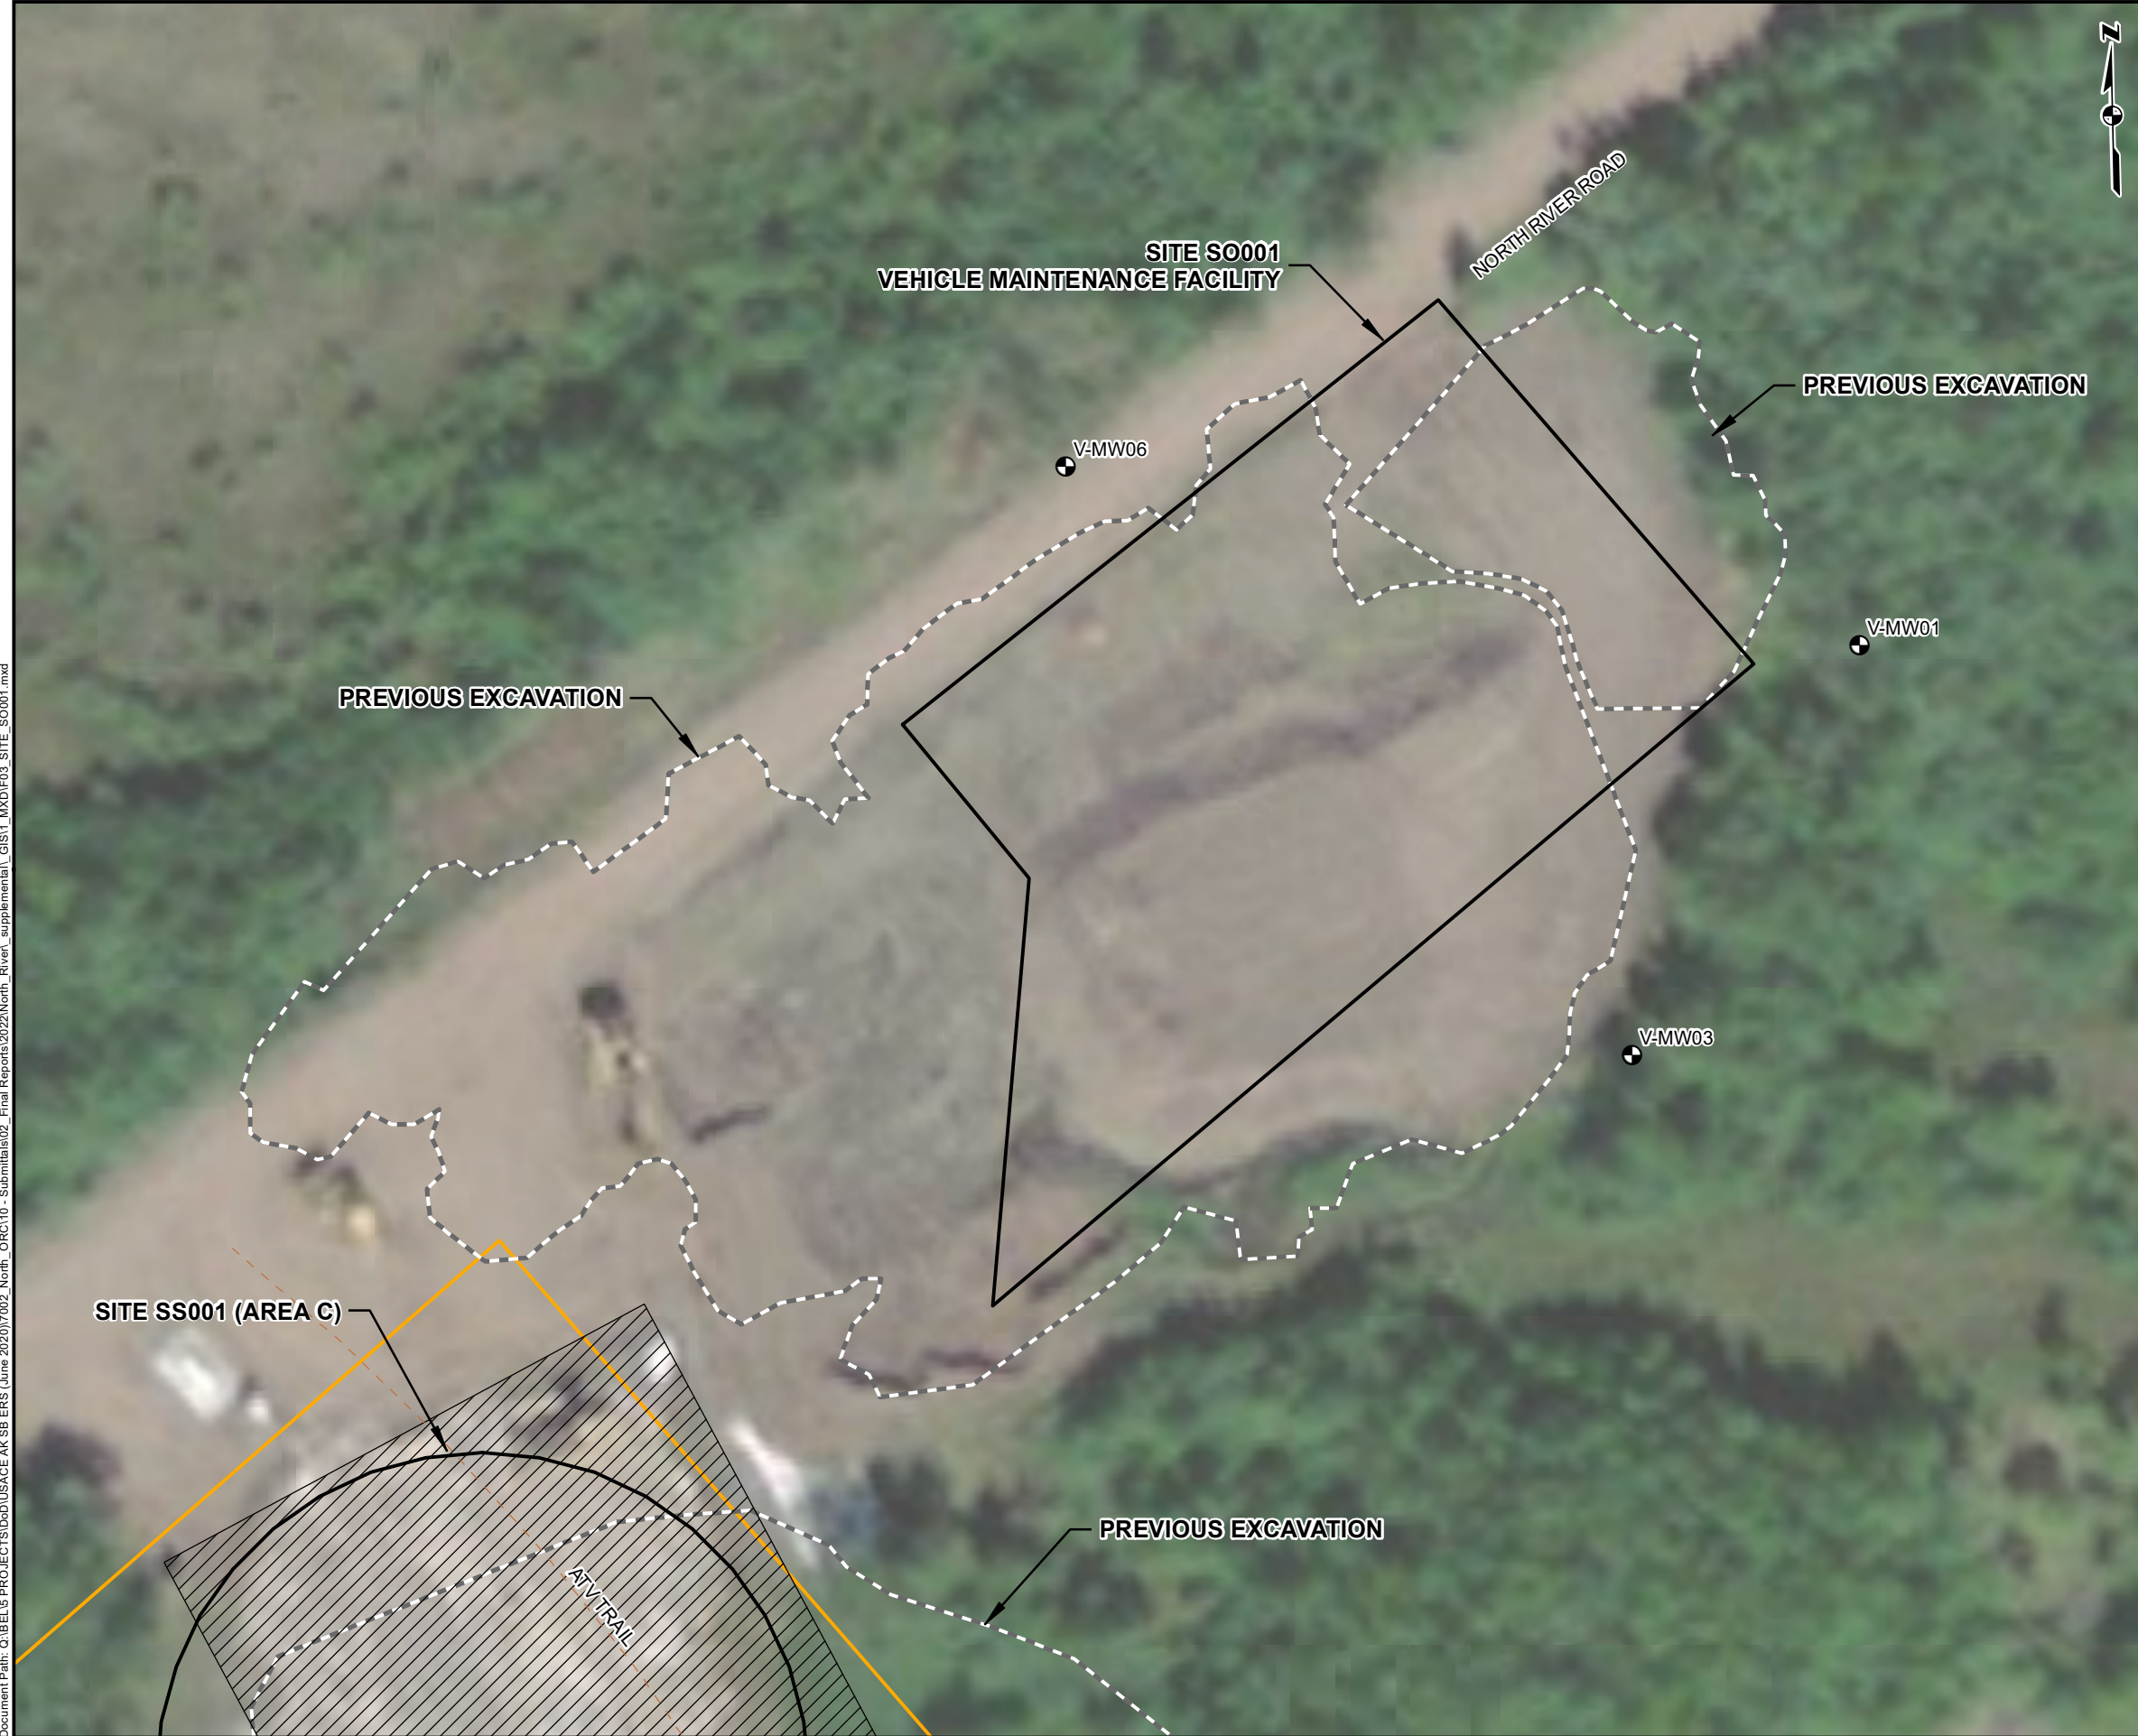
PROJECT No.: 700215	DATE: 4/19/2023	FIGURE: <b>3</b>
P.M.: M.O.	DRAWN: T.A.

REMEDIAL ACTION-OPERATION AND LONG-TERM  
MANAGEMENT REPORT  
NORTH RIVER RADIO RELAY STATION, ALASKA  
**SITE S0001 (VEHICLE MAINTENANCE FACILITY)**

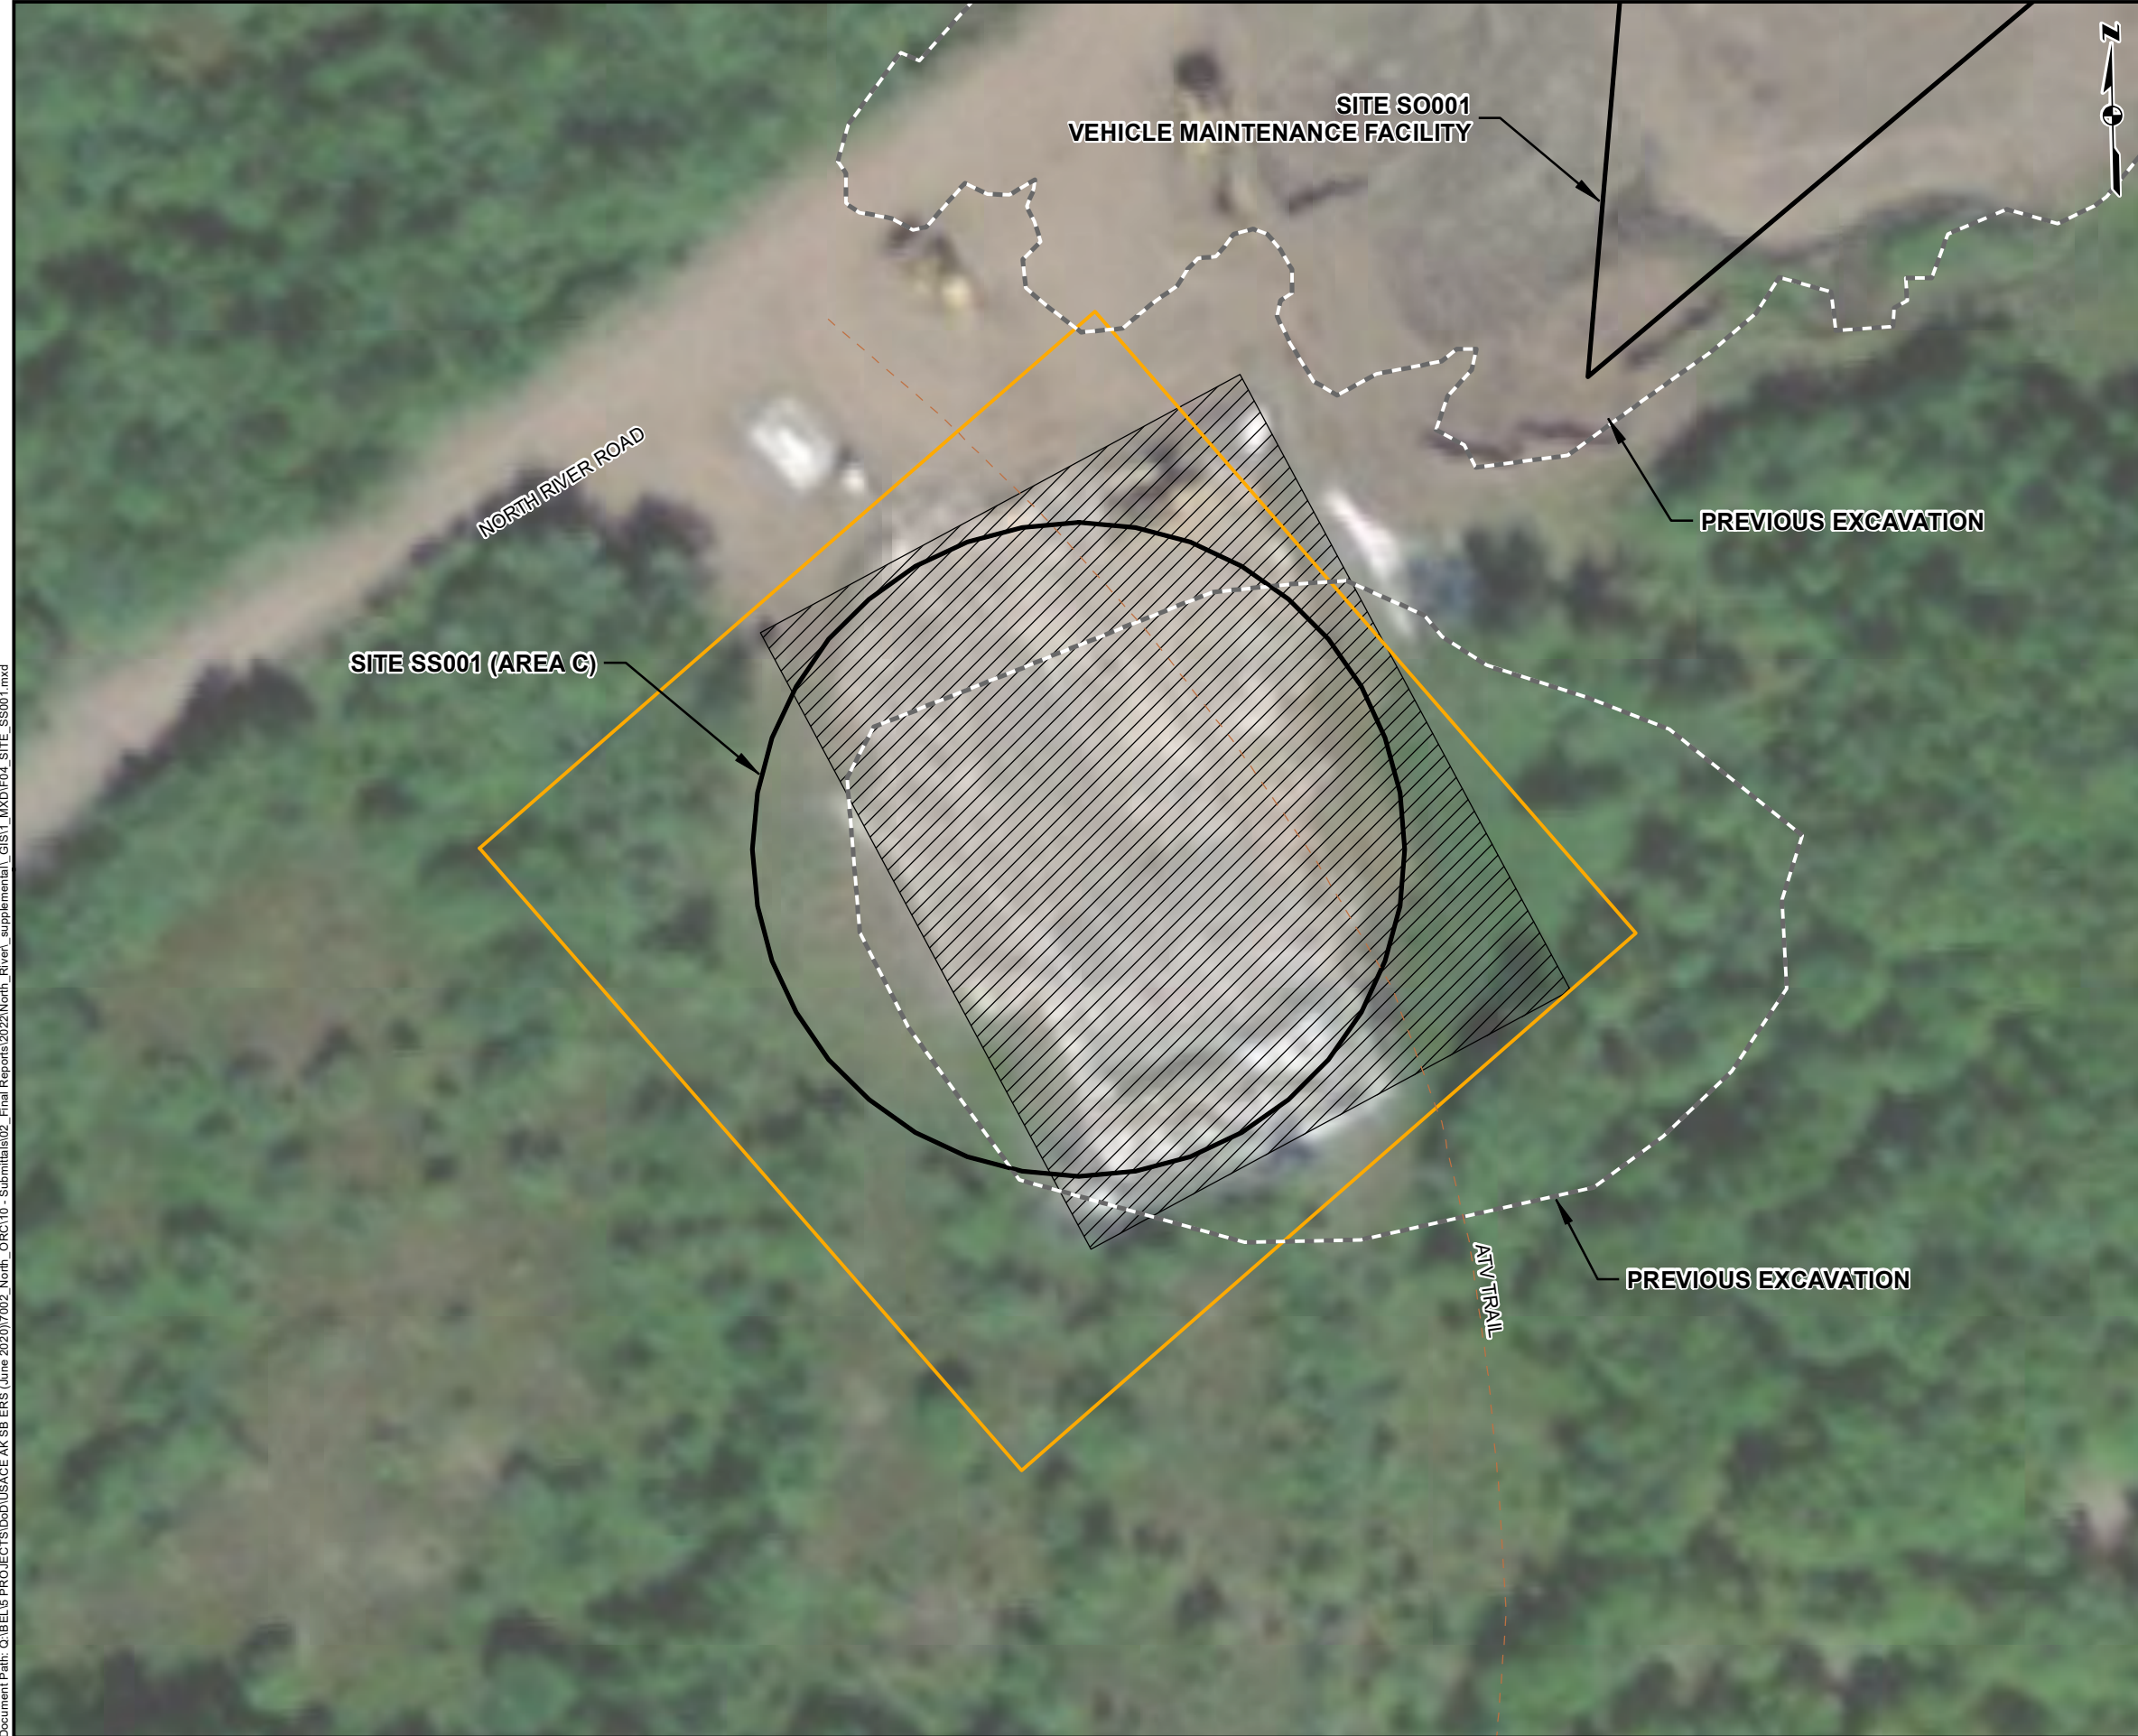
REMEDIAL ACTION-OPERATION AND LONG-TERM  
MANAGEMENT REPORT  
NORTH RIVER RADIO RELAY STATION, ALASKA  
**SITE SS001 (AREA C)**

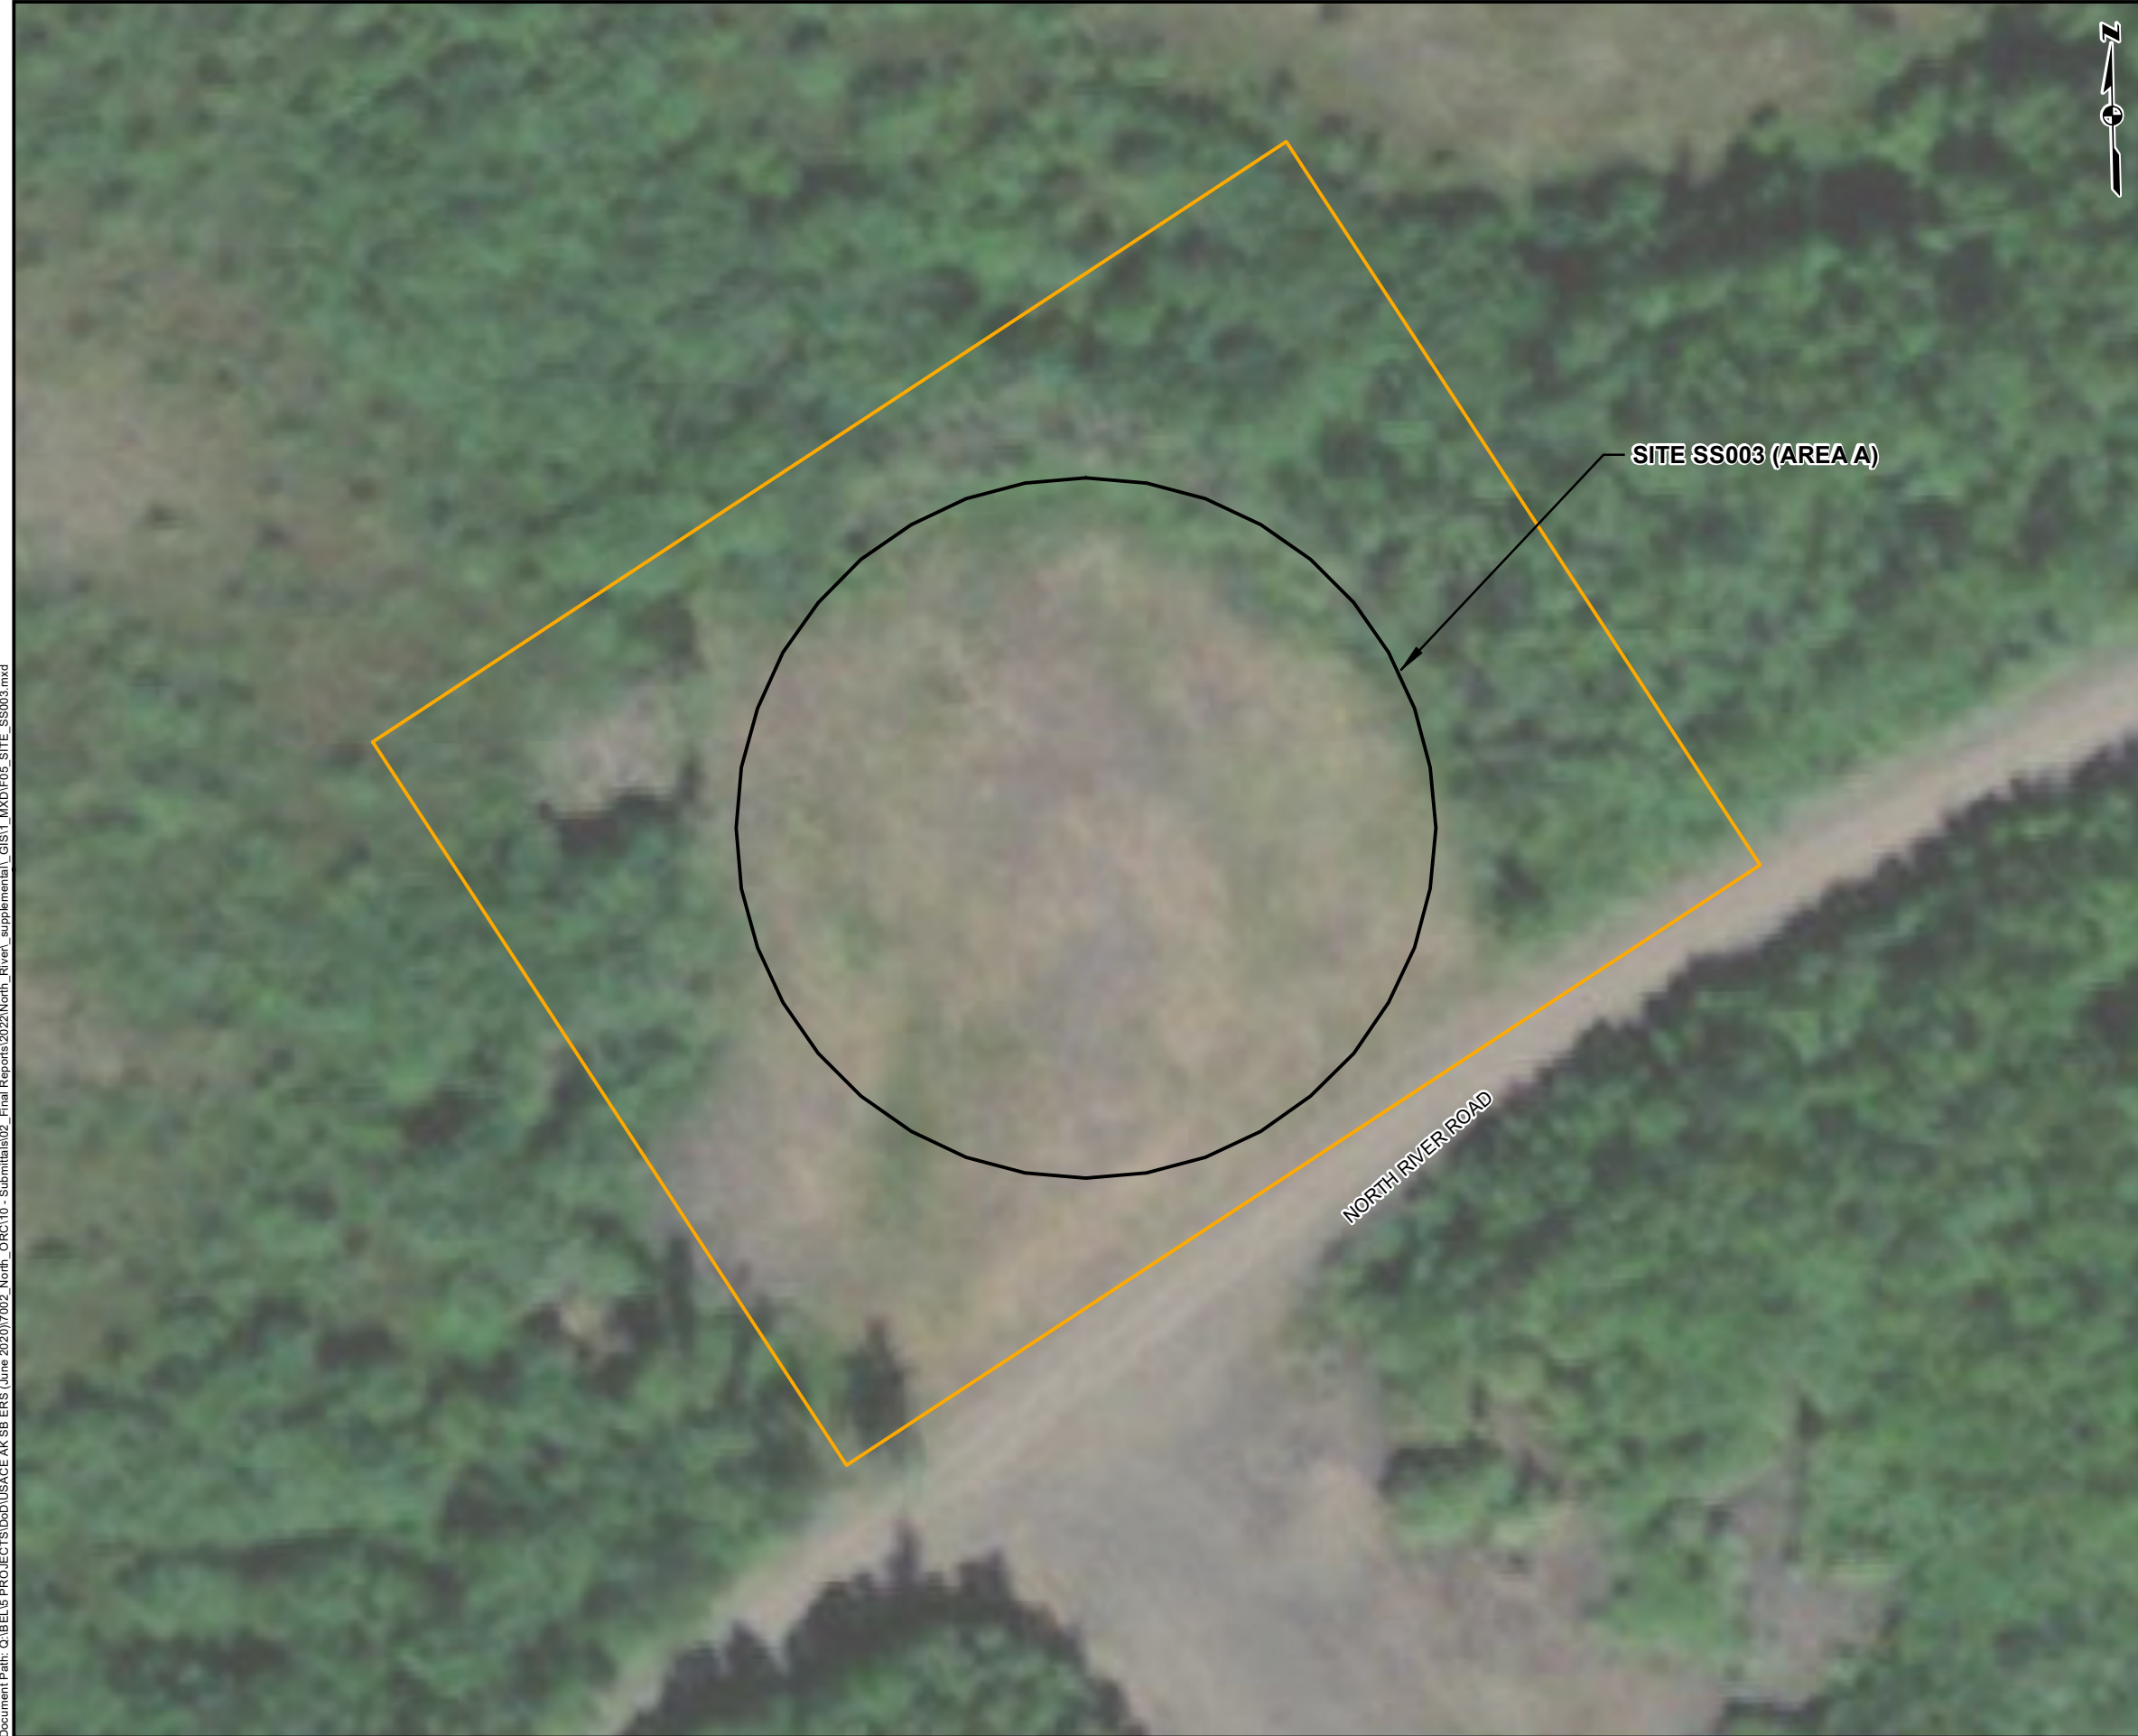
REMEDIAL ACTION-OPERATION AND LONG-TERM  
 MANAGEMENT REPORT  
 NORTH RIVER RADIO RELAY STATION, ALASKA  
**SITE SS003 (AREA A)**

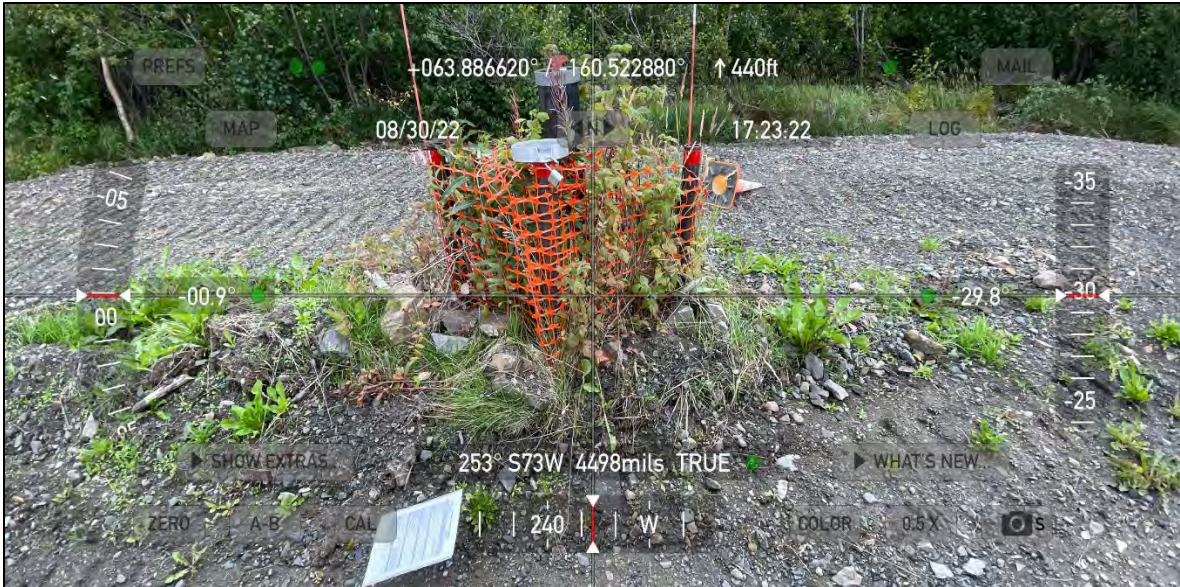
Photograph 1: SO001, Monitoring well V-MW06 mounded soil and rock around casing, view West, 08302022

At SO001, it is recommended that groundwater monitoring continues to evaluate the effectiveness of previous remedial activities. As recommended in the 2021 report, it is recommended that the inner casing of monitoring wells V-MW01 and V-MW06 be trimmed in order to secure the well and the existing lock replaced since these activities were not completed in 2022 due to an oversight. Also, as recommended in the 2021 report, it is recommended that IC signage be installed at Site SO001.

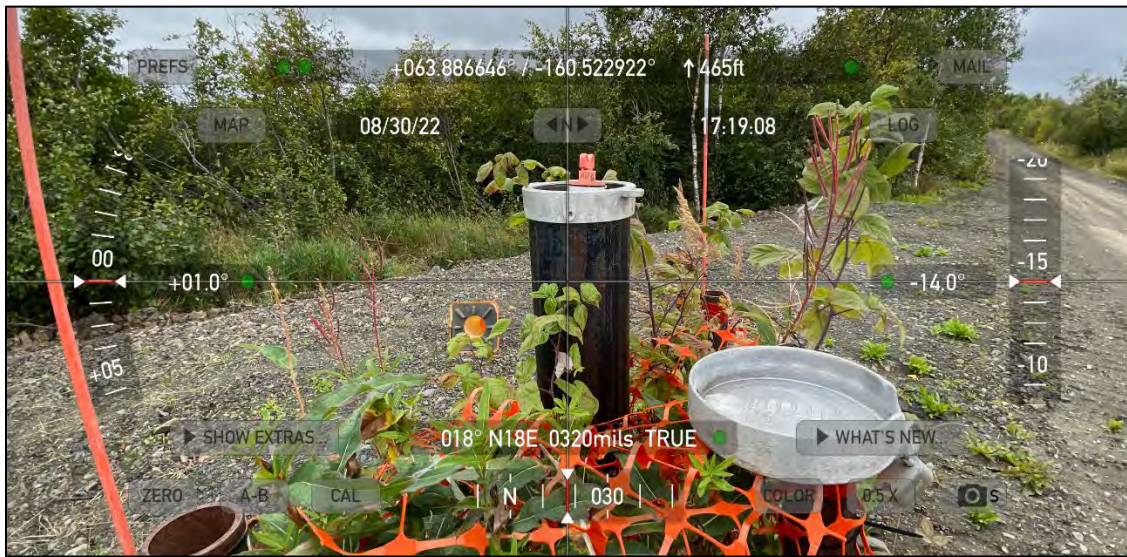
Photograph 2: SO001, Sampling monitoring well V-MW06, view northwest, 08302022

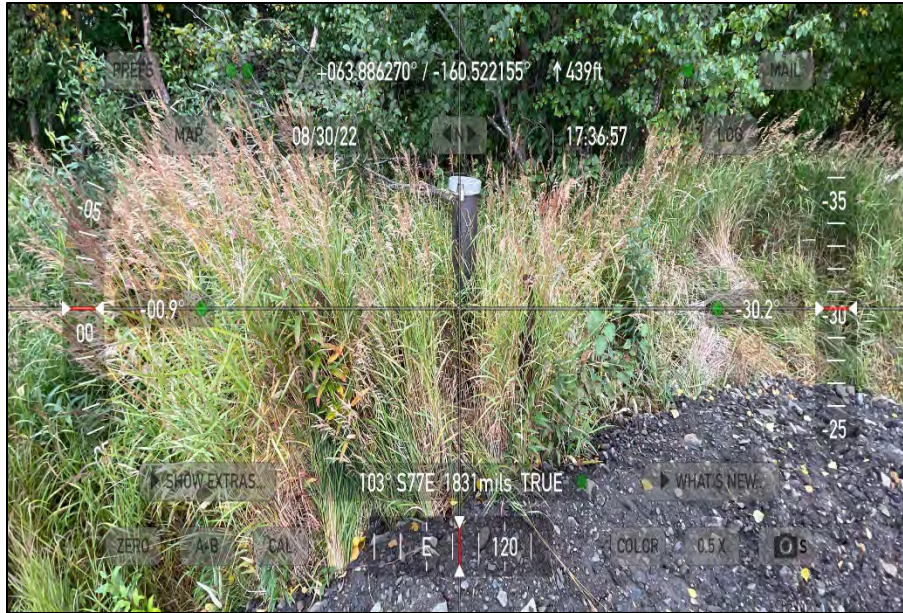
Photograph 3: SO001, Monitoring well V-MW03, view east, 08302022.

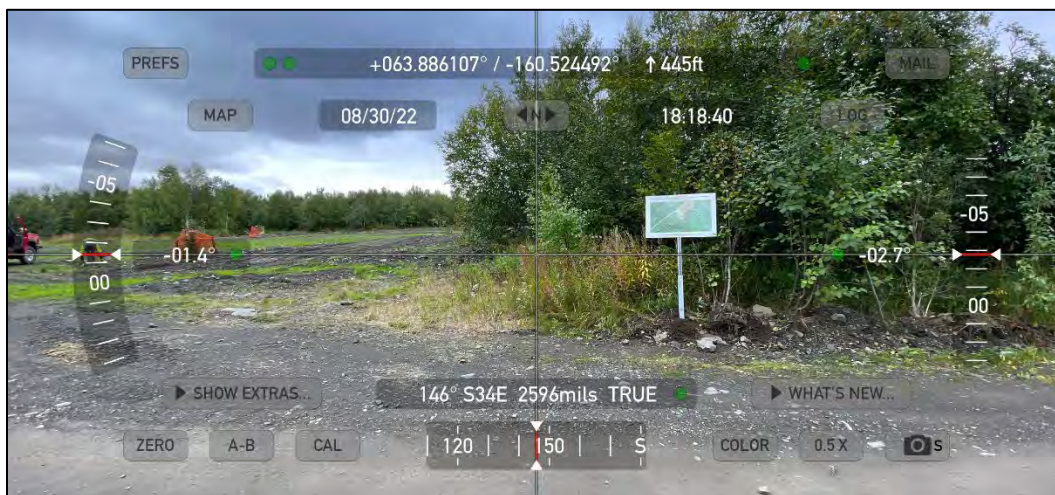
Two IC/LUC signs were installed at sites SS001 and SS003. The IC/LUC sign installed at Site SS001 was placed along the northwest boundary facing the access road. The IC/LUC sign installed at Site SS003 was placed on the west boundary also facing the access road. There were no signs previously observed at the sites.

Photograph 4: SS001, IC/LUC sign installed, view southeast, 08302022

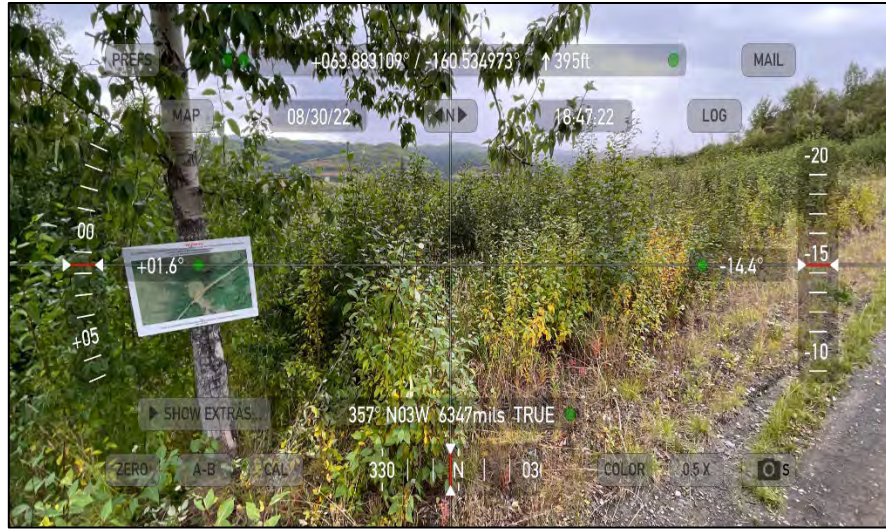
Photograph 5: SS003 IC/LUC sign installed, view north, 08302022

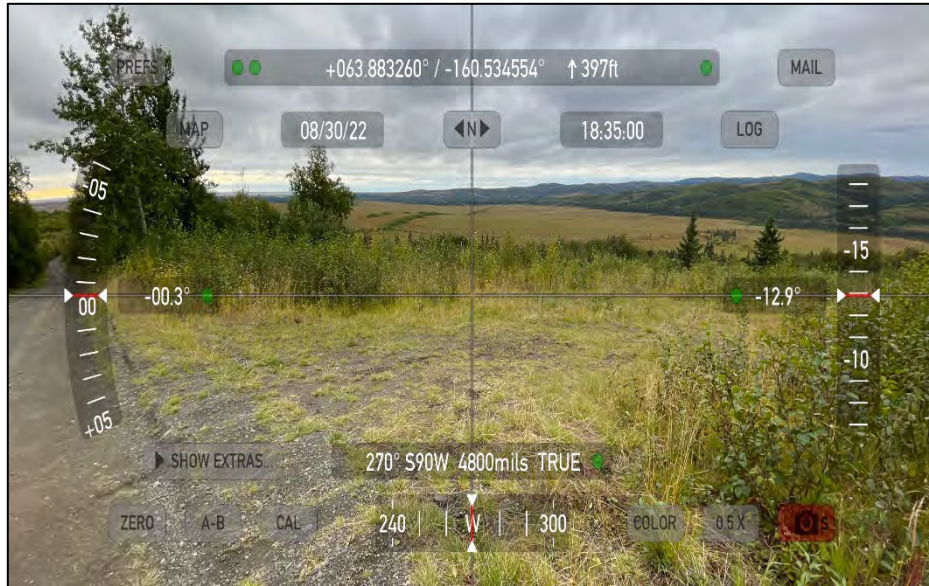
Site SS003 was visually inspected to determine whether the site is being disturbed. The site is a large field sloped away from the road and no fencing is present. No signs of stained or stressed vegetation were observed. No evidence of unauthorized excavation or groundwater use was observed. Tire marks were observed onsite. An IC/LUC sign was installed during this event. A visual inspection checklist for SS003 was completed and supporting photographic documentation was obtained.

Photograph 6: SS003, View of site SS003, view west, 08302022
