SUSPECTED UNCONTROLLED  
HAZARDOUS WASTE SITE INSPECTIONS

ALASKA HUSKY BATTERY - AKD009246497

THE ALASKA DEPARTMENT OF ENVIRONMENTAL CONSERVATION

MAY, 1986

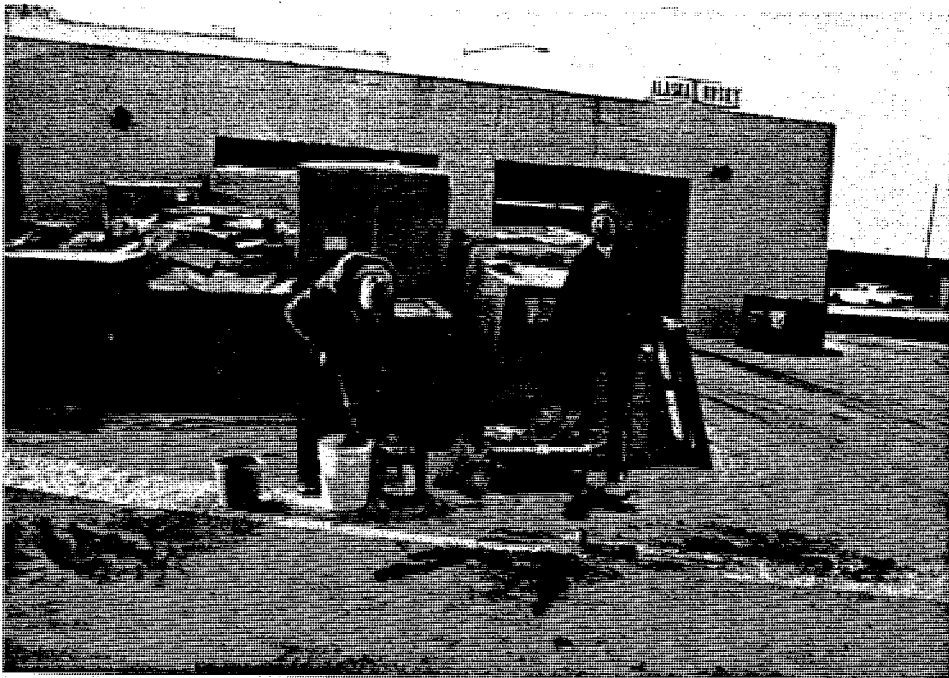
Split spoon washing on east side of property.

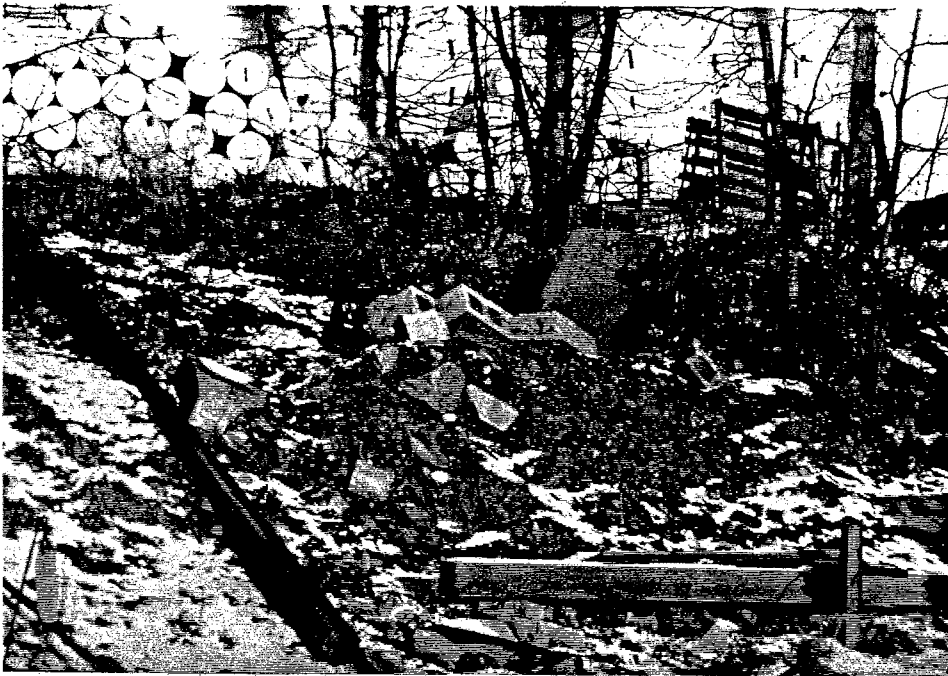
Pile of dirt and battery parts in rear of property.

- o Some debris, including used plastic battery case tops and lead terminal rings are piled up on the storage yard.
- o An unknown quantity of dilute acid and lead oxide has escaped from a broken sewer line and infiltrated into the surrounding soil. Discharge of sulfuric acid through this sewer line is likely to have been a contributing factor in its failure.

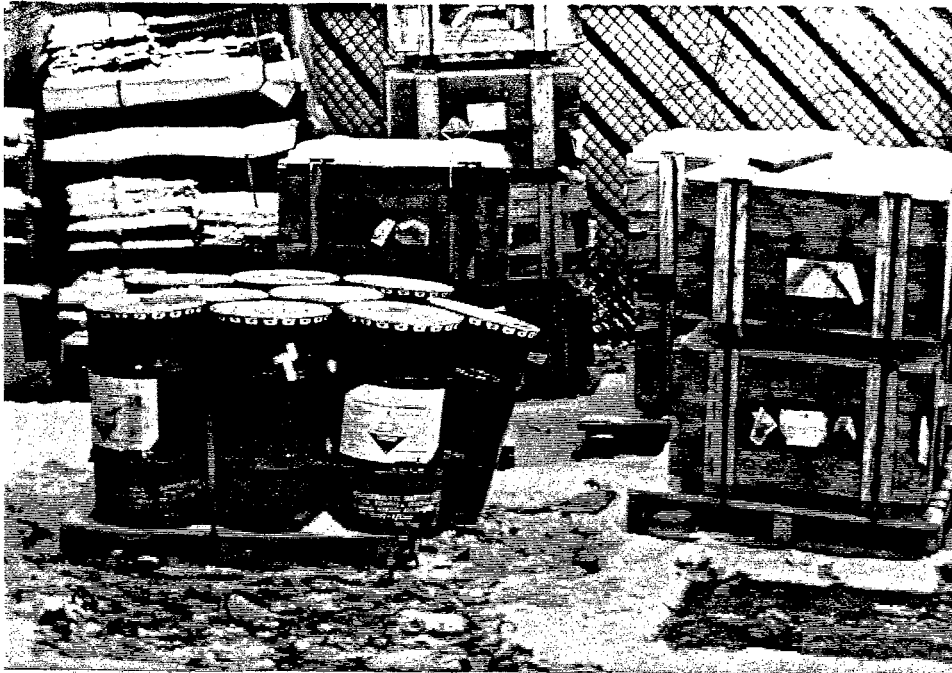
Observed along the south fence were 10 boxes of battery cases and fifty 15 gallon drums of sulfuric acid on pallets. In addition 8 to 12 crates containing five 1-gallon jugs of sulfuric acid were observed. Mr. Welker said the acid was received from the North Slope and represents only one quarter of the total shipment. Three quarters of the shipment were used during the previous two weeks (J. Welker, pers. comm., 11-13-85) to manufacture batteries.

Drums of  $H_2SO_4$  in rear of property.

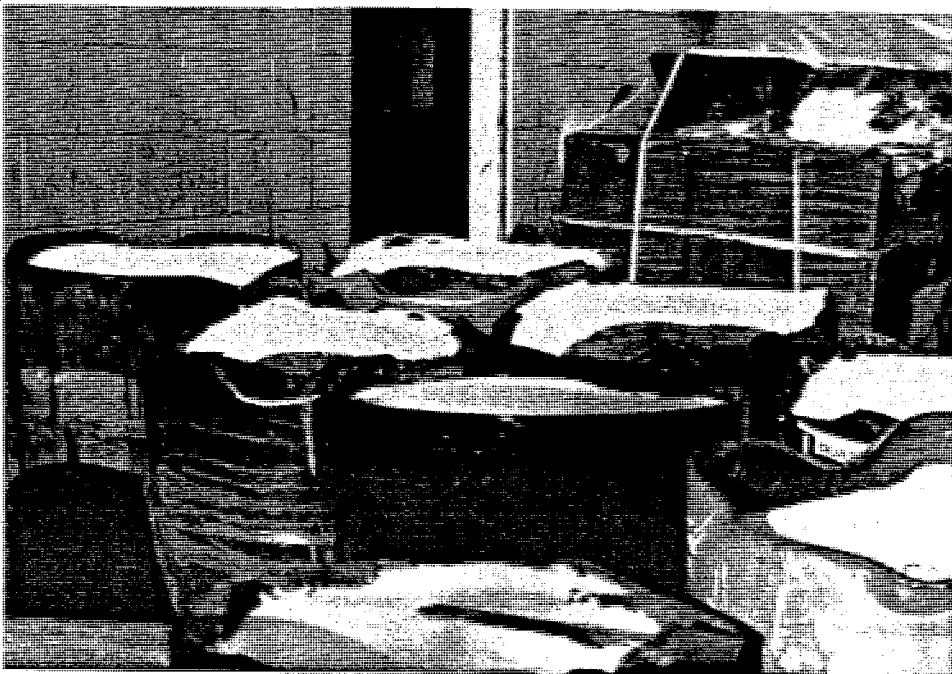
Drums of lead slag on east side of building.
