# Project Closeout Report

Containerized Hazardous, Toxic, and Radioactive Waste Project  
#F10AK0606-11

*C3, C4 - Point Carrew Garrison Area*

Yakutat Air Base Formerly Used Defense Site  
Yakutat, Alaska

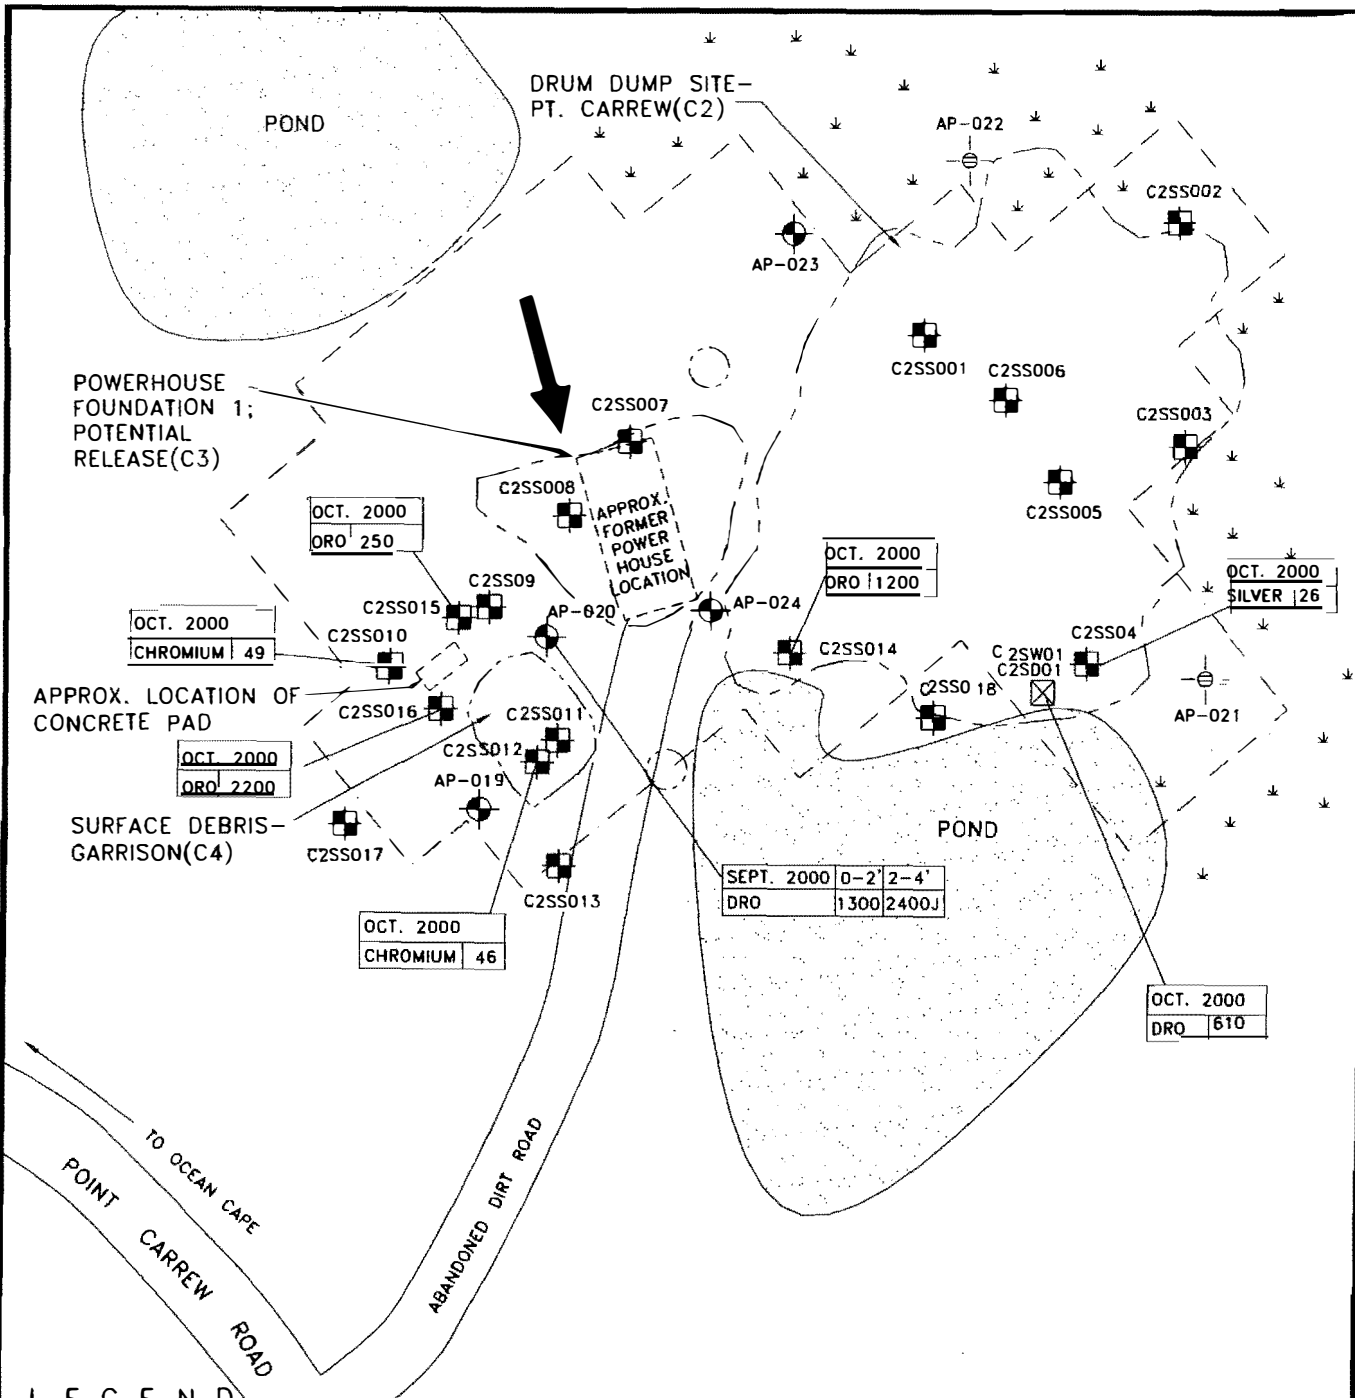
**FIGURE 3**  
POINT CARREW GARRISON  
CONCERN C2, C3 & C4

2000 REMEDIAL  
INVESTIGATION REPORT  
YAKUTAT AREA RI/FS  
YAKUTAT, ALASKA

**2000 USACE Remedial Investigation.** During a 2000 Remedial Investigation (RI) USACE performed analytical sampling of soil, surface water and groundwater. The sampling included the previously detected chemicals, bis(2-ethylhexyl)phthalate, 4,4'-dichlorodiphenyldichloroethane (DDD), aldrin, Aroclor 1242, Aroclor 1260, and lead. A maximum concentration of 2,400 mg/kg DRO in soil was reported, exceeding the 230 milligrams per kilogram (mg/kg) ADEC Method 2 cleanup level. All groundwater analytical results were below ADEC groundwater cleanup levels (USACE, 2003).

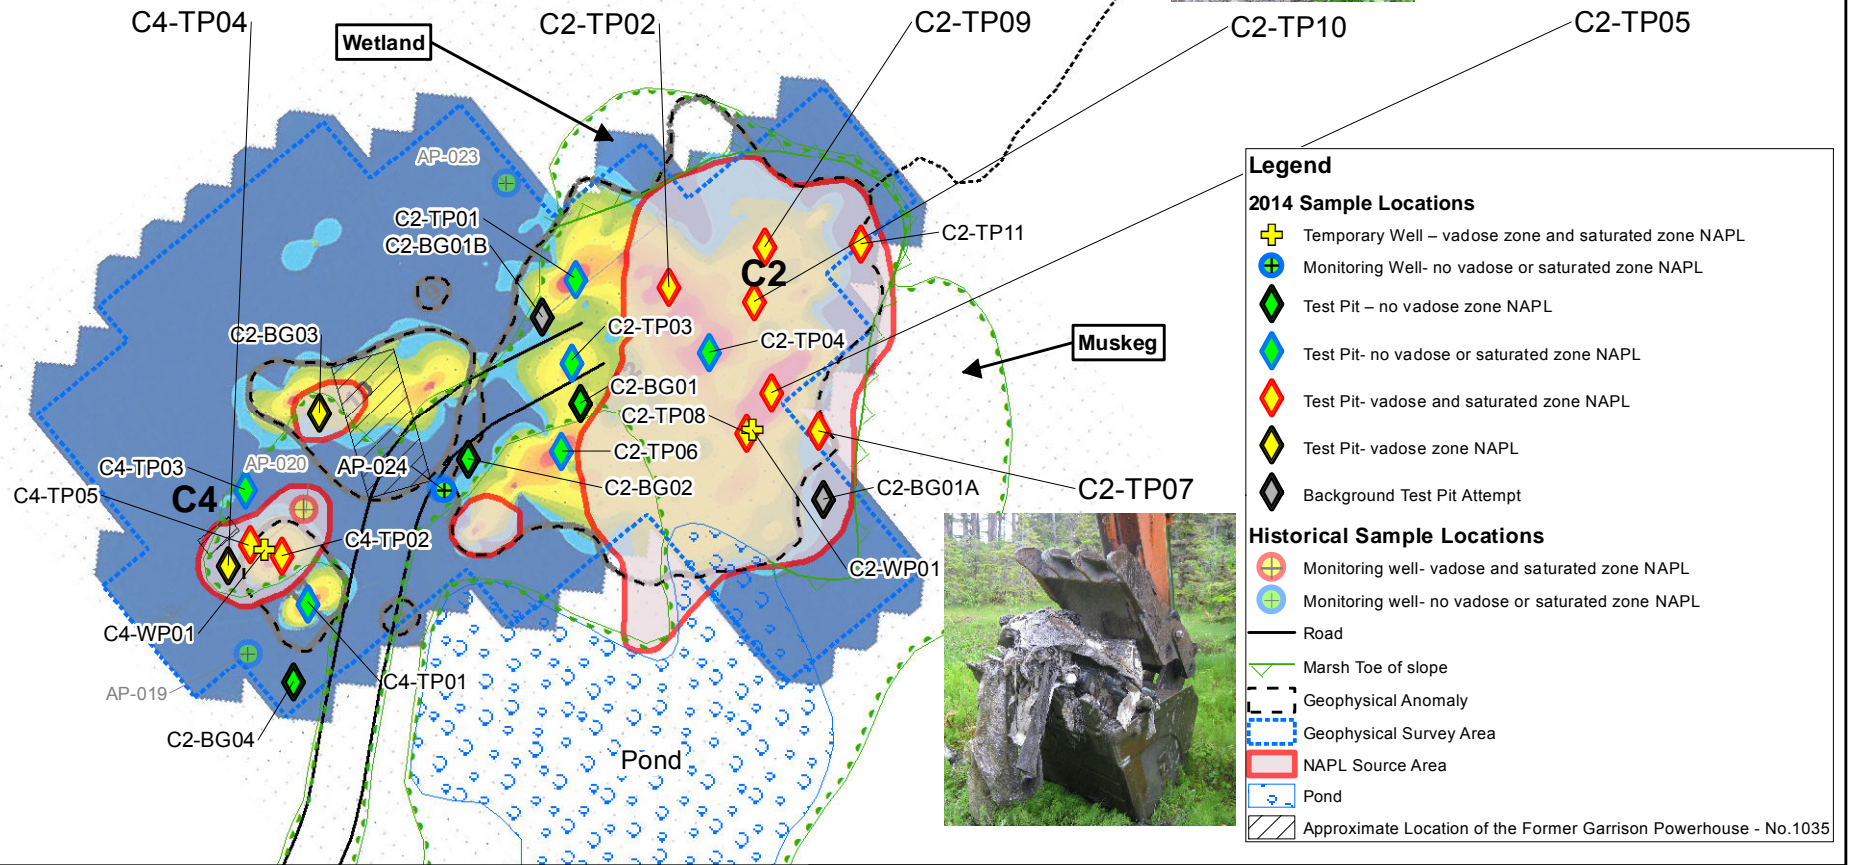
**FIGURE 4**

**AOCs C2 and C4  
Test Pit Locations and Observations**

Debris identified in test pits at AOC C2 during the RI includes glass bottles, cans, plastic bags, shoes, oil filters, tires, lumber, scrap metal, pipes, steel cable, and plastic sheeting. At AOC C2, a lens of soil contamination was found to start about 2 feet below ground surface (bgs) and extend to about 7 feet bgs. Used oil filters and oily waste were commingled with soil and are the likely source of contamination (Figure 4) (USACE 2016).

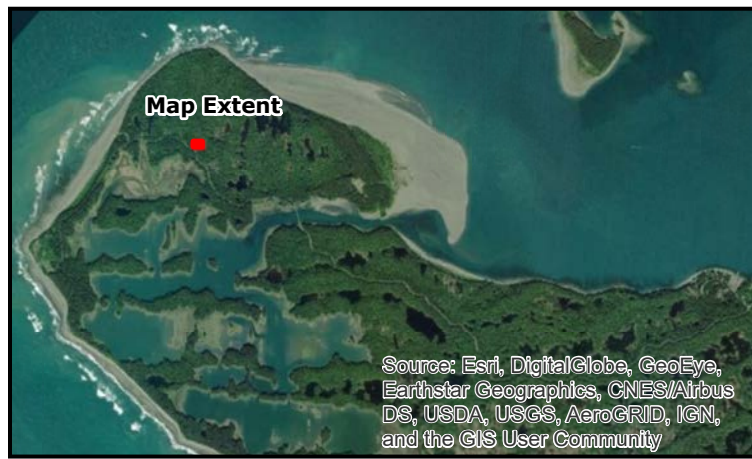
Sample ID	Date	Depth	DRO Aromatics	1-Methylnaphthalene	Dibenzo(a,h)anthracene
18YAKC4013SS	6/23/2018	6.0'	1,070	1.29 [0.0369]	0.171 [0.0591]
18YAKC4021SS <sup>D</sup>	6/23/2018	6.0'	1,197	1.01 [0.0369]	0.162 [0.0591]

Sample ID	Date	DRO
18YAKC4004GW	11/27/2018	2.16 [0.05]

FIGURE 5 – YAKUTAT AOC C3/C4 REMOVAL ACTION FINAL RESULTS AND AOCs C3/C4 & C2 BOUNDARY
