Proposed Plan for No Action

Atka Air Force Auxiliary Field FUDS on Atka, Alaska

USACE ANNOUNCES PROPOSED PLAN

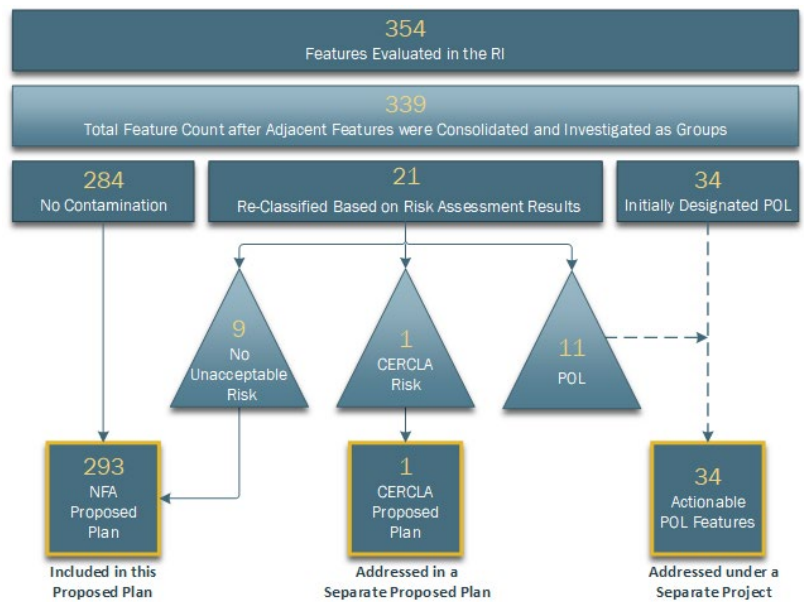
Diagram 1 – Current Status of Each Feature

Contamination in soil, groundwater, surface water, and sediment was identified at the site. Based on RI results, features were recommended and categorized as CERCLA, POL, or no further action (NFA). CERCLA and POL features were included in a quantitative assessment of risk. Following completion of the risk assessments, all but one CERCLA feature were recategorized as either POL or NFA. The 293 features addressed in this Proposed Plan were either determined to require no action or showed acceptable risk under CERCLA (Diagram 1). The current designation for each feature is depicted on Figure 2. Features designated as POL following completion of the risk assessments, as presented in Table 10-2 of the RI, are not included in this Proposed Plan. POLs are excluded from CERCLA but may be addressed under the authority of the DERP-FUDS (United States Code, Title 10, Section 2701, et seq.) if POL contamination poses an imminent and substantial endangerment to public health, welfare, or the environment. POL contamination at the Atka AF Aux FLD will be addressed under a separate project.

The one CERCLA feature at the site that presents an unacceptable risk will be addressed in a separate Proposed Plan. Of the 45 POL features, 34 have the potential for an imminent and substantial endangerment to human health or the environment and will be retained for separate evaluation and potential action under DERP (see Diagram 1).

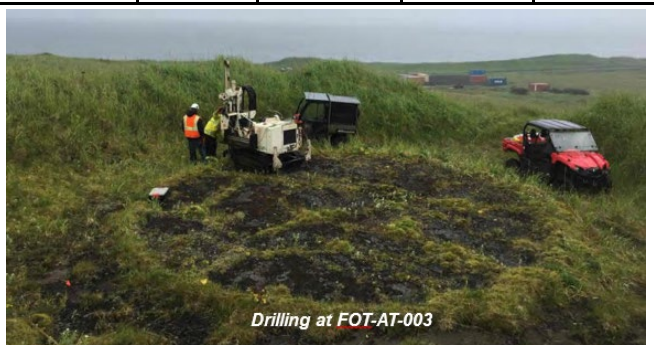
Drilling at FOT-AT-003

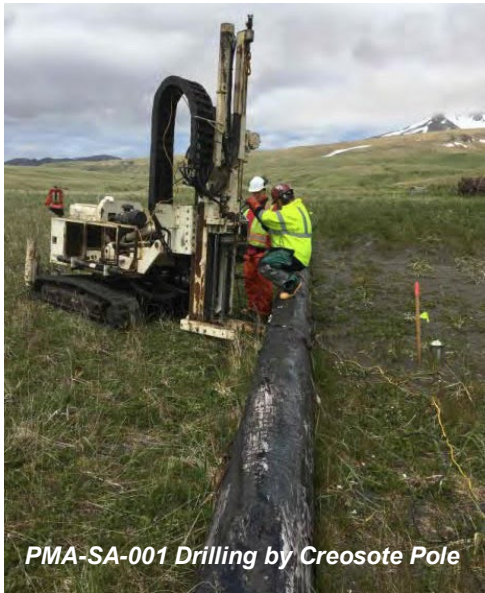
<p><i>PMA-SA-001 Drilling by Creosote Pole</i></p>																		
		<table border="1"> <thead> <tr> <th>Features Evaluated</th> <th colspan="5">Analytical Sampling</th> </tr> <tr> <th></th> <th>Soil (< 2')</th> <th>Soil (> 2')</th> <th>GW</th> <th>SED</th> <th>SW</th> </tr> </thead> <tbody> <tr> <td>7</td> <td>✓</td> <td>✓</td> <td>✓</td> <td></td> <td></td> </tr> </tbody> </table>	Features Evaluated	Analytical Sampling						Soil (< 2')	Soil (> 2')	GW	SED	SW	7	✓	✓	✓		
Features Evaluated	Analytical Sampling																			
	Soil (< 2')	Soil (> 2')	GW	SED	SW															
7	✓	✓	✓

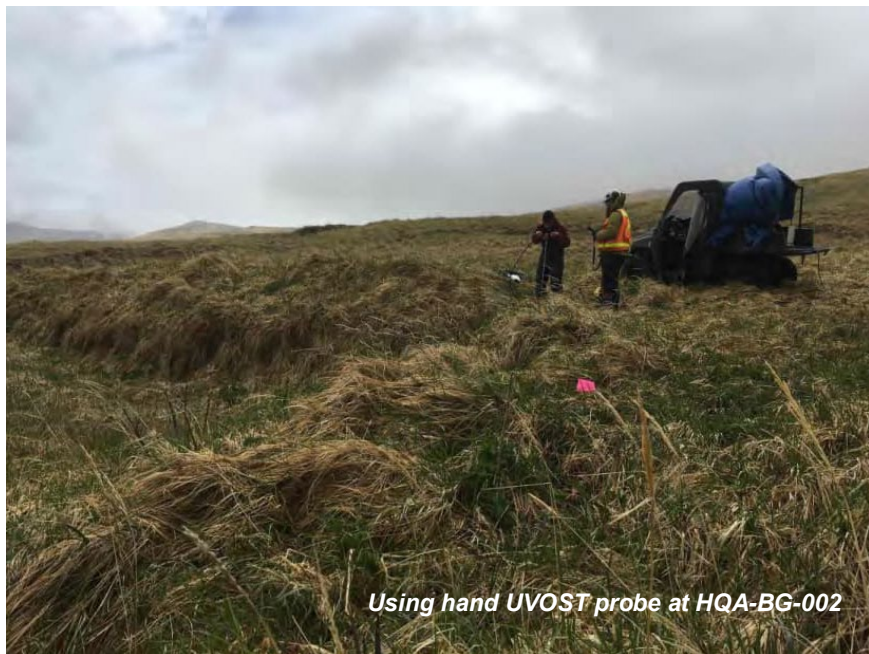
Using hand UVOST probe at HQA-BG-002

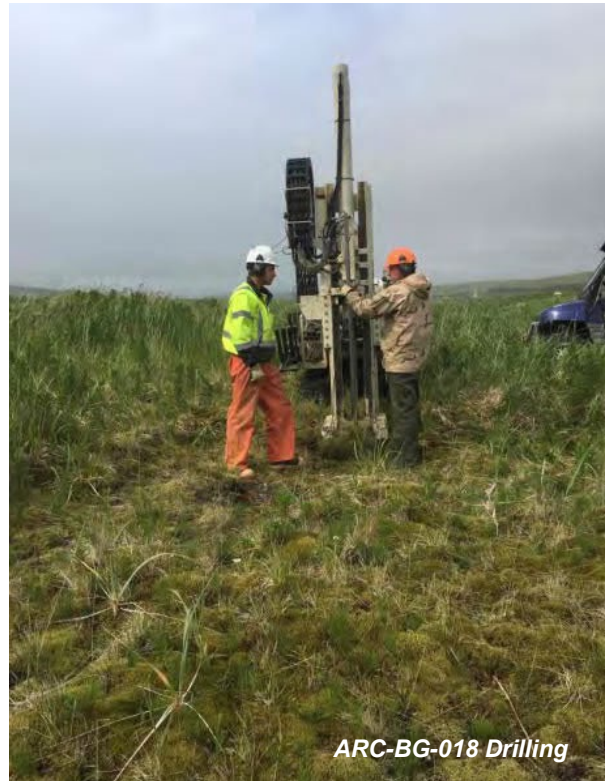
ARC-BG-018 Drilling
