SHANNON & WILSON

RE: MONITORING WELL DECOMMISSIONING REPORT, GRANT MINE SITE, ESTER DOME, ALASKA

Grant Mine Well Decom Report Project No. 31-1-20094

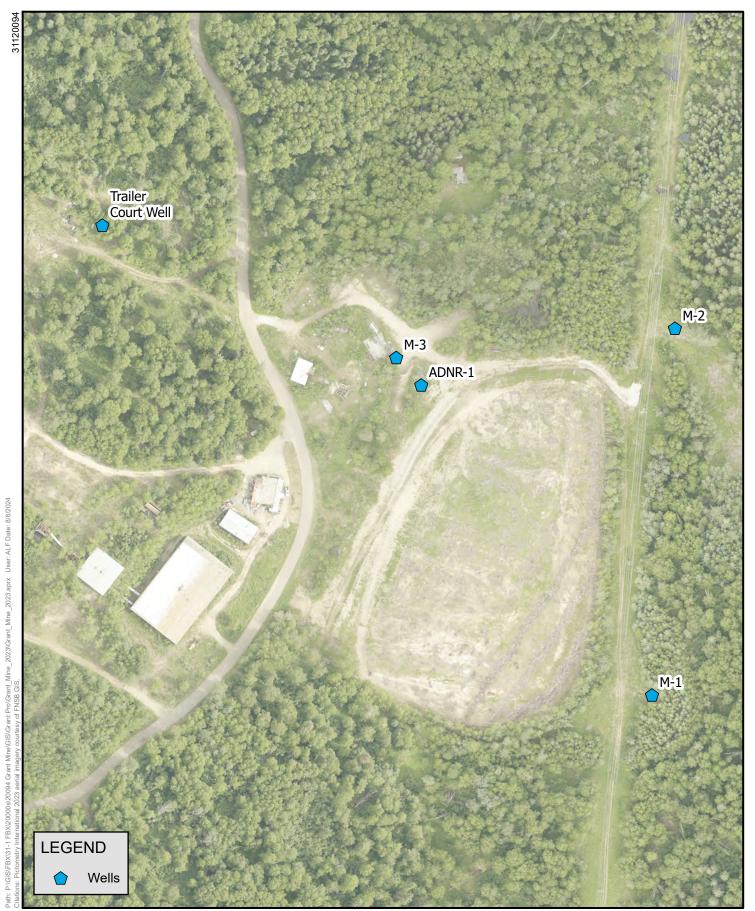
DECOMMISSIONED WELL LOCATIONS
Figure 1

Shannon & Wilson prepared this report to summarize methods used to decommission five groundwater monitoring wells (M-1, M-2, M-3, ADNR-1, and the Trailer Court Well) at the Grant Mine site on Ester Dome (Figure 1). In a letter dated November 29, 2021, the Alaska Department of Environmental Conservation (DEC) requested that monitoring wells at the site be decommissioned prior to site closure with the DEC Contaminated Sites Program.

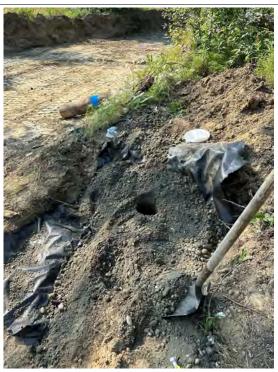
Photo 1: Backfill in progress at well M-3.

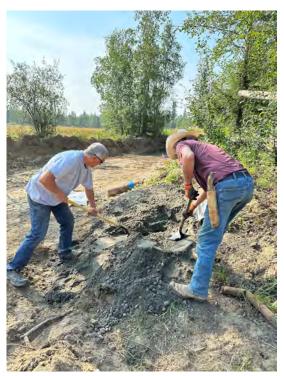
Photo 2: Backfill in progress at well M-3.

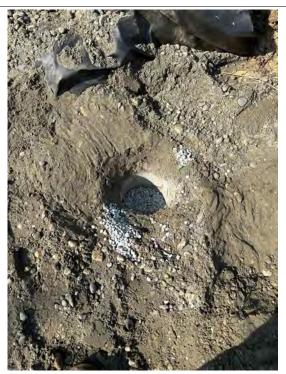
Photo 3: Bentonite chips placed within the top fifteen feet of well casing at well M-3.

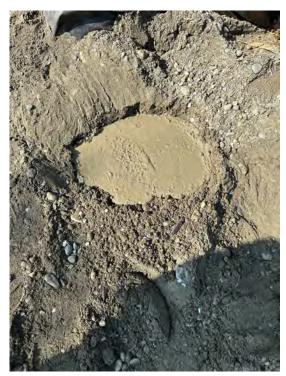
Photo 4: Cement cap placed to complete the backfilling of well M-3.

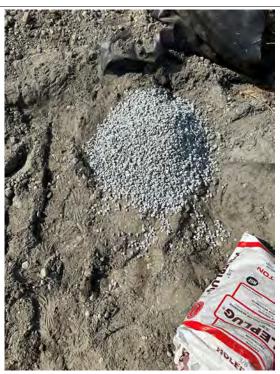
Photo 5: Bentonite chips placed on top of the cement cap at well M-3.

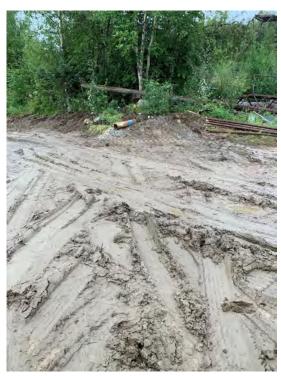
Photo 6: Location of well M-3 after the excavation around the well was backfilled.

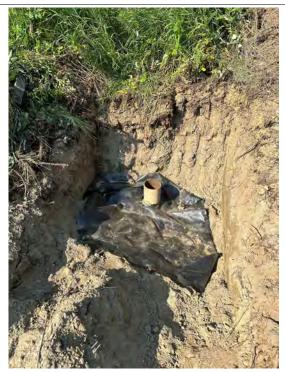
Photo 7: Excavation around the Pod Well in preparation for backfill.

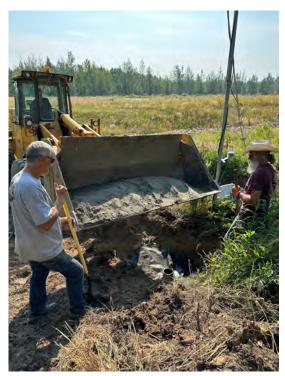
Photo 8: Backfill in progress at the Pod Well.

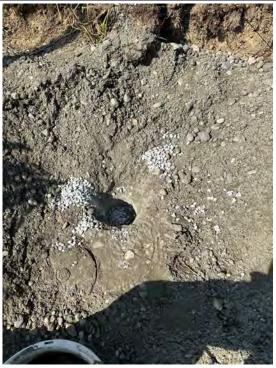
Photo 9: Bentonite chips placed within the top fifteen feet of well casing at the Pod Well.

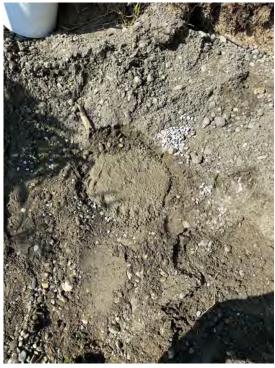
Photo 10: Cement cap placed to complete the backfilling of the Pod Well.

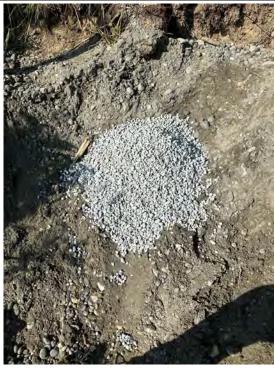
Photo 11: Bentonite chips placed on top of the cement cap at the Pod Well.

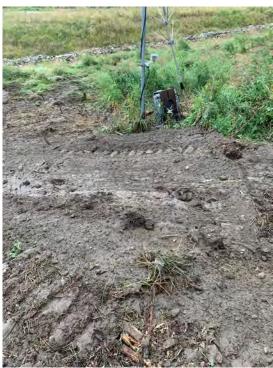
Photo 12: Location of the Pod Well after the excavation around the well was backfilled.

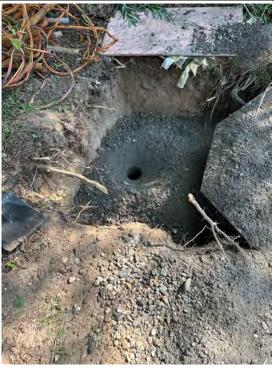
Photo 13: Backfill in progress at the Trailer Court Well.

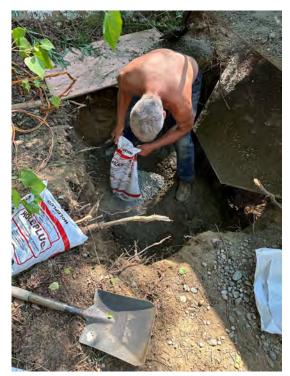
Photo 14: Backfill in progress at the Trailer Court Well.

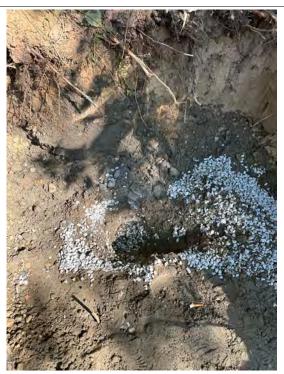
Photo 15: Bentonite chips placed within the top fifteen feet of well casing at the Trailer Court Well.

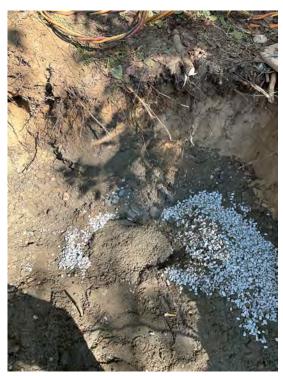
Photo 16: Cement cap placed to complete the backfilling of the Trailer Court Well.

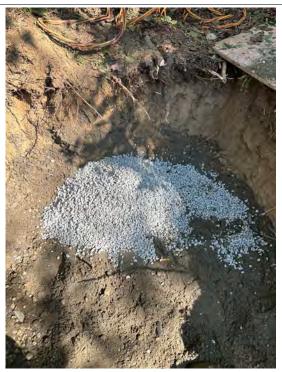
Photo 17: Bentonite chips placed on top of the cement cap at the Trailer Court Well.

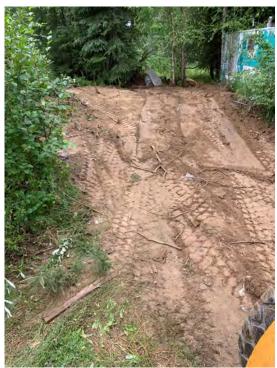
Photo 18: Location of the Trailer Court Well after the excavation around the well was backfilled.

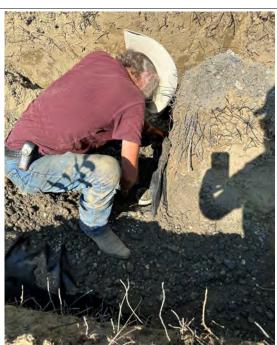
Photo 19: Bentonite chips placed within the top fifteen feet of well casing at well M-2.

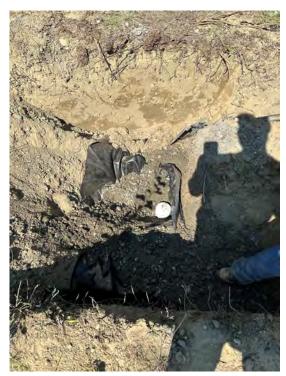
Photo 20: PVC cap glued on top of the well casing at well M-2.

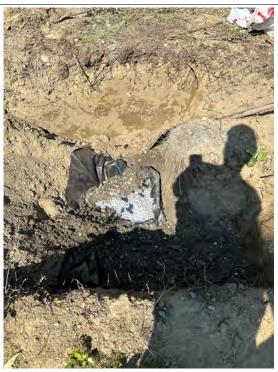
Photo 21: Bentonite chips placed on top of the PVC cap at well M-2.

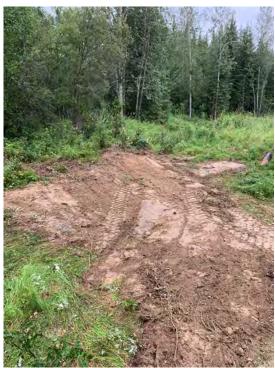
Photo 22: Location of well M-2 after the excavation around the well was backfilled.

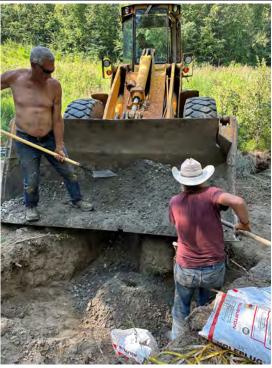
Photo 23: Backfill in progress at well M-1.

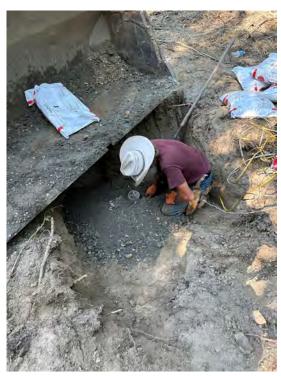
Photo 24: Bentonite chips placed within the top fifteen feet of well casing at well M-1.

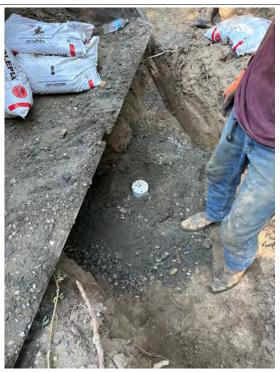
Photo 25: PVC cap glued on top of the well casing at well M-1.

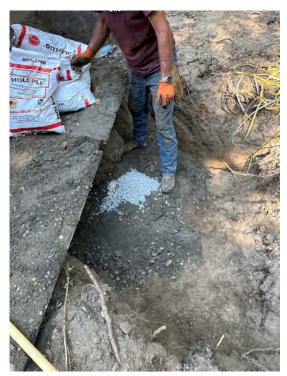
Photo 26: Bentonite chips placed on top of the PVC cap at well M-1.

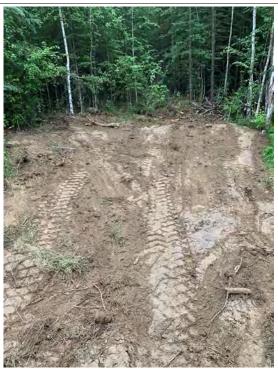
Photo 27: Location of well M-1 after the excavation around the well was backfilled.
