Re: Kotzebue Lot M Hangar Site Assessment Report

This letter report summarizes the results of a baseline environmental assessment conducted by OASIS Environmental, Inc. (OASIS) at the Crowley Marine Services, Inc. (Crowley) Kotzebue Hangar Facility. The Hangar is located on Lot M, Block 1, and is leased from the Alaska Department of Transportation and Public Facility (DOT&PF) under lease ADA-71219. Kotzebue is located at the north end of the Baldwin Peninsula in Kotzebue Sound; approximately 550 air miles northwest of Anchorage, Alaska (Figure 1).

ENVIRONMENTAL ASSESSMENT
 KOTZEBUE LOT M HANGAR
 Kotzebue, Alaska

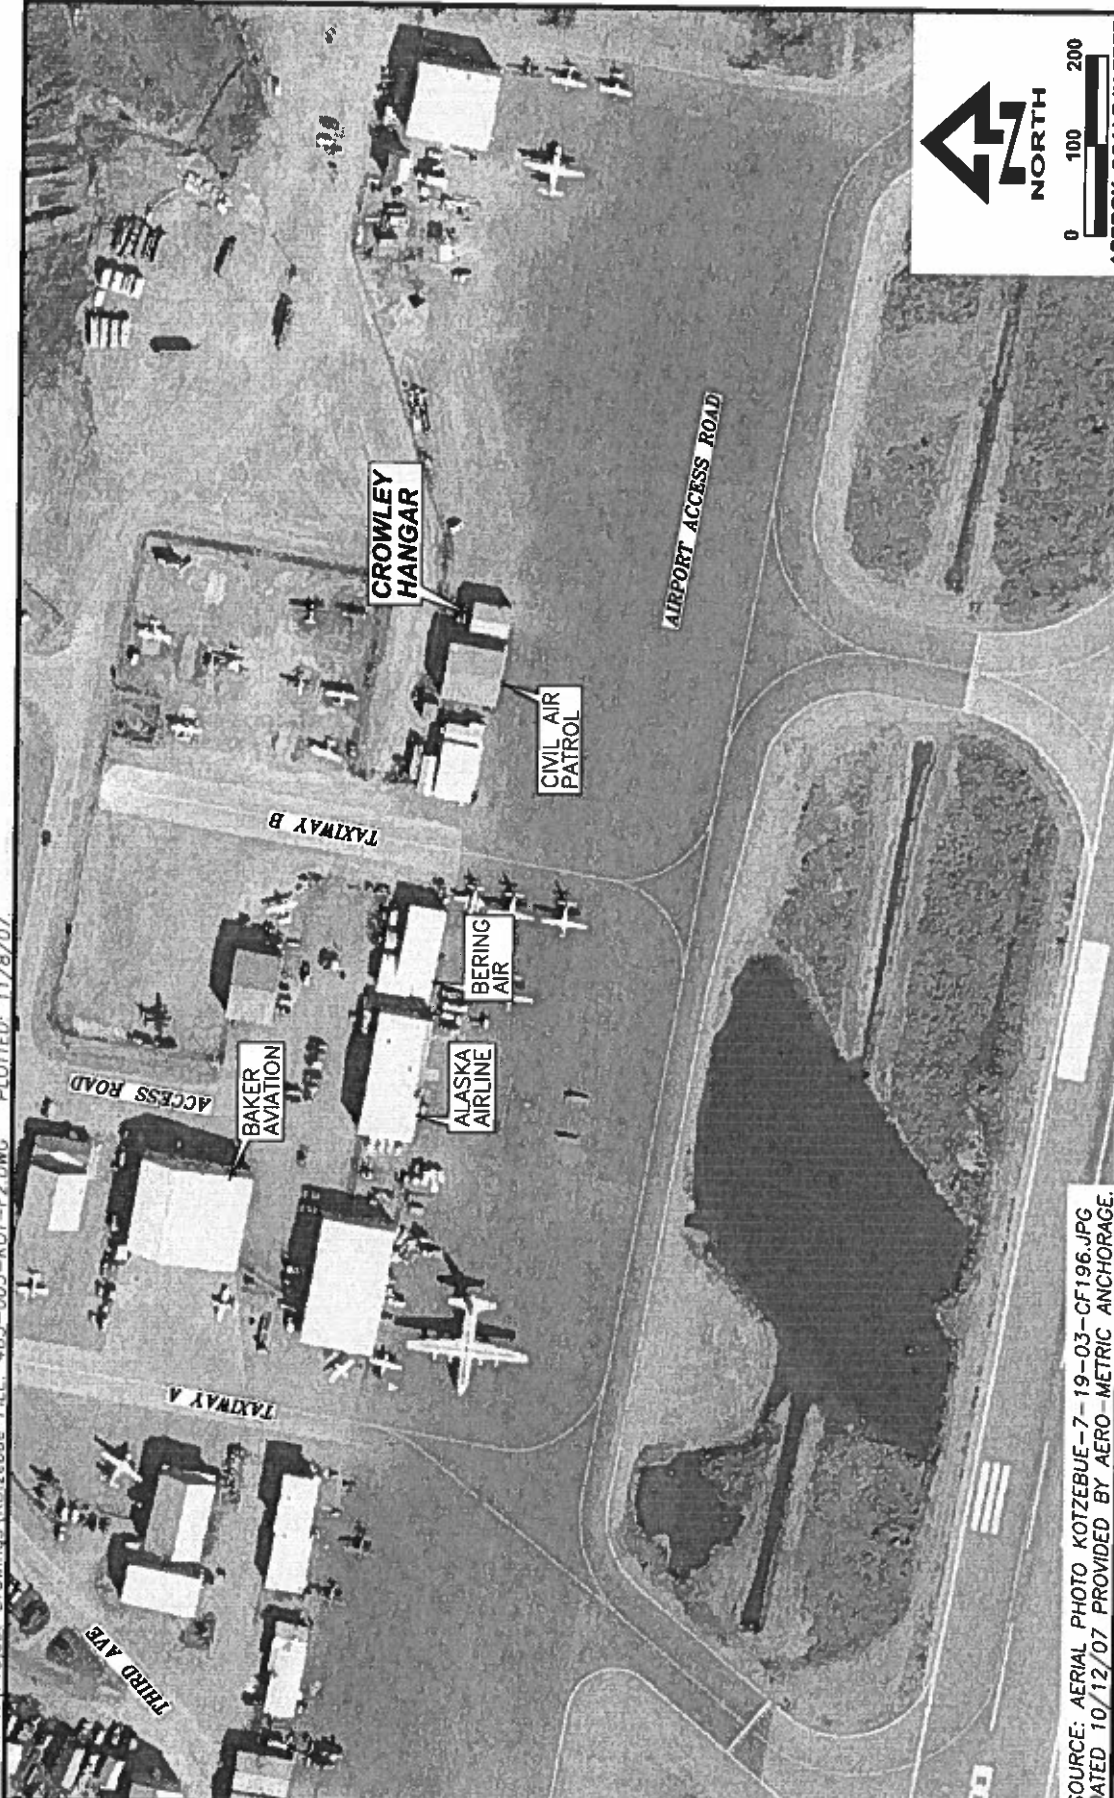
2

Crowley currently leases Lot M of Block 1 at the Ralph Wien Memorial Airport in Kotzebue, Alaska (see Figure 2). The lot is 60 feet wide and 125 feet deep, with one hangar building. The southern portion of the lot (3,000 square feet) is paved. The hangar building measures approximately 31 feet wide by 42 feet deep, with hangar doors abutting the paved portion of the site. The floor of the hangar is gravel and has a thick liner located 1.5 feet below clean gravel. The liner comes up the sides of three of the four interior walls of the hangar. The hangar building is used to house two fueling trucks.

SITE PLAN

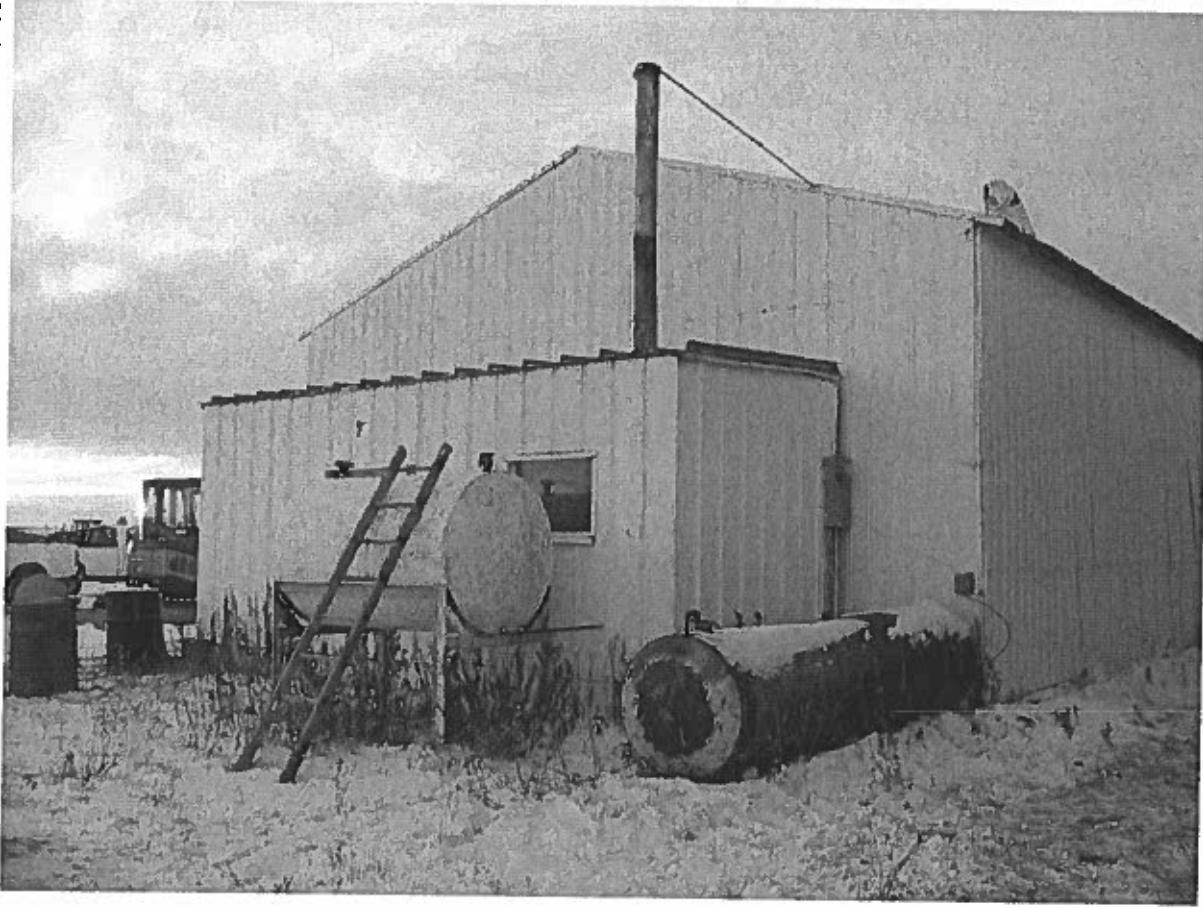
Photo: 6 Time: 0958 Date: 10/12/2007 Direction: Southeast
Subject: Crowley Hangar, view of two ASTs.

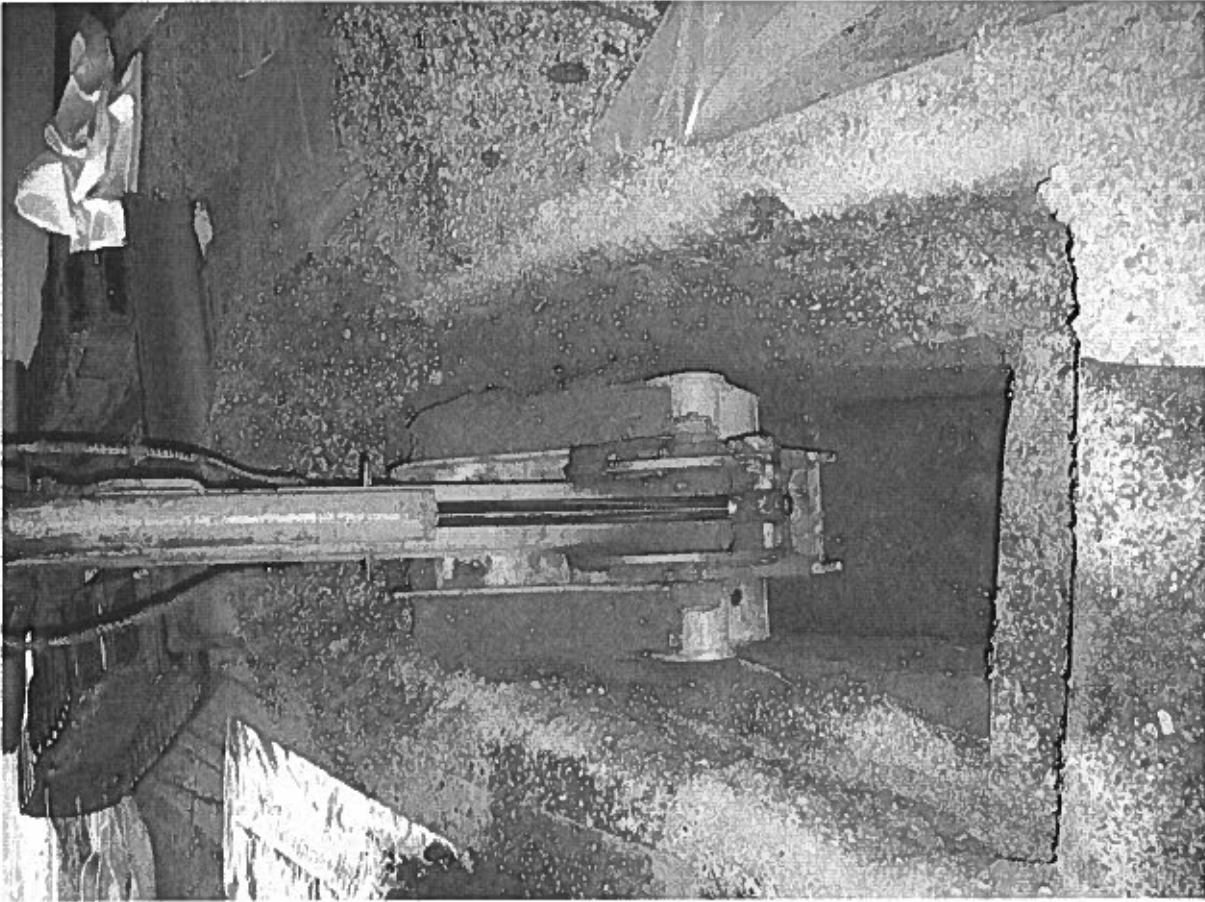
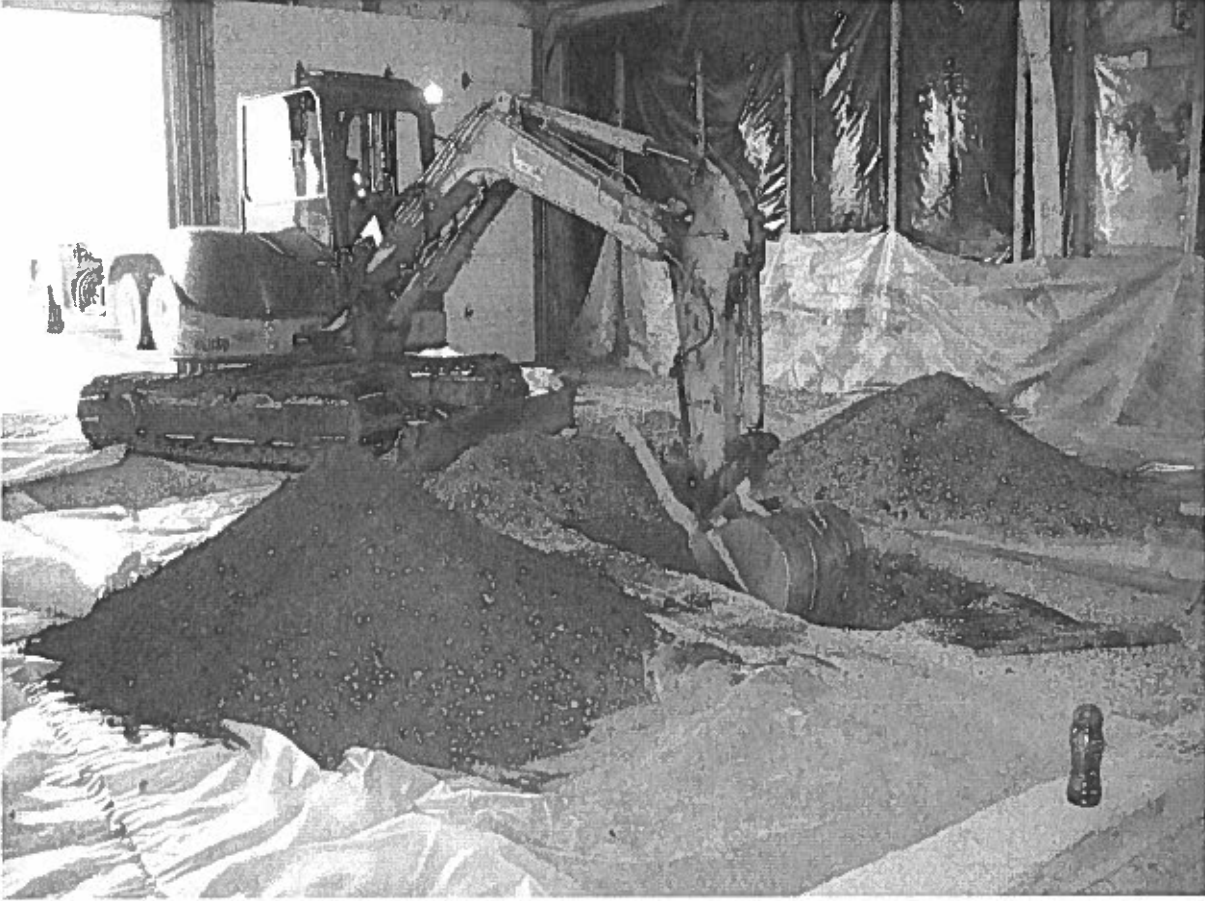
Test Pit No. 1 was located in the center of the hangar building. Initial excavation of this test pit included removal of 1.5 feet of gravel fill that is located on top of a liner that lines the entire building floor. OASIS collect a field screening sample of this gravel material for PID field screening and obtained a reading of 0 parts per million (ppm) above background. Once the first 1.5 feet of gravel was removed exposing the liner, the liner was cut and folded back. Poly sheeting was laid out for temporary placement of excavated soils from below the liner. The following field screening samples, depths, and results were obtained at Test Pit No. 1 from below the liner:

Test Pit 1		
Field No.	Depth (feet)	PPM
T1-1	1.5 to 2	1,140
T1-2	3 to 3.5	205
T1-3	5 to 5.5	82

OASIS collected three samples for off site analysis, one from each sampling interval at Test Pit No. 1. Sample no. 07-CLM-T1-01 was collected from soils just below the liner. Sample no. 07-CLM-T1-02 was collected from approximately 3 to 3.5 feet bgs and sample no. 07-CLM-T1-03 was collected from the bottom of the excavation at approximately 5.5 feet bgs. This location had the highest PID field screening readings, with PID reading decreased with depth to a low of 82 ppm. GRO results from all three samples exceeded the ADEC cleanup value of 100 ppm.

Photo: 10 Time: 1052 Date: 10/122007 Direction: South Subject: Excavating Test Pit 1 (T1).

Photo: 9 Time: 1052 Date: 10/12/2007 Direction: South Subject: Excavating Test Pit 1 (T1).

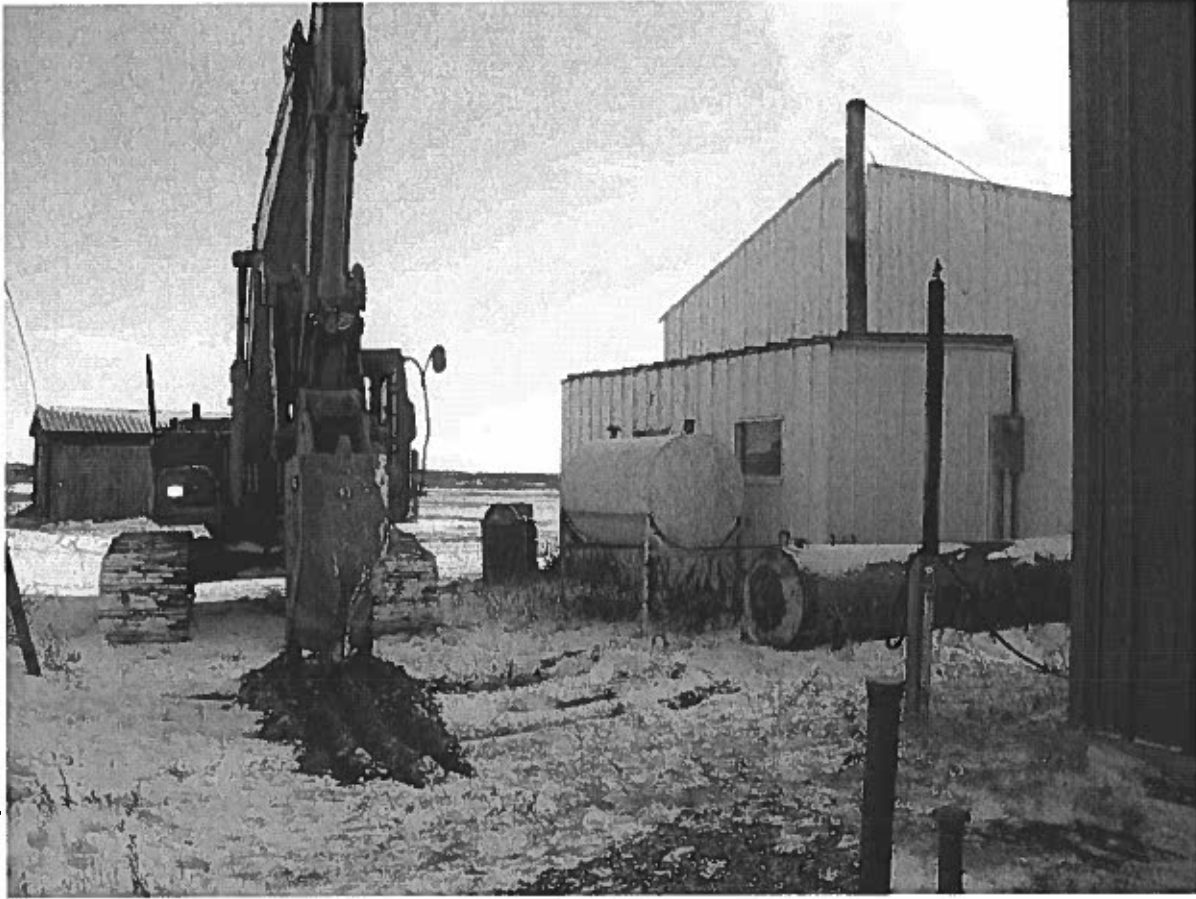
Test Pit No. 3 was located at the northwest corner of the lot. OASIS noted an underground storage tank located 13 feet west of the test pit location, on adjacent Lot L. The following field screening samples, depths, and results were obtained at Test Pit No. 3:

Test Pit 3		
Field No.	Depth (feet)	PPM
T3-1	0 to 1	0.4
T3-2	3	95
T3-3	6.5	14.9

At Test Pit No. 3, OASIS collected Sample No. 07-CLM-T3-02 from approximately 3 feet bgs. GRO, DRO, RRO and xylenes were detected in sample 07-CLM-T3-02, but below ADEC cleanup levels.

**Photo: 12 Time: 1338 Date: 10/12/2007 Direction: East
Subject: Excavating at Test Pit 3 (T3).**

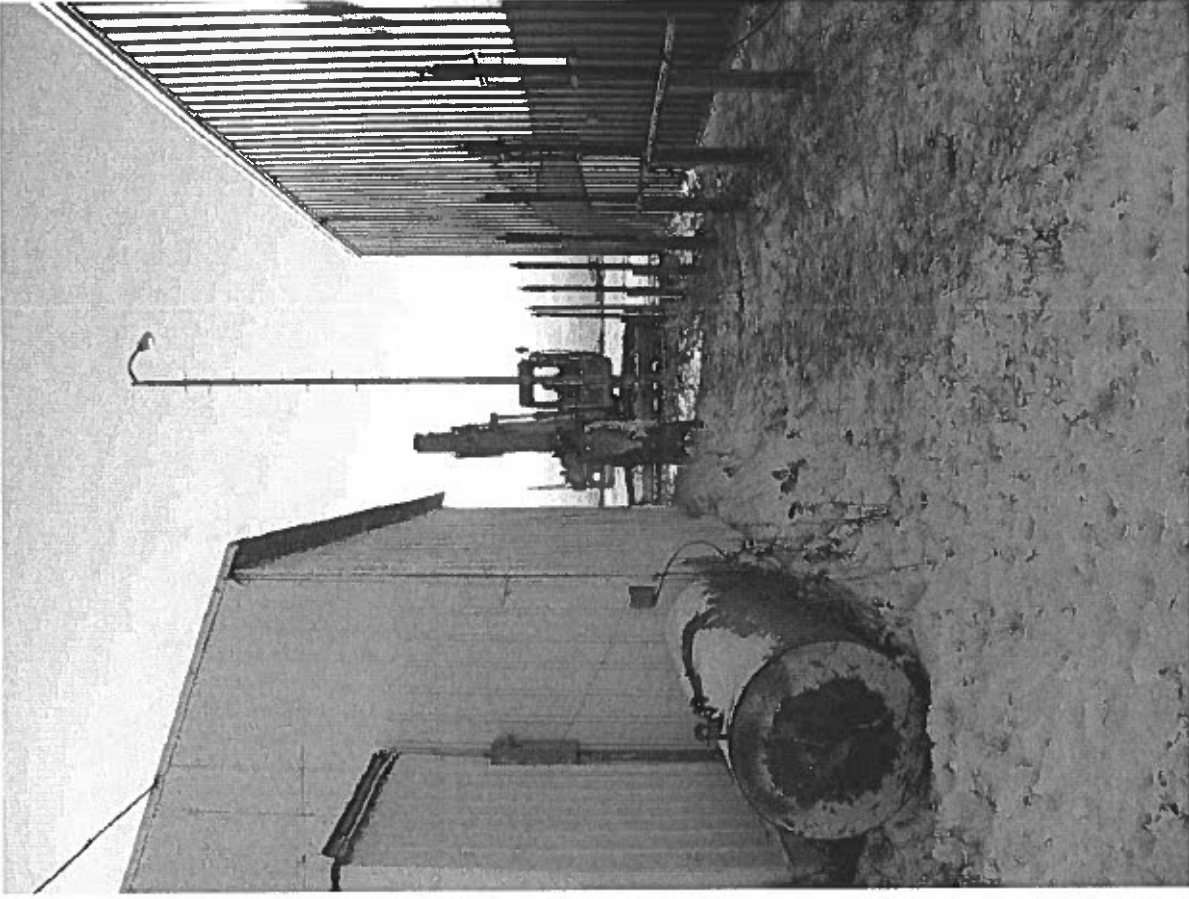
Test Pit No. 2 was located at the southwest corner of the Hangar, on the north edge of the airfield tarmac. The excavation was extended to 5.8 feet bgs. The following field screening samples, depths, and results were obtained at Test Pit No. 2:

Test Pit 2		
Field No.	Depth (feet)	PPM
T2-1	0 to 1	0.4
T2-2	3	79
T2-3	5.8	1.8

At Test Pit No. 2, OASIS collected Sample No. 07-CLM-T2-02 from approximately 3 feet bgs. Sample no. 07-CLM-T2-02 contained DRO at 1,500, well above the ADEC cleanup value of 200 ppm for DRO in soils. GRO, RRO, and xylenes were detected at this location; however concentrations did not exceed ADEC cleanup levels.

**Photo: 11 Time: 1316 Date: 10/12/2007 Direction: South
Subject: Excavating at Test Pit 2 (T2).**

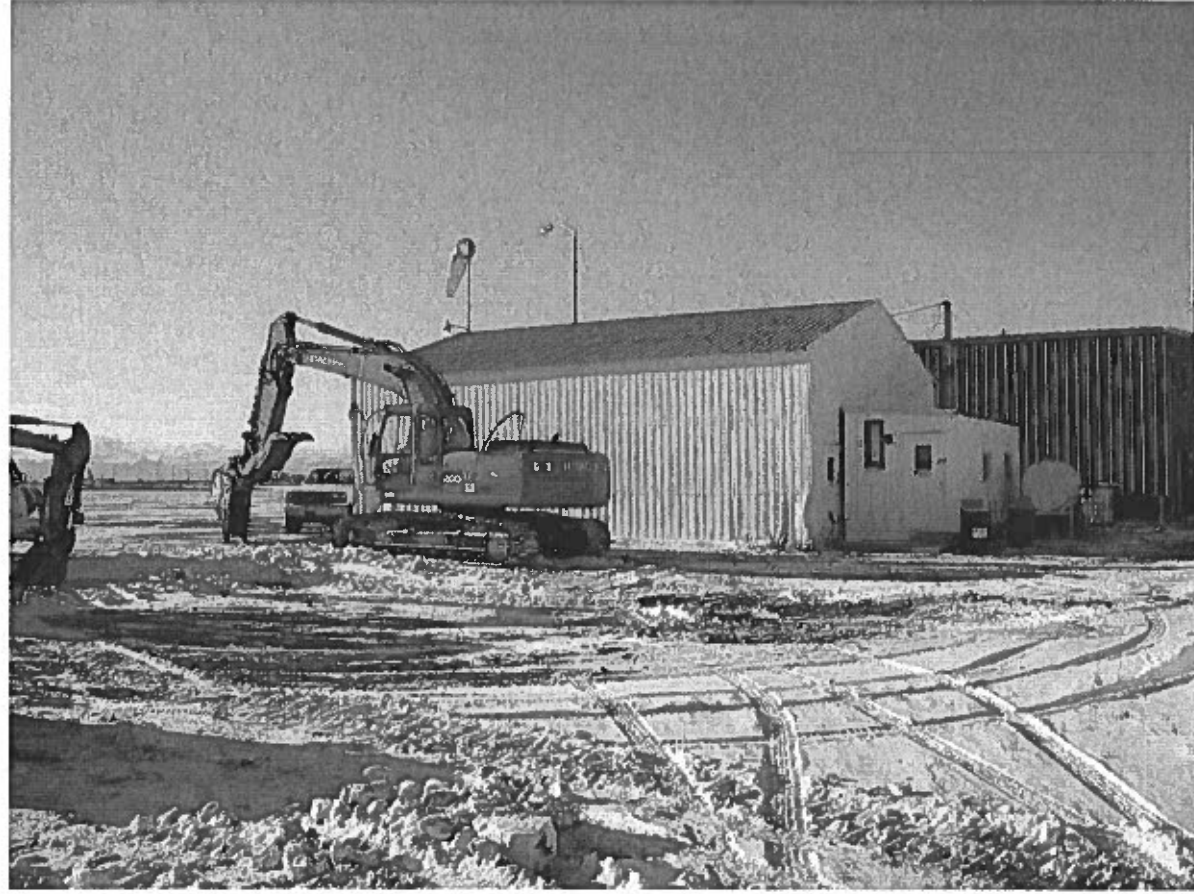
Test Pit No. 4 was located at the southeast corner of the lot, on the north edge of the airfield tarmac. The following field screening samples, depths, and results were obtained at Test Pit No. 4:

Test Pit 4		
Field No.	Depth (feet)	PPM
T4-1	0 to 1	1.7
T4-2	3.5	1.6
T4-3	7	1.1

At Test Pit No. 4, OASIS collected Sample No. 07-CLM-T4-01 from approximately 0 to 1 foot bgs. DRO and RRO were detected in sample 07-CLM-T4-01, but below ADEC cleanup levels.

Photo: 13 Time: 1437 Date: 10/12/2007 Direction: Southwest
Subject: Excavating at Test Pit 4 (T4).

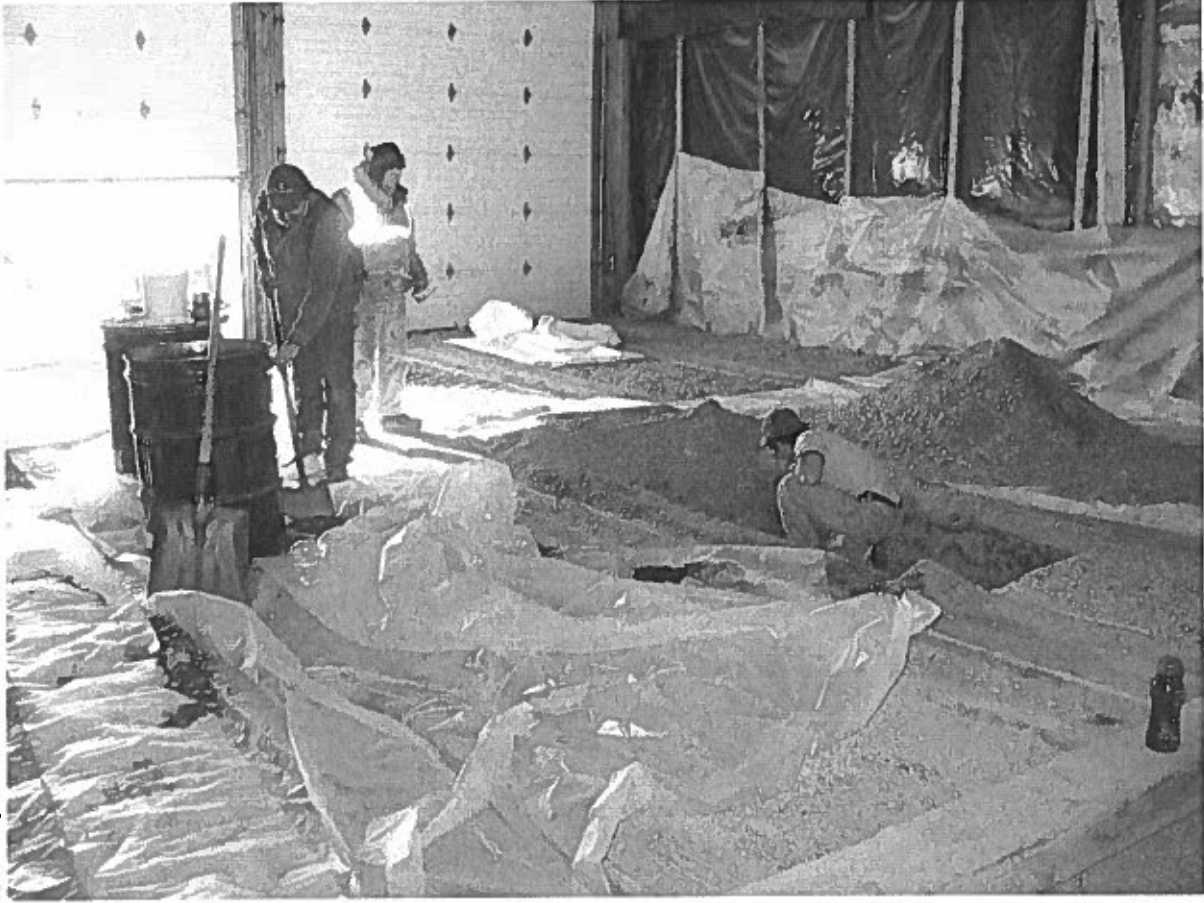
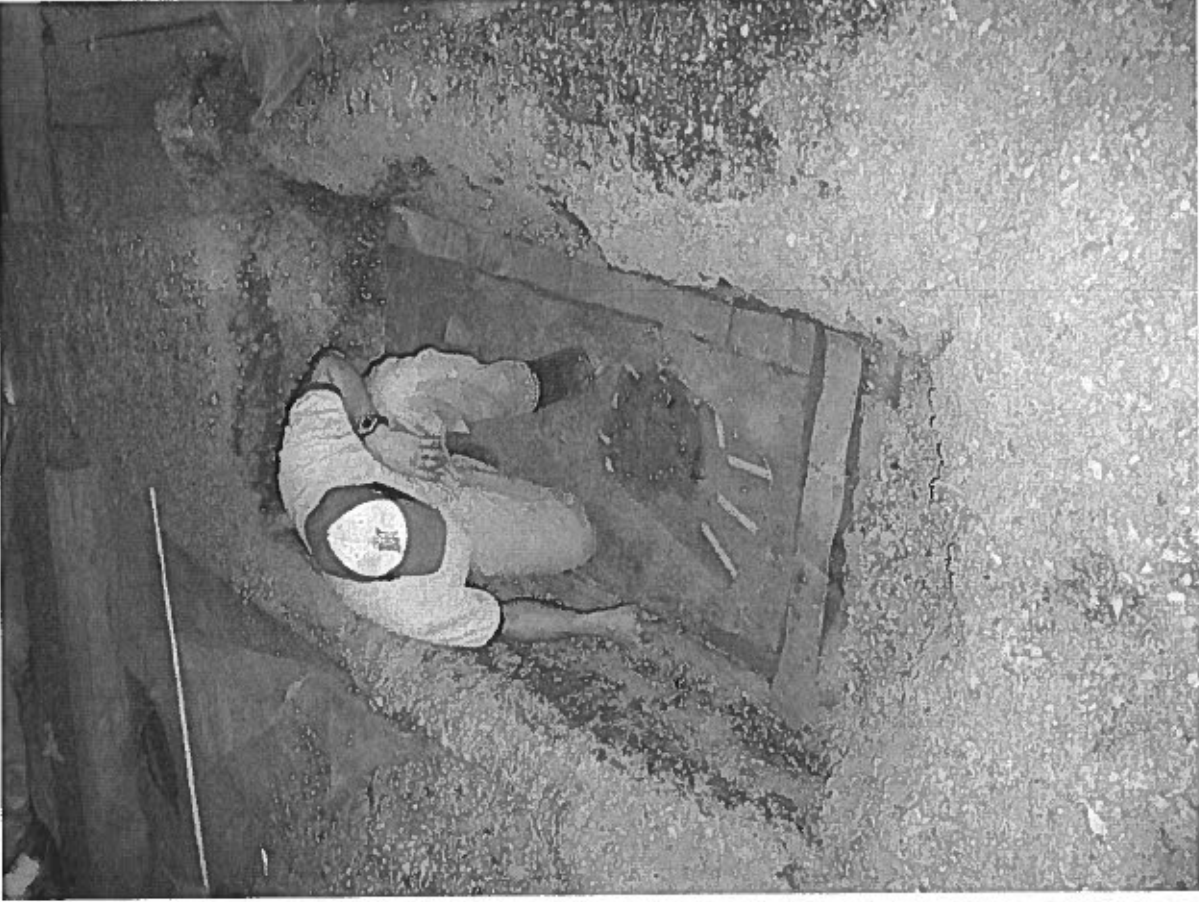
Photo: 16 Time: 1750 Date: 7/19/2007 Direction: South
Subject: Drumming soils and patching liner floor at Test Pit 1.

Photo: 15 Time: 1745 Date: 7/19/2007 Direction: North
Subject: Patching liner in floor of Hangar at Test Pit 1.

Excavated soils at Test Pit No. 1 were backfilled into the hole, and the liner was patched by Crowley. Because of soil fluffing during excavation, not all soils were placed back into the hole. Crowley drummed these remaining soils for off-site disposal with their normal operations waste stream.
