2013 LAND-FARM MONITORING ACTIVITIES

FEBRUARY 2015

Submitted to: **Icicle Seafoods, Inc.**
4019-21st Avenue West
Seattle, Washington 98199

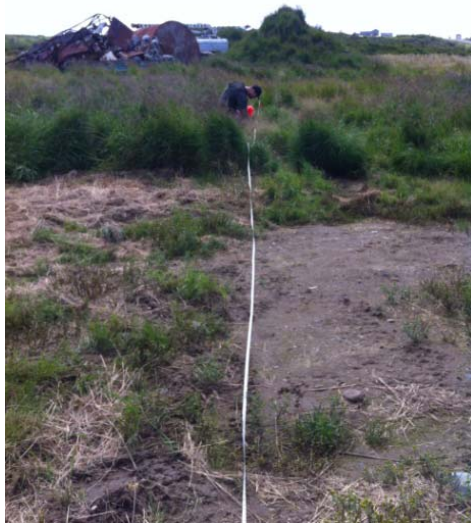
Photo 1. Establishing Grid for MI Sampling

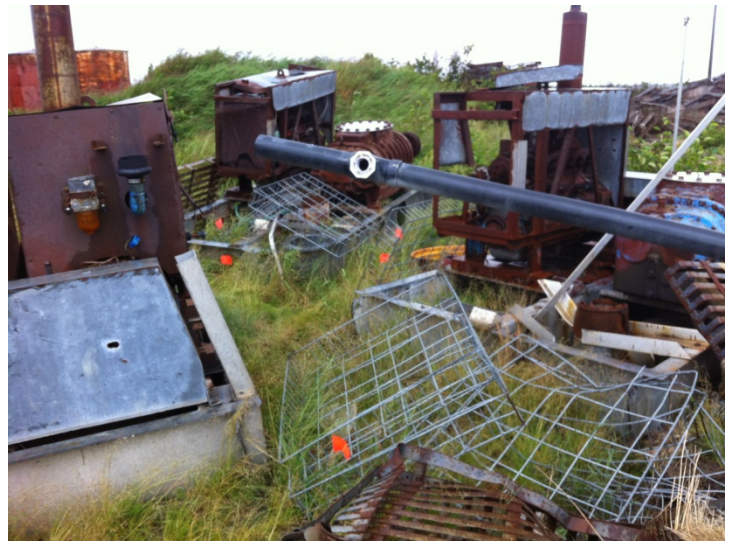
Photo 2. Establishing Grid for MI Sampling

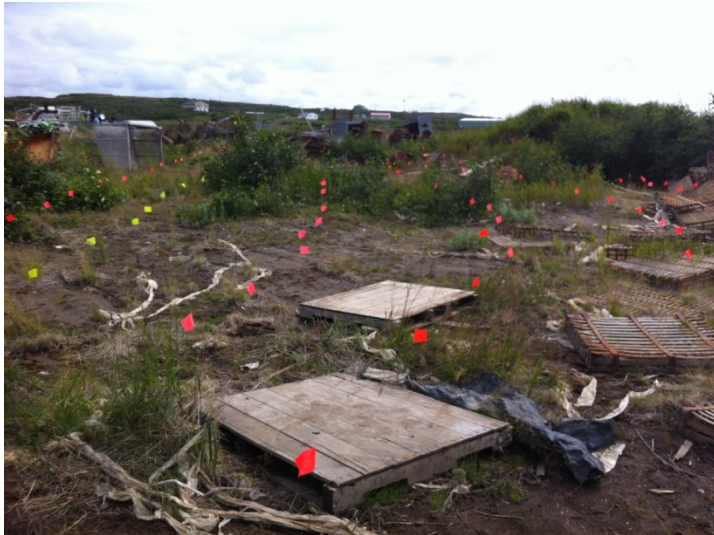
Photo 3. Establishing Grid for MI Sampling

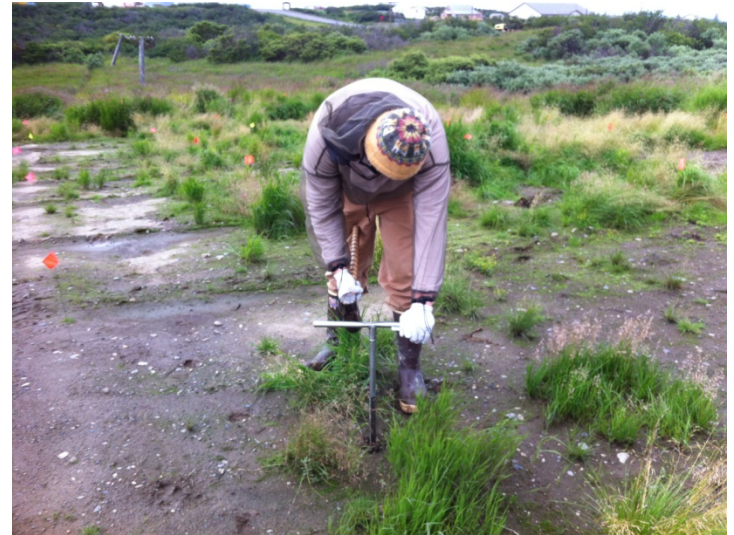
Volatile Sample Collection. The portion of each sample scheduled to be analyzed for GRO and BTEX were collected first. Each soil sample aliquot was collected utilizing a clean stainless steel sampling probe, which was 0.75-inch in diameter by 12-inches long (Photograph 4 in Appendix A). Approximately 2 to 5 grams of soil were collected from each aliquot and immediately placed into a 4-ounce amber glass jar, which had the methanol added prior to sample collection. To minimize volatilization of the contaminants, sieving was not performed for any volatile analyses (GRO or BTEX) after collection of the sample. The soil probe was decontaminated with an Alconox detergent solution, followed by a tap water rinse, between sampling each DU.

Photo 4. Collecting MI Sample Aliquot

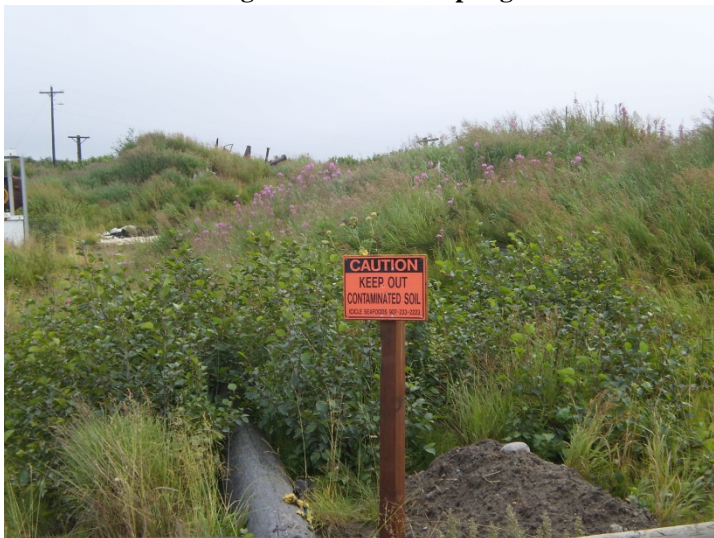
The signs marking the land-farmed soils were inspected during the 2013 field season, and the signs appeared to be in good condition. These signs warn people to stay out of the area because contaminated soils are present (Photograph 5 in Appendix A).

Photo 5. Sign for Land-Farm Areas
