Site Characterization Update: Chilkoot Lumber Company

7/11/2000

Introduction: This report was authored by Chilkat Environmental for Specialized Metal Recycling regarding the Chilkoot Lumber Company property in Haines, AK. The current intended use of the property includes recycling of the mill during summer of 2008 for future industrial uses by the site owner. The lumber mill was originally built in 1968 by local entrepreneur John Schnabel and reached a capacity of 300,000 board feet per day. The site includes a 600 foot dock, extensive mill infrastructure and a 5 megawatt thermal power plant that operated on wood waste.

Purpose: The purpose of this report is to provide timely reporting to maintain compliance with all applicable state and federal environmental regulations during the demolition of the site which is expected to be complete by August 15. To accomplish this we will summarize our progress and current activities.

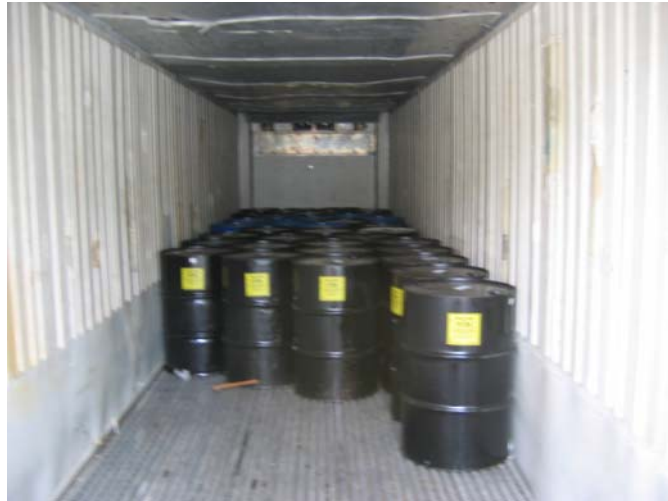
Photo 1: Trailer #1 includes Dielectric Fluid <50 ppm 38 drums and 1 overpack with gasoline contaminated at 5.87 ppm

Two trailers are being used currently to store the fluids we have drained. Trailer #1 contains 38 drums of <50ppm fluid. Trailer #2 includes 14 drums of >50ppm as well as 3 PCB transformers and a tote of PCB contaminated soil. See photos #1 and #2 respectively. Photo #3 below demonstrates removal of the last of 6 transformers from the powerhouse overhang. Photos # 4 through #6 illustrate transformer drainage technique to eliminate spillage.

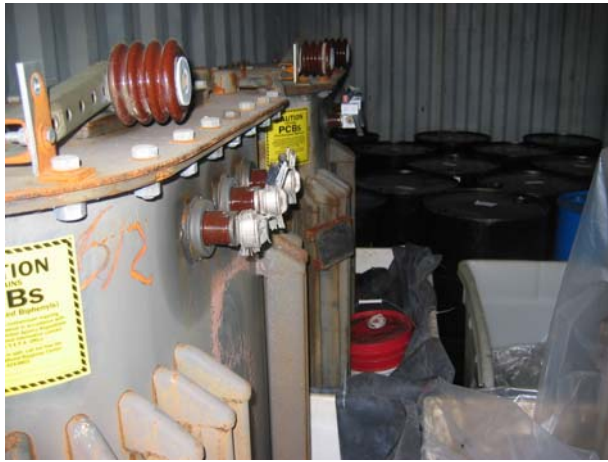
Photo 2: Trailer #2 includes 14 drums of 68ppm, 3 PCB transformers and one tote of PCB contaminated soil

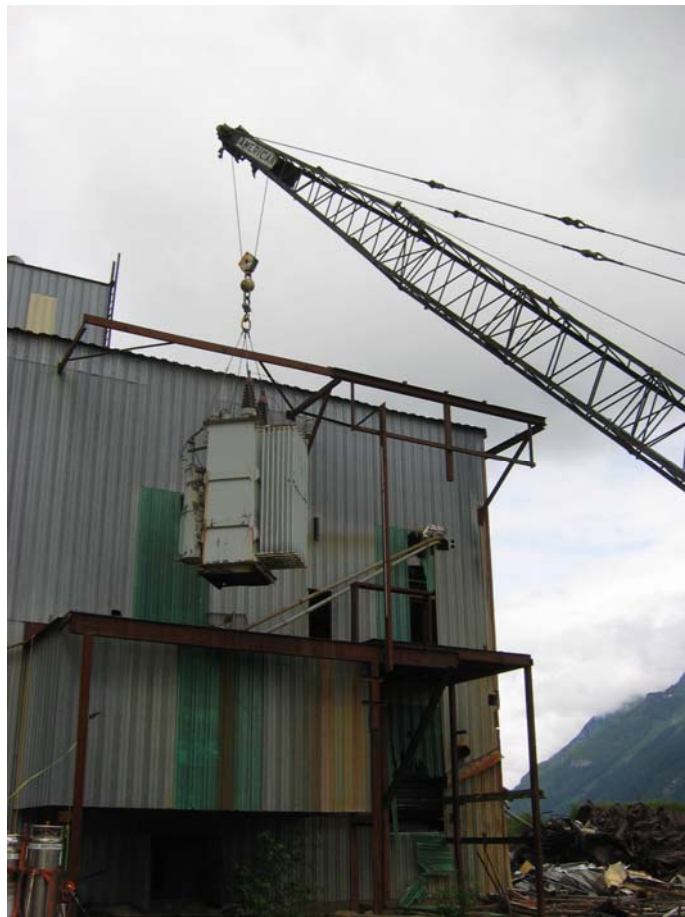
Photo #3: Removal of the last of 6 transformers from the powerhouse overhang. Transformers were drained in place before removal

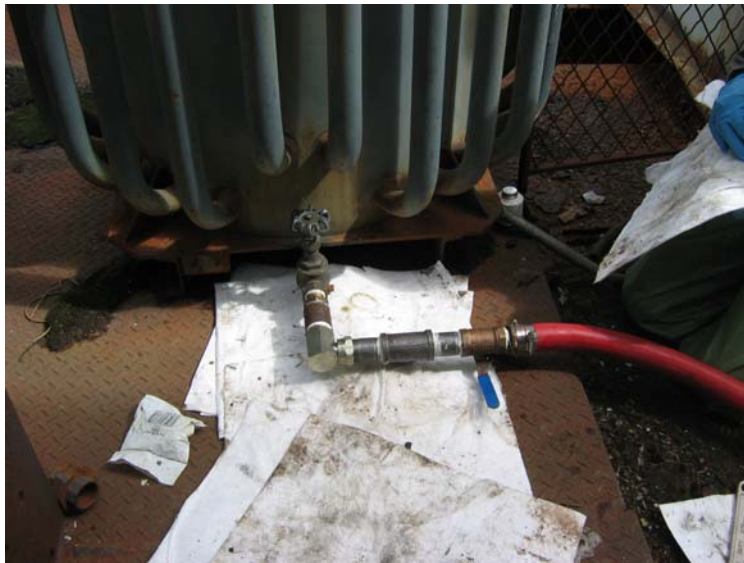
Photo #4: Redundant valve and leak proof drainage system with new high quality plumbing

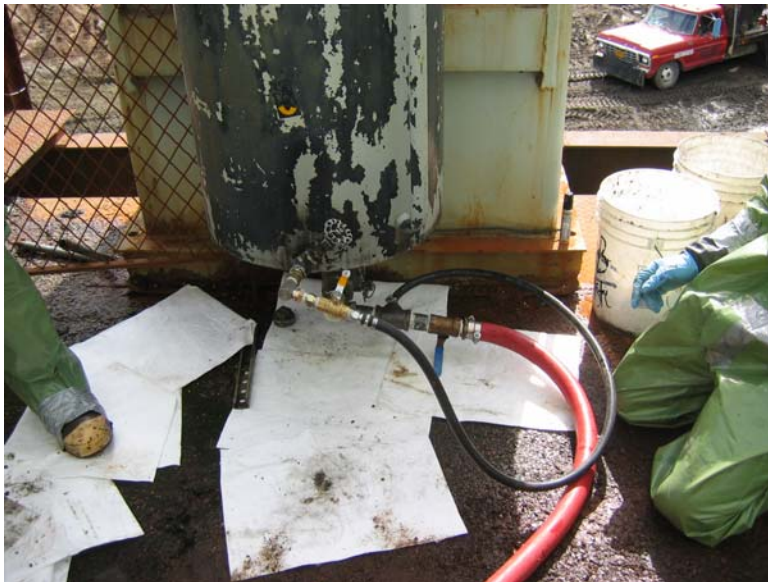
Photo #5: Redundant valves and leak proof drainage for 820 gallon transformers and expansion tank

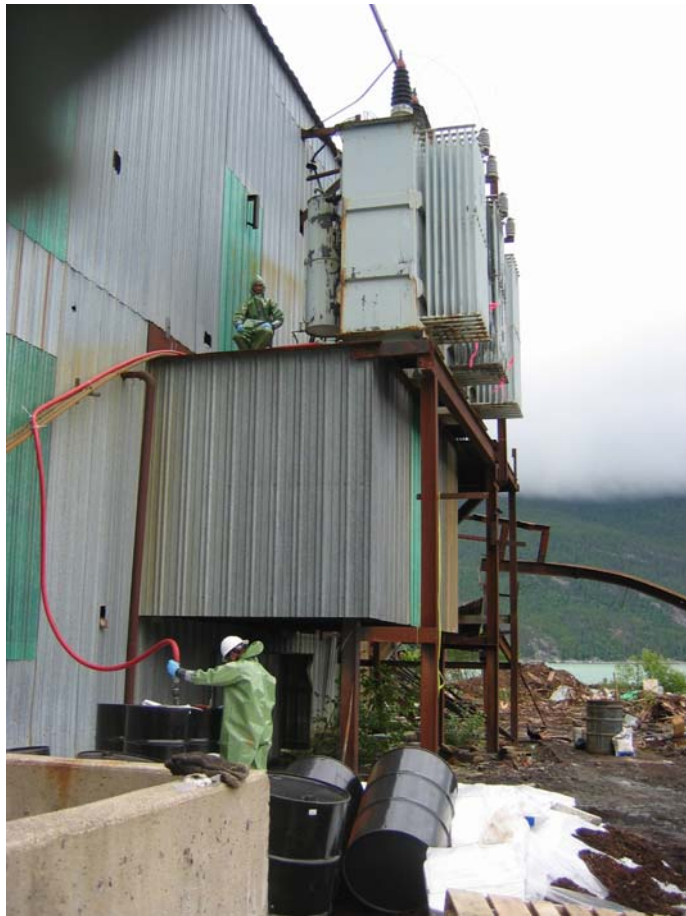
Photo #6: Transformer drainage system and containment berm. Tertiary valve at drum, secondary valve at transformer and first valve on transformer.

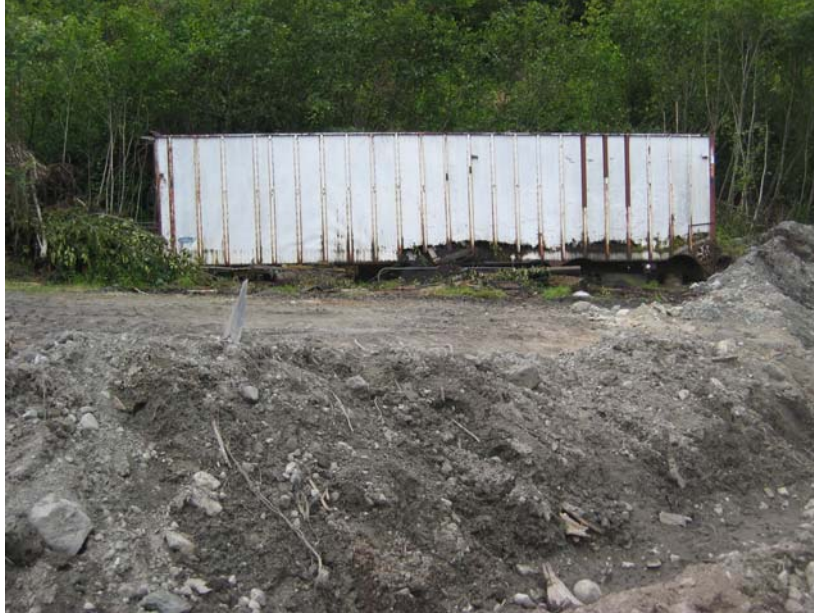
Precipitator ash has been suspected of containing Dioxin and RCRA metals. Ash beneath the precipitator was collected and added to the trailer containing the remainder of the material to permit recycling of the precipitator which was found to not contain ash.

Photo #7: Containment of precipitator ash

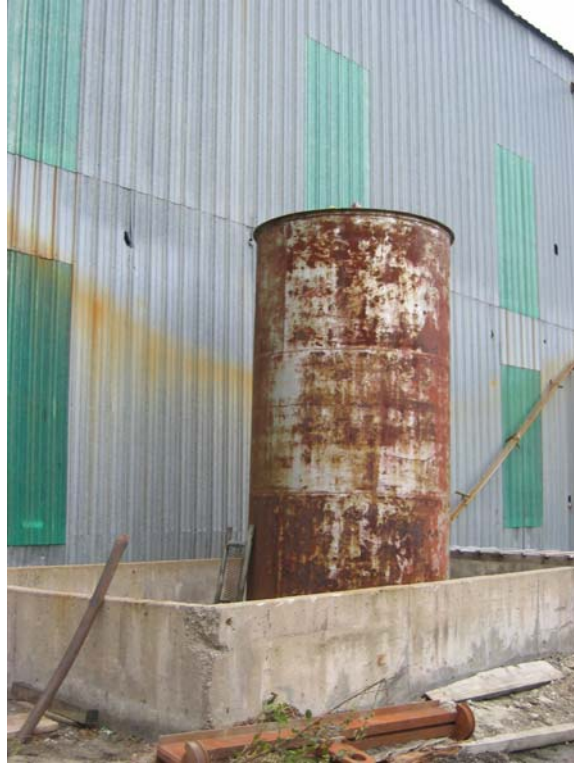
ADEC identified contaminated soil at the generator building, along the south wall of the powerhouse shop and in the unlined containment area for two 5000 gallon tanks. One tank has already been drained and removed. Contaminated soil will be easier accessed after the metal recycling project.

Photo #9: Tank containment area

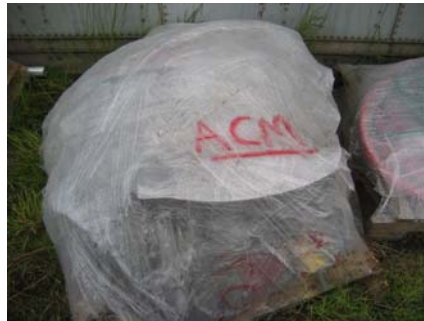
Asbestos – approximately 300 pounds of non-friable asbestos has been double bagged, palletized and shrink wrapped. Analyses for concrete board received 7-10-08 discovered 15% asbestos. This will also be double bagged, palletized and shrink wrapped. See Photo #11.

Photo #10: Asbestos

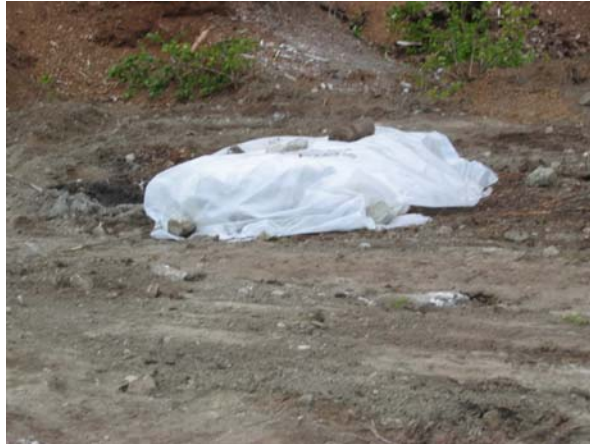
Photo #11 Asbestos concrete board

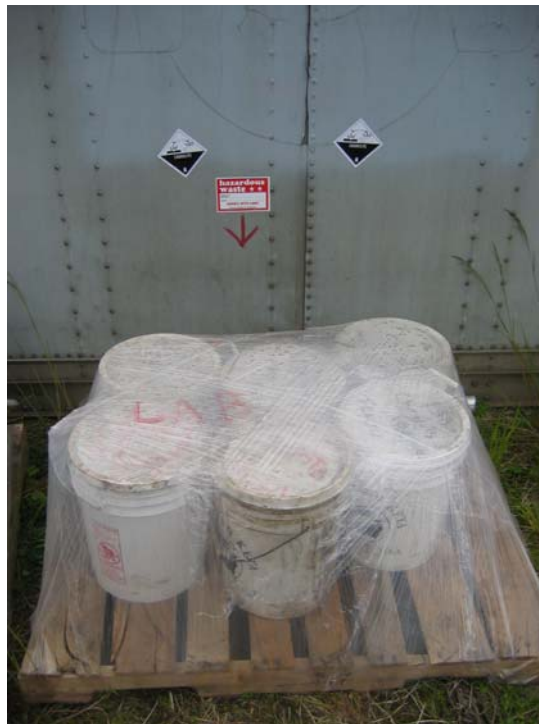
Lab Chemicals – Laboratory Chemical were removed from the powerhouse lab and placed upright stacked with one layer on the bottom of 5 gallon buckets and sealed. There are 7 buckets total. One is stored on another pallet labeled caustic. Lab chemicals are likely not compatible for storage together and must be properly managed and stored.

Photo #12: Lab Chemicals

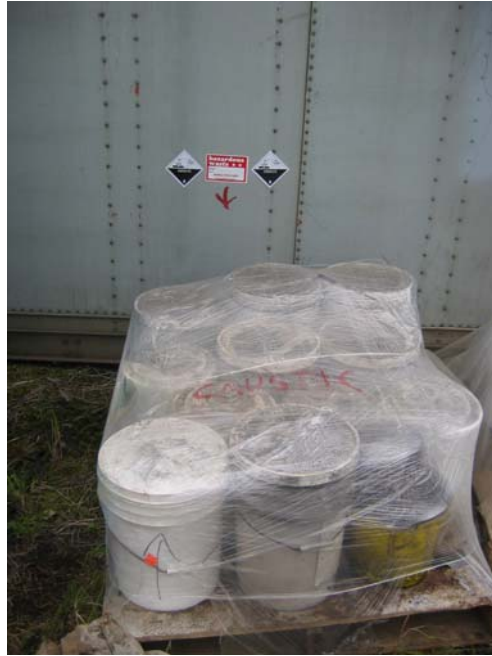
Caustic Chemicals – Caustic products are stored in 5 and 7 gallon buckets. These high alkaline products were used for raise the pH of boiler water.

Photo #13: Caustic Chemicals

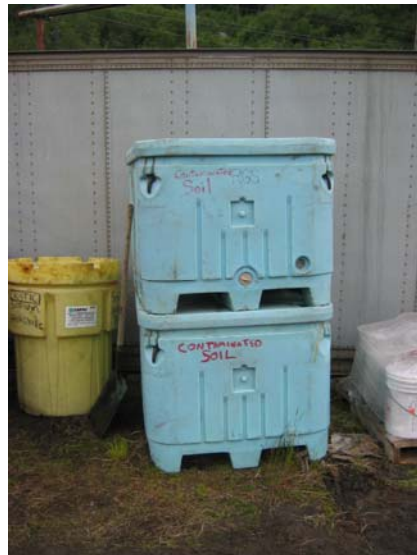
Contaminated Soil – Heavily contaminated organic soil was shoveled off the concrete floor of the powerhouse shop, generator shed and switch room. Soil was contained in two fish totes.

Photo #14: Contaminated Soil

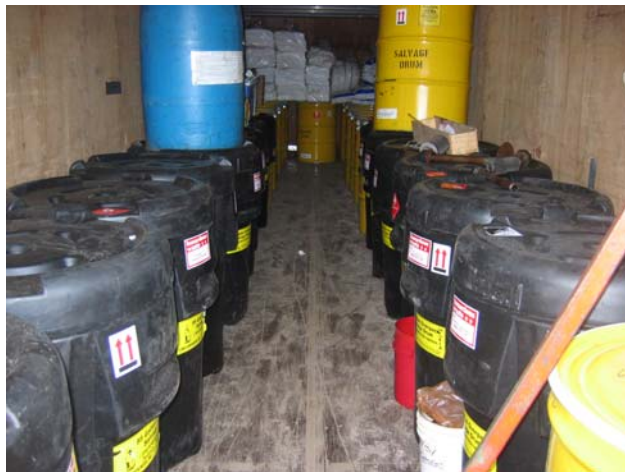
Overpacks – 36 overpacks are stored in and around trailer #3. This includes;

- 3 drums of Xylene (poor drums containing new product)
- 16 drums of overpacked 55 gallon drums (containing oil based paint in failing drums)
- 1 overpack full of 1 gallon containers of liquid oil based paint
- 6 overpacks of suspected NP-1 wood preservative (The drums were severely deteriorated. To reduce personnel risk drums were pumped with a drum pump into new drums. 3 overpacks include the new drums containing the fluid. 3 overpacks include the deteriorated drums with under 2 gallons of fluid each.),
- 1 overpack of Exxon Type 3 Heavy grease lubricant. (drum is failing but product is new)
- 8 overpacks of Sodium Hydroxide (pH ranging from 11 to 14. Product used to alkalinize boiler water)
- 1 overpack with PCB contaminated solid waste

Photo #15: Overpack Trailer from entrance

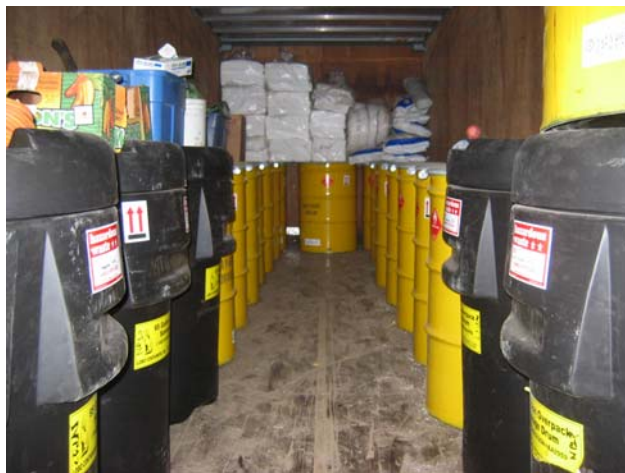
Photo #16: Overpack Trailer from center

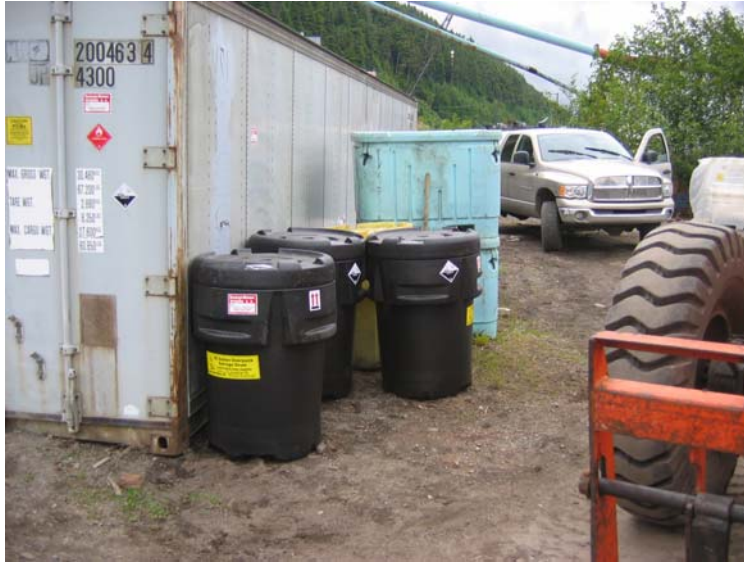
Photo #17: Overpack overflow adjacent to Overpack trailer

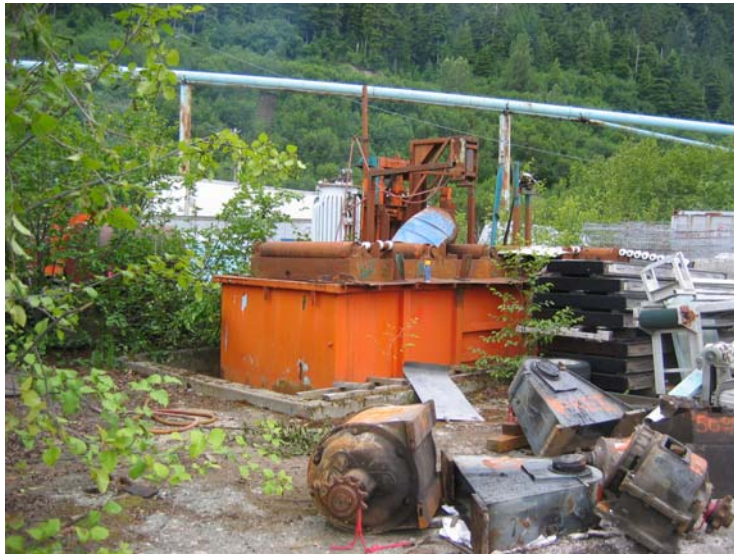
The dip tank was used to preserve wood by submerging sawn lumber in NP-1 wood preservative manufactured by Kop-Coat. The tank has been flushing with rainwater for at least 17 years since it was last used. However, due to its past use, ADEC has requested the estimated 2000 gallons of tank water be pumped through a carbon filter before discharge. Chilkat Environmental will filter out the water as soon as possible to use the containment for improved safety of transformer draining which is planned to occur by 7-18-08.

Photo #18: Dip Tank includes orange metal structure and concrete containment. Drained gear boxes are in the foreground destined for recycling

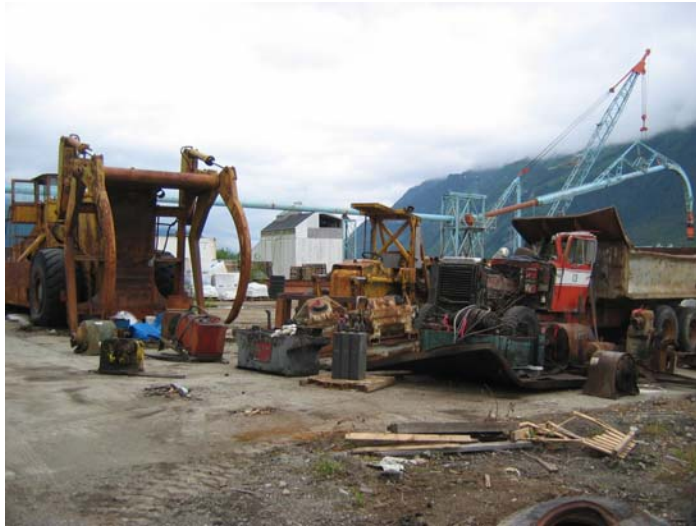
- Log loader
- Log Yarder
- Grader
- Car
- Dump truck
- Approximately 12 gear boxes and 6 hydraulic units
- Forklift
- 3 large gear boxes and wood chip blower above road
- Drum of waste diesel at bunkhouse
- 3 to 5 non-detect transformers
- Underground storage tank above ground with fluid near bunkhouse

Photo #19: Some of the equipment left to drain on concrete pad

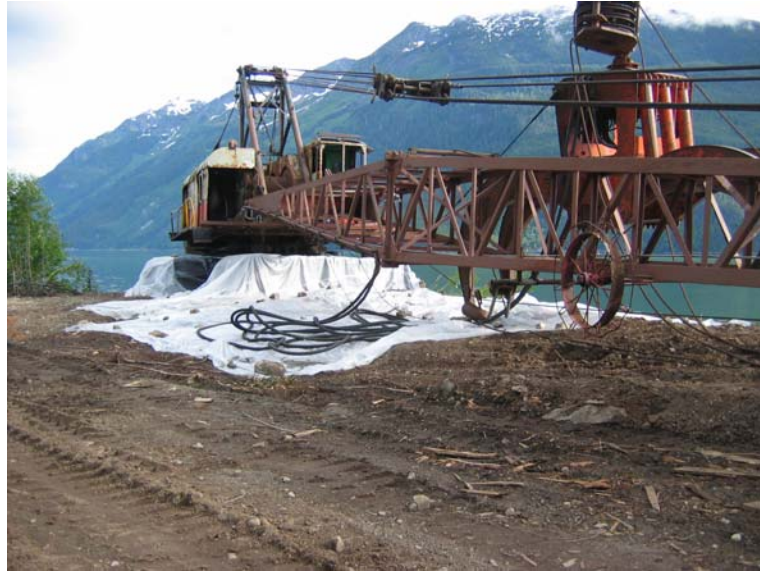
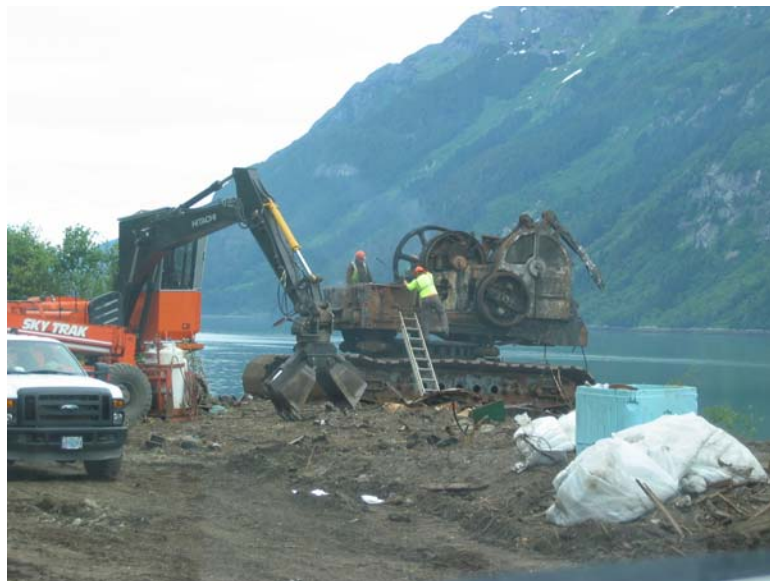
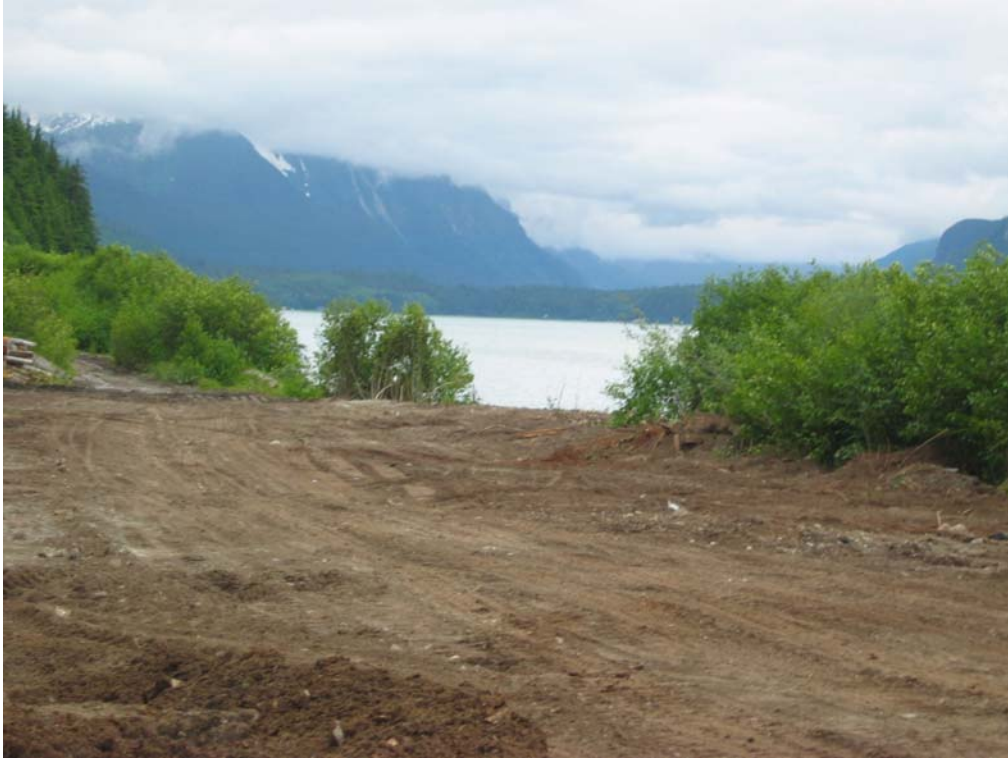
Chilkat Environmental was able to get the crane running for SMR to remove the boom and swing the counter weight away from the ocean to prevent loss of containment. Removal of the crane was very successful with no loss of fluids or debris.

Photo # 20: "Going"

Photo # 22: "Gone"
