**Sampling and Analysis Report (2018)**  
**Haines Sawmill Site: Stockpile B**  
**File: 1508.38.009; Hazard ID 2378**

Kai Environmental Consulting Services, LLC  
9000 Glacier Highway, Suite 302  
Juneau, AK 99801

**February 2019**

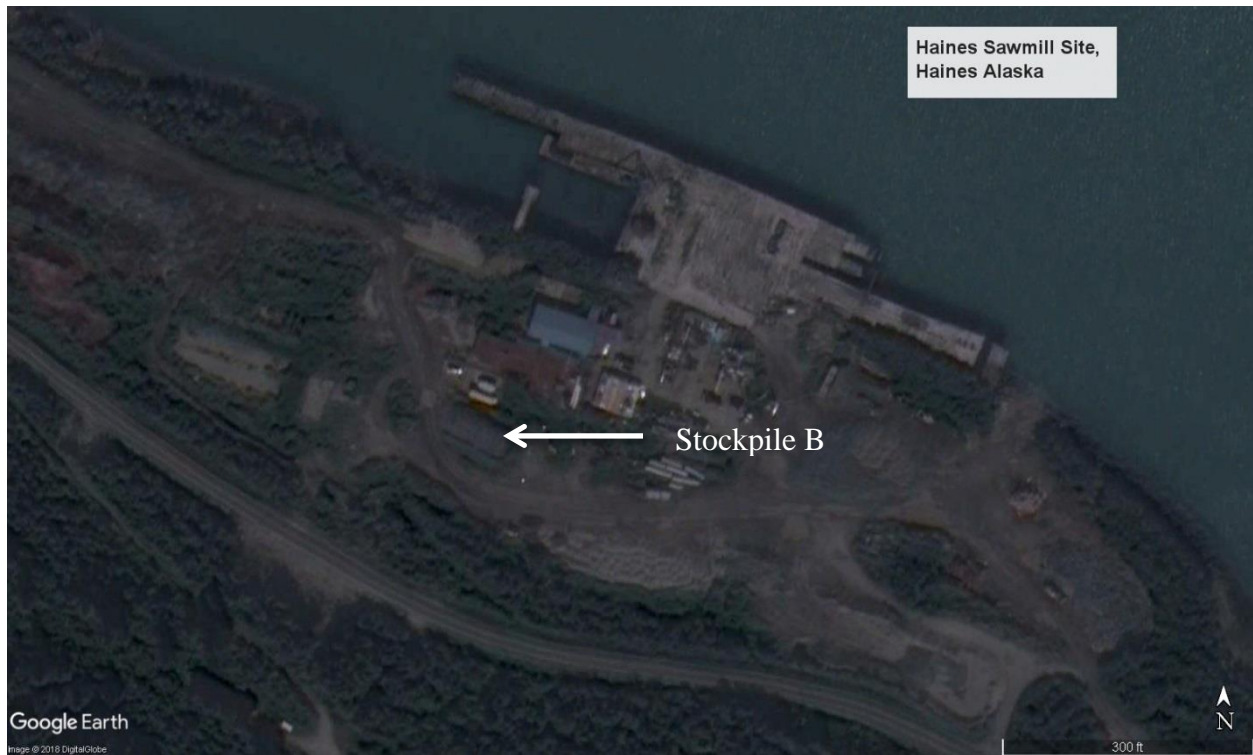
**Photo 1. Location of Stockpile B at the Haines Sawmill site in Haines, Alaska.**

The original dimensions of Stockpile B were 73 feet long by 29 feet wide by 16 feet tall (Chilkat Environmental, 2014), equating to approximately 1,255 cubic yards of contaminated soil. Records indicate that an estimated 170-320 cubic yards of soil remain in the stockpile, dependent upon whether or not a lift of 150 cubic yards was performed in the fall of 2016 (Chilkat Environmental, 2016b). It is located on relatively flat ground approximately 200 feet from the shoreline. Photo 1 depicts 2015 Google Earth aerial imagery of the Haines Sawmill site, indicating the location of Stockpile B.
