**NEW STUYAHOK OLD AVEC TANK FARM
DIESEL CONTAMINATED SOIL**

SITE INVESTIGATION REPORT

ADEC Project: #11269925601

TPECI Project: #1146-04

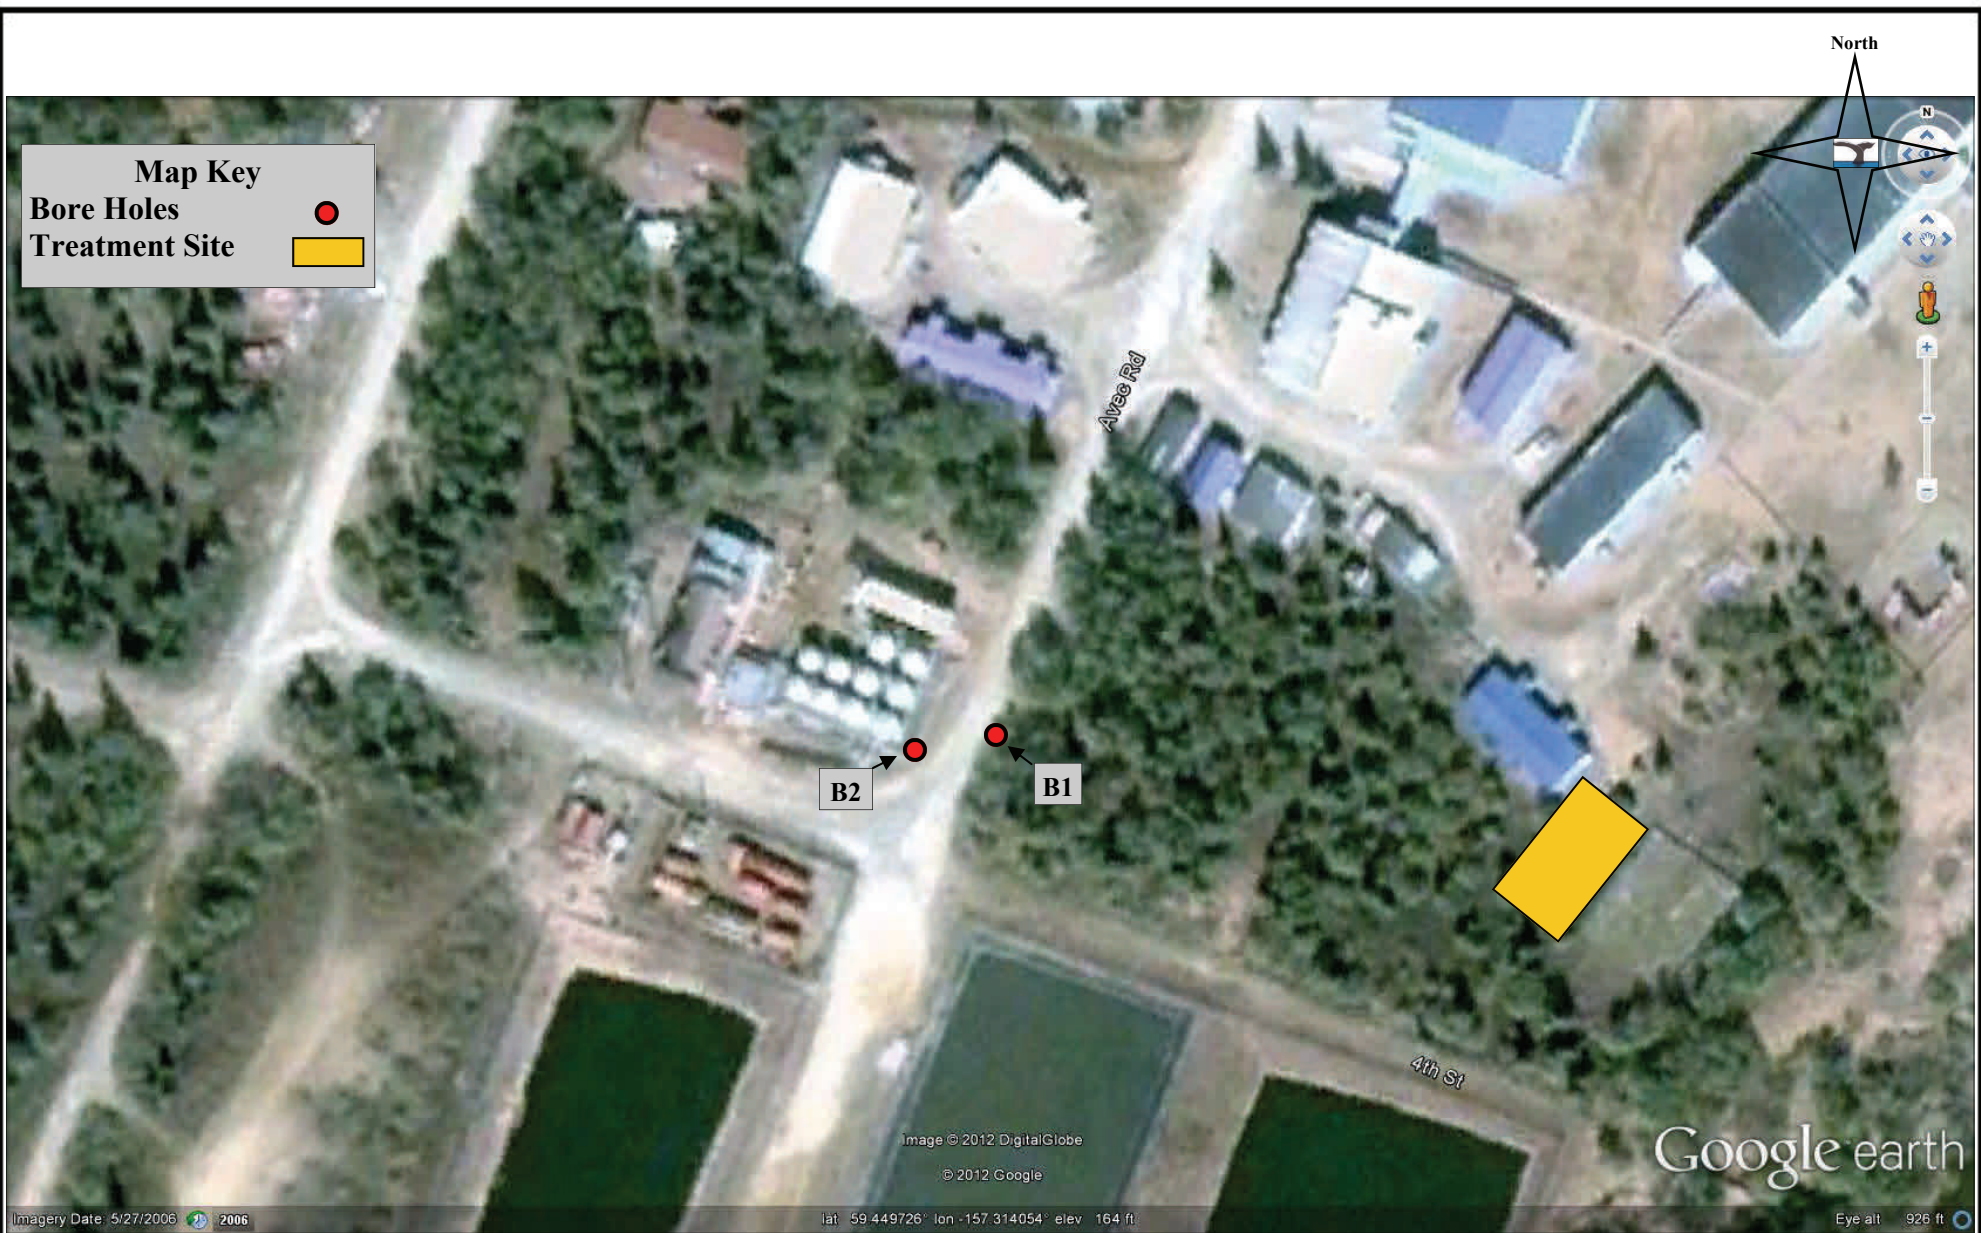
TPECI staff confirmed utility locations and Discovery Drilling moved into position at bore hole #1. This bore hole was located across the street from the new City tank farm dike (Figure 2). After a safety meeting, Discovery began drilling using an auger attachment and direct push split spoon sampler. No frozen soil was encountered. Samples were collected at five foot increments to the 25-27 foot depth. Samples were collected as described in the approved Corrective Action Plan. The PVC well screen was then inserted into the bore hole.

Once complete, Discovery relocated the drill rig and set up to begin drilling bore hole #2. This bore hole was located at the southeast corner of the new City tank farm dike, approximately six feet from the dike wall. Samples were collected in the same manner as bore hole #1. No frozen soil was encountered. Samples were collected to the 20-22 foot depth.

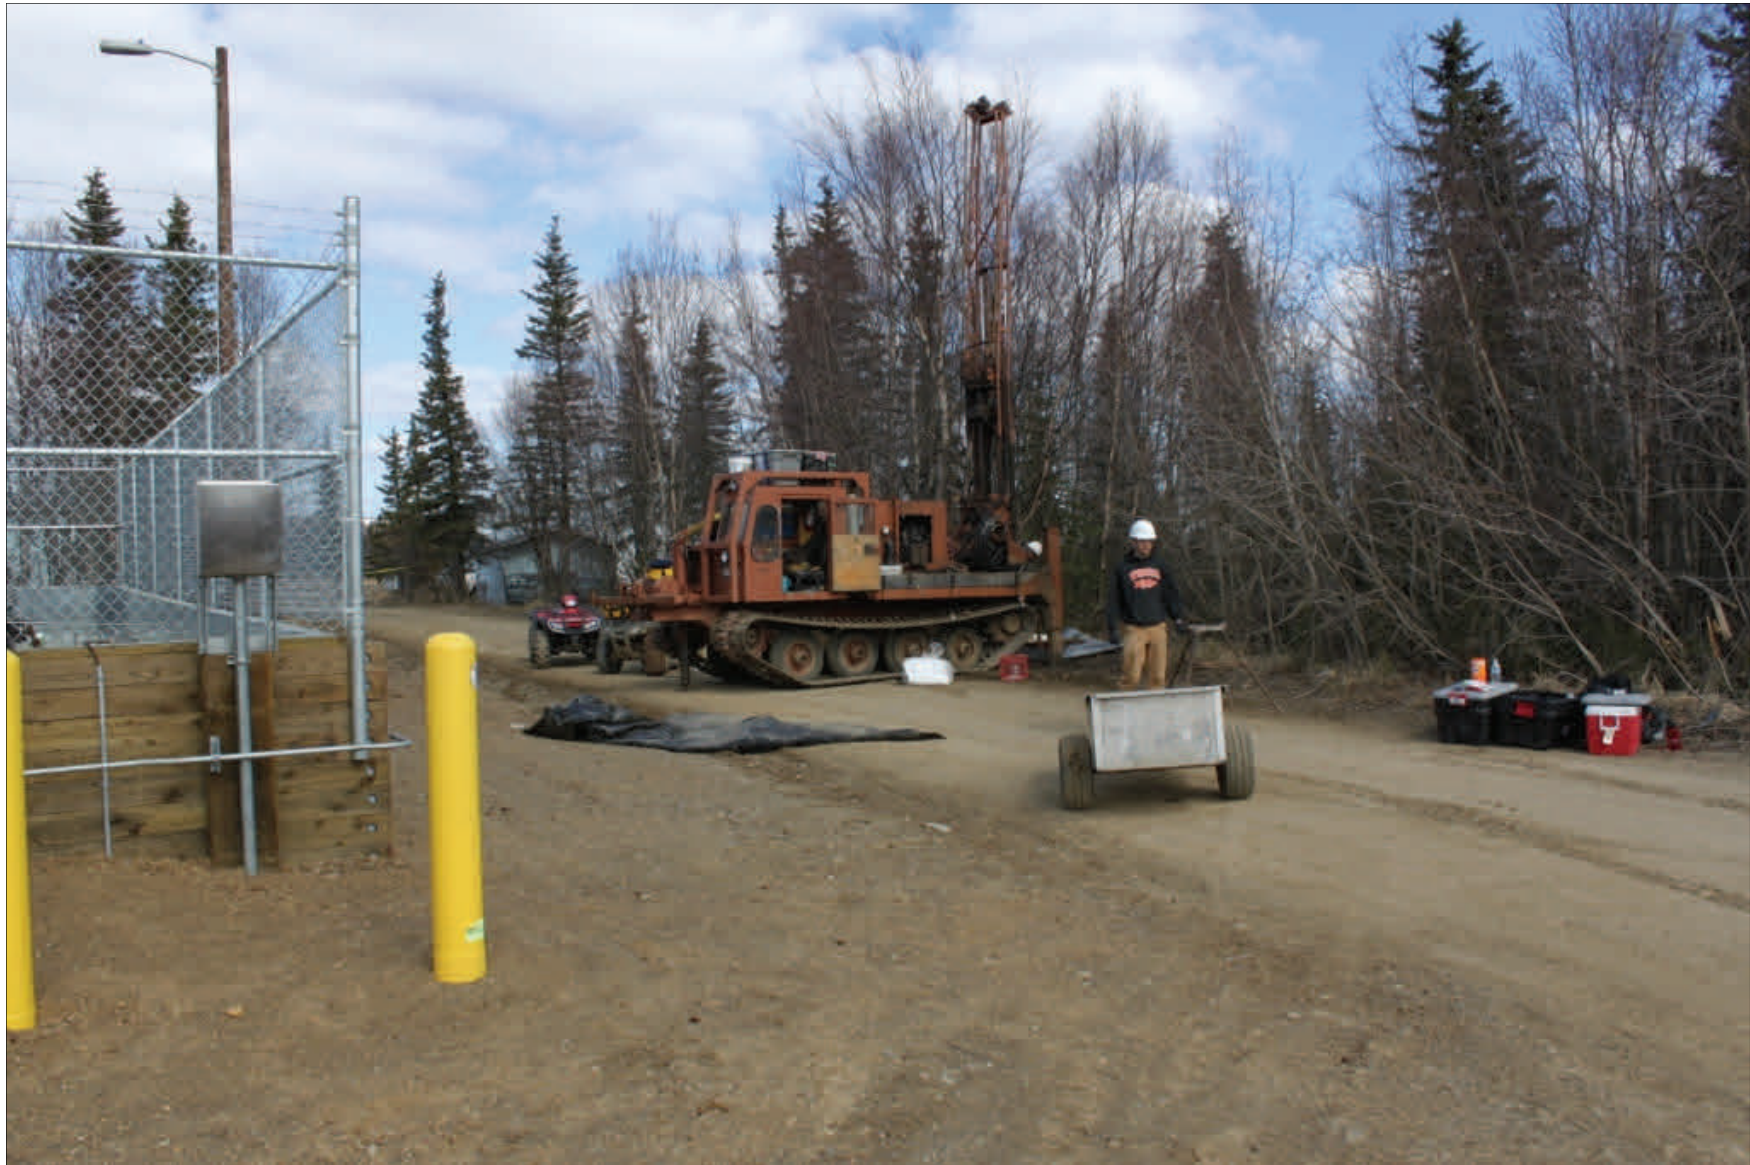
Appendix A, Page #1

Bore Hole #1—East of New Tank

Concentrations for DRO at soil sample B1 – 10-12 was 500 mg/Kg, which exceeded the ADEC cleanup levels of 250 mg/Kg. The water sample at MW#1 was 1.9 mg/Kg, which slightly exceeded the ADEC cleanup levels of 1.5 mg/Kg. Concentrations for DRO at soil sample B2 – 10-12 was 668 mg/Kg. Groundwater results did not show concentrations above ADEC cleanup levels in MW#2.

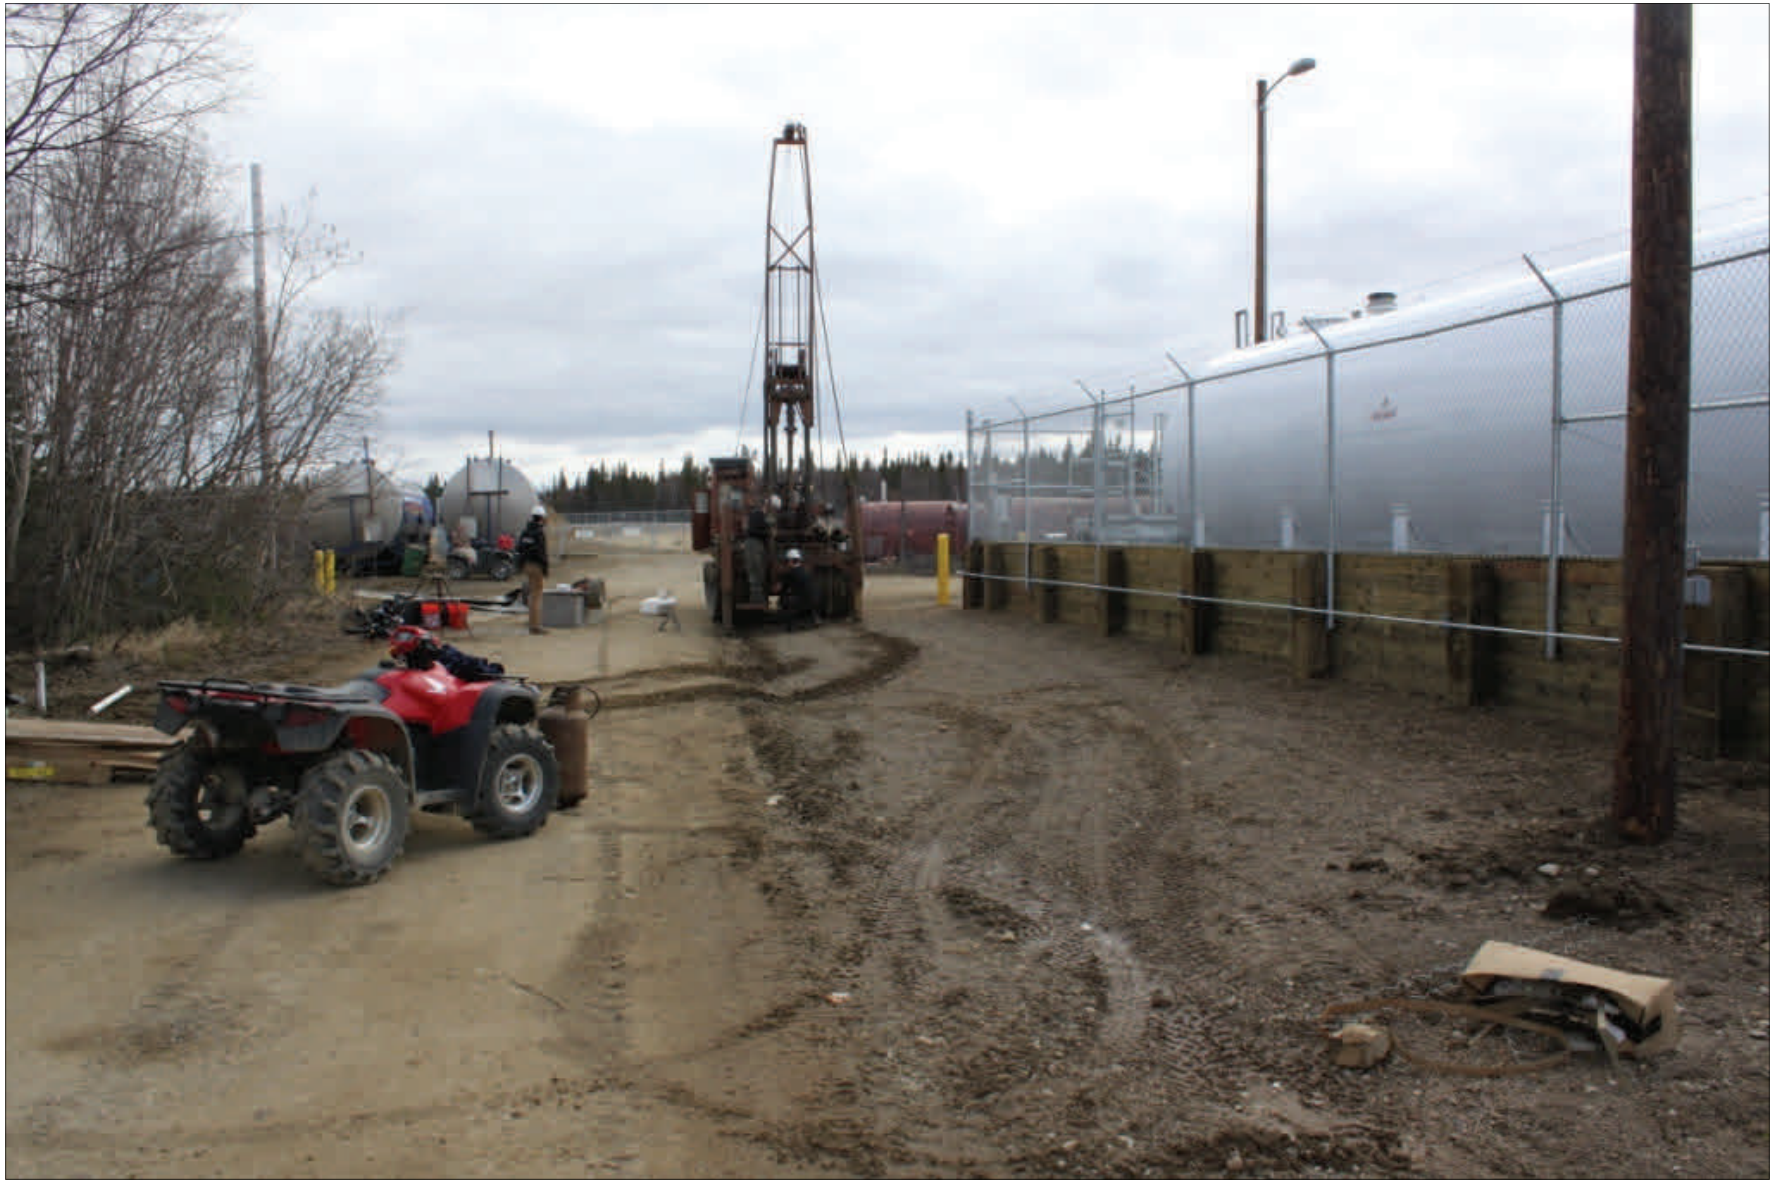
Appendix A, Page #2

Bore Hole #2—SE Corner of New Tank Farm

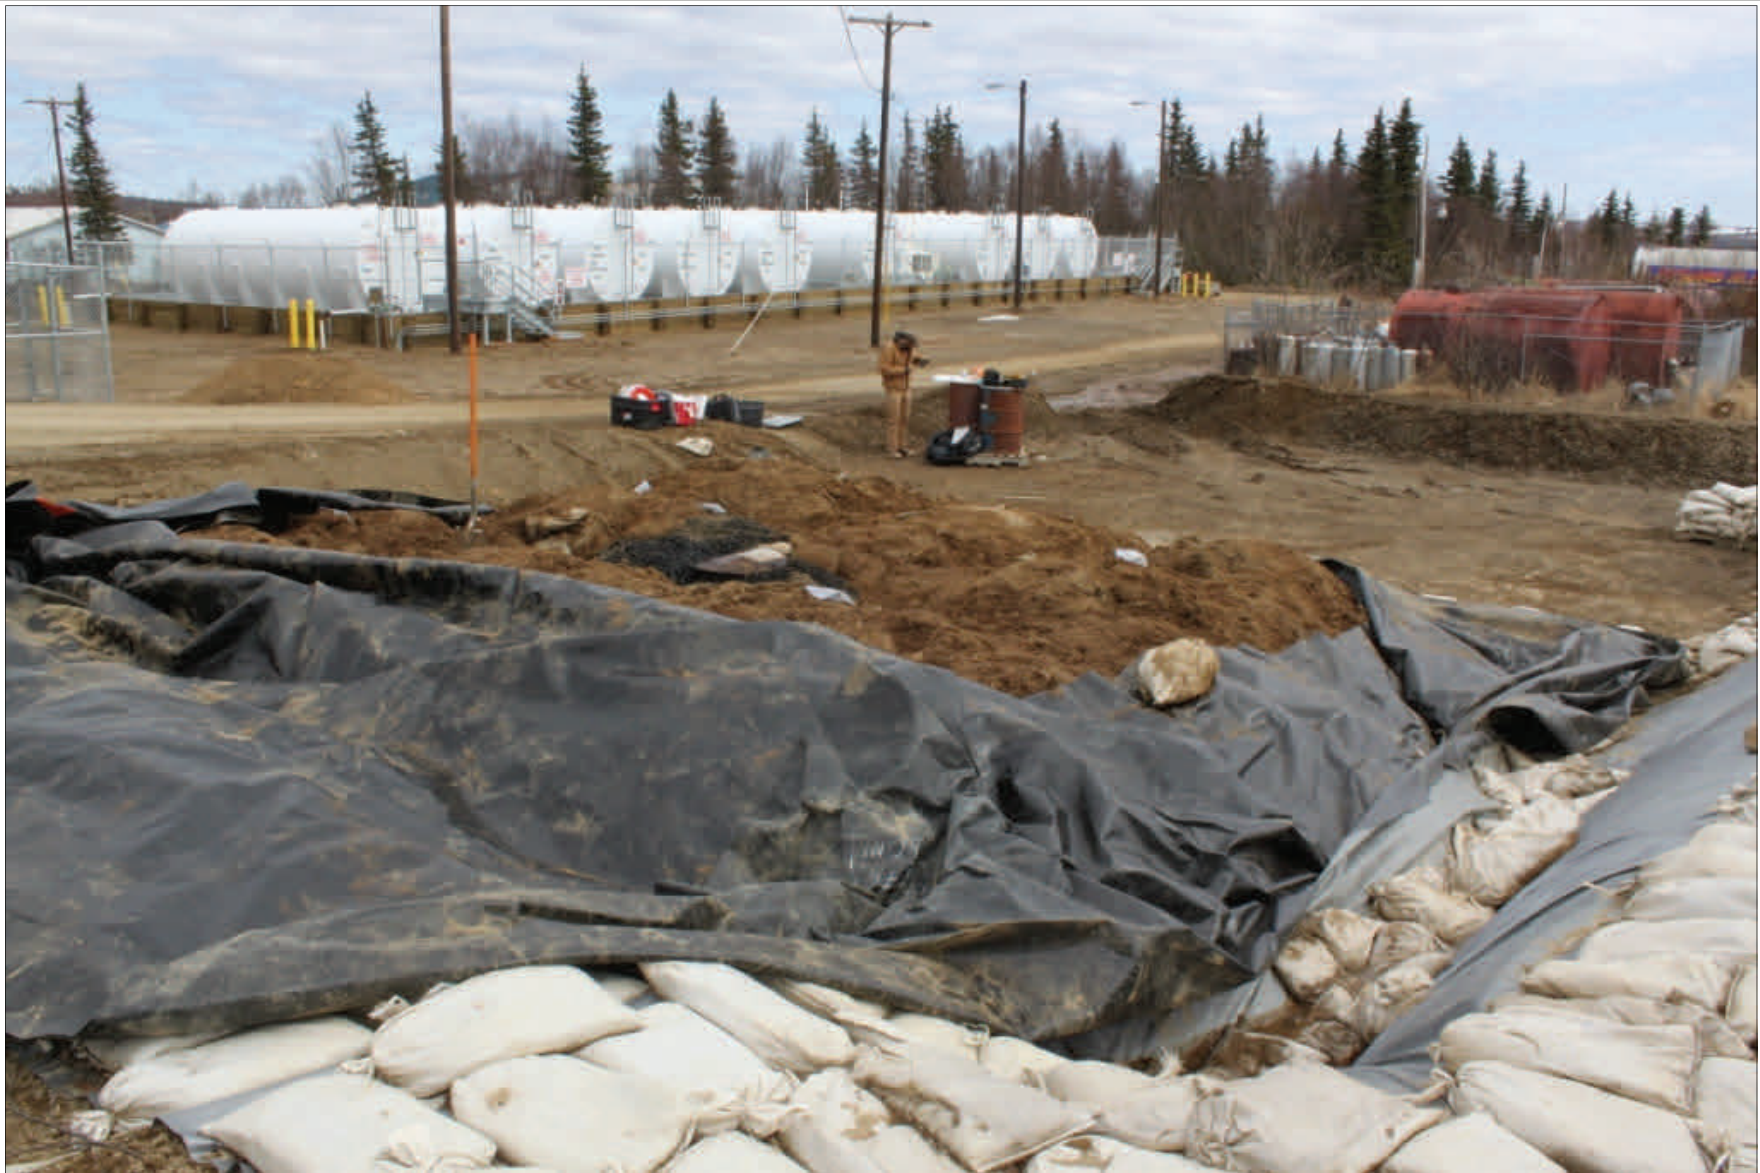
Appendix A, Page #3

Stockpile Sampling

On Wednesday May 16, 2012, TPECI staff, Wade Collins and Erik Mundahl, traveled to New Stuyahok, Alaska. Once on site, the stockpile materials was uncovered. A total of seven screenings were collected. From those screenings, three samples were sent to the laboratory for analysis. Table 1 displays the screening results.

TPECI used the ADEC Method Two-Petroleum Hydrocarbon Soil Cleanup Level for the analysis of laboratory samples. Soil samples collected from the stockpile showed high levels of DRO. The highest DRO samples were collected and the results were 8,220 mg/Kg for S4, 12,200 mg/Kg for S5, and 9,360 mg/Kg for S6. The ADEC cleanup level for DRO was 250 mg/Kg. The stockpile materials will be tilled and sampled in accordance with the Landfarming Technical Memorandum (March, 2011).

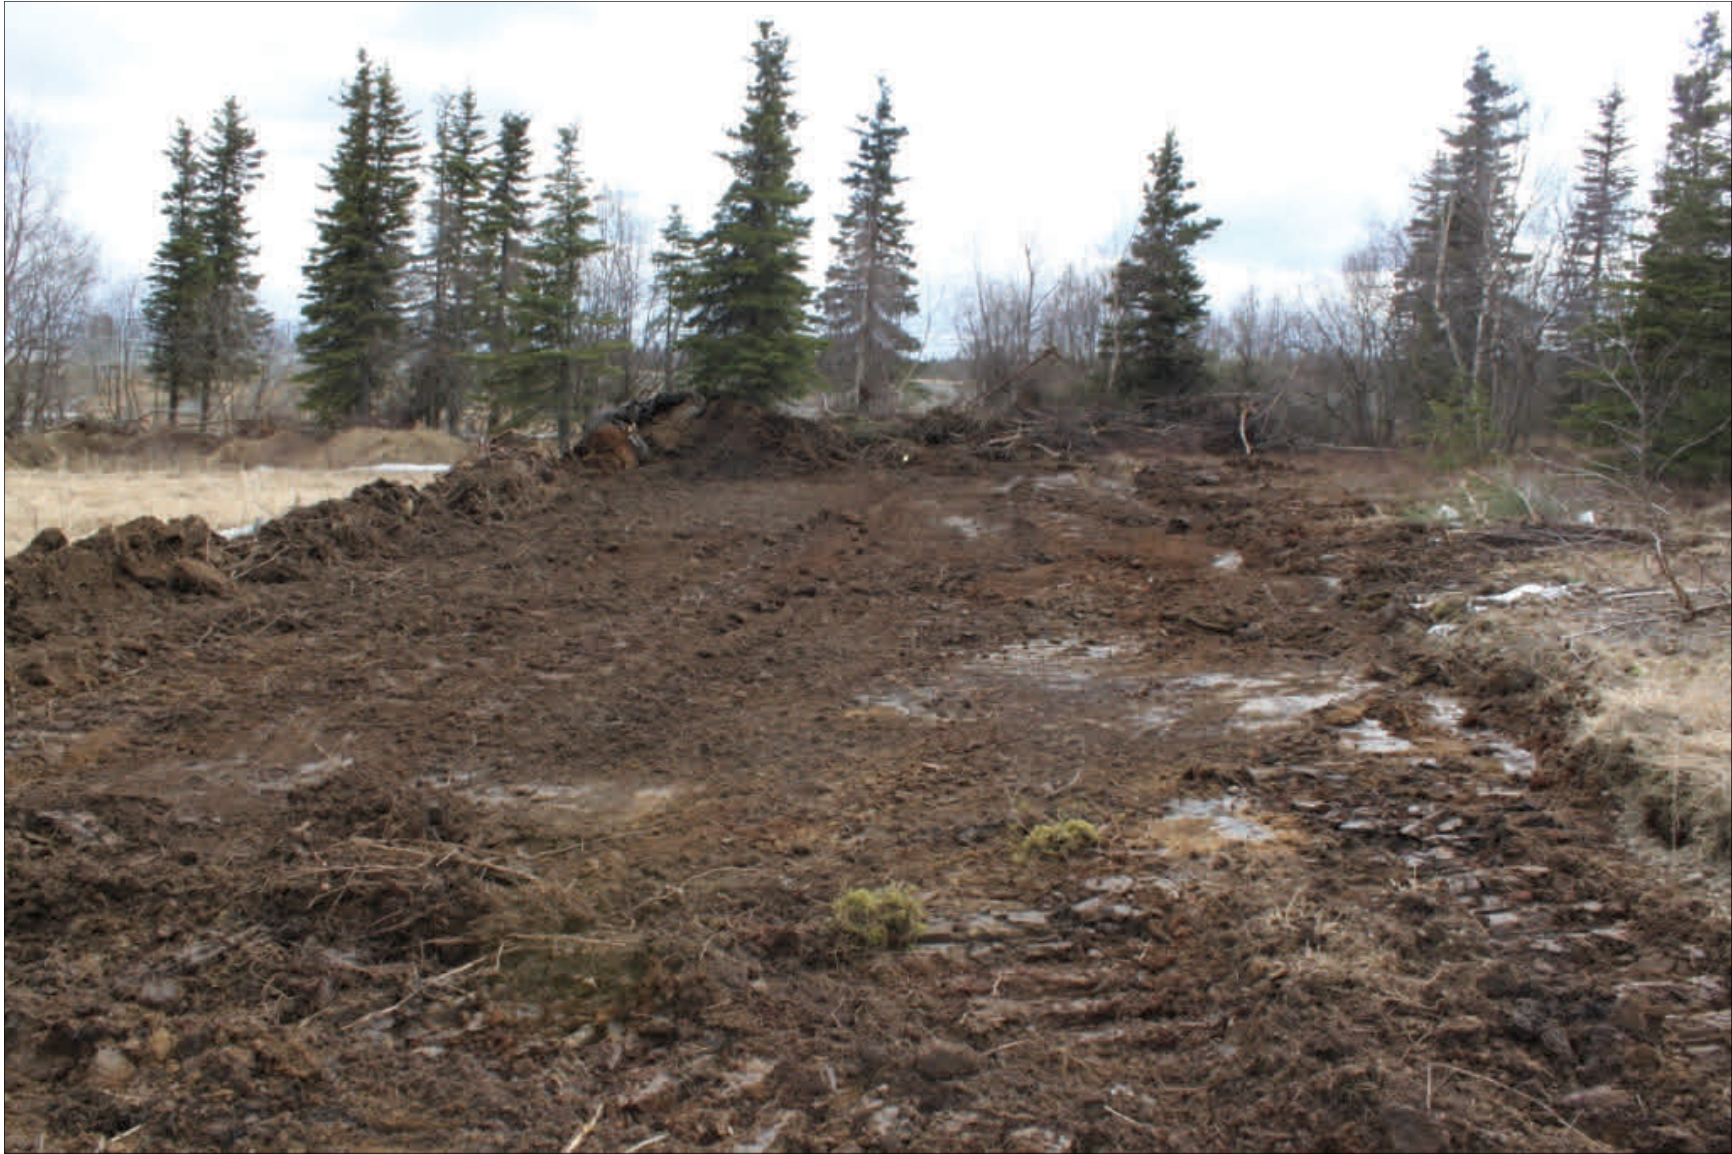
Appendix A, Page #4

Treatment Site Before Material was Brought in

TPECI staff inspected the Southwest Region School District (SRSD) property that was to be used as a treatment site for the 70-cubic yards of contaminated soil. After confirming the location with SRSD, STG cleared vegetation and built berms using clean soil.

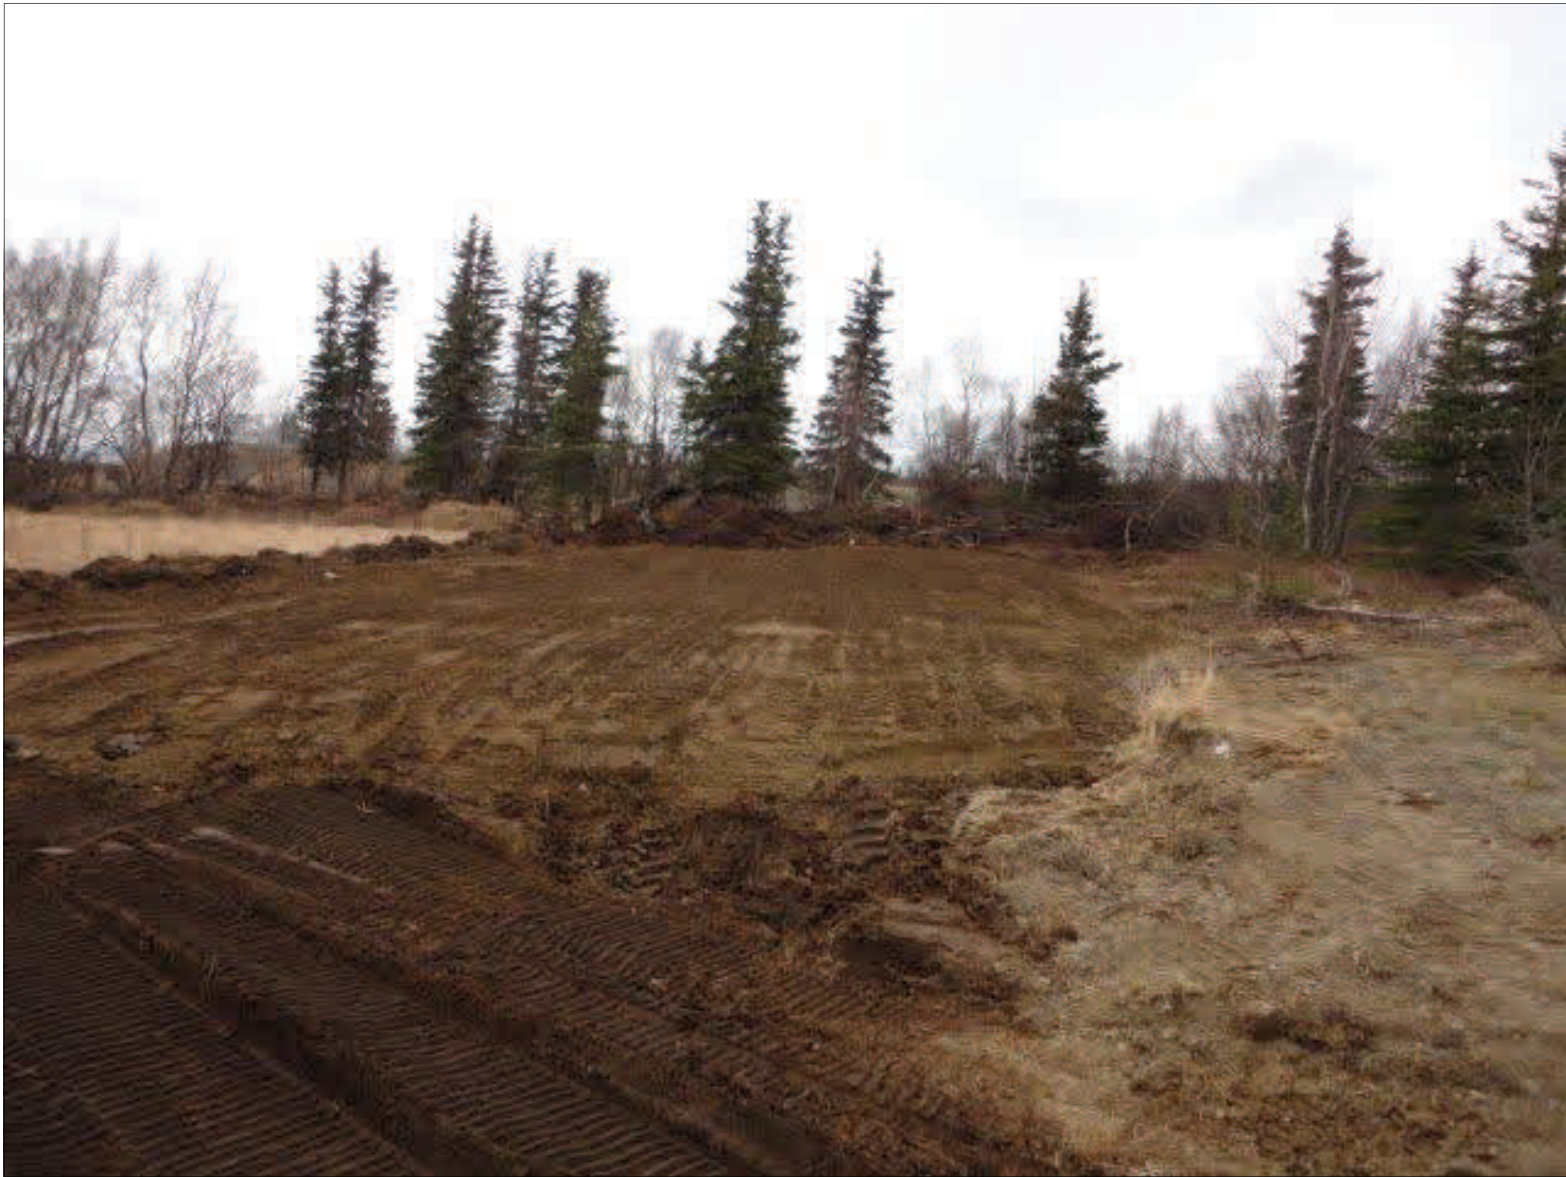
Appendix A, Page #5

Treatment Site With Contaminated Soil

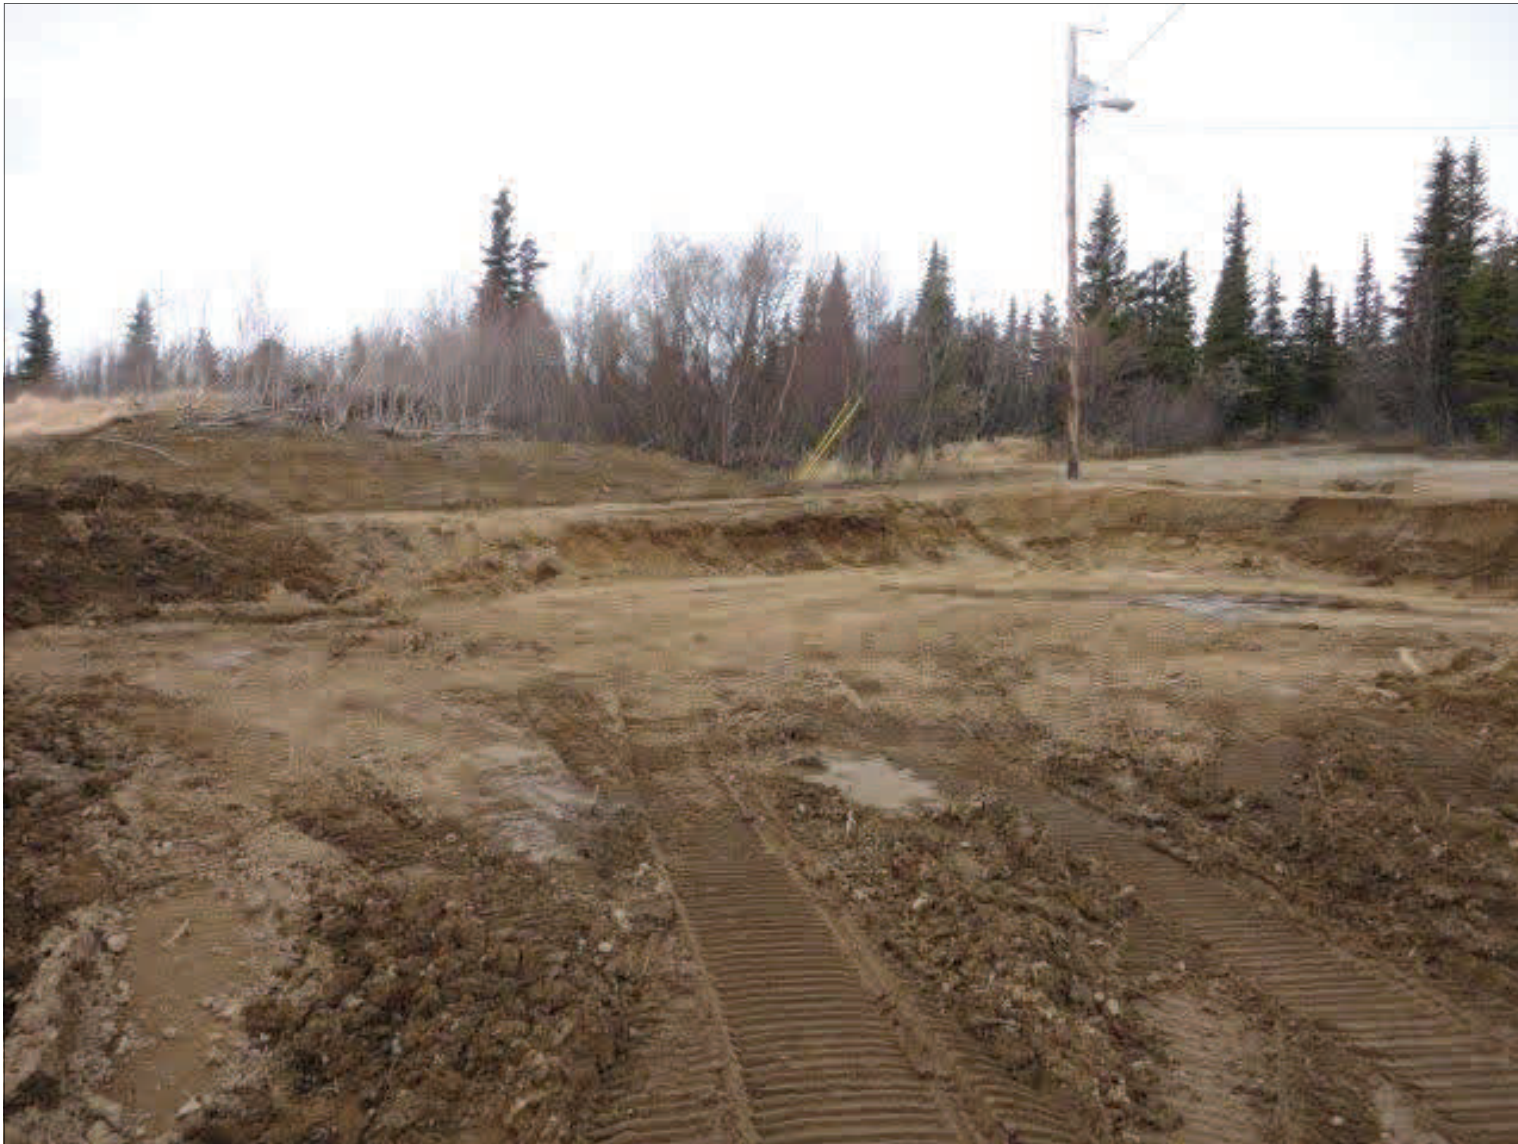
Appendix A, Page #6

Former Stockpile Area
