**FINAL
2024 LONG-TERM MANAGEMENT AND REMEDIAL
ACTION OPERATIONS REPORT**

**Cape Romanzof Long Range Radar Site, Alaska
Sites LF003, SS010, SS015, SS016, SS017, and ST009**

November 2025

North Wind-EA, JV
2525 C Street, Suite 130
Anchorage, Alaska 99503

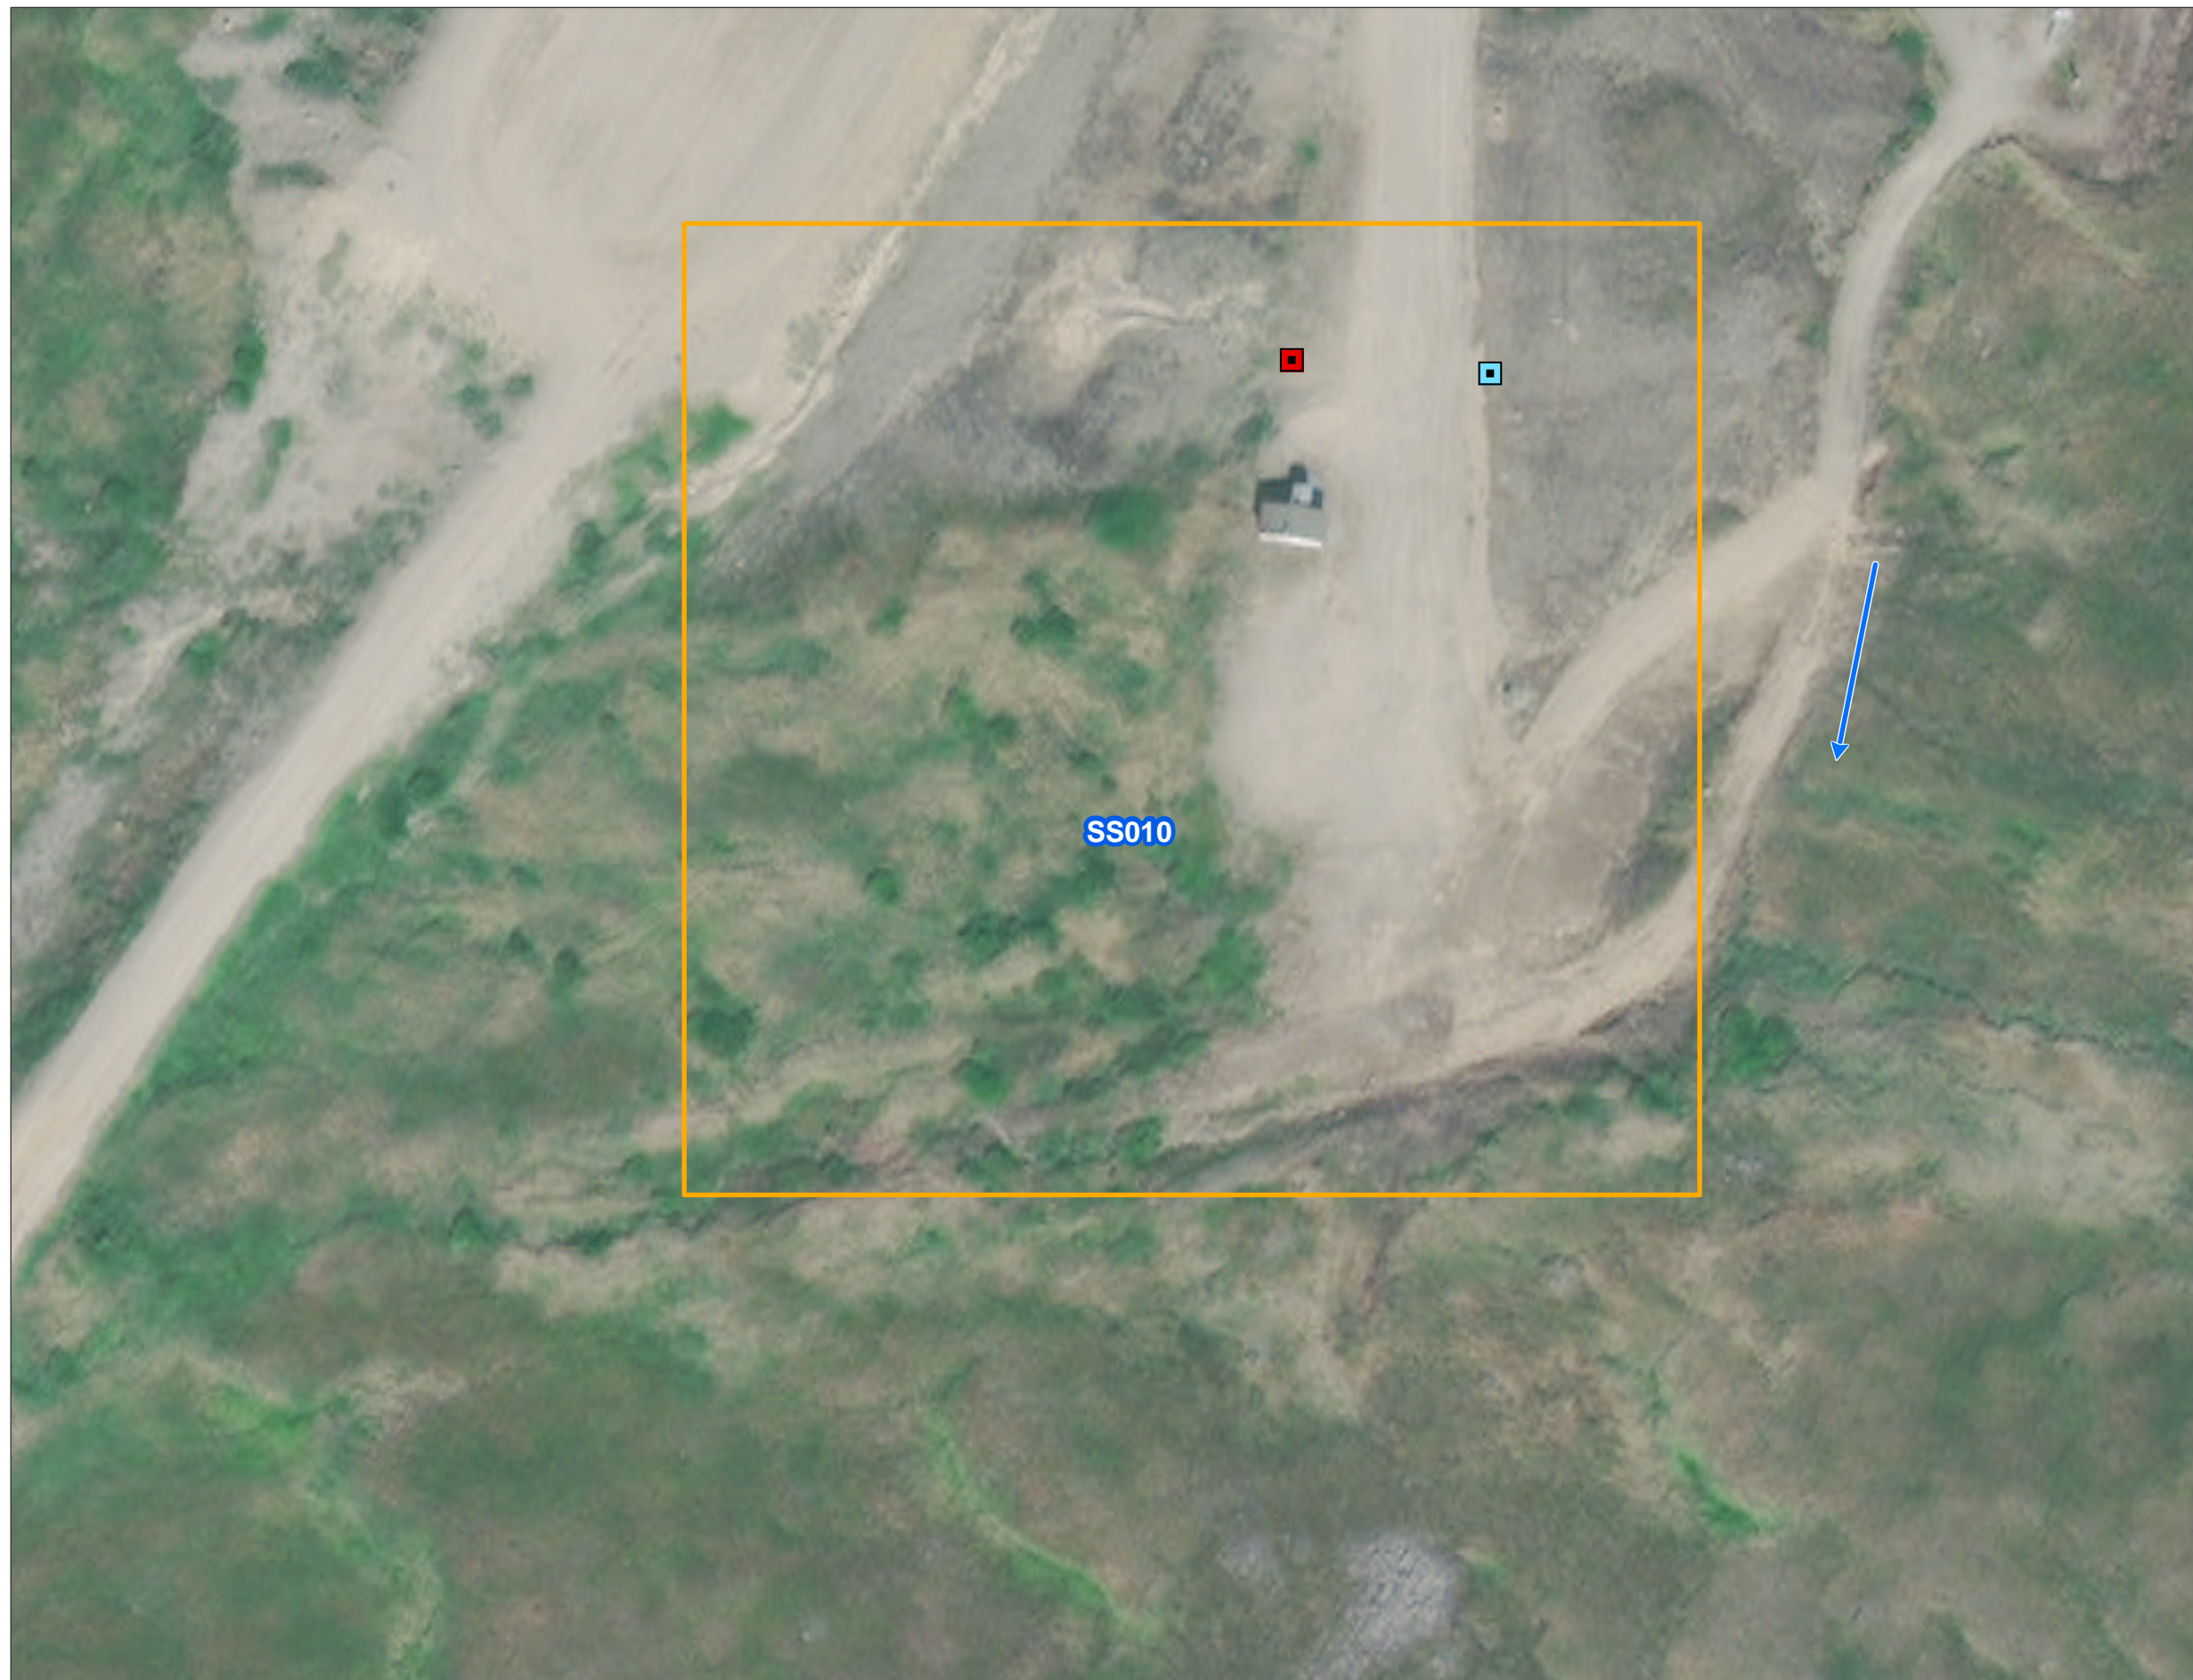
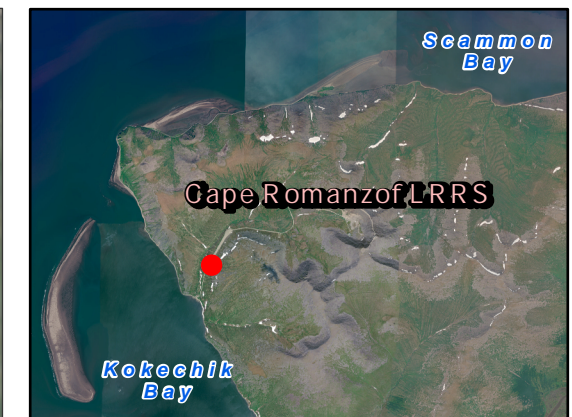
Figure 2 - LF003 Surface Water and Sediment Analytical Results

Samples LF003-SW03-071524 and FD LF003-SW99-071524 were collected for laboratory analysis of PCBs by U.S. Environmental Protection Agency (EPA) Solid Waste (SW) Method 8082. The analytical results are presented in Section 3.2. The QC samples included one FD sample and additional aliquots for designated MS/MSD samples submitted to the laboratory with the primary surface water sample. Figure 2 shows the surface water collection locations and results at Site LF003.

Field sampling forms are provided in Appendix B. Figure 2 shows the sediment collection locations. The analytical results are presented in Section 3.2.

Total PCB concentrations in sediment samples were all ND. Current and historical detections for sediment are listed below in Table 3. The site layout, sample locations, and summary tables of analytical results are presented in Figure 2. Table C- 5 in Appendix C presents the full summary of the 2024 analytical results.

There was no evidence of settling on the capped surface. Petroleum sheen and chemical odors were not observed or evident at the cap or at surface water downgradient to the southwest. Areas of exposed geotextile liner were observed along the southern portion of the excavation area. The site had some debris, including plastic markers and metal materials. Vehicle tracks were observed in the flat/pull-off area of the site. The site had damaged or missing silt fences. All silt fences were in various states of disrepair and non-operative condition due to high winds. The damage to the silt fences include those done by wind damage where they were observed ripped and partially attached to bent posts and completely missing given by standalone posts with no attached fabric. No discolored vegetation was observed. All monitoring wells appeared intact and in good condition. No wildlife was present and no evidence of animal burrows was observed. The site was lightly vegetated on the cap surface and south/west side slopes, and up to 90 percent (%) vegetated on the east side slope. Two LUC signs found damaged in 2023 were replaced with new signs during this site visit. One sign was installed on the east side of the site on the south side of the road (Appendix A, Photograph 01), and the other sign was installed on the west side of the site on the south side of the road (Appendix A, Photograph 02). The LUC area and the locations of the newly installed LUC signs are shown on Figure 2.

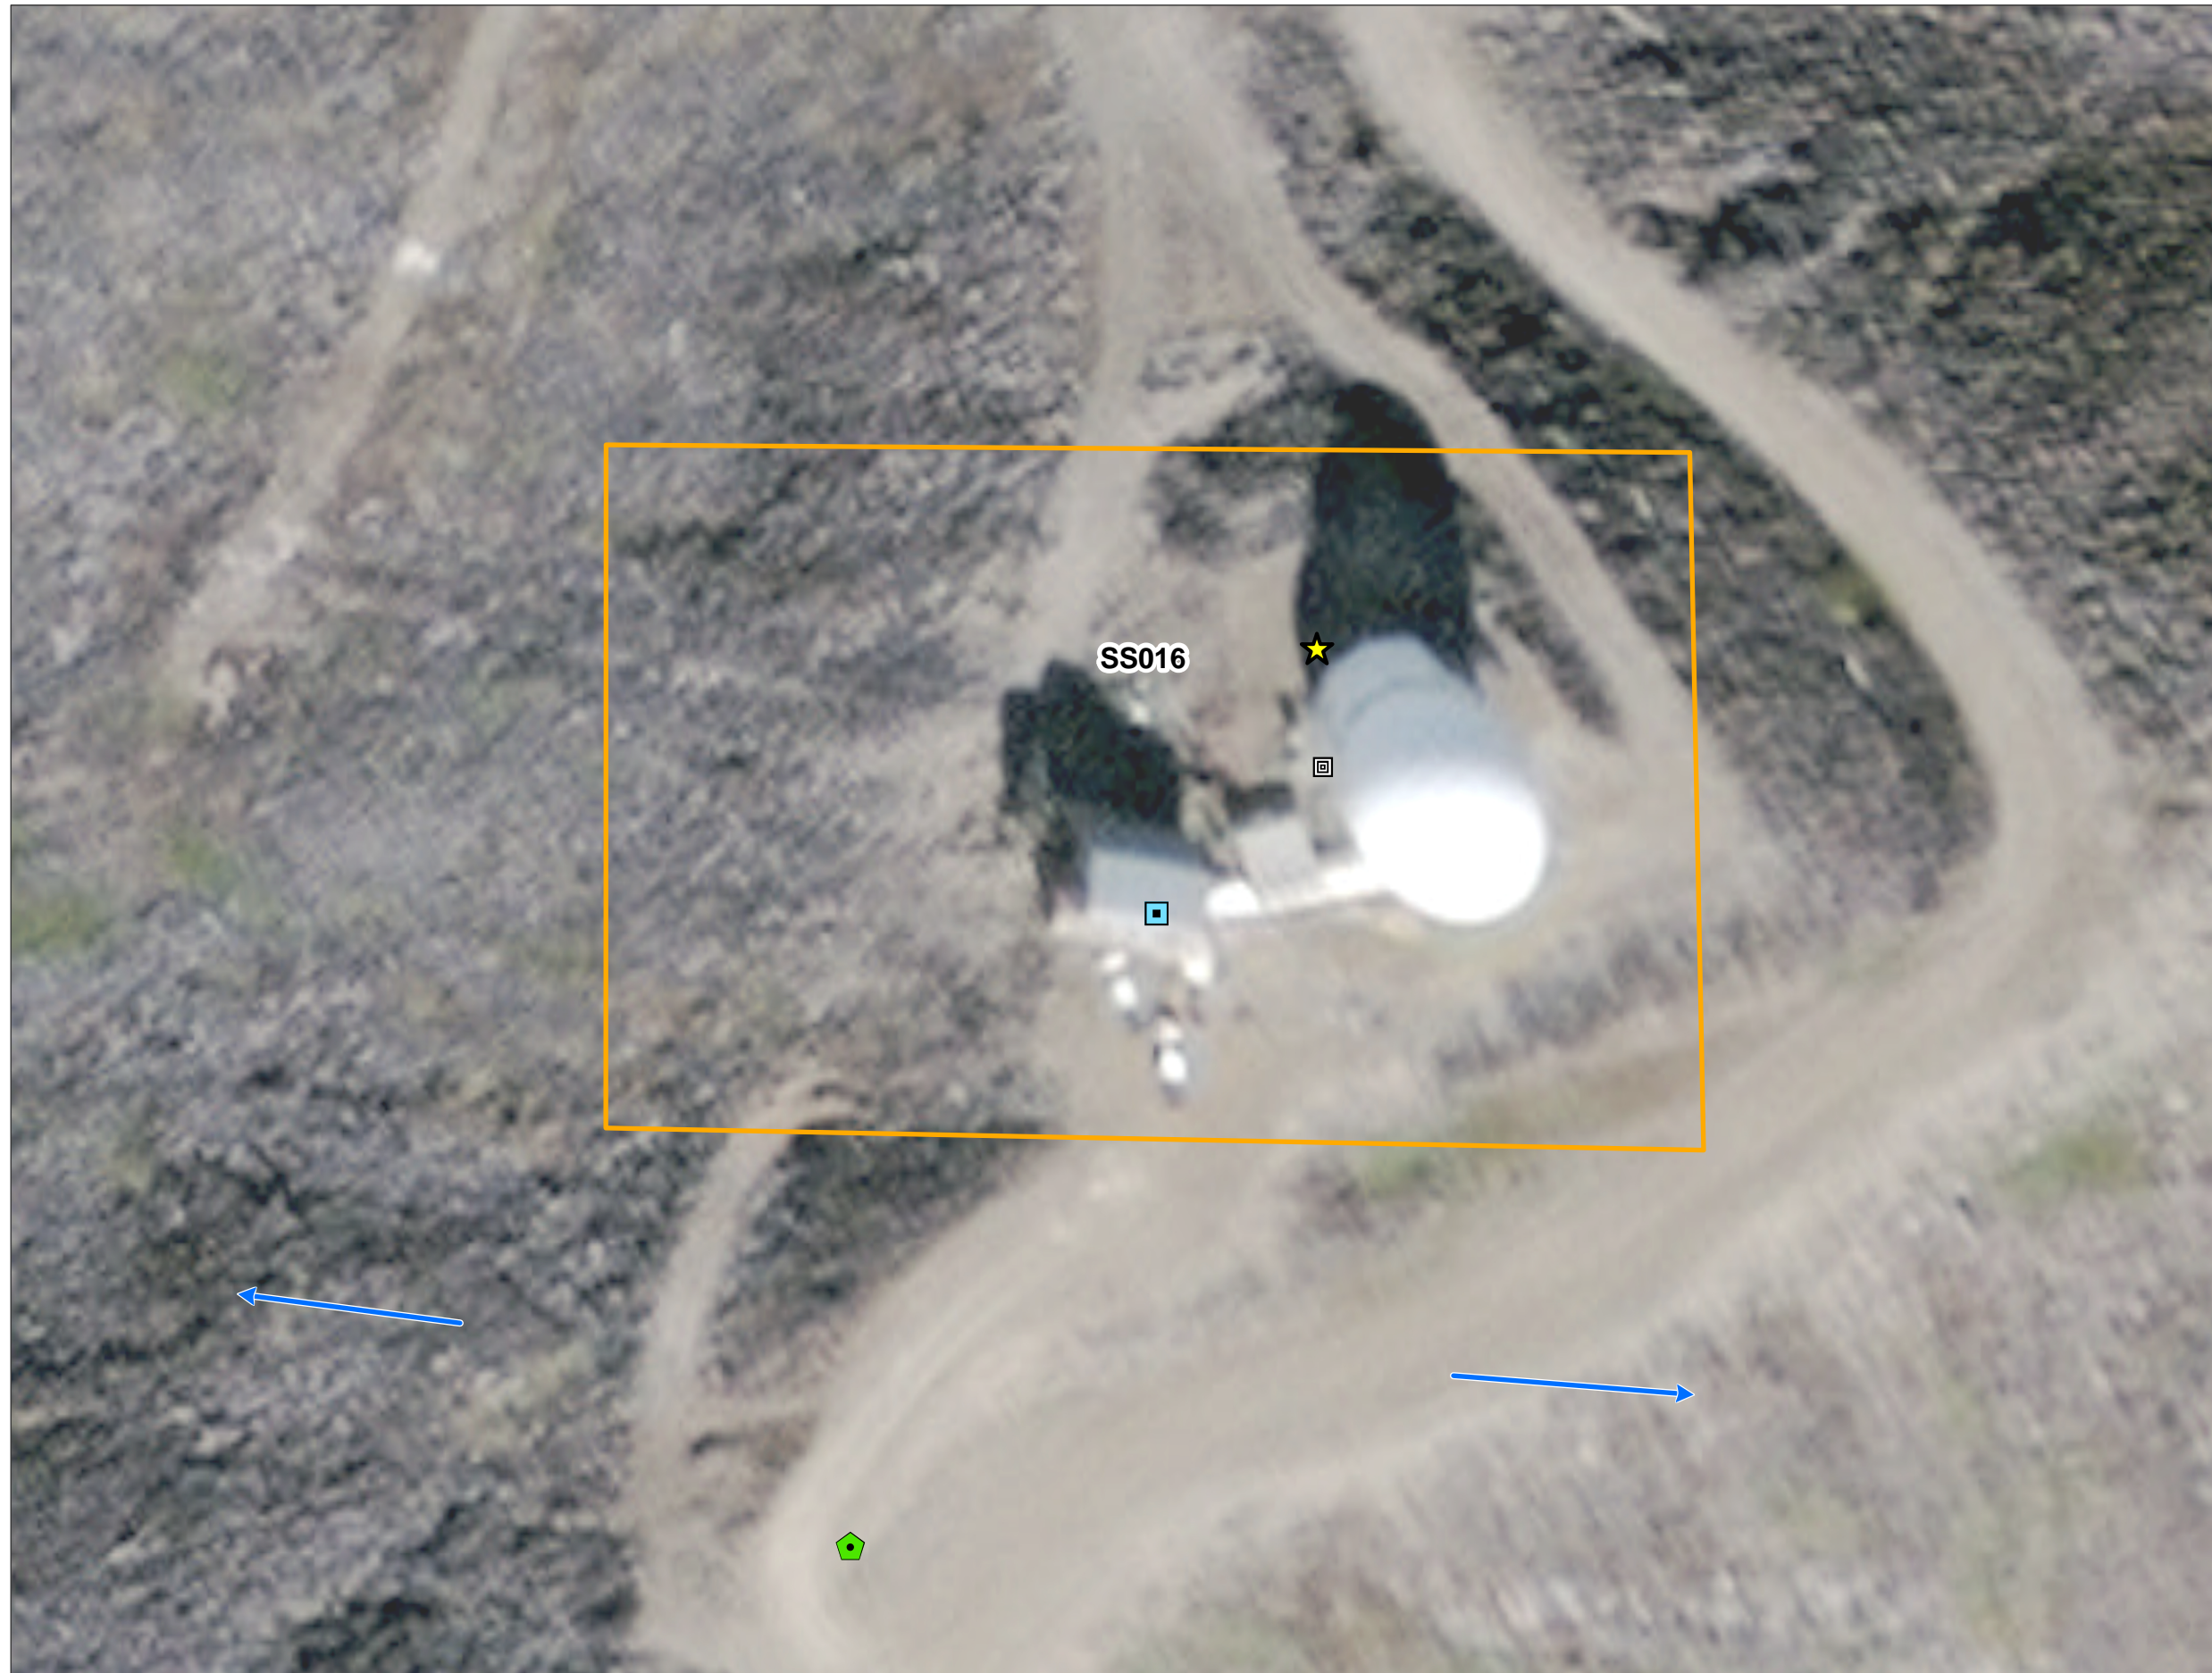
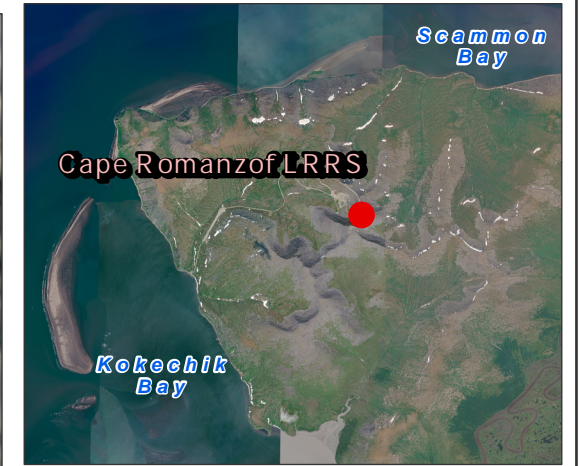
Figure 4 - SS015 Groundwater Analytical Results

Analytical results showed detections from each of the monitoring wells. Exceedances to the ADEC cleanup levels were only observed in monitoring well WW01. Figure 4 shows the site layout, monitoring well locations and summary tables of analytical results. Table 1 lists the 2024 analytical results.

Sample ID: SS015-WW01-071324				
Analyte	Method	Unit	CL ¹	Result
GRO	AK101	µg/L	2200	618 [50.0]
DRO	AK102	µg/L	1500	11900 [400]
RRO	AK103	µg/L	1100	ND [600]
Benzene	SW8260D	µg/L	4.6	40.5 [0.500]
Toluene	SW8260D	µg/L	1100	0.310 [0.600] J
Ethylbenzen	SW8260D	µg/L	15	18.9 [0.500]
Xylenes (Tot	SW8260D	µg/L	190	38.7 [1.50]

Sample ID: SS015-WW06-071324				
Analyte	Method	Unit	CL ¹	Result
GRO	AK101	µg/L	2200	15.7 [50.0] BJ
DRO	AK102	µg/L	1500	603 [400] J
RRO	AK103	µg/L	1100	ND [600]
Benzene	SW8260D	µg/L	4.6	ND [0.500]
Toluene	SW8260D	µg/L	1100	ND [0.600]
Ethylbenzen	SW8260D	µg/L	15	ND [0.500]
Xylenes (Tot	SW8260D	µg/L	190	ND [1.50]

There was minor evidence of settling on parts of graded surface areas, but there were no observations of ponded water. Trash, metal, and construction debris were observed throughout the site, some possibly wind-blown from another location. Exposed geotextile fabric was observed in some locations (Figure 4). Monitoring wells present at this site were observed to be in good condition. Vehicles were observed driving on the road around the site boundary. Survey marker nails were present, but they are not tied to the National Geodetic Survey database. The site did not appear to have surface erosion, discolored vegetation, or previously buried materials exposed at the ground surface with the exception of geotextile fabric. No wildlife was present and no evidence of animal burrows was observed. The site is 80% vegetated. Two LUC warning signs were present, upright, and in fair condition (Appendix A,

Photographs 16 & 17). One LUC sign was found destroyed and on the ground in the northeastern area of the site (Appendix A, Photograph 18). One new LUC was installed in the southern area of the site (Appendix A, Photograph 15). The LUC area is shown on Figure 4.

All groundwater monitoring wells at the Lower Camp UST Site SS015 (SS015-WW01, SS015-WW05, SS015-WW06) were sampled on 13 July 2024 and analyzed for GRO, DRO, RRO, and BTEX. All groundwater monitoring wells at the Former Truck Fueling Station (Spill Site 3) Site ST009 (ST009-MW04 and ST009-MW07), with the exception of ST009-MW09, were sampled on 14 July 2024 and analyzed for GRO, DRO, and BTEX. Locations of groundwater monitoring wells for Sites SS015 and ST009 are shown on Figure 4 and Figure 7, respectively.

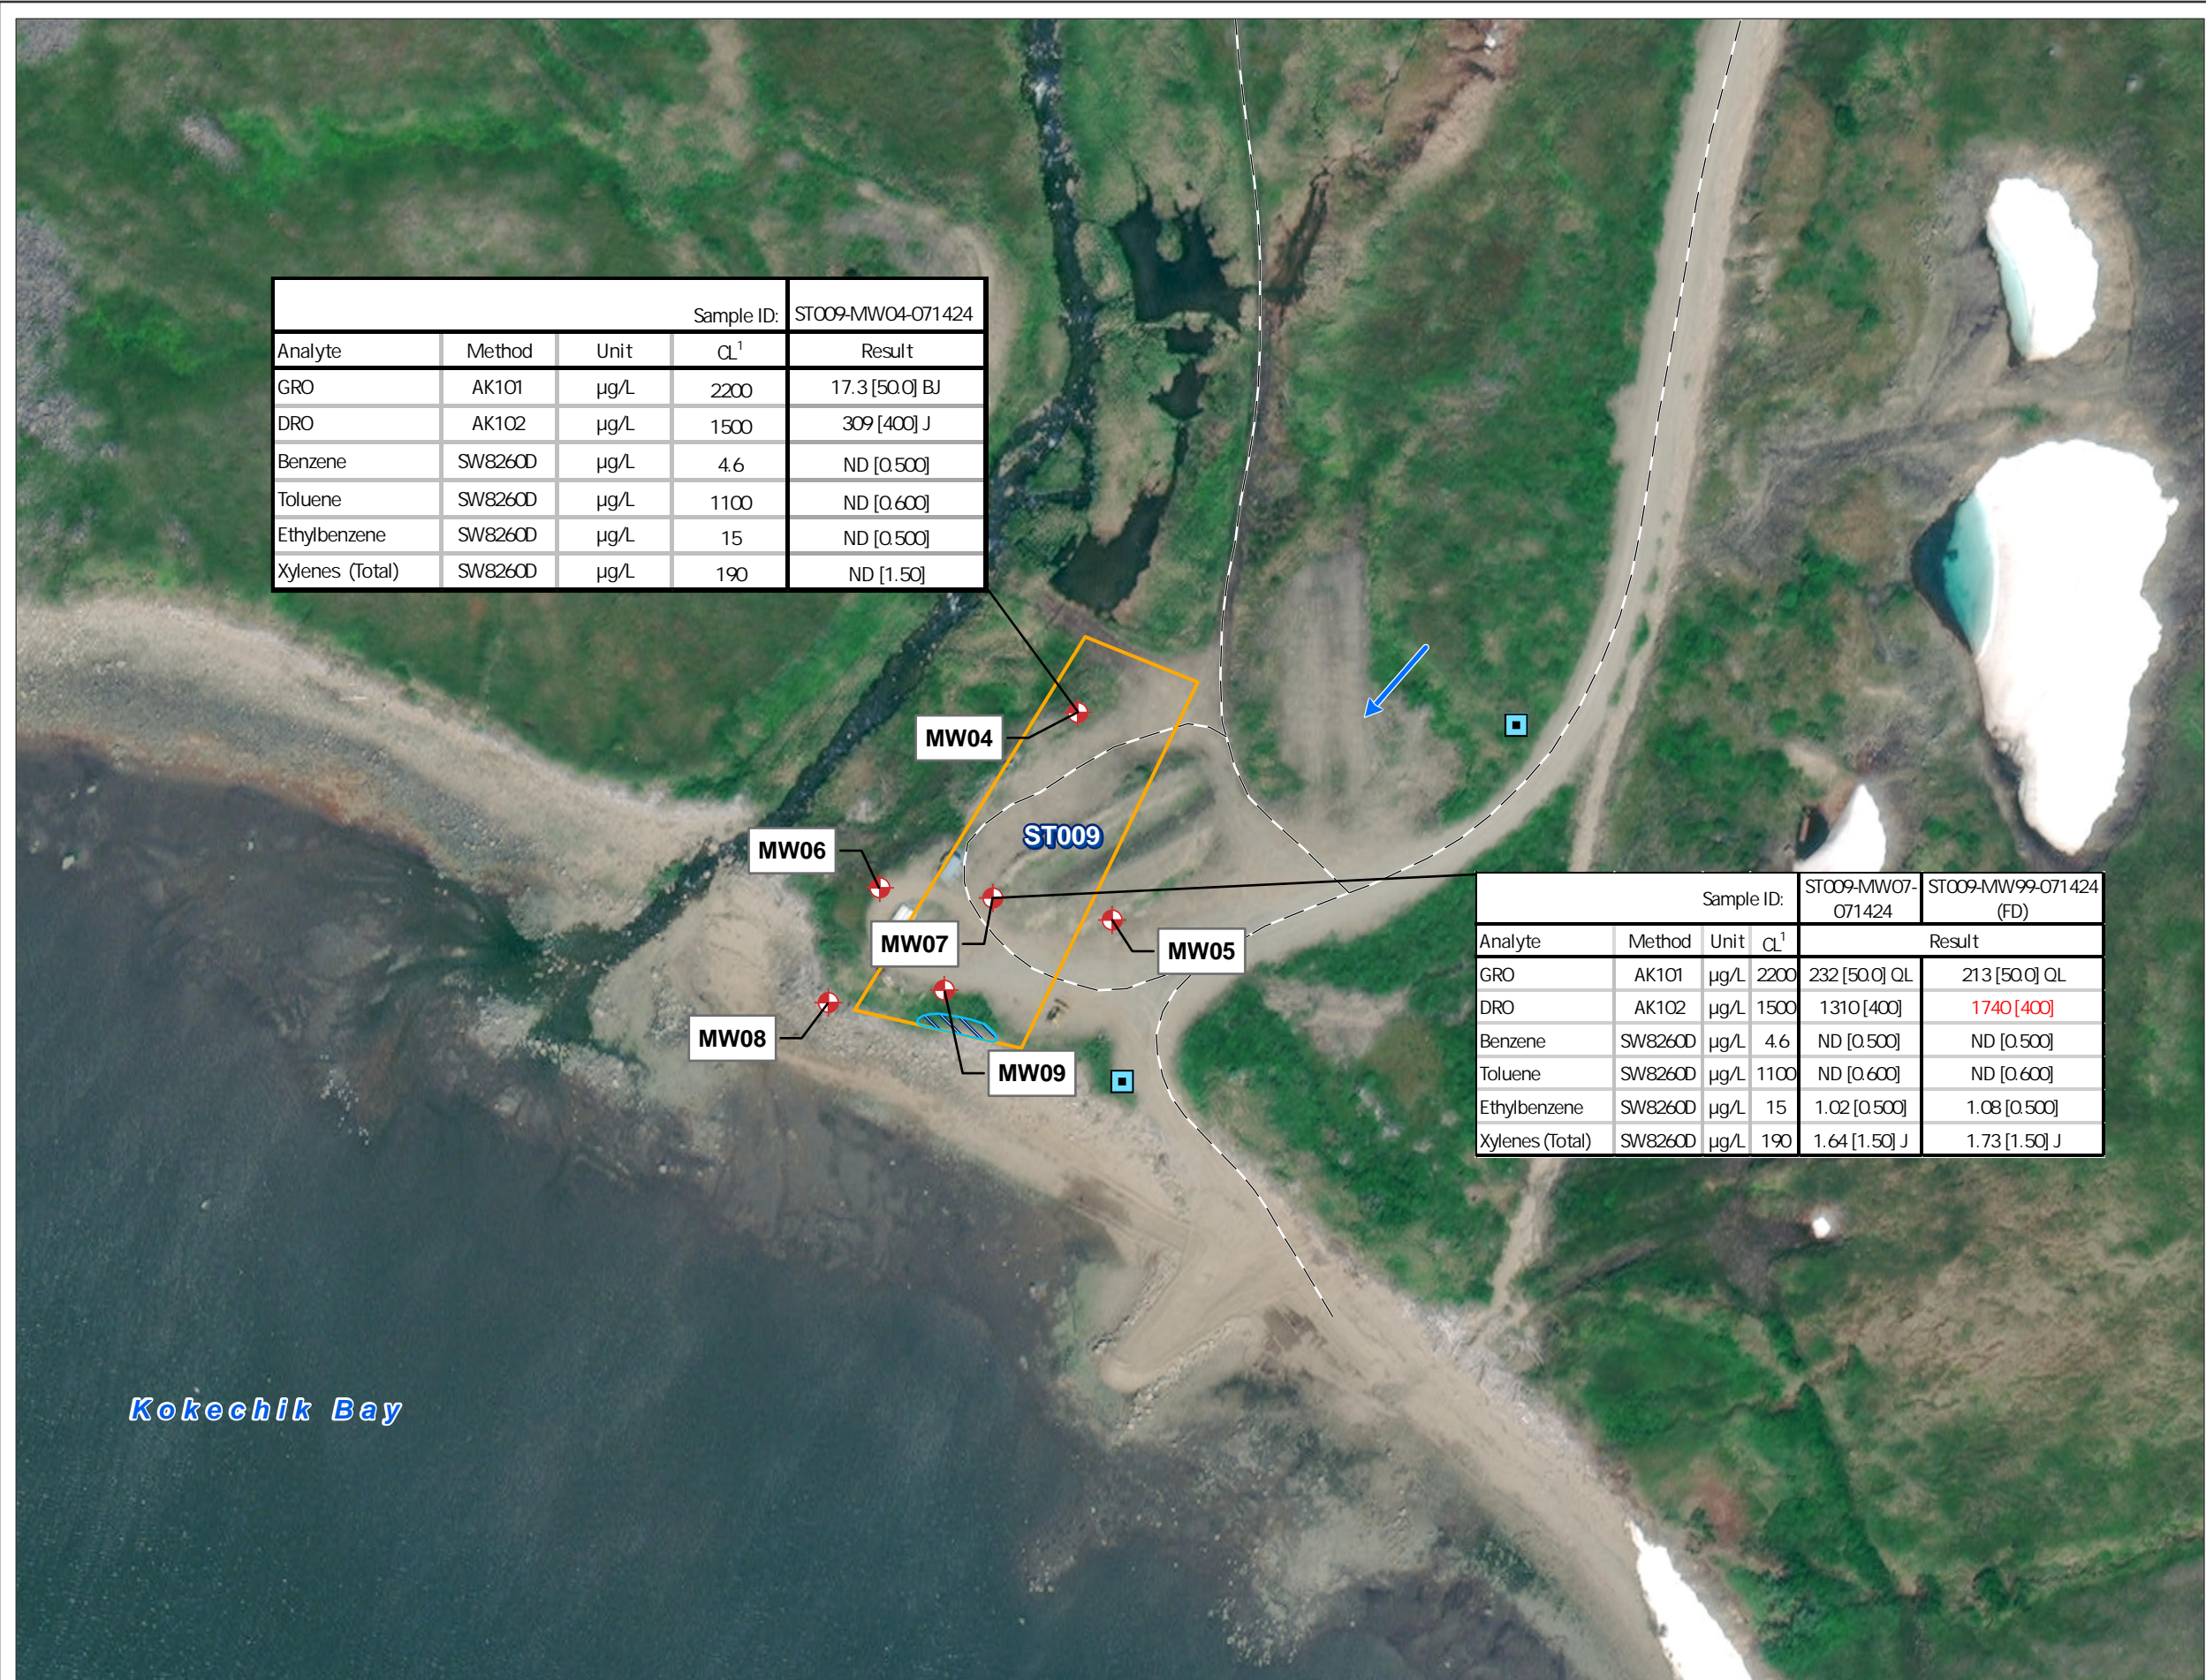
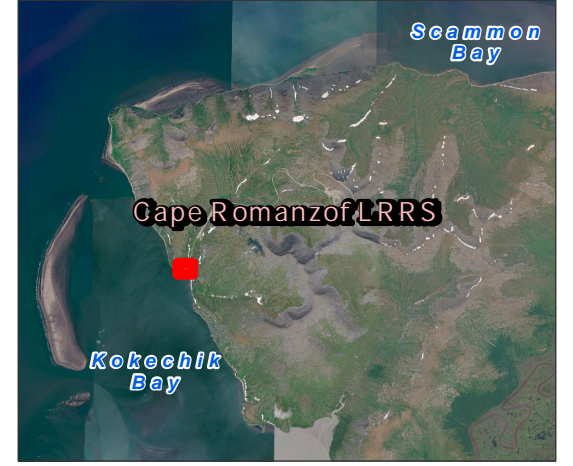
Figure 6 - SS017 Land Use Control Area

The building has been removed from this site. Portions of the building footprint exist and scattered remnants of metal, concrete and wood debris are still present. There was no evidence of settling on the capped surface and no observations of ponded water. The concrete footprint of the former building was observed, as well as geotextile fabric along the excavation boundary (Appendix A, Photograph 33). Vehicle tracks were present in the southwest/southeast portion of the site. Surface erosion and discolored vegetation were not observed. No wildlife was present and no evidence of animal burrows was observed. The site is approximately 25% vegetated. Two LUC signs were observed in good condition (Appendix A, Photographs 31 & 32). The LUC area is shown on Figure 6.

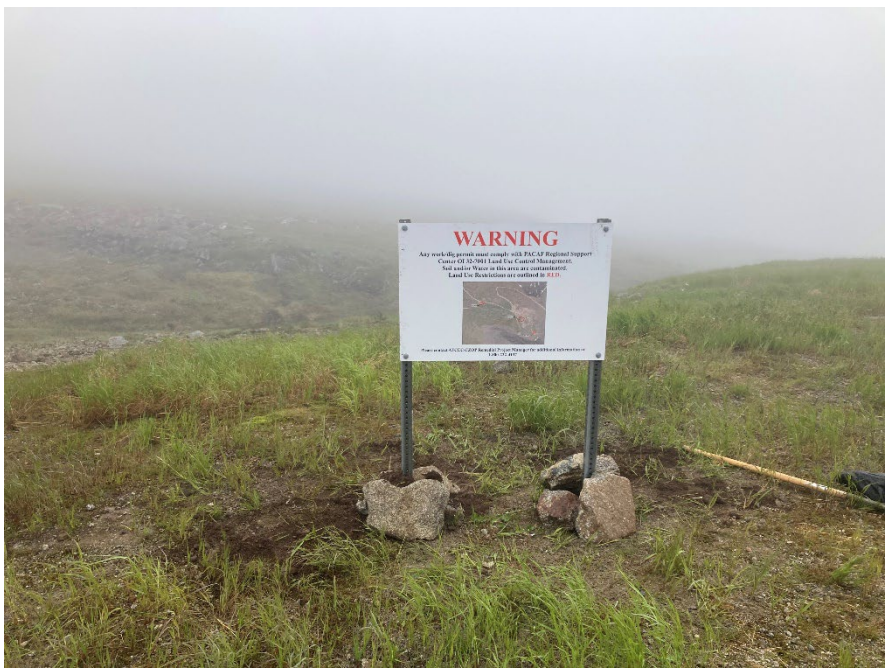
Photograph No.: 01	Photo ID: E LUC Sign LF003

Date Taken: 07/15/2024		
Photograph taken by: C. Aronson		
Direction: South	Location: LF003	
Description: New LUC sign installed near the eastern boundary of LF003 along access road.

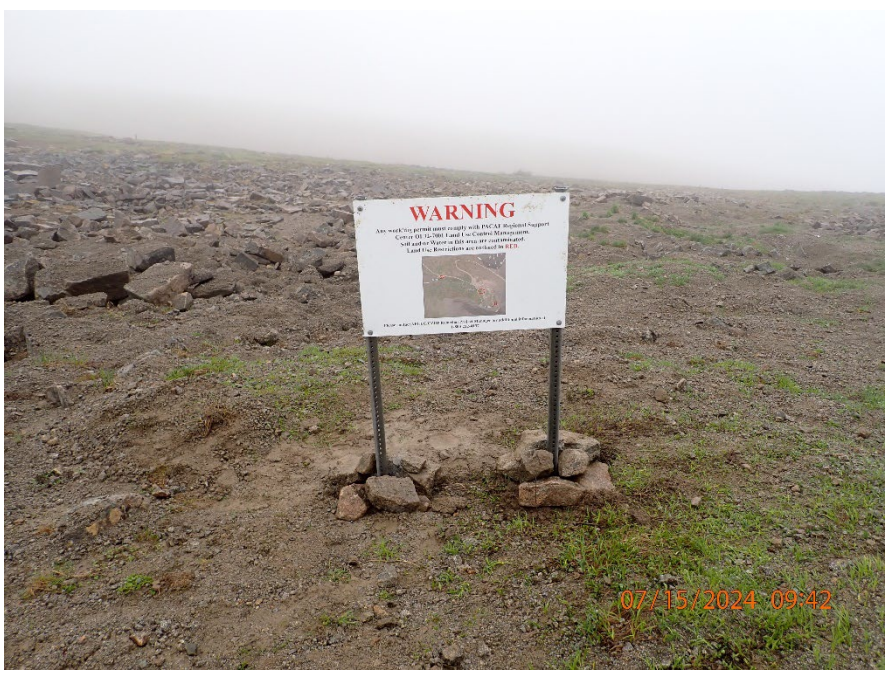
Photograph No.: 02	Photo ID: P7150294

Date Taken: 07/15/2024		
Photograph taken by: C. Aronson		
Direction: South	Location: LF003	
Description: New LUC installed near the western boundary of LF003.

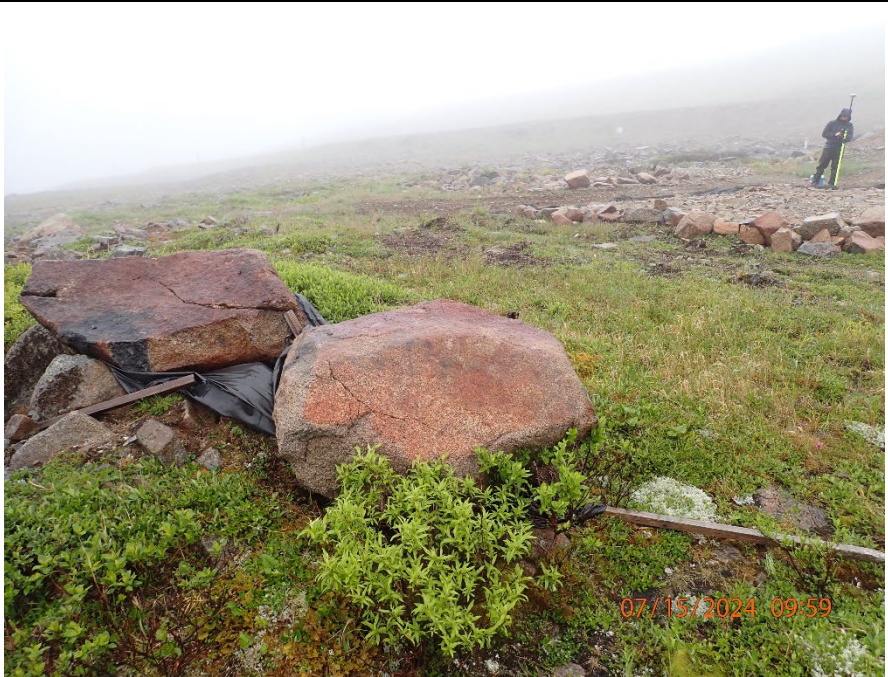
Photograph No.: 04	Photo ID: P7150305
Date Taken: 07/15/2024	
Photograph taken by: C. Aronson	
Direction: North	Location: LF003
Description: Destroyed silt fencing at sample location SO2.

A photograph showing a rocky, hazy landscape. In the foreground, there are large, reddish-brown rocks and some green vegetation. A black geotextile fabric is draped over the rocks. In the background, a person is visible standing near a silt fence. A timestamp in the bottom right corner reads "07/15/2024 09:59".

The ICs at Sites SS010, SS015, SS016, SS017, and ST009 are functioning as intended to protect human receptors from exposure to contaminated media. Erosion soil control barriers (silt fencing) at Site LF003 are either functioning poorly or non-existent. Minor erosion exists along the side slopes of the landfill cap at Site LF003, and the landfill liner is exposed in some areas. Litter and vehicle tracks observed at Sites LF003, SS010, SS015, SS016, SS017, and ST009 suggest these sites are occasionally accessed, and wind erosion may have exposed some liner and metal debris at Sites LF003, SS015, and SS017. Although geotextile fabric was observed exposed at Site SS016, due to its proximity to the radar dome that has live high voltage power cables, transformer boxes, and the tight constraints of the surrounding buildings, and the limited amount of fabric exposed, it is not recommended that additional fill be added to cover exposed fabric.

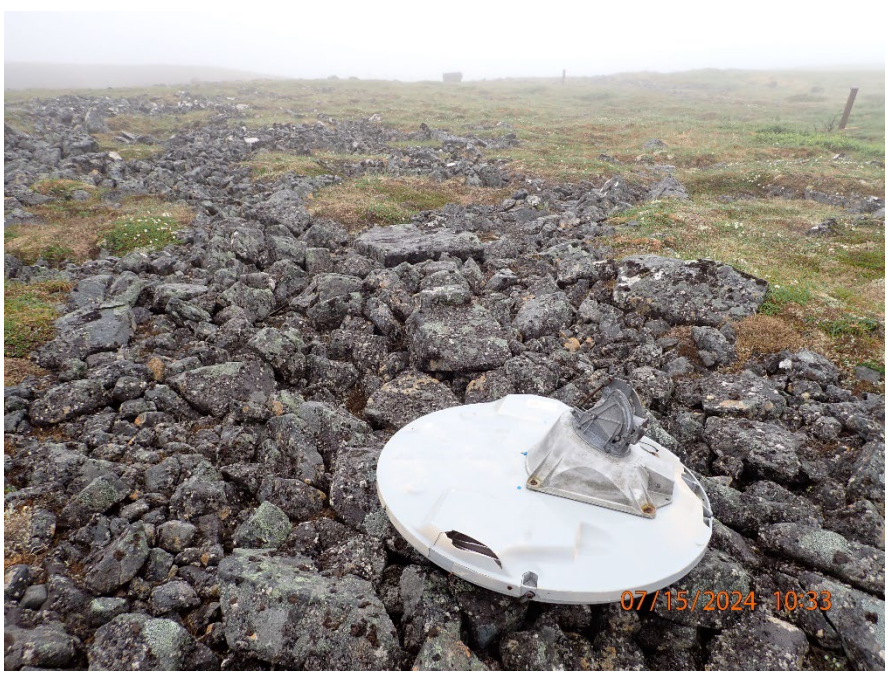
Photograph No.: 05	Photo ID: P7150312
Date Taken: 07/15/2024	
Photograph taken by: C. Aronson	
Direction: Northeast	Location: LF003
Description: Debris at LF003.

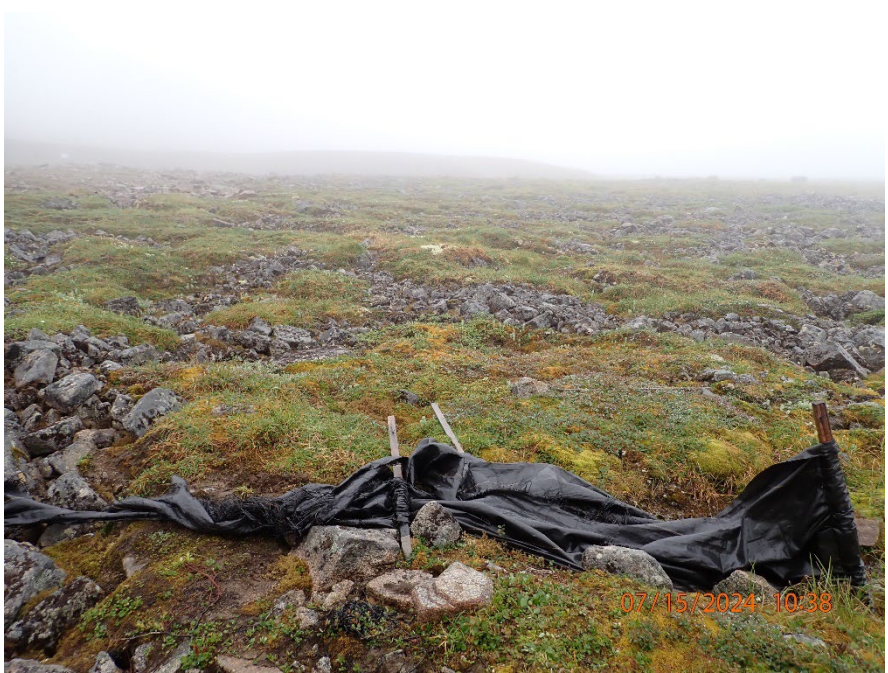
Photograph No.: 06	Photo ID: P7150315
Date Taken: 07/15/2024	
Photograph taken by: C. Aronson	
Direction: Northeast	Location: LF003
Description: Destroyed silt fencing at sample location SO1.

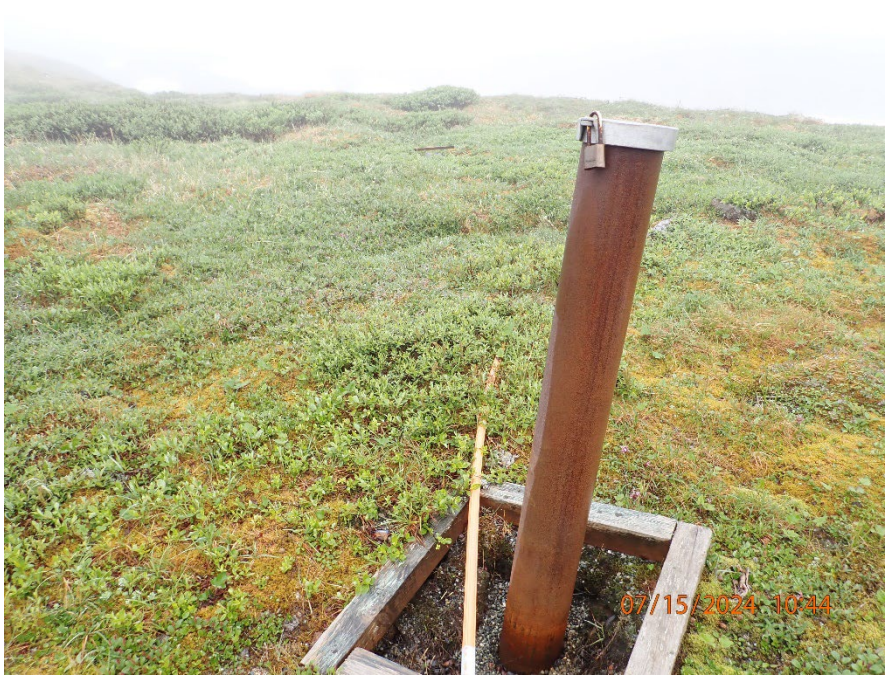
Photograph No.: 08	Photo ID: P7150319
Date Taken: 07/15/2024	
Photograph taken by: C. Aronson	
Direction: Northeast	Location: LF003
Description: Groundwater monitoring well CMW-6.

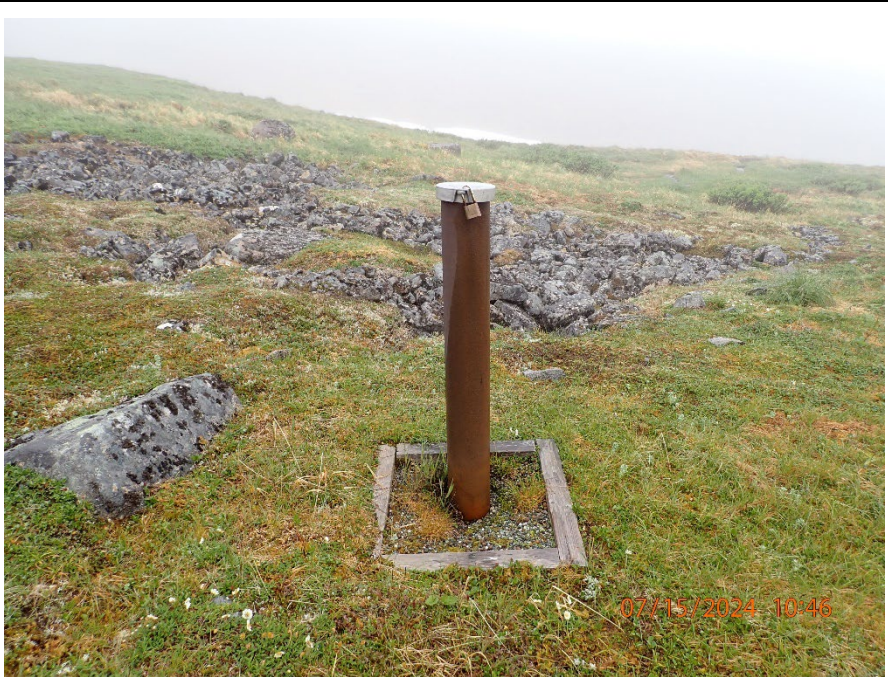
Photograph No.: 09	Photo ID: P7150320
Date Taken: 07/15/2024	
Photograph taken by: C. Aronson	
Direction: North	Location: LF003
Description: Groundwater monitoring well CMW-3.

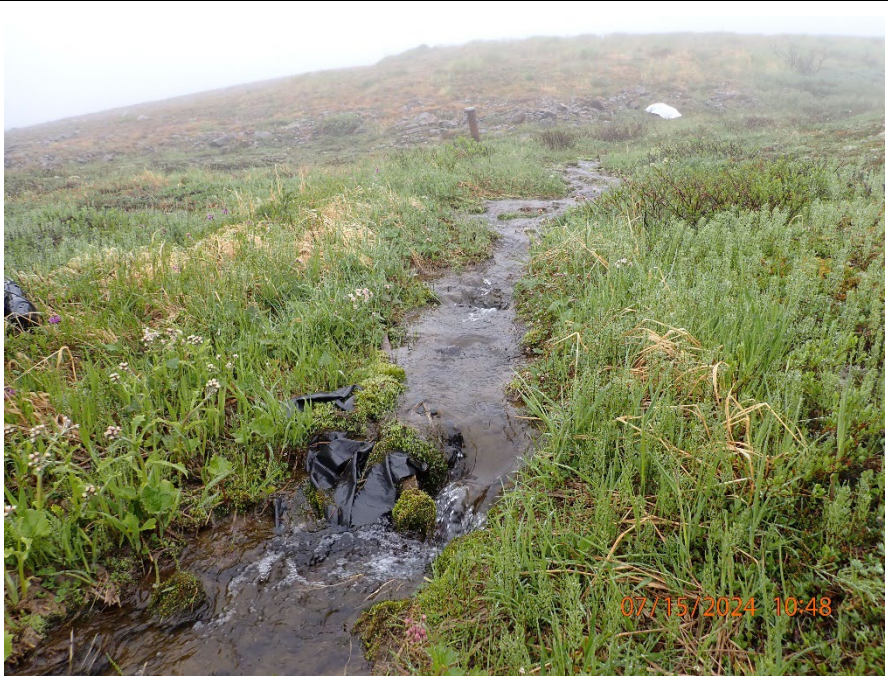
Photograph No.: 10	Photo ID: P7150321
Date Taken: 07/15/2024	
Photograph taken by: C. Aronson	
Direction: North	Location: LF003
Description: Destroyed silt fencing at sample location SO3 and SW03.

A photograph showing a destroyed silt fence in a grassy field. The fence is made of black plastic and is partially collapsed. The surrounding area is covered in green and brown vegetation. A white plastic bag is visible in the background. The photo is timestamped 07/15/2024 10:48.

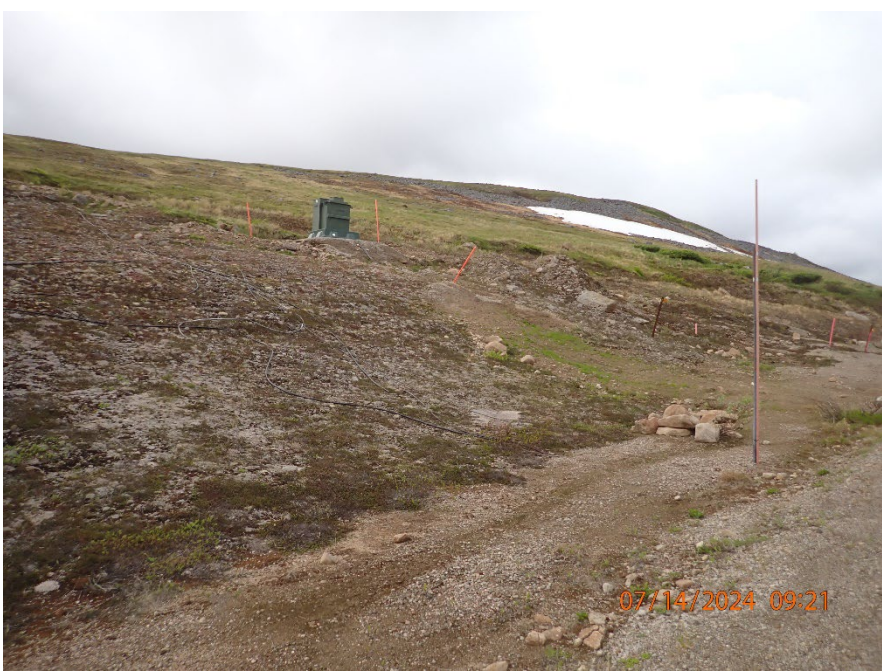
Photograph No.: 13	Photo ID: P7140260

Date Taken: 07/14/2024		
Photograph taken by: C. Aronson		
Direction: Southeast	Location: SS010	
Description: View of area and condition of southeastern boundary.

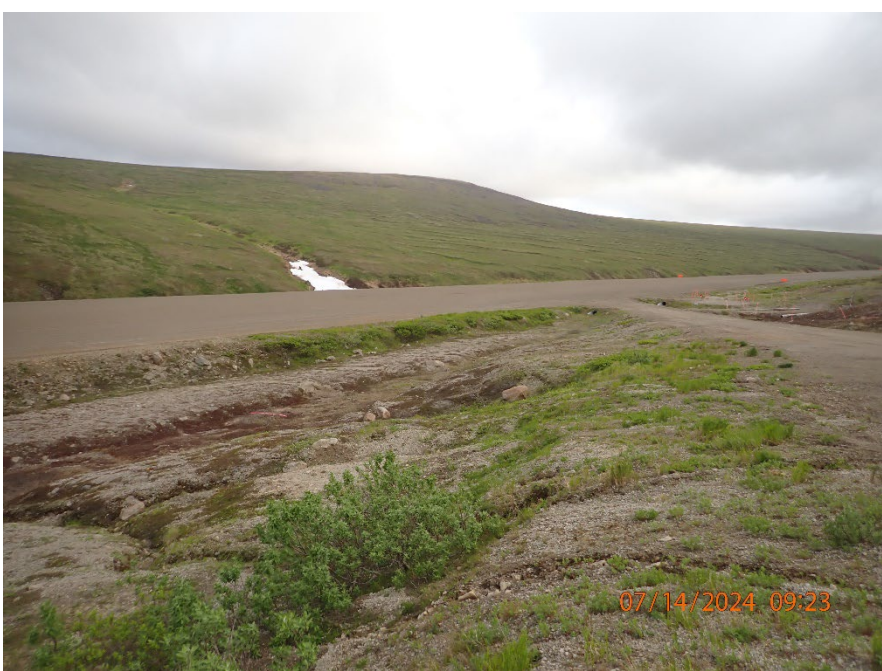
Photograph No.: 14	Photo ID: P7140266

Date Taken: 07/14/2024		
Photograph taken by: C. Aronson		
Direction: North	Location: SS010	
Description: View of area and condition of northern boundary toward runway.

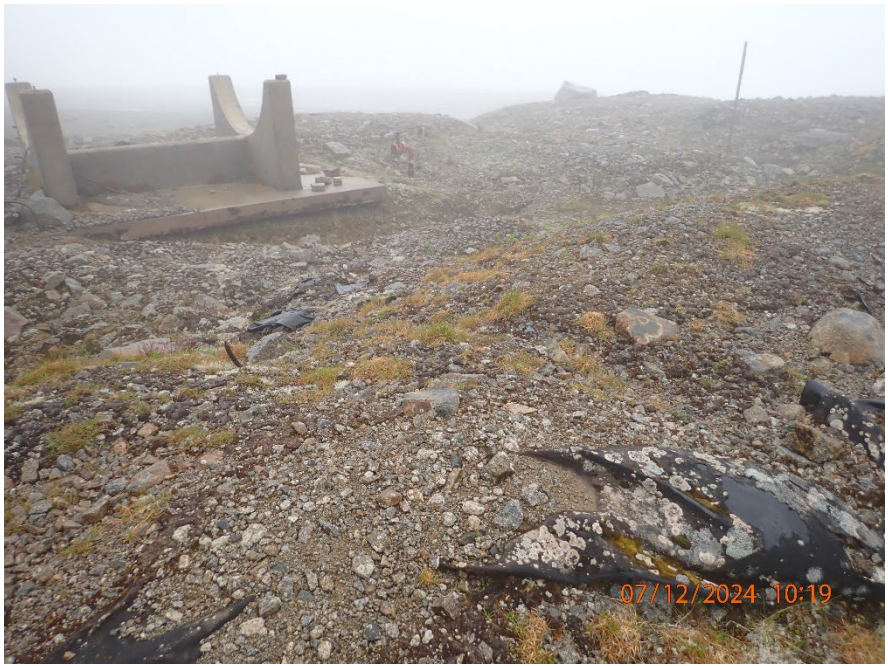
Photograph No.: 19	Photo ID: P7120193

Date Taken: 07/12/2024		
Photograph taken by: C. Aronson		
Direction: Southwest	Location: SS015	
Description: Geotextile fabric and storage tank remnants.

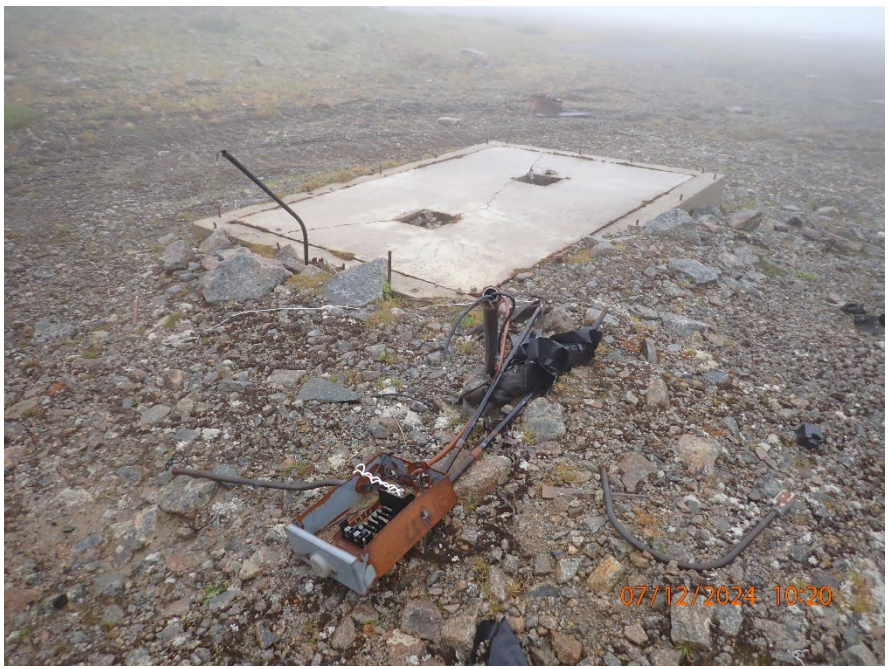
Photograph No.: 20	Photo ID: P7120197

Date Taken: 07/12/2024		
Photograph taken by: C. Aronson		
Direction: South	Location: SS015	
Description: Concrete foundation and debris.

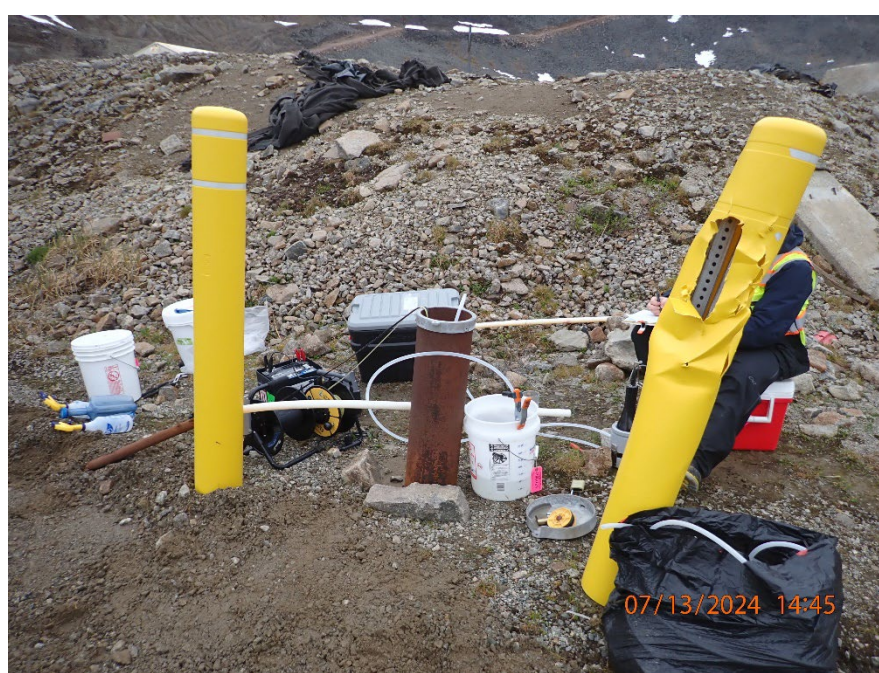
Photograph No.: 25	Photo ID: P7130252
Date Taken: 07/13/2024	
Photograph taken by: C. Aronson	
Direction: East	Location: SS015
Description: Collecting groundwater quality parameters at monitoring well WW-01. Exposed geotextile fabric behind well.
