**FINAL
2024 LONG-TERM MANAGEMENT AND REMEDIAL
ACTION OPERATIONS REPORT**

**Cape Romanzof Long Range Radar Site, Alaska
Sites LF003, SS010, SS015, SS016, SS017, and ST009**

November 2025

North Wind-EA, JV
2525 C Street, Suite 130
Anchorage, Alaska 99503

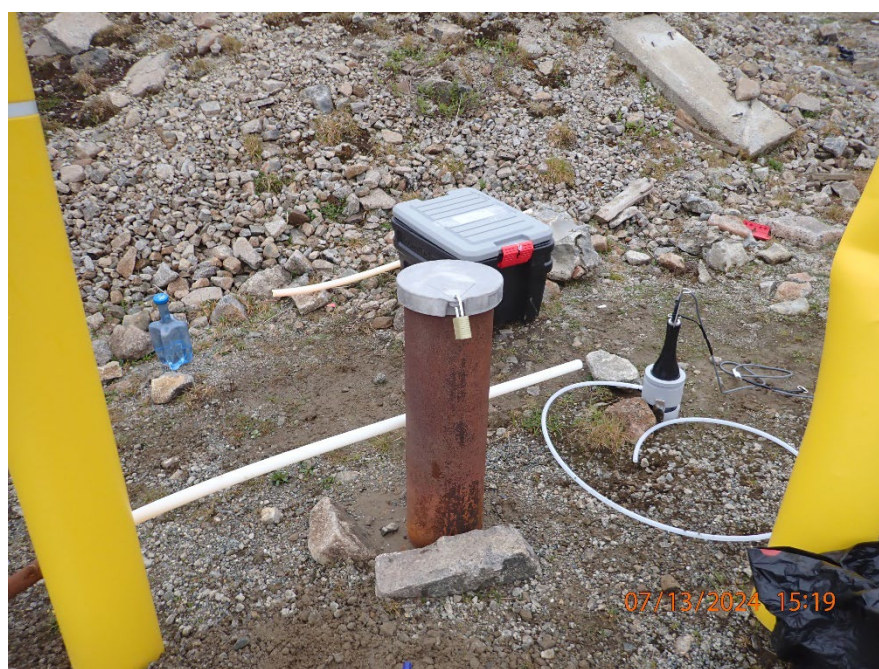
Photograph No.: 27	Photo ID: P7120218
Date Taken: 07/12/2024	
Photograph taken by: C. Aronson	
Direction: South	Location: SS016
Description: Location where LUC sign was installed in 2023. This sign was removed and re-located along access road to SS016.

The building and debris have been removed from this site. Although portions of the building footprint exist at the site, there was no debris present. There was no evidence of settling on the site's surface and no observations of ponded water. No monitoring wells were present. A small patch of geotextile fabric was observed near the radar dome (Appendix A, Photograph 29), as well as one survey marker. Vehicle tracks were observed, indicating the Base Operations Support (BOS) contractor accesses this site; use of the site by the BOS contractor was confirmed, and use aligned with the support contract. Surface erosion, discolored vegetation, and previously buried debris were not observed. No wildlife was present and no evidence of animal burrows was observed. The site is approximately 5 to 10% vegetated. The LUC sign located on the north side of the utility shed was removed and reinstalled along the access road's last turn on the approach to the site for greater visibility (Appendix A, Photographs 27 & 28). The LUC area is shown on Figure 5.

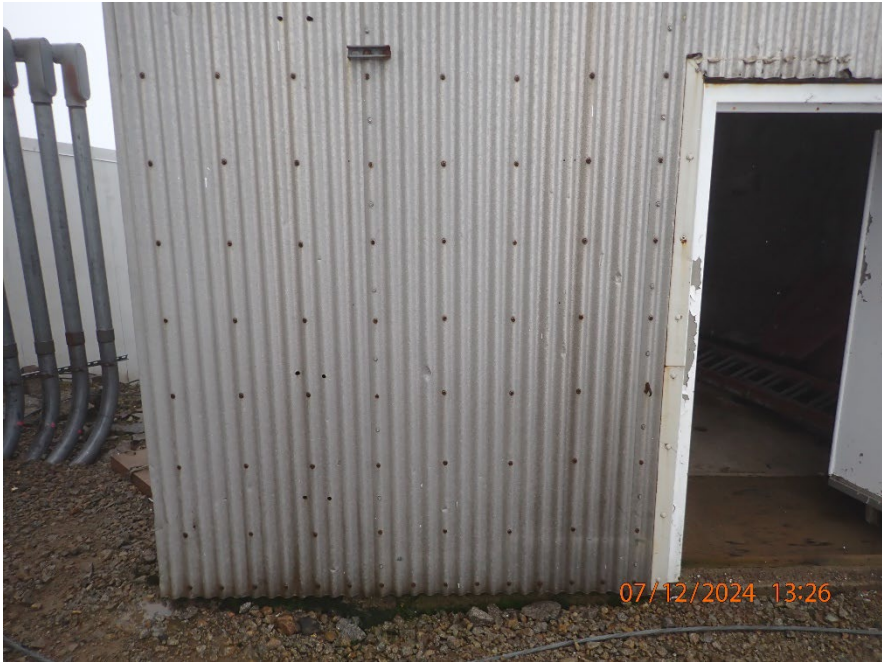
A photograph showing the exterior of a building with corrugated metal siding. On the left, three large grey pipes run vertically. On the right, a white door is slightly ajar, revealing a dark interior. The ground is covered in gravel and dirt. An orange timestamp in the bottom right corner reads '07/12/2024 13:26'.

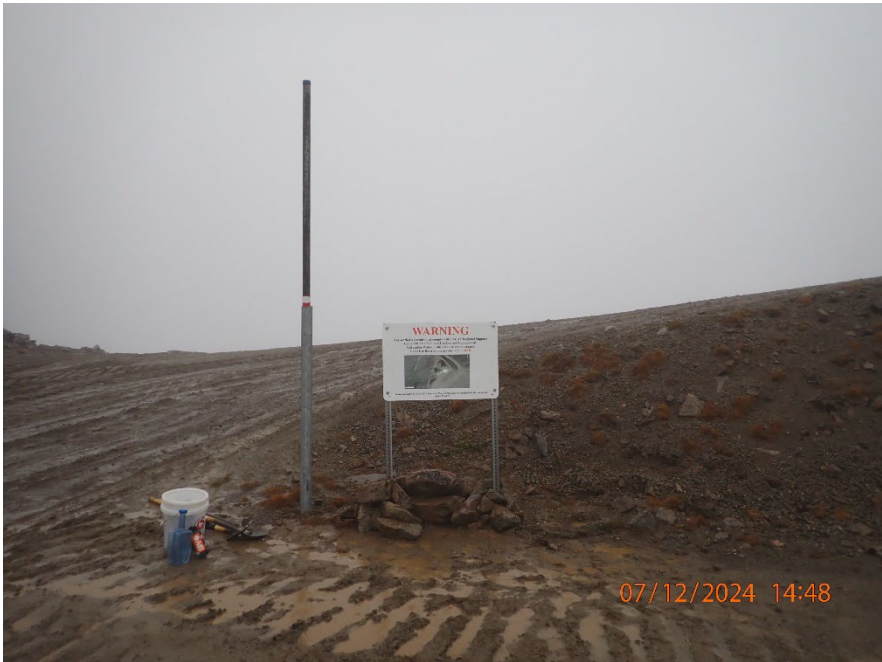
Photograph No.: 28	Photo ID: P7120232
Date Taken: 07/12/2024	
Photograph taken by: C. Aronson	
Direction: West	Location: SS016
Description: Location where LUC sign was relocated along access road to SS016.

A photograph of a dirt access road in a desolate, hilly landscape. A tall, thin metal pole stands in the center. To its right, a white warning sign is mounted on two metal posts. The sign features a picture of a dog and the word 'WARNING' in red. A white bucket and some tools are on the ground near the base of the pole. An orange timestamp in the bottom right corner reads '07/12/2024 14:48'.

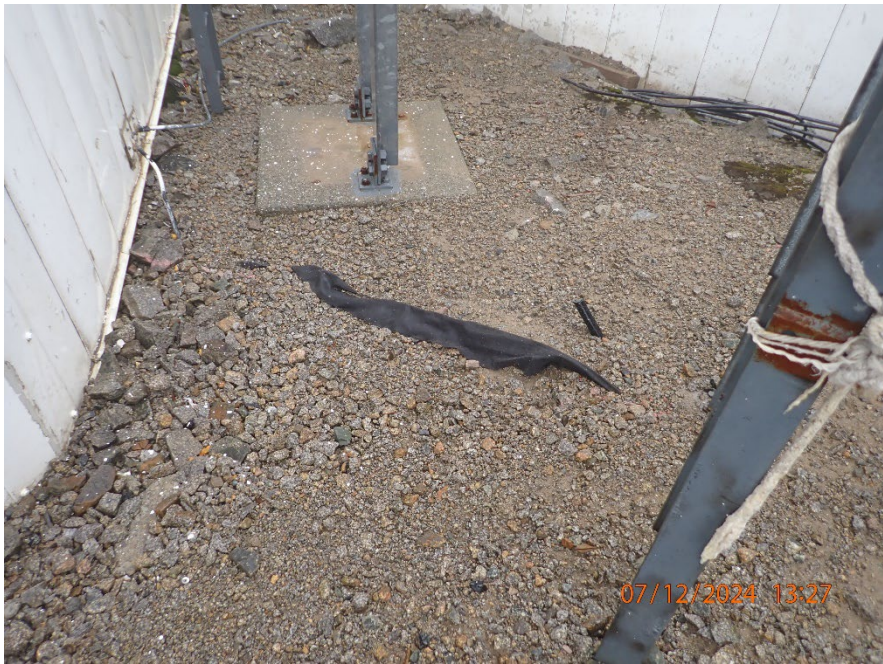
Photograph No.: 29	Photo ID: P7120219
Date Taken: 07/12/2024	
Photograph taken by: C. Aronson	
Direction:	Location: SS016
Description: Geotextile fabric exposed near building.

A photograph showing a gravel-covered ground area next to a white building. A piece of dark, black geotextile fabric is lying on the gravel. A metal post is visible in the center, and a blue metal beam is on the right. A timestamp in the bottom right corner reads "07/12/2024 13:27".

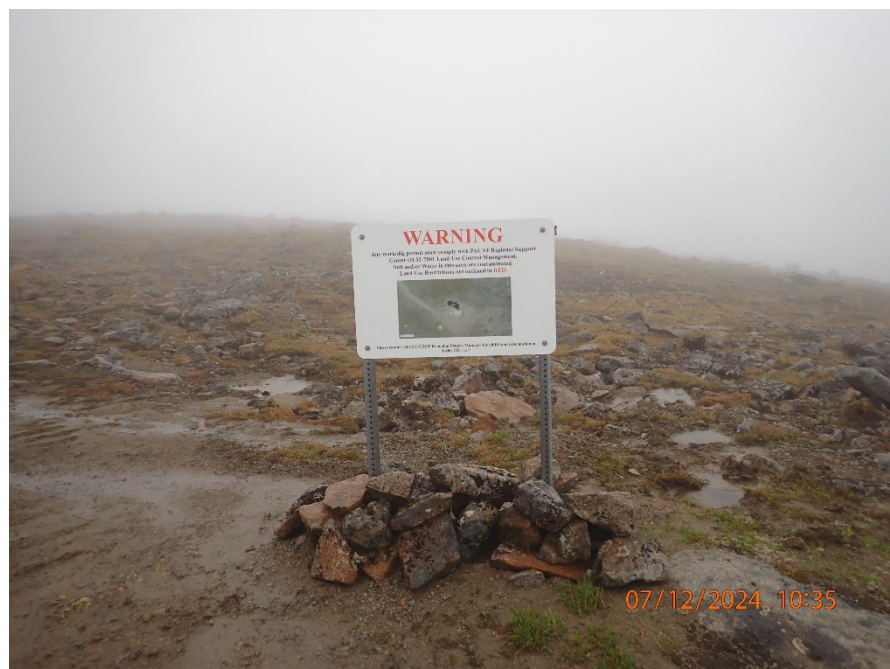
Photograph No.: 32	Photo ID: P7120210
Date Taken: 07/12/2024	
Photograph taken by: C. Aronson	
Direction: East	Location: SS017
Description: Existing LUC sign in the northern area of SS017.

The building has been removed from this site. Portions of the building footprint exist and scattered remnants of metal, concrete and wood debris are still present. There was no evidence of settling on the capped surface and no observations of ponded water. The concrete footprint of the former building was observed, as well as geotextile fabric along the excavation boundary (Appendix A, Photograph 33). Vehicle tracks were present in the southwest/southeast portion of the site. Surface erosion and discolored vegetation were not observed. No wildlife was present and no evidence of animal burrows was observed. The site is approximately 25% vegetated. Two LUC signs were observed in good condition (Appendix A, Photographs 31 & 32). The LUC area is shown on Figure 6.

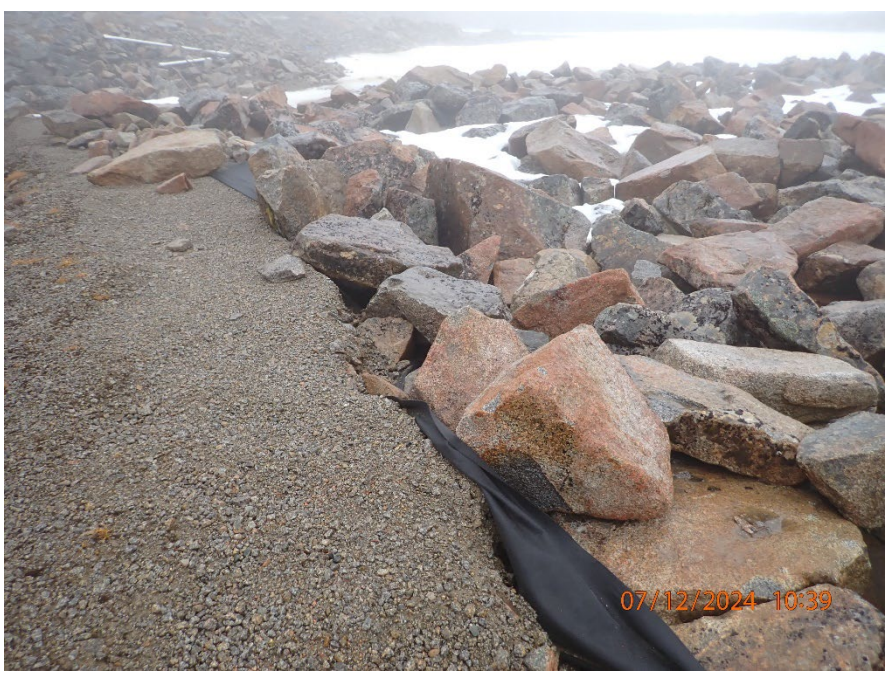
Photograph No.: 33	Photo ID: P7120213
Date Taken: 07/12/2024	
Photograph taken by: C. Aronson	
Direction: Southeast	Location: SS017
Description: Geotextile fabric at former building footprint.

A photograph showing a gravel path on the left leading to a rocky shoreline. A black geotextile fabric is laid out on the ground, partially covered by large, reddish-brown rocks. In the background, there is a body of water and a hazy sky. A timestamp in the bottom right corner reads "07/12/2024 10:39".

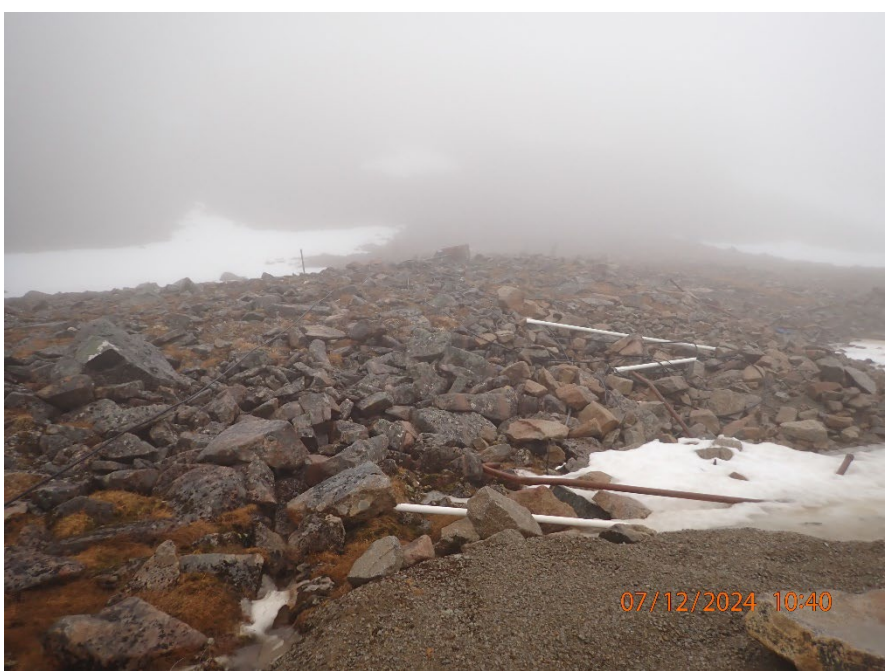
Photograph No.: 34	Photo ID: P7120215
Date Taken: 07/12/2024	
Photograph taken by: C. Aronson	
Direction: Southeast	Location: SS017
Description: Various debris at SS017.

A photograph showing a wide expanse of a rocky shoreline covered with various pieces of debris, including pipes and other unidentifiable objects. The rocks are dark and jagged. In the background, there is a body of water and a hazy sky. A timestamp in the bottom right corner reads "07/12/2024 10:40".

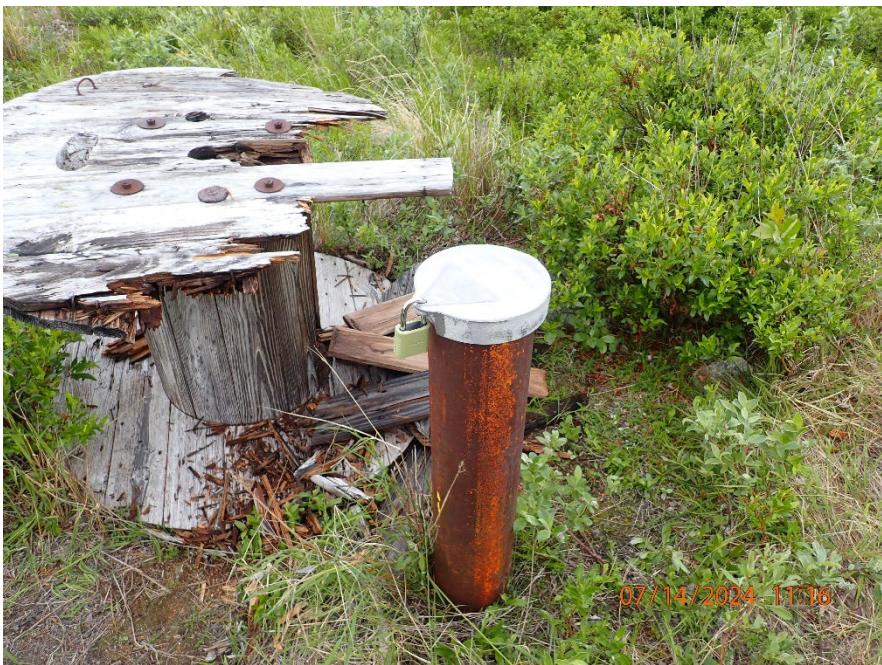
Photograph No.: 39	Photo ID: P7140292
Date Taken: 07/14/2024	
Photograph taken by: C. Aronson	
Direction: Southwest	Location: ST009
Description: MW07 with new combination lock.

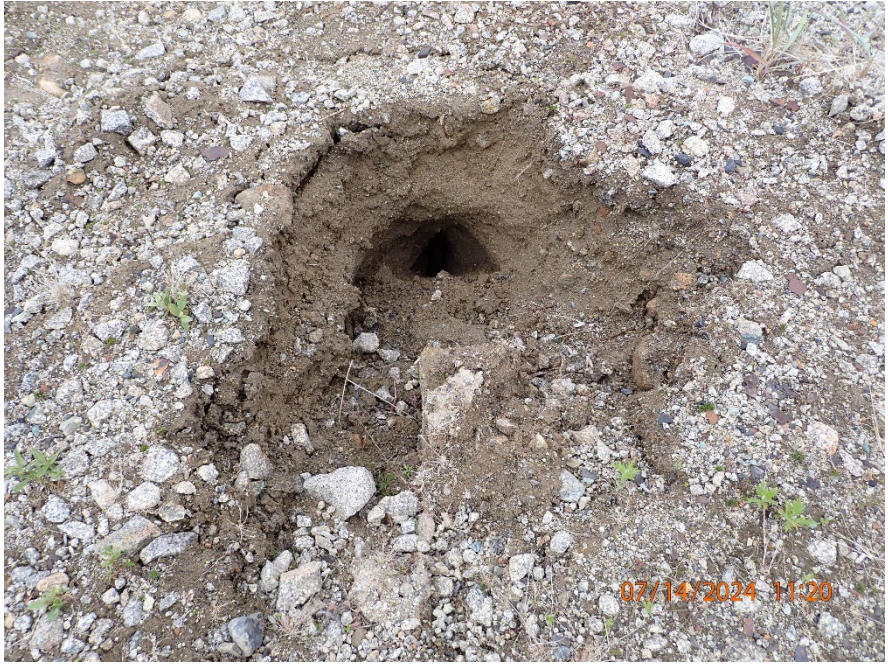
Photograph No.: 41	Photo ID: P7140286

Date Taken: 07/14/2024		
Photograph taken by: M. Rafter		
Direction: Down	Location: ST009	
Description: Observation of probable animal burrow.

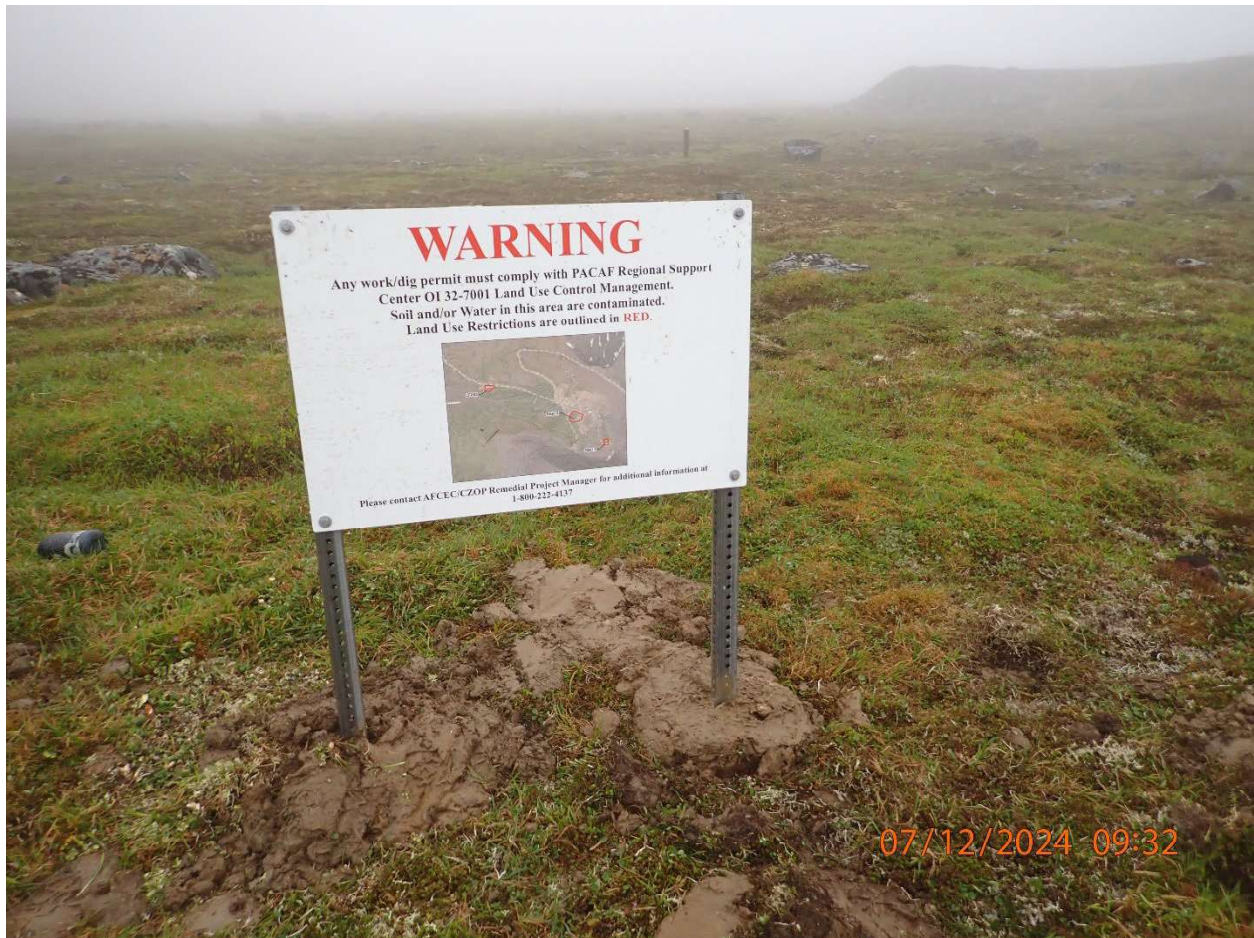
View northeast. New LUC sign installed at SS015. Monitoring well WW-06 is visible behind the sign.

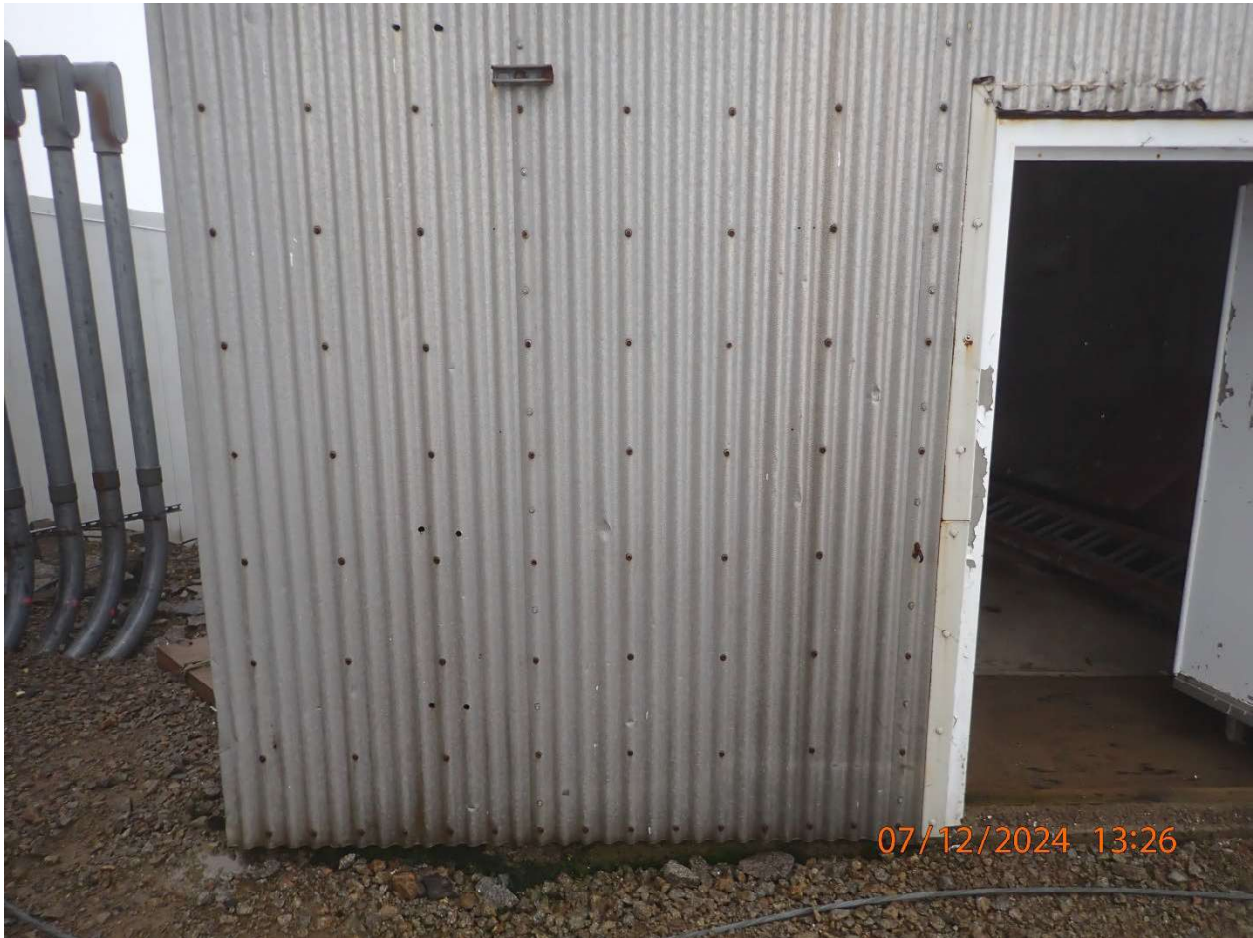
View south. Location of where a LUC sign was installed in 2023 and removed and relocated in 2024.

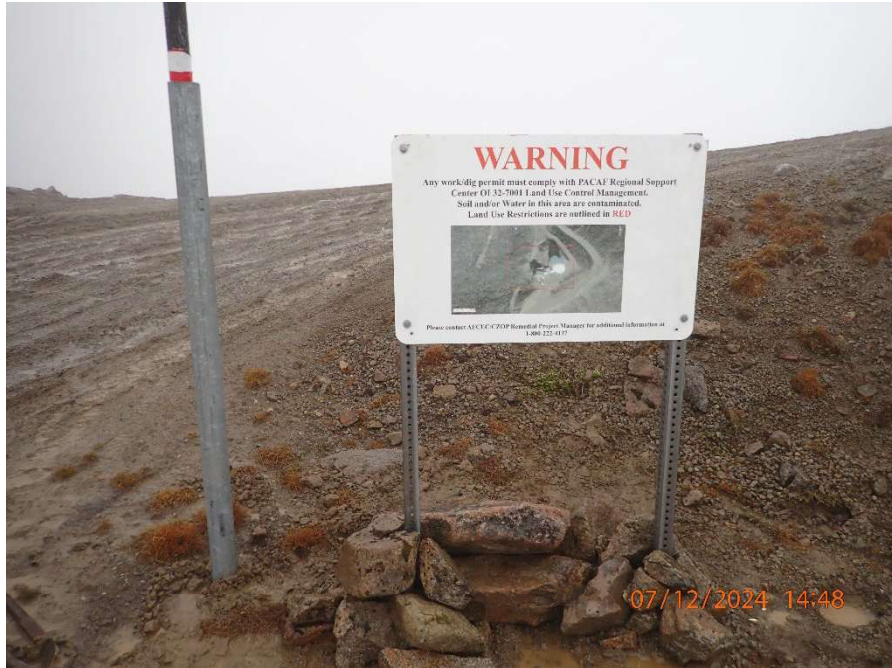
View west. New location of LUC sign removed from north side of building at SS016.

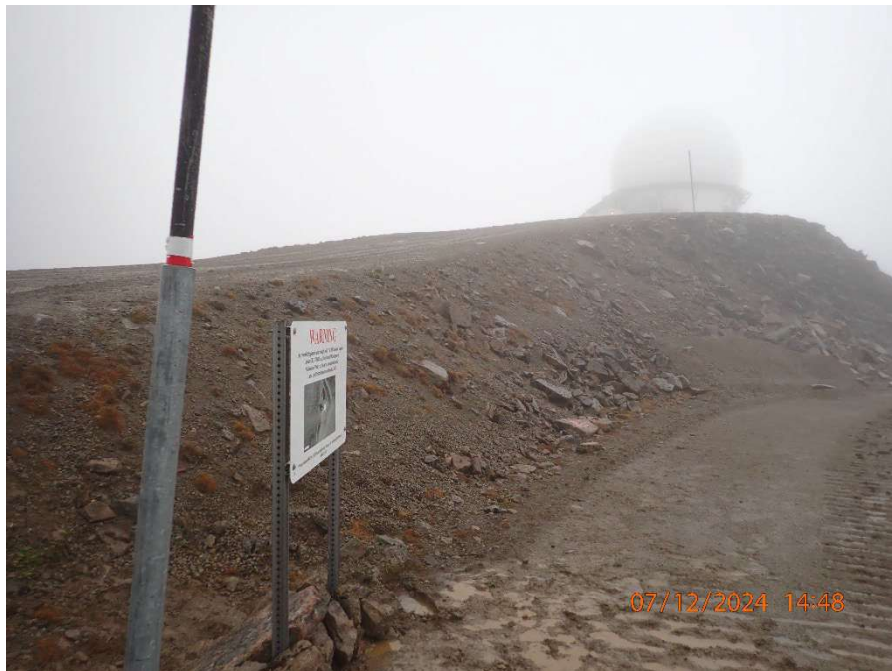
View north. New location of LUC sign removed from north side of SS016 building showing proximity to access road and building.

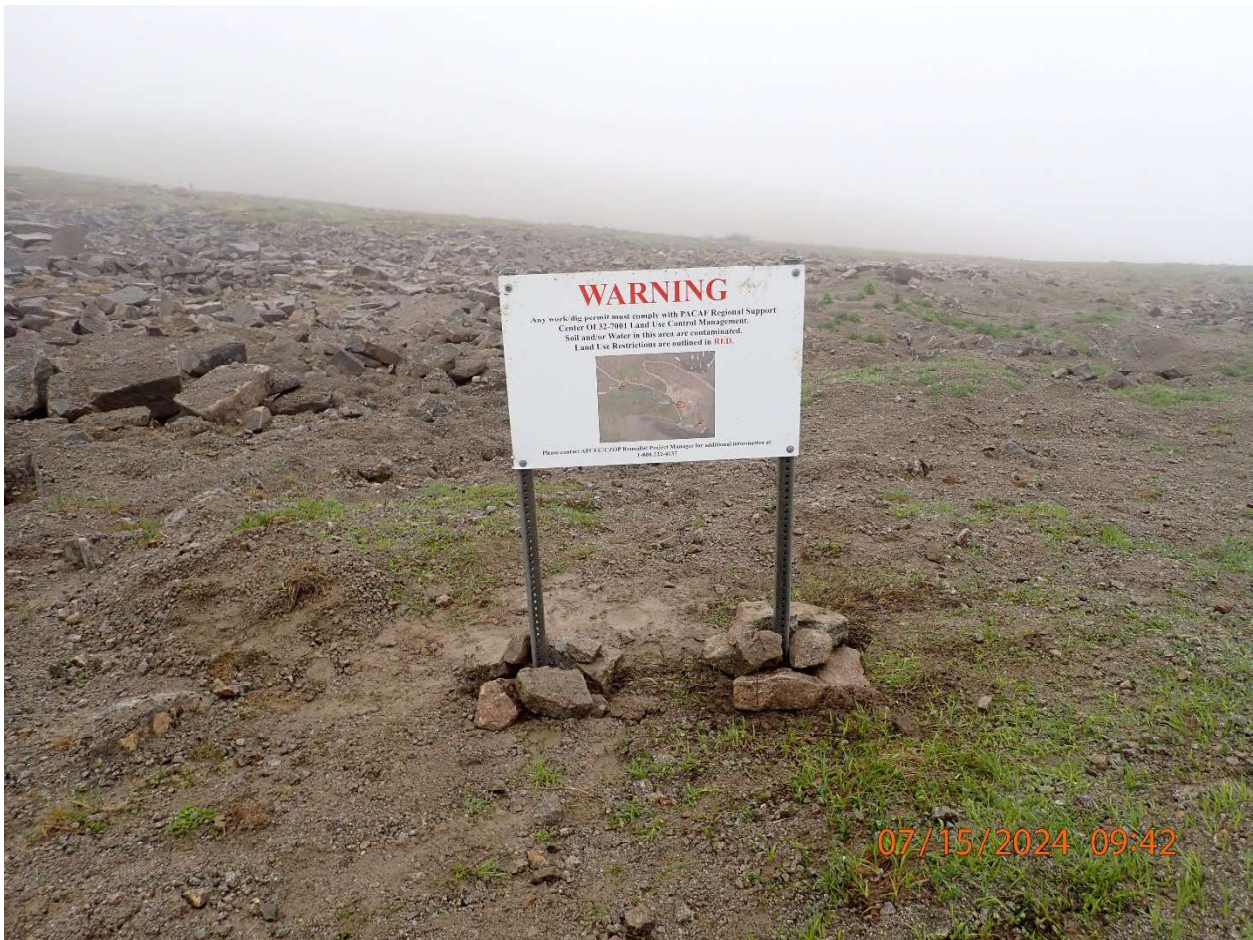
View south. New LUC sign on the west side of LF003.

There was no evidence of settling on the capped surface. Petroleum sheen and chemical odors were not observed or evident at the cap or at surface water downgradient to the southwest. Areas of exposed geotextile liner were observed along the southern portion of the excavation area. The site had some debris, including plastic markers and metal materials. Vehicle tracks were observed in the flat/pull-off area of the site. The site had damaged or missing silt fences. All silt fences were in various states of disrepair and non-operative condition due to high winds. The damage to the silt fences include those done by wind damage where they were observed ripped and partially attached to bent posts and completely missing given by standalone posts with no attached fabric. No discolored vegetation was observed. All monitoring wells appeared intact and in good condition. No wildlife was present and no evidence of animal burrows was observed. The site was lightly vegetated on the cap surface and south/west side slopes, and up to 90 percent (%) vegetated on the east side slope. Two LUC signs found damaged in 2023 were replaced with new signs during this site visit. One sign was installed on the east side of the site on the south side of the road (Appendix A, Photograph 01), and the other sign was installed on the west side of the site on the south side of the road (Appendix A, Photograph 02). The LUC area and the locations of the newly installed LUC signs are shown on Figure 2.

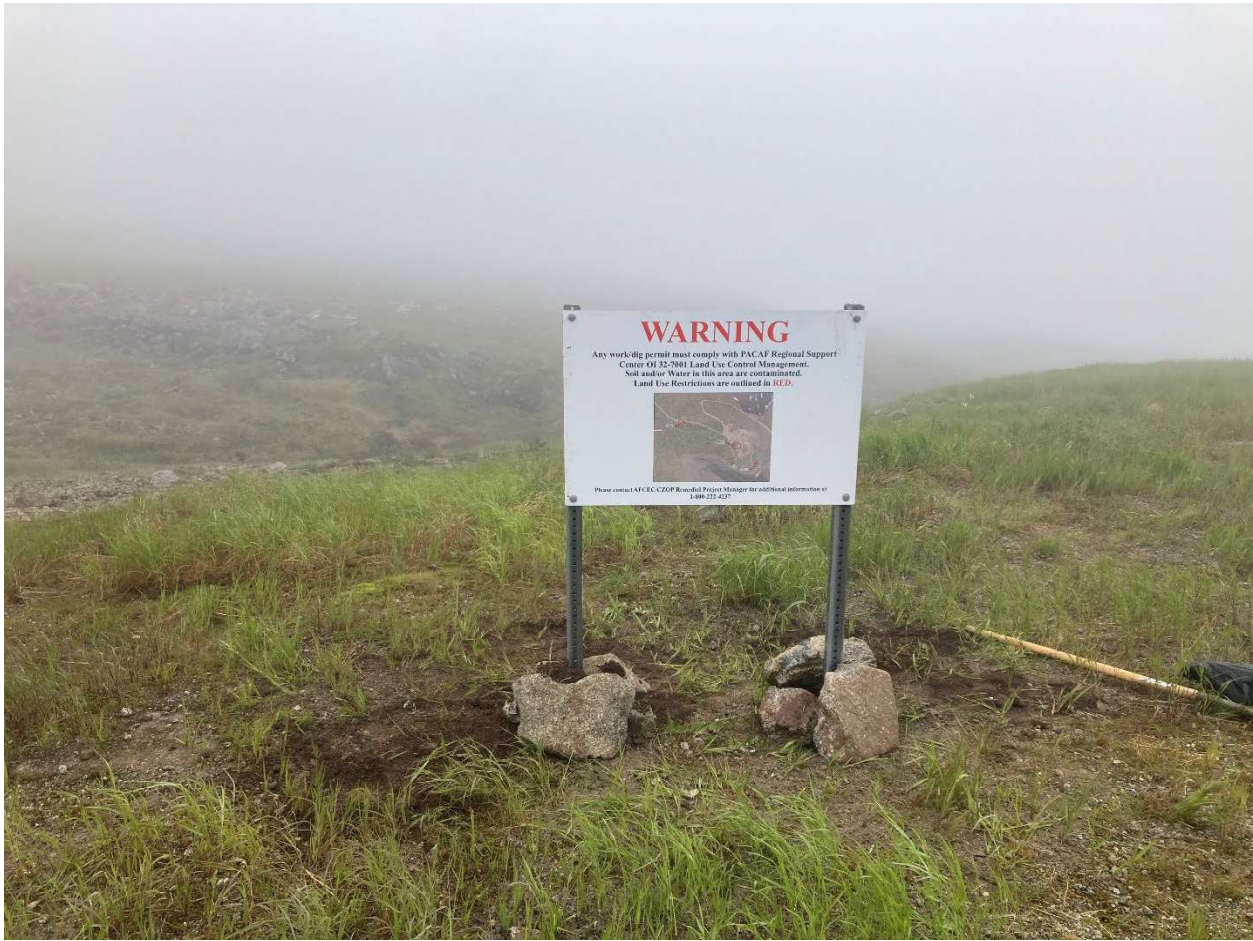
View south. New LUC sign on the east side of LF003.
