**SITE INSPECTION REPORT
FOR
TREADWELL MINE
JUNEAU, ALASKA**

Contract No.: 18-444-88

Report Prepared by: ECOLOGY AND ENVIRONMENT, INC.

Date: September, 1991

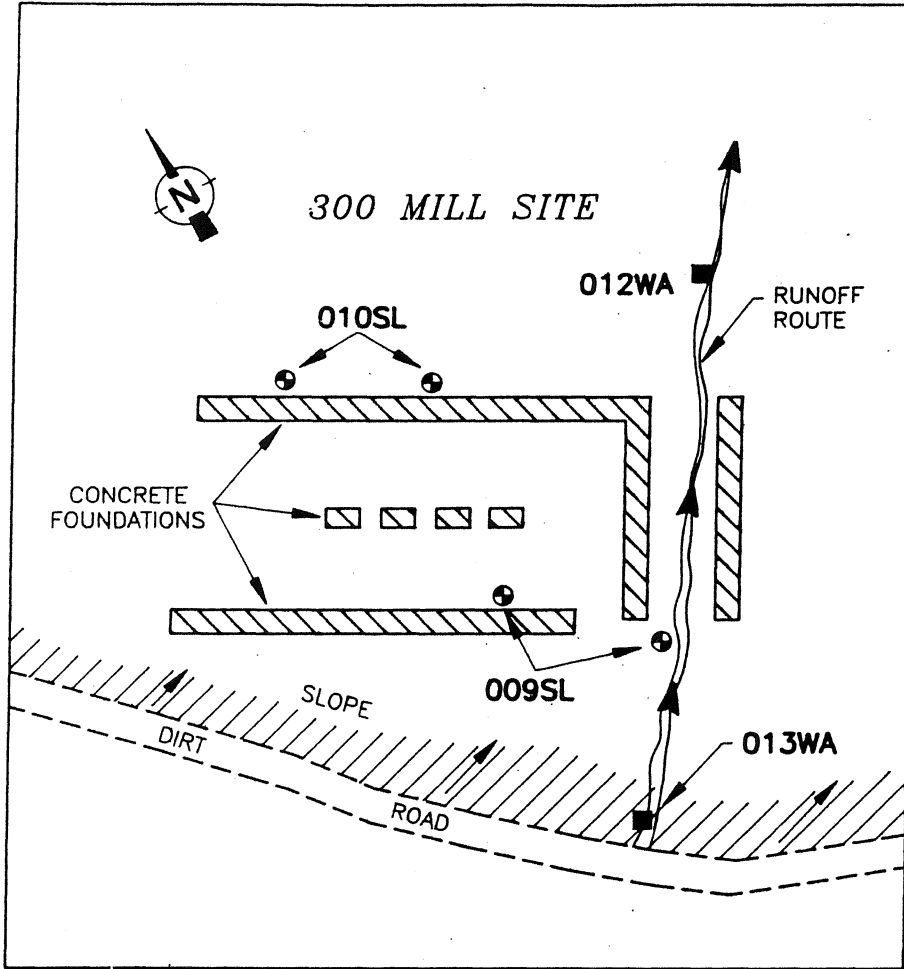
TREADWELL MINE SSI Douglas, Alaska CONTRACT 18-444-88	
TITLE: 300- AND 240- MILL SITE SAMPLE LOCATION MAP	
Project No. JL4010	
ecology & environment, inc. ANCHORAGE, ALASKA	FIG. 4
Date: 05/91 Drawn by: RSM Scale: NTS

Four surface water samples were collected for the SSI. Samples were collected from surface run-off downgradient of the 300 Mill and 240 Mill (Figure 4) and the Cyanide tailings (Figure 5). A water sample collected up-gradient from the 300 Mill will be compared to the downgradient samples to determine the presence of contaminants migrating via surface run-off. Table 4-1 summarizes the type, number, location and rationale of all water samples collected for the SSI.
