## **2006 Semi-Annual Fugitive Dust MOU Report**

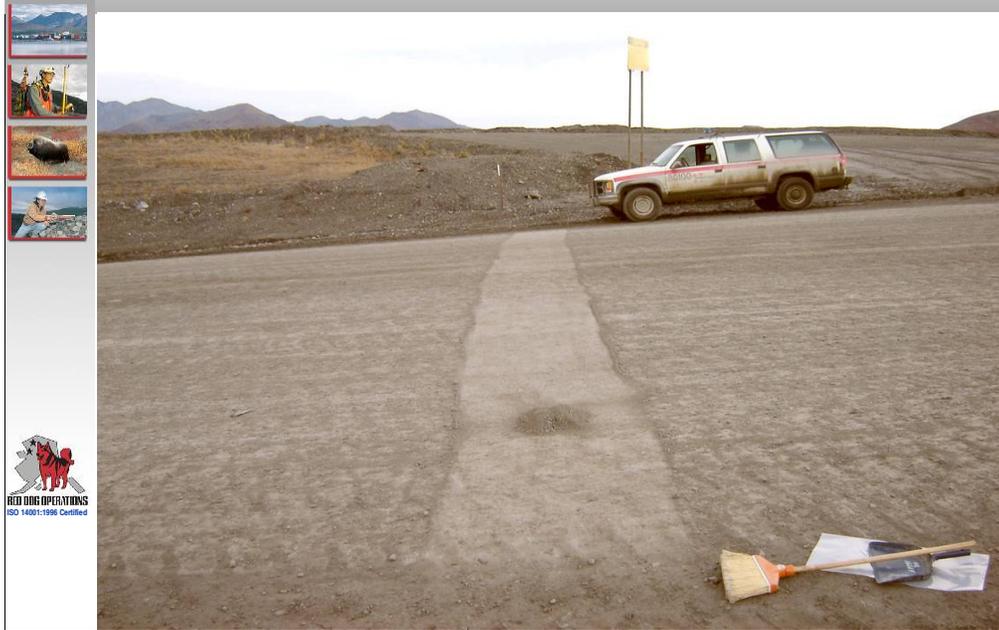
# Road Source Sampling

Example of EPA collection method to determine the silt content of mine haul roads for input into the source contribution and modeling analysis.

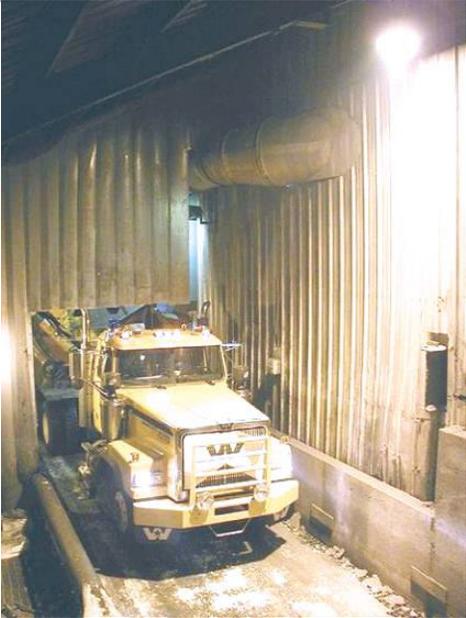
# CSB Truck Loading

Dust control system in the concentrate loading area of the mine Concentrate Storage Building.

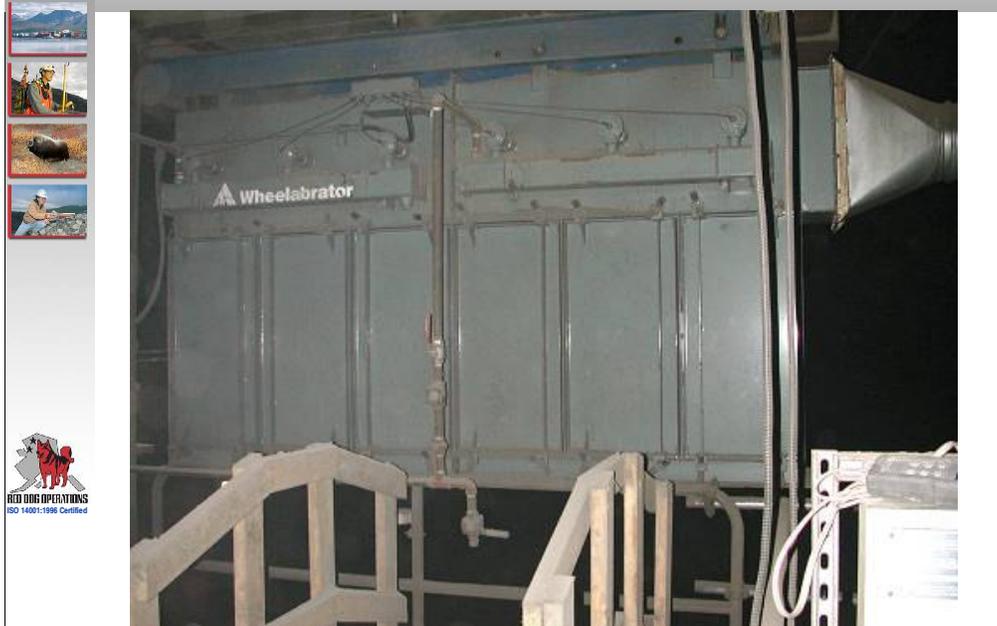
## CSB Prototype Baghouse

Prototype baghouse within the Mine Concentrate Storage Building. The unit is being operated to evaluate the performance of filter media within the CSB which can have very high moisture and extremely cold temperatures.

- Dry filtration technology (baghouse using PTFE filters) is applicable for full scale CSB dust control bearing in mind that there will be periods of time when flow will be restricted due to high relative humidity in the building.
- Preliminary engineering for dust control system is currently under development. Delivery of preliminary engineering is expected in January.

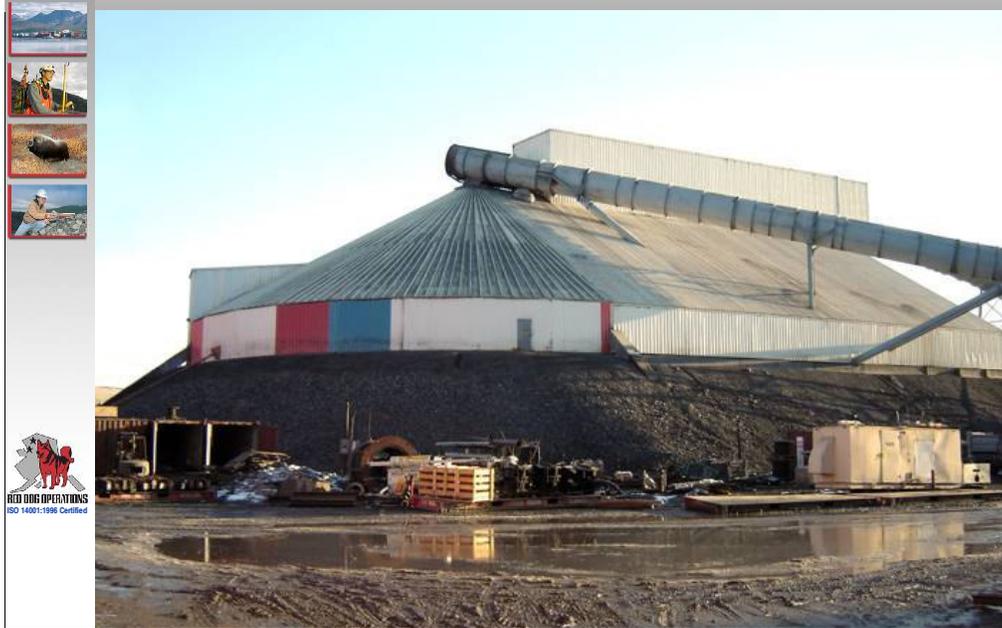
## Coarse Ore Storage Bldg Roof Before

Dark regions of the curved roof are holes in the sheet metal.

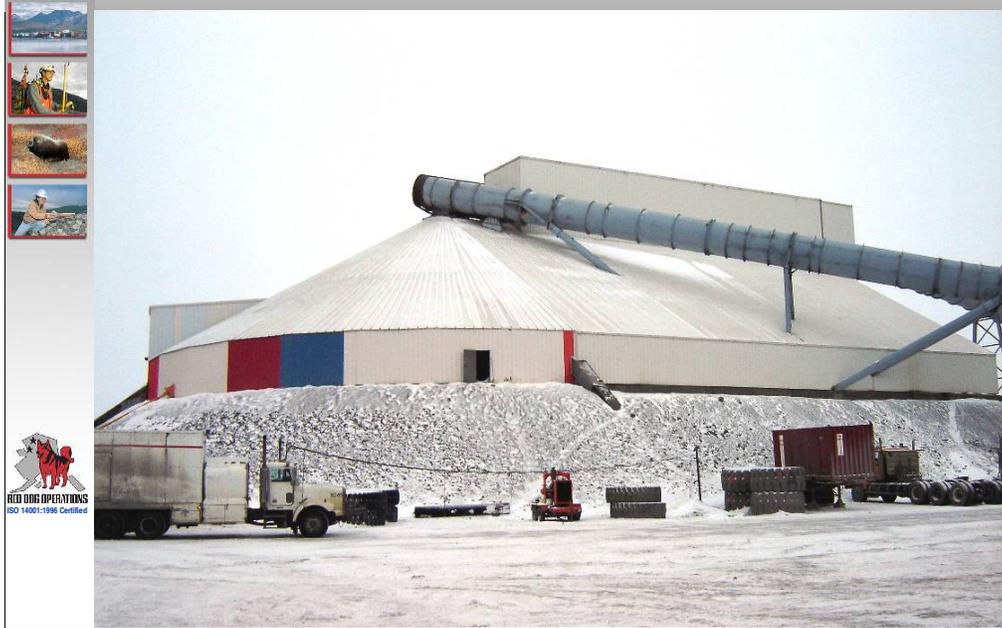
## Coarse Ore Storage Bldg After

Note the new roof on the curved portion of the COSP

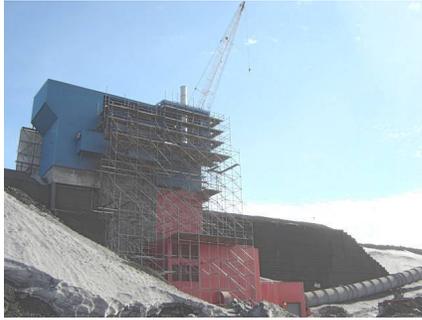
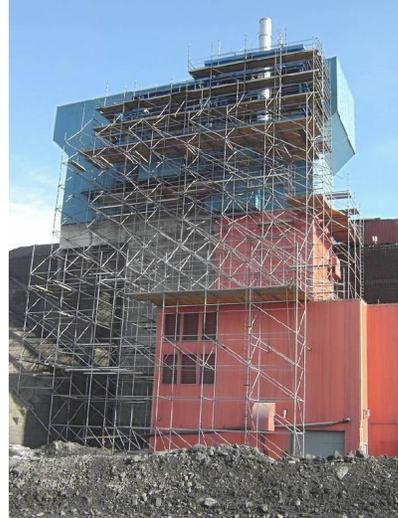
# Gyratory Crusher

The Gyratory Crusher Dump Pocket Baghouse construction

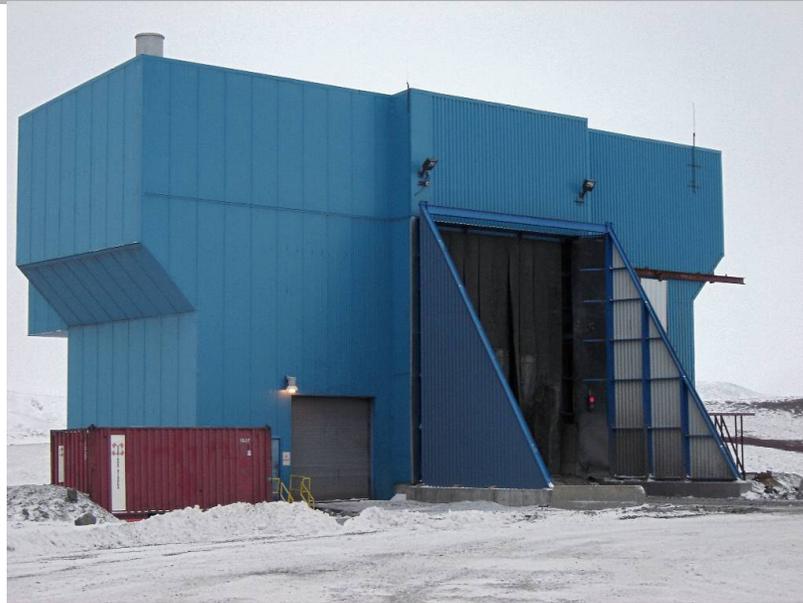
# Gyratory Crusher

The Gyratory Crusher Dump Pocket Baghouse construction. Note new wing-walls and baghouse stack in foreground.

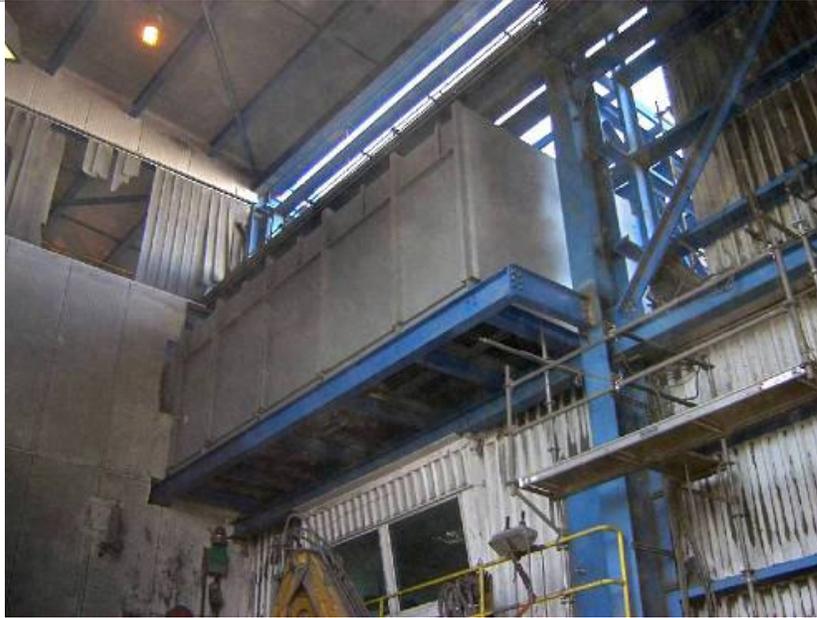
## Plenum within Gyratory

Air plenum for the Gyratory Crusher Dump Pocket Baghouse. The Plenum is directly above the dump pocket.

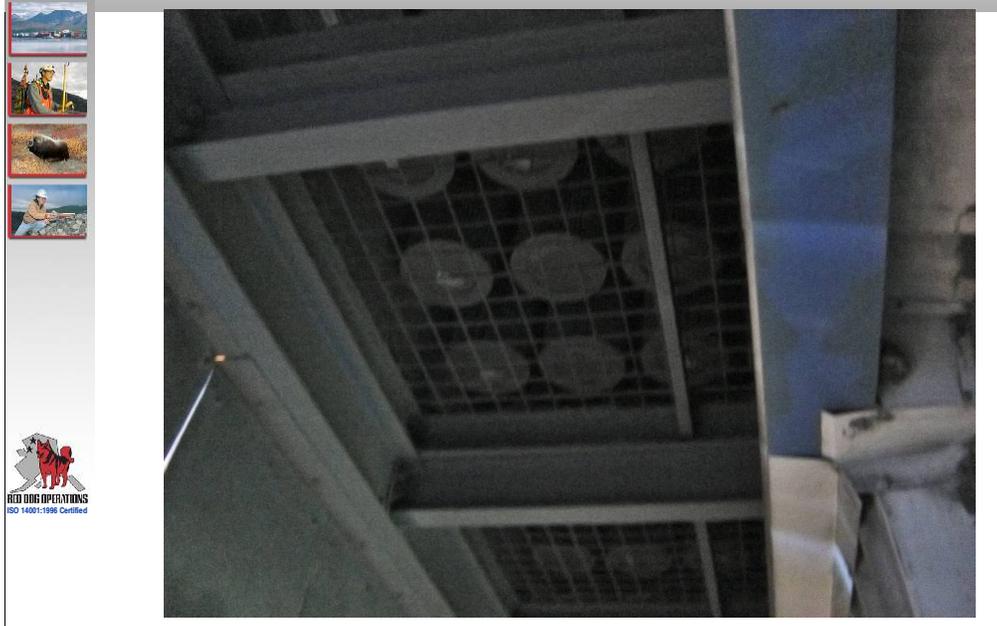
## Plenum within Gytratory

The Gytratory Crusher Dump Pocket Baghouse construction. Note filter assemblies (circles).

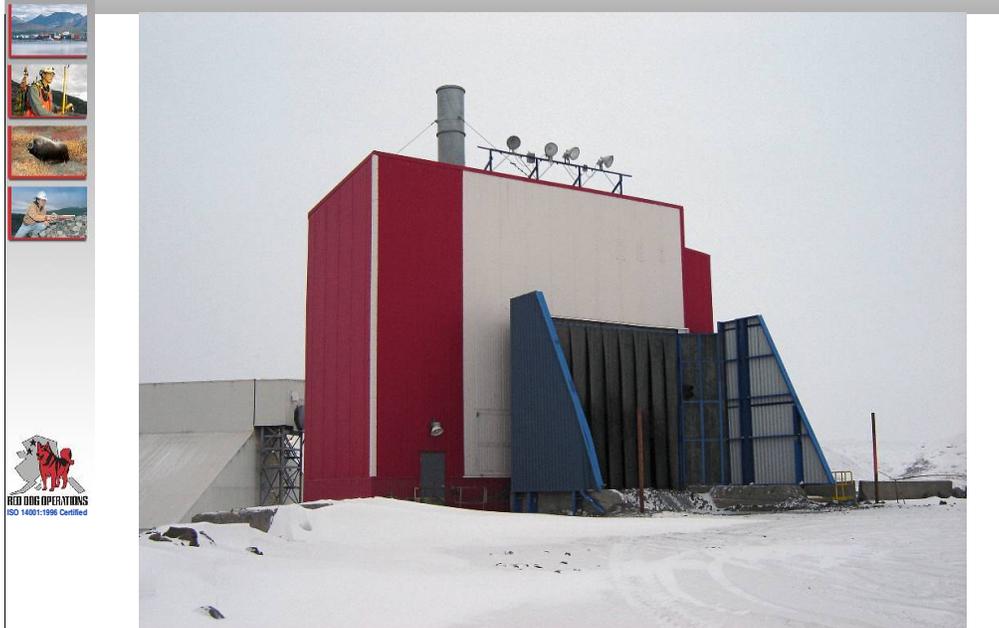
# Jaw Crusher

Jaw Crusher with newly installed baghouse, stilling curtains, and wing walls.

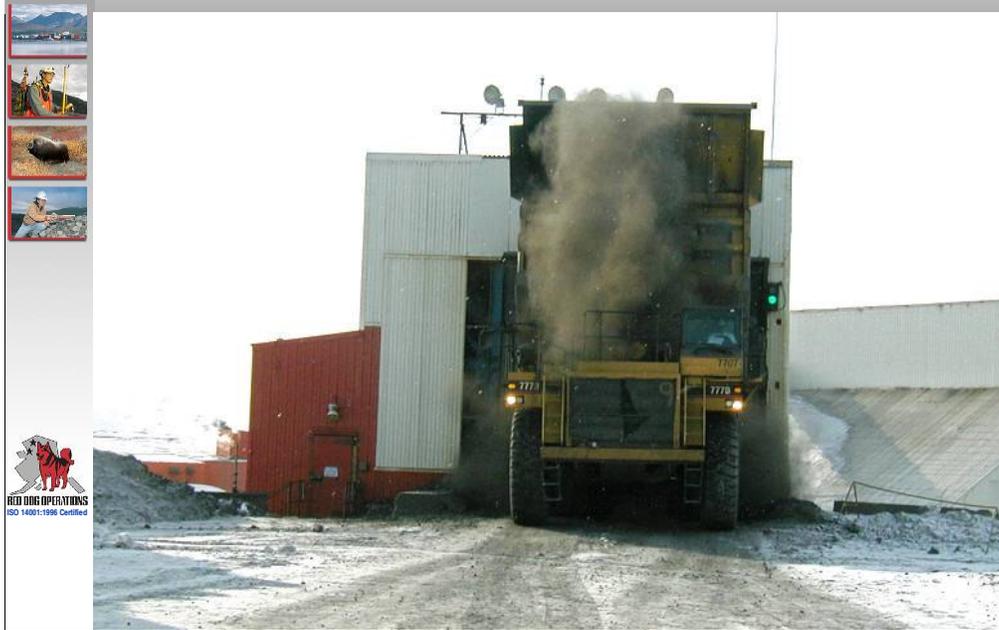
## Dump Pocket Emission Before

Fugitive dust from ore unloading at the Jaw Crusher dump pocket prior to baghouse installation.

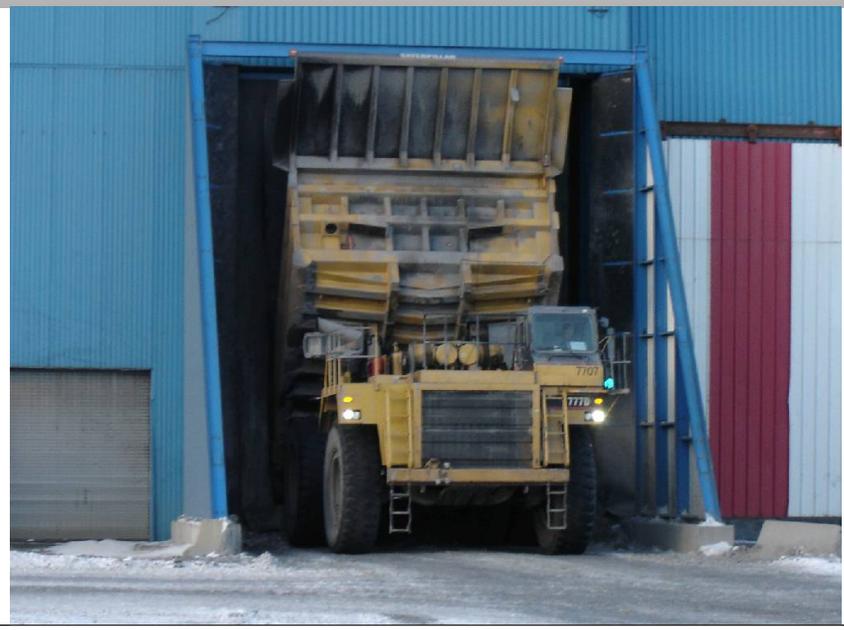
## Dump Pocket Emission After

Unloading of ore at the Gyratory Crusher dump pocket post installation of baghouse, and wing-walls.

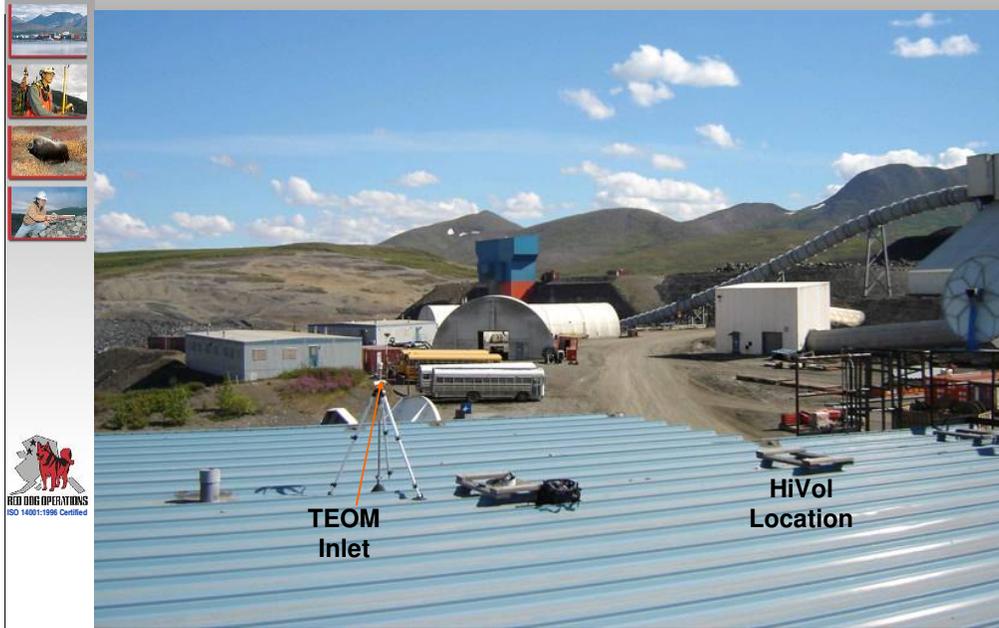
# PAC TEOM & HiVol

View from the roof of the PAC looking east toward the gyratory crusher showing the locations of the TEOM inlet and the Hi Vol location.

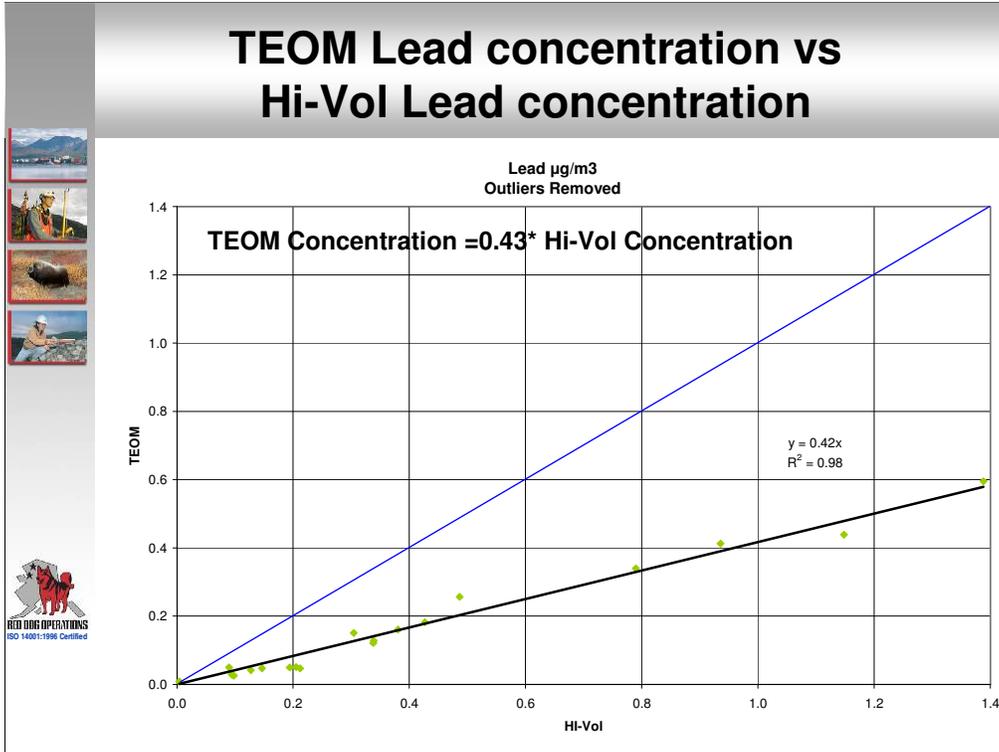
Correlation between TSP from TEOM and TSP from a Wedding Hi-Vol Particulate Monitor. From Comparison of the Total Suspended Particulate Collection Efficiency of a HI-Vol Particulate Collection System and a R&P 1400AB TEOM Particulate Collection System

TSP trends as measured by TEOM or TSP monitor corrected by correlation in the previous slide.

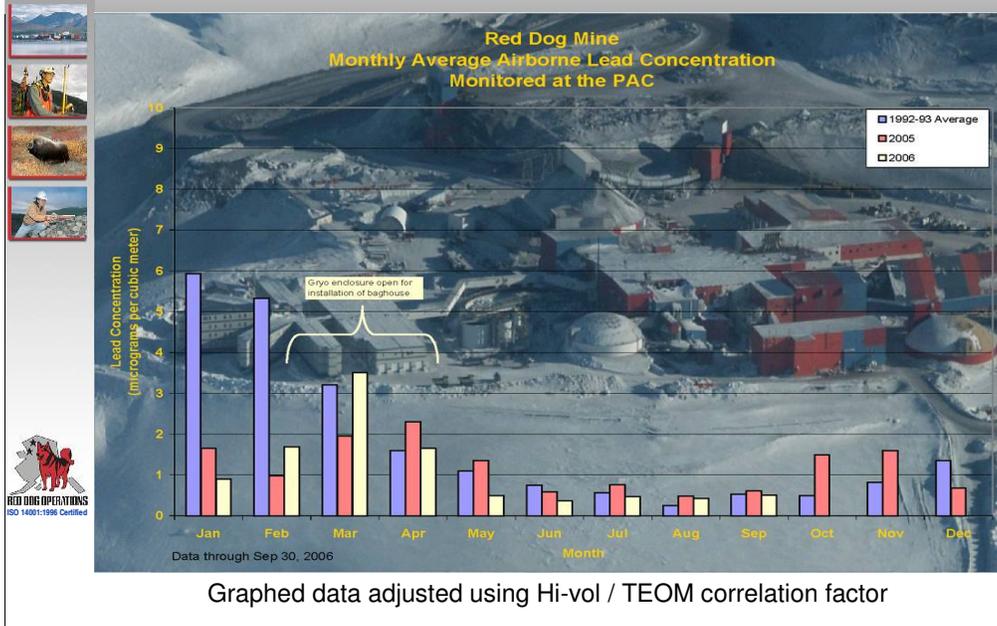
# Pb in Air From PAC TEOM

Graphed data adjusted using Hi-vol / TEOM correlation factor

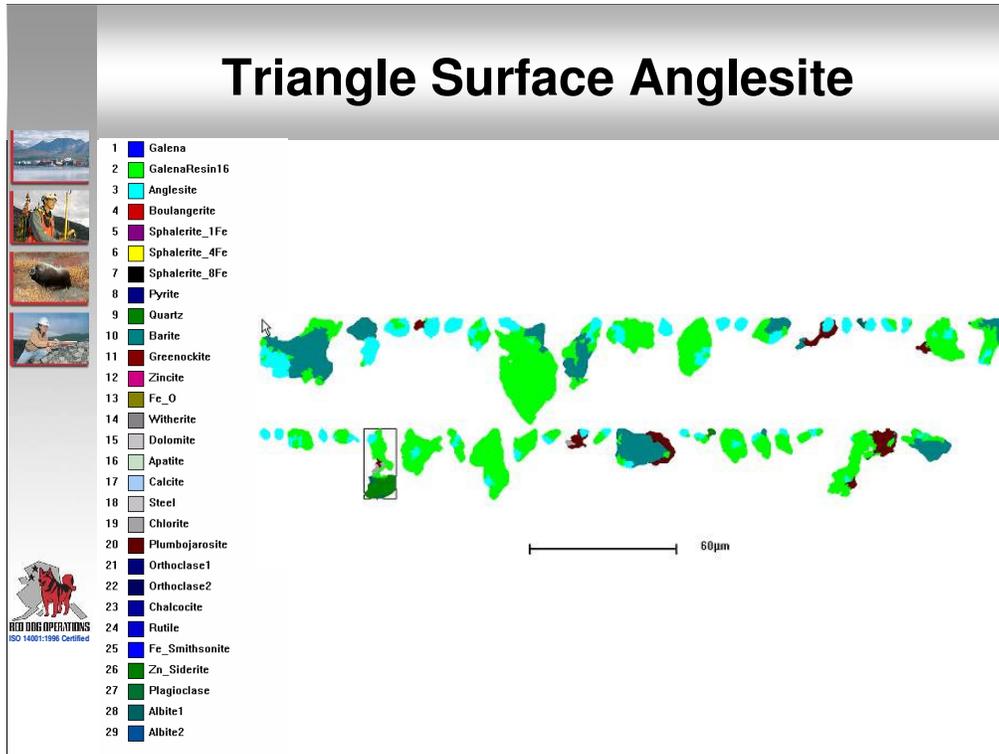
The MLA system combines an SEM, energy dispersive spectral (EDS) X-ray analysis and a backscatter electron (BSE) detector with image analysis. The MLA is capable of generating quantitative mineral identification.

Lead grains recovered in the Triangle Surface soil sample contain both galena and Anglesite  $PbSO_4$ .

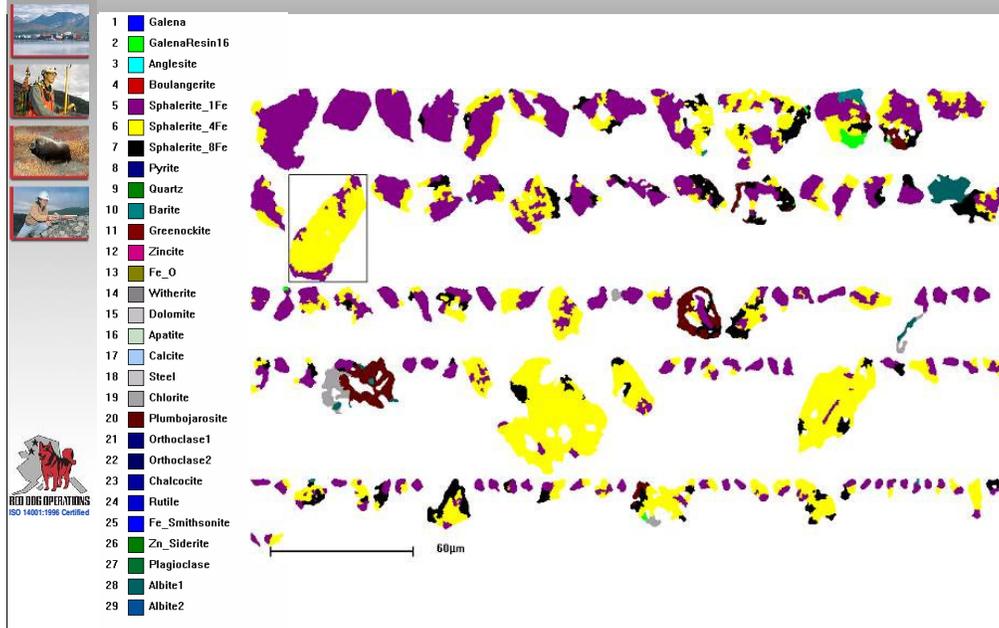
# Triangle Surface Sphalerite

Zn bearing grains from the Triangle surface soil contain sphalerite with variable Fe content minor barite and trace galena. Note how corroded some grains are.

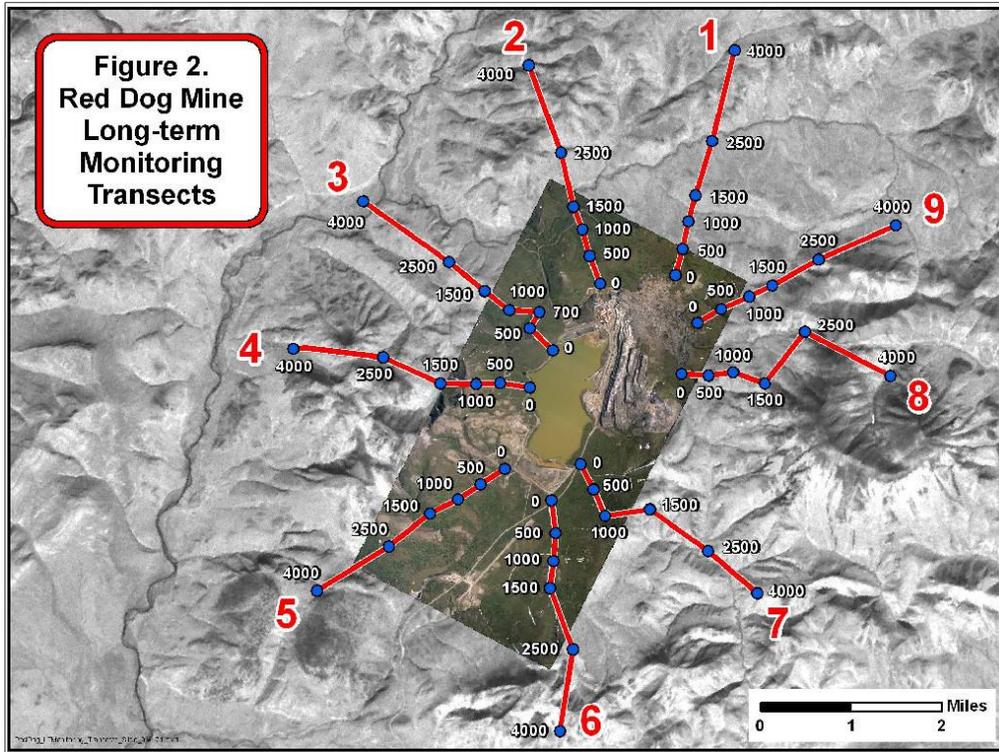
- Established long-term monitoring transects (4 km long) in July 2006, with intervening plots starting at 0 m to 4000 m. Plant cover was quantitatively measured and vascular plants identified to species; non-vascular plants (lichens, mosses, and liverworts) were identified to genus, with species identification where possible.
- Set up treatment plots in August 2006 at three locations near the mine: the triangle area, the west tailings area, and north of the Red Dog Creek diversion (Figure 1). At each site, dolomitic lime was applied at a rate of 500 lbs/acre. Additional treatments may be applied in the future, pending results from the plant tissue and soil analysis (not available at the time of the 2006 August treatment effort).

Numbers are meters from the beginning of the transect.
