Alaska Department of Environmental Conservation (ADEC) Solid Waste Program (Kitrina Persson and Elizabeth Stergiou) conducted a Coastal Impact Assistance Program (CIAP), Waste Erosion Assessment and Review (WEAR) site visit for the Village of Chignik Lagoon on August 2nd, 2012. This site was revisited on August 19, 2014 by Stephen Price and David Carlson. The following narrative is a brief description of our findings during the 2012 and 2014 inspections.

WEAR Sites:

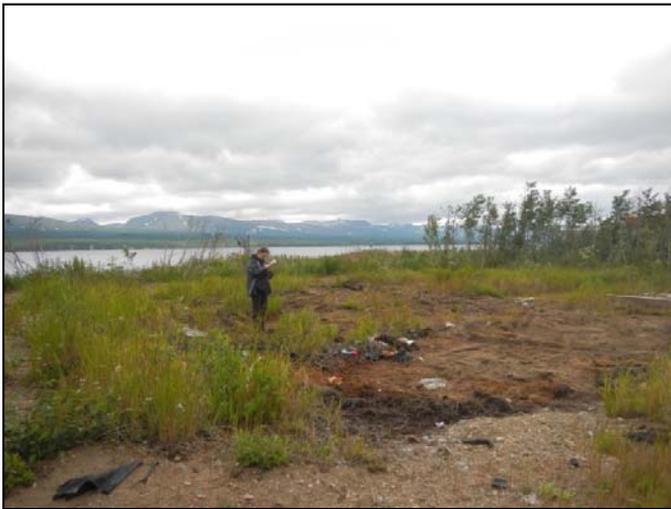
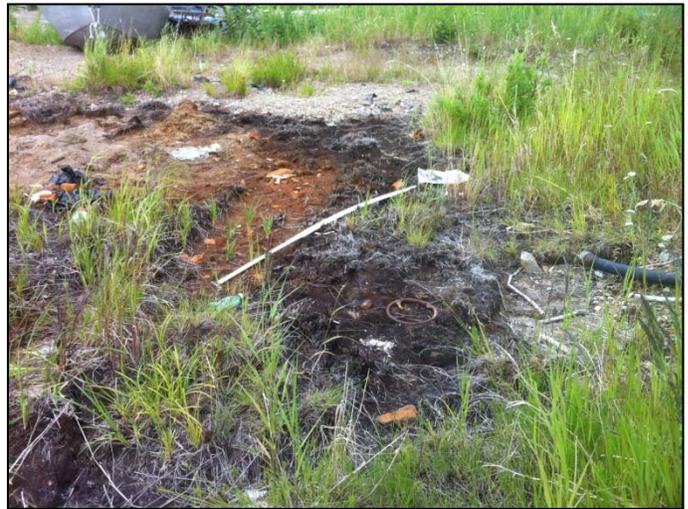
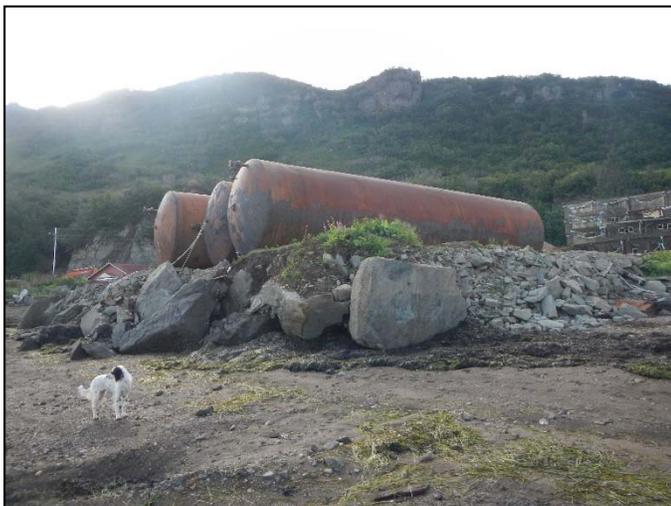
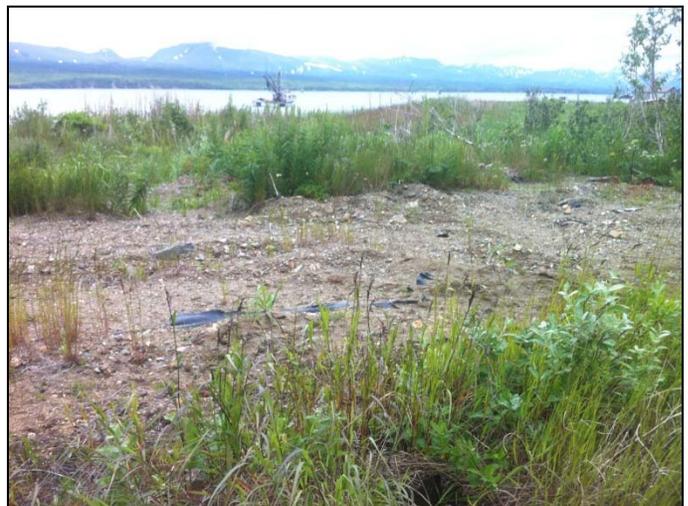
- **Removed Tank Farm, 56.309929/-158.540255 (Abandoned)** – The three horizontal tanks that used to occupy this site were removed by a resident and brought to the north end of the runway where they remain. The tanks were still at the runway in the 2014 visit. The site, which has staining and dead vegetation, is approximately eight feet from the actively eroding beach of Chignik Lagoon.

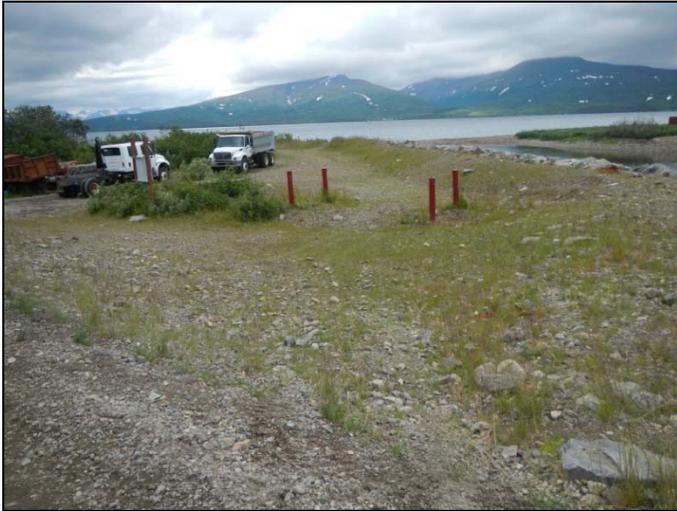
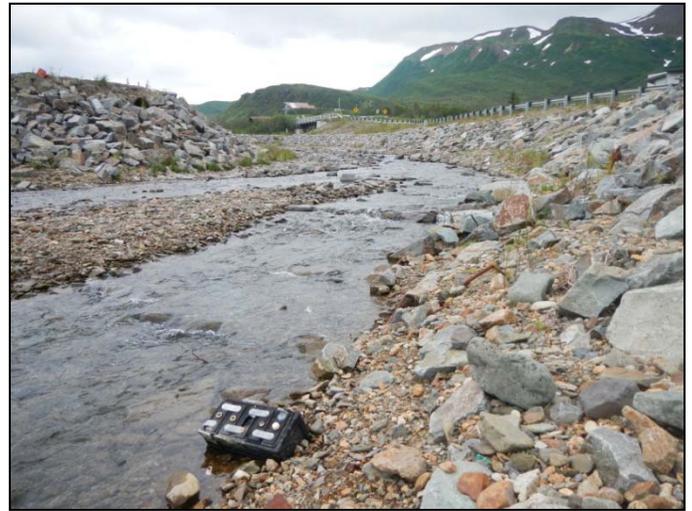
- **Packer's Creek/Runway Landfill, 56.308981/-158.539028 (Closed)** – This site is to the south of the runway extension area; the area is cleared and there are bollards where a new sewer tank sits. Dumpsters are located at the edge of the clearing near some alders. Some of the waste from this closed landfill was reported to be dug up when the new sewer tank was installed. However, there was evidence that waste still remained in the area including batteries which were observed both near the dumpsters and in the creek. A wall of rip rap was installed when the creek was rerouted for the runway extension project back in 2011.

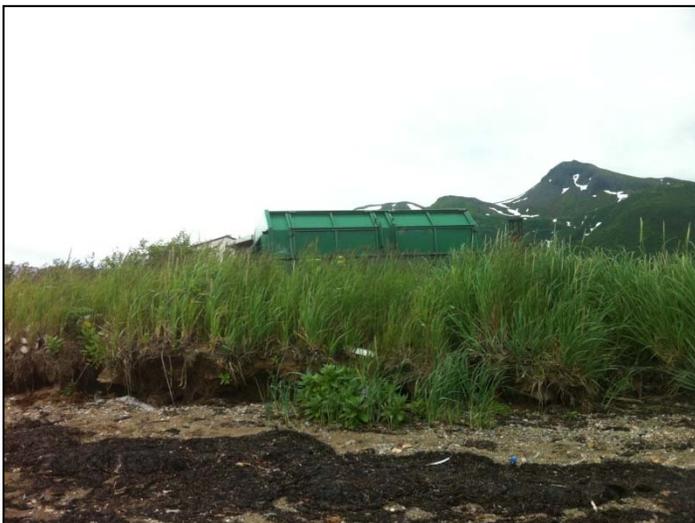
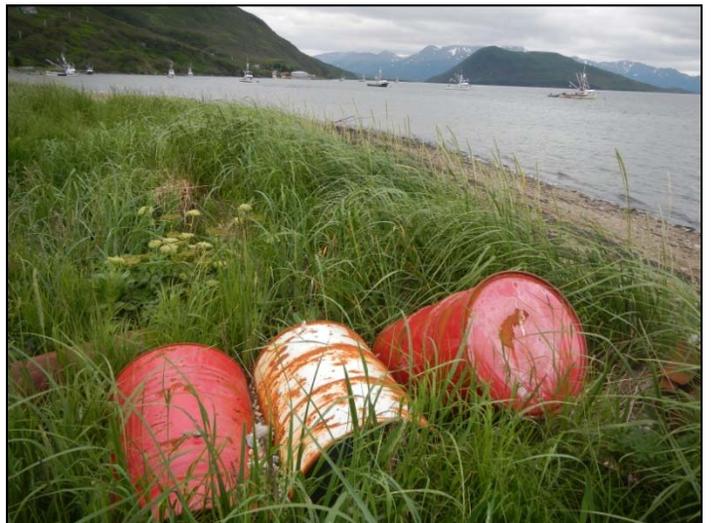
- **West Landfill, 56.309713/-158.540655 (Closed)** – This old landfill is located less than 100 feet southwest of the Removed Tank Farm site on the west end of town. There was garbage from the eroding bank, several drums, plastics, cans, battery remains, a trailer frame, and other waste lying on the beach side from the dumpster area in town. It is located near the actively eroding beach of Chignik Lagoon.

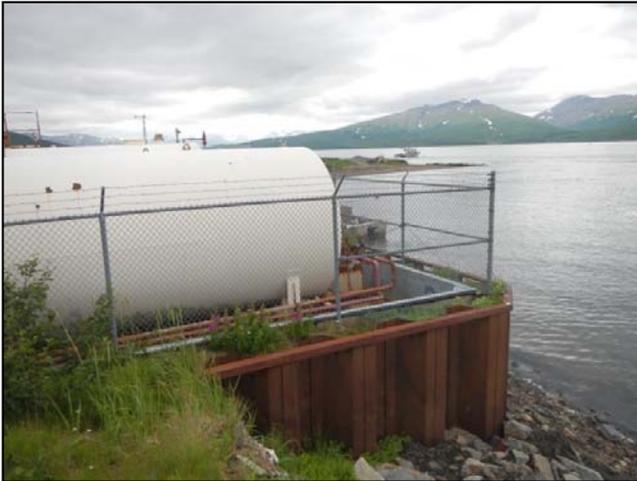
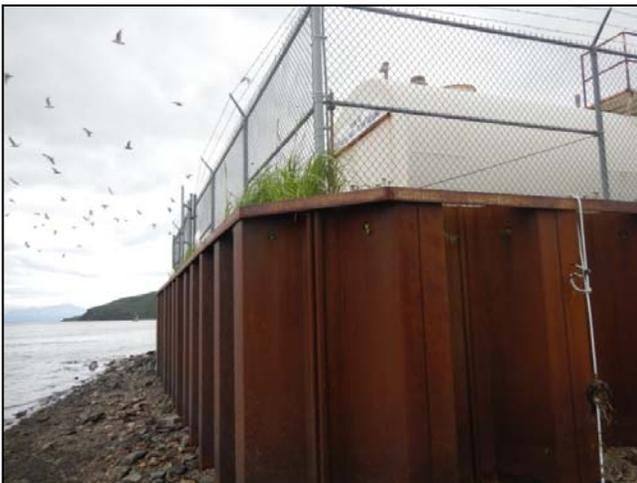
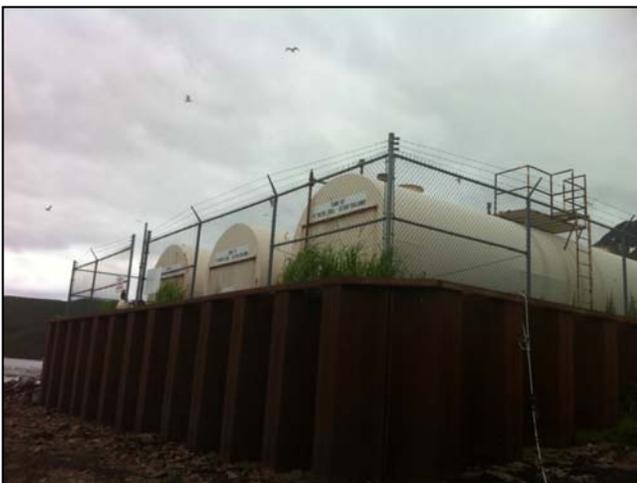
2012 Photos

- **Tank Farm, 56.311568/-158.536438 (Active)** – This tank farm was constructed in 2001 through a Denali Commission project. It is owned and operated by the Native Village of Chignik Lagoon. It consists of four horizontal tanks within a fenced, sheet pile bulkhead retaining wall. The total capacity is 62,100 gallons: two 22,300 gallon diesel tanks, one 13,500 gallon gasoline tank, and one 4,000 gallon gasoline tank. The three larger horizontal tanks are within a metal lined, wooded walled, secondary containment. This site also serves as the community fueling station. It is directly on Chignik Lagoon, which is less than 10 feet away.

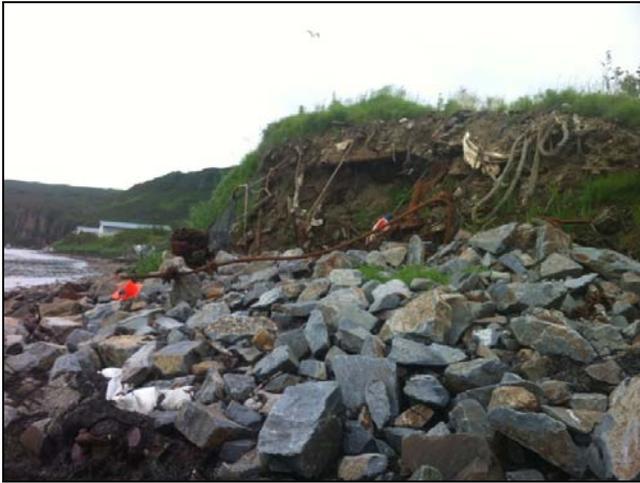
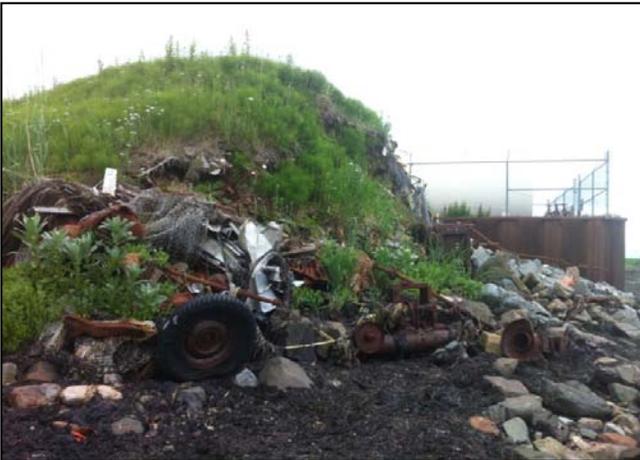
2012 Photos

- **Old Cannery Landfill, 56.311637/-158.536188 (Closed)** – This site is actively eroding into the lagoon and is located where the cannery used to be. A new tank farm was built abutting the edge of the old landfill, and it appears that part of the landfill would have been removed during the tank containment construction. It is impacted by the tides of Chignik Lagoon, which is less than 10 feet away.

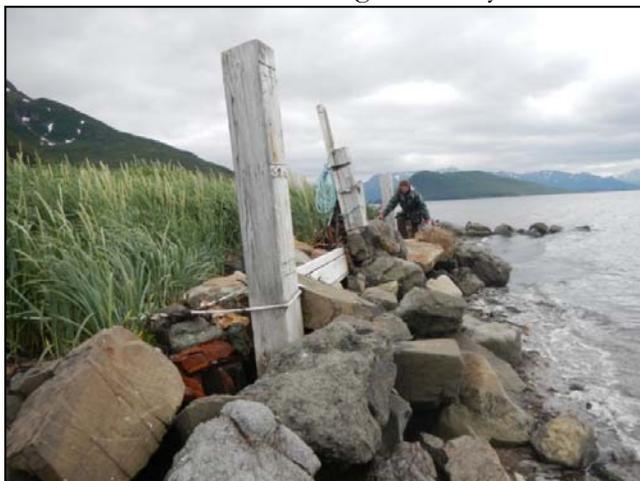
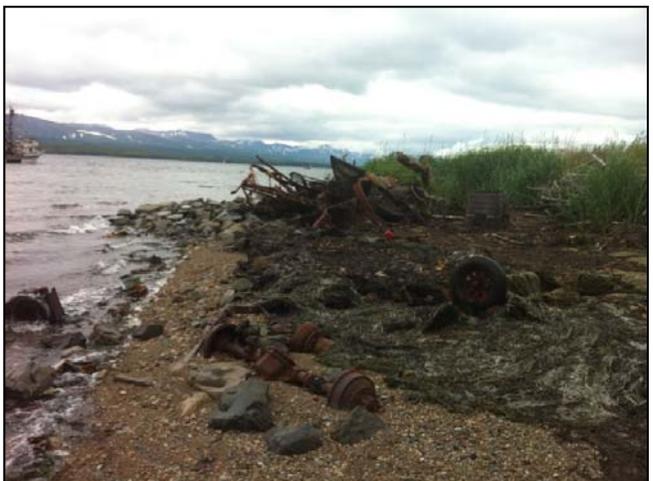
- **Beach Erosion Control, 56.312133/-158.533887 (Active)** – For approximately 1 mile in either direction from the new tank farm location, metals, tires, and fishing nets are placed on the beach by residents for erosion control. Also, beach front property owners are building infrastructure and placing heavy items on the beach in attempt to halt their loss of land. Sand and the erosion control items are being moved by tides and storms.

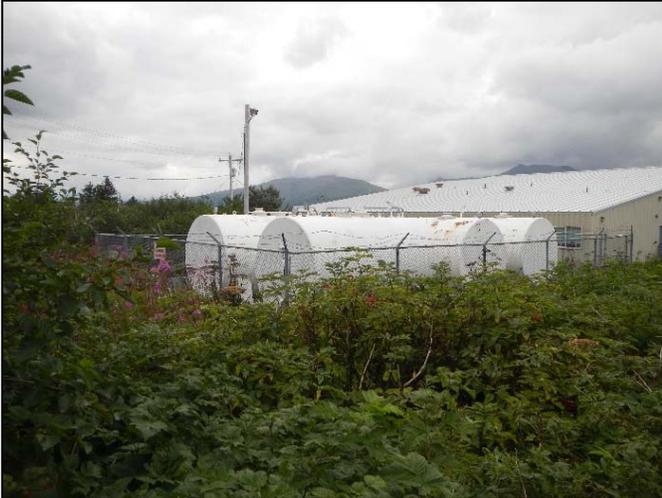
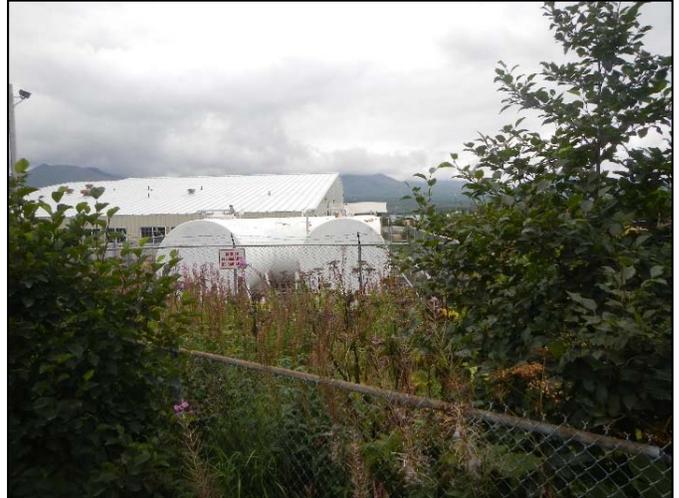
- **School Tank Farm, 56.308383/-158.537123 (Active)** –The tank farm has been in this location since around 1980. It is owned and operated by the Lake and Peninsula School District. The current tank farm was refurbished in 2001 through a Denali Commission project. It contains four tanks with a total capacity around 50,000 gallons of diesel. The area is fully fenced and the tanks within a metal diked secondary containment wall. This site is located 300 feet south of Packer’s Creek and 400 feet south of the runway.
