CIAP WEAR Trip Report  
Crooked Creek (population 93)  
September 16, 2014

Alaska Department of Environmental Conservation (ADEC) Solid Waste Program (Doug Huntman and Sarah Durand) conducted a Coastal Impact Assistance Program (CIAP), Waste Erosion Assessment and Review (WEAR) site visit for the Village of Crooked Creek, September 16<sup>th</sup>, 2014. The following narrative is a brief description of our findings during our September inspection.

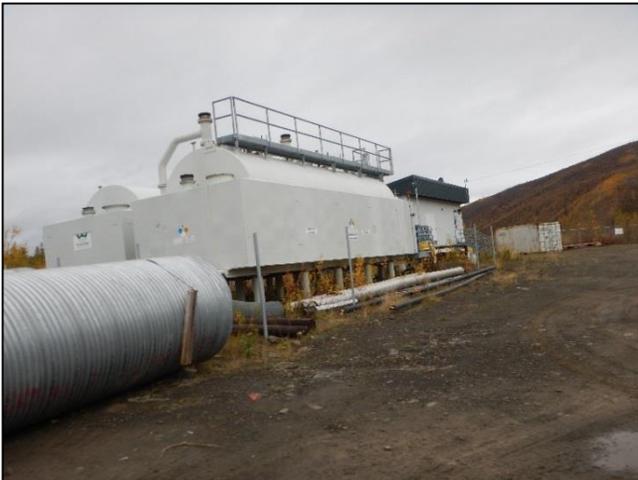
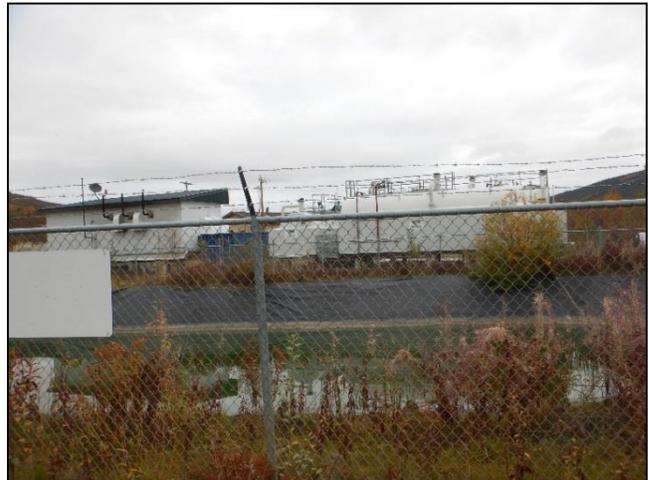
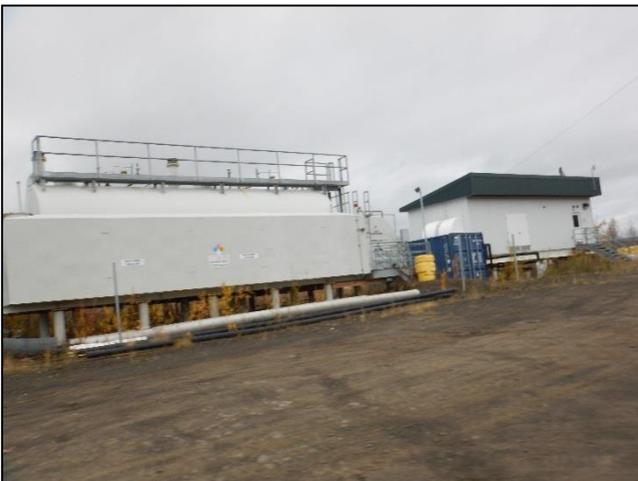
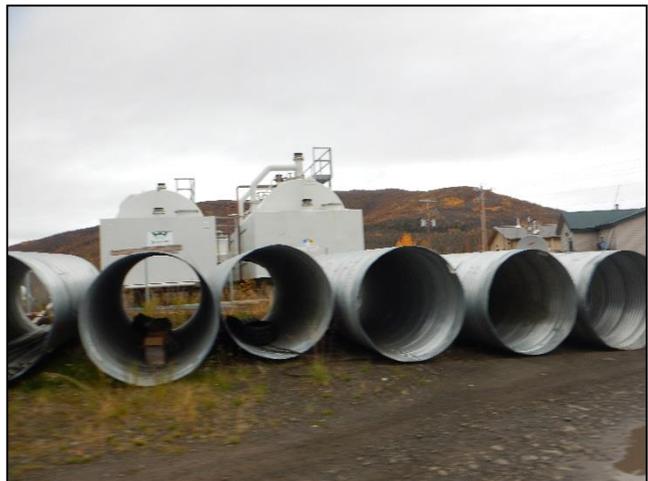
- **MKEC Tank Farm, 61.860507/-158.137403 (Active)** — The tank farm is an engineered facility owned by Middle Kuskokwim Electric Cooperative Inc. (MKEC), which supplies fuel to the local power plant. It was constructed around 2006 and has a total capacity of 48,000 gallons of diesel. It consisting of three double-walled fuel tanks: two horizontal 20,000 gallon tanks and one approximately 8,000 gallon horizontal tank. The tanks are elevated on 5 foot pilings in an unfenced area. The facility is located on a hill above town adjacent to the sewage lagoon. The closest water body is Village Creek approximately 590 feet to the west. The Kuskokwim River is approximately 1,100 feet to the east from the tank farm.

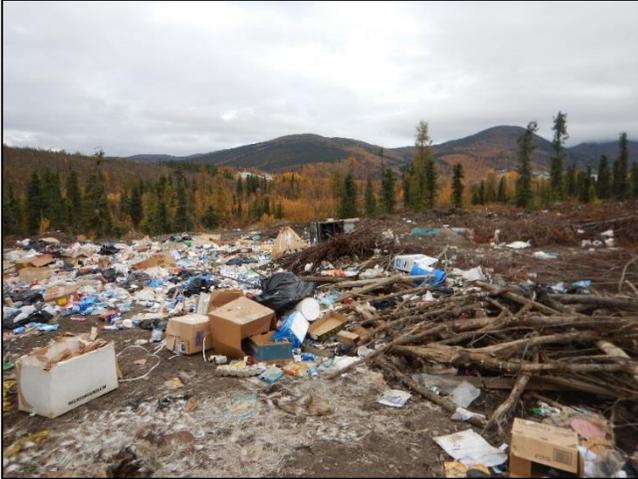
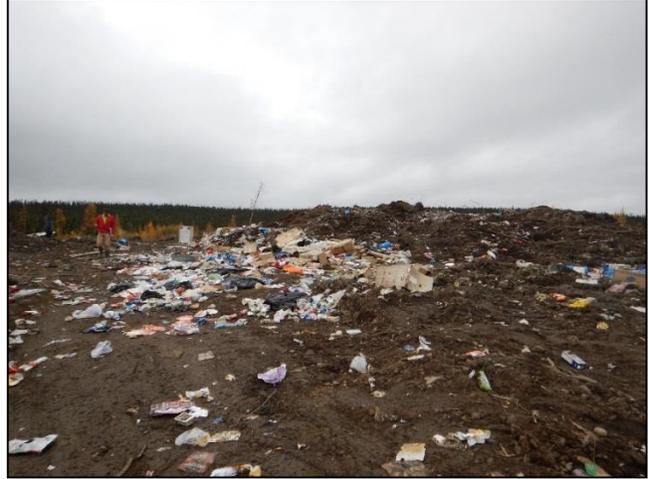
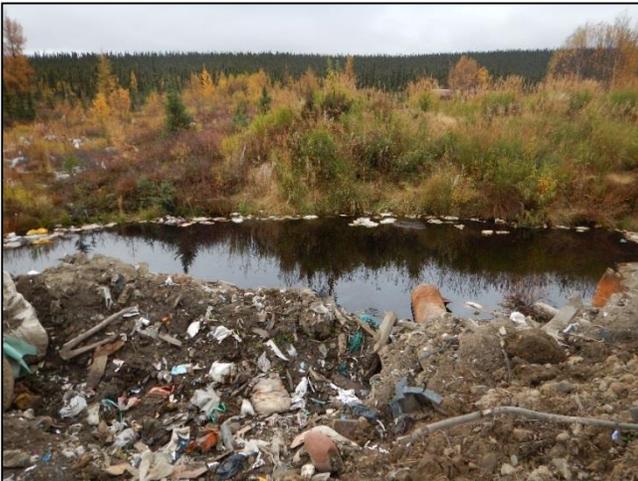
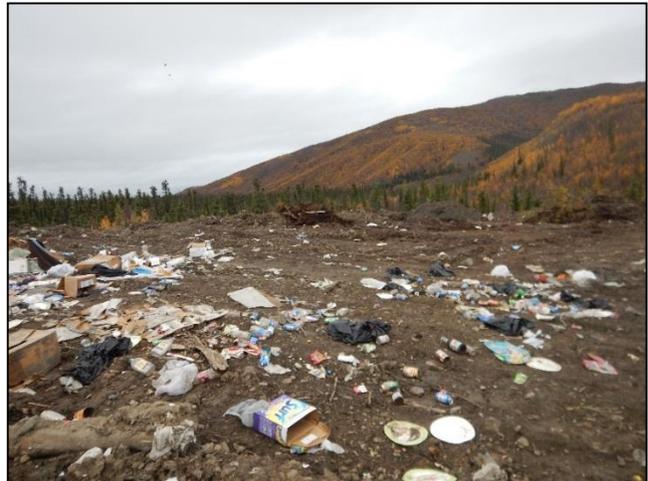
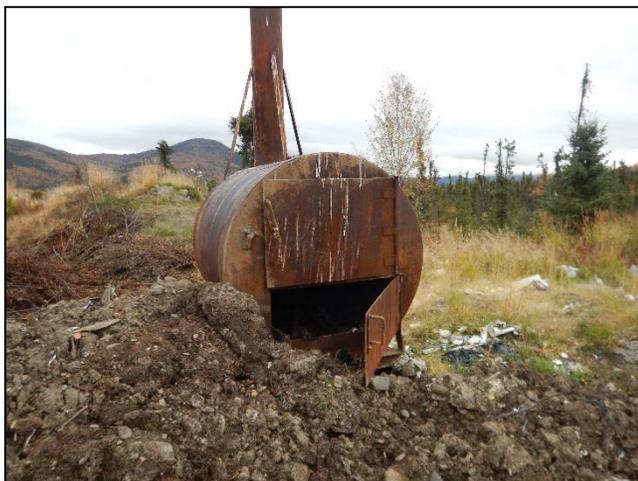
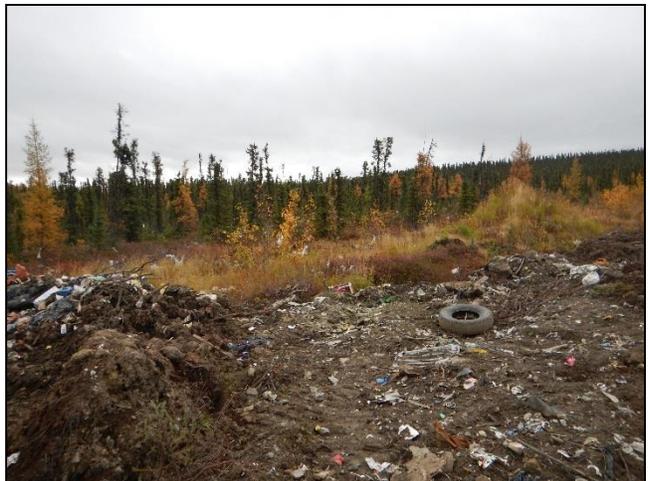
- **Landfill, 61.859327/-158.141988 (Active)** – The landfill is a permitted facility operated by the City of Crooked Creek. It was constructed around 1995 and operates as an area fill landfill. It has no fence or berms to contain the waste or to restrict public access. Waste is spread out over 1.5 acres. There is a Shorty’s burn unit on site. It is located on a hillside above town with the Village Creek running directly adjacent on the northwest side of the landfill. There is no history of flooding at the landfill although ponding is present. The Kuskokwim River is approximately 1,500 feet to the east.

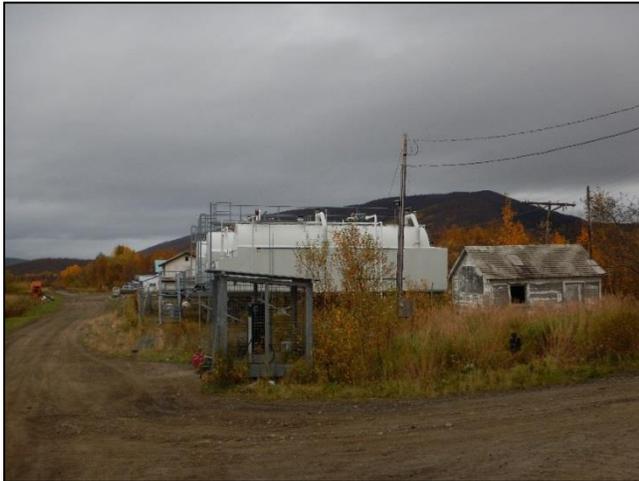
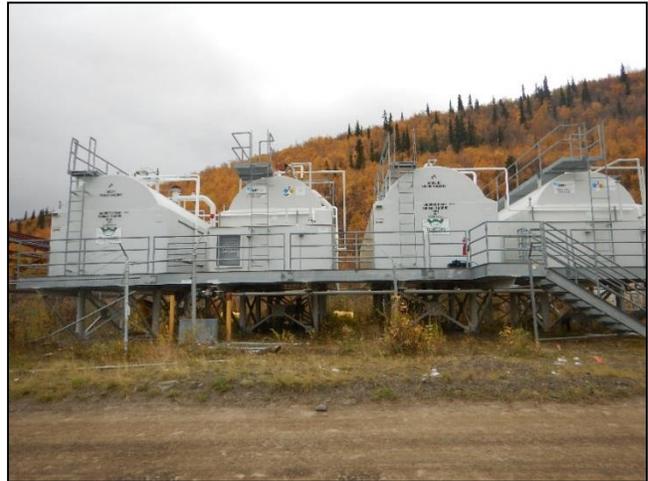
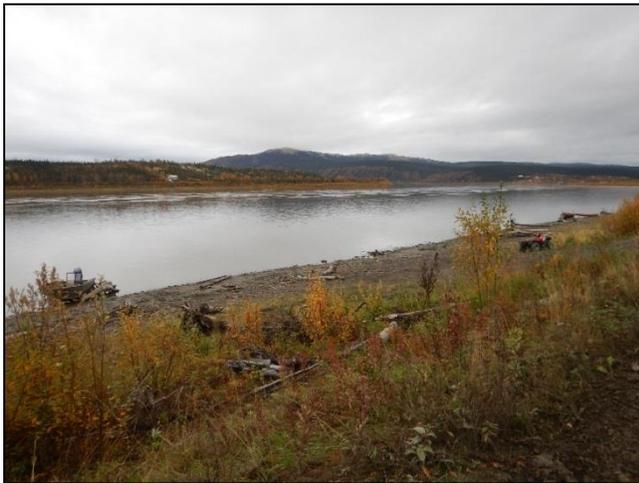
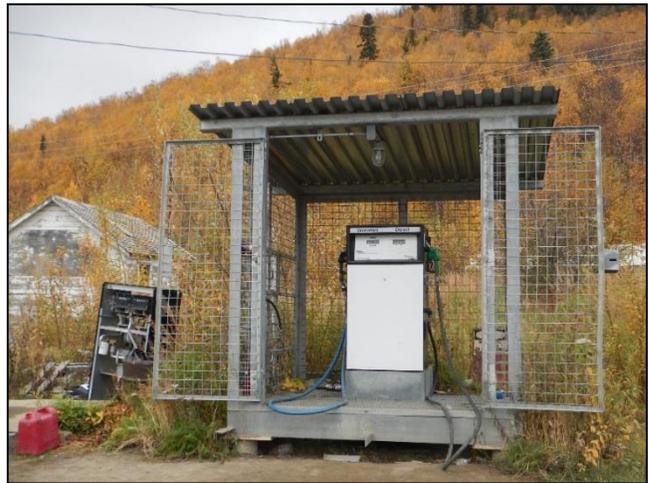
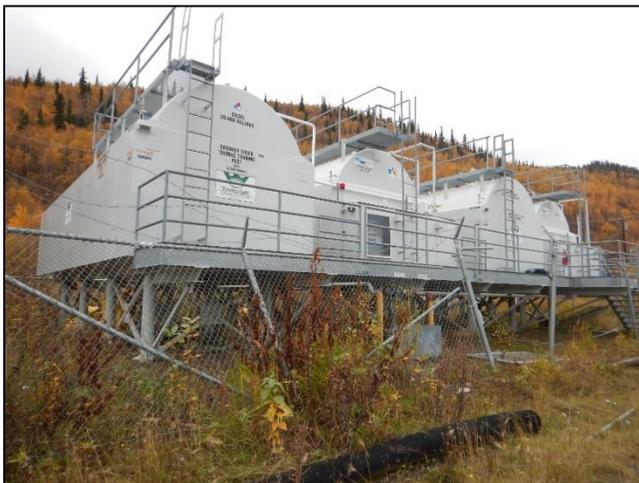
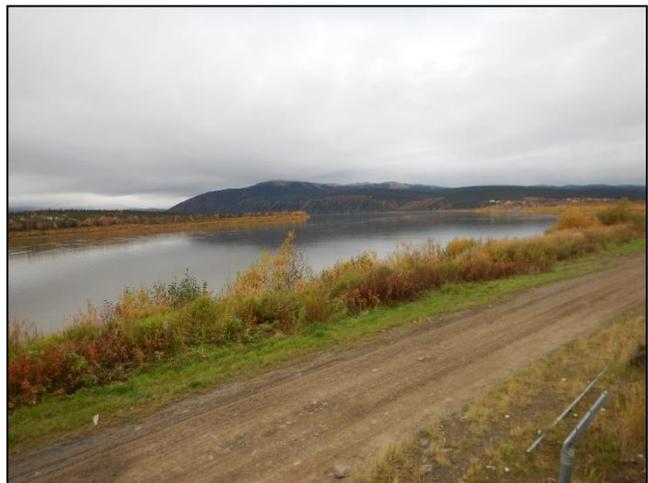
- **Thomas Trading Post Tank Farm, 61.869357/-158.112772 (Active)** – The facility is owned and operated by the Thomas Trading Post Store. It serves as the fueling station for the community and was constructed around 2006. It is an engineered facility consisting of four, double-walled tanks with a total capacity of 60,000 gallons: 20,000 gallon diesel tank, 20,000 gallon gasoline tank, 10,000 gallon diesel tank, and 10,000 gallon gasoline tank. This facility is built on approximately 5 foot metal pilings and is partially fenced. The Kuskokwim River is 100 feet to the south. This area is susceptible to flooding and has a known history of flooding almost yearly; however, there are no known erosional issues along this area of the Kuskokwim River according to locals.
