Alaska Department of Environmental Conservation (ADEC) Solid Waste Program (Stephen Price and David Carlson) conducted a Coastal Impact Assistance Program (CIAP), Waste Erosion Assessment and Review (WEAR) site visit for Ivanof Bay on August 21th, 2014. The following narrative is a brief description of our findings during the August inspection. The community of Ivanof Bay has been abandoned for the past ten years and only occasionally has residents. Upon our visit in 2014, Ivanof Bay had a population of two.

WEAR Sites

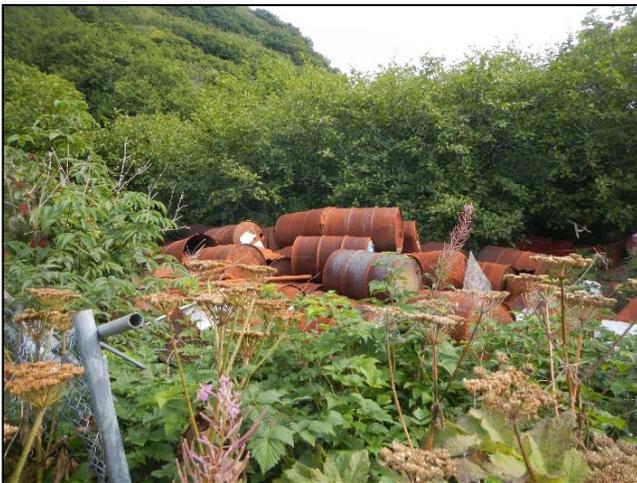
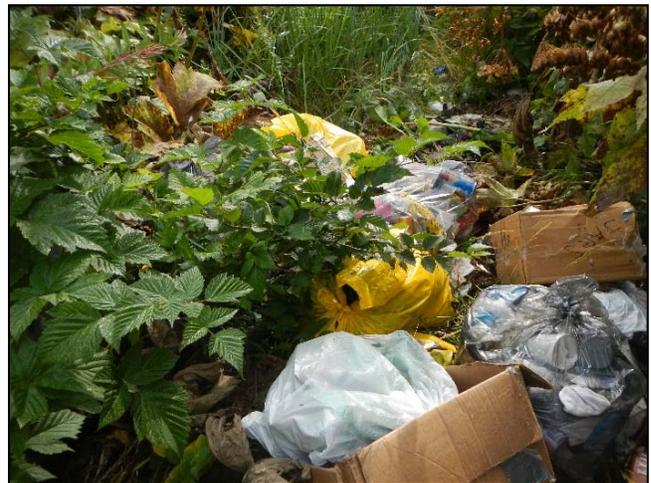
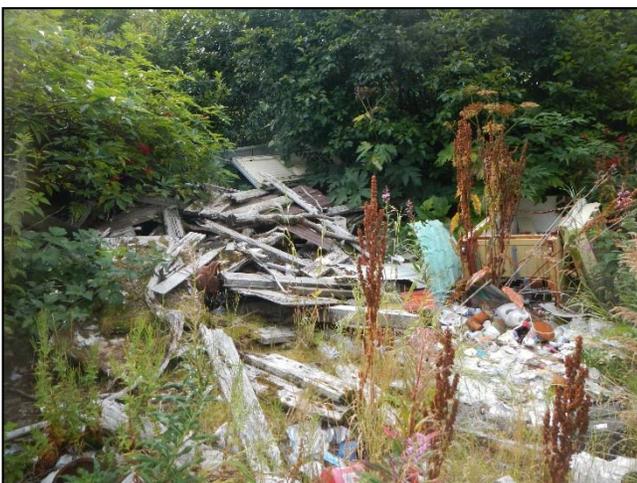
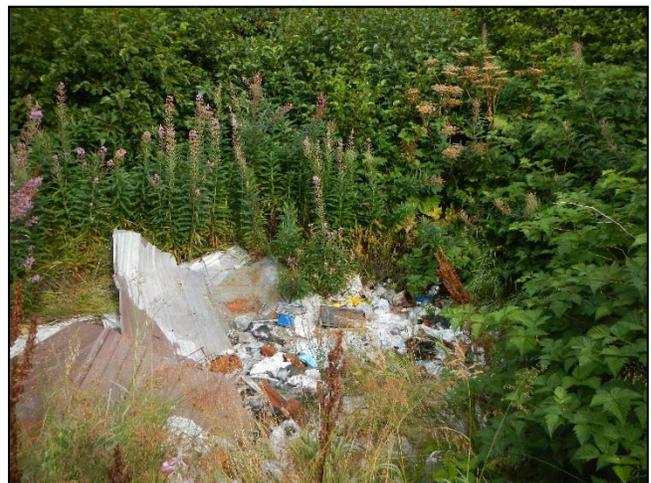
- **Landfill, 55.901691/-159.4910362 (Inactive)** –The landfill is quite overgrown and contains municipal waste and a pile of rusted, empty drums. It was primarily in operation around the 1980s-2004. It currently only accrues a small amount of municipal waste due to the sporadic population. The landfill is located on the west side of the community and about 330 feet from Ivanof Bay. The bay was reported and calculated to have a slow erosion rate of less than a foot per year.

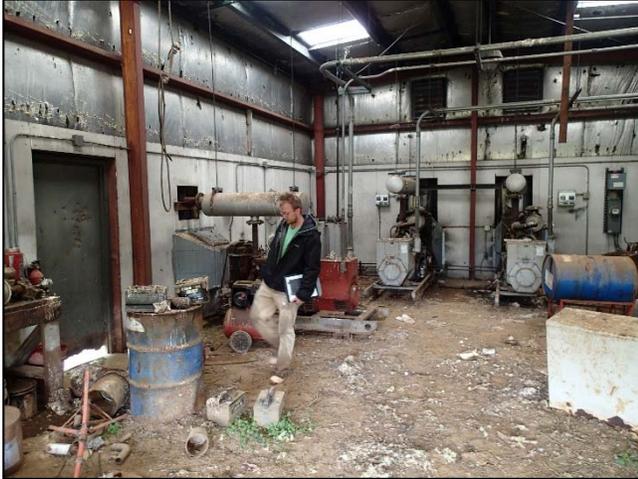
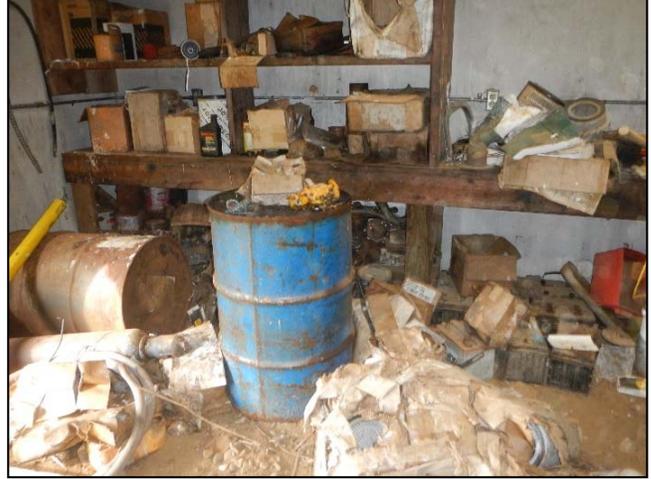
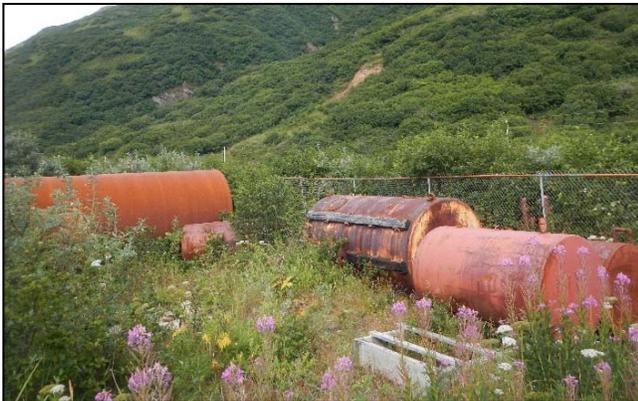
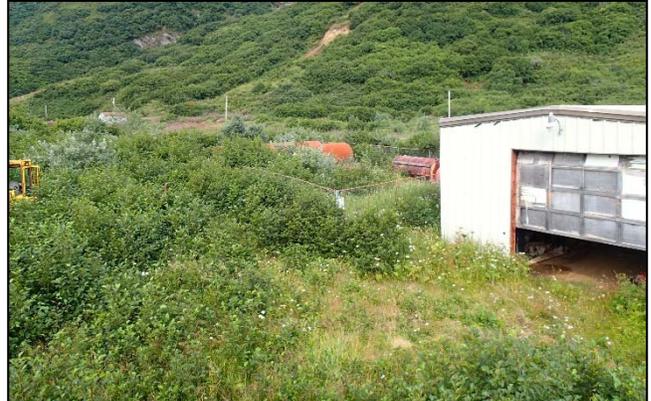
- **Power Plant and Tank Farm, 55.901144/-159.489584 (Abandoned)** – This site is the abandoned power plant and associated tank farm for the community. Everything is inactive and hasn't been in use for several years. The tank farm consists of one large, three medium and one small tank within a fenced area. The power plant contains with machinery, several lead-acid batteries, generators and various 5 gallon containers with unknown contents. The building door was open with evidence of birds nesting in it. In the tank farm area, there were no signs of stressed vegetation and brush was growing around the tanks. This site is located 100 feet from Ivanof Bay.

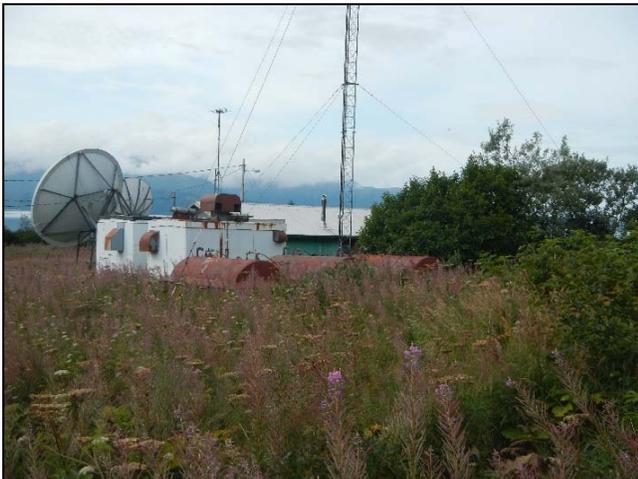
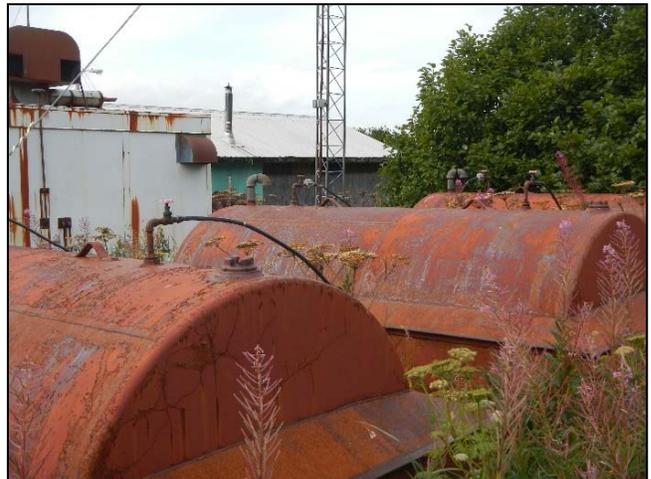
- **Satellite Tanks, 55.902115/-159.486759 (Abandoned)** — This tank farm is located by the old Community Hall/Port Office per the Division of Community and Regional Affairs 2002 map. There are several large satellites near these tanks. The site contains three 7,500 gallon tanks that are very rusted and not in use. They appear to be for an old generator or power plant building. Brush has grown over the tanks, and there were no signs of stressed vegetation. This site is over 420 feet from Ivanof Bay.

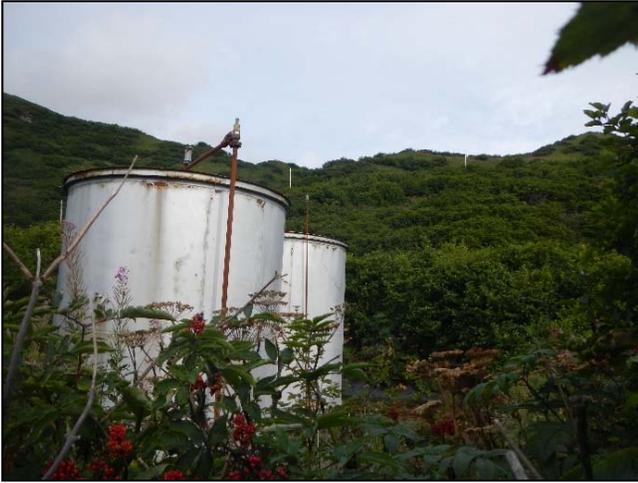
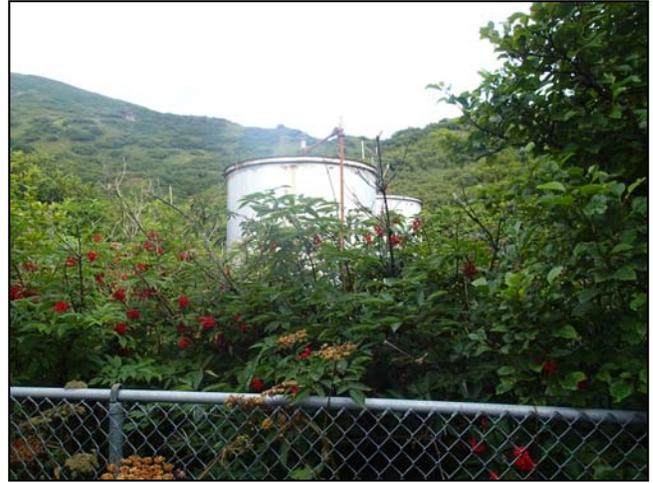
- **Vertical School Tanks, 55.903623/-159.484339 (Abandoned)** – These tanks were reported to be the fuel tanks for the old school and have been in place since around the 1970s. The site includes two vertical fuel tanks of approximately 10,000 gallon capacity. There were no signs of stressed vegetation. The tanks are completely over-grown and no longer accessible. They are owned by the Lake and Peninsula School District. This site is 1,000 feet from Ivanof Bay.

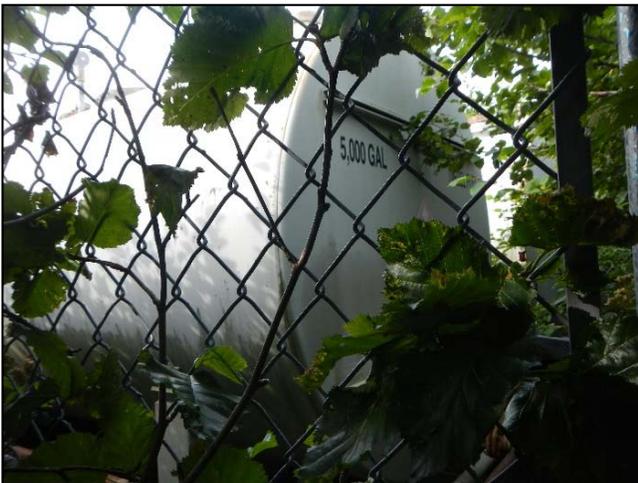
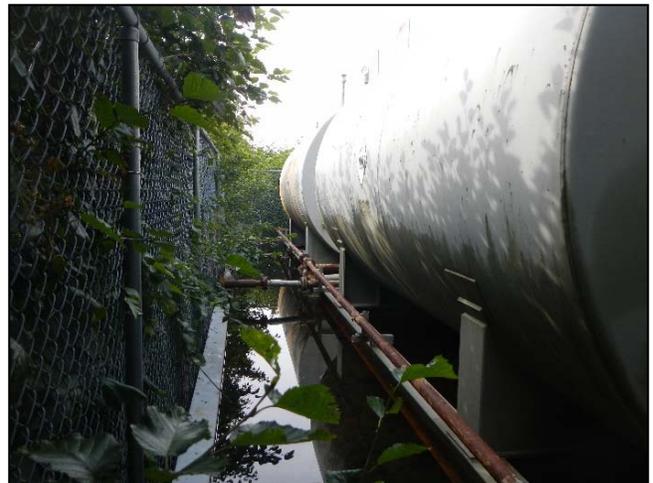
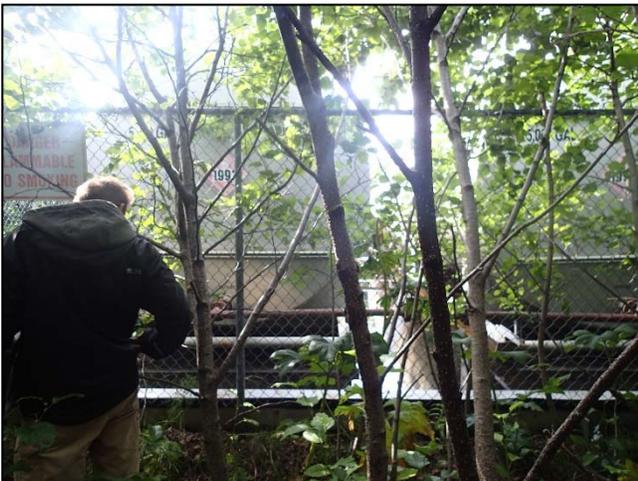
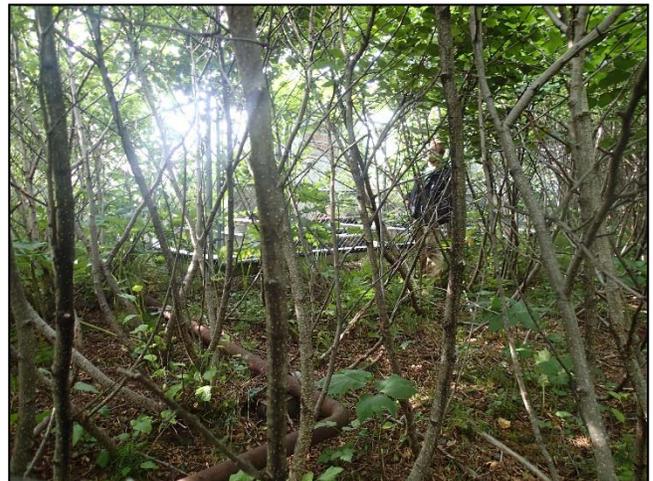
- **School Tank Farm, 55.903651/-159.484821 (Abandoned)** – This tank farm was used for the newer school; however, the tanks have not been used since the school was closed in 2003. It was constructed around the 1990s. The site includes four horizontal 5,000 gallon tanks. The tank farm is lined and fully fenced, but it is completely overgrown and inaccessible. This site is 1,000 feet from Ivanof Bay, which has very gradual erosion.

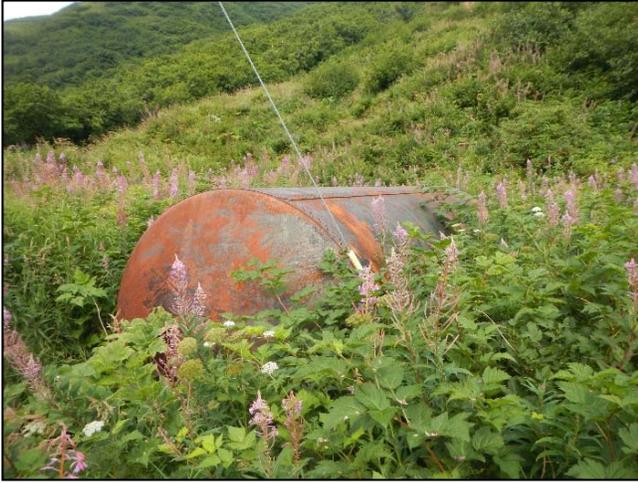
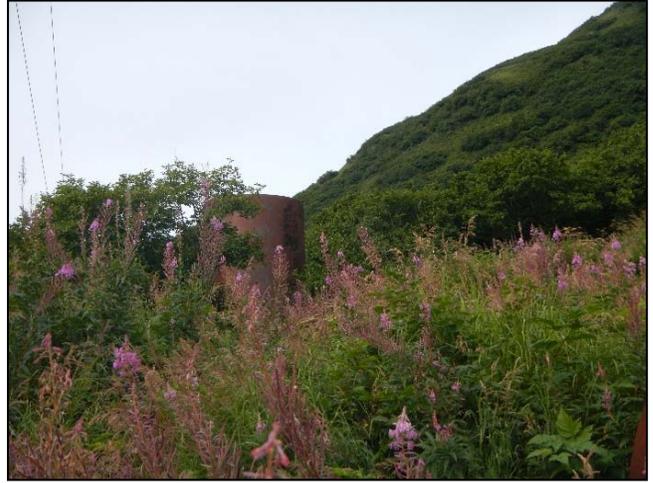
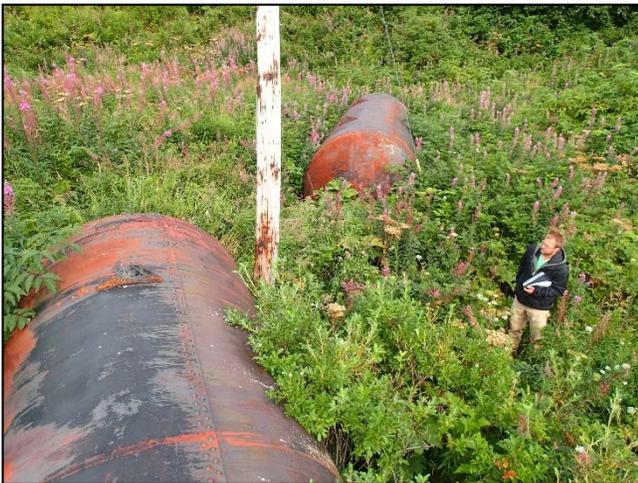
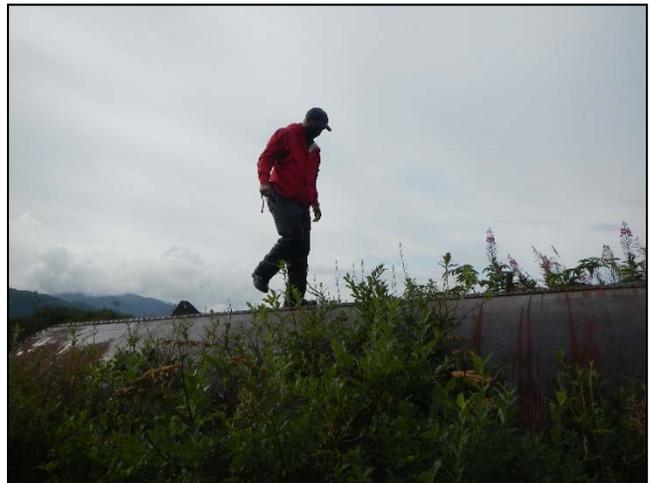
- **Abandoned Tanks, 55.901388/-159.491513 (Abandoned)** – This site includes three 10,000 gallon fuel tanks. The tanks are located about 100 feet west of the landfill. There were no signs of stressed vegetation. The tanks were overgrown with brush. The tanks were reported to be well over thirty years old. They are on a Division of Community and Regional Affairs 1982 map and are labeled ‘Old fuel storage tanks’ even at that time. The tanks are 300 feet from Ivanof Bay which is very slowly eroding.
