CIAP WEAR Trip Report
Kalskag, Upper and Lower (population 520)
June 20-21, 2012

Alaska Department Environmental Conservation (ADEC) Solid Waste Program (Doug Huntman and Jamie Gorman) conducted a Coastal Impact Assistance Program (CIAP), Waste Erosion Assessment and Review (WEAR) site visit for the Villages of Lower Kalskag and Upper Kalskag, June 20th – 21st, 2012. Vivian Changsak, Assistant Administrator for the Village of Lower Kalskag, participated on the site visits. The following narrative is a brief description of our findings during the June inspection.

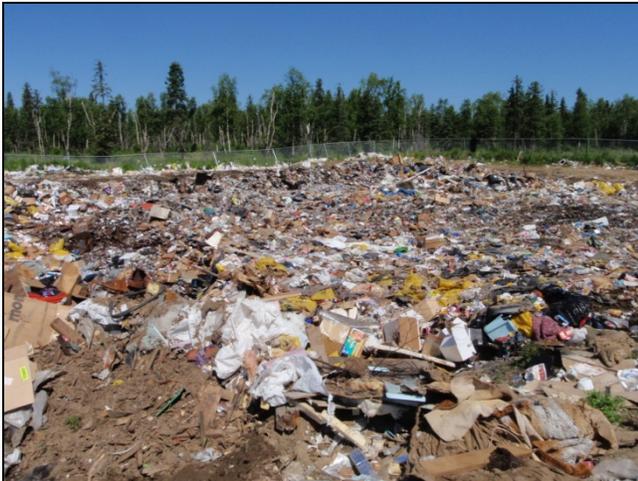
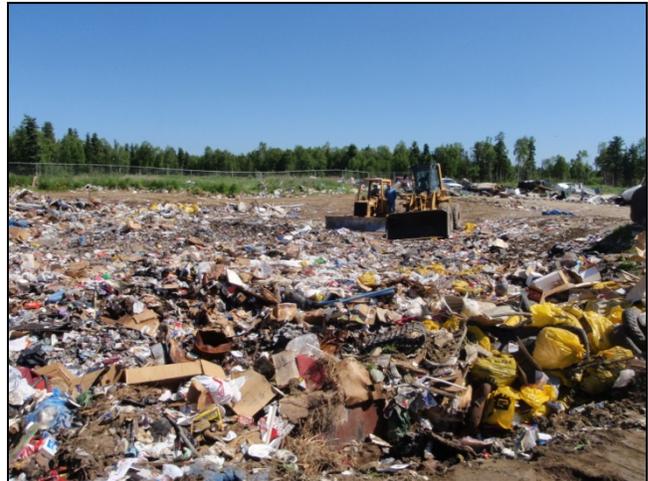
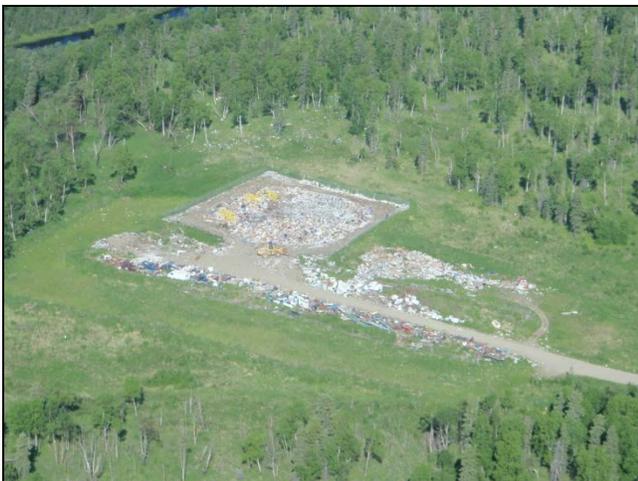
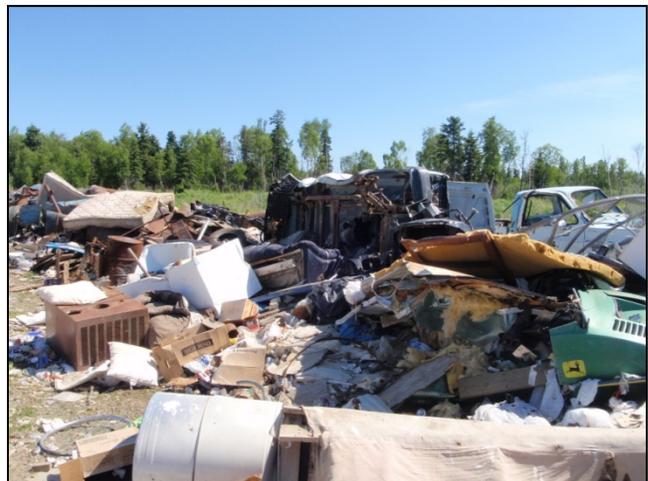
- **Landfill, 61.510595/-160.378706 (Active)** – The landfill was constructed in Lower Kalskag around 1995. It accepts waste from both Upper and Lower Kalskag residents. The landfill is operated as a self-haul site with unlimited access. There is: waste spread throughout the site, uncontrolled open burning, and disposal of prohibited and hazardous waste at the landfill. We spoke to the operator and city administrators about consolidating, compacting and covering the site to further reduce the impact the landfill has on the surrounding environment. Efforts were made to clean up the site during our 2012 visit. It is located 2,175 feet from the edge of the Kuskokwim River. Per the the US Army Corps of Engineers - 2009 Alaska Baseline Erosion Assessment (BEA) study, this section of river is eroding at 1.5 feet per year.

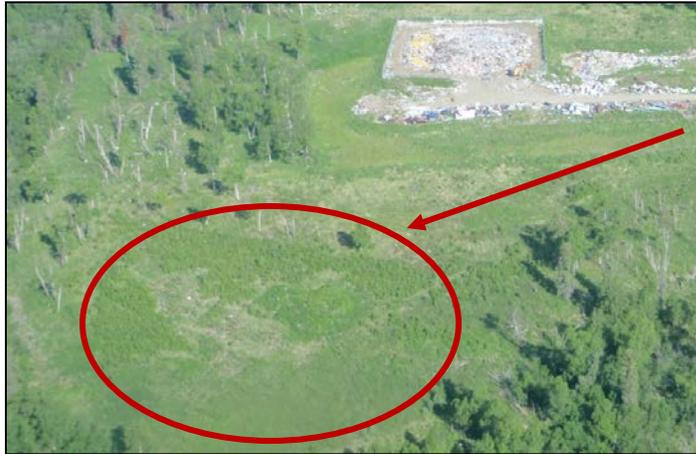
- **1990s Landfill, 61.509647/-160.378184 (Closed)** – This landfill is located in Lower Kalskag and was used by the residents of Upper and Lower Kalskag from around 1985-1995. It accepted primarily municipal waste. When it reached capacity, it was closed and the current landfill was built adjacent to it on the north side. During the inspection, the area appeared covered and well-vegetated. It is 1,800 feet west of the Kuskokwim River and 570 feet from Oxbow Lake. Per the BEA study, this section of river is eroding at 1.5 feet per year.

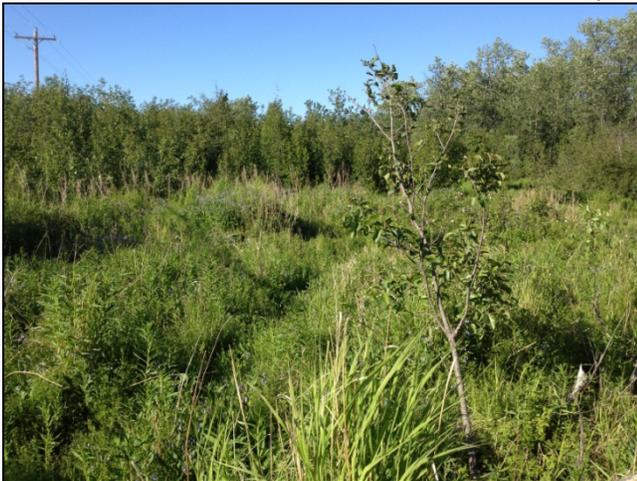
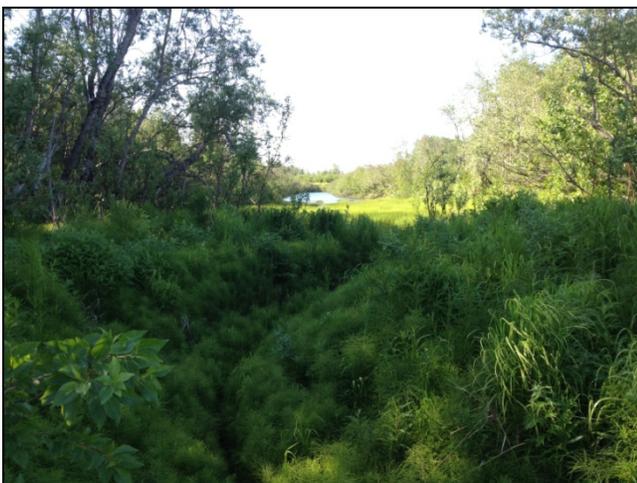
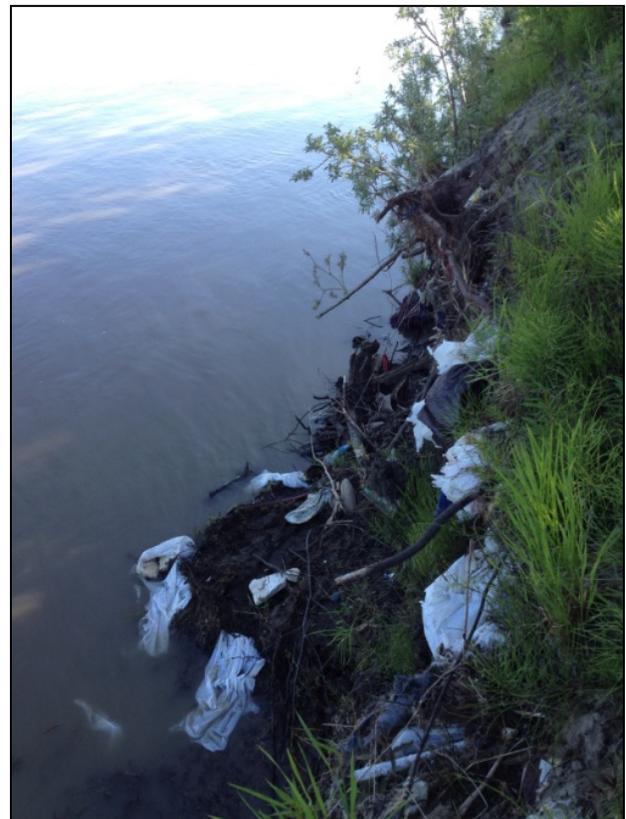
- **1980s Landfill, 61.521622/-160.353064 (Retired)** – This old landfill is located northeast of Lower Kalskag on the east side of the road. It was used by both Upper and Lower Kalskag residents. This landfill was covered and left to re-vegetate. Buried refuse is resurfacing due in part to incomplete cover, but mainly due to a river-fed slough that is carrying the trash out to the river. The site is located about 3,960 feet north of Lower Kalskag and is around 750 feet west of the Kuskokwim River. Per the BEA study, this section of river is eroding at 3.0 feet per year

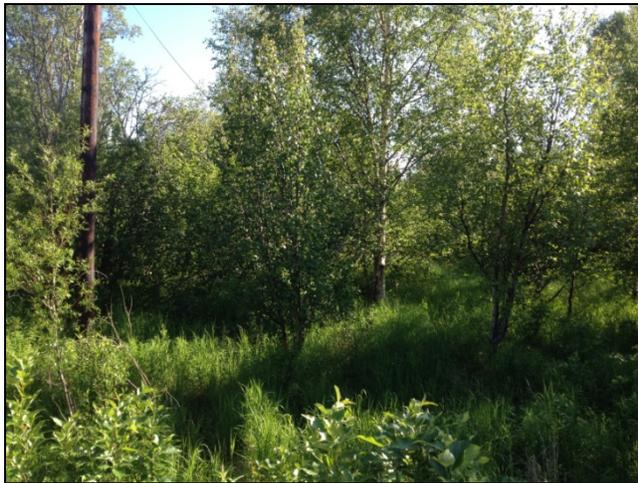
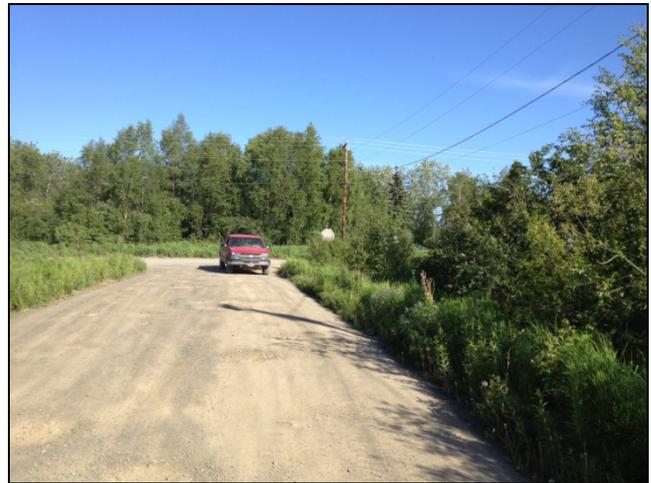
- **1970s Main Street Landfill, 61.518511/-160.354888 (Retired)** – This landfill was reportedly retired in the early 1970’s. It appears on a 1979 map of Lower Kalskag by the Alaska Division of Community and Regional Affairs. The landfill was used primarily for municipal waste. The area was totally re-vegetated with large birch trees and no smell or disturbed vegetation was observed. The area was located 290 feet from the banks of the Kuskokwim River. Per the BEA study, this section of river is eroding at 3.0 feet per year.

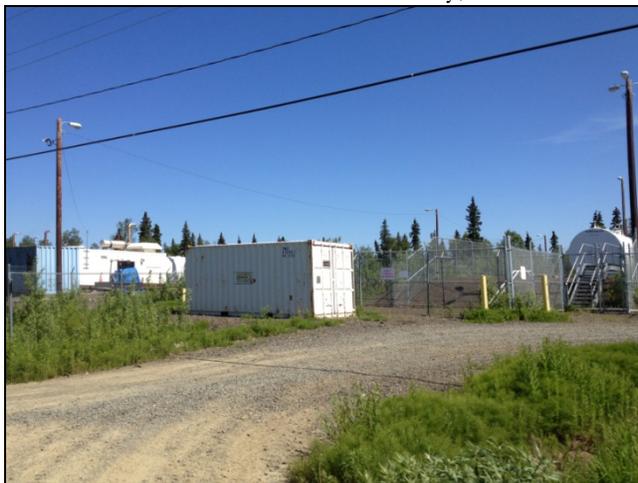
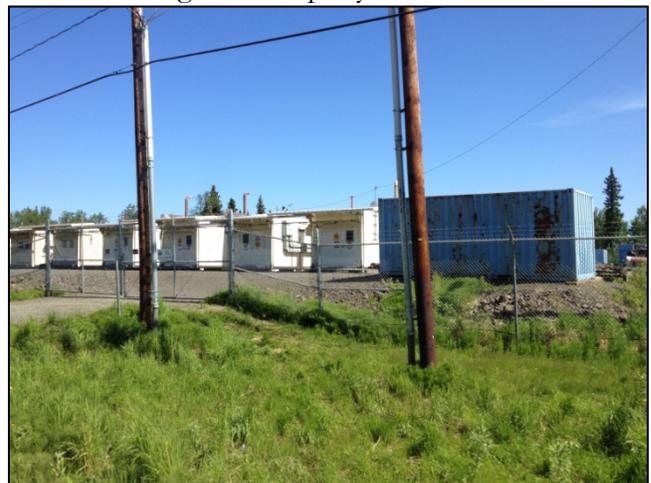
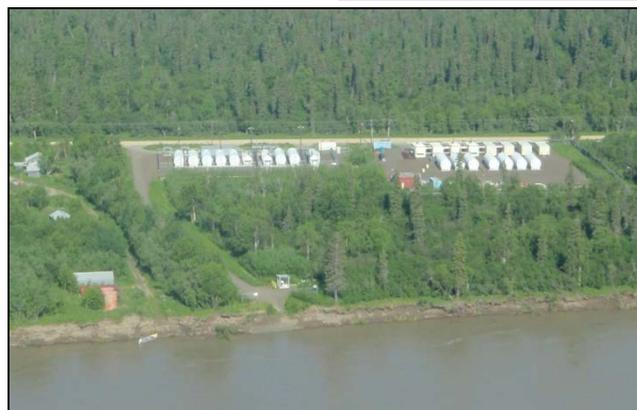
- **Consolidated Tank Farm, 61.526208/-160.348904 (Active)** – This consolidated tank farm is located between Upper and Lower Kalskag. It provides fuel storage for Upper Kalskag, Lower Kalskag and the Kuspuk School District. The tank farm was funded through the Denali Commission and AVEC; and was completed in 2004. The tank farm is located 450 feet from the Kuskokwim. Per the BEA study, this section of river is eroding at 6 feet per year.

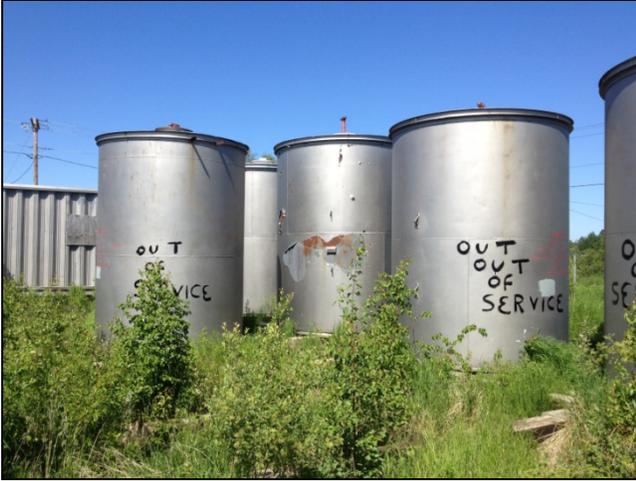
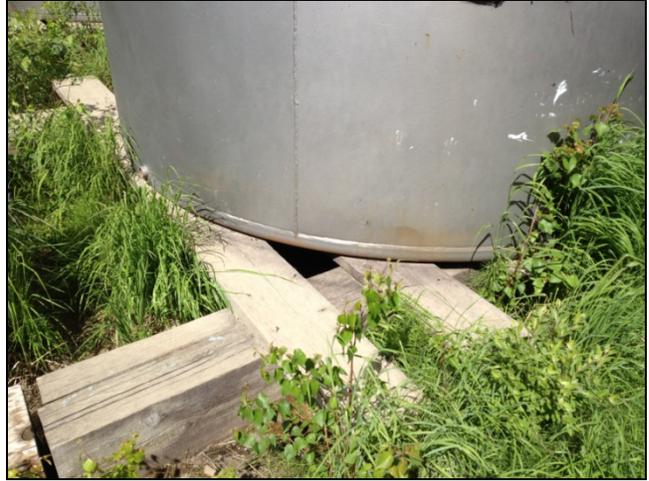
- **Old AVEC Tank Farm, 61.512810/-160.363054 (Active)** – This old tank farm and power plant in Lower Kalskag is a Brownfield site under the Contaminated Sites Program (File ID 2427.57.001). It was reported as operational from 1969-2004 when a new power plant and consolidated tank farm were built. Screening samples were collected in 2008. Several tanks have been removed from their foundation, blocked, and prepared for removal. The tanks are located close to the tribal office, a school, and several residences. The area smelled of diesel. The tanks are approximately 605 feet from the Kuskokwim River bank. Per the BEA study, this section of the river is eroding at 1.5 feet per year.

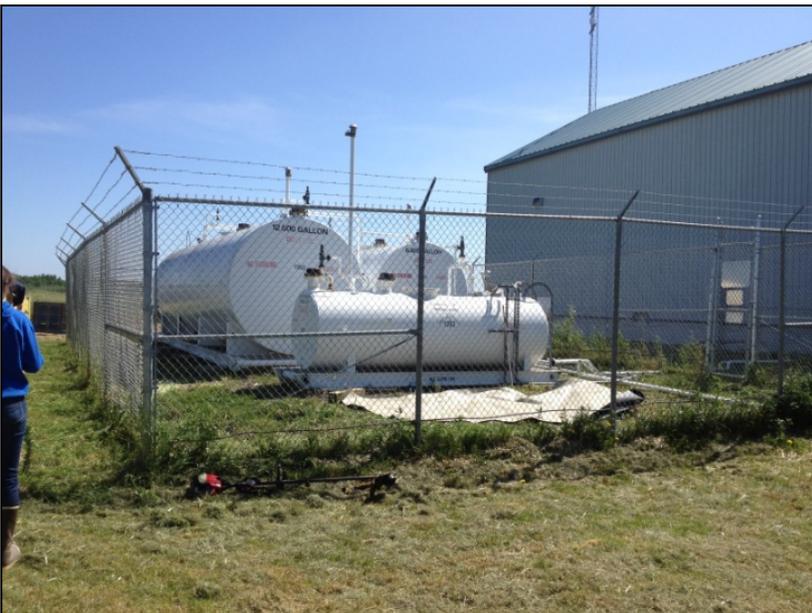
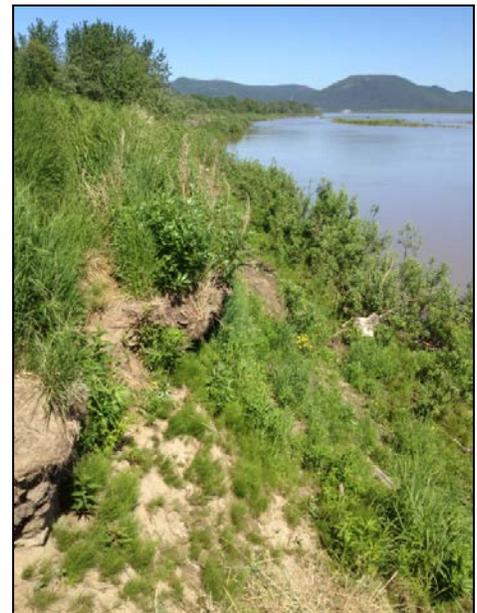
- **Elementary School Tank Farm, 61.512284/-160.361306 (Active)** – The elementary school tank farm has three horizontal diesel tanks: 12,000 gallon, 8,000 gallon, and approximately 1,000 gallon. The tank farm is located in Lower Kalskag about 260 feet from the Kuskokwim River in a fenced area and is owned by the Kuspuk School District. The marine header for refueling is, however, located around 15 feet from the edge of the river. The header is connected to the tanks with above ground piping approximately 180 feet in length. The banks along this section of the river are severely eroding. There were up-rooted trees evident, as well as cracks in the soil and evidence of dirt eroding into the river. It was reported that the erosion was seasonal. Storms in both the spring and fall are responsible for most of the damage. Erosion rates were reported by locals as between 1 and 15 feet per year; and the BEA study report an erosion rate of 1.5 feet.

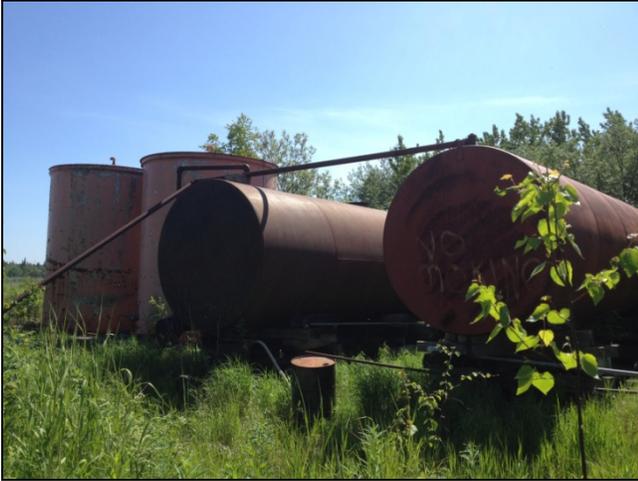
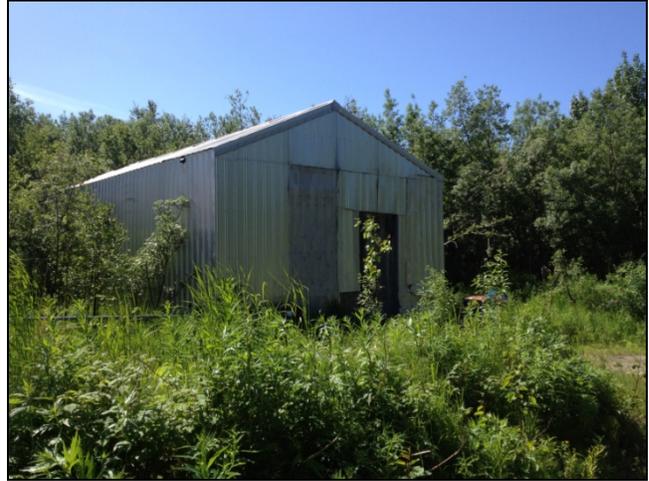
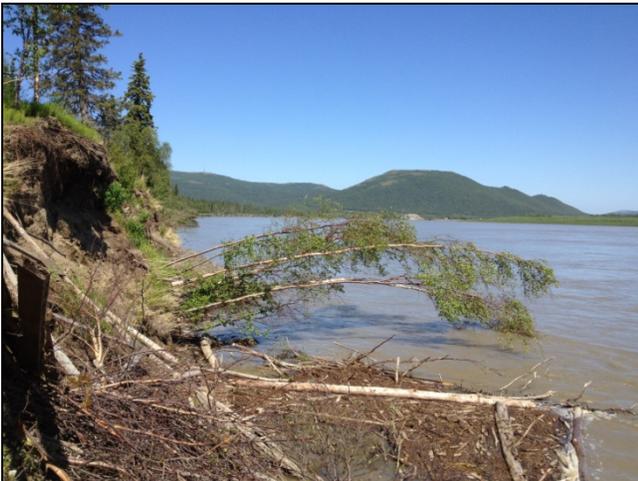
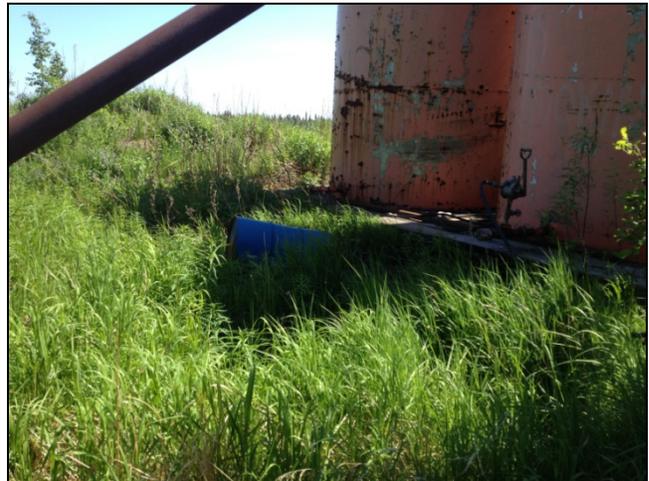
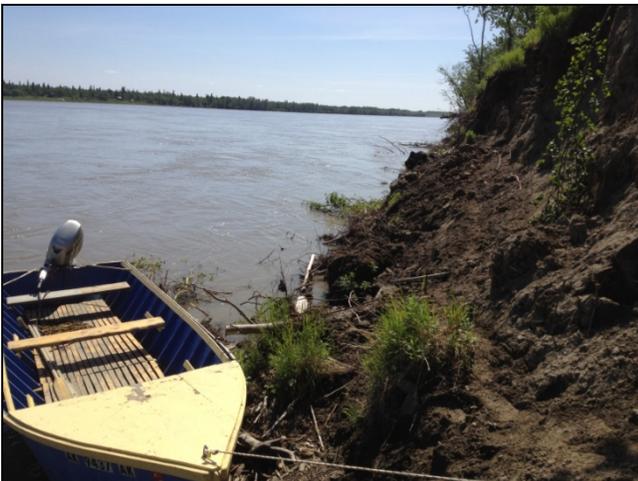
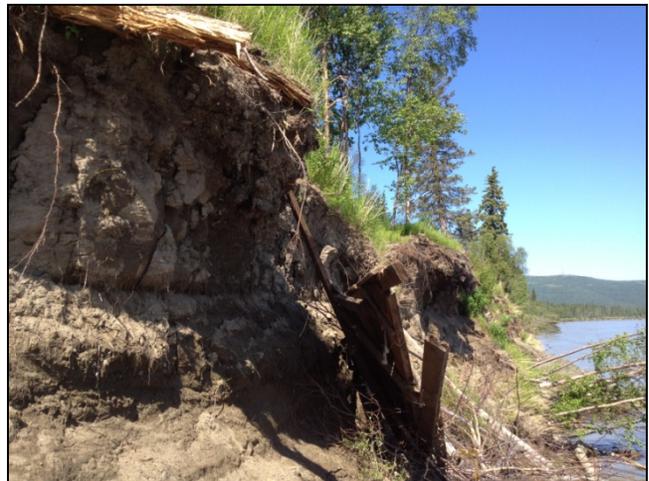
- **1980s Fuel Station, 61.525096/-160.345878 (Abandoned)** – The old gas station was reportedly shut down in the early 1980s. The site is located near the consolidated tank farm between Upper and Lower Kalskag. It consists of a large metal out-building, two horizontal fuel tanks and two vertical fuel tanks. The two horizontal tanks appear to have a 10,000 gallon capacity. All tanks are up on wooden blocks. There is no noticeably disturbed vegetation near the tanks, which are approximately 60 feet from the Kuskokwim River. The bank is highly eroded in this area; trees with leaves and freshly disturbed soil were observed in the river at this location. The bank is eroding at a rate of 6 feet per year according to the BEA study. The riverbank area immediately adjacent to the site is used as a small boat launch.

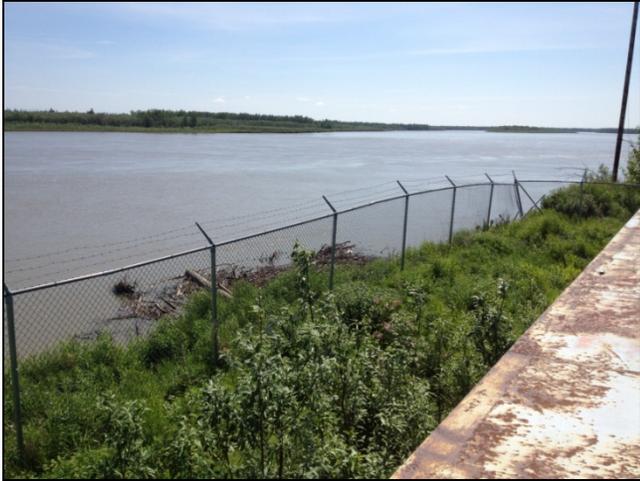
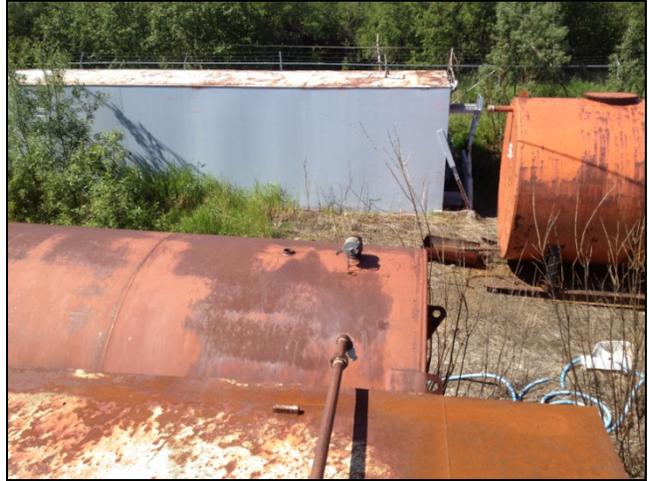
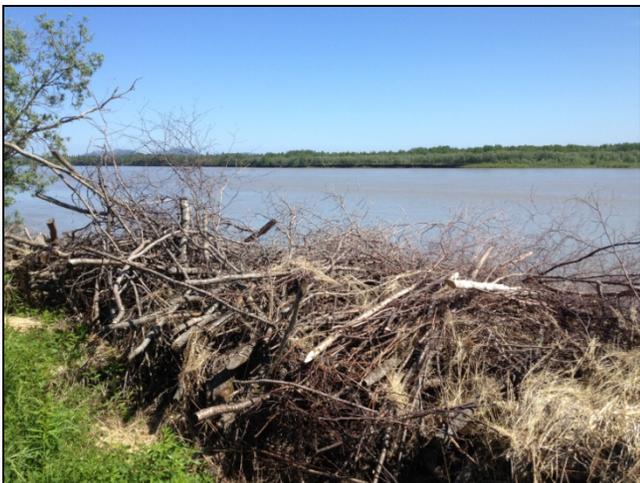
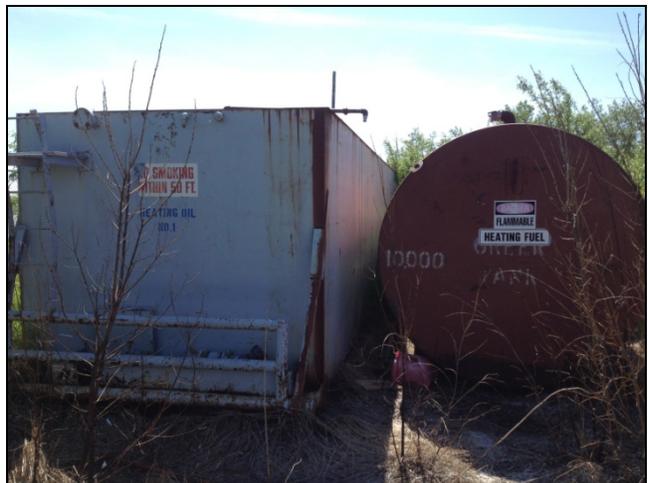
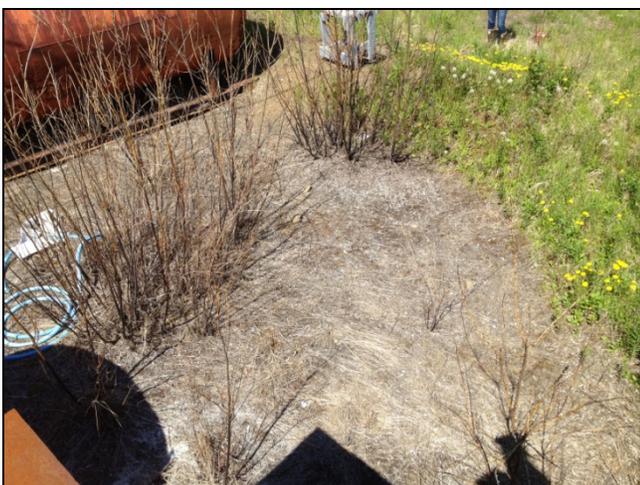
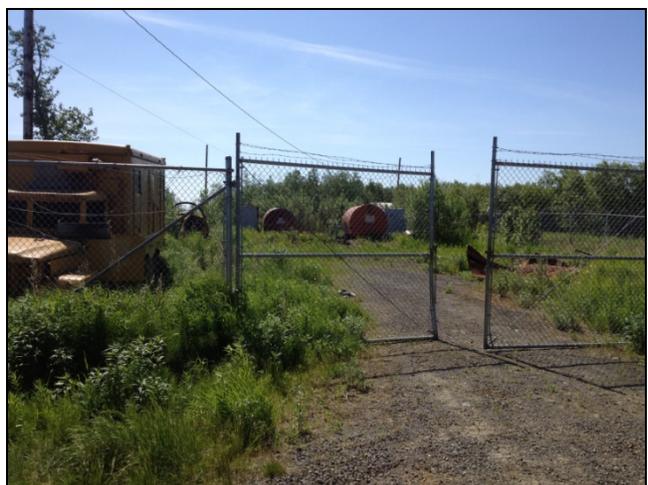
- **1990s Fuel Station, 61.509903/-160.362093 (Abandoned)** – This site was a public fuel station in Lower Kalskag that closed around 1998. The site is privately owned by a former teacher, Mark Steer. This site had at least 5 tanks on the property, with two large tanks having at least a 12,000 gallon capacity. The area smelled of fuel, and there was a large section of dead vegetation surrounding the tanks. It is less than 40 feet from the Kuskokwim River, which is actively eroding at a rate of 1.5 feet per year according to the BEA study. Brush had recently been placed along the bank between the site and the river in an effort to mitigate erosion. The site is roughly an acre and a half in size. The nearest house is about 50 feet away.
