WEAR Sites

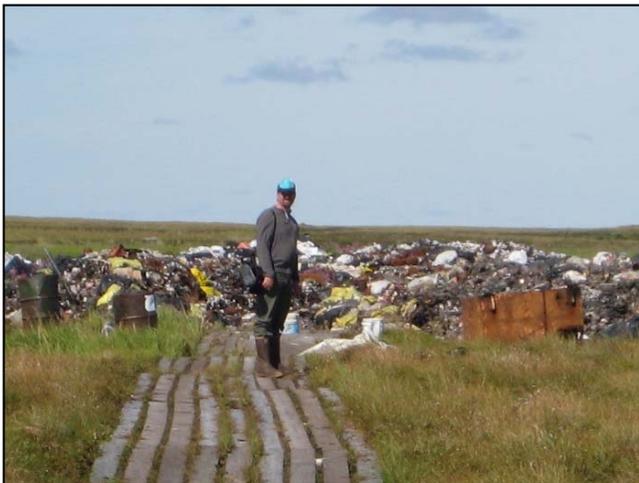
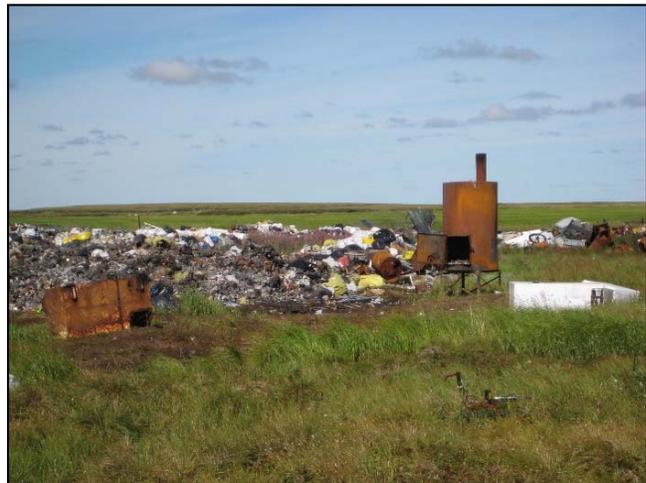
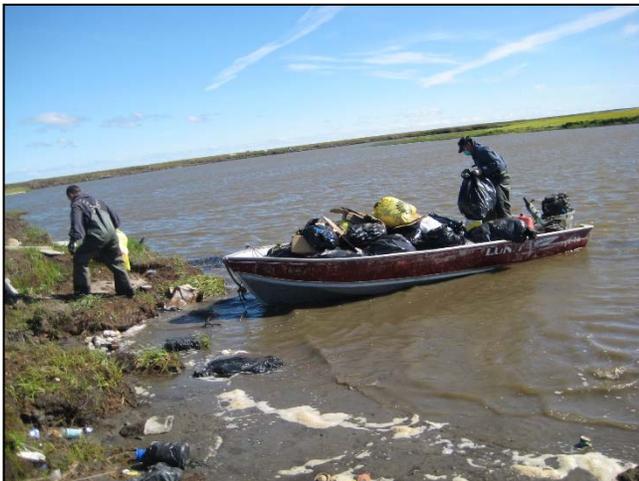
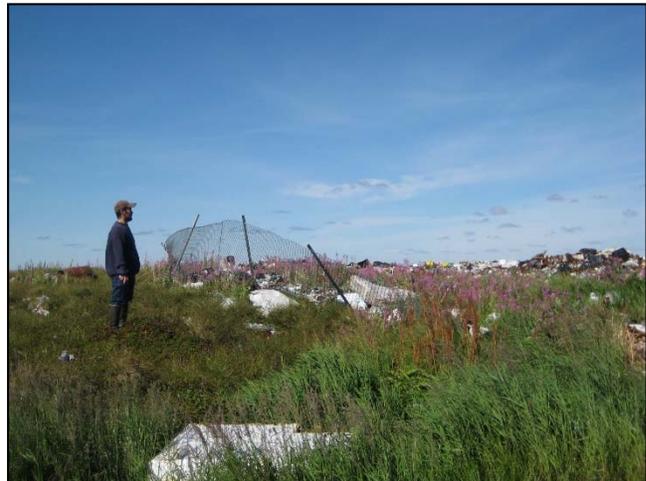
- **Backhaul Staging Area, 60.937262/-164.627492 (Active)** – This area between the sewage lagoon and the river is used as storage for items that could potentially be backhauled. It is 0.14 acres and includes old snow machines, barrels, cable, and other miscellaneous metals and woods. Although the end goal is for backhaul, the site is not very organized and it would be hard to get items from the site onto a barge in its current state. It lies 90 feet from the Kealavik River and 600 feet from the Ninglick River which is eroding on the south Newtok shore at 42 feet per year according to the BEA study.

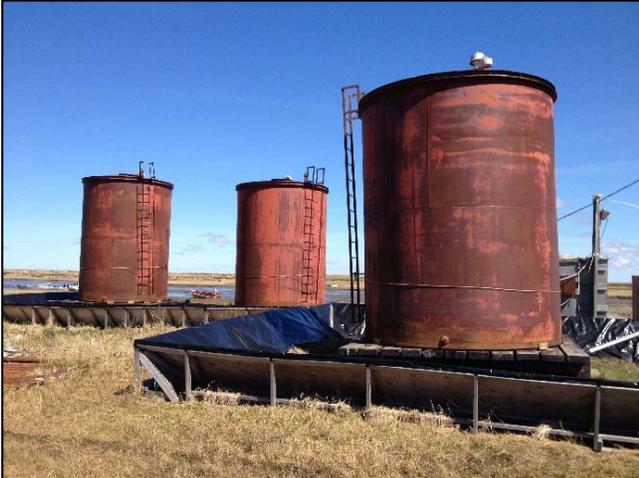
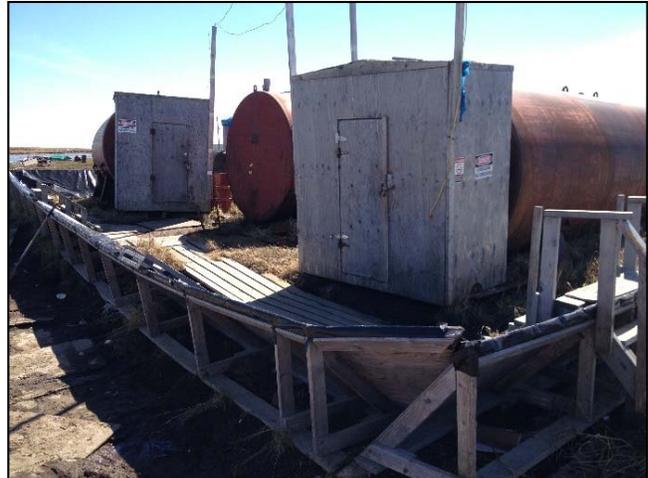
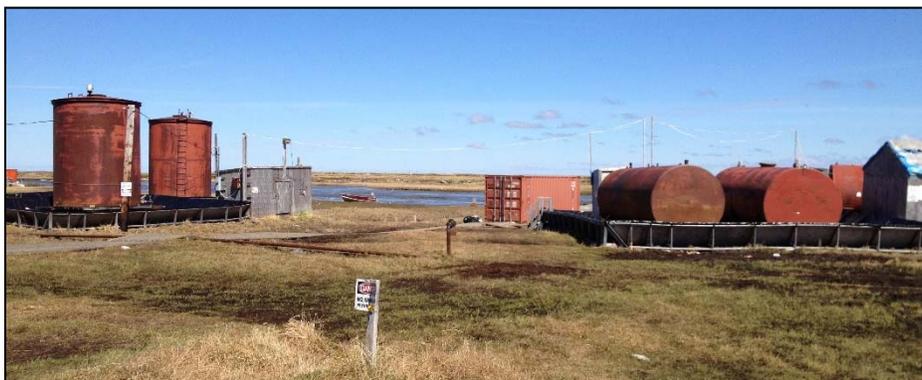
- **LKSD Tanks, 60.936874/-164.628458 (Active)** – This site is owned by the Lower Kuskokwim School District (LKSD) and contains two large fuel tanks and around fourteen barrels, some marked “waste oil”. The tanks are within secondary containment, but it was in a state of extreme disrepair as the ground had subsided in one corner. It was full of water in the corner with the metal containment twisted and bent. The site has a fence, but it is in such poor condition it is no longer a barrier to public access. It is found next to the school, 300 feet from the Kealavik River, and 550 feet from the Ninglick River which is eroding at 42 feet a year per the BEA study.

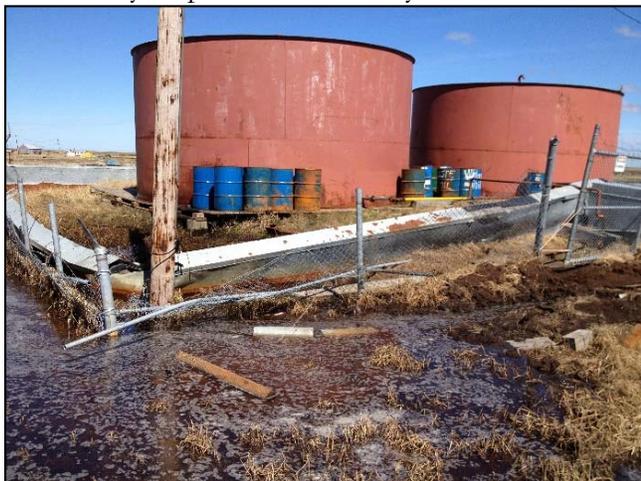
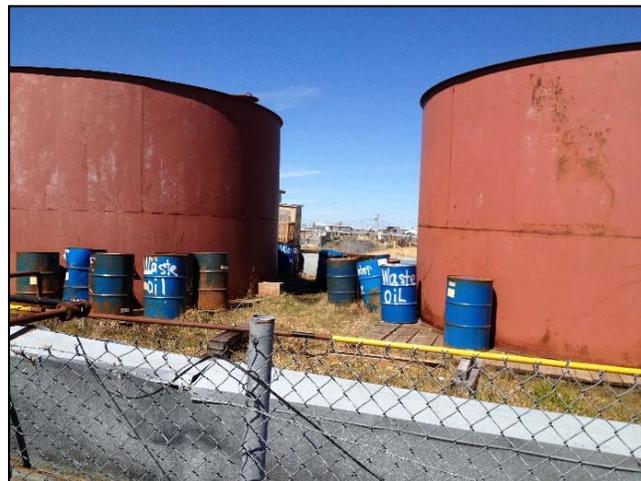
- **Old BIA School, 60.939193/-164.63042 (Active)** – This former Bureau of Indian Affairs (BIA) school site is a Brownfield site under the Contaminated Sites Program (File ID 2434.57.001). It includes the former school building, water well, a warehouse and a former tank farm with five large upright tanks. There are also two generators in the warehouse. A Brownfield Assessment was conducted on the site in 2009. Contaminated soil has been found around the school building and old tank farm. The site is 300 feet from the Kealavik River and 1,500 feet from the Ninglick River, which is eroding at 42 feet a year per the BEA study.

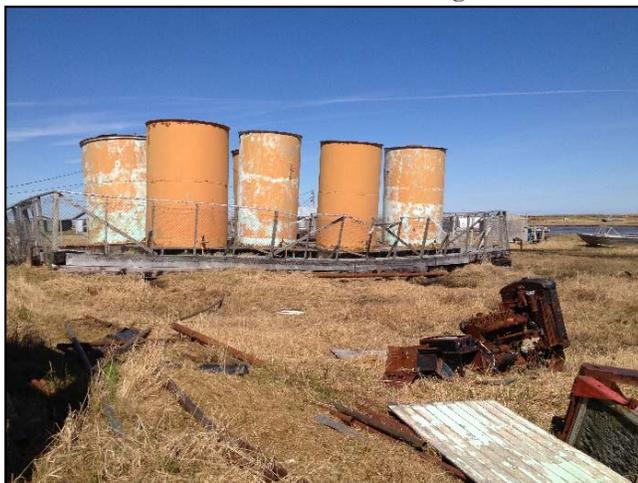
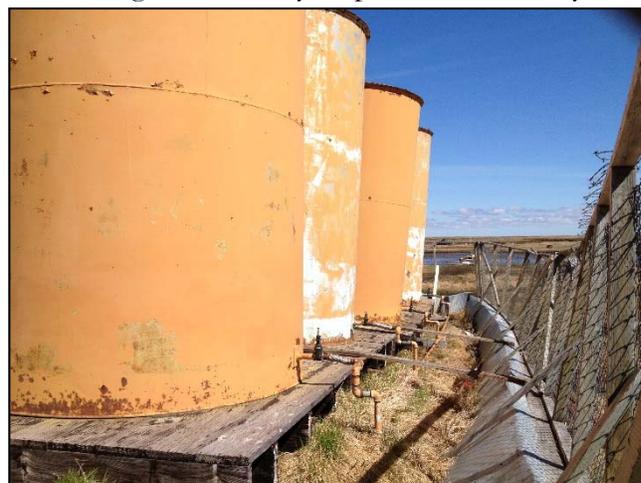
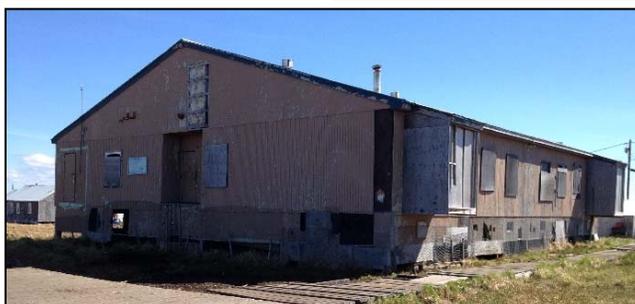
- **TC/IGAP Tank, 60.94172/-164.63415 (Abandoned)** – This site includes a single horizontal tank jointly owned by the tribal council and the Indian General Assistance Program (IGAP) sitting on a black tarp. The black tarp could function as secondary containment, but is set in a way where any leak would run off onto the ground. The tank was reported as not in use and possibly empty. This site is found 150 feet from the Kealavik River.

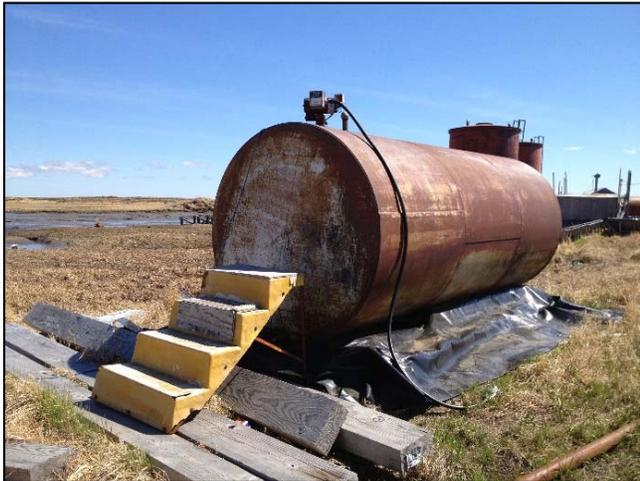
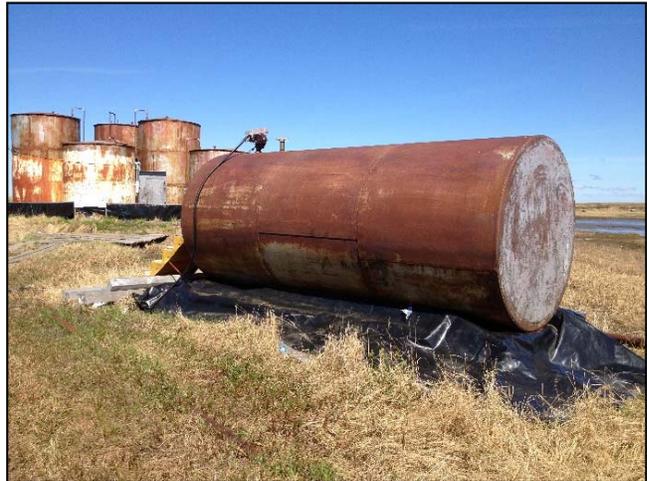
- **Toms Store Tanks, 60.940574/-164.630361 (Active)** – This site, owned by Toms Store LLC, is located 450 feet north of the old BIA school. It includes seven tanks, two of which were double-walled. No fence or lining was in place for any of the tanks. Sheen and distressed vegetation was observed at the site. The Kealavik River, the nearest source of erosion, is 2 feet from the closest tank and 30 feet from the farthest tanks.

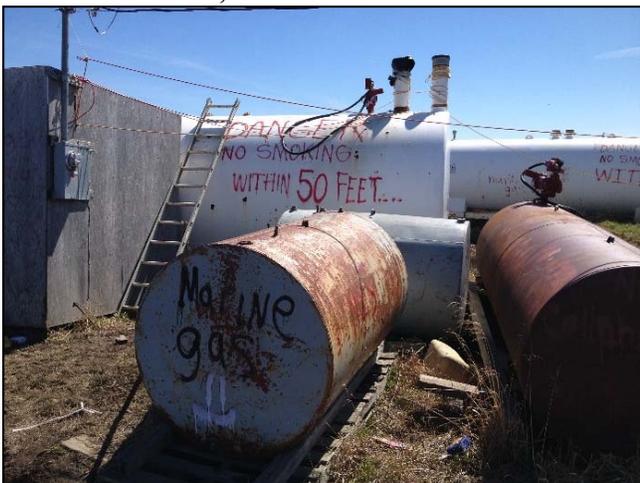
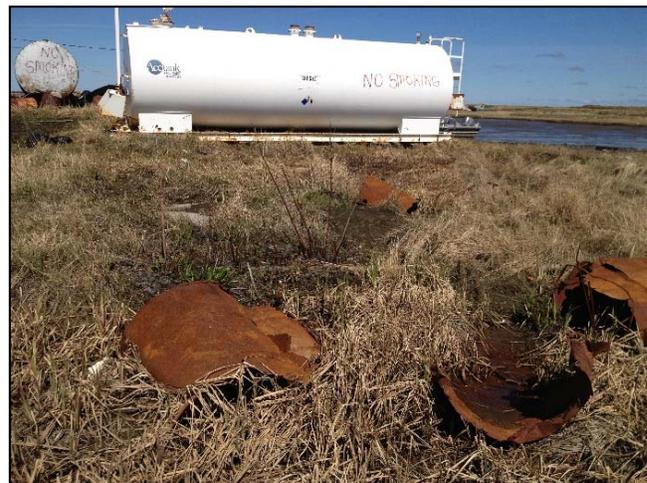
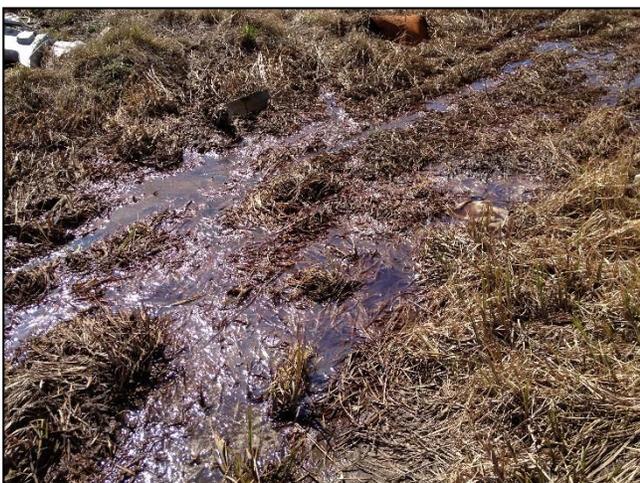
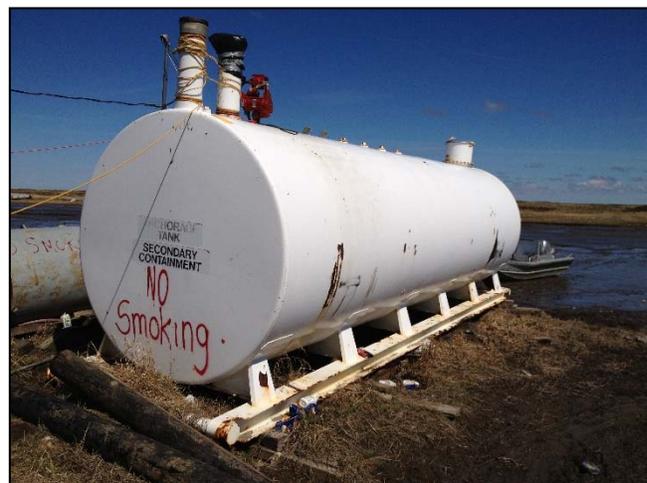
- **UPC Generator Building, 60.937884/-164.63104 (Active)** – This site is owned by Ungusraq Power Company (UPC) and is a generator building that provides electricity for the community. Blackened soil and dead vegetation was observed around drums at the site. The building is actually being supported on one corner by one of the four drums. There was also a sheen noted in water in the surrounding area. The site is 600 feet from the Kealavik River and 1,100 feet from the Ninglick River which is eroding at 42 feet a year per the BEA study.

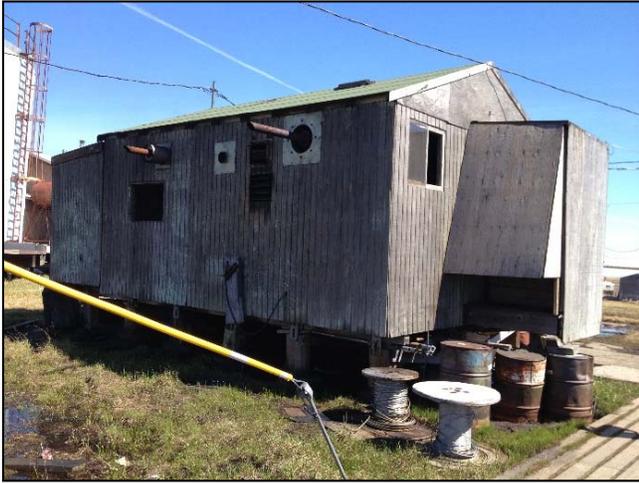
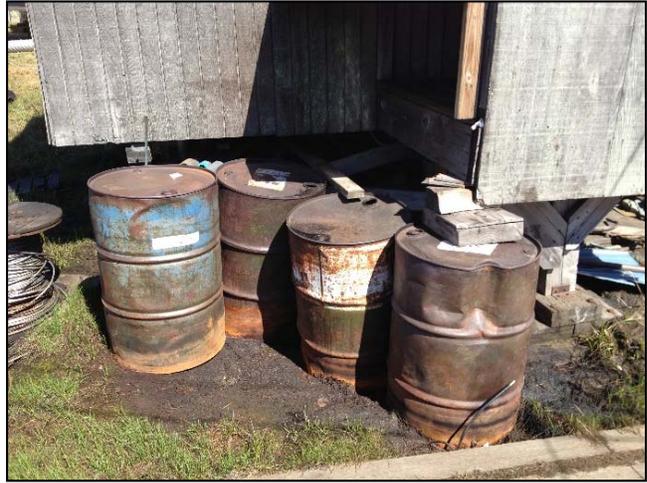
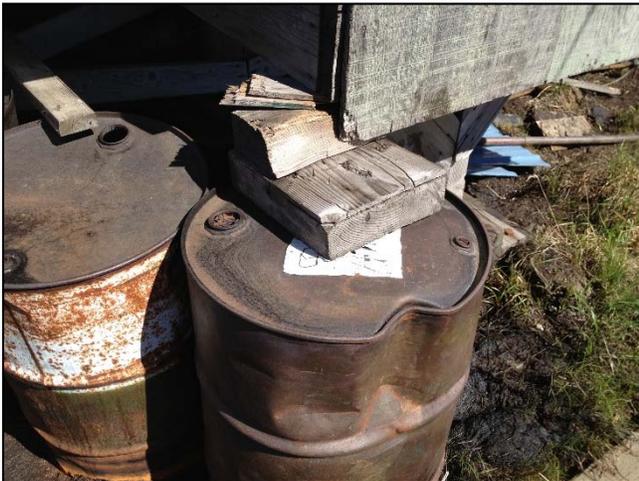
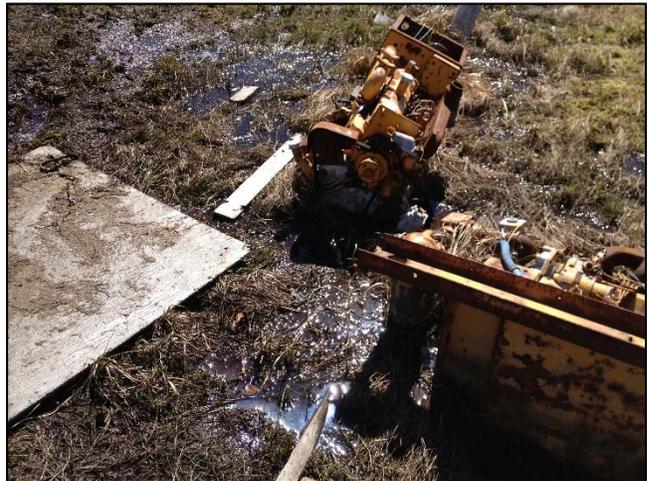
- **UTC Tanks, 60.941922/-164.634327 (Active)** – This site, owned by Ungusraq Tribal Council (UTC), includes five vertical tanks within secondary containment. The site is built up on a slight elevation and is within a black tarp that acts as the secondary containment. It is 105 feet from the Kealavik River.
