Alaska Department Environmental Conservation (ADEC) Solid Waste Program (Doug Huntman, Trisha Bower, and Jacob Timmons) conducted a Coastal Impact Assistance Program (CIAP), Waste Erosion Assessment and Review (WEAR) site visit for Nightmute on June 18th, 2013. The following narrative is a brief description of our findings during our June inspection.

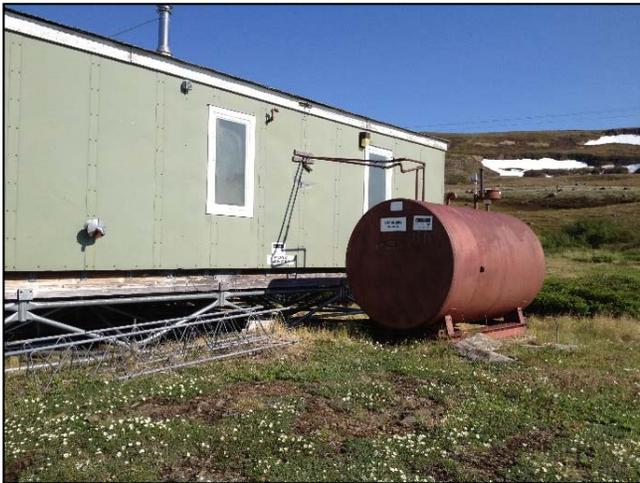
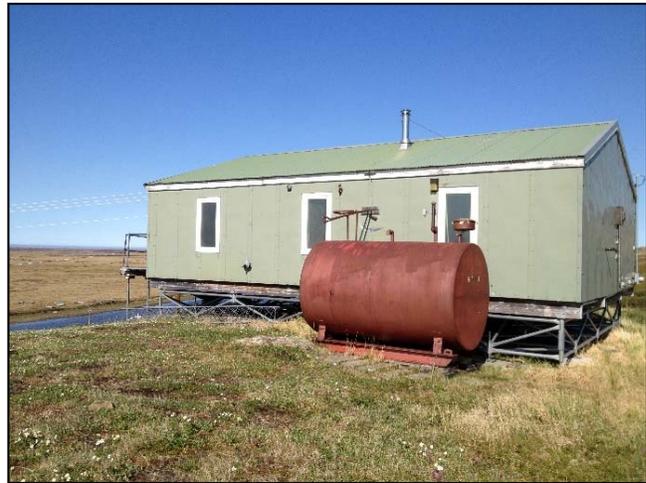
- **AKARNG Armory, 60.479585/-164.724916 (Closed)** – This Alaska Army National Guard Armory is listed in the DEC Contaminated Sites database (File ID 2435.38.001) with status “Cleanup Complete.” It was a contaminated site due to petroleum contamination from a leak in a heating oil system recorded as early as 1998. Remediation work was performed and it was declared clean in 2013. The armory is elevated on a hill 350 feet from the Toksook River, which was reported as eroding at 3 feet per year.

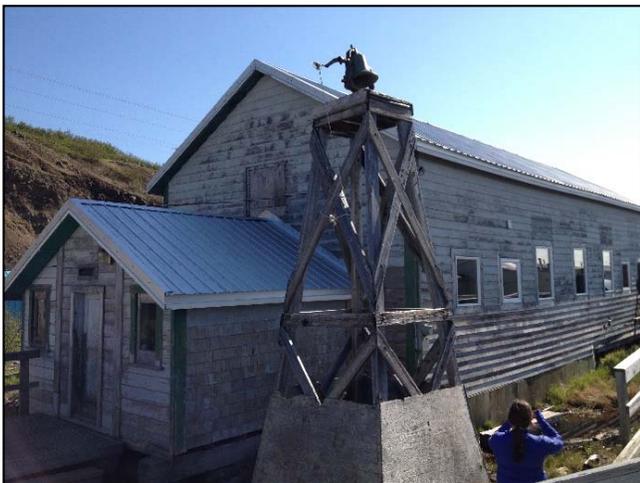
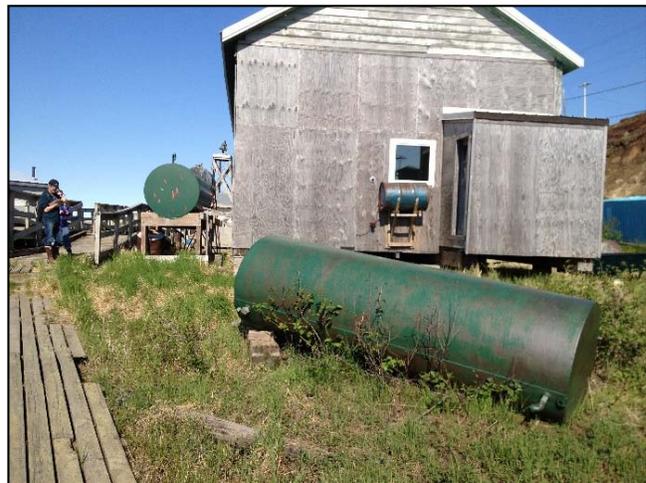
- **Catholic Church, 60.478577/-164.724286 (Closed)** – This site is a DEC Contaminated Site (File ID 2435.38.005) due to petroleum contamination. There are three day tanks and two barrels included in this site. Sheen was observed in a small pool near the boardwalk adjacent to the church. The site is listed with a status of “Cleanup Complete” in the Contaminated Sites’ database as the level of contamination does not currently pose a risk to human health or the environment. The site is 80 feet from the Toksook River, the nearest source of erosion.

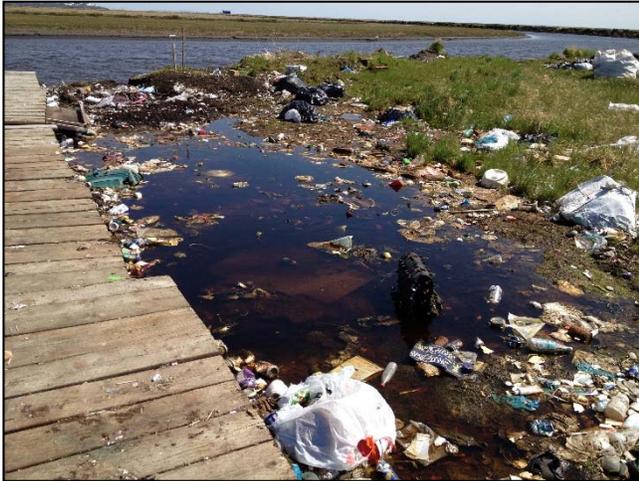
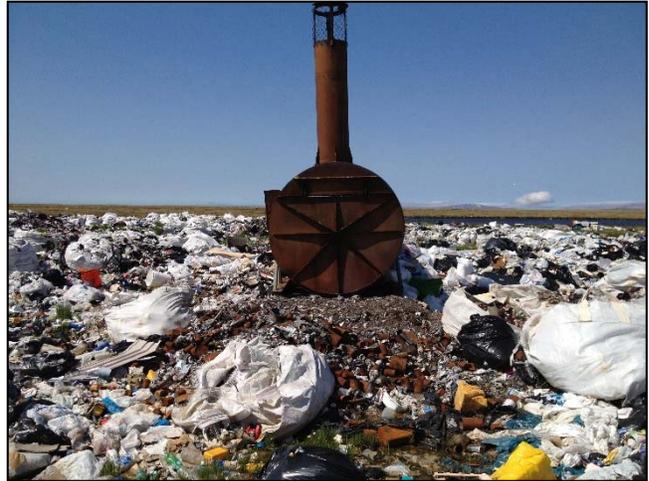
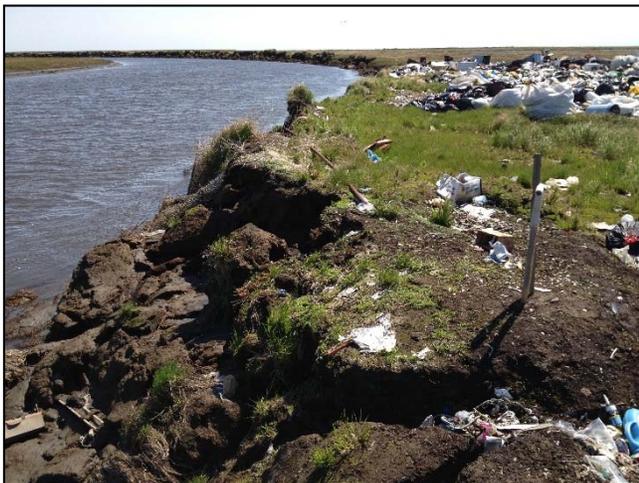
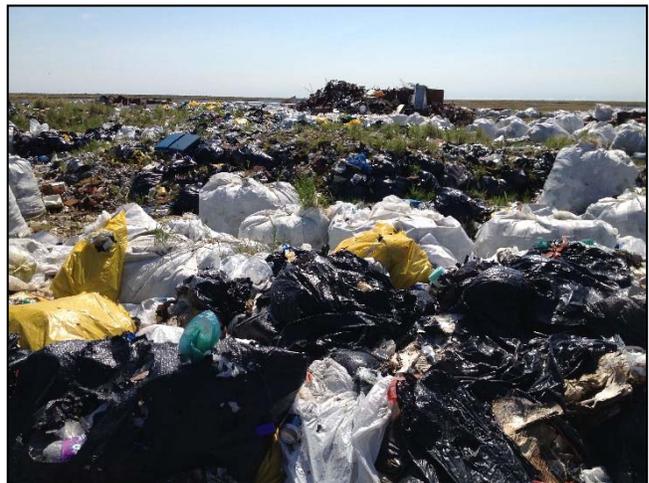
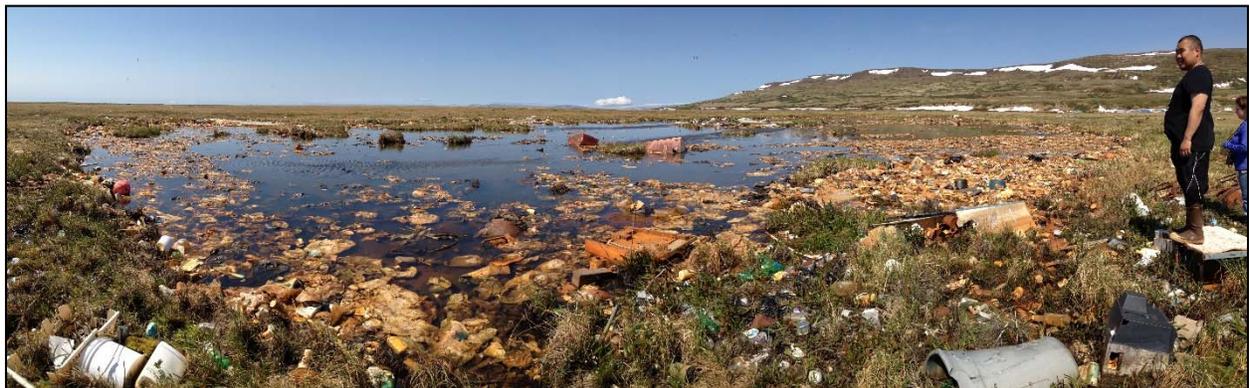
- **Landfill, 60.471436/-164.731179 (Active)** – Nightmute has a summer and a winter landfill. The summer landfill is the primary landfill. It is located approximately ½ mile down the Toksook River from the community on the other side of the riverbank. The site is only accessible by boat and is actively eroding into the river with over 3 feet of shoreline reported lost to erosion each year. The site is accessible by a short, wooden boardwalk from the riverbank to the landfill. Waste is spread throughout the 3 acre site with no clear working face. There is a Tok burn unit at the site that did not appear to be used by the community, which was purchased in 2006 through the Denali Commission. The winter landfill (bottom picture) is located ¼ mile north of the summer landfill. It is a tundra pond that waste is placed on top of in the winter, which then sinks into the pond during break-up. Neither site has a fence or a landfill operator. Residents self-haul waste to the sites; however, both sites are not accessible year-round due to freeze-up and break-up. Both sites are unpermitted and flood seasonally.

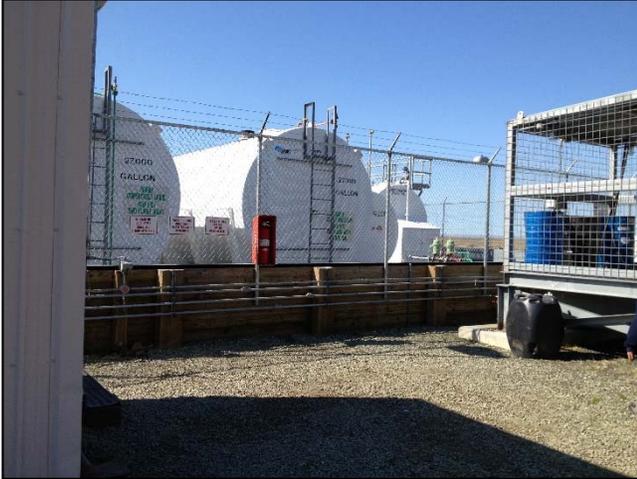
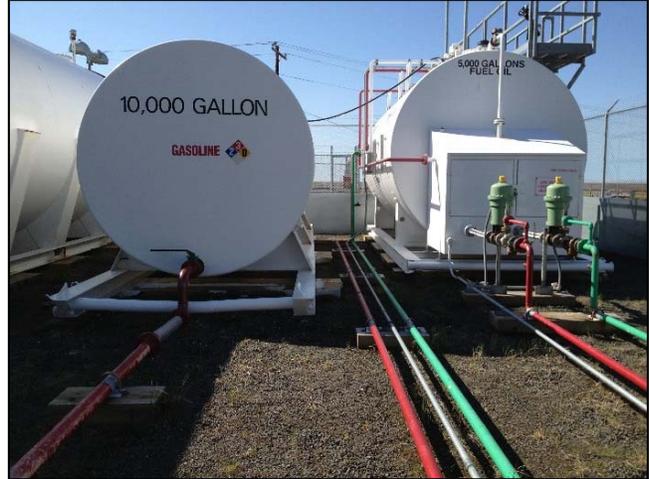
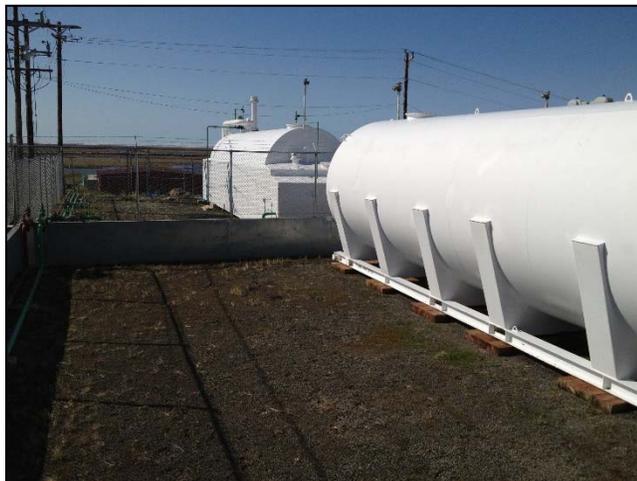
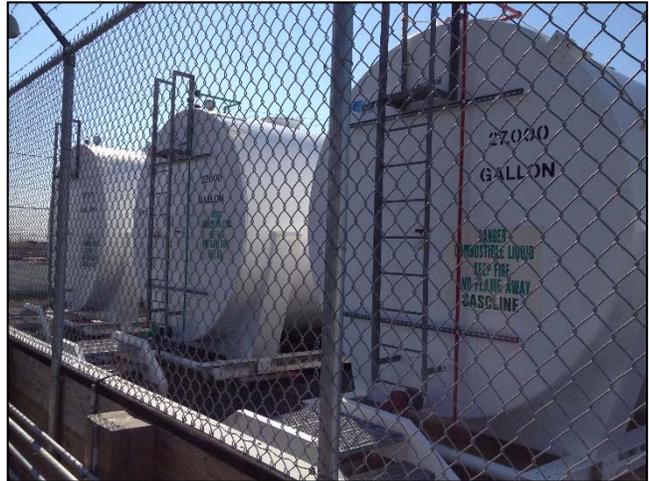
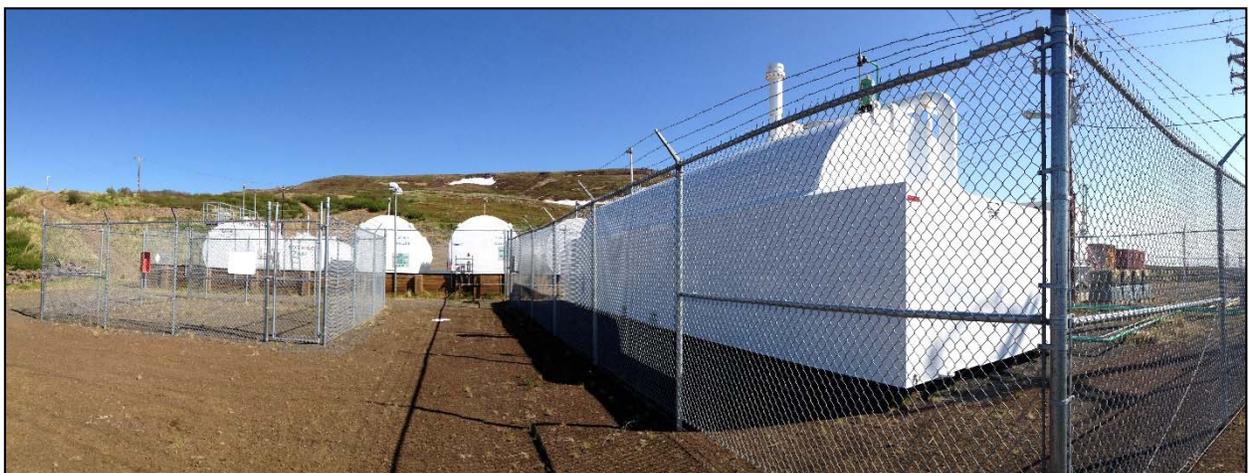
- **Community Tank Farm, 60.47893/-164.720837 (Active)** – This community tank farm was constructed in 2009 through a Denali Commission project. It contains a total of six fuel tanks with a total capacity of 128,000 gallons of gasoline and diesel. The City of Nightmute owns three 27,000 gallon tanks, one 10,000 gallon tank, and two 5,000 gallon tanks within a lined steel diked cell. The Lower Kuskokwim School District (LKSD) owns a self-diked 27,000 gallon diesel tank in a separate cell. The City tanks are also used for retail sales, which are operated by the Nightmute Tribal Council. It sits on a hill above the Toksook River 600 feet away.

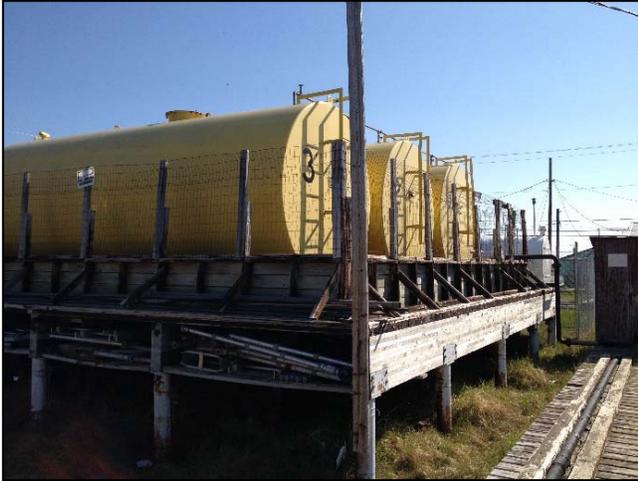
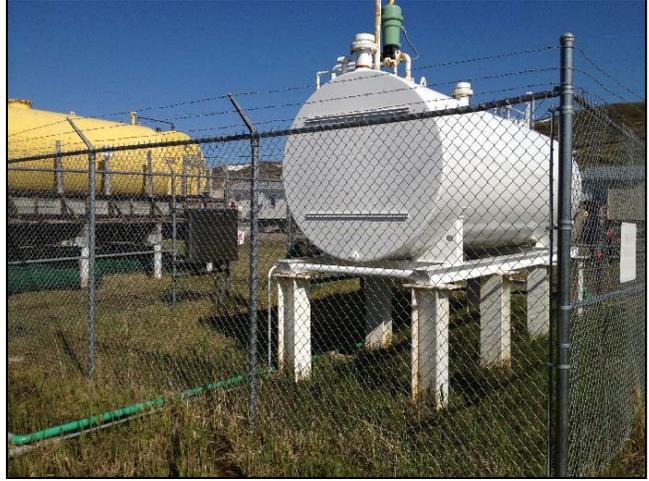
- **School Tanks, 60.477128/-164.721696 (Active)** – This site includes four older yellow tanks upon a raised, fenced wooden platform, and one white diesel tank that is in an adjacent fenced area. All tanks are owned and operated by the Lower Kuskokwim School District (LKSD). Sheen and some stressed or dead vegetation was observed in a muddy area around the four yellow tanks. These four tanks were emptied of their contents in 2009 and are no longer in use since the construction of a new LKSD tank located at the City Tank Farm. The 4,000 gallon, white, diesel tank was constructed in 2008 and is actively in use by the school. The site is 300 feet from the Toksook River.

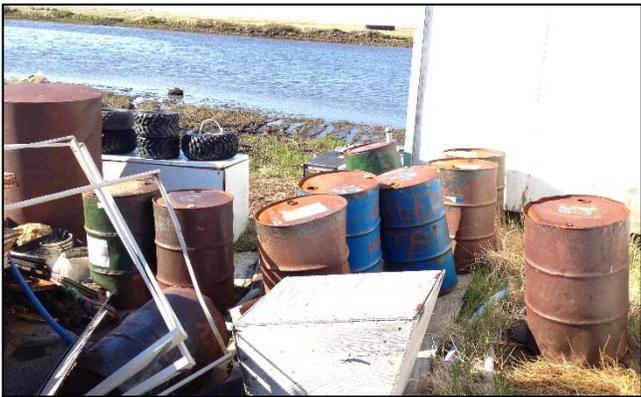
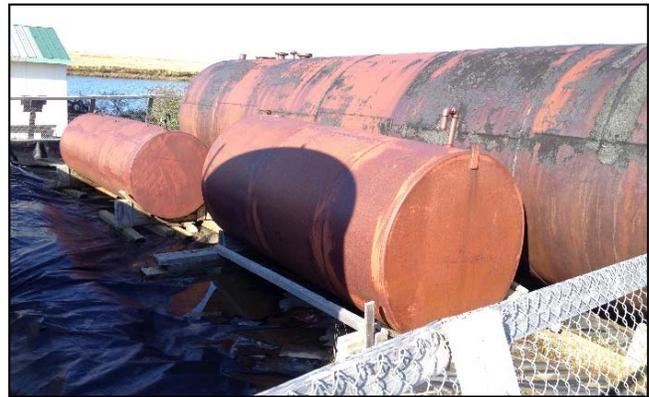
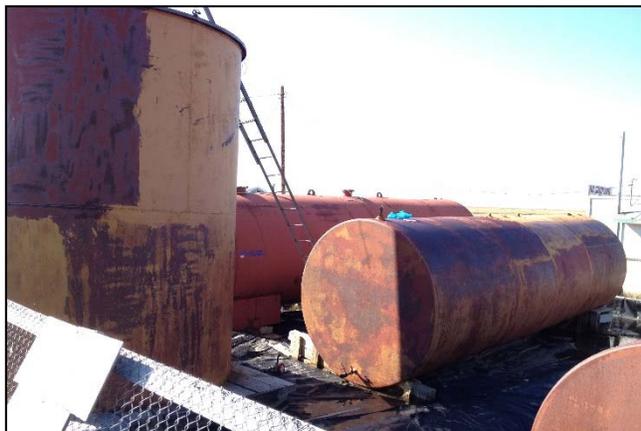
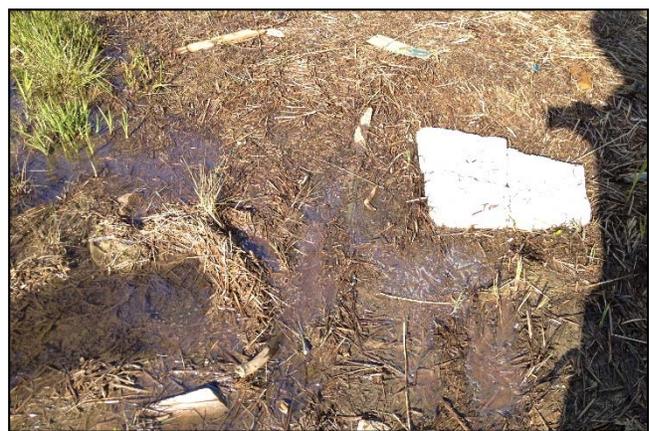
- **City Tank Farm, 60.480736/-164.734906 (Active)** – This site contains a total of seven fuel tanks: five red horizontal tank, one white horizontal 10,000 gallon tank, and one vertical tank. There are also around twelve barrels with unknown contents at the site. Most of the tanks are disconnected; however, some of them remained connected and could be in use. During the visit, concern was expressed of leakage toward the river. Sheen was observed at the site in a muddy area between the site and the Toksook River, which lies 50 feet away.

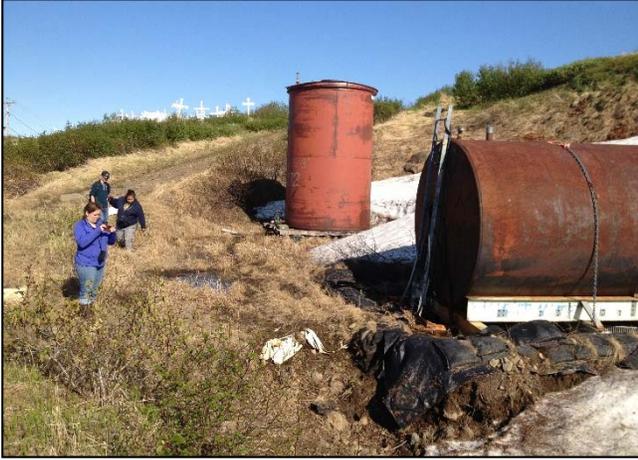
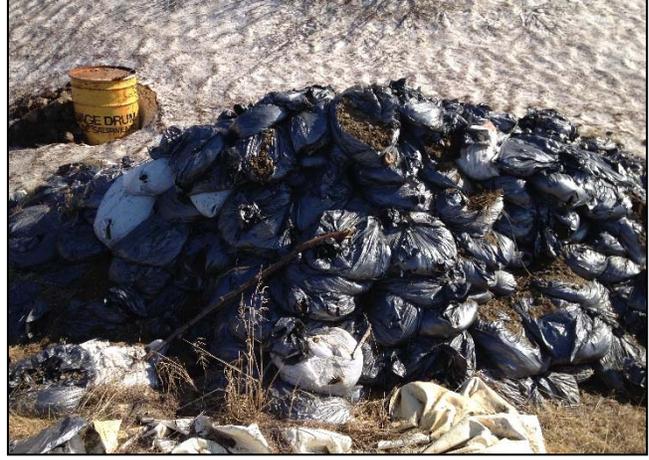
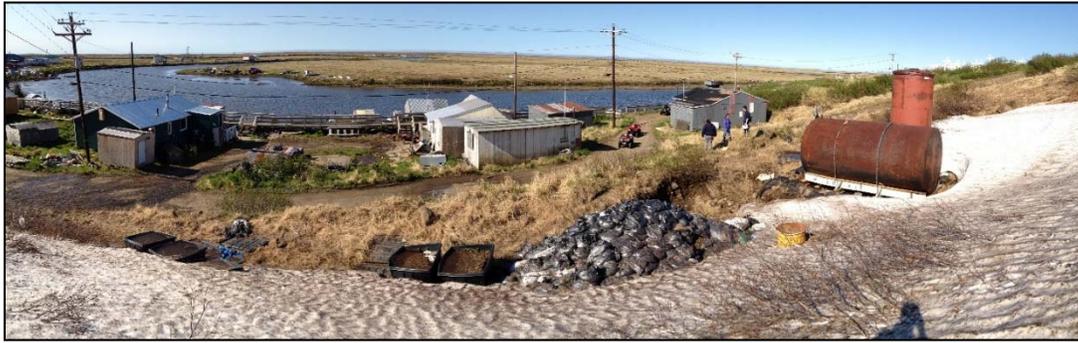
- **AVEC Tanks, 60.479066/-164.725941 (Abandoned)** – This site contains one vertical and one horizontal tank that were reported to belong to AVEC. Both tanks are disconnected and abandoned in place after the 2009 construction of the Community Tank Farm. There are also bags and plastic totes of contaminated soil. The bags were broken with soil spilling out, and the plastic totes were open to the elements with water pooling on top of the soil. The site is not fenced and is accessible to the public. It is located on a hillside 130 feet from the Toksook River.

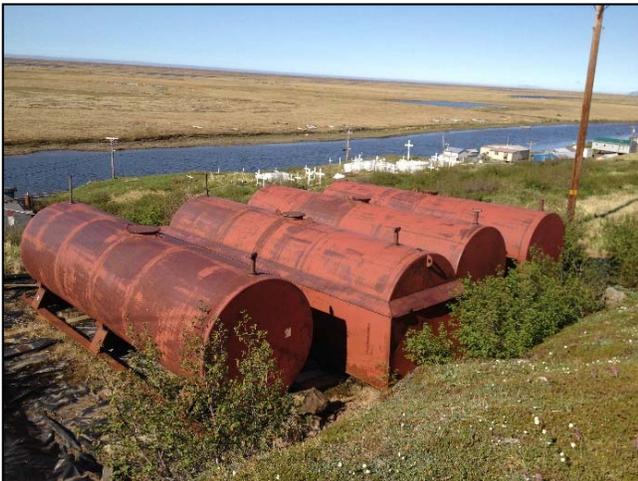
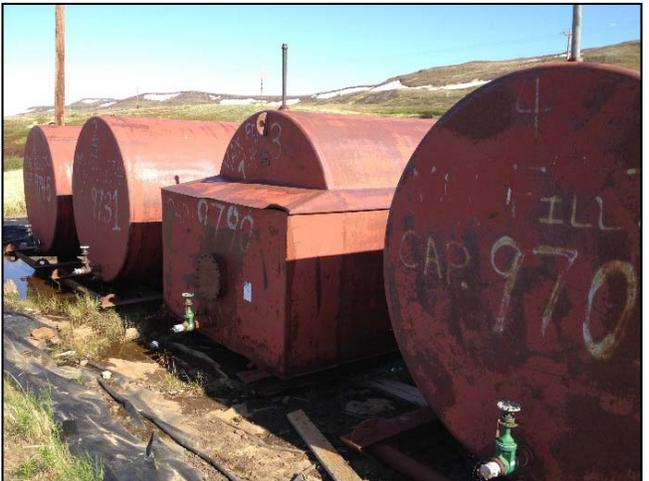
- **AVEC Tank Farm, 60.479501/-164.725439 (Abandoned)** – This site contains four 10,000 gallon diesel tanks owned by AVEC. The tanks sit on a black liner that could be compromised due to vegetation growing on top. A petroleum odor and dead and stressed vegetation was observed around the tanks. The tanks were emptied of their contents and abandoned in place after the Community Tank Farm was constructed in 2009. The site is located high on a hillside 250 feet from the Toksook River near the armory building.
