Alaska Department of Environmental Conservation (ADEC) Solid Waste Program (Trisha Bower and Rebecca Colvin) conducted a Coastal Impact Assistance Program (CIAP), Waste Erosion Assessment and Review (WEAR) site visit for Saint Michael on July 31st, 2014. Michelle Snowball, IGAP Coordinator, participated in the site visit. The following narrative is a brief description of our findings during the July inspection.

WEAR Sites

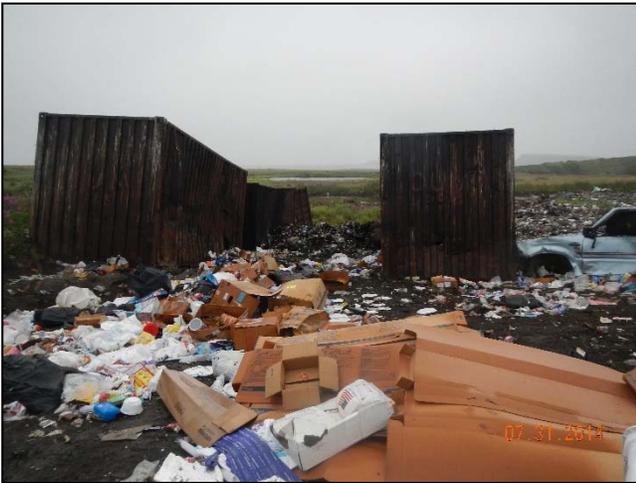
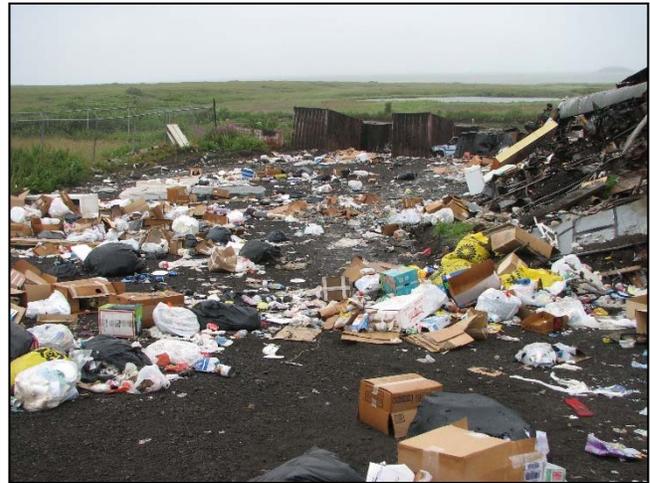
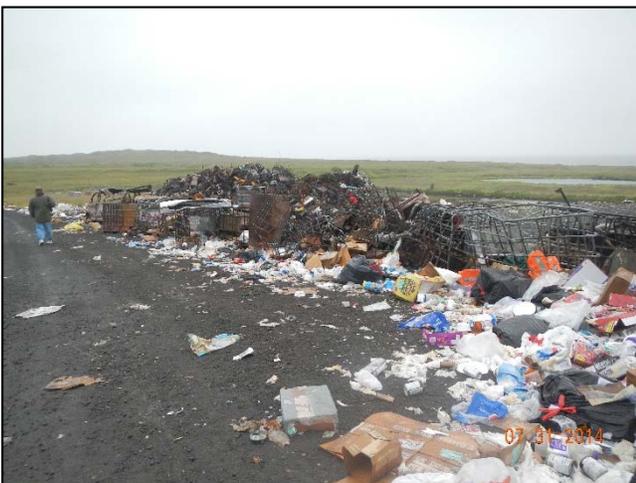
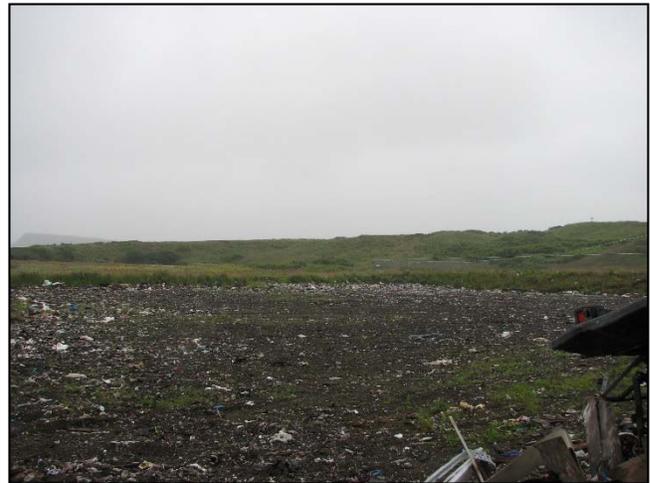
- **Landfill, 63.483465/-162.039482 (Active)** – This unpermitted landfill is operated by the City of Saint Michael and has been in operations since around the late 1980s. A large scale cleanup of the landfill was conducted before the site visit. Half of the landfill is closed with intermediate cover and is blocked off by a line of vehicles and metals to prevent future waste disposal in this closed area. However waste had been dumped along the line of vehicles. The active disposal area of the landfill is accessed by a break in the vehicles at the far end of the landfill. There are two connex containers encasing the active area, where burning on the ground is performed. Even with the recent cleanup, waste is already spreading out from the active area and is also along the roadside. The landfill is located less than ½ mile north of the community along a maintained gravel road and is 1,740 feet from an actively eroding area.

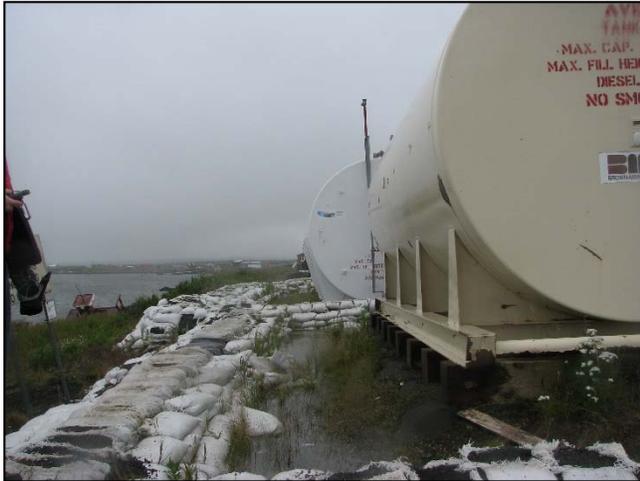
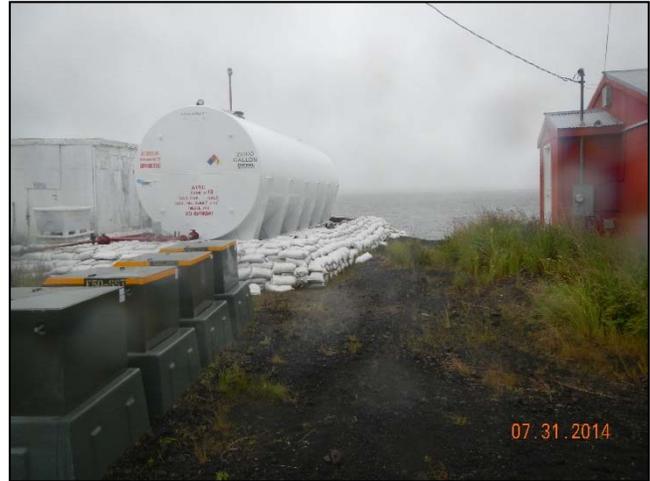
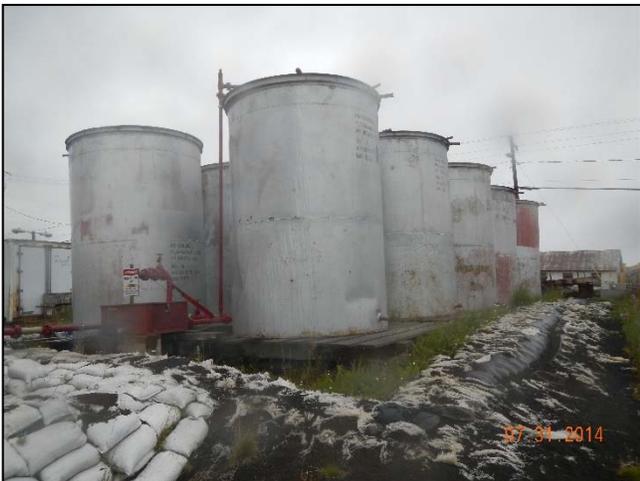
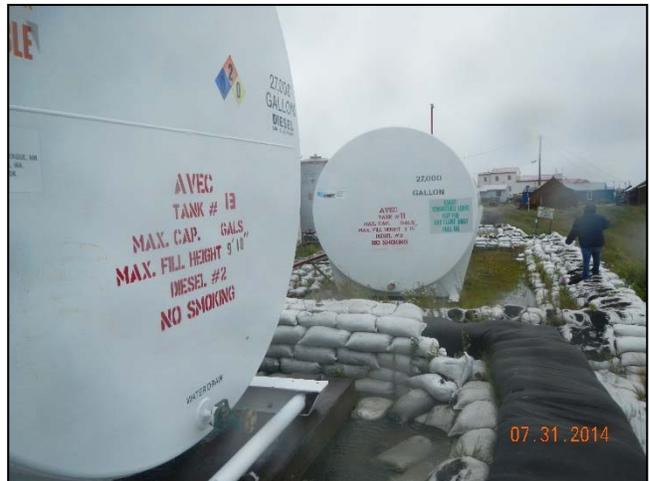
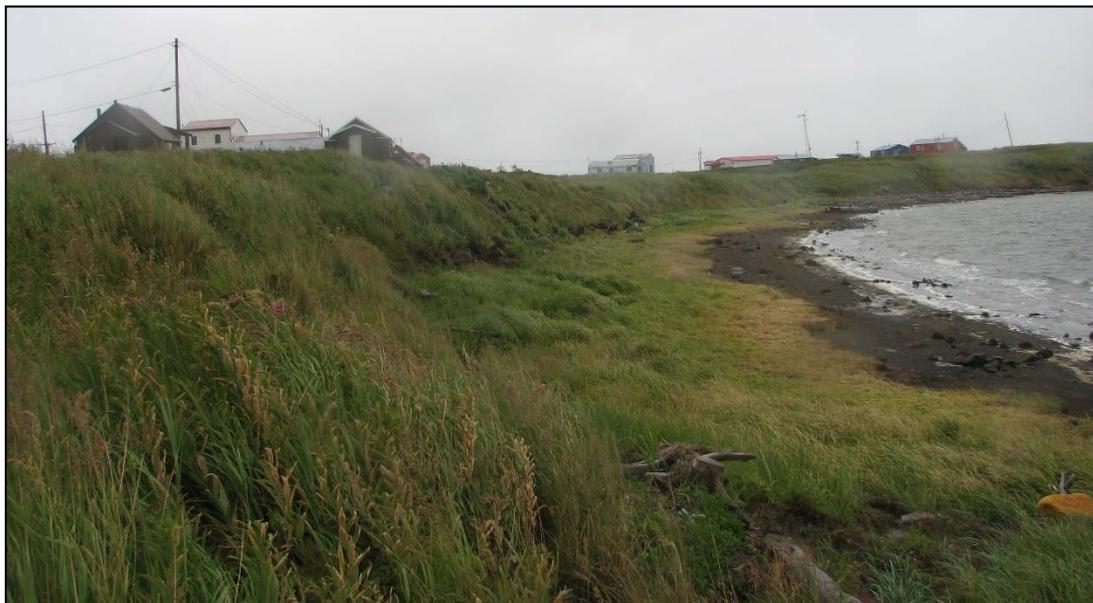
- **AVEC Tank Farm, 63.477841/-162.038179 (Active)** – This tank farm is owned and operated by AVEC to supply fuel for the adjacent power plant. It has been in place since the 1970s and consists of 6 vertical fuel tanks on wooden pallets in a lined area surrounded by sandbags. It also has 3 new horizontal fuel tanks each in three separate lined areas surrounded by sandbags. All 9 tanks are unfenced, open to public access and are connected to piping. They have an estimated combined capacity of 108,000 gallons. The closest tank is located 35 feet from the high tide line and 70 feet from the beach of Saint Michael Bay. The Army Corps of Engineers 2009 *Baseline Erosion Assessment* (BEA) reports erosion at 3 feet per year.

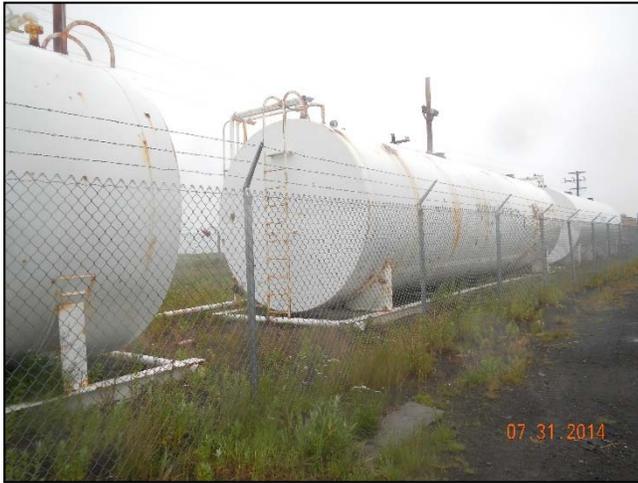
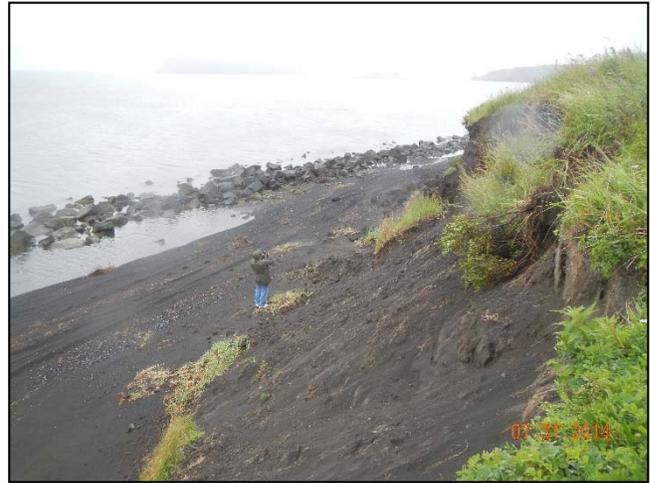
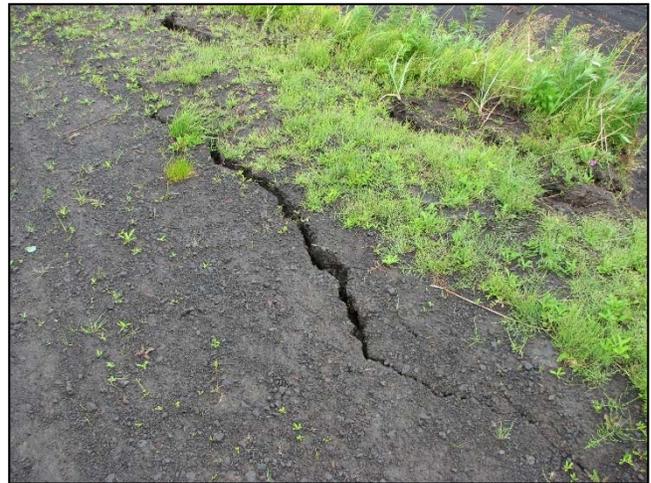
- **School Tank Farm, 63.483085/-162.029172 (Active)** – This tank farm is owned and operated by the Bering Strait School District (BSSD). It was constructed in 2008 and provides fuel to the school and the adjacent back-up power plant for the community. It consists of three 30,000 gallon double-walled fuel tanks in a fully fenced area and is located 160 feet north of the school on the old runway. It is 760 feet from Norton Sound which is eroding at 3 feet per year according to the BEA study.

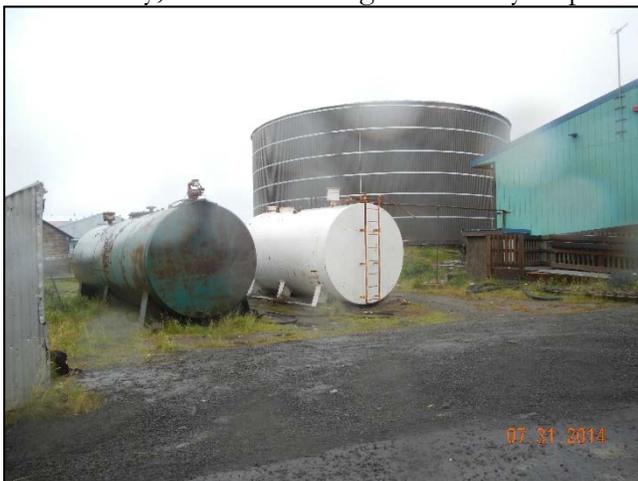
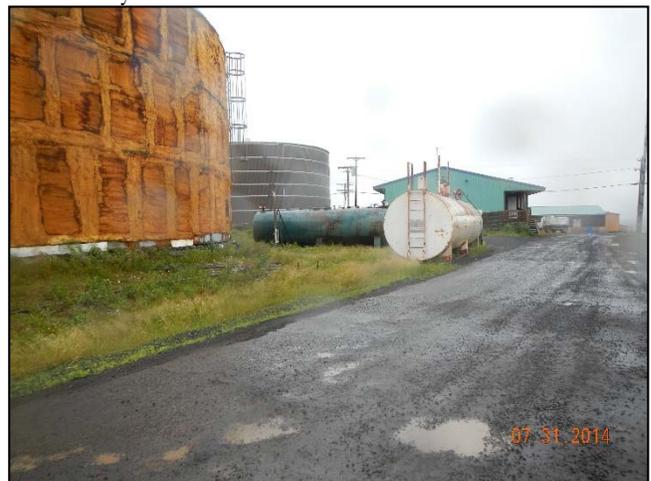
- **Retail Fuel Tanks, 63.478453/-162.039412 (Active)** – This site contains three horizontal fuel tanks that are owned and operated by the City of Saint Michael for retail fuel sales. There is no visible liner and no fence; however, the tanks appeared to be double-walled. They are centrally located in town between the two drinking water storage tanks. Tank capacity and contents are unknown. This site is located 320 feet from the high tide line of Saint Michael Bay, which is eroding at 3 feet a year per the BEA study.

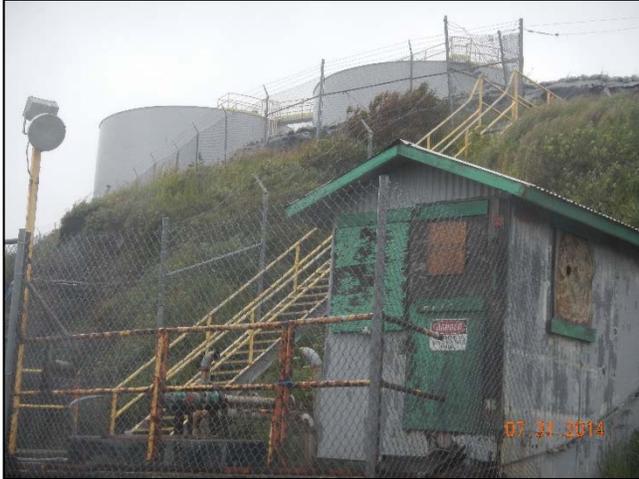
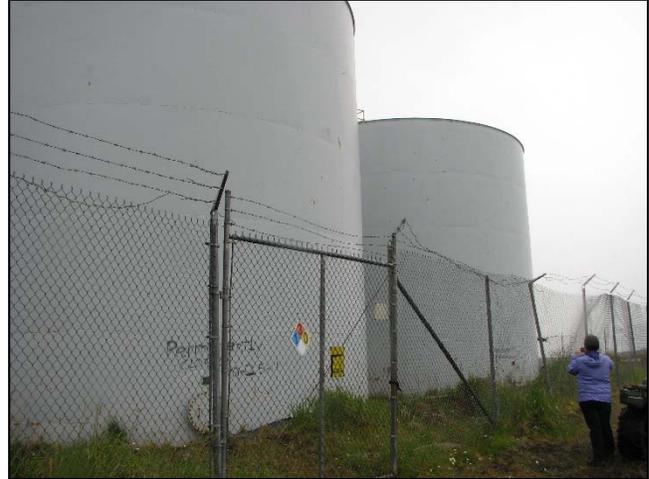
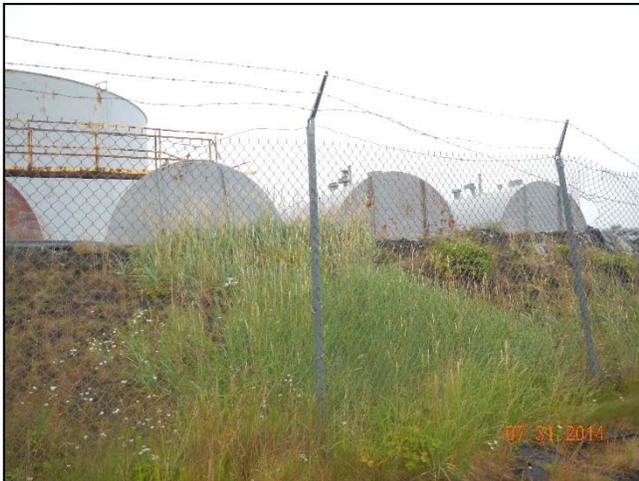
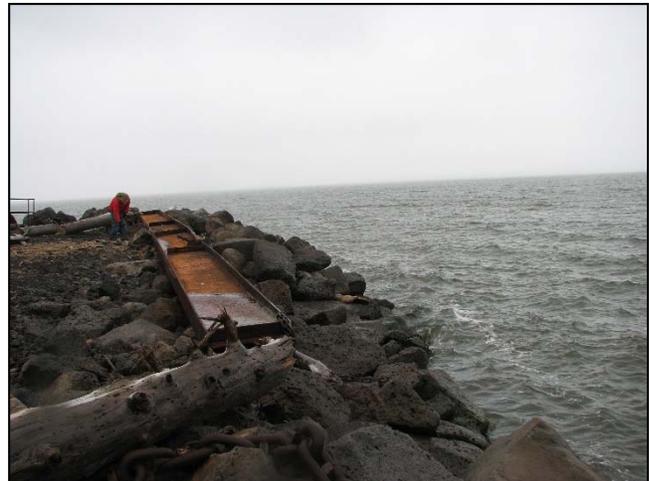
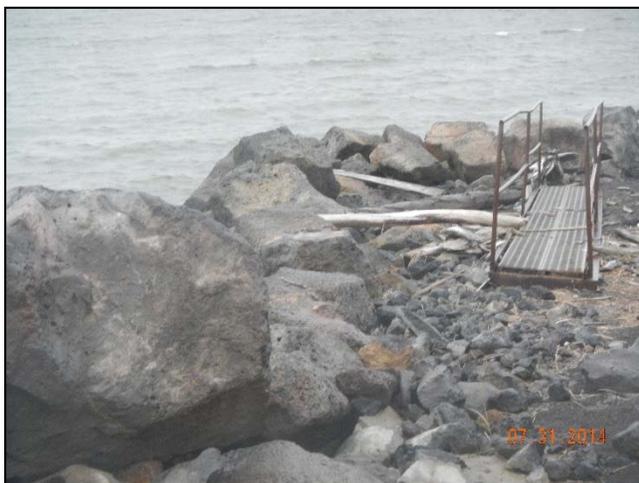
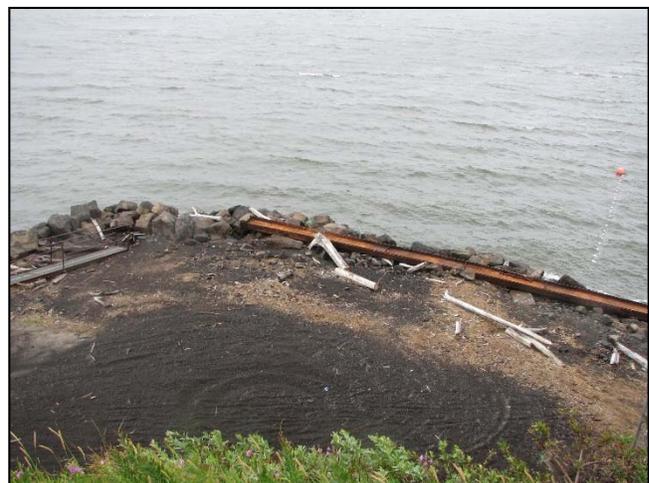
- **Crowley Tank Farm, 63.484225/-162.007373 (Abandoned)** – This tank farm is located one mile east of town at the end of a gravel road on a spit into Norton Sound. A tank farm has been in this location since the 1970s. It was last owned and operated by Crowley Marine Services until its closure in October 2011. It consists of 4 vertical fuel tanks and 5 horizontal fuel tanks. Although the facility is closed, the tanks and related structures remain within a locked and fenced area. The tanks are each labeled ‘Permanently Closed 10-25-11’. This site is located on bedrock and the base of the site has riprap of large boulders installed along the shoreline for erosion mitigation. It is 74 feet from the closest section of riprap.

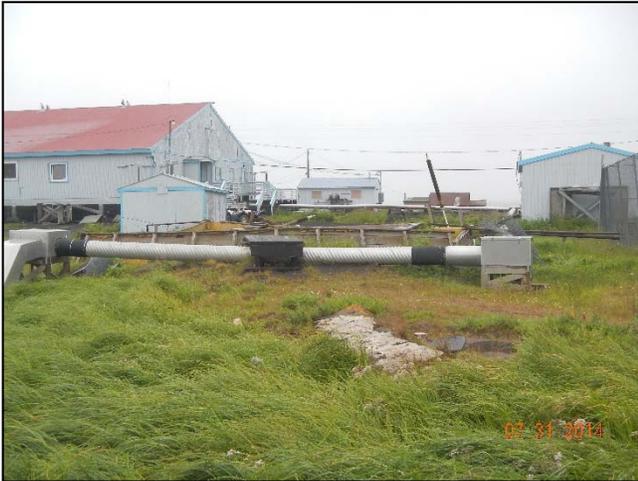
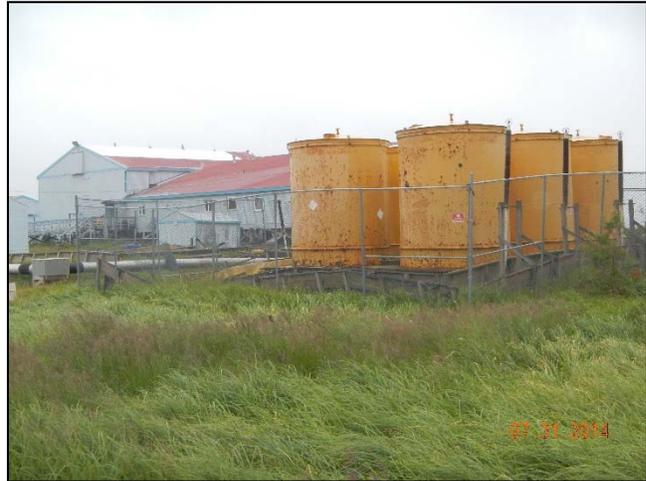
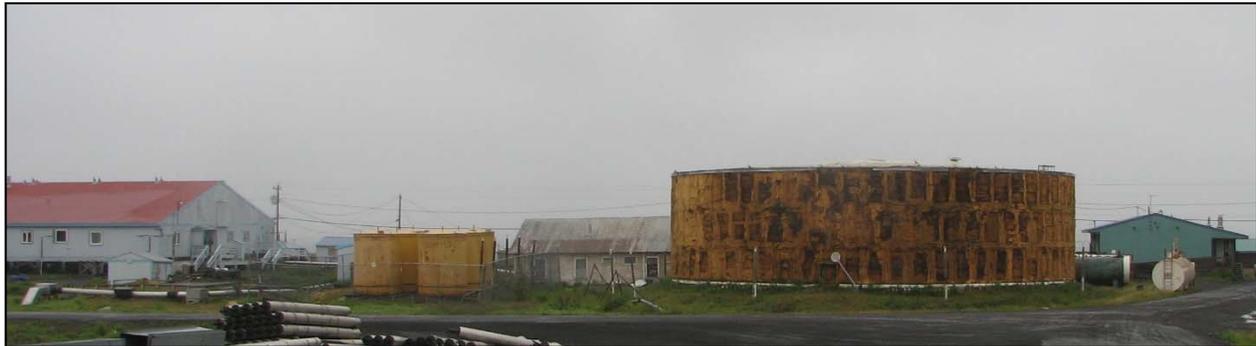
- **City Tank Farms, 63.478754/-162.038569 (Inactive)** – This site consisted of two adjacent tank farms which have been in place since at least the 1990s. The tanks were originally owned by the Bering Strait School District, but it was reported that they were given to the City of Saint Michael when the new school was constructed around 2008. The tank farm on the east side had 4 vertical fuel tanks on wooden pallets within a fenced area. These tanks had been removed and cut up for disposal at the time of the site visit; however the supporting structure was still in place. The west tank farm consists of 6 vertical, yellow fuel tanks on wooden pallets within a fenced area. This tank farm is planned to also be removed by the City. The remaining tank farm is approximately 380 feet from the high tide line of Saint Michael Bay, which is eroding at 3 feet per year according to the BEA study.

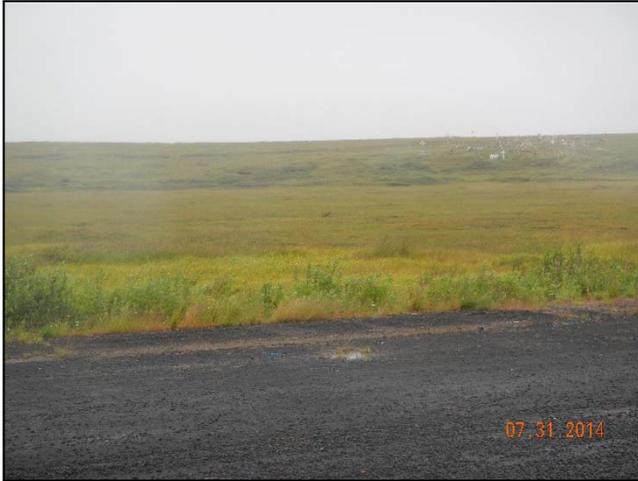
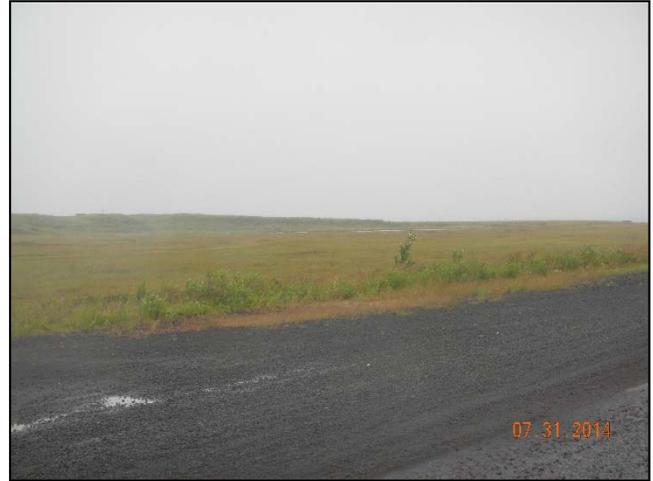
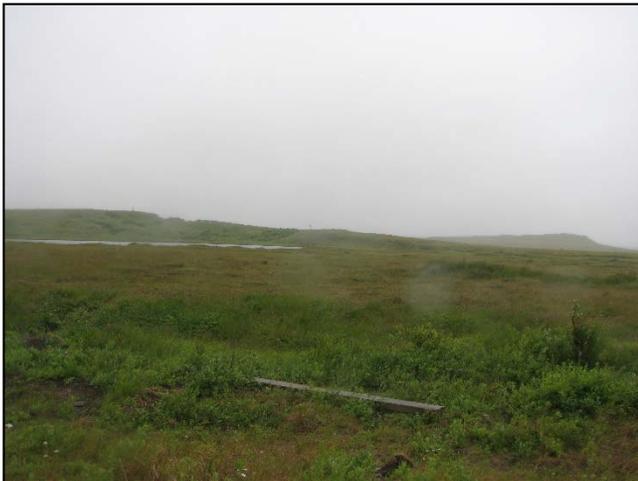
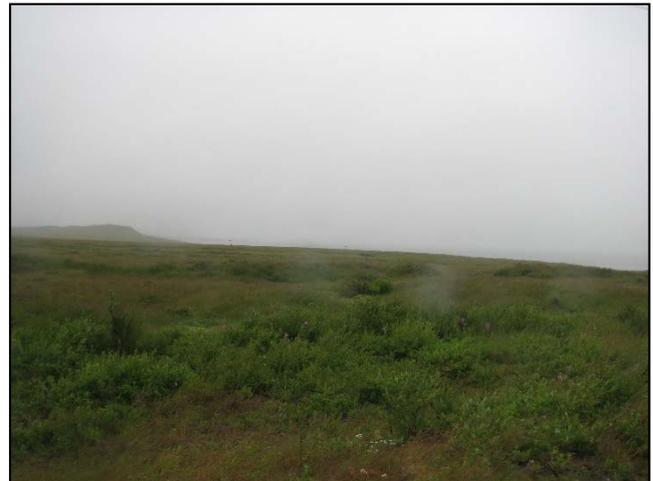
- **Former Airstrip, 63.483577/-162.030929 (Active)** – This site is an active site under the Contaminated Sites Program (File ID 640.38.002) due to historic contamination that could date back to Fort Saint Michael being in operation from 1897-1923. The site consisted of several contaminated areas along the airstrip including: tar pits, a barrel and batteries dump, a closed landfill, and a drum disposal area. There have been several cleanups of these sites throughout recent years and exposed drums, barrels and batteries have been removed. At the time of the site visit, we could not find visible evidence of barrels, waste, or drums. Future cleanup work is planned for this site under the Contaminated Sites Program. At the closest point, this site is less than 250 feet from the north end of the airstrip, which is eroding at 3 feet a year per the BEA study.
