November 20, 2012

**RE: STOCKPILE SAMPLING AND MANAGEMENT, KOBUK ABANDONED TANK FARM, KOBUK, ALASKA; ADEC HAZARD ID 4615**

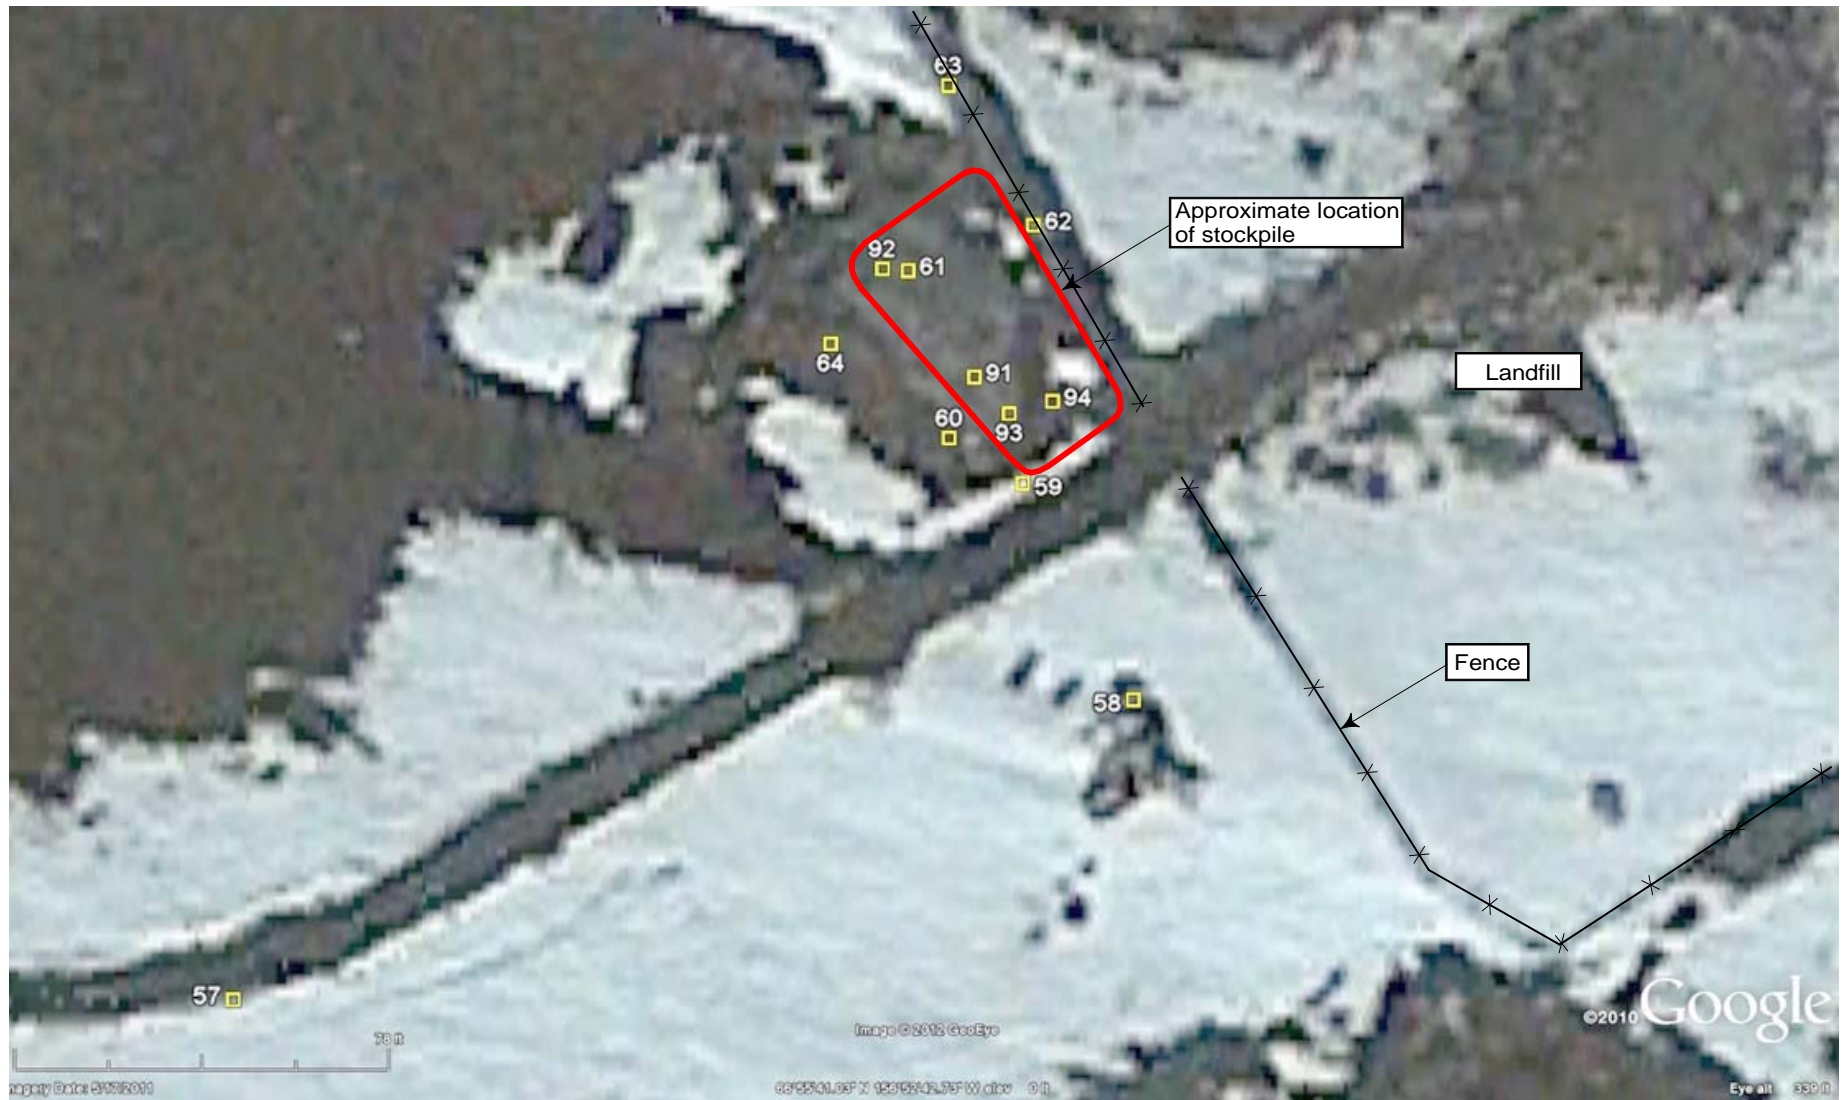
Kobuk Abandoned Tank Farm Kobuk, Alaska	
<b>SITE PLAN STOCKPILE SITE</b>	
November 2012	32-1-17480-002
<b>SW</b> SHANNON & WILSON, INC. Geotechnical & Environmental Consultants	<b>Fig. 2</b>

A Shannon & Wilson field representative traveled to Kobuk on August 15, 2012 to conduct stockpile sampling and visual site assessment of the Backup Generator Site. A site plan showing the stockpile and global positioning system (GPS) waypoint locations of site photographs and analytical sample locations is provided as Figure 2.

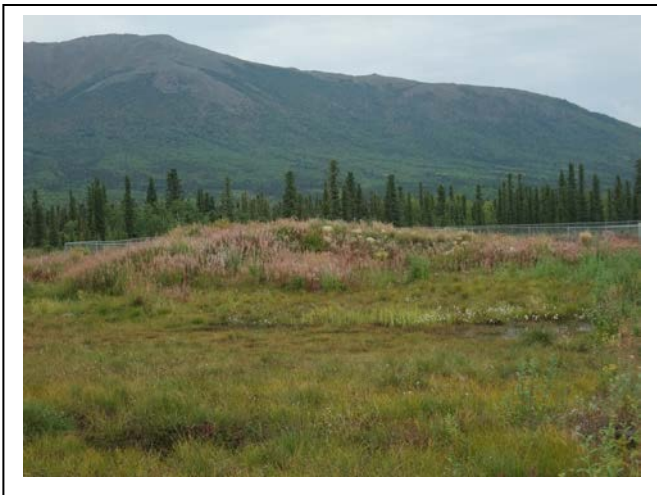
At the time of the site visit, the stockpile had vegetation growing on it (Photo 1) and the top liner of the stockpile was weathered and deteriorating (Photo 2). The stockpile was approximately 6 feet high above ground surface at the northwest end, and sloped to approximately 2 feet high above ground surface at the southeast end. Our field representative estimated the volume of the stockpile as 200 cubic yards (cy). The field representative collected soil samples using a shovel.

Photo 1: Looking northeast, vegetation was growing out of the stockpiled soil. (Waypoint 57, 8/15/2012)

the soil to be used as landfill cover material in a lined landfill, which presumably prevents potential impact from soil to groundwater. If this material is determined to not be suitable for reuse in the landfill, we recommend applying soil amendments (fertilizers) and/or tilling the soil to reduce the DRO concentrations.

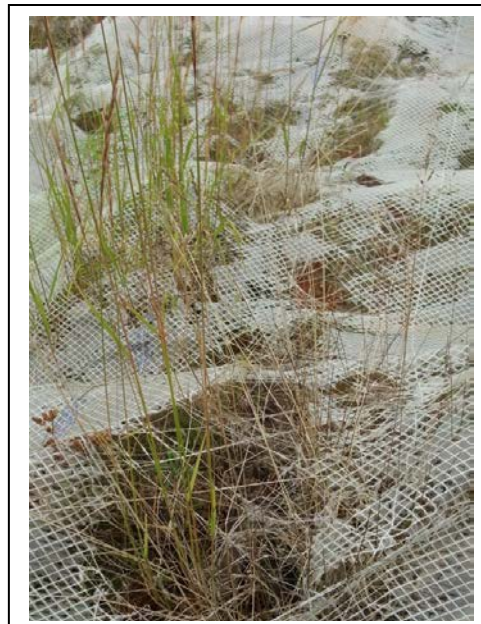
Photo 2: The top cover of the stockpile appeared weathered and was deteriorating. (Waypoint 59, 8/15/2012)

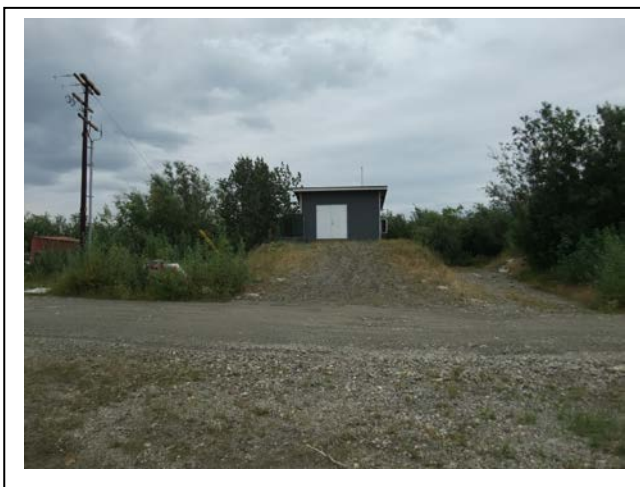
Shannon & Wilson's field representative visited the Backup Generator Site on August 15, 2012 to observe and document the current site conditions. Photographs of the site observations are included in Attachment 1. A site plan showing the backup generator building and GPS waypoint locations of the site photographs is provided as Figure 4. The backup generator building is located on a hill (Photo 3) and several other utilities are present in the surrounding area,

Photo 3: Looking east across the access road at the Backup Generator Building. (Waypoint 65, 8/15/2012)

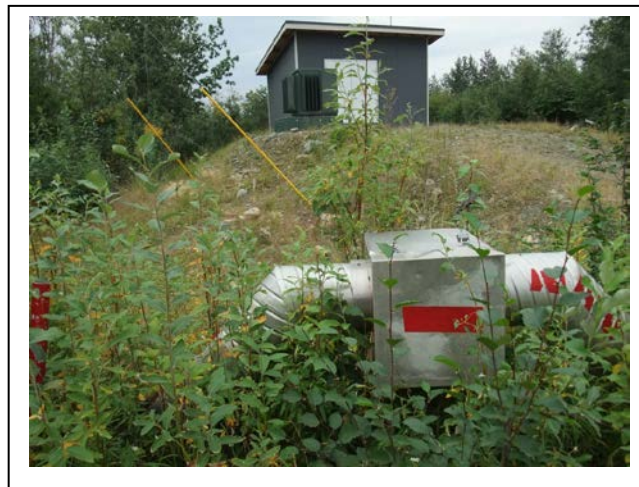
including a sewer line (Photo 4) and transformer marked as less than 50 ppm polychlorinated biphenyls (Photo 5). Caution tape labeled with “Danger Asbestos” was observed around the generator building (Photo 6). Access roads are present to the south and west of the generator building (Photo 7). Miscellaneous debris was observed to the south and north of the generator building (Photos 8 and 9). The largest pile of debris was located to the north and appeared to contain sections of sewer line, metal pipes, plastic liner, tubing, cables, and wire (Photo 10).

Photo 4: Looking east, the sewer line was observed to the west of the Backup Generator Building. (Waypoint 67, 8/15/2012)

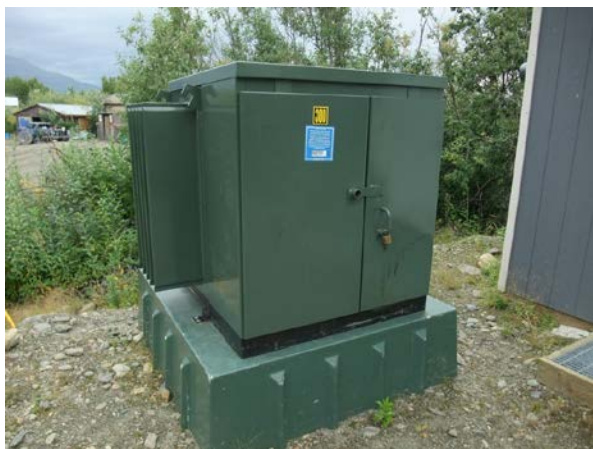
Photo 5: Looking north, a transformer was observed adjacent to the Backup Generator Building. (Waypoint 68, 8/15/2012)

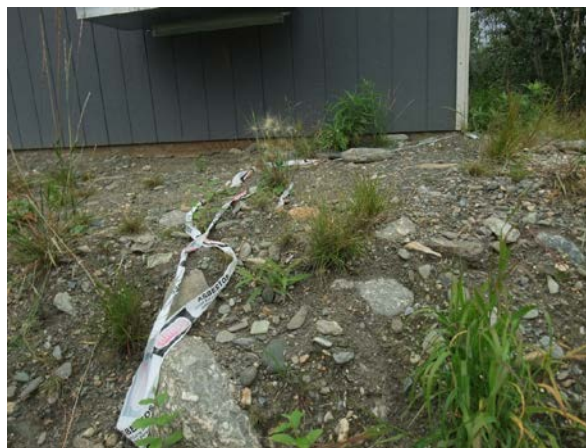
Photo 6: Looking north, caution tape indicating asbestos dangers was observed on the ground adjacent to the Backup Generator Building. (Waypoint 75, 8/15/2012)

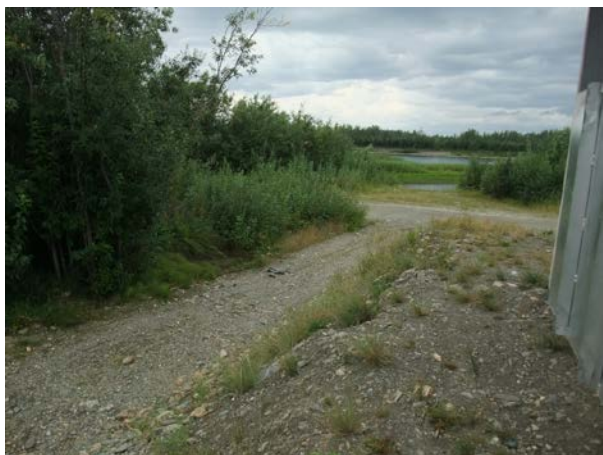
Photo 7: Looking west at the access roads in the vicinity of the Backup Generator Building. (Waypoint 69, 8/15/2012)

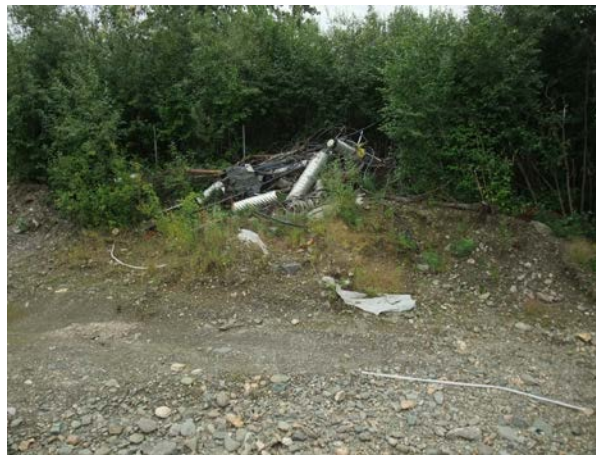
Photo 8: Looking south, debris was observed to the south of the Backup Generator Building. (Waypoint 69, 8/15/2012)

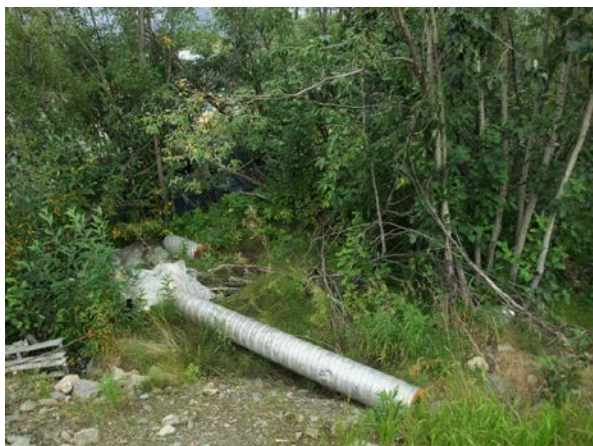
Photo 9: Looking north, debris was observed to the north of the Backup Generator Site. (Waypoint 70, 8/15/2012)

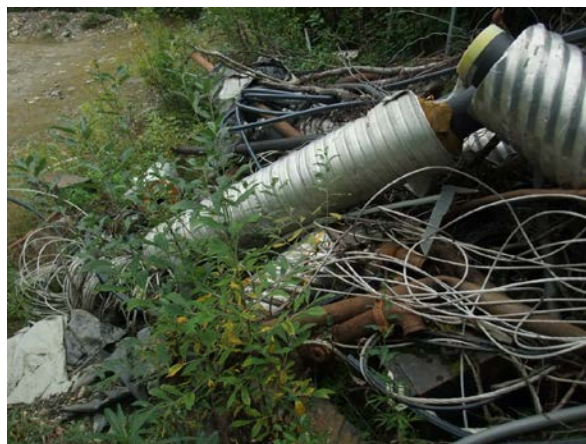
Photo 10: Looking east, the largest pile of debris contained sewer line, piping, cables, wire, and plastic liner. (Waypoint 76, 8/15/2012)

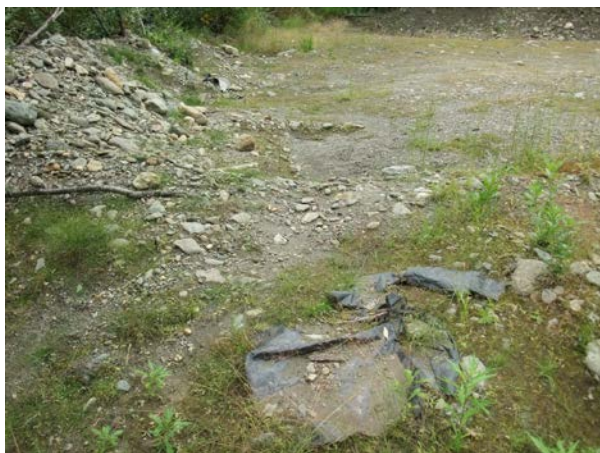
The ground surface around the Backup Generator Site was also observed. Gravelly fill material appeared to have been placed around the site to facilitate roads. Black liner material was observed in several places in the fill material (Photos 11 and 12). In addition, piles of granular soil were observed along the access roads (Photo 13).

Photo 11: Looking south, liner material was observed in road areas around the Backup Generator Site. (Waypoint 72, 8/15/2012)

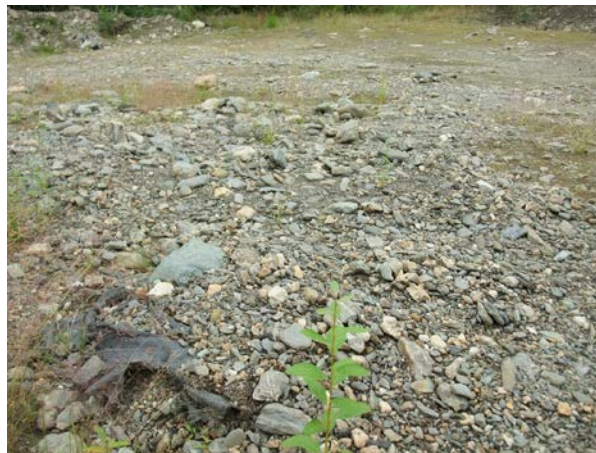
Photo 12: Looking southeast, liner was observed along the edge of the gravel fill material. (Waypoint 82, 8/15/2012)

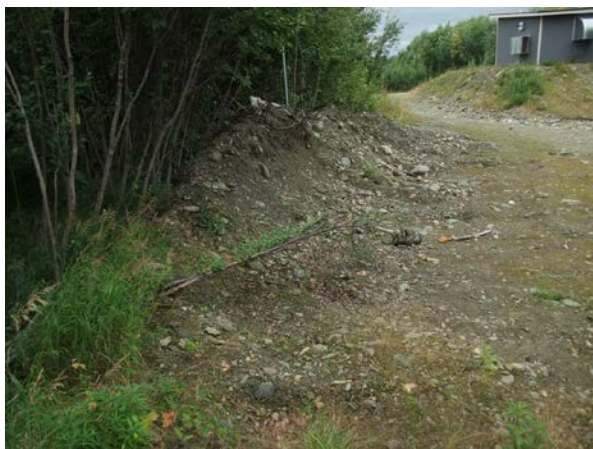
Photo 13: Looking west, berms of fill material were observed along the access road. (Waypoint 73, 8/15/2012)

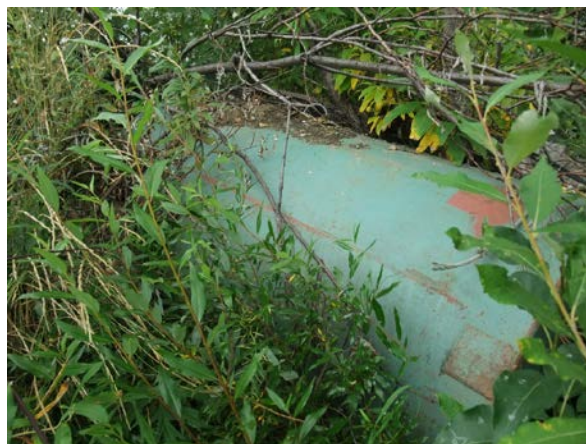
The areas surrounding the Backup Generator Site were also observed. An apparently abandoned tank measuring approximately 6 feet long and 3.5 feet in diameter was observed to the northwest of the site (Photo 14). Beyond the tank, an abandoned truck was observed (Photo 15). A second tank marked as a 500-gallon tank was observed in the woods to the north of the site (Photo 16).

Photo 14: Looking east, a tank measuring 6 feet long and approximately 3.5 feet in diameter was observed in the woods adjacent to the Backup Generator Site. (Waypoint 79, 8/15/2012)

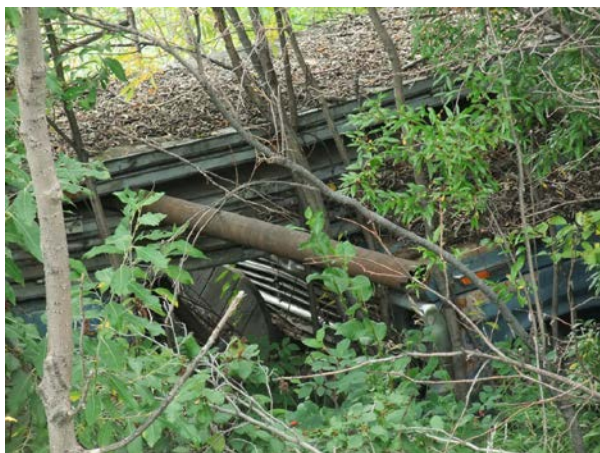
Photo 15: Looking northeast, an abandoned truck was observed in the woods to the northeast of the Backup Generator Site. (Waypoint 80, 8/15/2012)

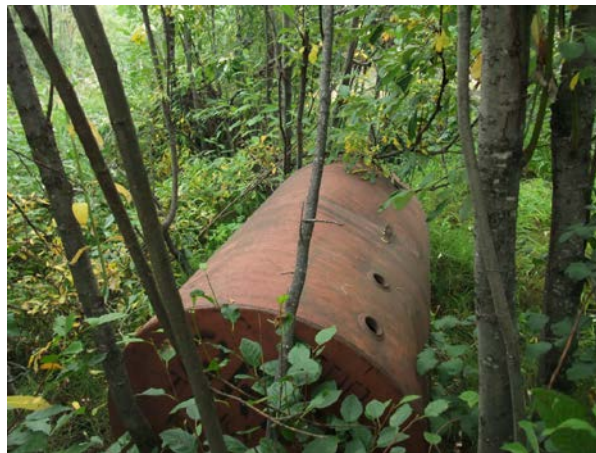
Photo 16: Looking south, a tank marked as 500-gallon was observed in the woods to the north of the Backup Generator Site. (Waypoint 90, 8/15/2012)
